Expertise

Protocol number: 46812951  
Order No. / Reference: 26732960  
Inspection date: 30 Jul 2026

Manufacturer: Mercedes-Benz

Model: GLE-Coupe 350 de 4Matic 9G-TRONIC Exclusive

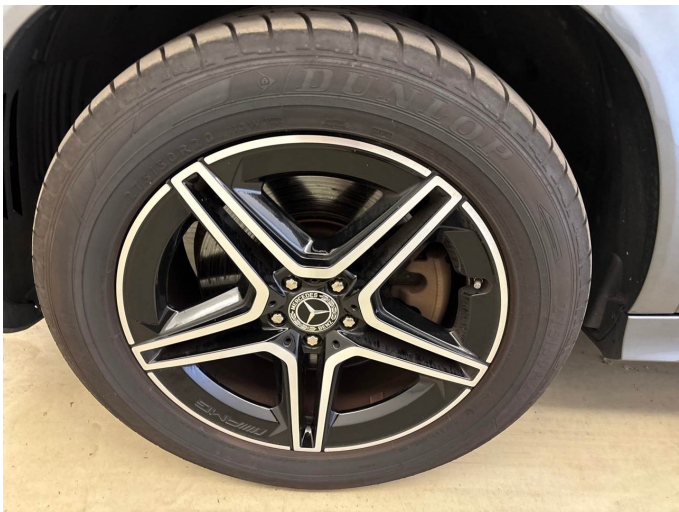
Figure 12: Mounted tyres

| # | Tyre size | Type of tyre | Manufacturer | Tread depth |
|---|---|---|---|---|
| 1) | 275/50 R20 113W | Summer tyres on Light alloy | Dunlop | 6mm / 6mm |
| 2) | 275/50 R20 113W | Summer tyres on Light alloy | Dunlop | 6mm / 6mm |

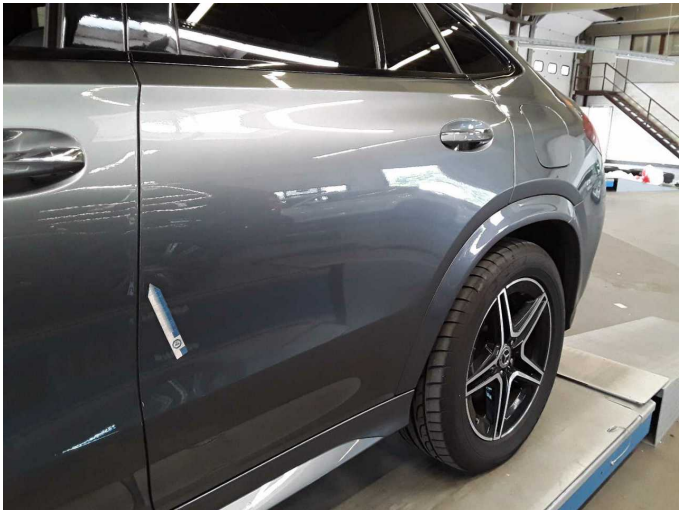
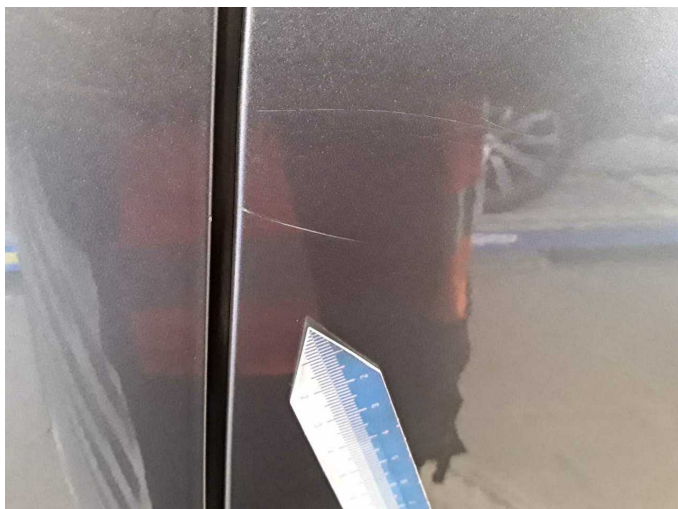
Damage 1: Door - rear left side: Door - Scratch(es) - Cover / polish

**Damage 1:** Door - rear left side: Door - Scratch(es) - Cover / polish

| No. | Component group | Description |
|---|---|---|
| 1 | Door - rear left side | Door - Scratch(es) - Cover / polish |

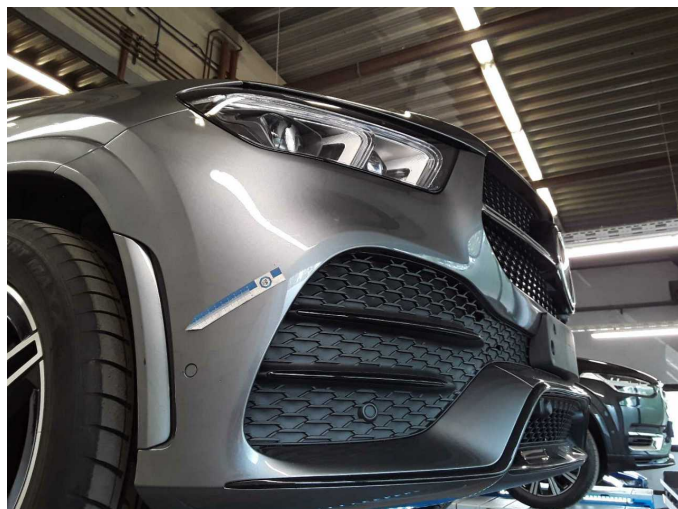
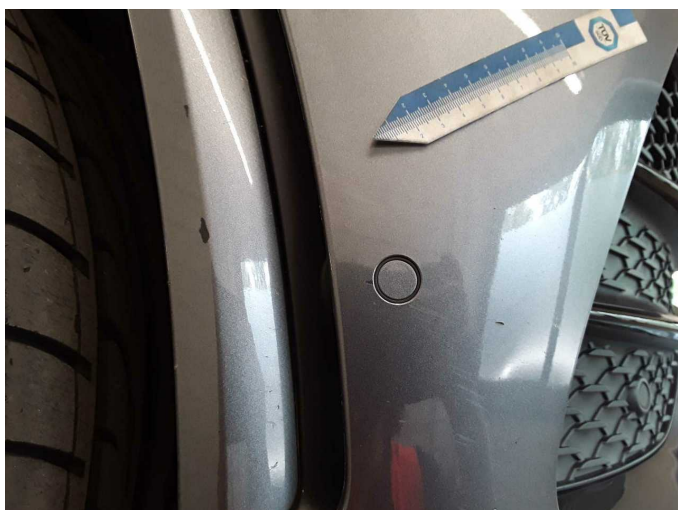
**Damage 2:** Front bumper: Front bumper - Scratched - Smart repair

| No. | Component group | Description |
|---|---|---|
| 2 | Front bumper | Front bumper - Scratched - Smart repair |

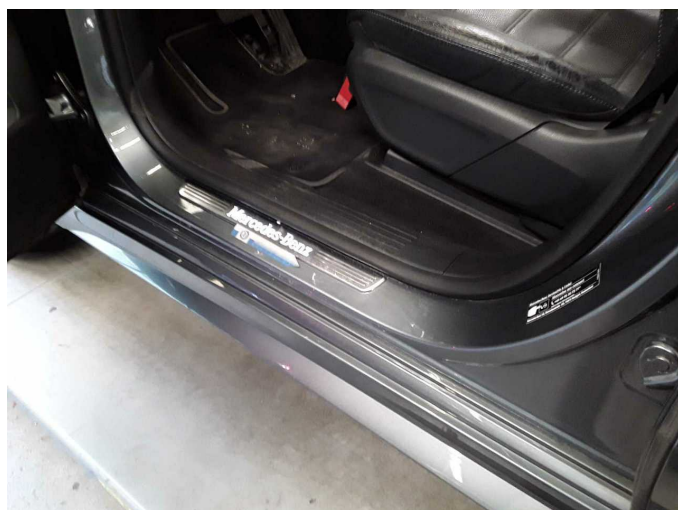
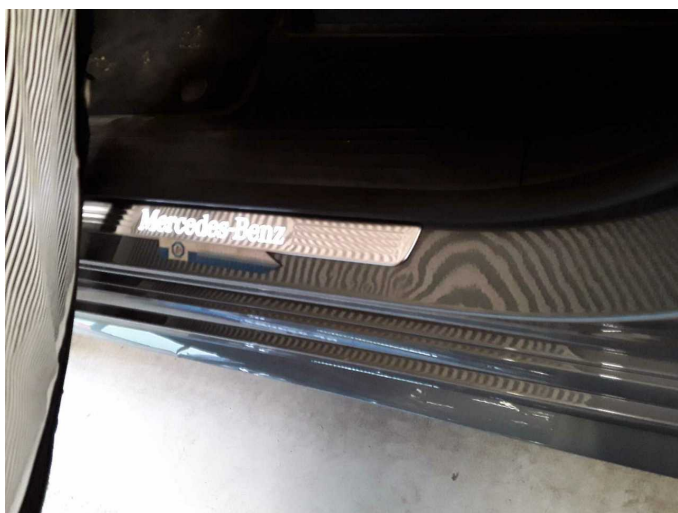
**Damage 3:** Sill - left side: Sill - dent(s) - Smooth repair work

| No. | Component group | Description |
|---|---|---|
| 3 | Sill - left side | Sill - dent(s) - Smooth repair work |

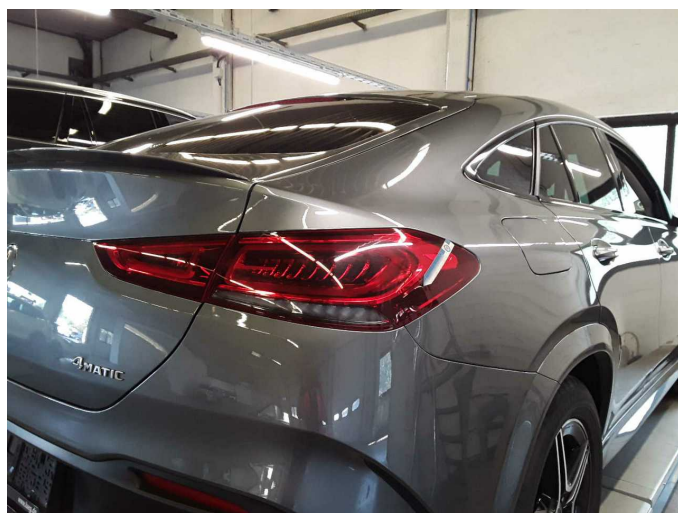
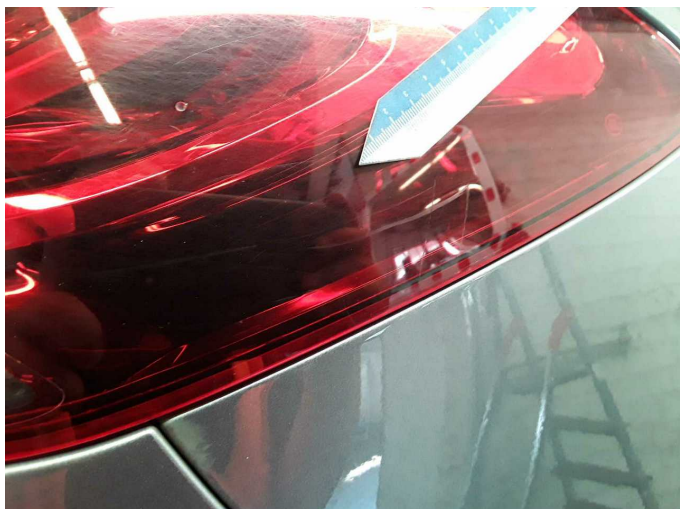
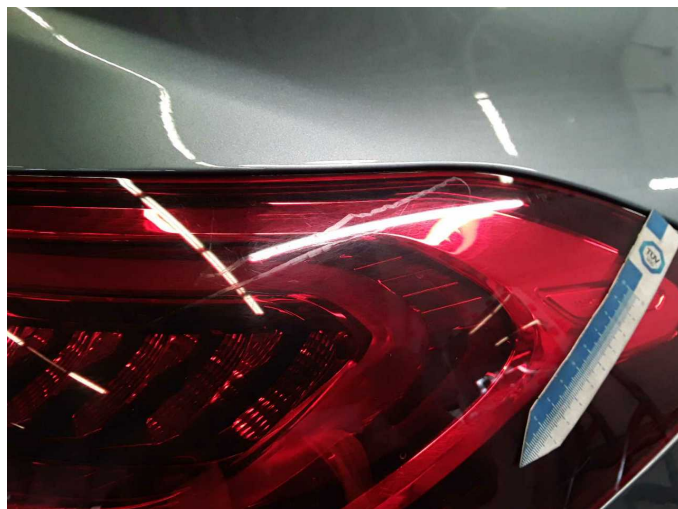
**Damage 4:** Tail light: Tail lamp - right side - Scratched - Replace

| No. | Component group | Description |
|---|---|---|
| 4 | Tail light | Tail lamp - right side - Scratched - Replace |

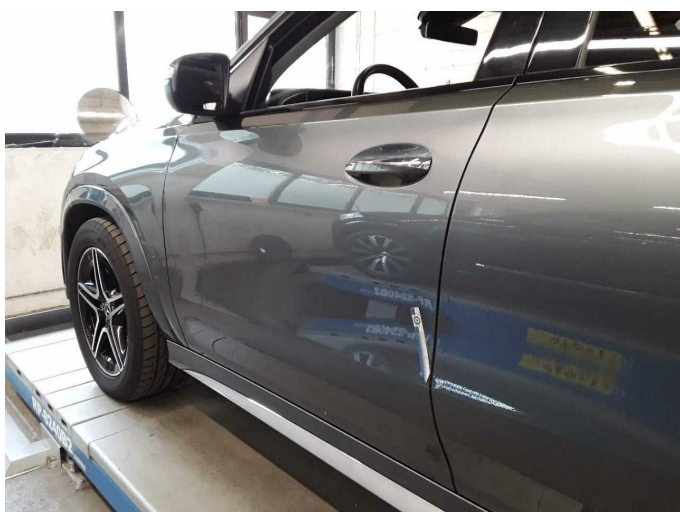
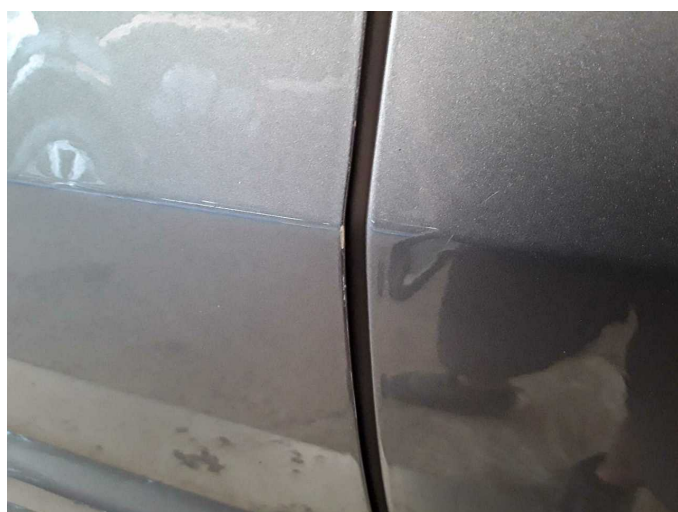
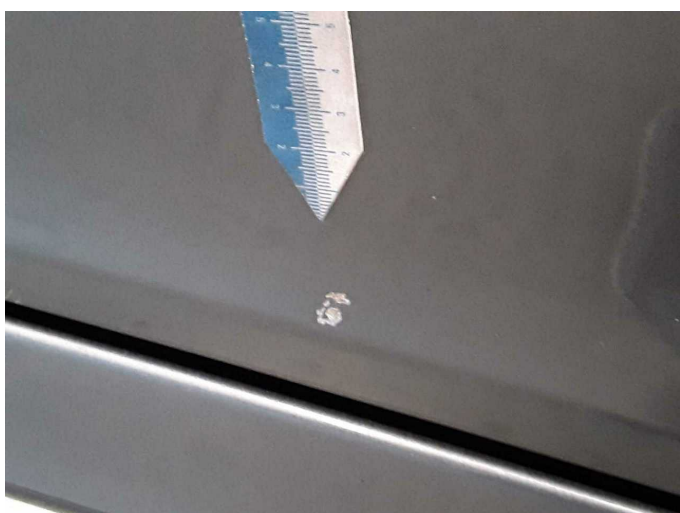
**Damage 5:** Door - front left side: Door - Scratched - Paint

| No. | Component group | Description |
|---|---|---|
| 5 | Door - front left side | Door - Scratched - Paint |

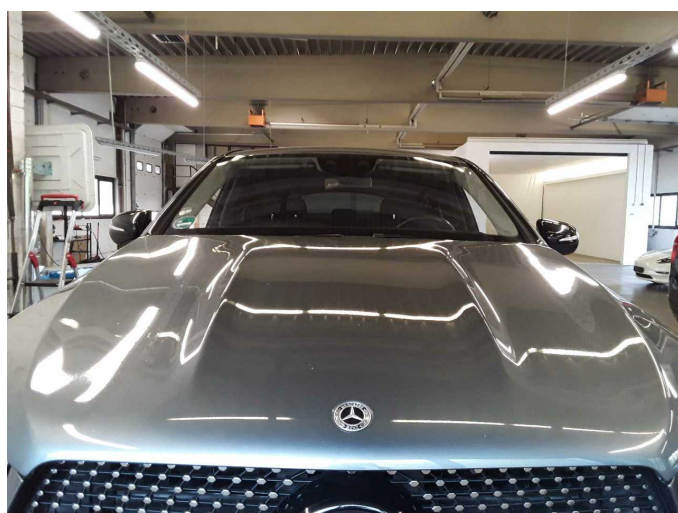
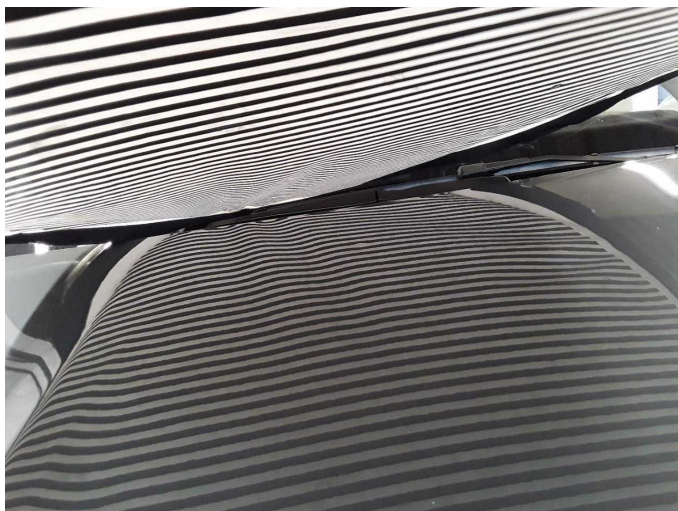
| No. | Component group | Description |
|---|---|---|
| 1 | Bonnet | Bonnet - dent(s) - No deduction |

**Wear and tear 1:** Bonnet: Bonnet - dent(s) - No deduction

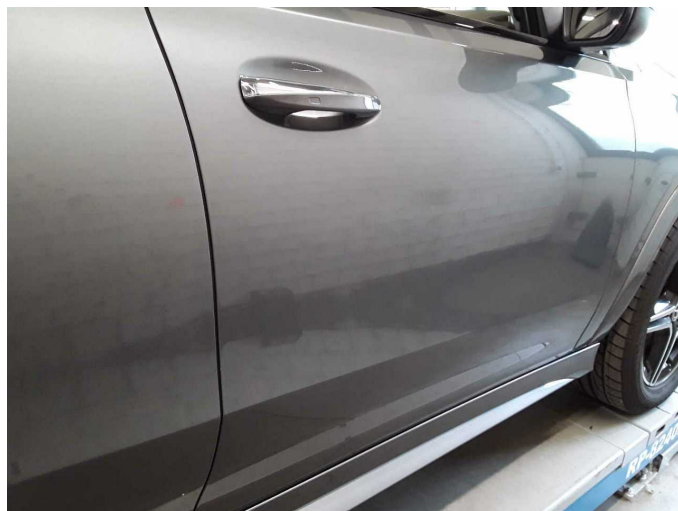
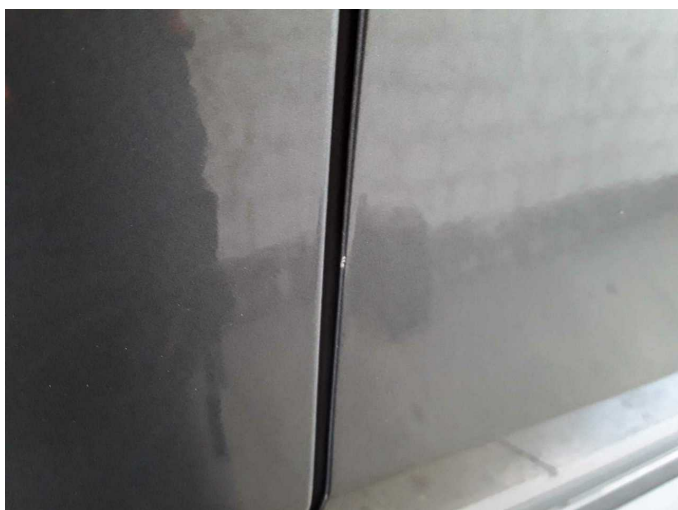
| No. | Component group | Description |
|---|---|---|
| 2 | Door - front right side | Door edge - Scratched - No deduction |

**Wear and tear 2:** Door - front right side: Door edge - Scratched - No deduction

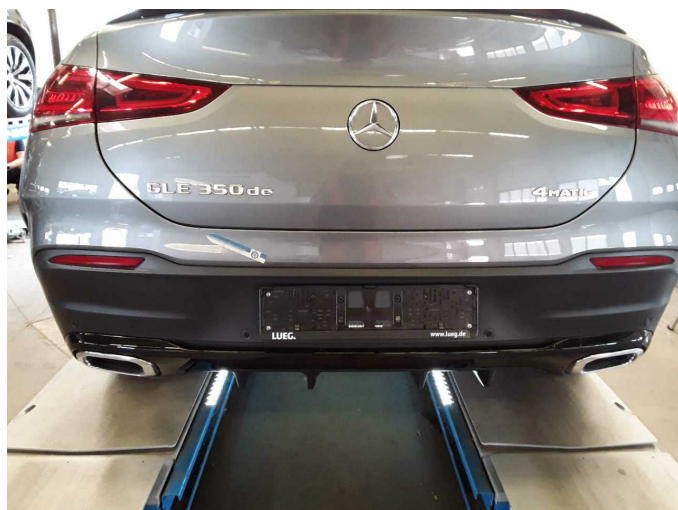
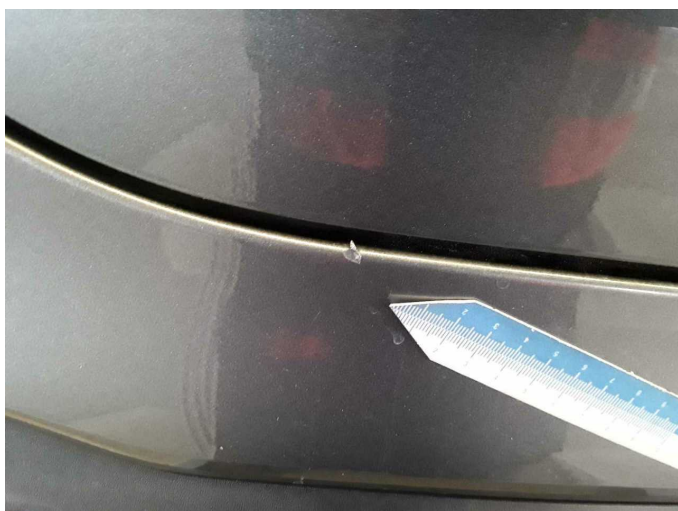
| No. | Component group | Description |
|---|---|---|
| 3 | Rear bumper | Rear bumper - Scratch(es) - No deduction |

**Wear and tear 3:** Rear bumper: Rear bumper - Scratch(es) - No deduction
