Expertise

Protocol number: 46136629  
Order No. / Reference: 26472890  
Inspection date: 24 Jun 2026

Manufacturer: Volkswagen

Model: Touran 2.0 TDI SCR DSG Comfortline

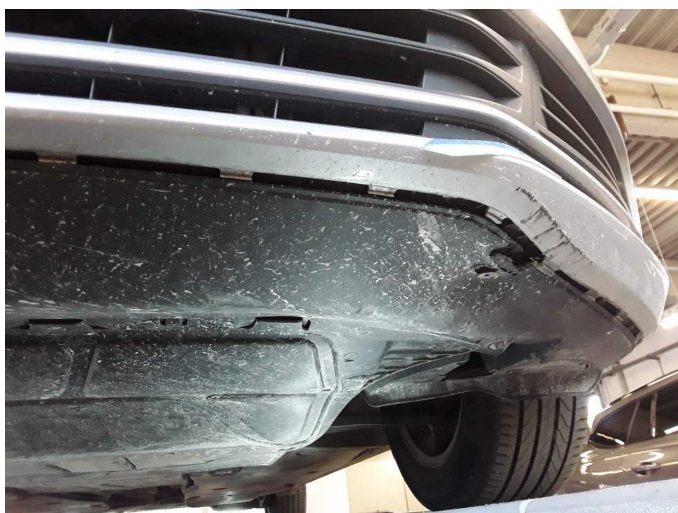
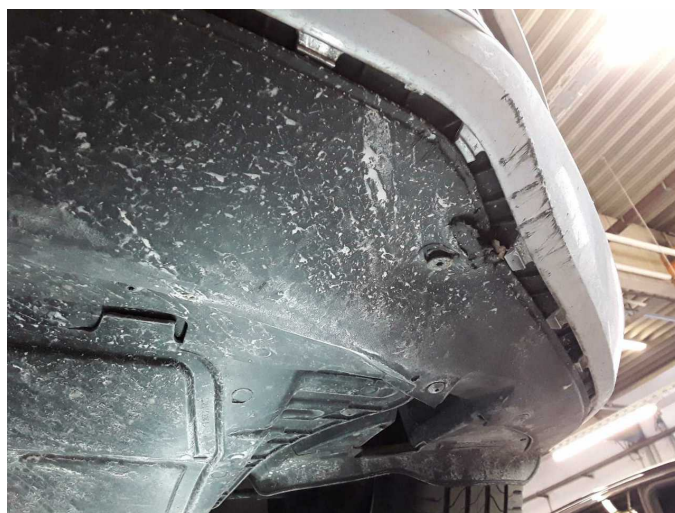
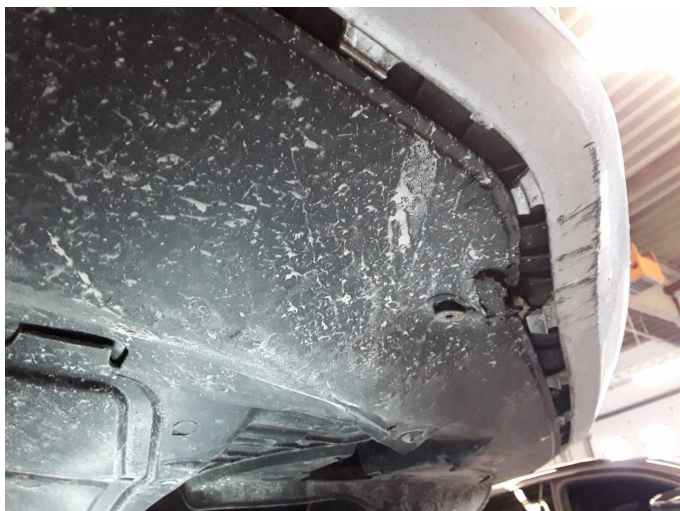
| No. | Component group | Description |
|---|---|---|
| 1 | Body | Underbody panelling - Broken / torn - Replace |

Damage 1: Body: Underbody panelling - Broken / torn - Replace

**Damage 1:** Body: Underbody panelling - Broken / torn - Replace

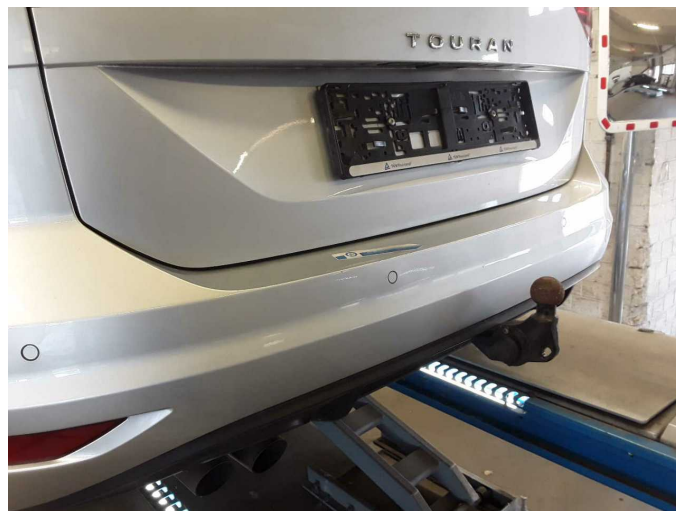
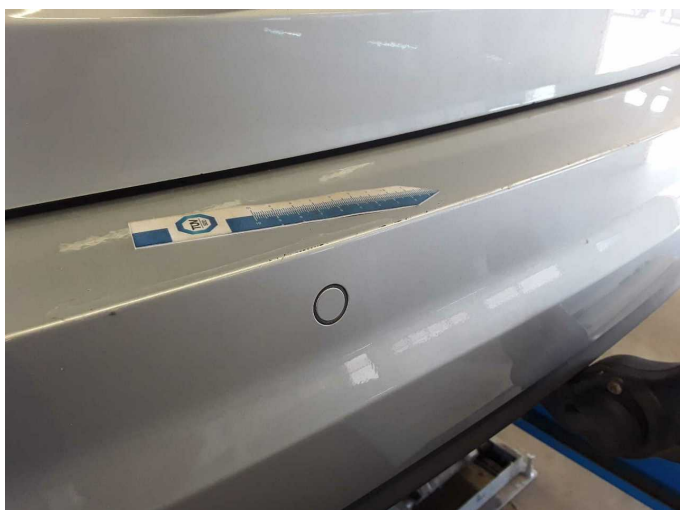
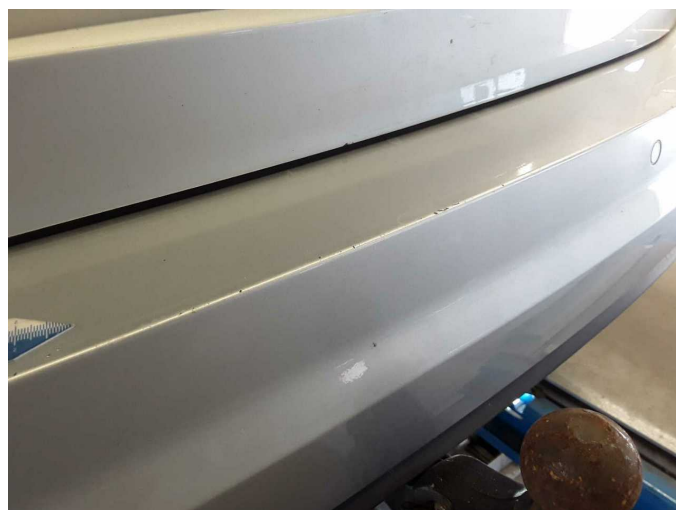
| No. | Component group | Description |
|---|---|---|
| 2 | Rear bumper | Rear bumper - Scratch(es) - Paint |

**Damage 2:** Rear bumper: Rear bumper - Scratch(es) - Paint

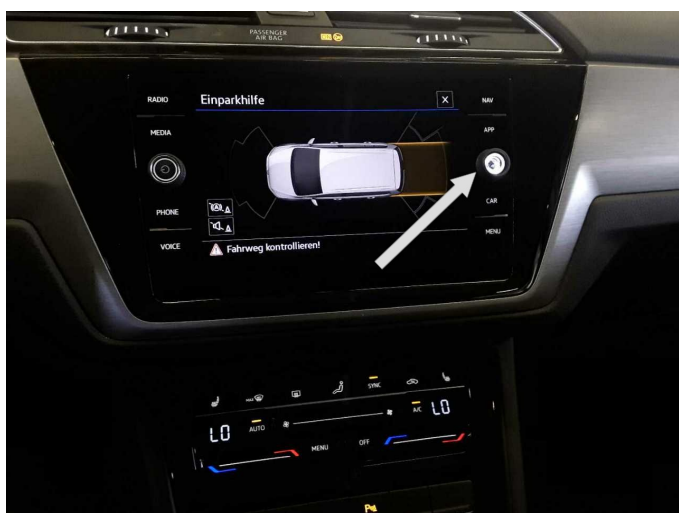
| No. | Component group | Description |
|---|---|---|
| 3 | Multimedia system | Screen (Knopf) - Damaged - Replace |

**Damage 3:** Multimedia system: Screen (Knopf) - Damaged - Replace

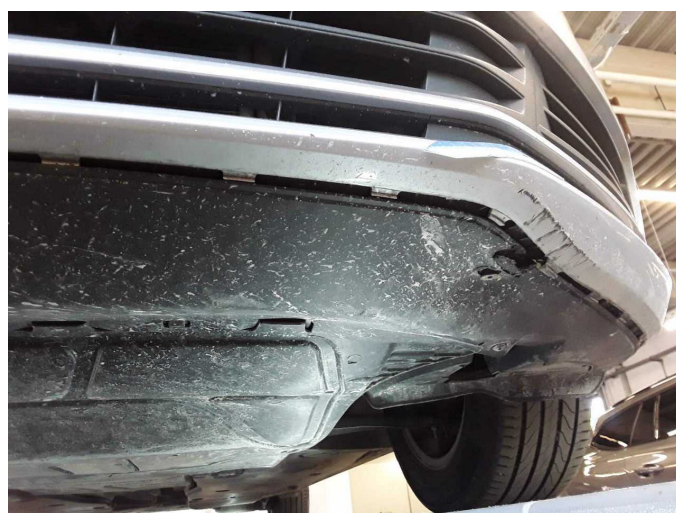
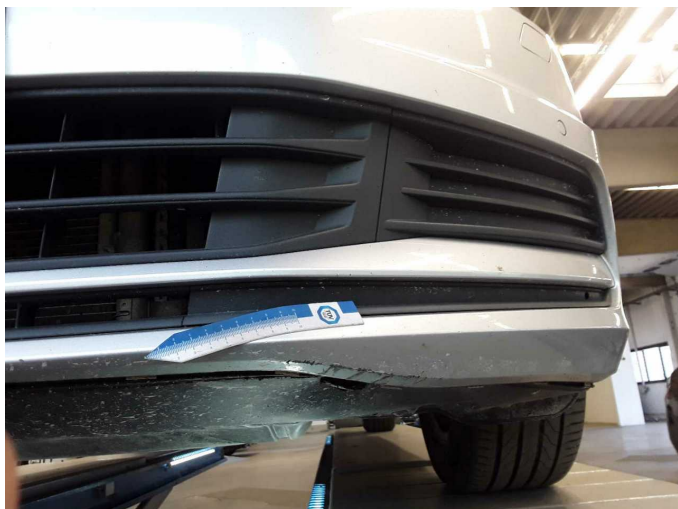
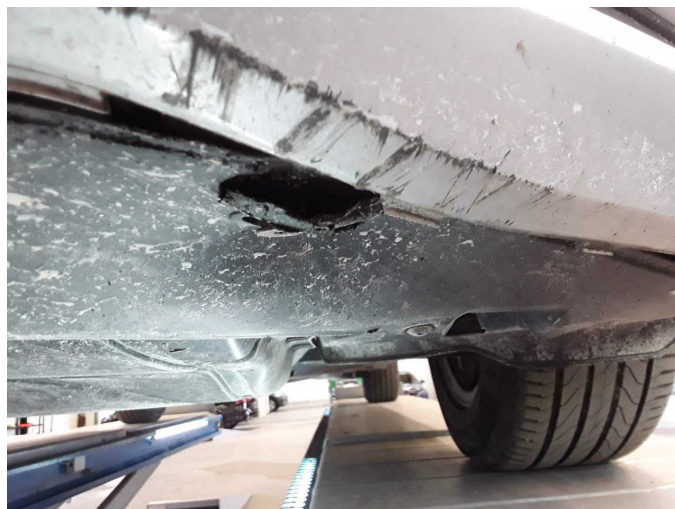
| No. | Component group | Description |
|---|---|---|
| 4 | Front bumper | Front bumper - Damaged - repair according to calculation |

**Damage 4:** Front bumper: Front bumper - Damaged - repair according to calculation

Die beigefügte Reparaturkostenkalkulation wurde nach bestem Wissen und Gewissen unter eingeschränkten Besichtigungsbedingung im demontagefreien Zustand erstellt. Es können aufgrund verdeckter Beschädigung, Mehrkosten und somit Abweichung der für die Stoßstange ausgewiesenen Reparaturkosten nicht ausgeschlossen werden.

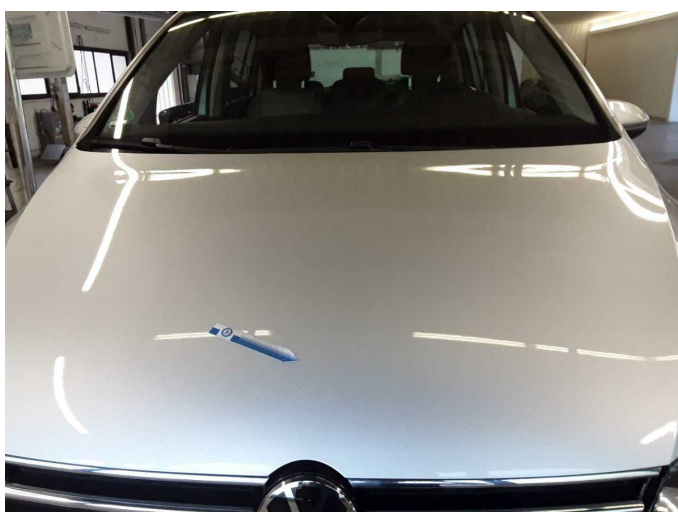
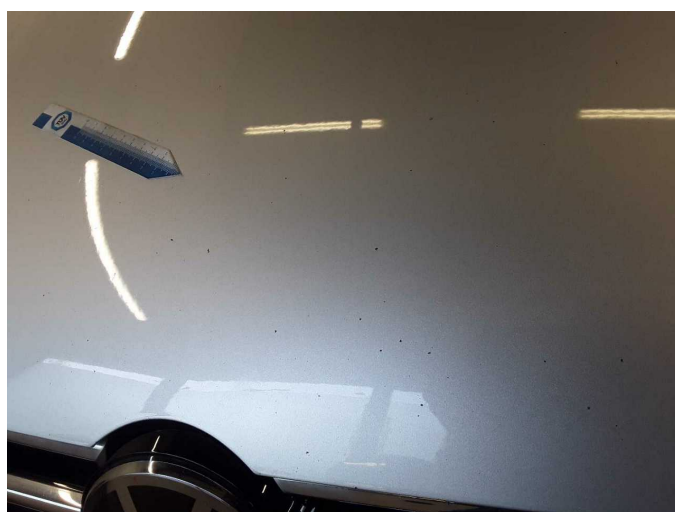
| No. | Component group | Description |
|---|---|---|
| 1 | Bonnet | Bonnet - Stone chips - No deduction |

**Wear and tear 1:** Bonnet: Bonnet - Stone chips - No deduction

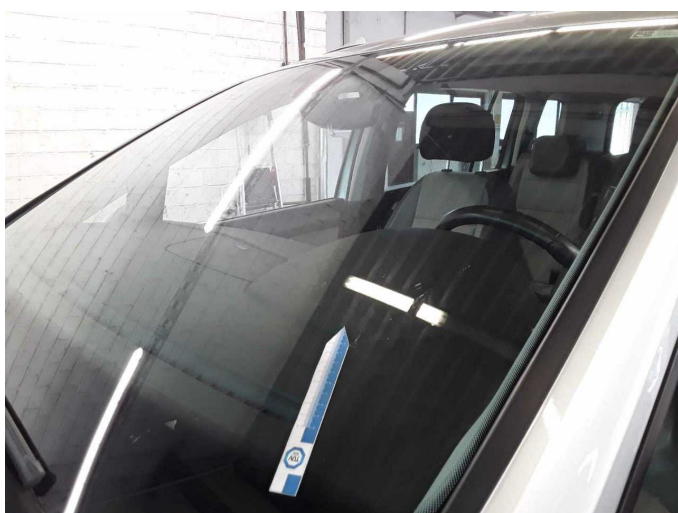
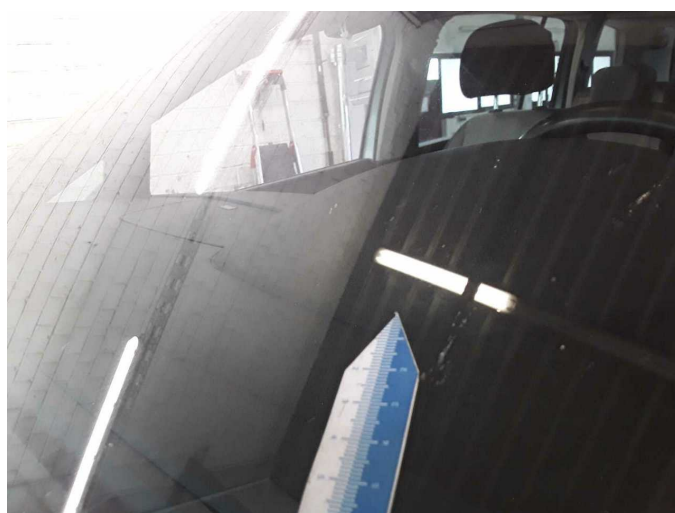
| No. | Component group | Description |
|---|---|---|
| 3 | Vehicle glazing | Windscreen - Stone chips - No deduction |

**Wear and tear 3:** Vehicle glazing: Windscreen - Stone chips - No deduction

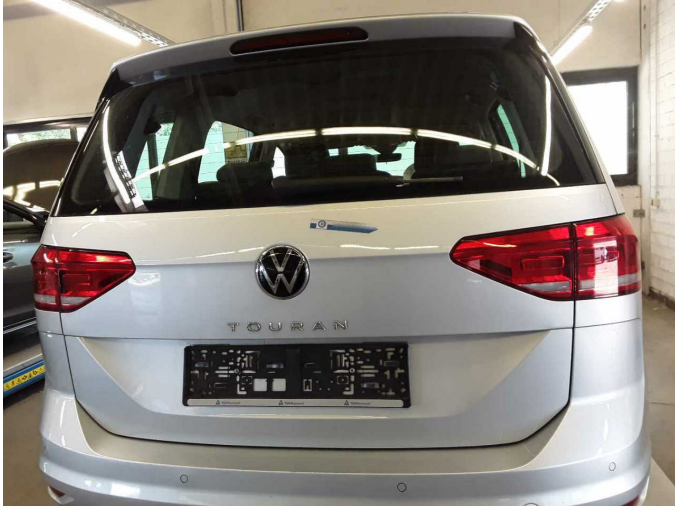
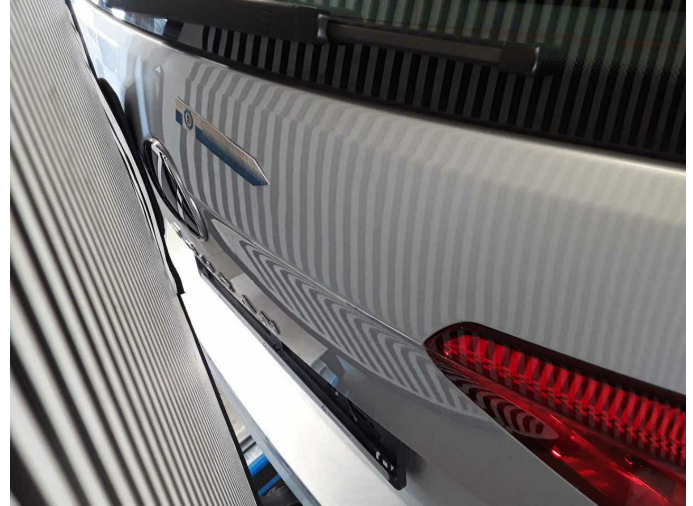
| No. | Component group | Description |
|---|---|---|
| 4 | Boot lid / rear door | Boot lid - dent(s) - Smooth repair work |

**Wear and tear 4:** Boot lid / rear door: Boot lid - dent(s) - Smooth repair work

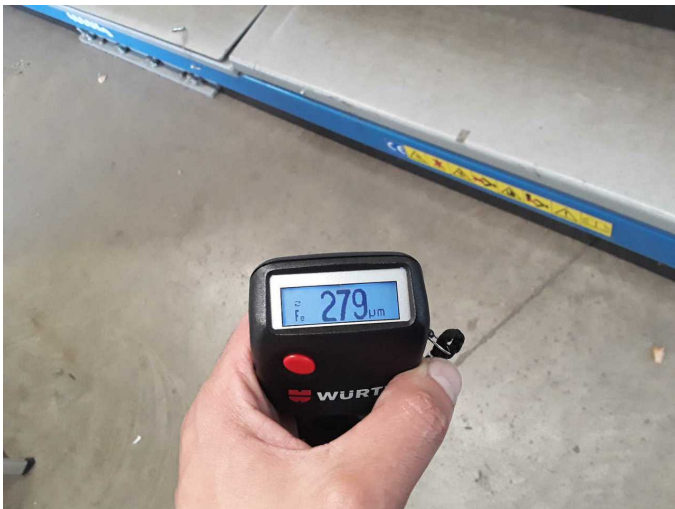
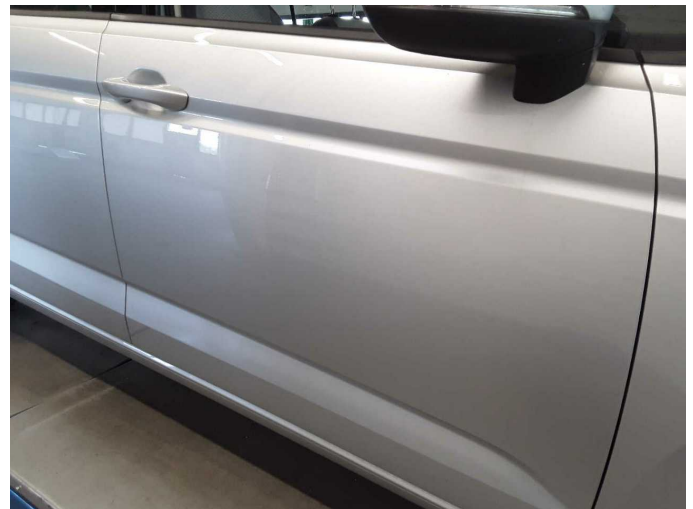
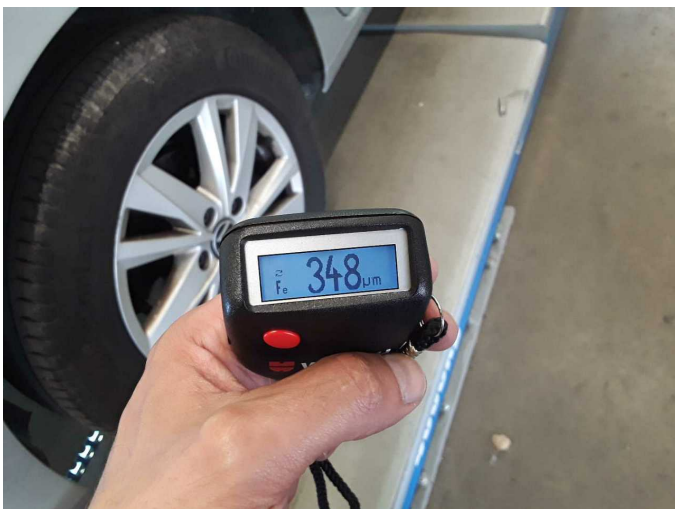
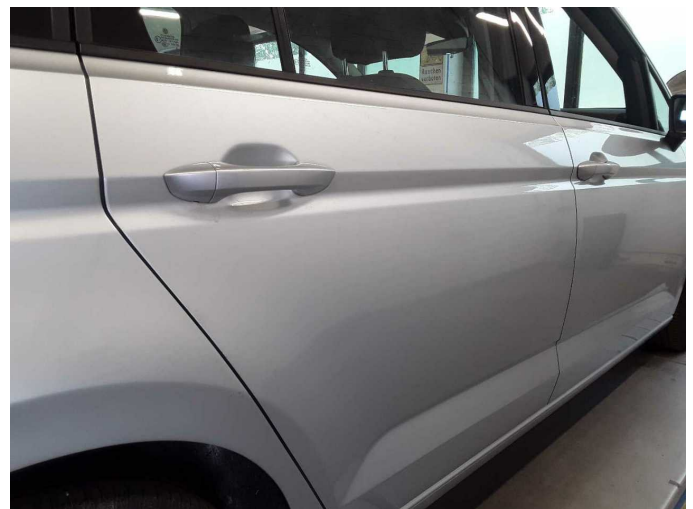
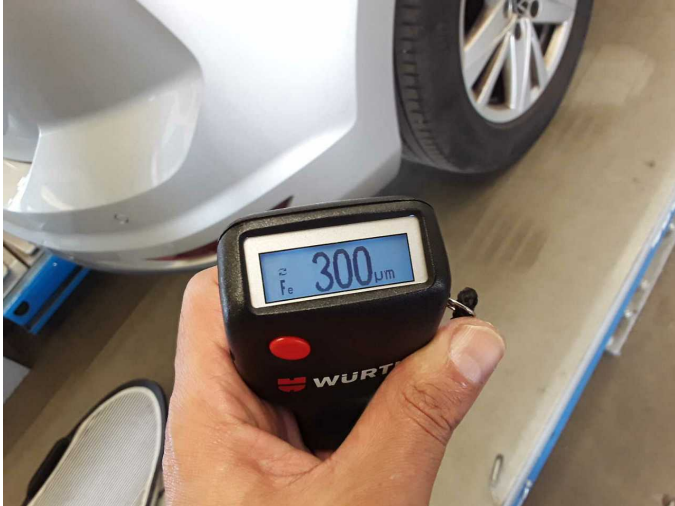
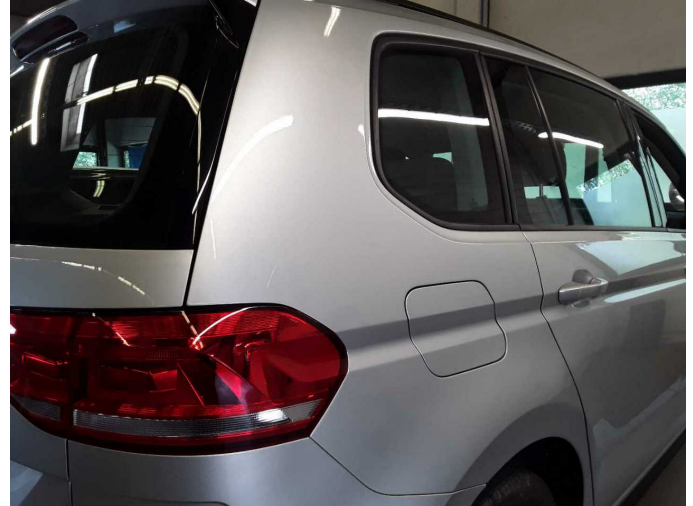
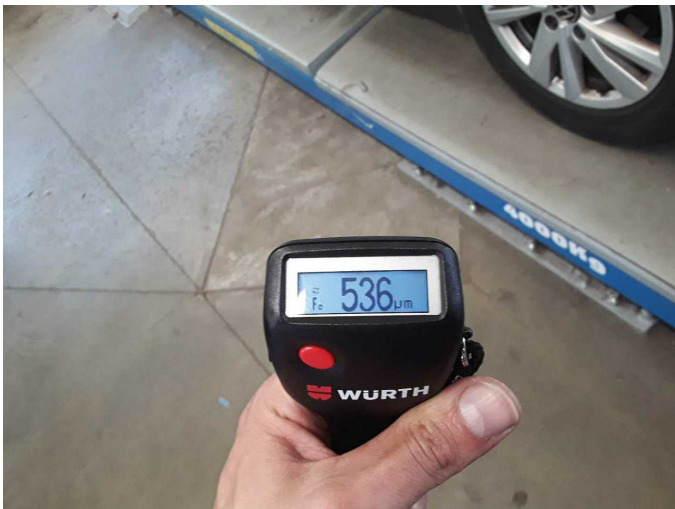
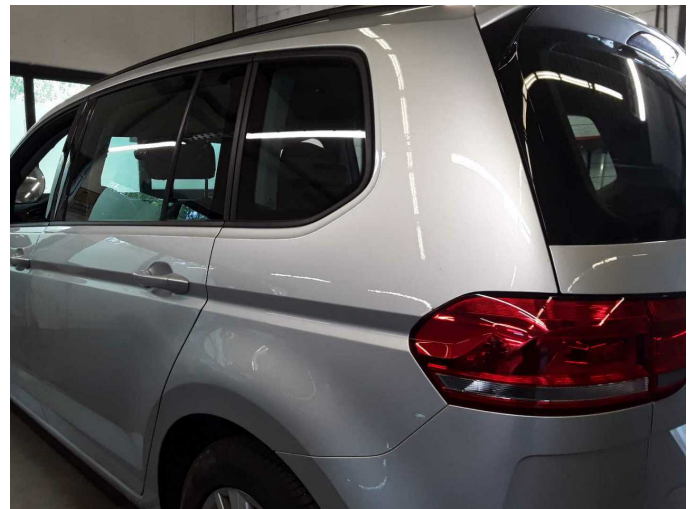
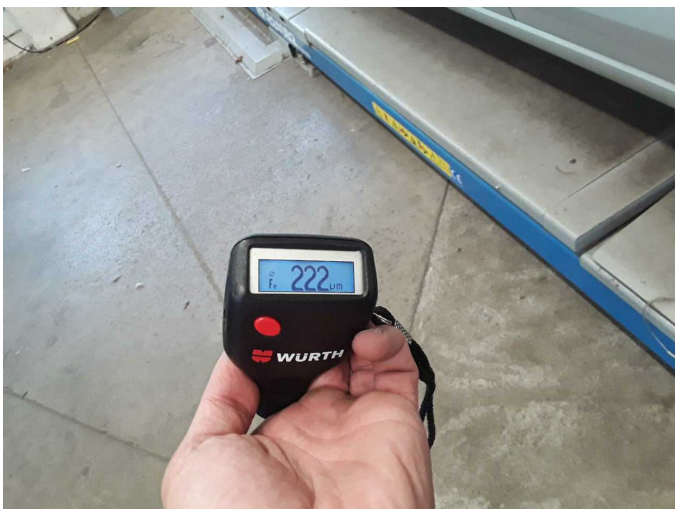
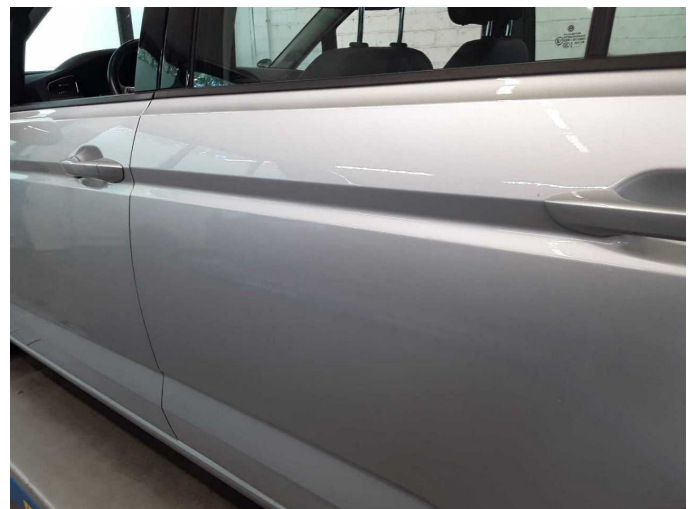
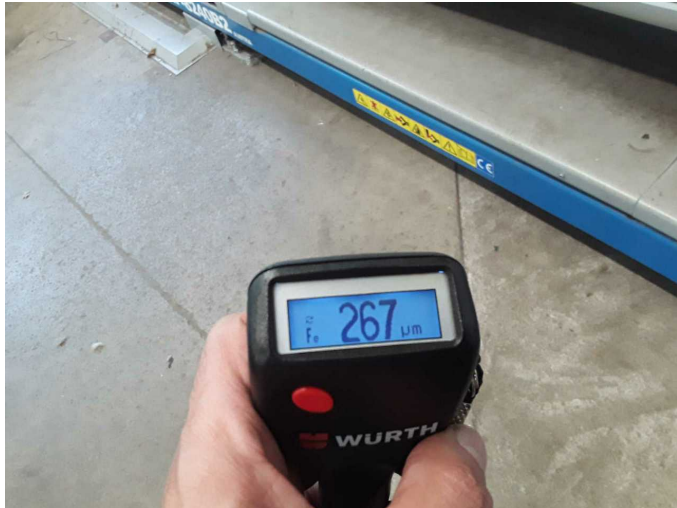
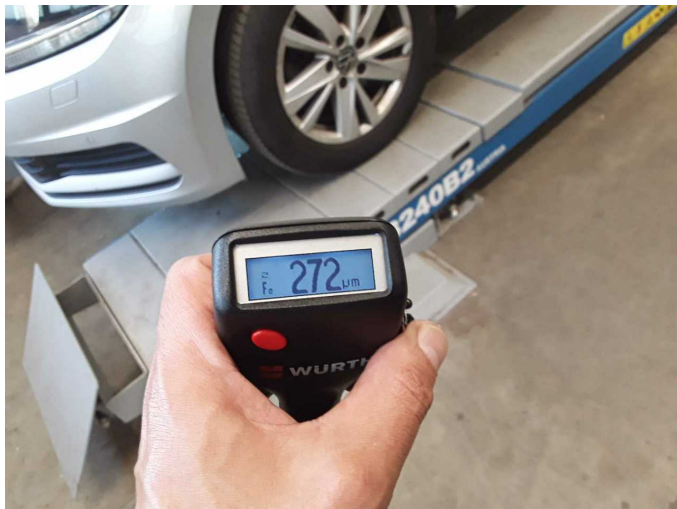
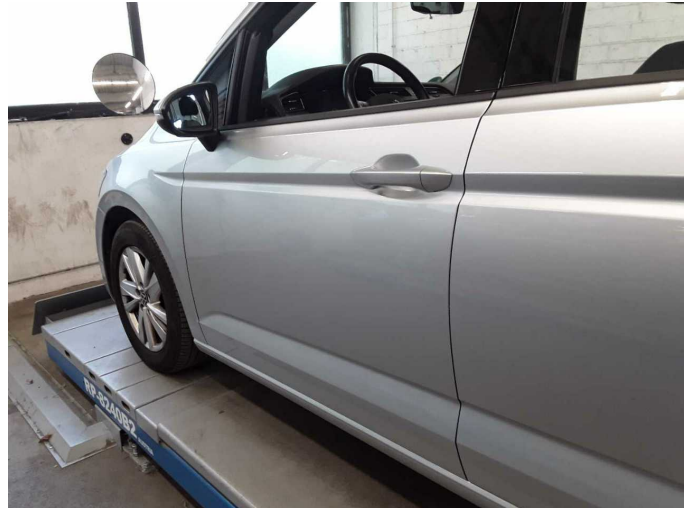
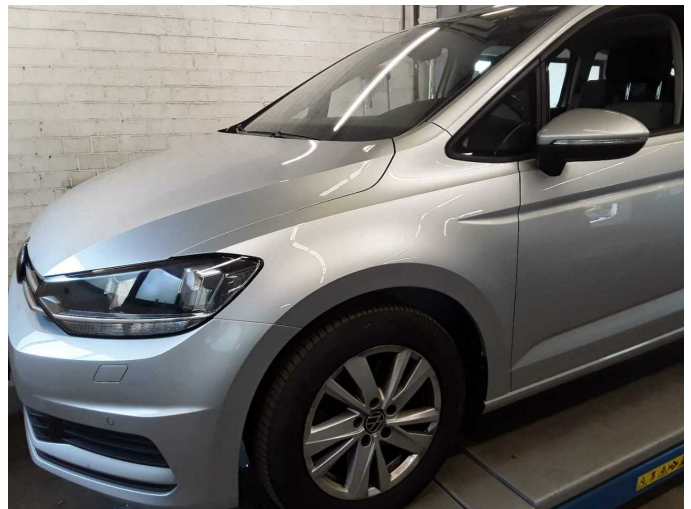
- Mudguard - left side, Side panel - rear left side, Side panel - rear right side, Door - rear left side, Door - rear right side, Door - front left side, Door - front right side, Professionally carried out, Invoice of repair done Non-existent

| Mudguard - left side | 272 µm | Side panel - rear left side | 536 µm |
| Side panel - rear right side | 300 µm | Door - rear left side | 222 µm |
| Door - rear right side | 348 µm | Door - front left side | 267 µm |
| Door - front right side | 279 µm | | |

**Repainting 1:** Mudguard - left side, Side panel - rear left side, Side panel - rear right side, Door - rear left side, Door - rear right side, Door - front left side, Door - front right side
