Expertise

Protocol number: 46449702  
Order No. / Reference: 26630936  
Inspection date: 9 Jul 2026

Manufacturer: Audi

Model: A4 Avant 40 TDI S tronic advanced

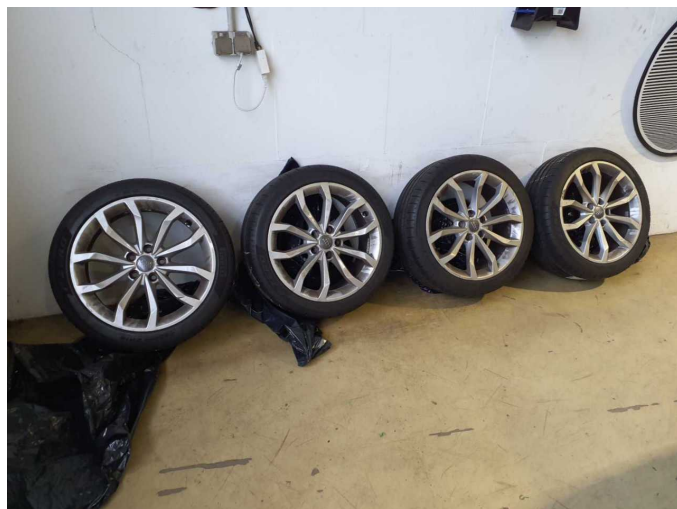
Figure 14: Additional tyres

| No. | Component group | Description |
|---|---|---|
| 12 | 2nd wheel set | 1 alloy rim - Scratch(es) - Replace |

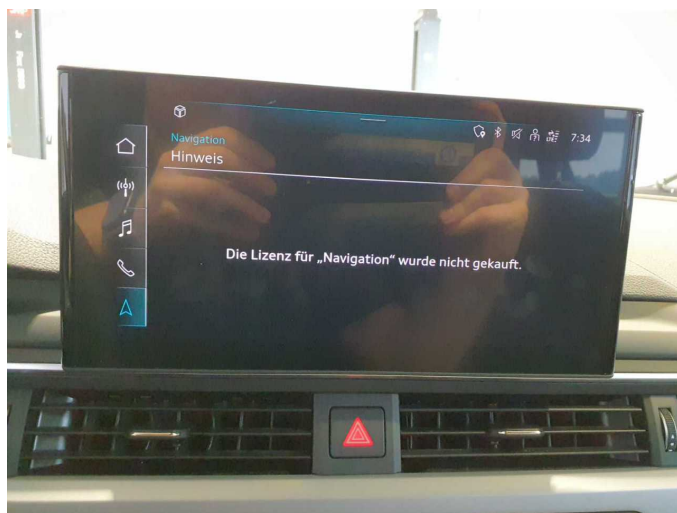
Figure 16: Navigation

| No. | Component group | Description |
|---|---|---|
| 3 | Multimedia system | Navigation data storage (keine Lizenz) - Missing - No deduction |

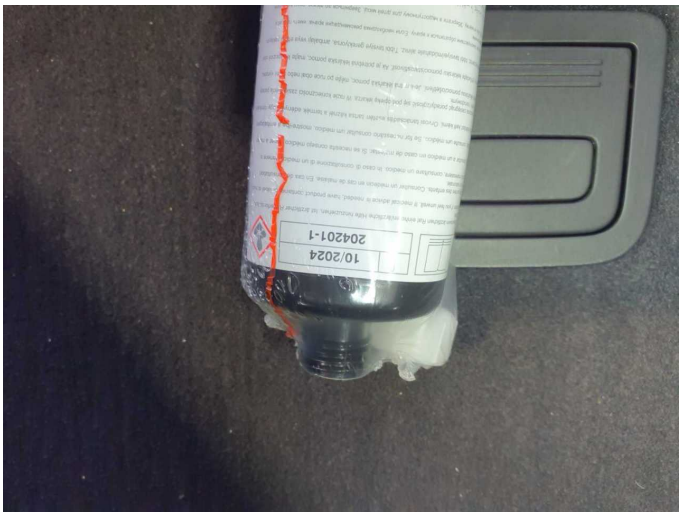
| No. | Component group | Description |
|---|---|---|
| 2 | Equipment | Tirefit filler - Expired - Replace |

Damage 2: Equipment: Tirefit filler - Expired - Replace

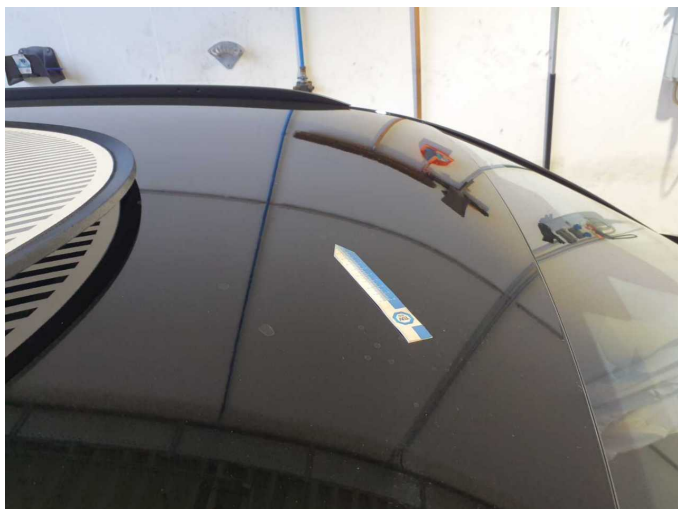
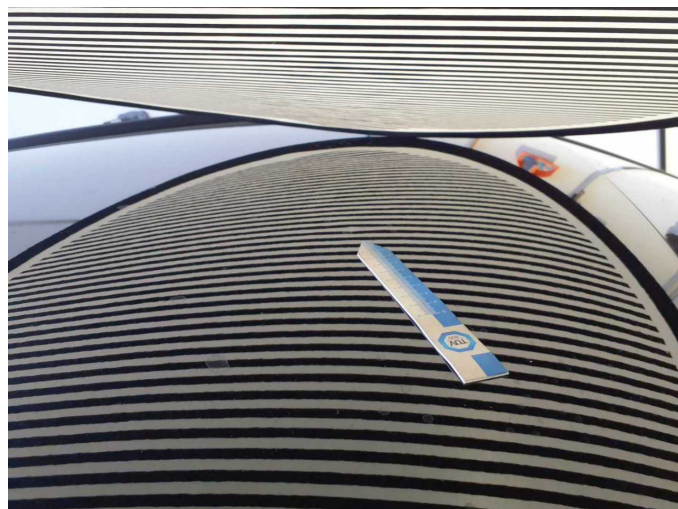
| No. | Component group | Description |
|---|---|---|
| 3 | Roof | Roof - dent(s) - Smooth repair work |

**Damage 3:** Roof: Roof - dent(s) - Smooth repair work

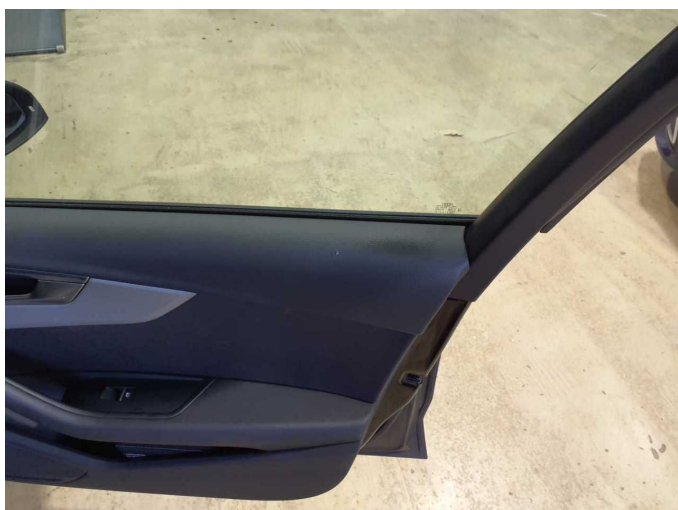
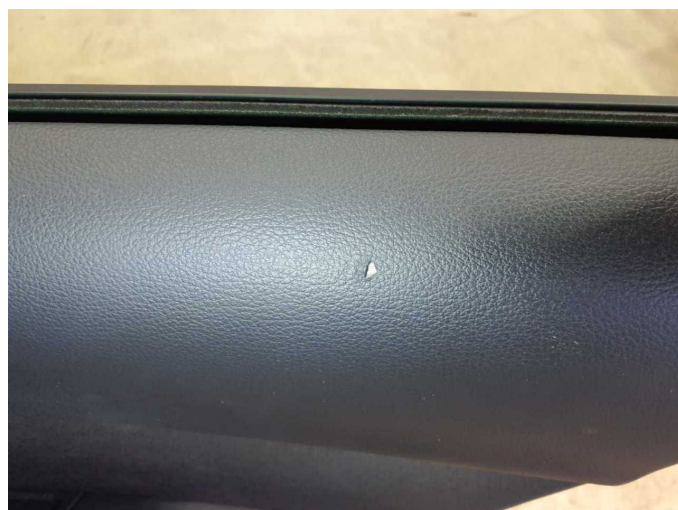
| No. | Component group | Description |
|---|---|---|
| 4 | Trim / covers | Door trim - front right side - Scratch(es) - Smart repair |

**Damage 4:** Trim / covers: Door trim - front right side - Scratch(es) - Smart repair

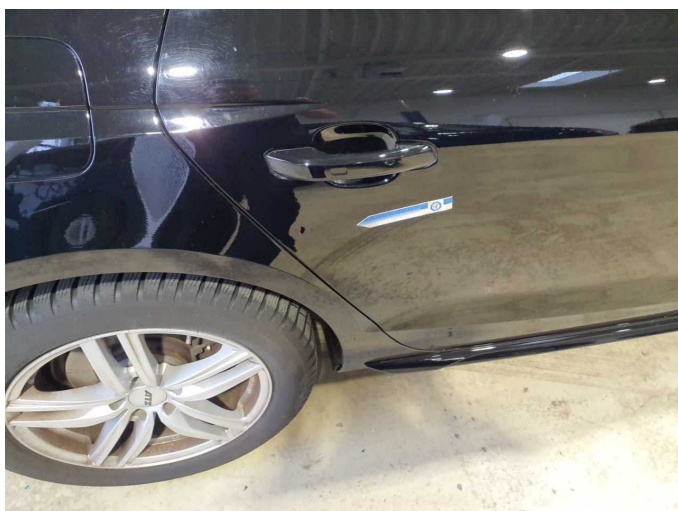
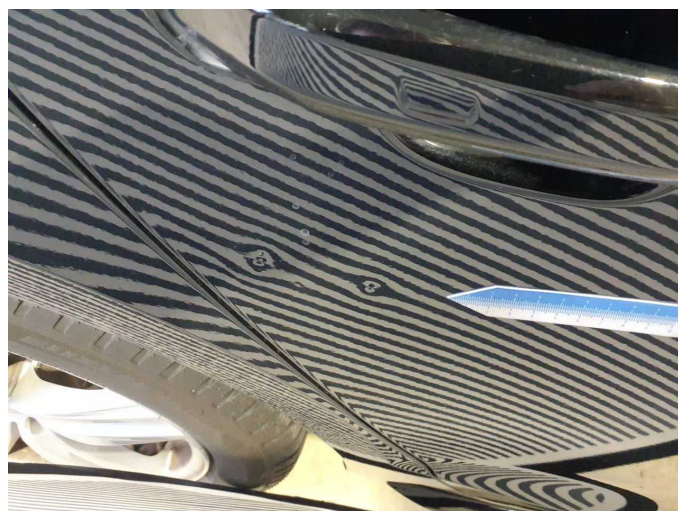
| No. | Component group | Description |
|---|---|---|
| 5 | Door - rear right side | Door - Dent / paintcoat damage - Smart repair |

**Damage 5:** Door - rear right side: Door - Dent / paintcoat damage - Smart repair

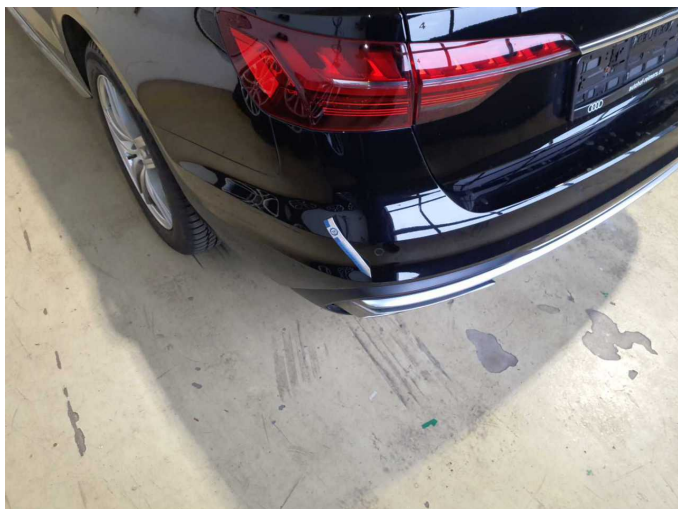
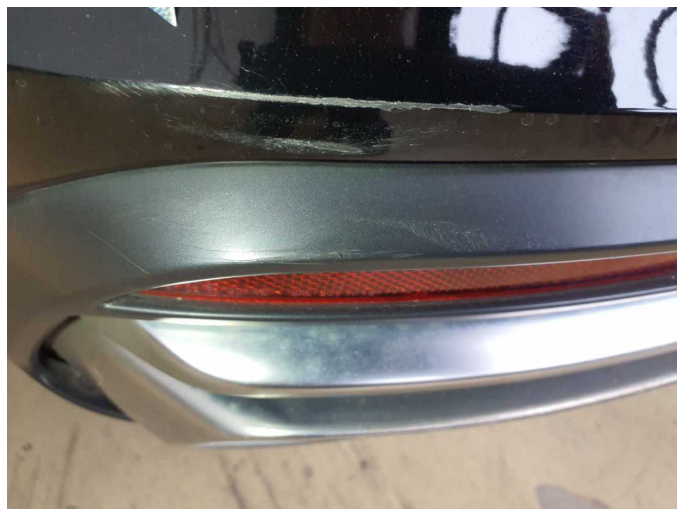
| No. | Component group | Description |
|---|---|---|
| 6 | Rear bumper | Spoiler - Scratch(es) - Replace |

**Damage 6:** Rear bumper: Spoiler - Scratch(es) - Replace

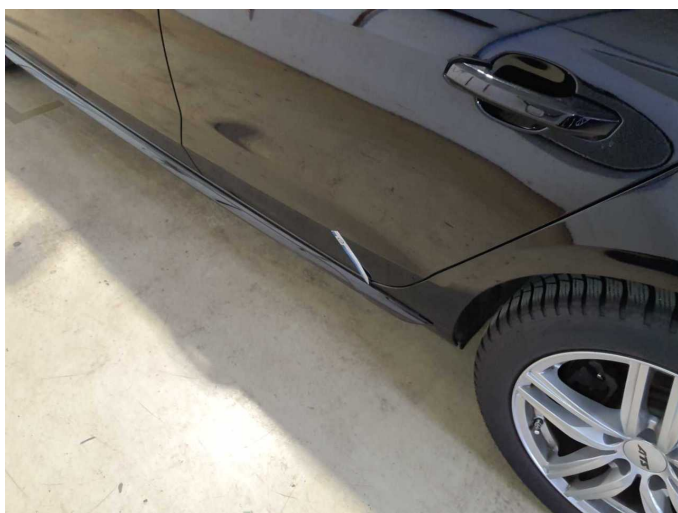
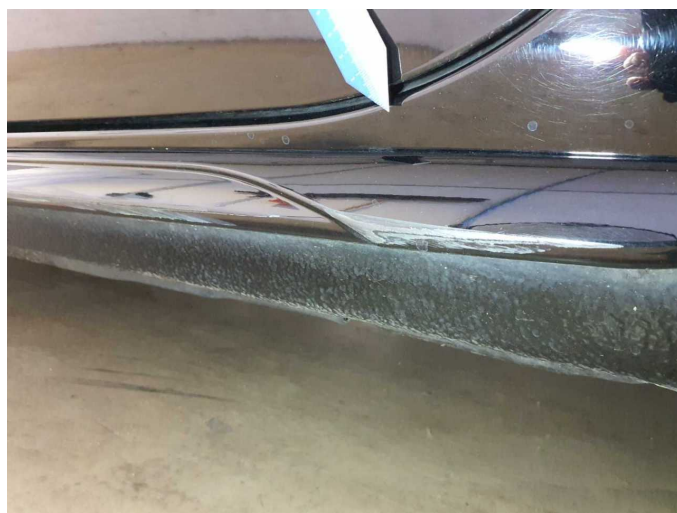
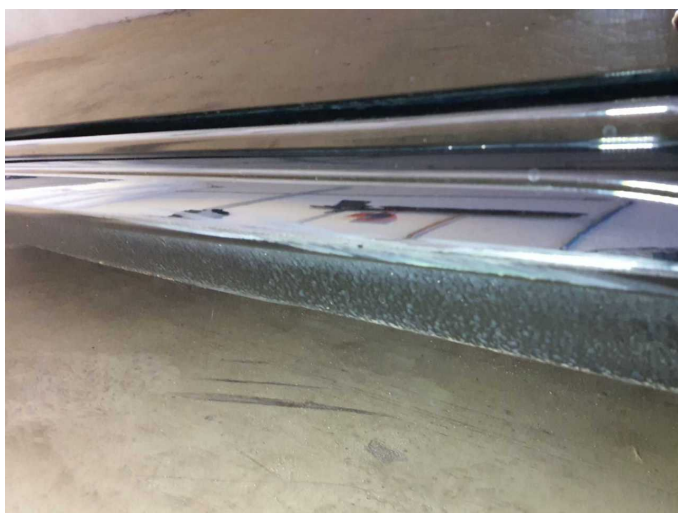
| No. | Component group | Description |
|---|---|---|
| 7 | Sill - left side | Trim - Scratch(es) - Replace |

**Damage 7:** Sill - left side: Trim - Scratch(es) - Replace

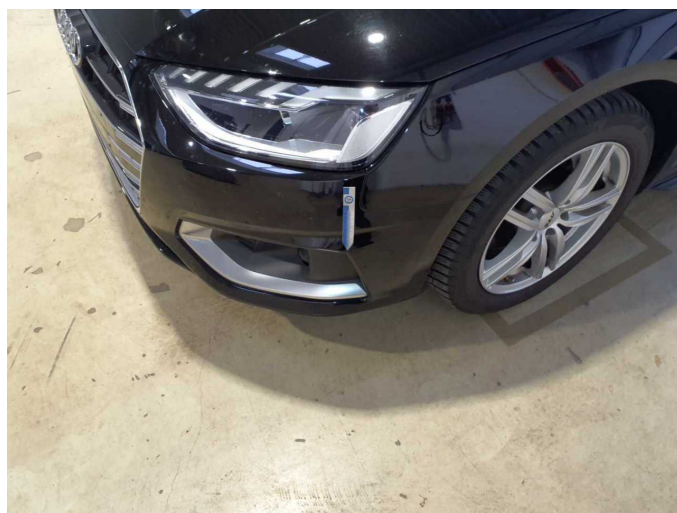
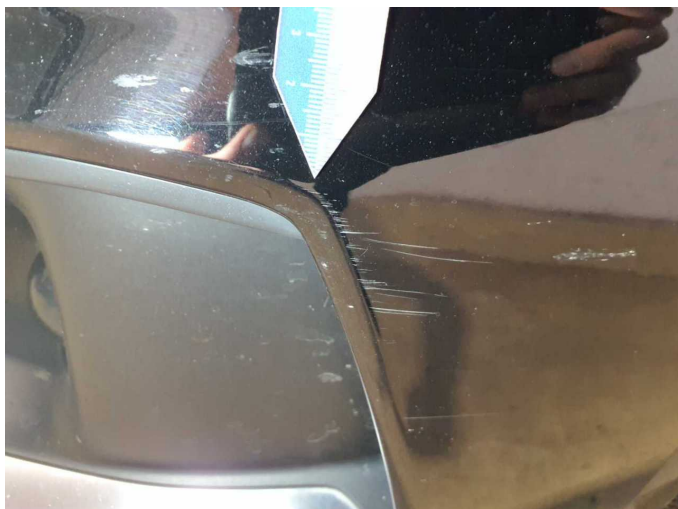
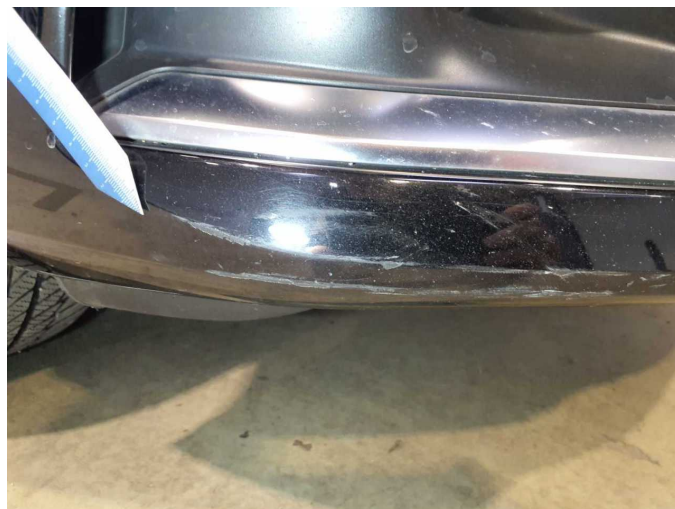
| No. | Component group | Description |
|---|---|---|
| 8 | Front bumper | Front bumper - Scratch(es) - Paint |

**Damage 8:** Front bumper: Front bumper - Scratch(es) - Paint

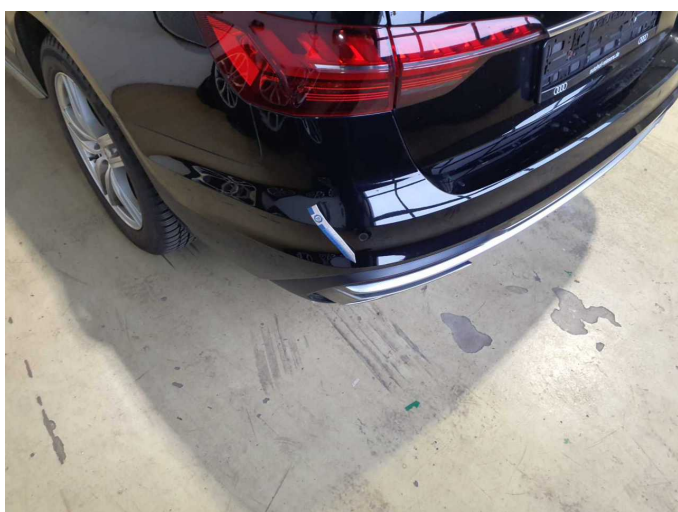
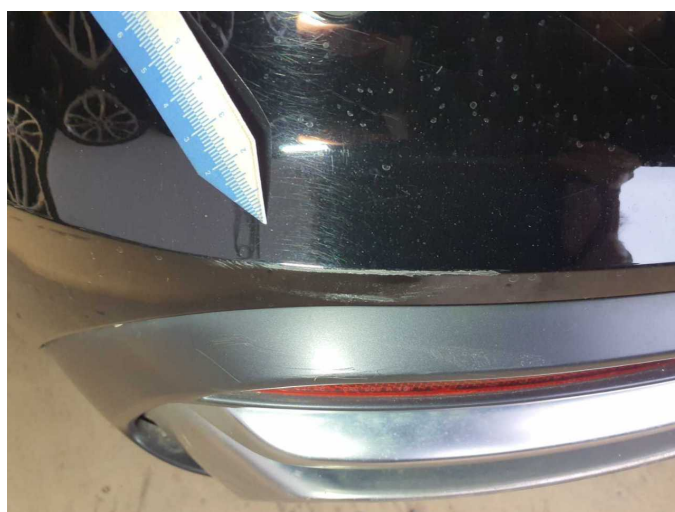
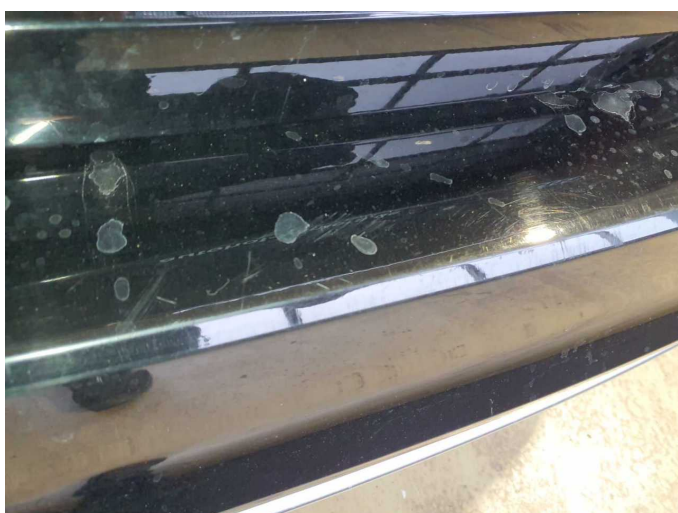
| No. | Component group | Description |
|---|---|---|
| 9 | Rear bumper | Rear bumper - Scratch(es) - Paint |

**Damage 9:** Rear bumper: Rear bumper - Scratch(es) - Paint

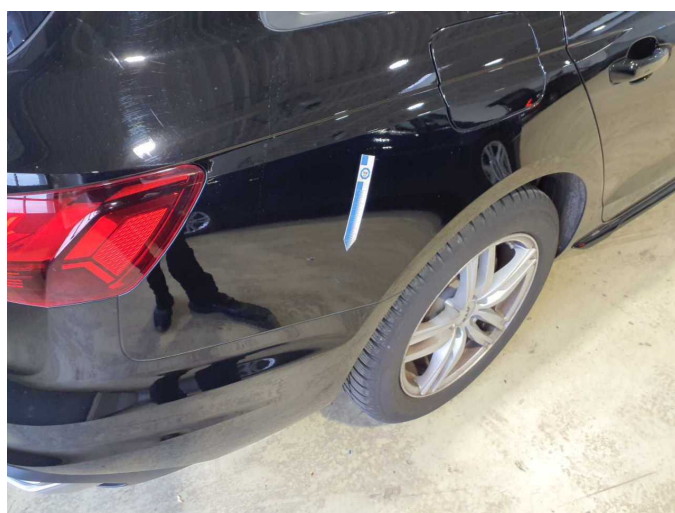
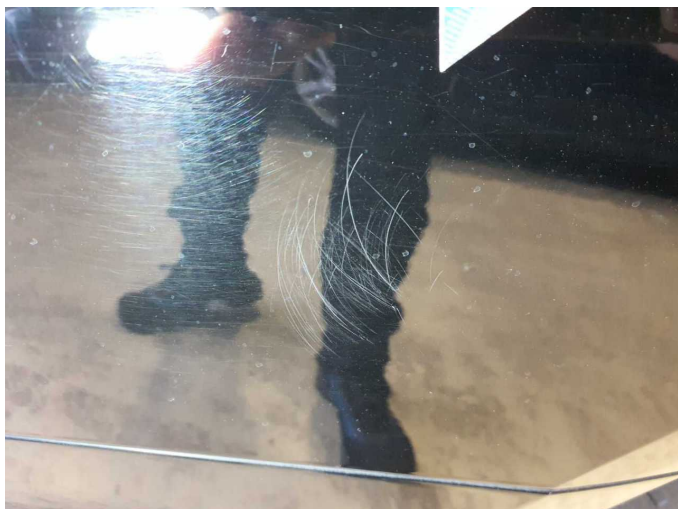
| No. | Component group | Description |
|---|---|---|
| 10 | Side panel - rear right side | Side panel - Scratch(es) - Paint |

**Damage 10:** Side panel - rear right side: Side panel - Scratch(es) - Paint

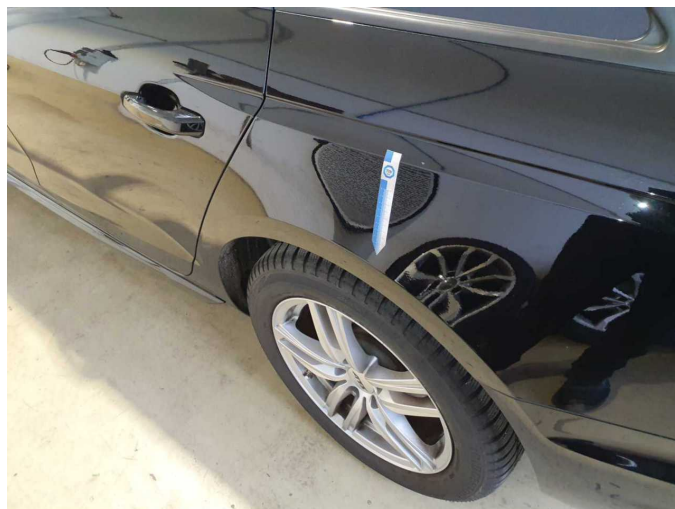
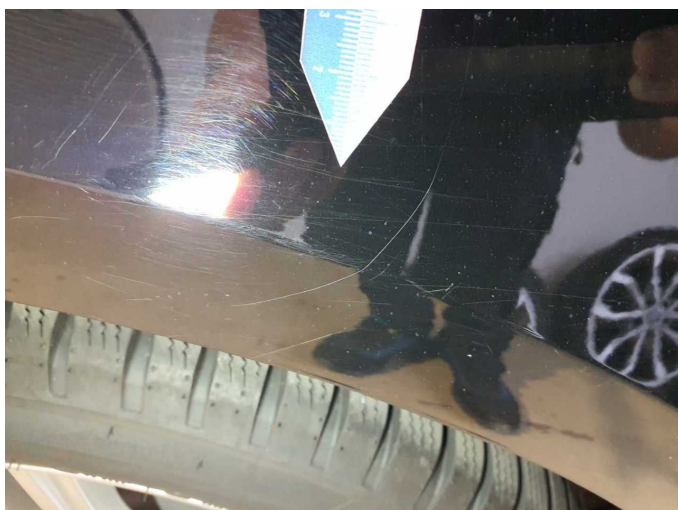
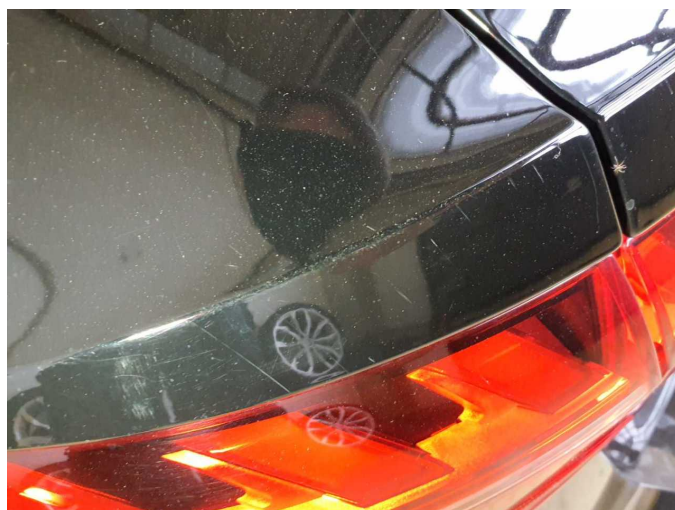
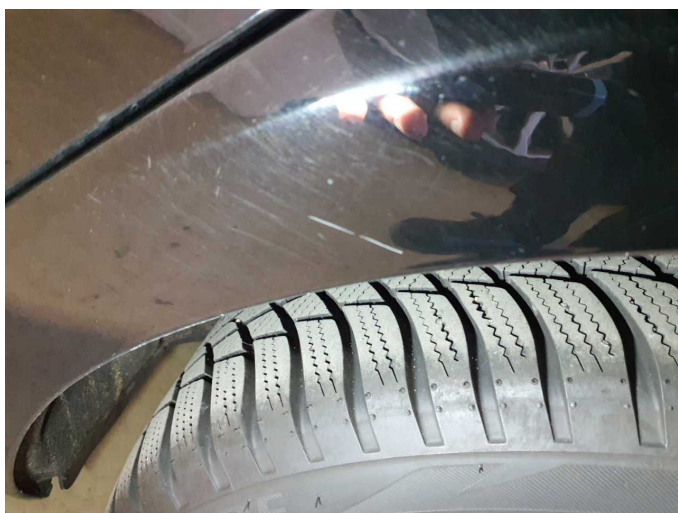
| No. | Component group | Description |
|---|---|---|
| 11 | Side panel - rear left side | Side panel - Scratch(es) - Paint |

**Damage 11:** Side panel - rear left side: Side panel - Scratch(es) - Paint

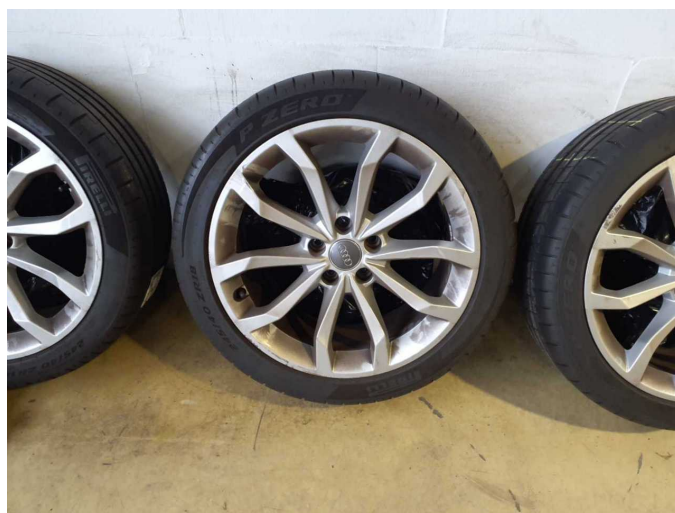
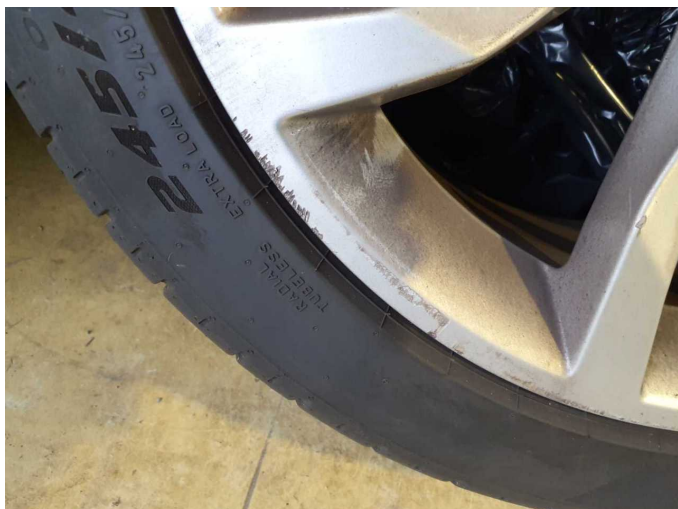
**Damage 12:** 2nd wheel set: 1 alloy rim - Scratch(es) - Replace

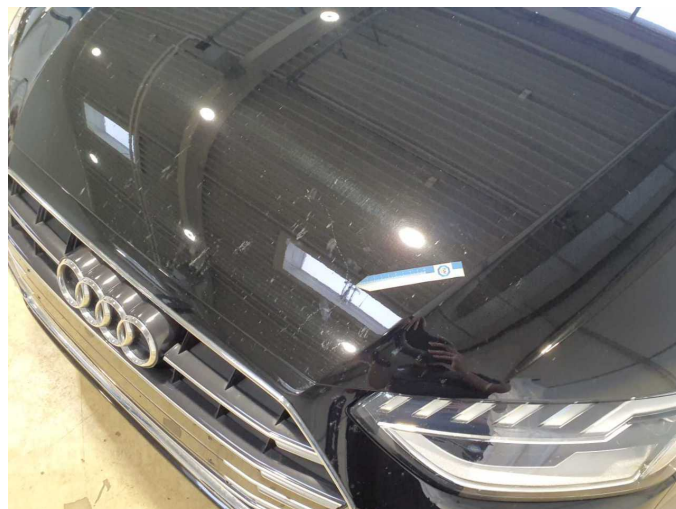
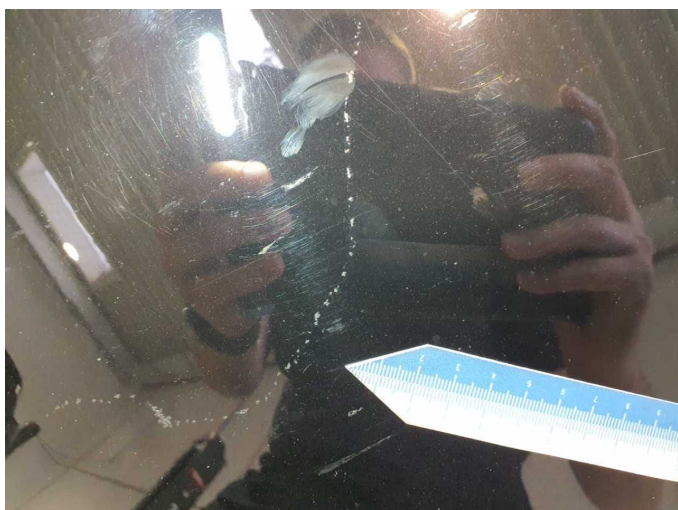
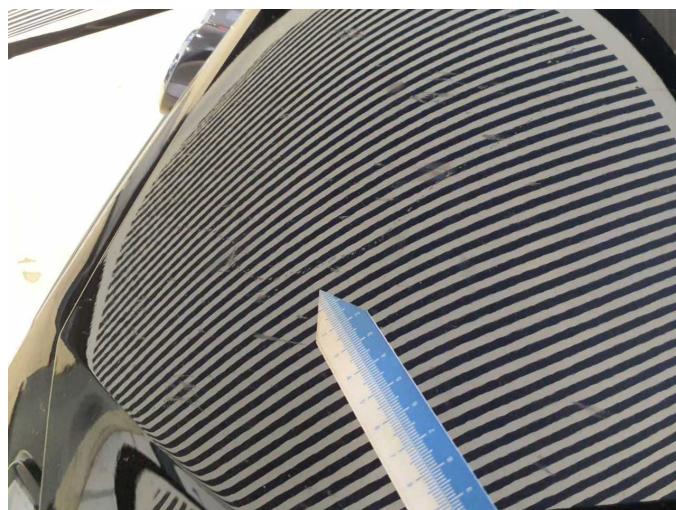
| No. | Component group | Description |
|---|---|---|
| 13 | Bonnet | Bonnet - Paint defect - Repair and paint |

**Damage 13:** Bonnet: Bonnet - Paint defect - Repair and paint

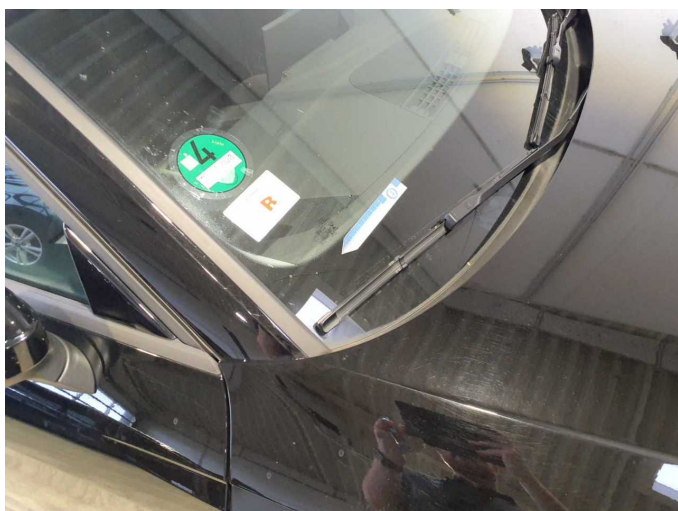
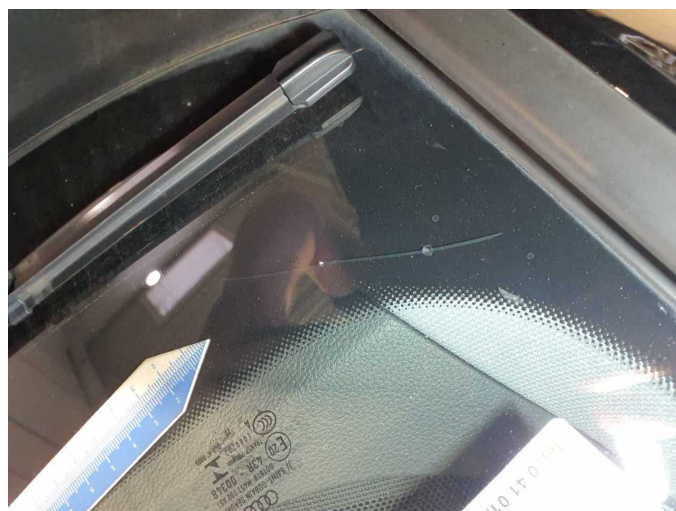
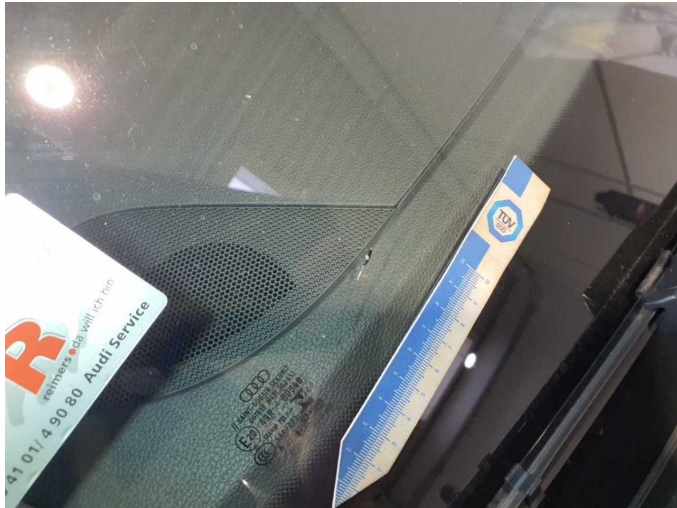
| No. | Component group | Description |
|---|---|---|
| 14 | Vehicle glazing | Windscreen - Broken / torn - Replace |

**Damage 14:** Vehicle glazing: Windscreen - Broken / torn - Replace

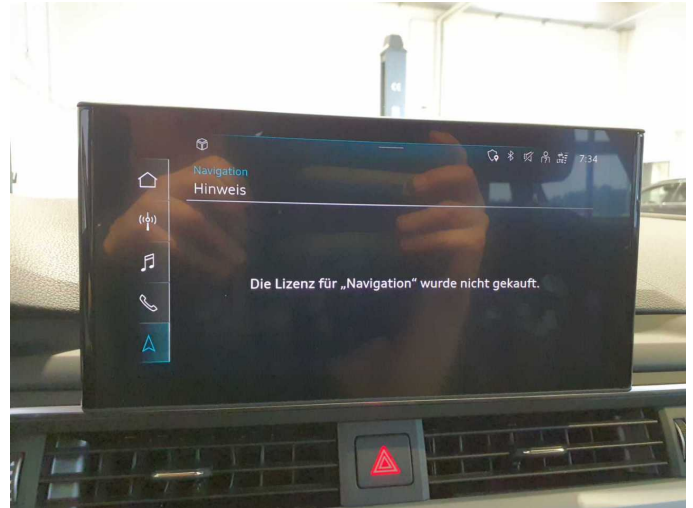
**Wear and tear 3:** Multimedia system: Navigation data storage (keine Lizenz) - Missing - No deduction
