Expertise

Protocol number: 46139363  
Order No. / Reference: 26570796  
Inspection date: 23 Jun 2026

Manufacturer: Mercedes-Benz

Model: A 250 e 8G-DCT Progressive Advanced

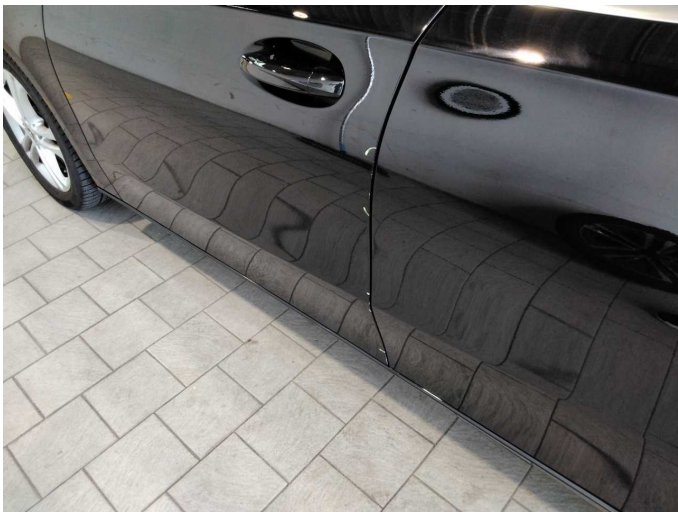
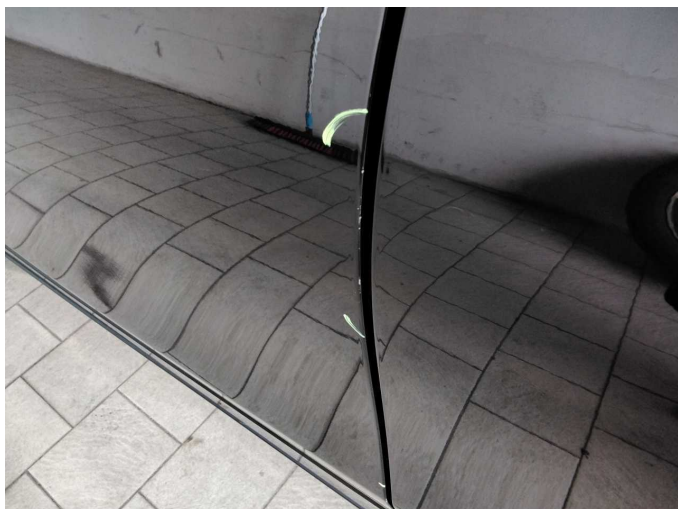
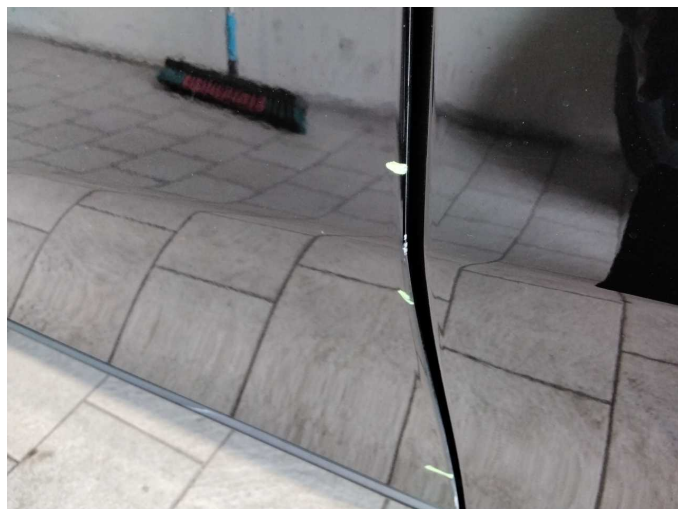
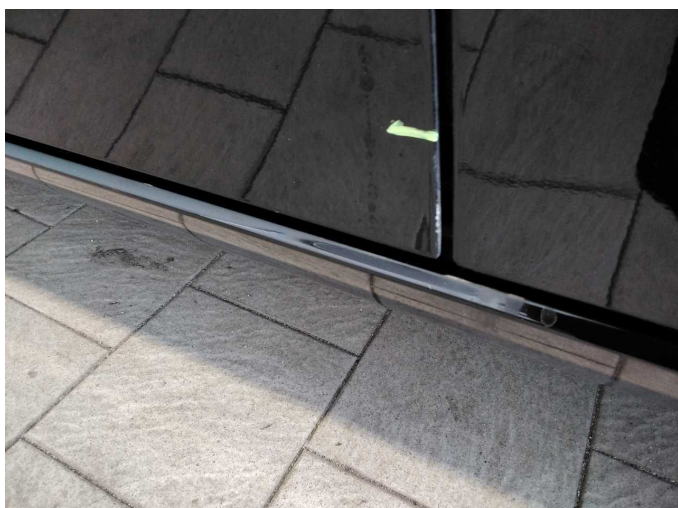
| No. | Component group | Description |
|---|---|---|
| 1 | Door - front left side | Door edge - Scratch(es) - Smart repair |

Damage 1: Door - front left side: Door edge - Scratch(es) - Smart repair

**Damage 1:** Door - front left side: Door edge - Scratch(es) - Smart repair

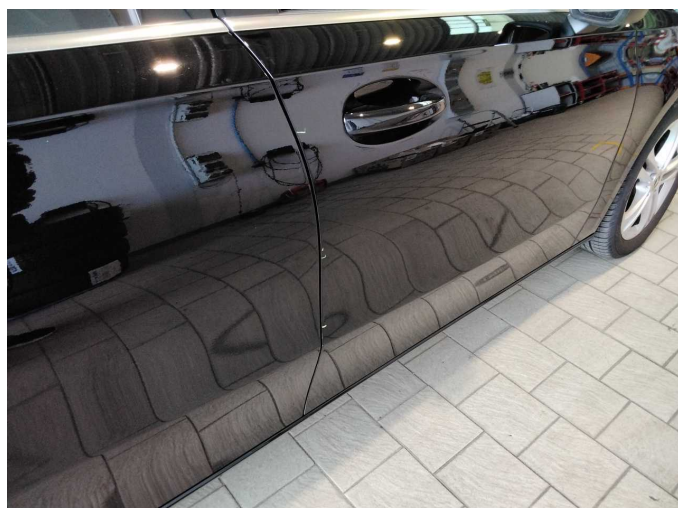
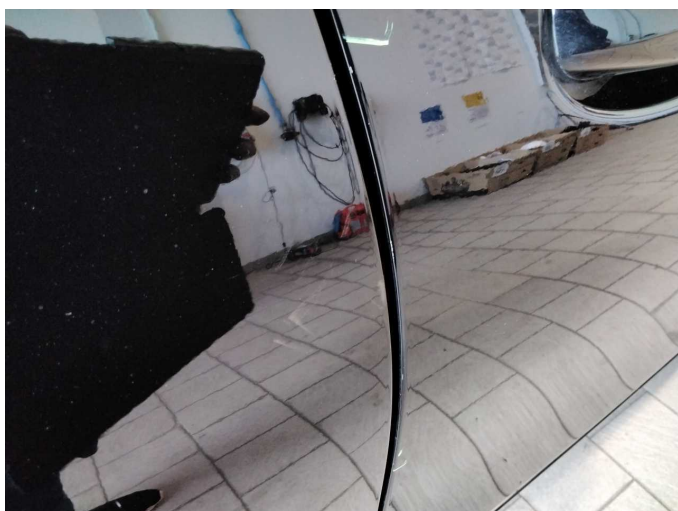
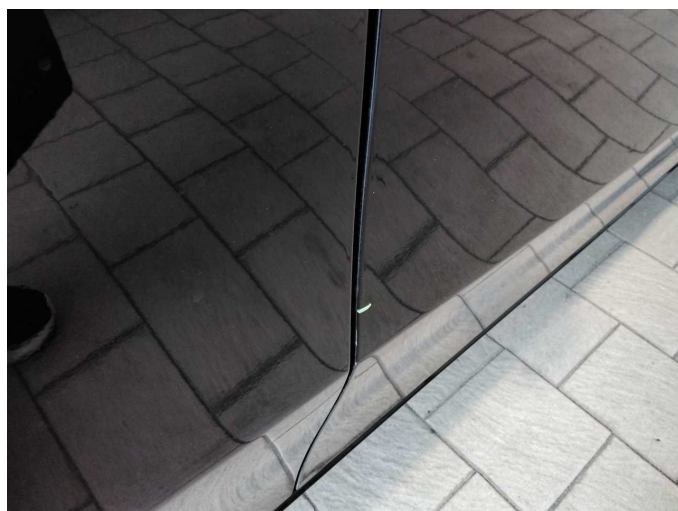
| No. | Component group | Description |
|---|---|---|
| 2 | Door - front right side | Door edge - Scratch(es) - Smart repair |

**Damage 2:** Door - front right side: Door edge - Scratch(es) - Smart repair

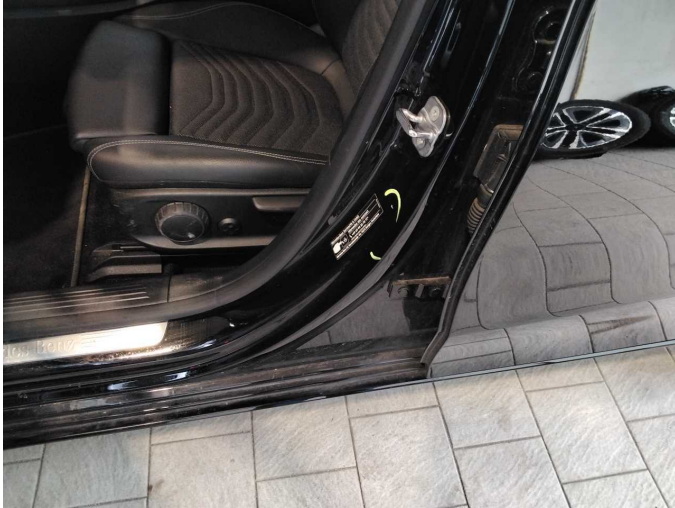
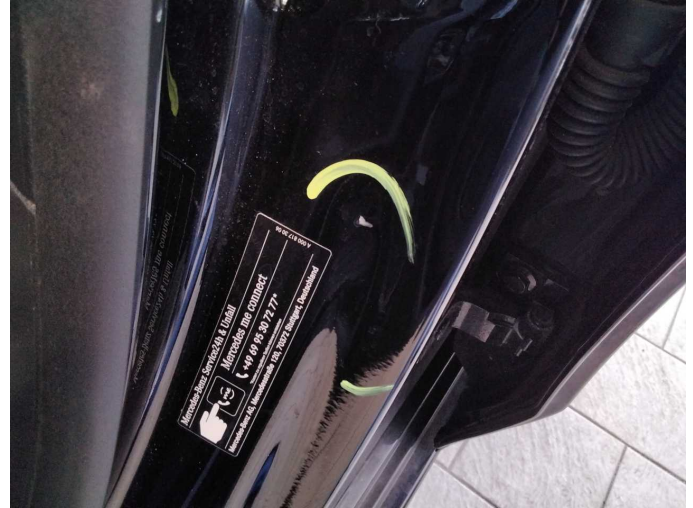
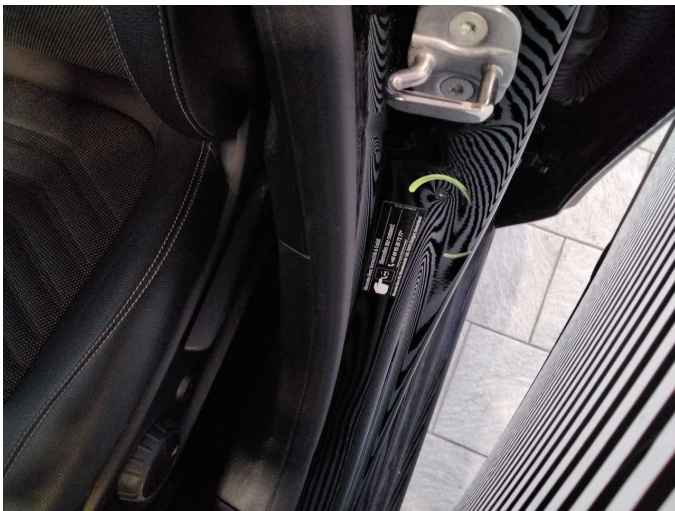
| No. | Component group | Description |
|---|---|---|
| 3 | Body | B-pillar - left side - Dent / paintcoat damage - Smart repair |

**Damage 3:** Body: B-pillar - left side - Dent / paintcoat damage - Smart repair

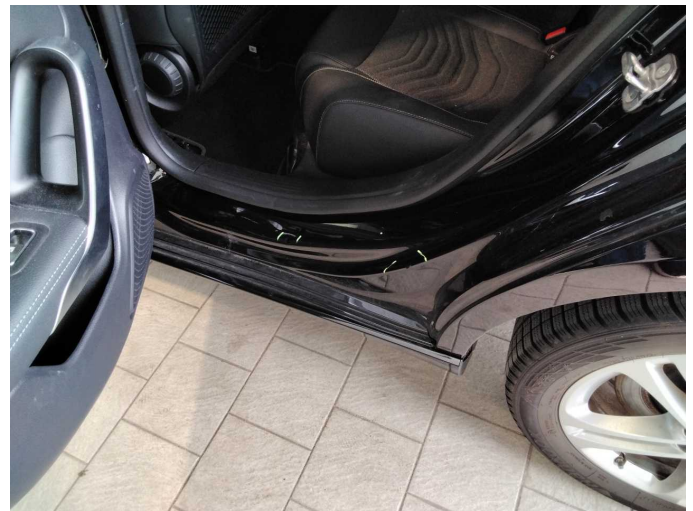
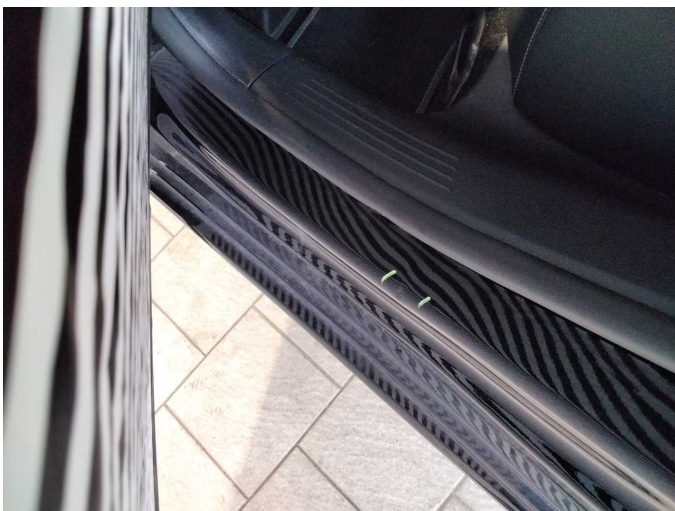
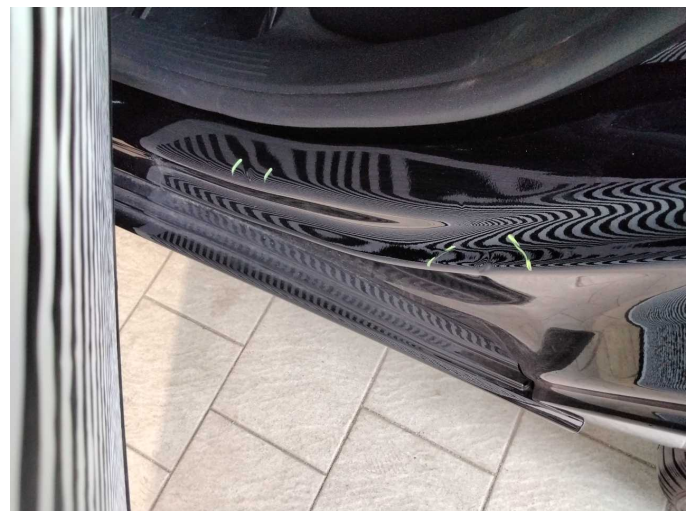
| No. | Component group | Description |
|---|---|---|
| 4 | Body | C-pillar - left side - dent(s) - Smart repair |

**Damage 4:** Body: C-pillar - left side - dent(s) - Smart repair

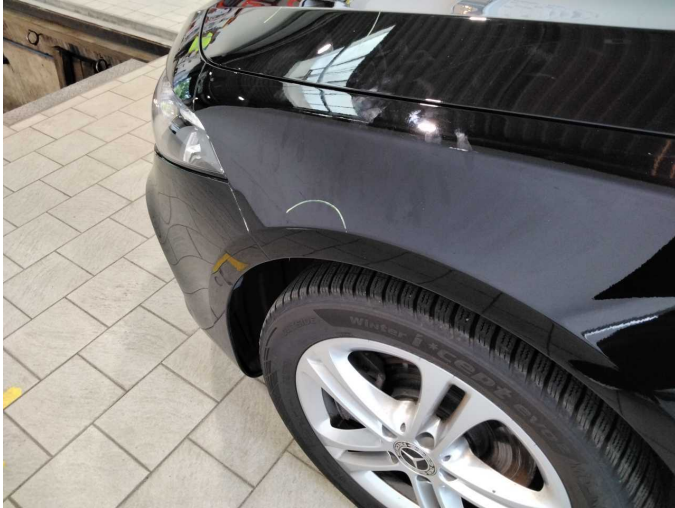
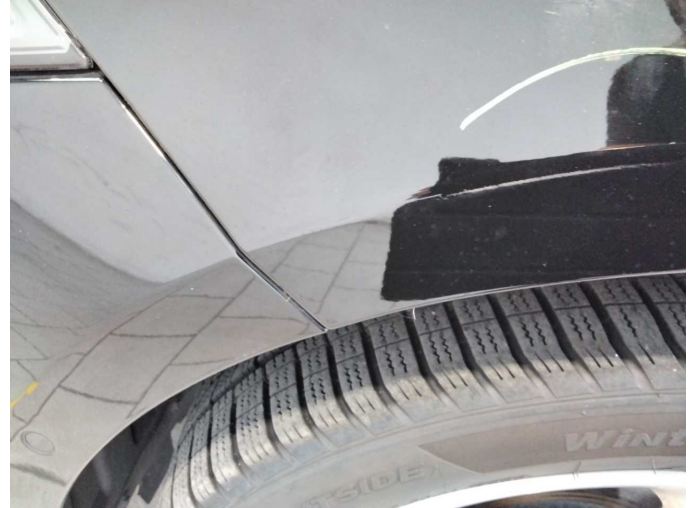
| No. | Component group | Description |
|---|---|---|
| 5 | Mudguard - left side | Mudguard - left side - Scratch(es) - Smart repair |

**Damage 5:** Mudguard - left side: Mudguard - left side - Scratch(es) - Smart repair

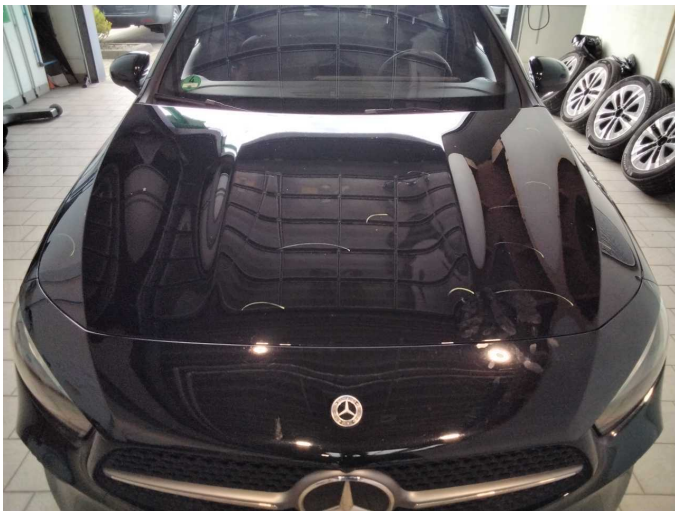
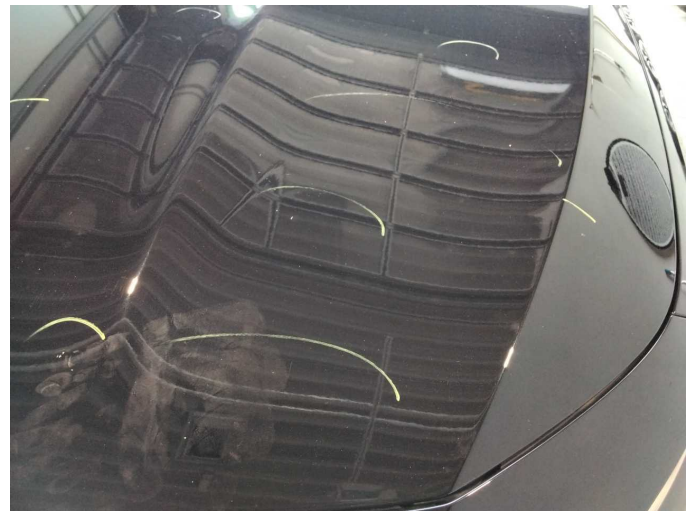
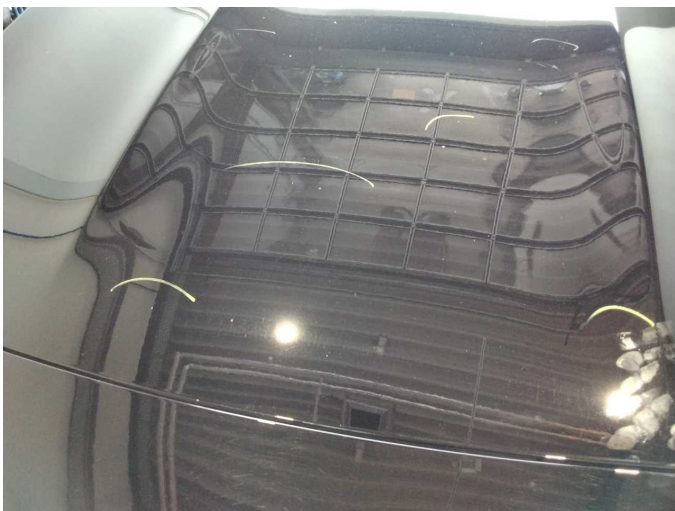
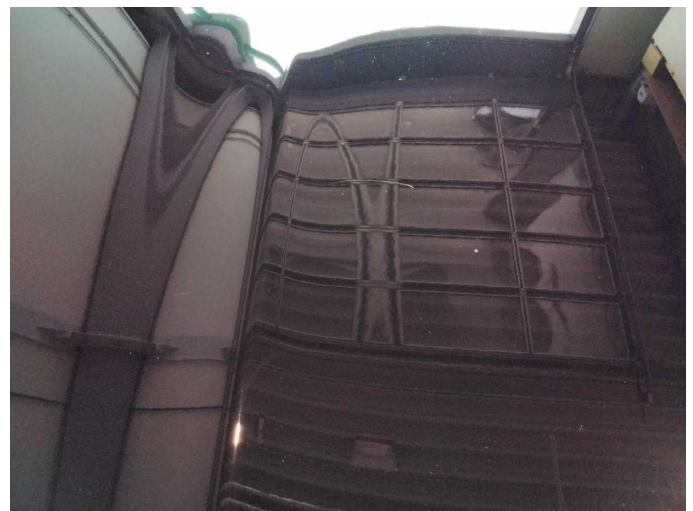
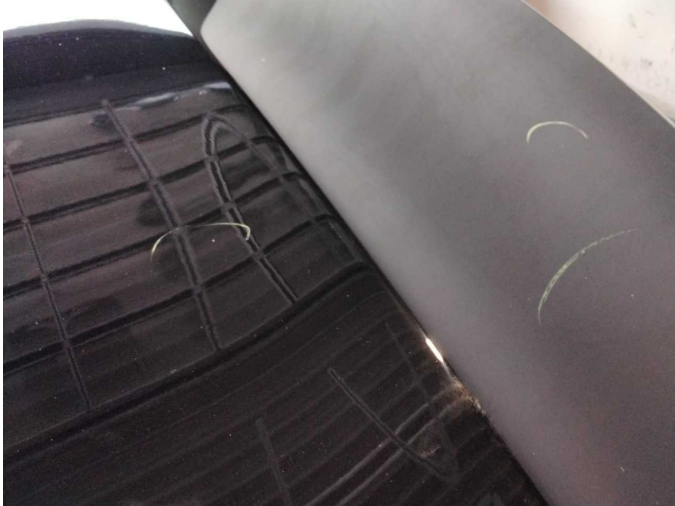
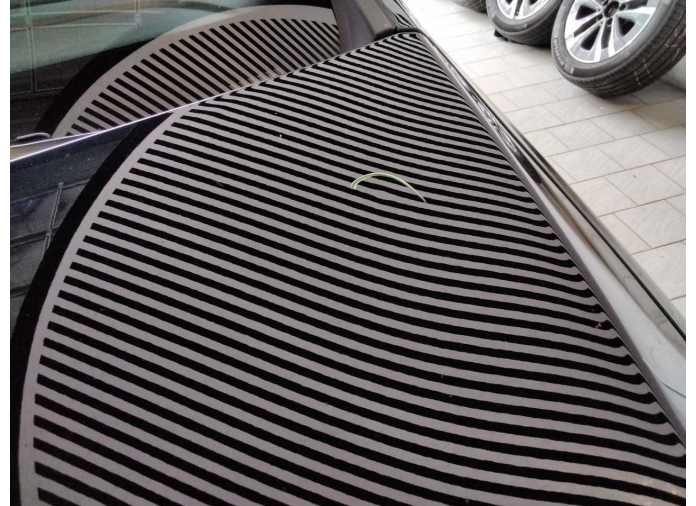
| No. | Component group | Description |
|---|---|---|
| 6 | Bonnet | Bonnet - Dent / paintcoat damage - Repair and paint |

**Damage 6:** Bonnet: Bonnet - Dent / paintcoat damage - Repair and paint

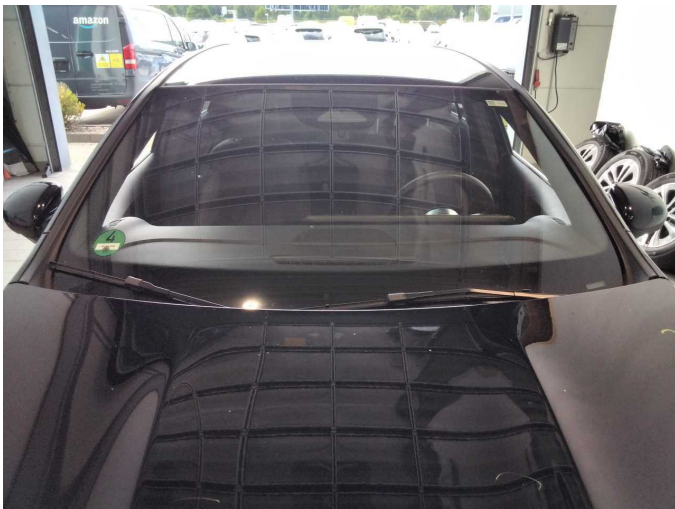
| No. | Component group | Description |
|---|---|---|
| 1 | Vehicle glazing | Windscreen - Stone chips - No deduction |

**Wear and tear 1:** Vehicle glazing: Windscreen - Stone chips - No deduction

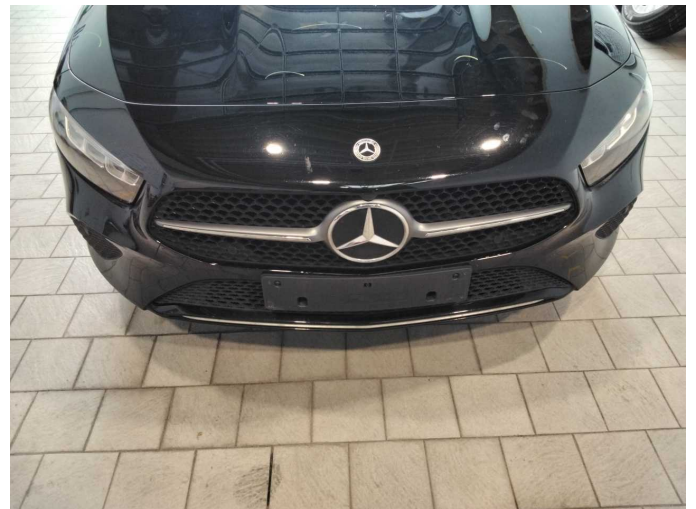
| No. | Component group | Description |
|---|---|---|
| 2 | Front bumper | Front bumper - Stone chips - No deduction |

**Wear and tear 2:** Front bumper: Front bumper - Stone chips - No deduction

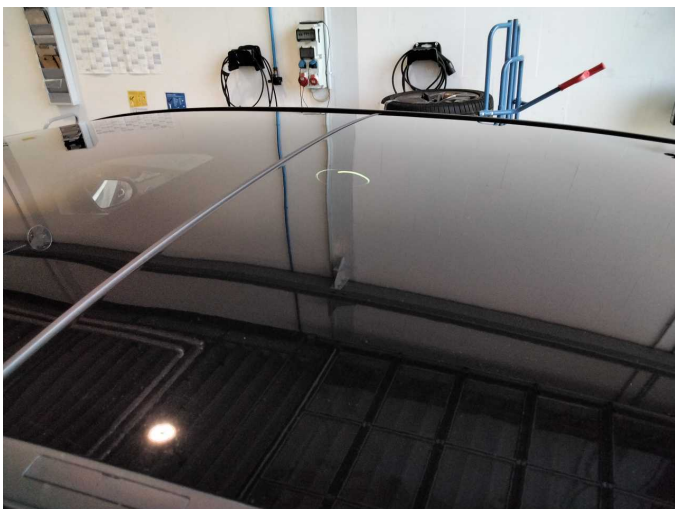
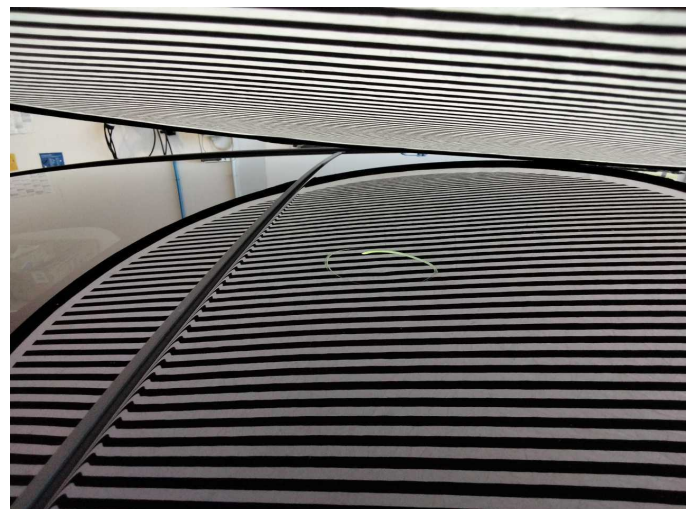
| No. | Component group | Description |
|---|---|---|
| 3 | Roof | Roof - dent(s) - Smooth repair work |

**Wear and tear 3:** Roof: Roof - dent(s) - Smooth repair work
