Expertise

Protocol number: 46093698  
Order No. / Reference: 26504743  
Inspection date: 23 Jun 2026

Manufacturer: Volkswagen

Model: Tiguan Allspace 2.0 TDI SCR DSG Life

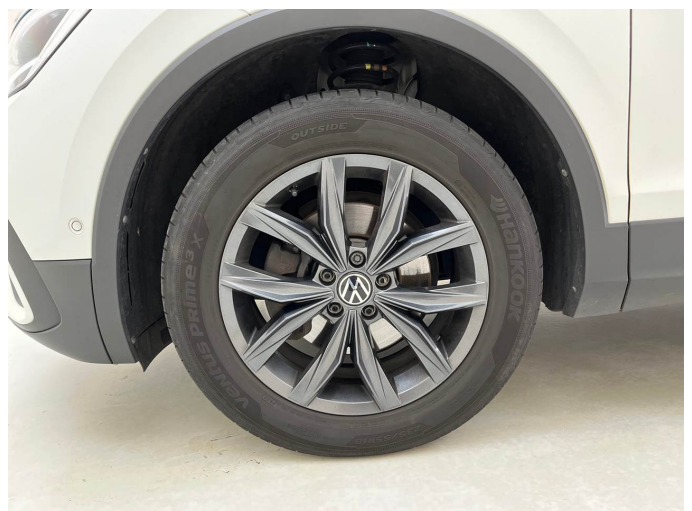
Figure 12: Mounted tyres

| # | Tyre size | Type of tyre | Manufacturer | Tread depth |
|---|---|---|---|---|
| 1) | 235/55 R18 100V | Summer tyres on Light alloy | Hankook | 4mm / 4mm |
| 2) | 235/55 R18 100V | Summer tyres on Light alloy | Michelin | 6mm / 6mm |

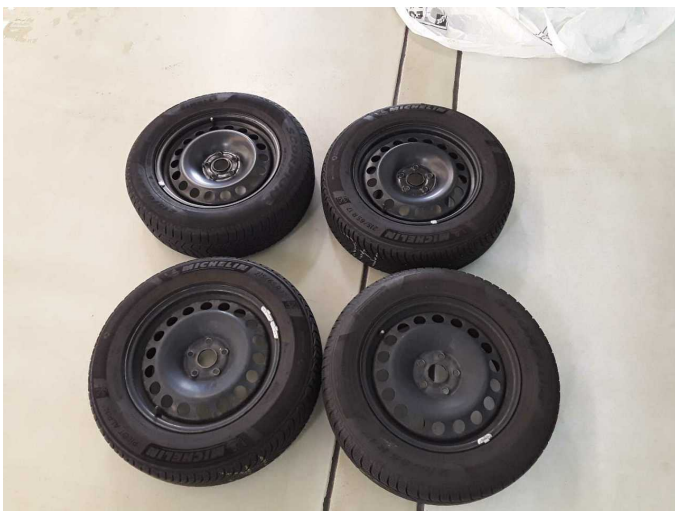
Figure 17: Additional tyres

| # | Tyre size | Type of tyre | Manufacturer | Tread depth |
|---|---|---|---|---|
| 1) | 215/65 R17 99H | Winter tyres on Steel | Pirelli | 5mm / 5mm |
| 2) | 215/65 R17 99H | Winter tyres on Steel | Michelin | 6mm / 6mm |

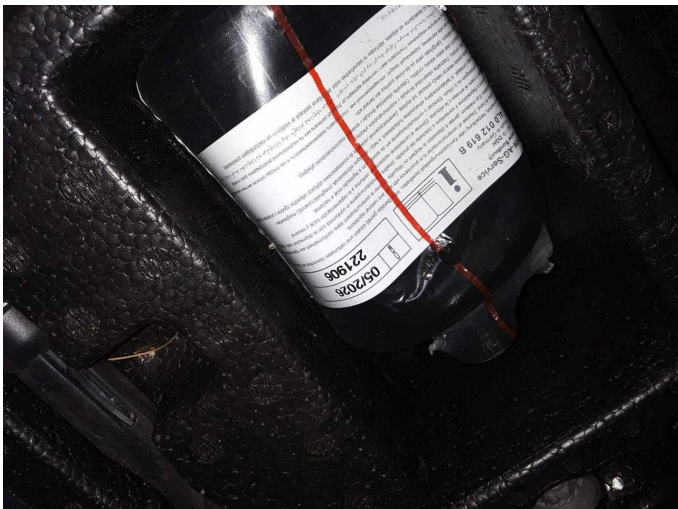
Damage 2: Equipment: Tirefit filler - Due - Replace

| No. | Component group | Description |
|---|---|---|
| 2 | Equipment | Tirefit filler - Due - Replace |

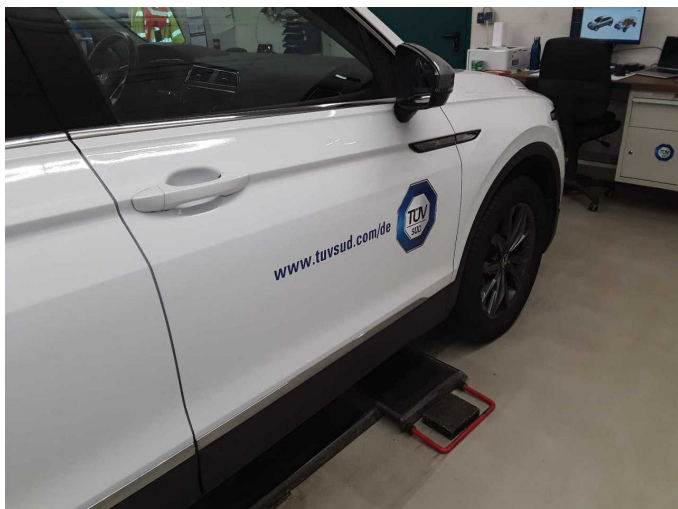
**Damage 3:** Body: Body - Glued / labelled - De-glue / neutralise

| No. | Component group | Description |
|---|---|---|
| 3 | Body | Body - Glued / labelled - De-glue / neutralise |

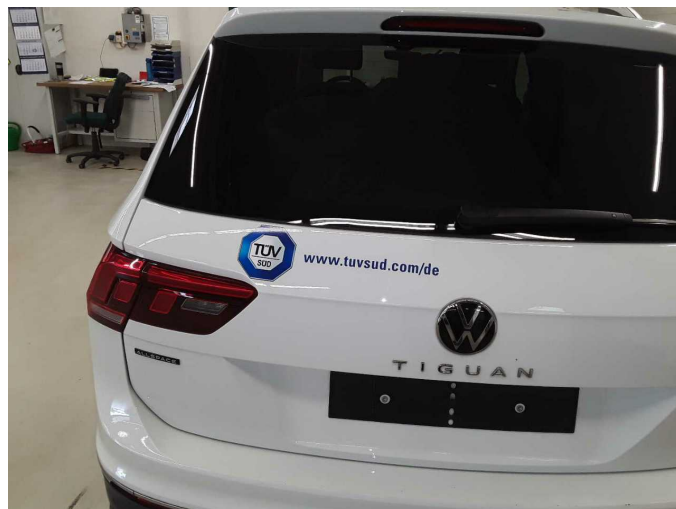
**Damage 3:** Body: Body - Glued / labelled - De-glue / neutralise

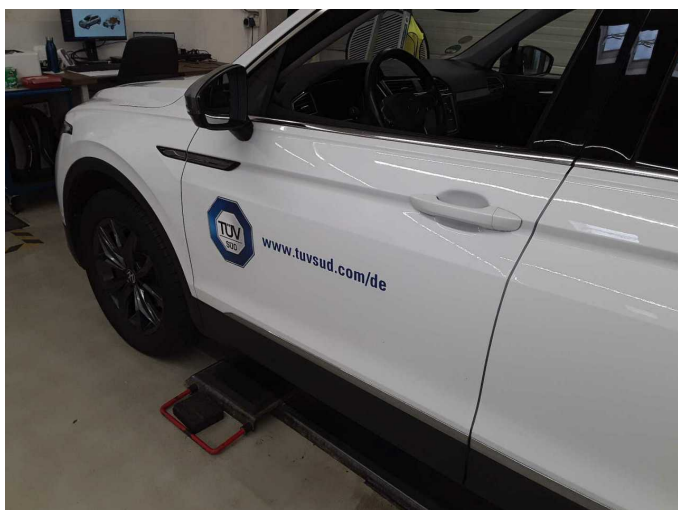
**Damage 3:** Body: Body - Glued / labelled - De-glue / neutralise

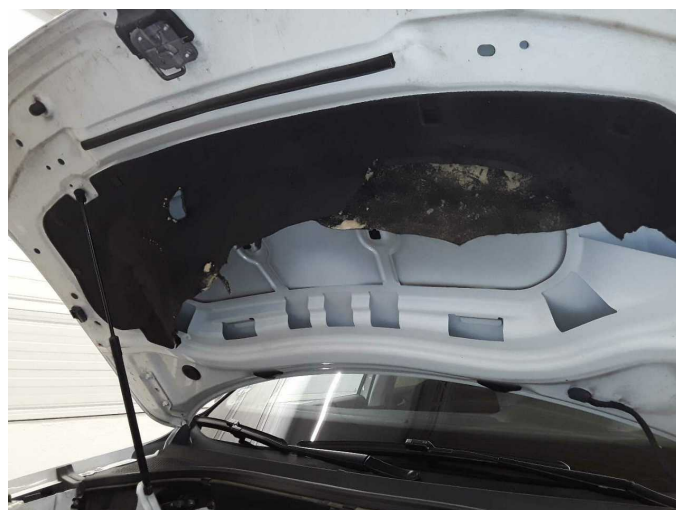
**Damage 4:** Bonnet: Insulation lining - Damage caused by marten / rodent  
- Replace

| No. | Component group | Description |
|---|---|---|
| 4 | Bonnet | Insulation lining - Damage caused by marten / rodent - Replace |

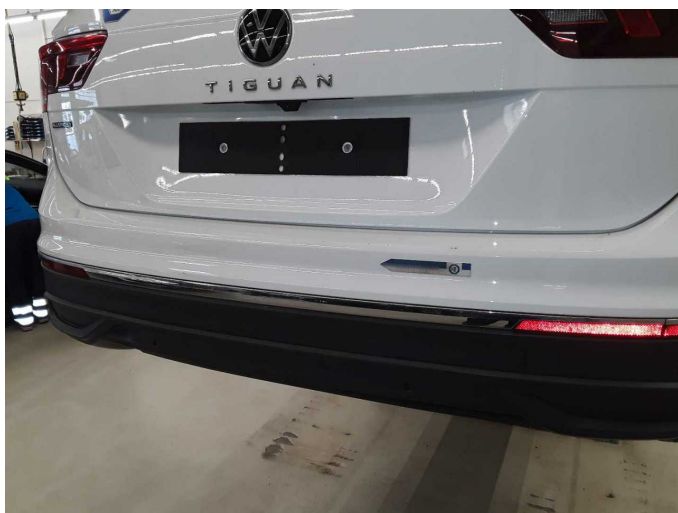
**Damage 5:** Rear bumper: Rear bumper - Scratch(es) - Smart repair

| No. | Component group | Description |
|---|---|---|
| 5 | Rear bumper | Rear bumper - Scratch(es) - Smart repair |

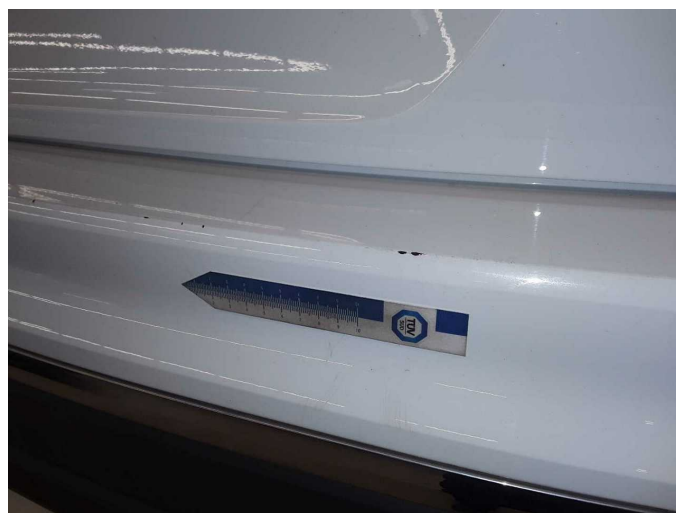
**Damage 5:** Rear bumper: Rear bumper - Scratch(es) - Smart repair

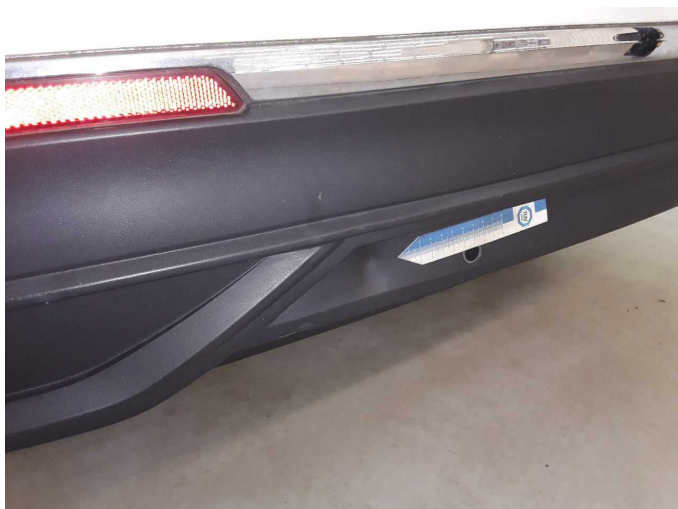
**Damage 6:** Rear bumper: Spoiler (unlackiert) - dent(s) - Replace

| No. | Component group | Description |
|---|---|---|
| 6 | Rear bumper | Spoiler (unlackiert) - dent(s) - Replace |

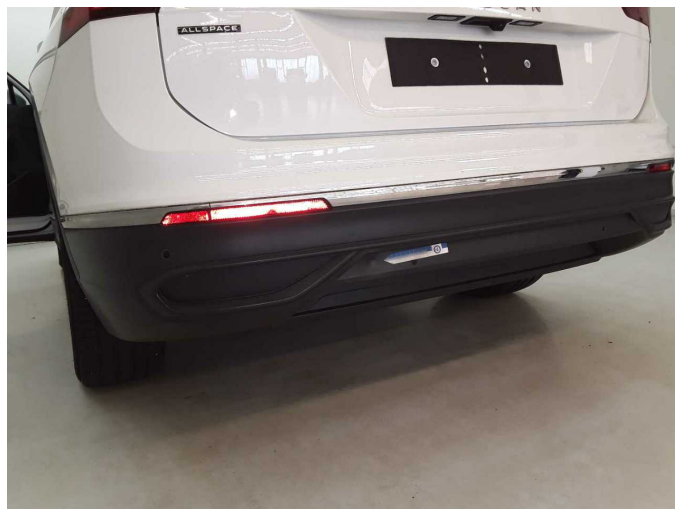
**Damage 6:** Rear bumper: Spoiler (unlackiert) - dent(s) - Replace

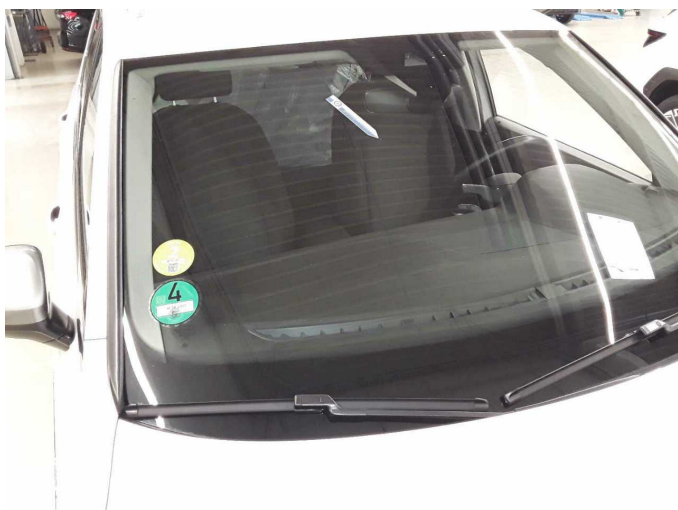
**Damage 7:** Vehicle glazing: Windscreen - Stone chips - Replace

| No. | Component group | Description |
|---|---|---|
| 7 | Vehicle glazing | Windscreen - Stone chips - Replace |

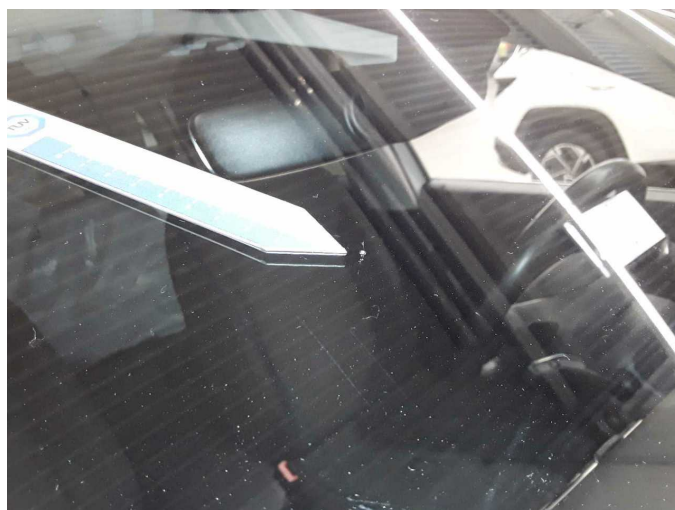
**Damage 7:** Vehicle glazing: Windscreen - Stone chips - Replace
