Expertise

Protocol number: 45897264  
Order No. / Reference: 26446232  
Inspection date: 11 Jun 2026

Manufacturer: Volkswagen

Model: Passat Variant 2.0 TDI SCR DSG Business

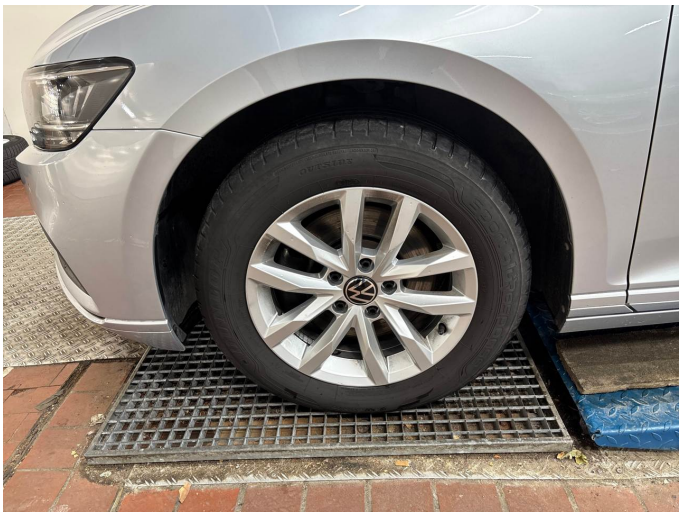
Figure 12: Mounted tyres

| # | Tyre size | Type of tyre | Manufacturer | Tread depth |
|---|---|---|---|---|
| 1) | 215/60 R16 95V | Summer tyres on Light alloy | Dunlop | 5mm / 5mm |
| 2) | 215/60 R16 95V | Summer tyres on Light alloy | Continental | 0mm / 0mm |

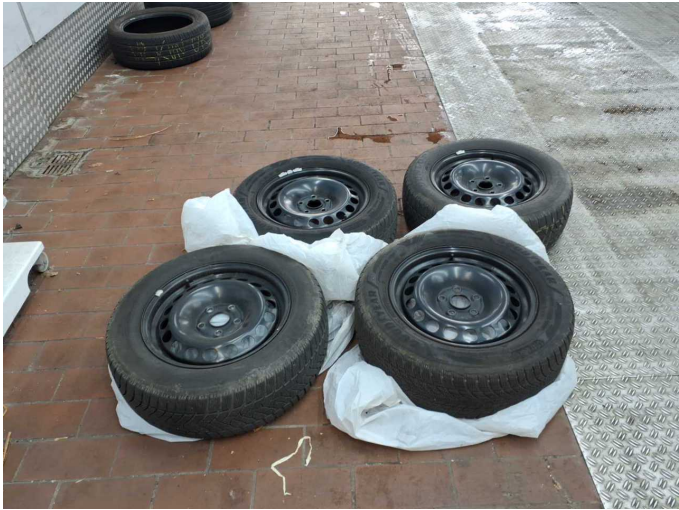
Figure 16: Additional tyres

| # | Tyre size | Type of tyre | Manufacturer | Tread depth |
|---|---|---|---|---|
| 1) | 215/60 R16 95H | Winter tyres on Steel | Goodyear | 5mm / 5mm |
| 2) | 215/60 R16 95H | Winter tyres on Steel | Dunlop | 7mm / 7mm |

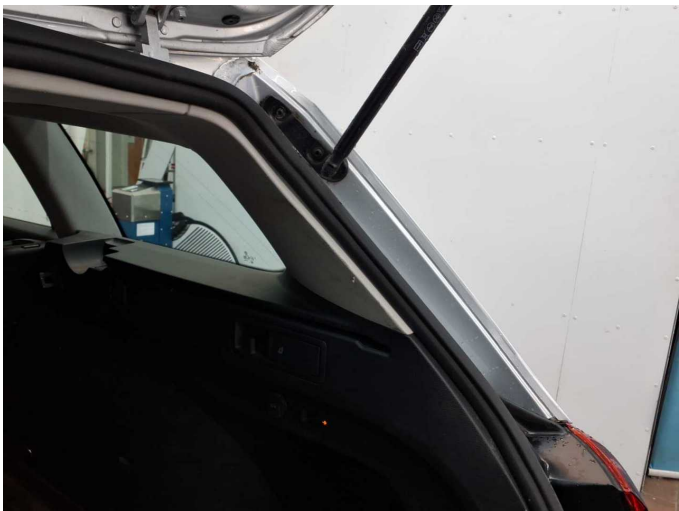
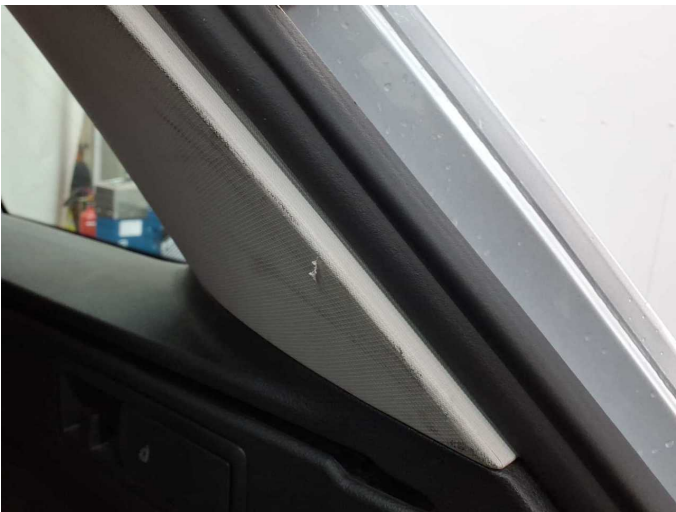
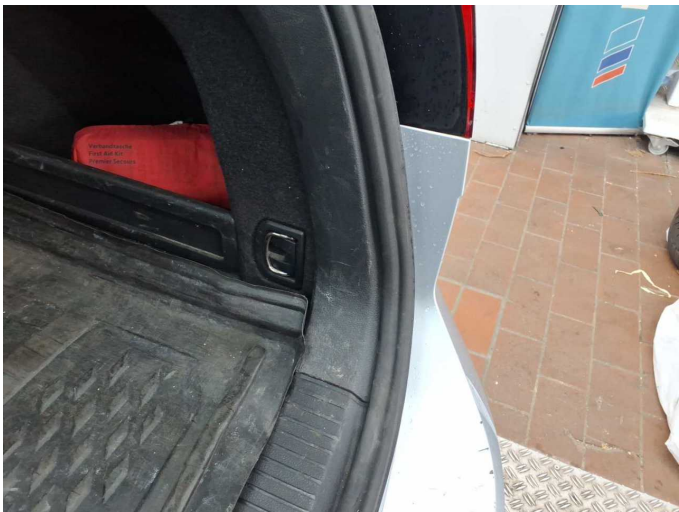
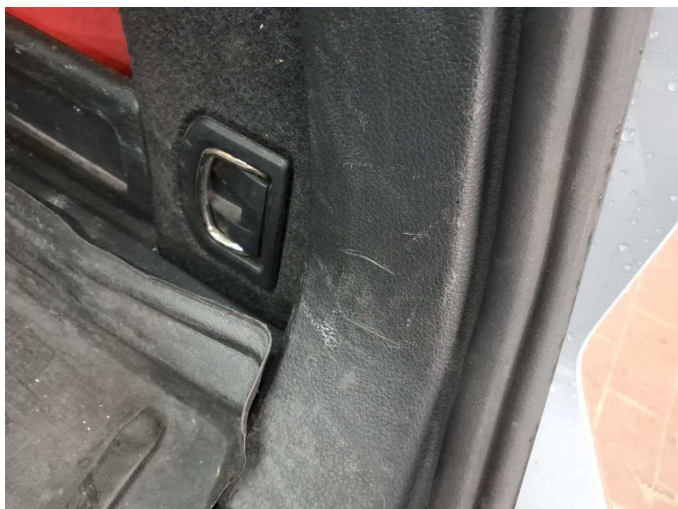
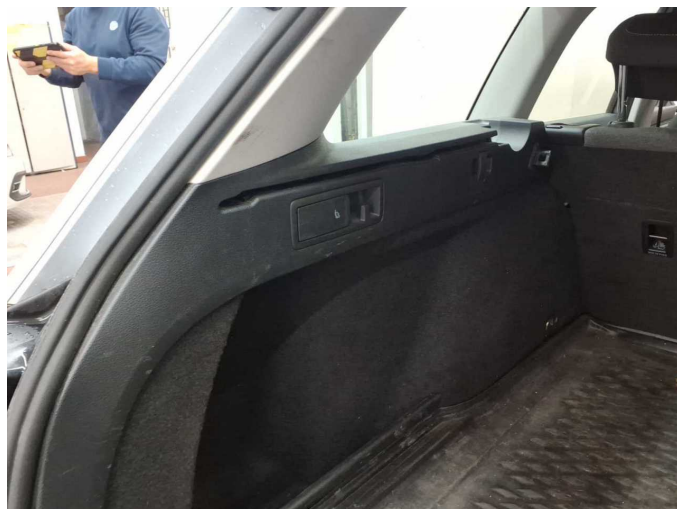
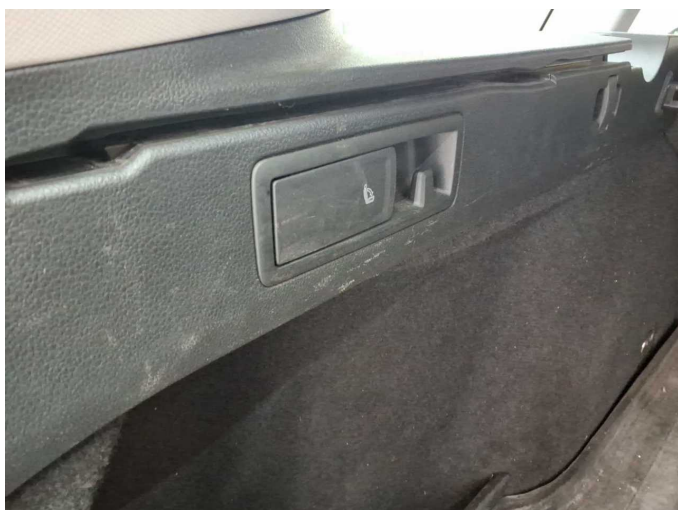
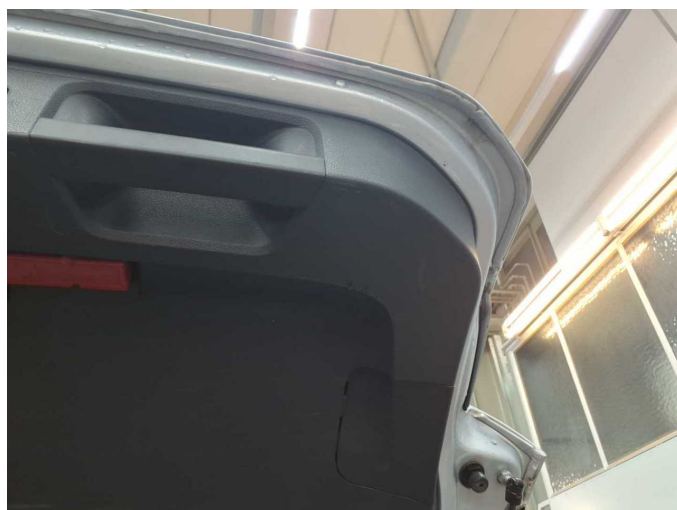
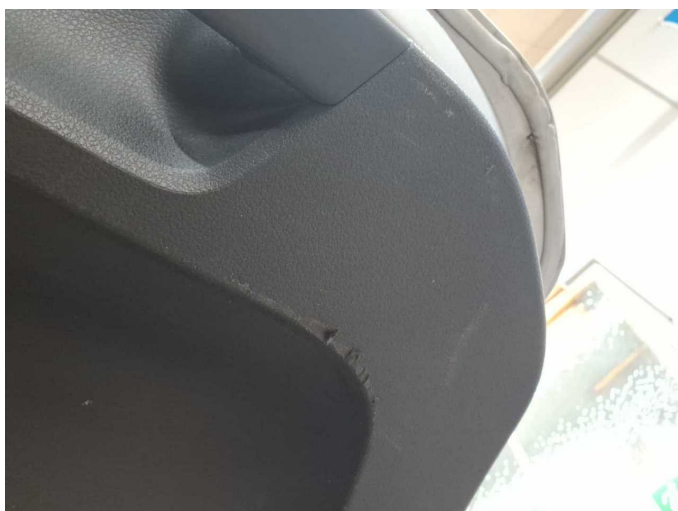
| No. | Component group | Description |
|---|---|---|
| 1 | Interior | Interior - Scratch(es) - Loss in value |

Damage 1: Interior: Interior - Scratch(es) - Loss in value

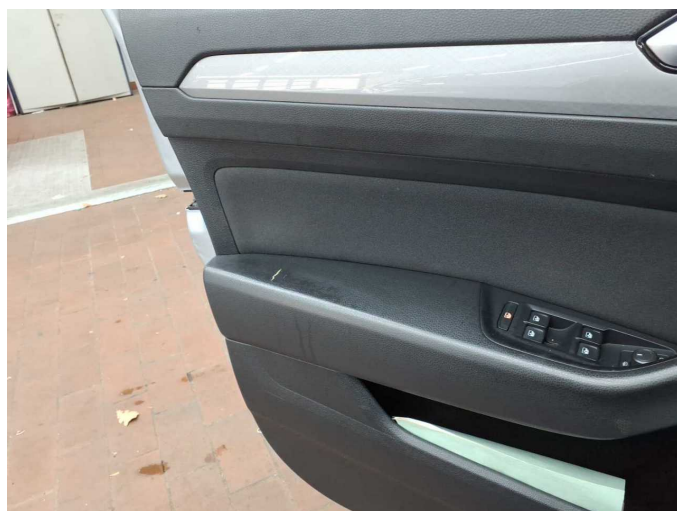
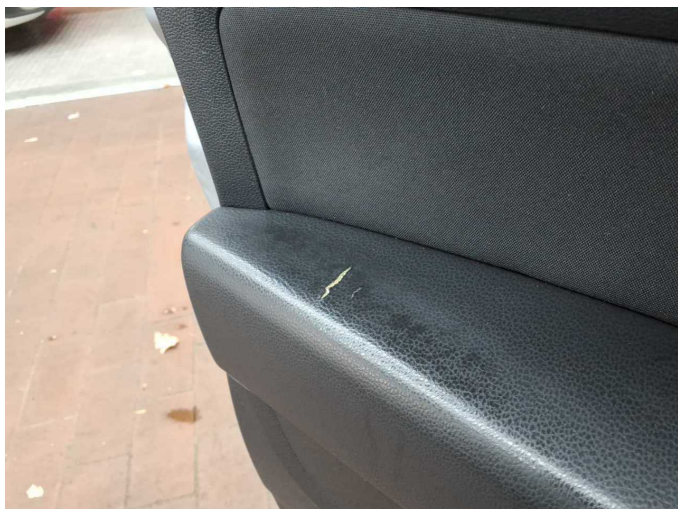
| No. | Component group | Description |
|---|---|---|
| 2 | Trim / covers | Door trim - front left side (Armauflage) - Broken / torn - Replace |

**Damage 2:** Trim / covers: Door trim - front left side (Armauflage) - Broken / torn - Replace

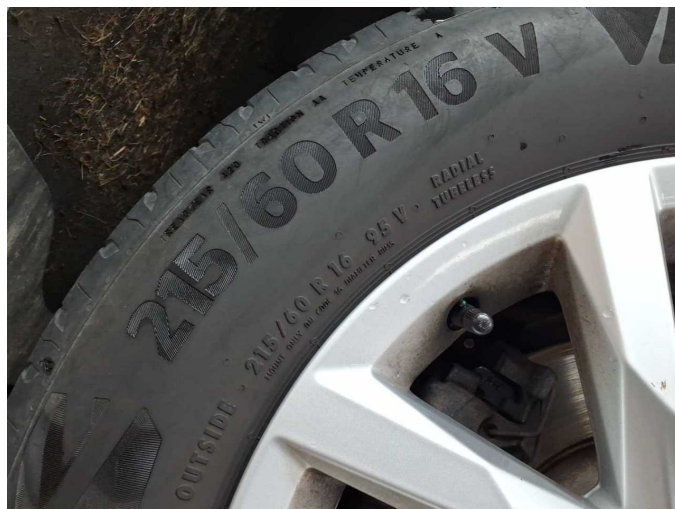
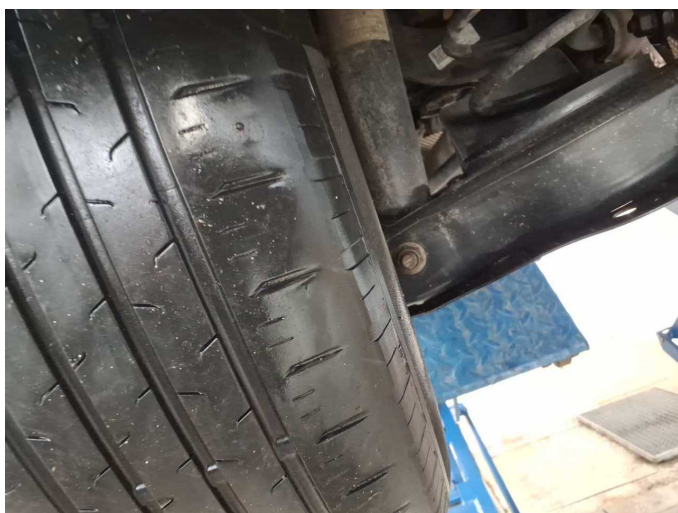
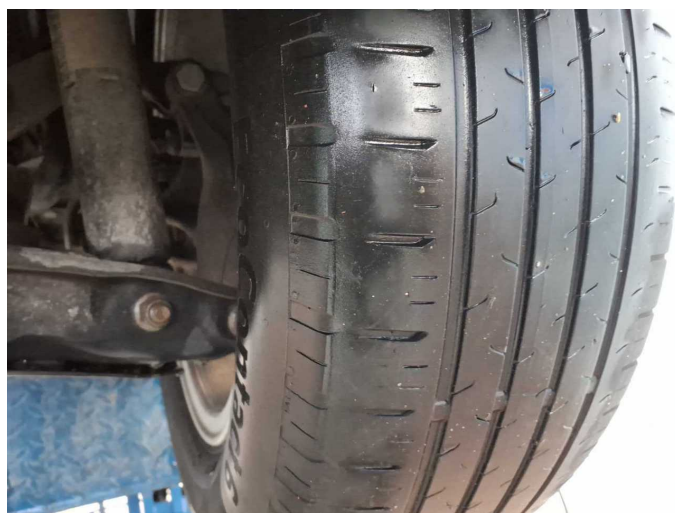
| No. | Component group | Description |
|---|---|---|
| 3 | Wheel / tyres | Tyre - right - Worn - Replace |

**Damage 3:** Wheel / tyres: Tyre - right - Worn - Replace

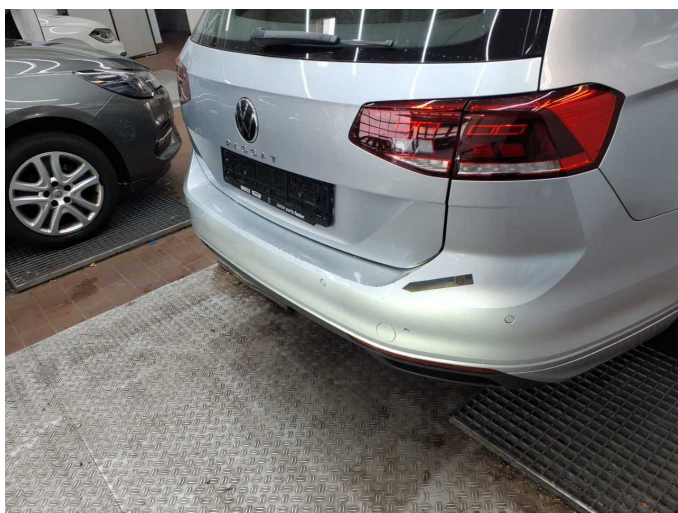
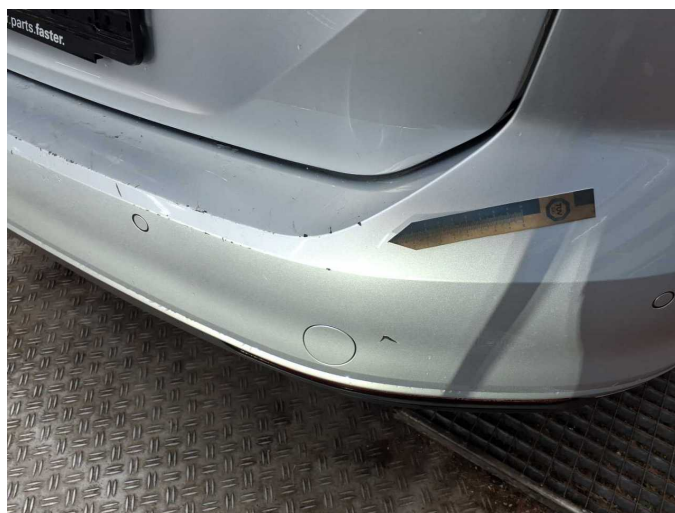
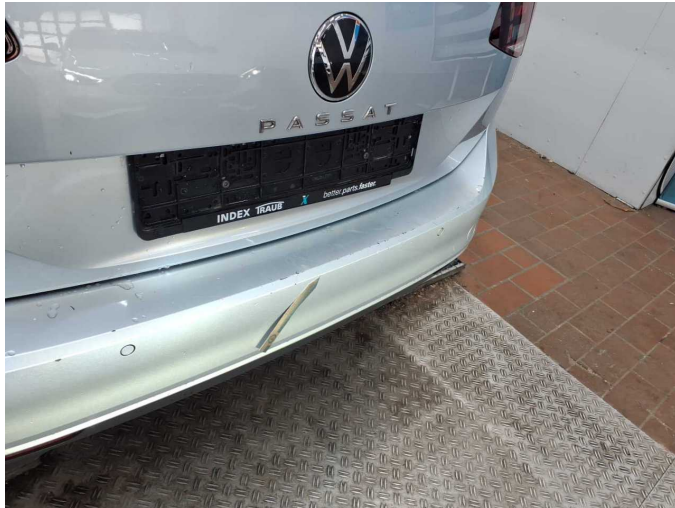
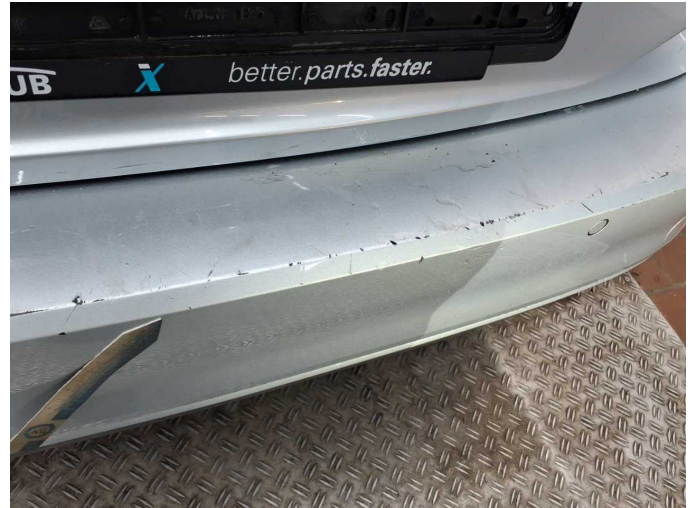
| No. | Component group | Description |
|---|---|---|
| 4 | Rear bumper | Rear bumper - Scratch(es) - Paint |

**Damage 4:** Rear bumper: Rear bumper - Scratch(es) - Paint

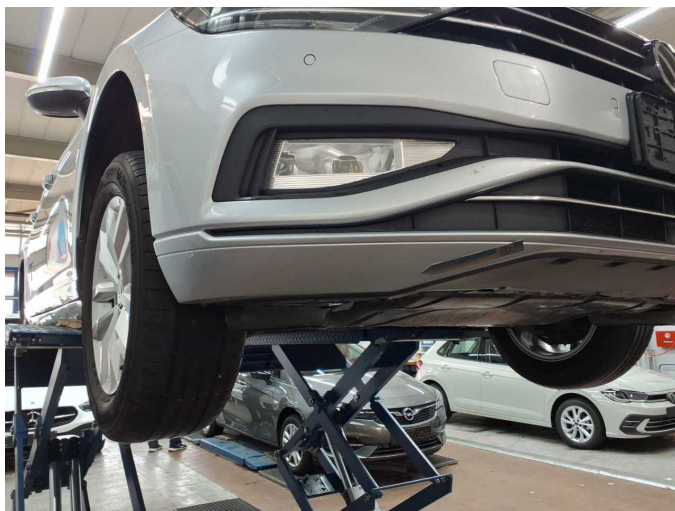
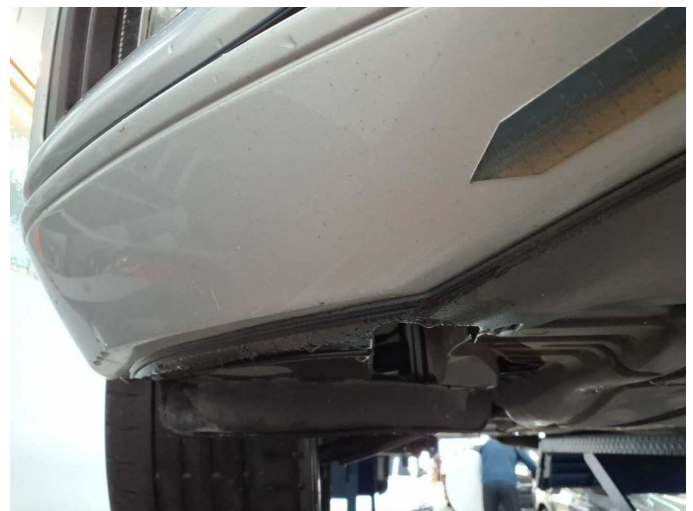
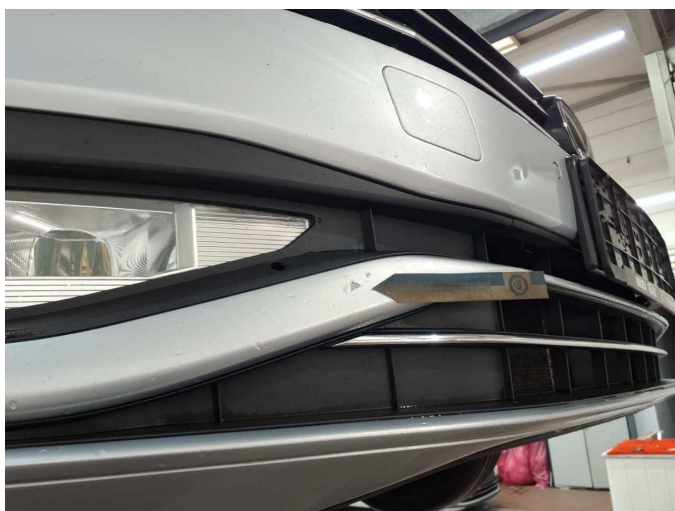
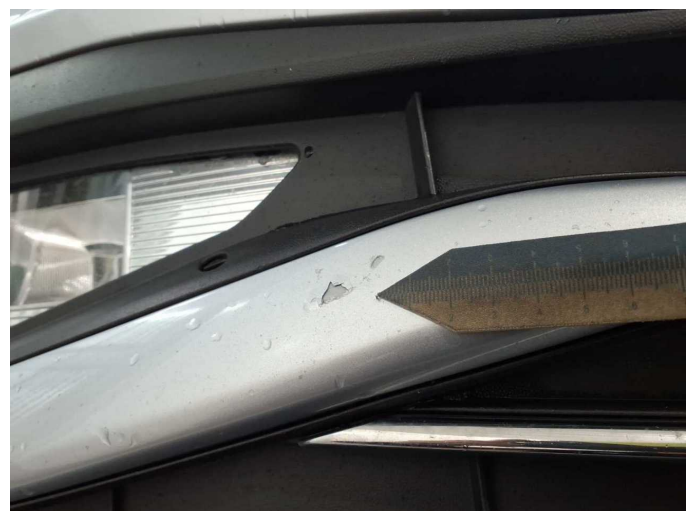
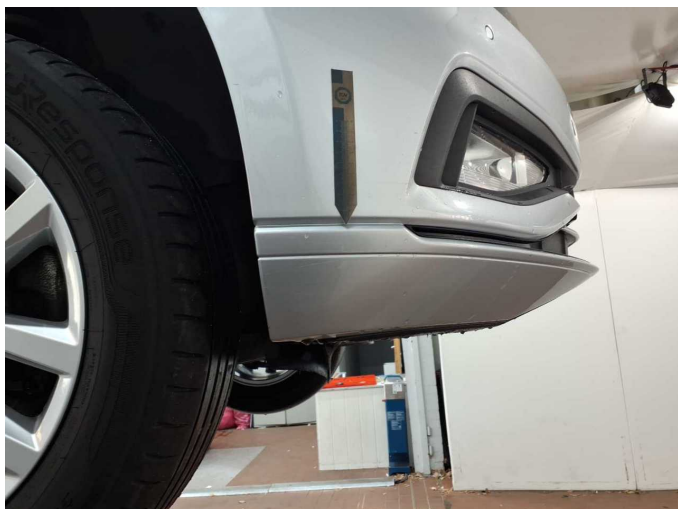
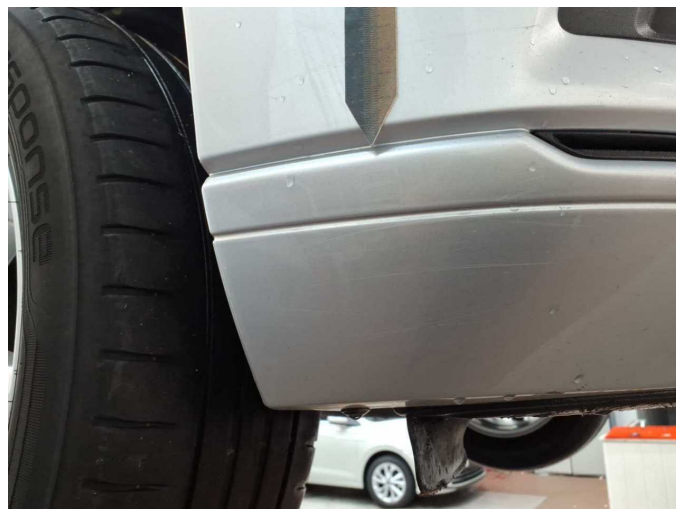
| No. | Component group | Description |
|---|---|---|
| 5 | Front bumper | Front bumper - Scratch(es) - Paint |

**Damage 5:** Front bumper: Front bumper - Scratch(es) - Paint

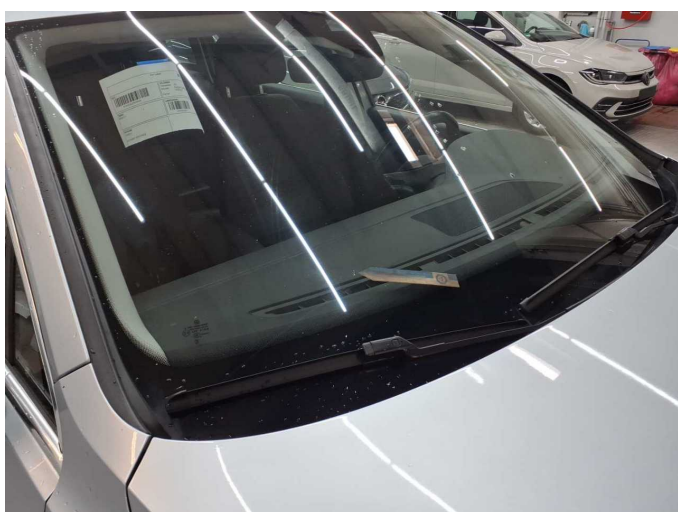
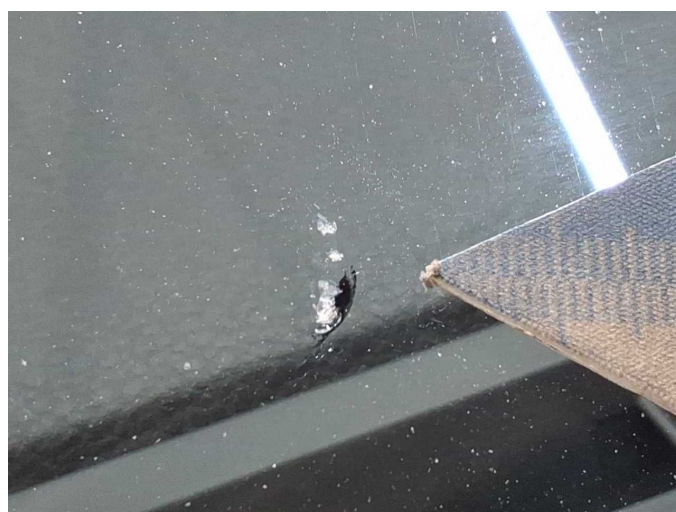
| No. | Component group | Description |
|---|---|---|
| 6 | Vehicle glazing | Windscreen - Stone chips - Replace |

**Damage 6:** Vehicle glazing: Windscreen - Stone chips - Replace

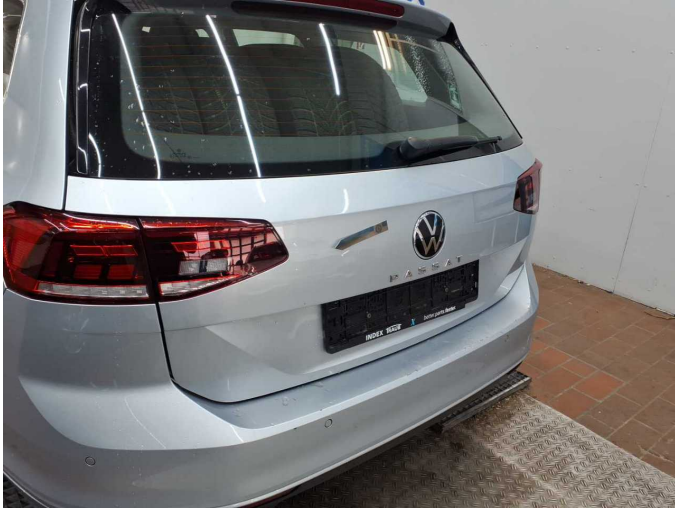
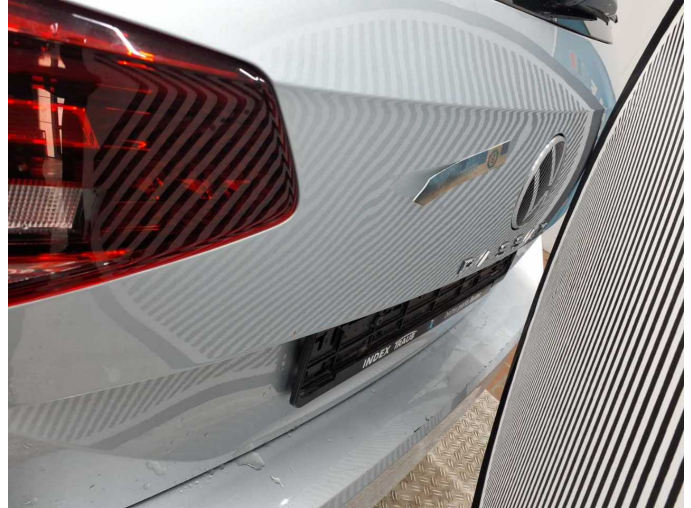
| No. | Component group | Description |
|---|---|---|
| 6 | Boot lid / rear door | Boot lid - dent(s) - No deduction |

**Wear and tear 6:** Boot lid / rear door: Boot lid - dent(s) - No deduction

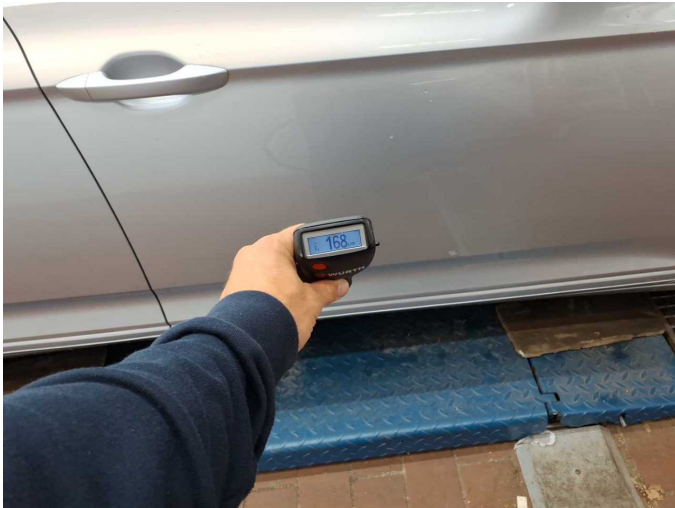
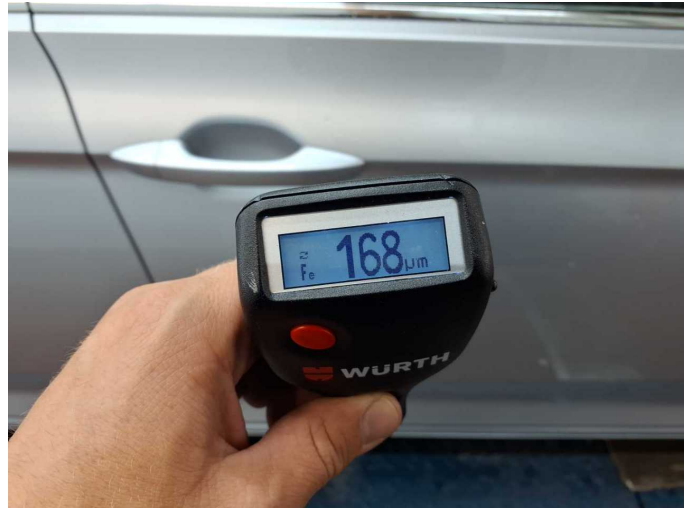
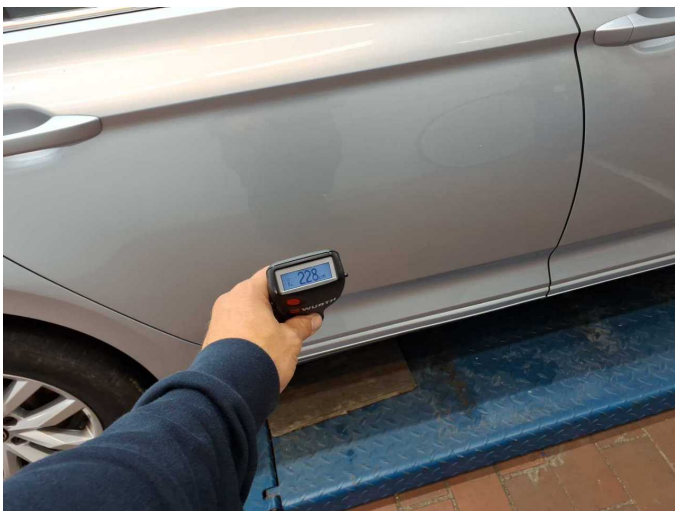
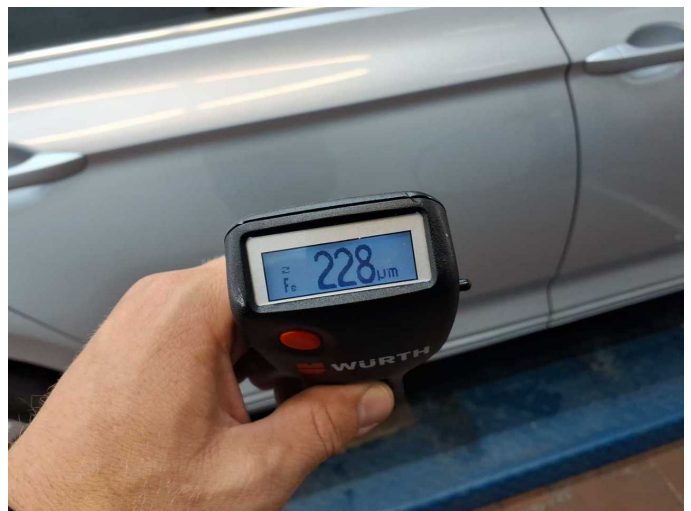
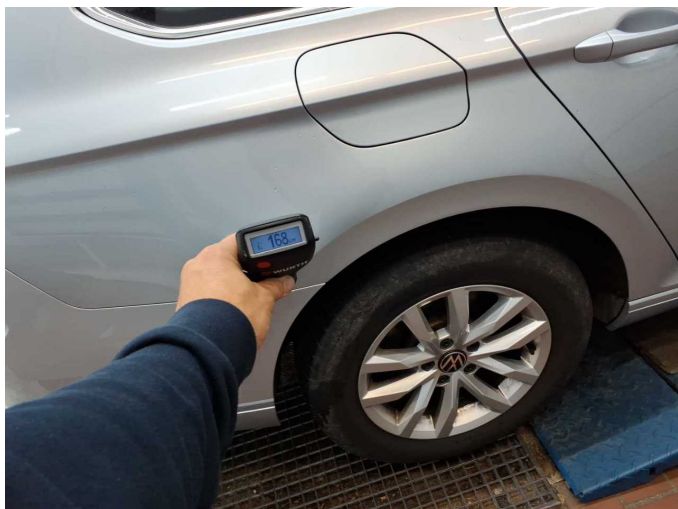
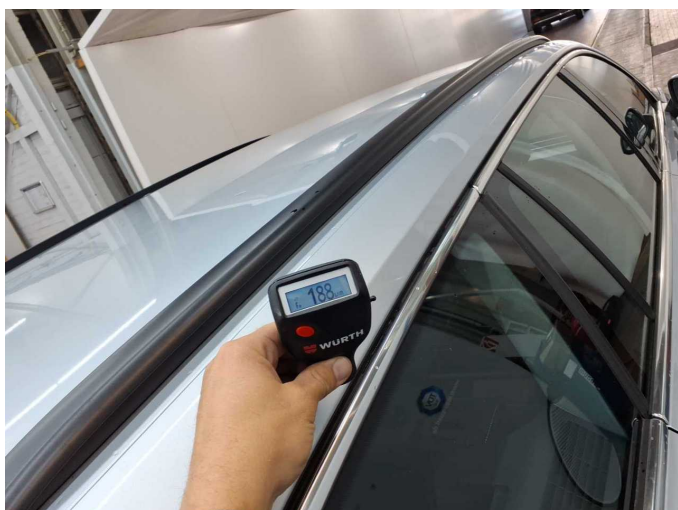
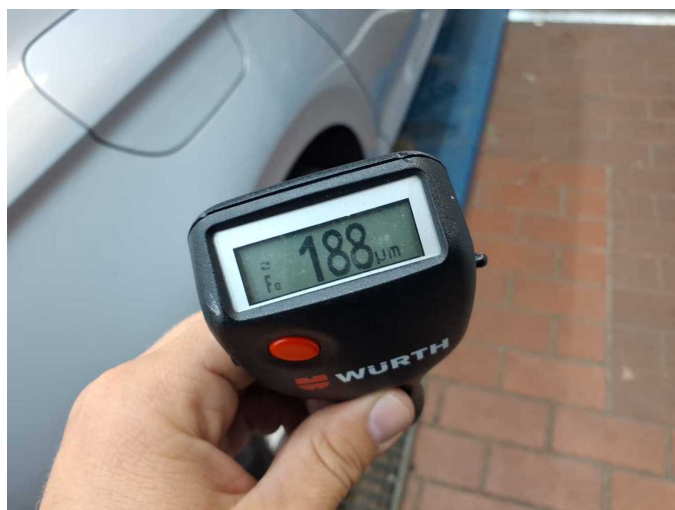
| 1 | Roof rail - right side, Side panel - rear right side, Door - rear right side, Door - front right side, Professionally carried out, Invoice of repair done<br>Non-existent |

| Roof rail - right side | 188 µm | Side panel - rear right side | 168 µm |
| Door - rear right side | 228 µm | Door - front right side | 168 µm |

**Repainting 1:** Roof rail - right side, Side panel - rear right side, Door - rear right side, Door - front right side

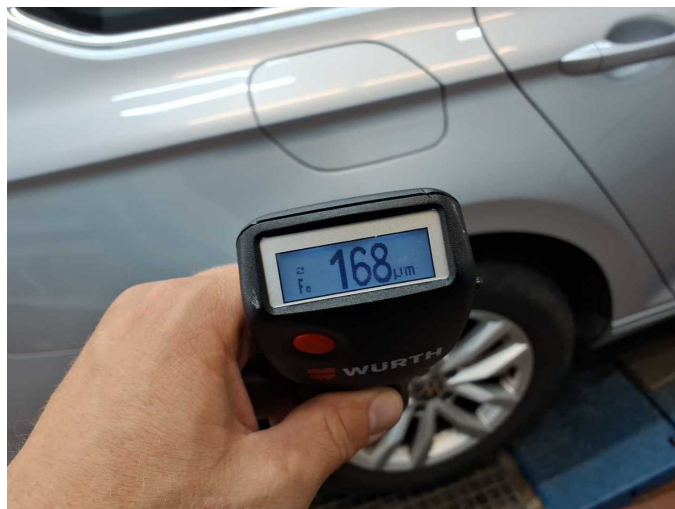
**Repainting 1:** Roof rail - right side, Side panel - rear right side, Door - rear right side, Door - front right side

According to available information previous damages were repaired at the vehicle. Traces of repairs, which allow conclusions about the area of repair, were not recognizable during the inspection.
