Expertise

Protocol number: 46667763  
Order No. / Reference: 26678440  
Inspection date: 20 Jul 2026

Model: GLE 300 d 4Matic 9G-TRONIC

VIN: W1N1671091A673411

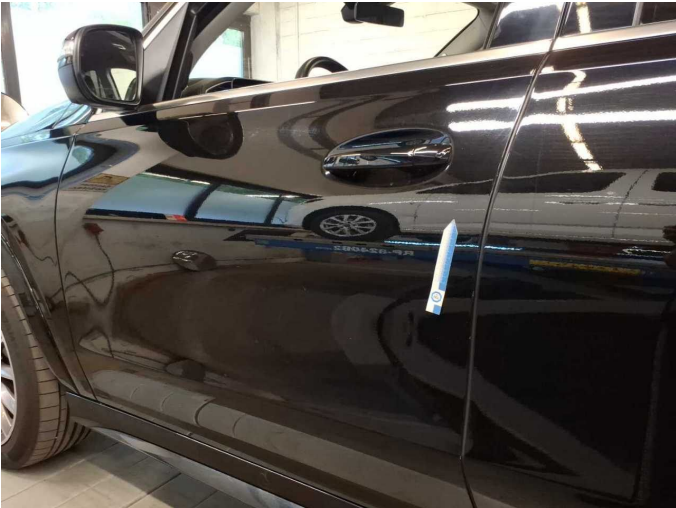
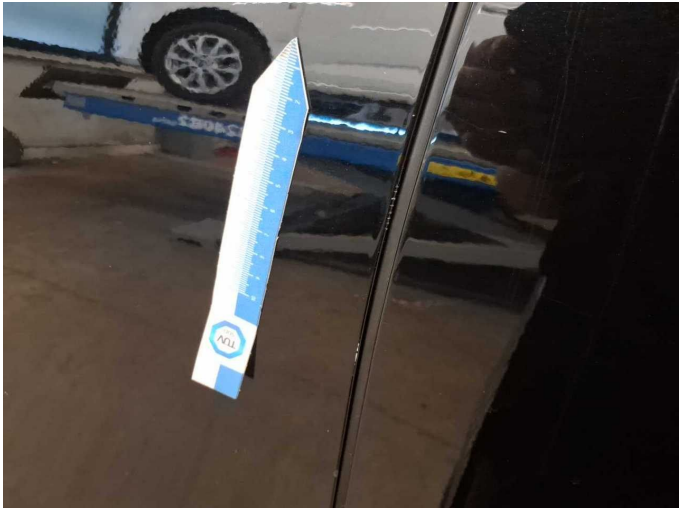
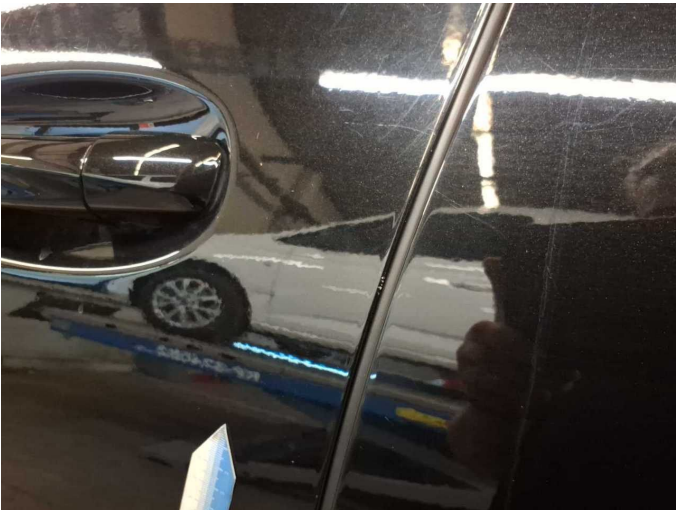
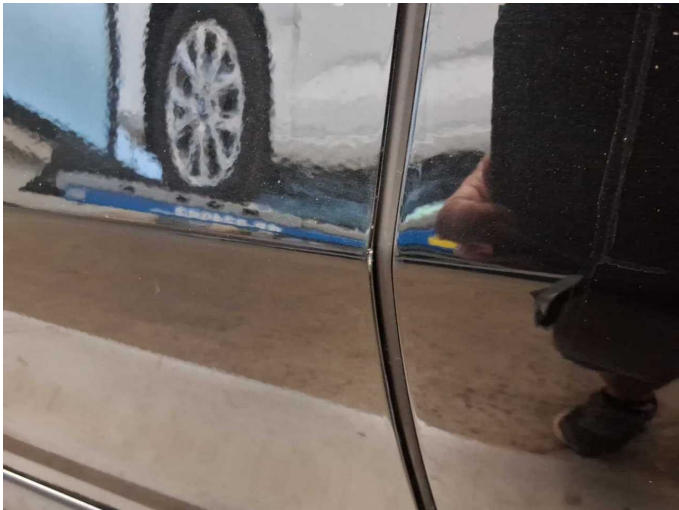
| No. | Component group | Description |
|---|---|---|
| 1 | Door - front left side | Door edge - Scratched - Smart repair |

Damage 1: Door - front left side: Door edge - Scratched - Smart repair

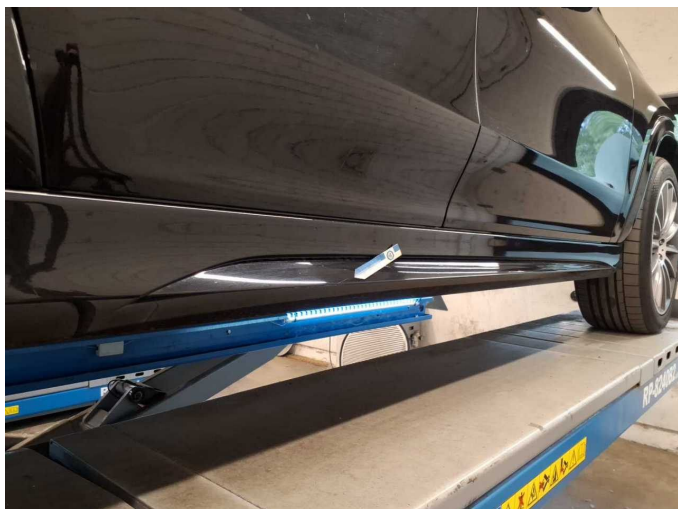
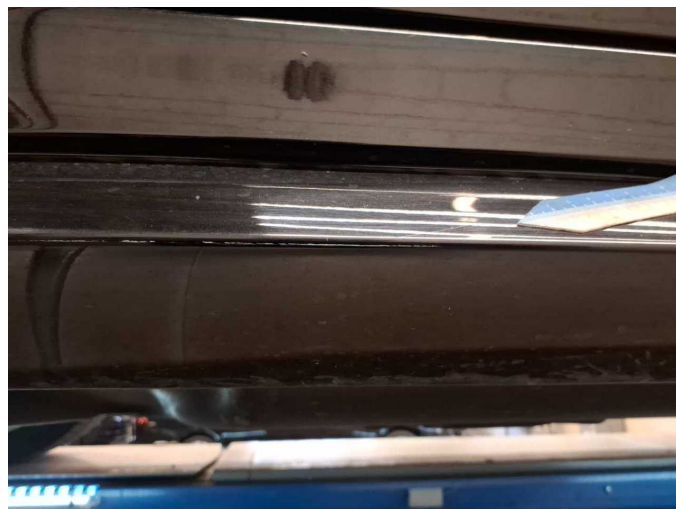
| No. | Component group | Description |
|---|---|---|
| 2 | Sill - right side | Trim - Scratched - Smart repair |

**Damage 2:** Sill - right side: Trim - Scratched - Smart repair

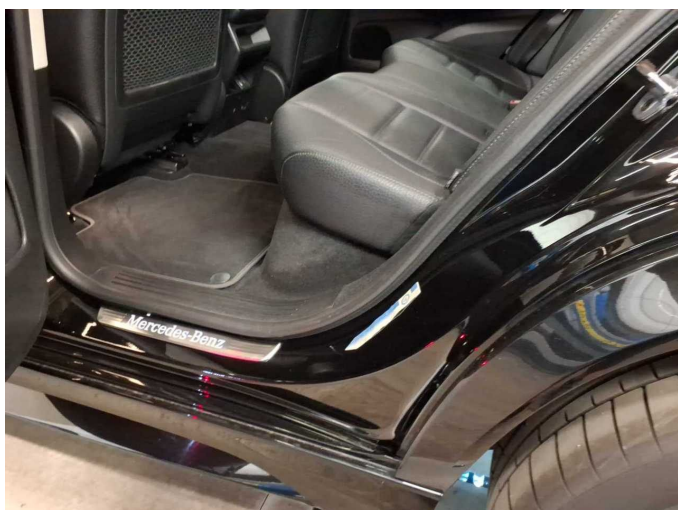
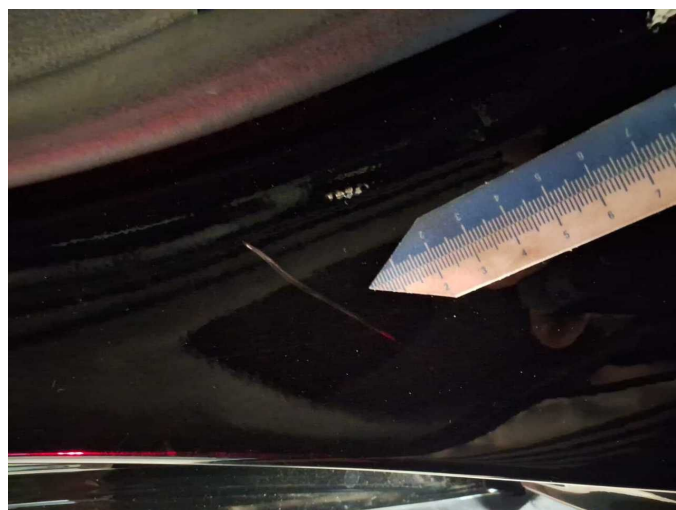
| No. | Component group | Description |
|---|---|---|
| 3 | Side panel - rear left side | Sill - Scratch(es) - Smart repair |

**Damage 3:** Side panel - rear left side: Sill - Scratch(es) - Smart repair

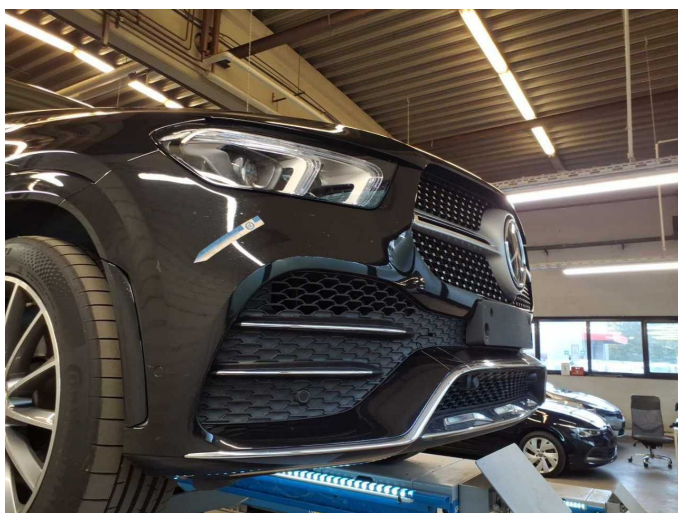
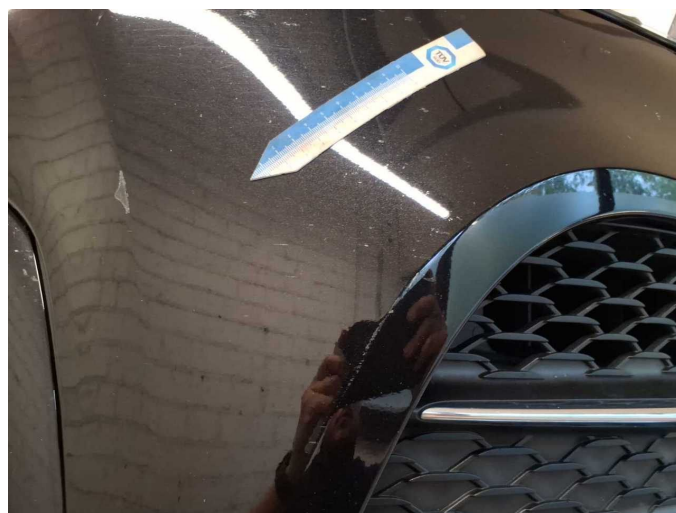
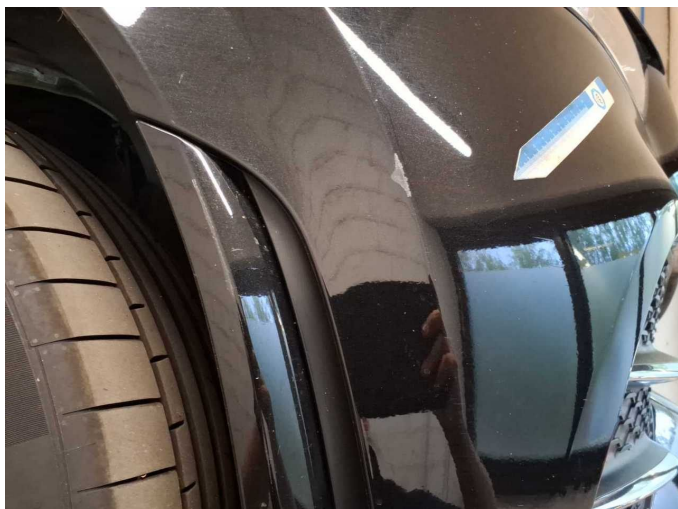
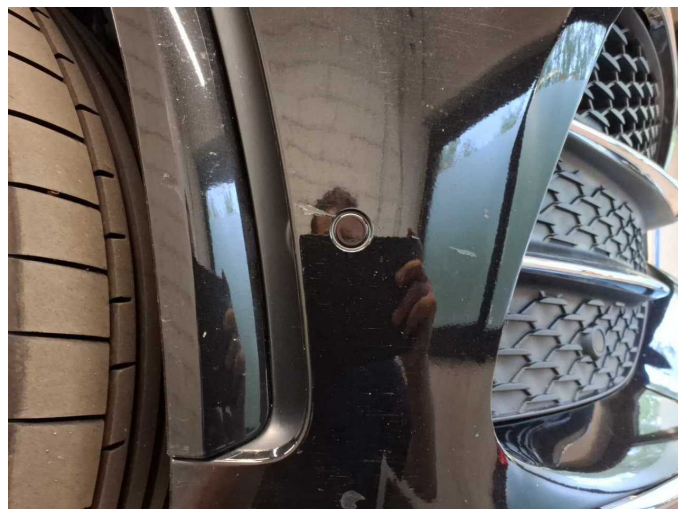
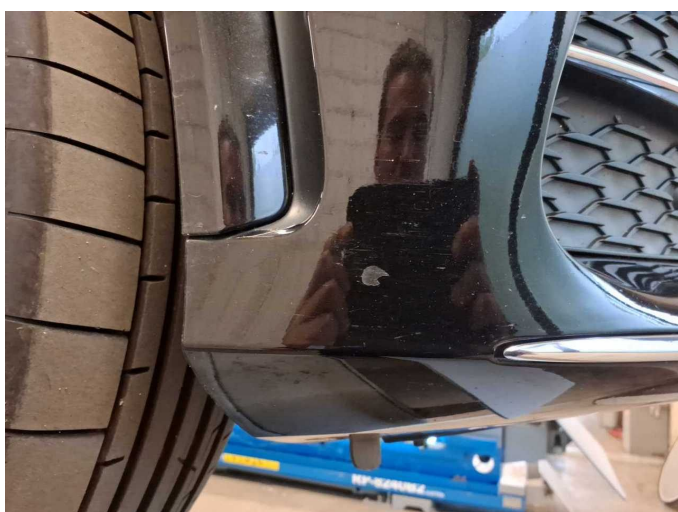
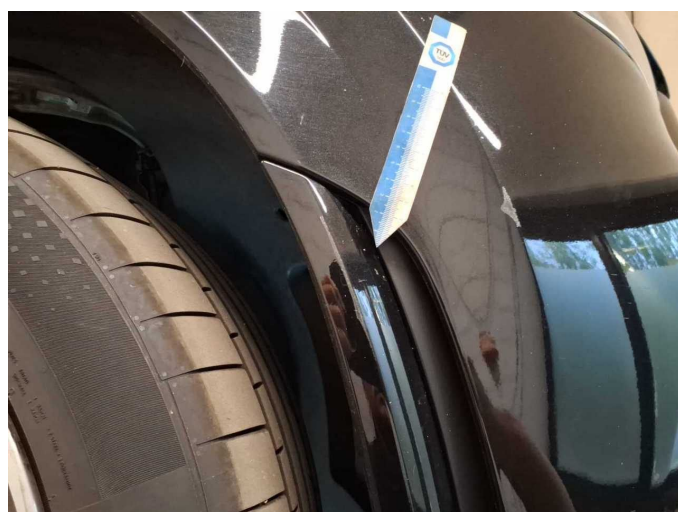
| No. | Component group | Description |
|---|---|---|
| 4 | Front bumper | Front bumper - Scratched - Smart repair |

**Damage 4:** Front bumper: Front bumper - Scratched - Smart repair

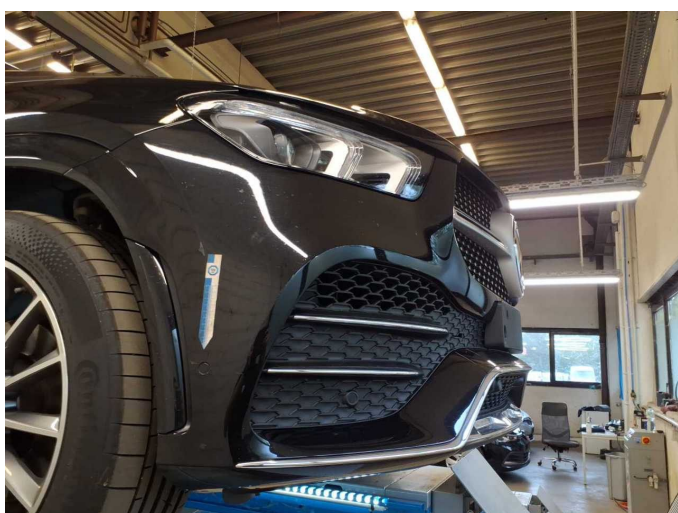
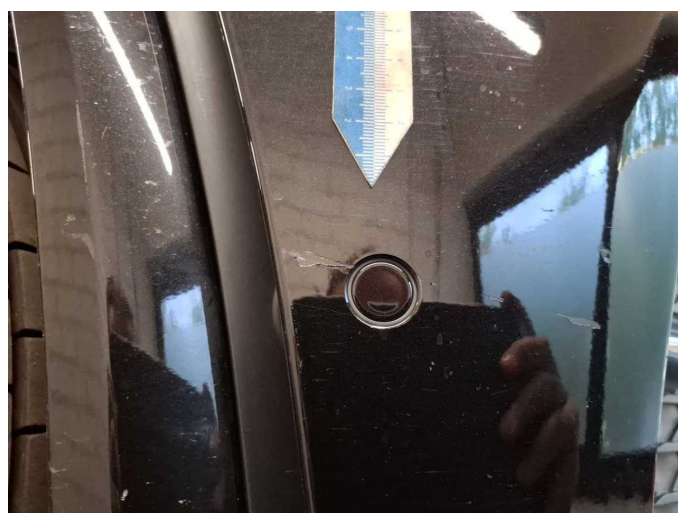
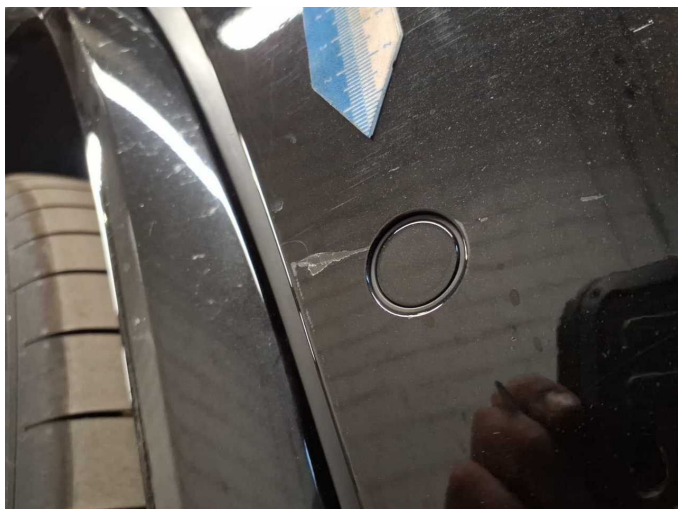
| No. | Component group | Description |
|---|---|---|
| 5 | Front bumper | Bumper with Parktronic - Malposition - Set / adjust |

**Damage 5:** Front bumper: Bumper with Parktronic - Malposition - Set / adjust

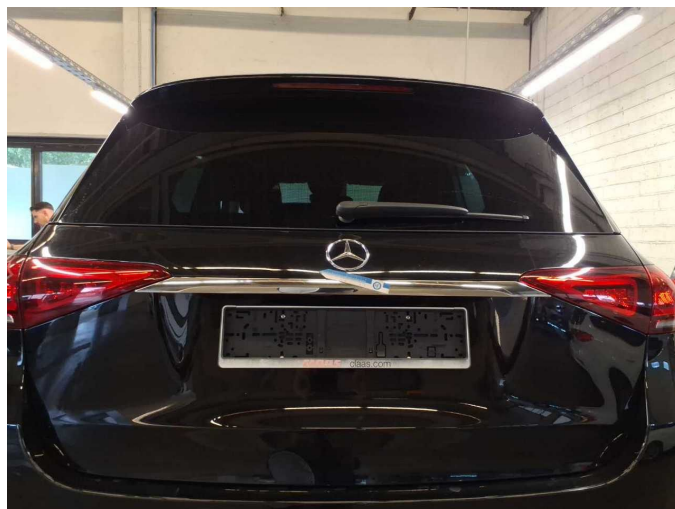
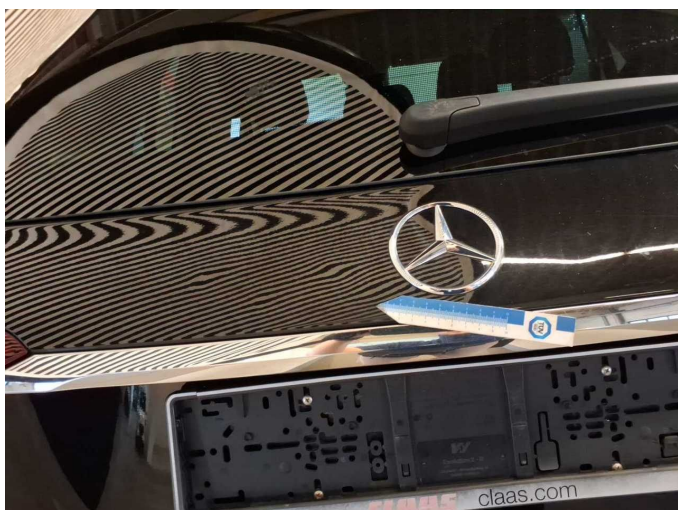
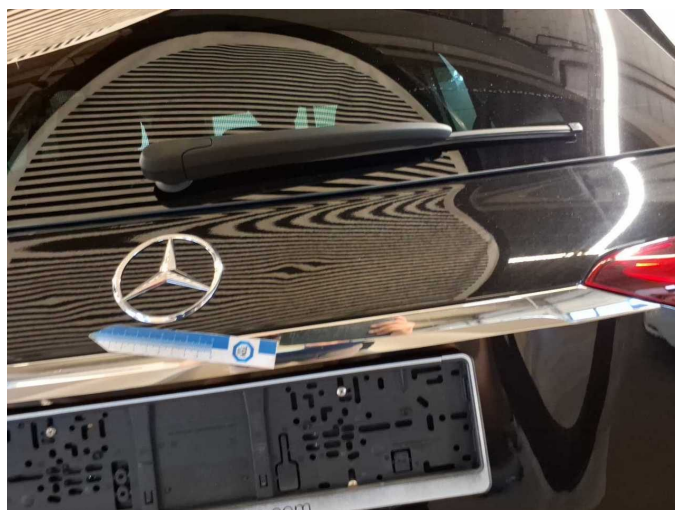
| No. | Component group | Description |
|---|---|---|
| 6 | Boot lid / rear door | Boot lid - dent(s) - Smooth repair work |

**Damage 6:** Boot lid / rear door: Boot lid - dent(s) - Smooth repair work

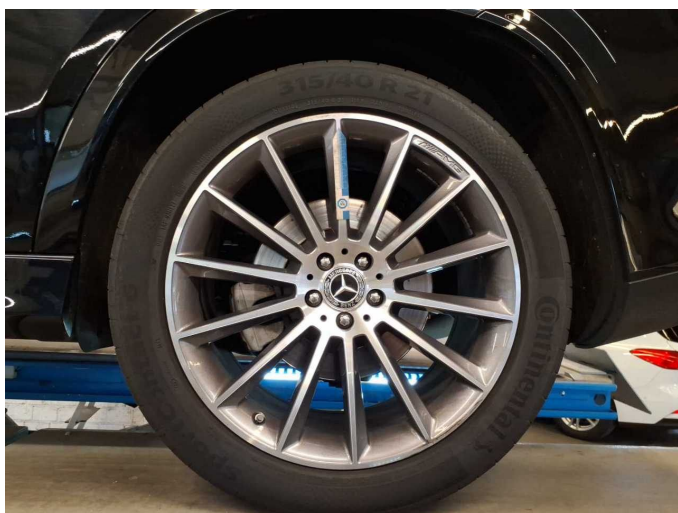
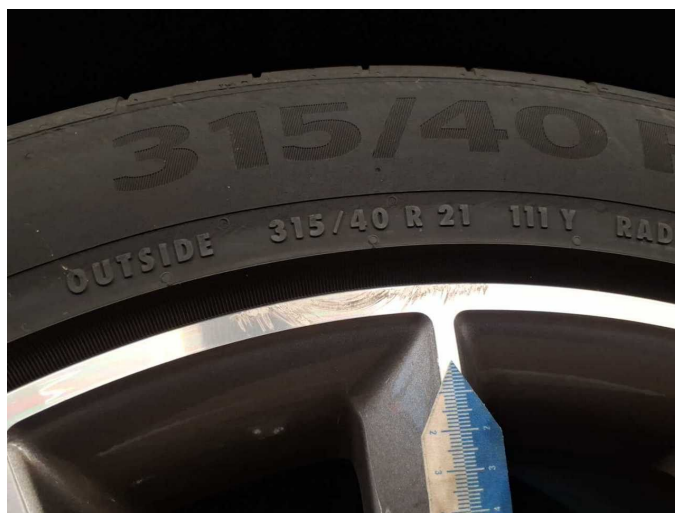
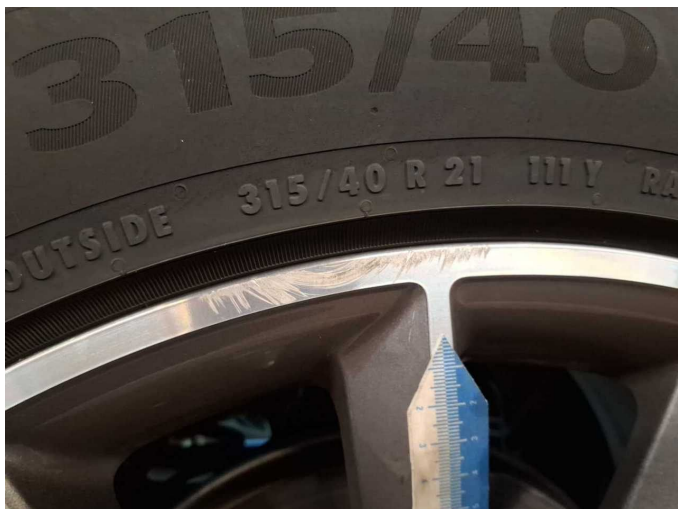
| No. | Component group | Description |
|---|---|---|
| 7 | Wheel / tyres | Alloy rim - rear left side - Scratched - Loss in value |

**Damage 7:** Wheel / tyres: Alloy rim - rear left side - Scratched - Loss in value

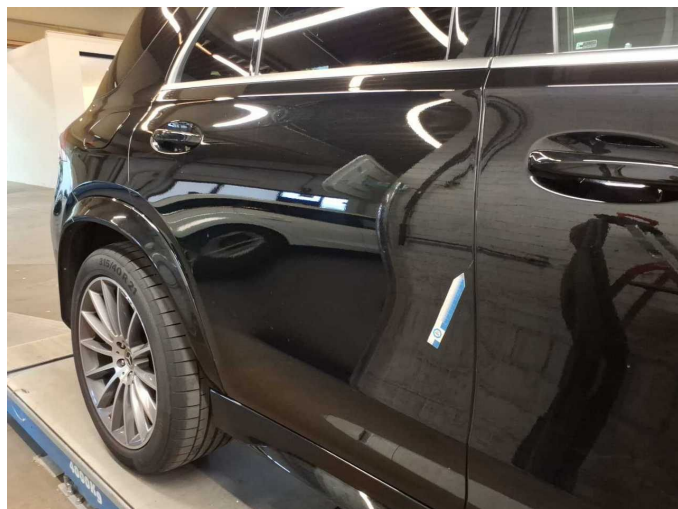
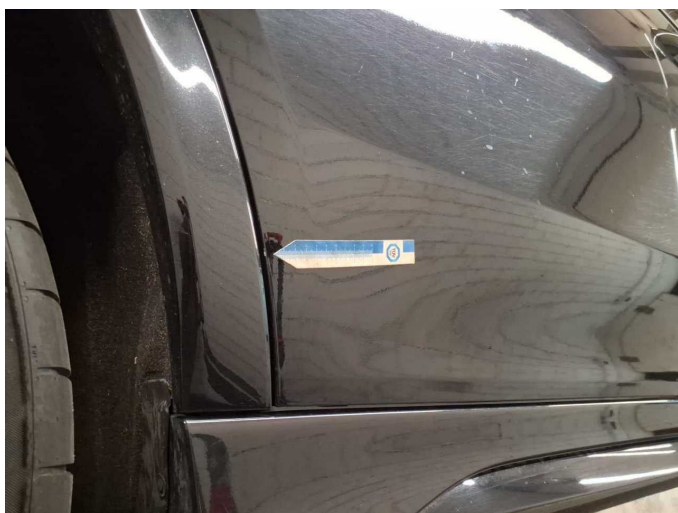
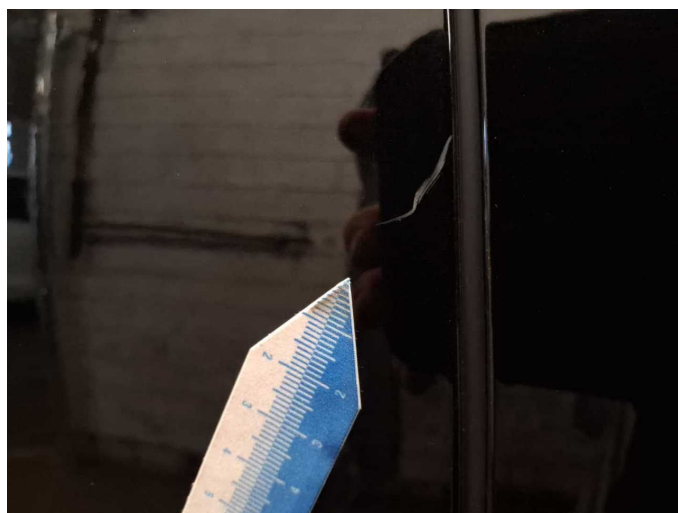
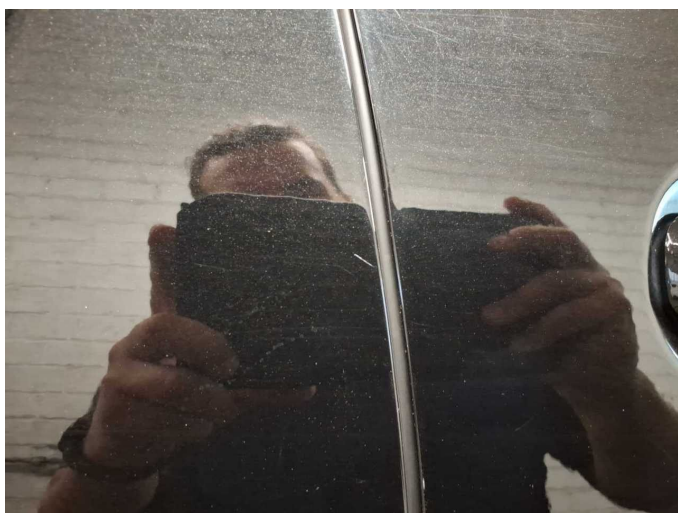
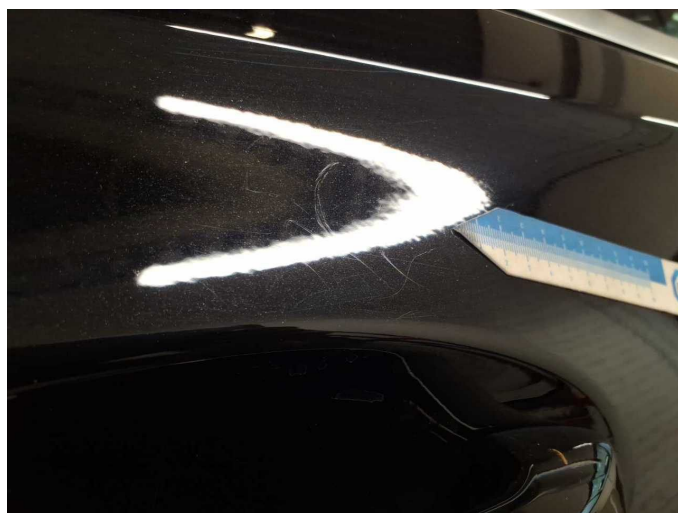
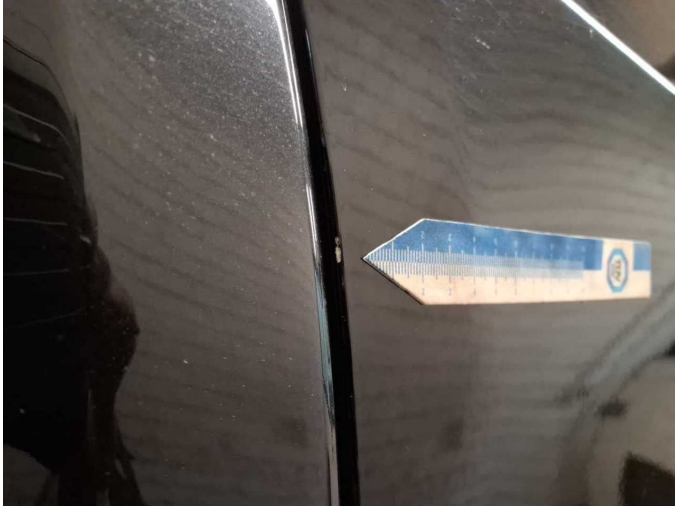
| No. | Component group | Description |
|---|---|---|
| 8 | Door - rear right side | Door - Scratched - Paint |

**Damage 8:** Door - rear right side: Door - Scratched - Paint

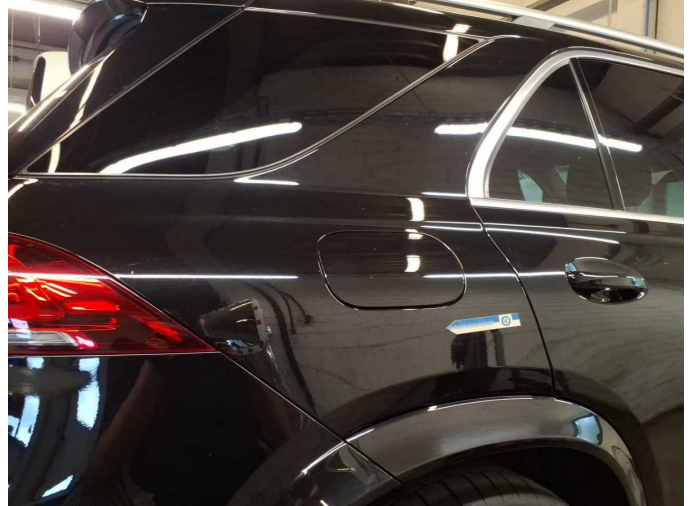
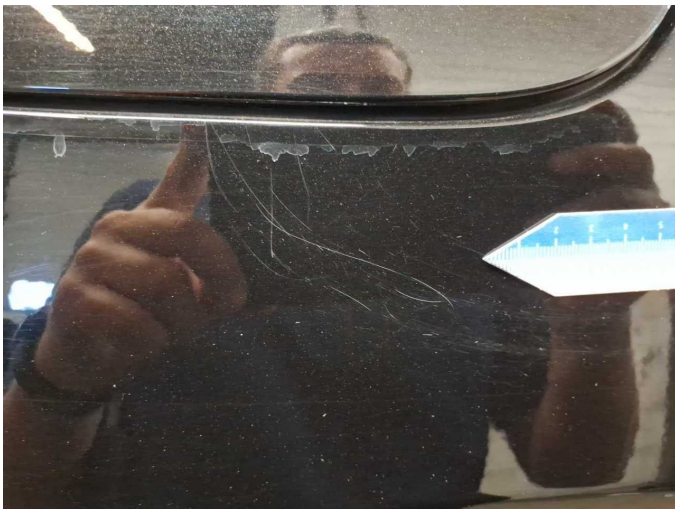
| No. | Component group | Description |
|---|---|---|
| 9 | Side panel - rear right side | Side panel - Scratched - Paint |

**Damage 9:** Side panel - rear right side: Side panel - Scratched - Paint

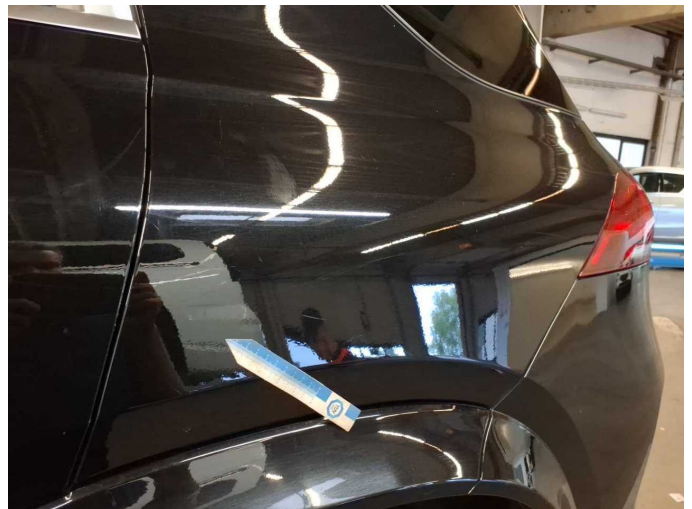
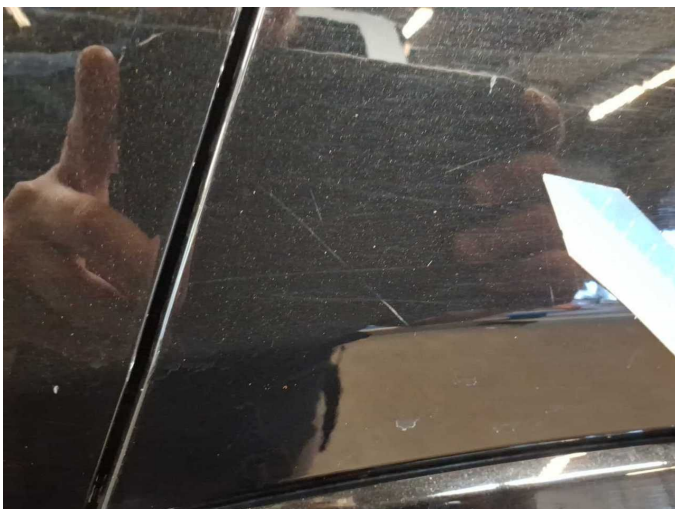
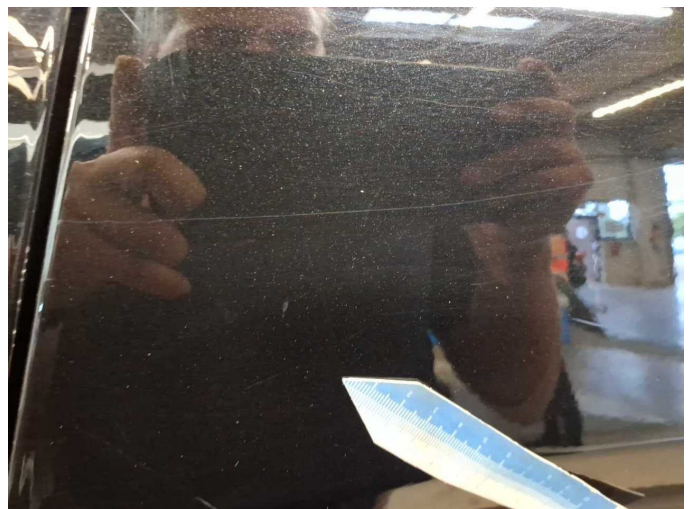
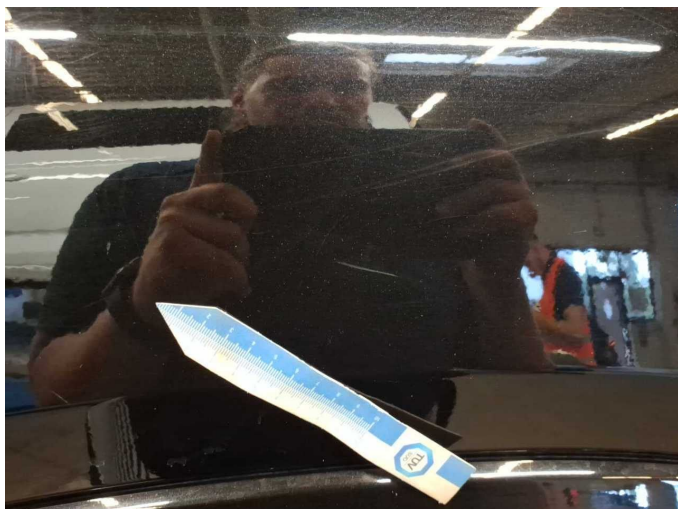
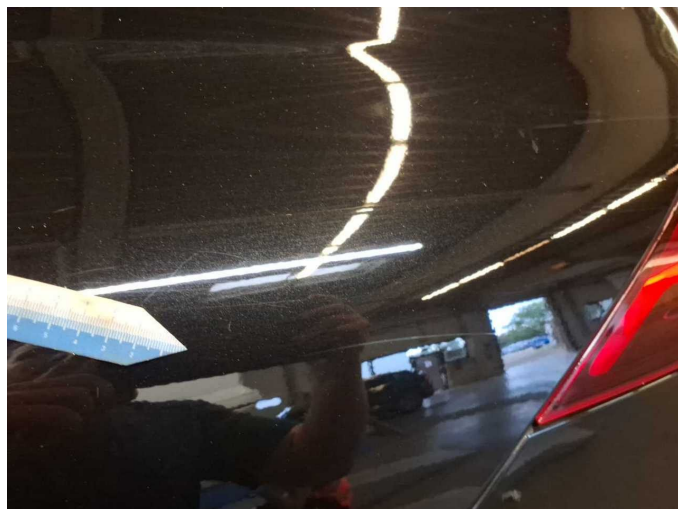
| No. | Component group | Description |
|---|---|---|
| 10 | Side panel - rear left side | Side panel - Scratched - Paint |

**Damage 10:** Side panel - rear left side: Side panel - Scratched - Paint

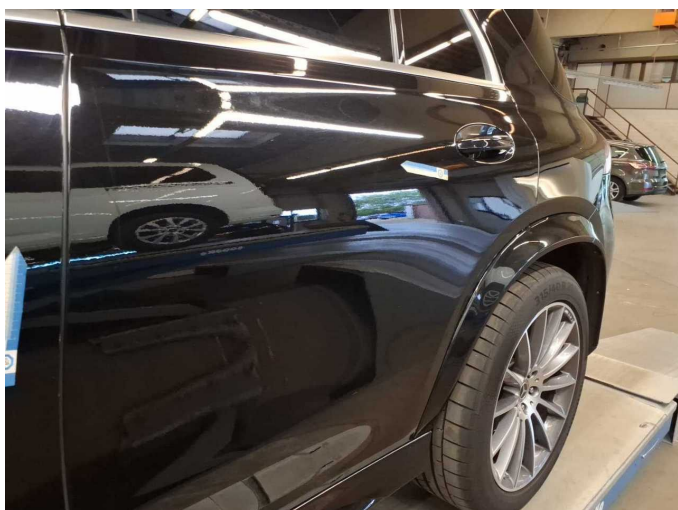
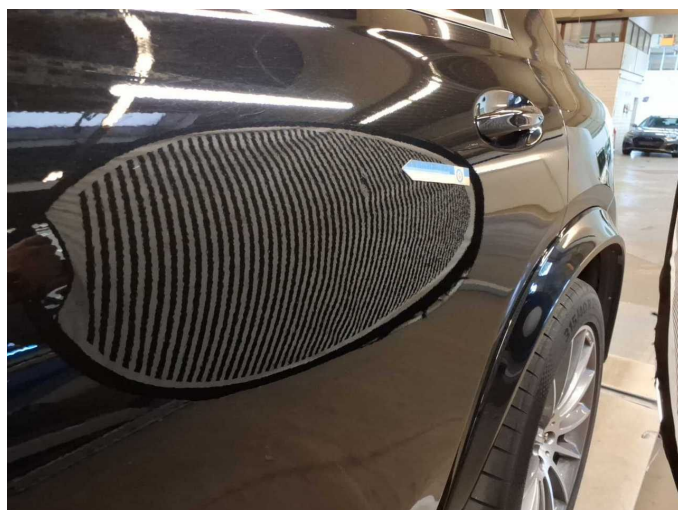
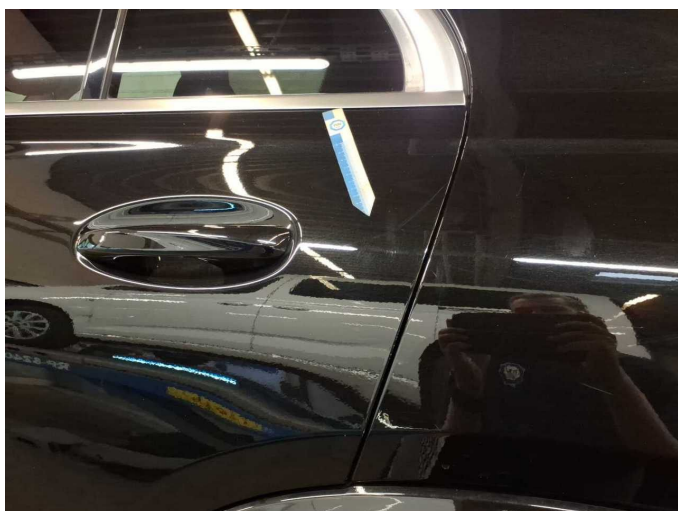
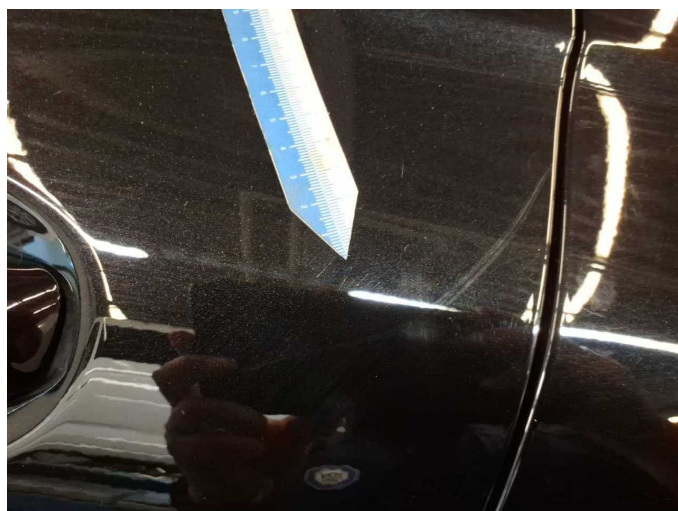
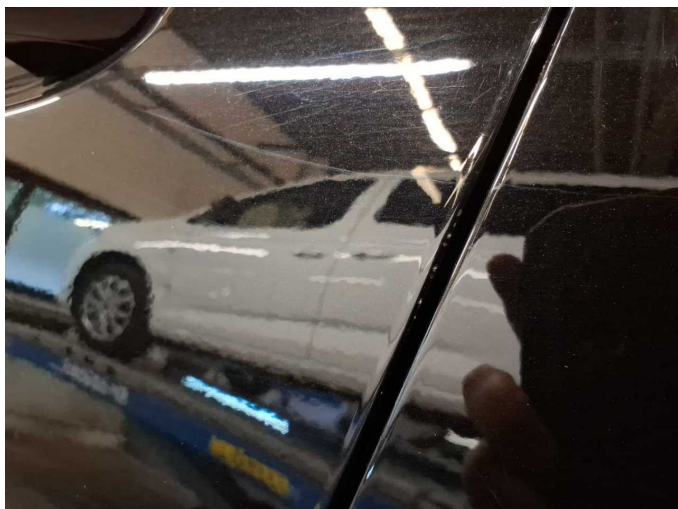
| No. | Component group | Description |
|---|---|---|
| 11 | Door - rear left side | Door - Dent / paintcoat damage - Repair and paint |

**Damage 11:** Door - rear left side: Door - Dent / paintcoat damage - Repair and paint

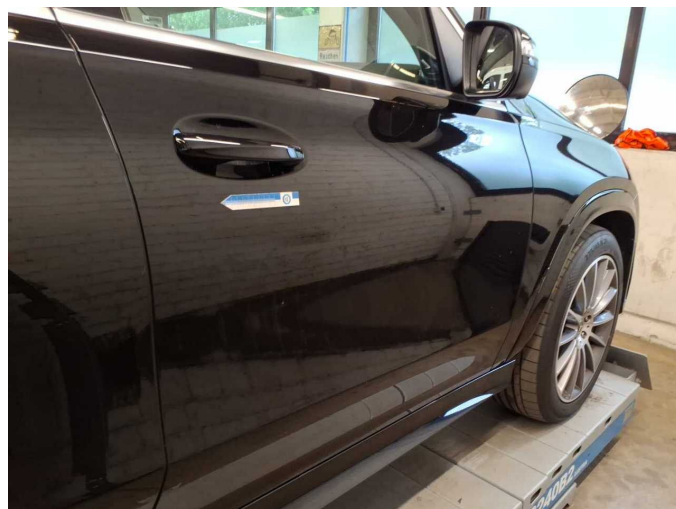
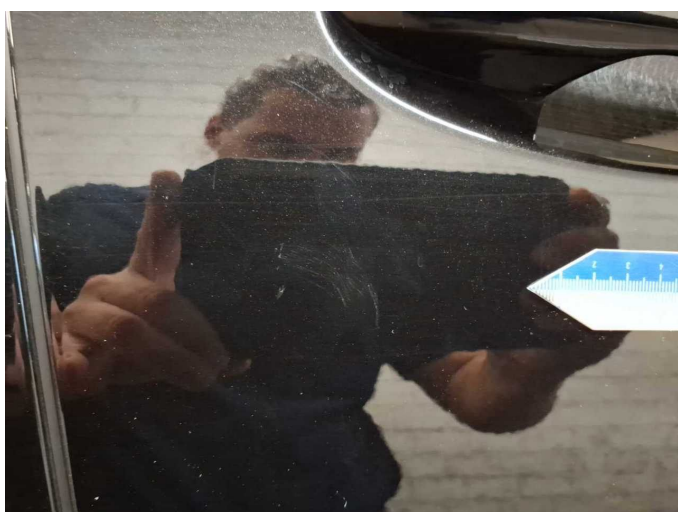
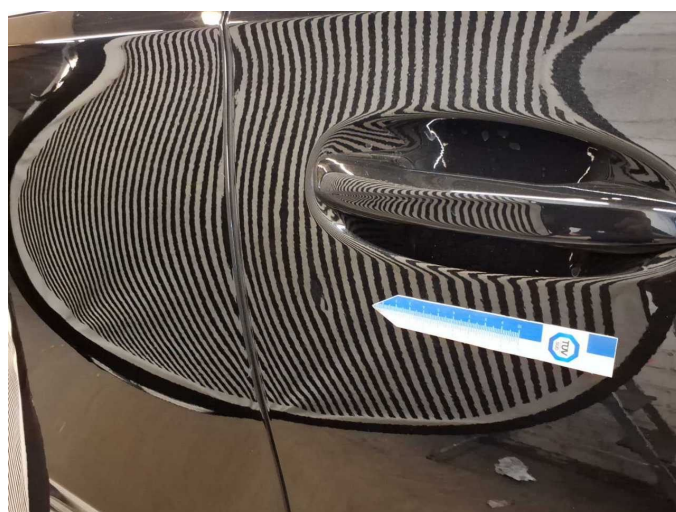
| No. | Component group | Description |
|---|---|---|
| 12 | Door - front right side | Door - Dent / paintcoat damage - Repair and paint |

**Damage 12:** Door - front right side: Door - Dent / paintcoat damage - Repair and paint

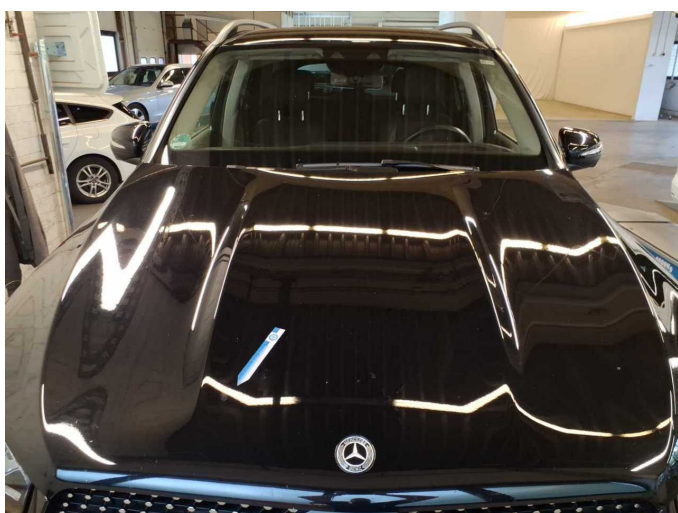
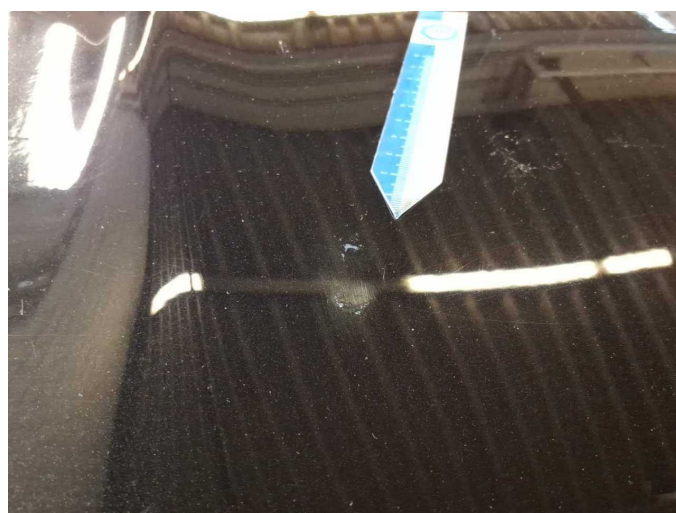
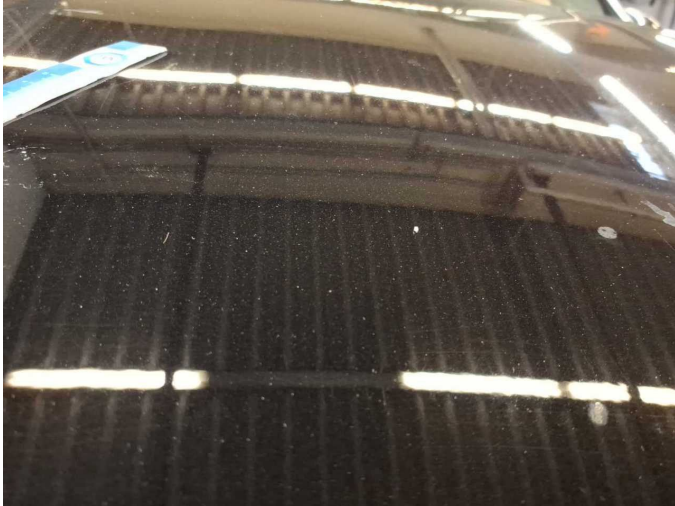
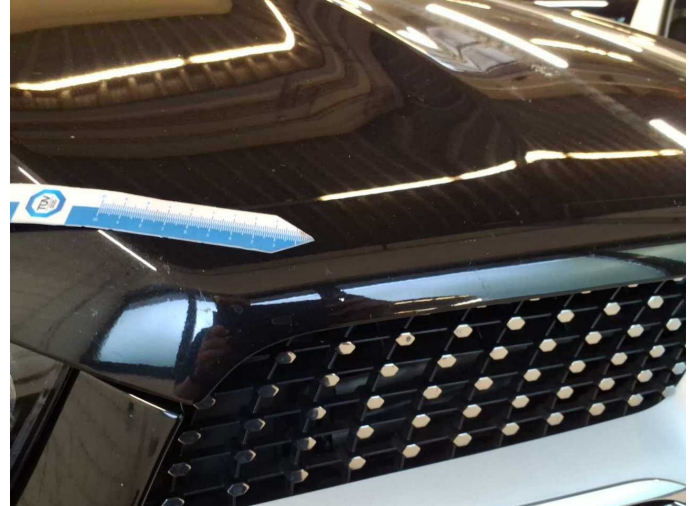
| No. | Component group | Description |
|---|---|---|
| 13 | Bonnet | Bonnet - Scratched - Paint |

**Damage 13:** Bonnet: Bonnet - Scratched - Paint

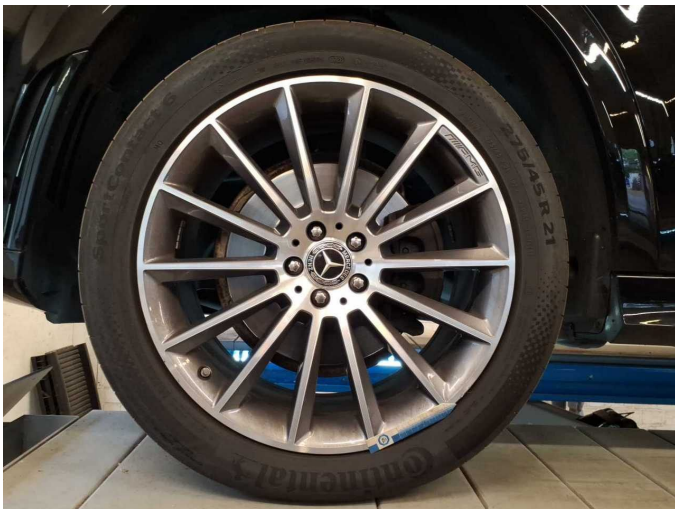
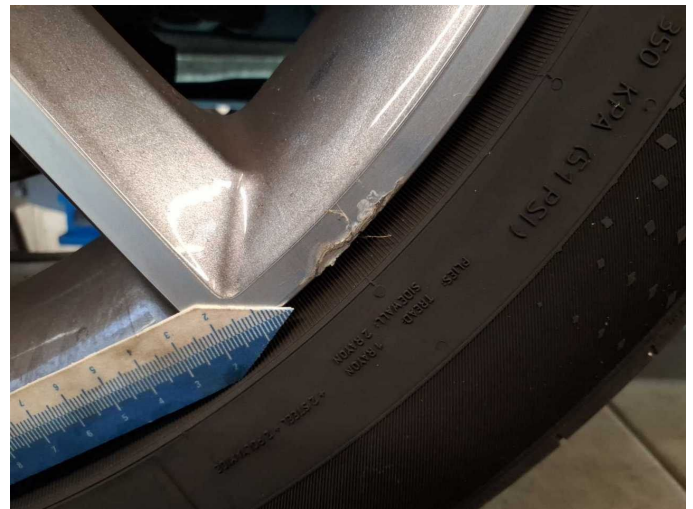
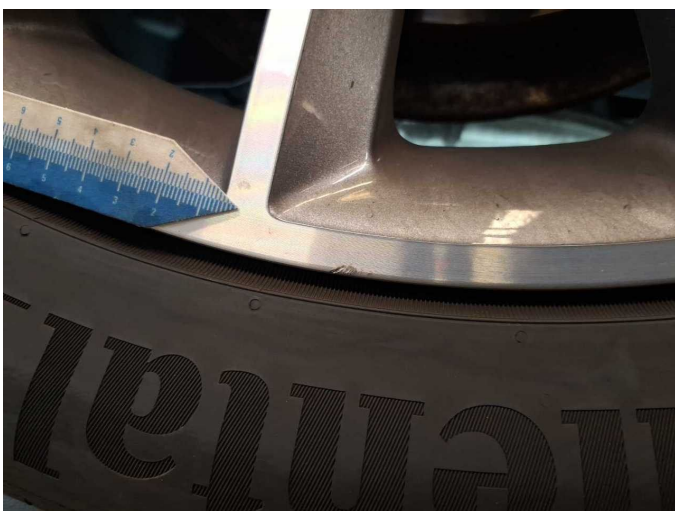
| No. | Component group | Description |
|---|---|---|
| 14 | Wheel / tyres | Alloy rim - front left side (Materialabtrag) - Scratched - Replace |

**Damage 14:** Wheel / tyres: Alloy rim - front left side (Materialabtrag) - Scratched - Replace

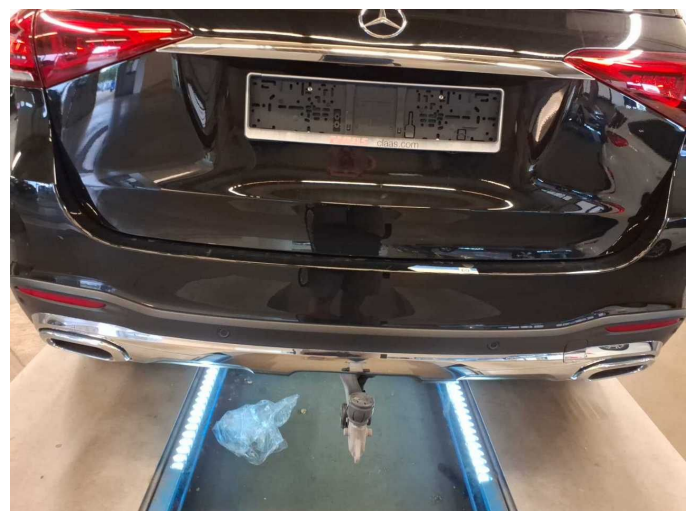
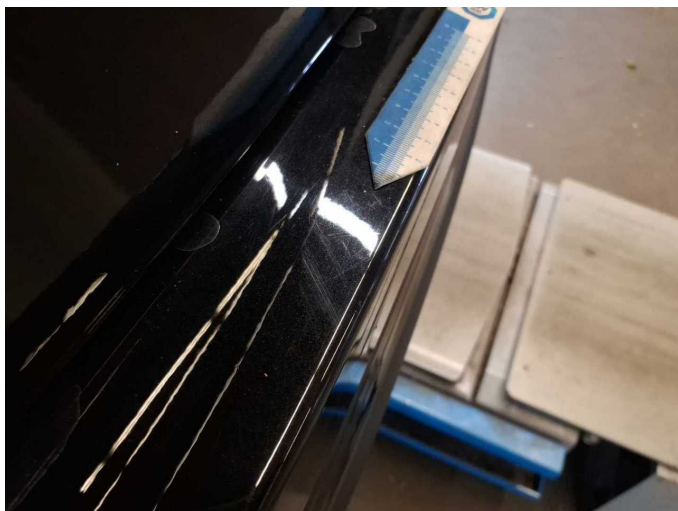
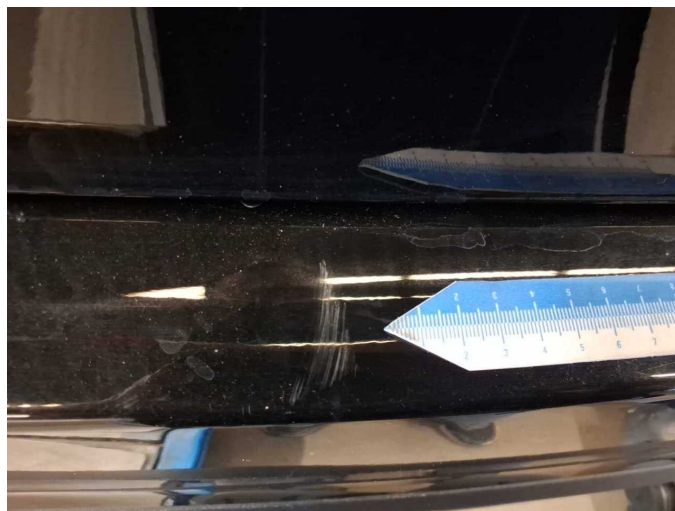
| No. | Component group | Description |
|---|---|---|
| 1 | Rear bumper | Rear bumper - Scratch(es) - No deduction |

**Wear and tear 1:** Rear bumper: Rear bumper - Scratch(es) - No deduction
