Expertise

Protocol number: 46886243  
Order No. / Reference: 26847185  
Inspection date: 4 Aug 2026

Manufacturer: Skoda  
VIN: TMBJH7NP4P7065172

Model: Superb Combi 2.0 TDI DSG Style

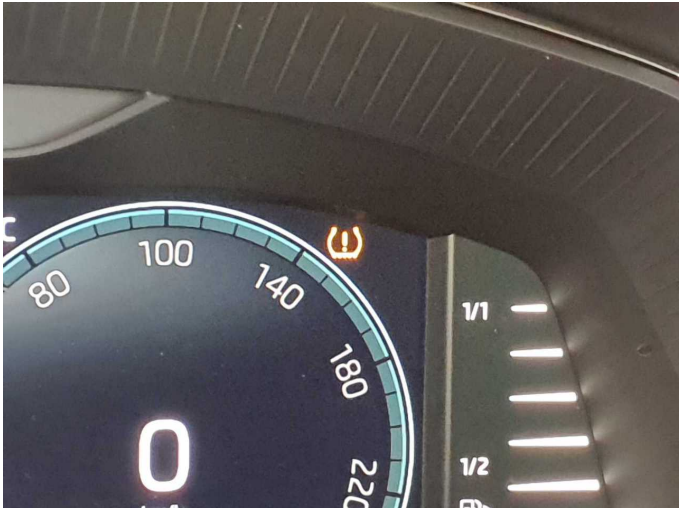
| No. | Component group | Description |
|---|---|---|
| 1 | Instrument panel | Indicator light (Reifendruck) - on - Perform diagnosis |

Damage 1: Instrument panel: Indicator light (Reifendruck) - on - Perform diagnosis

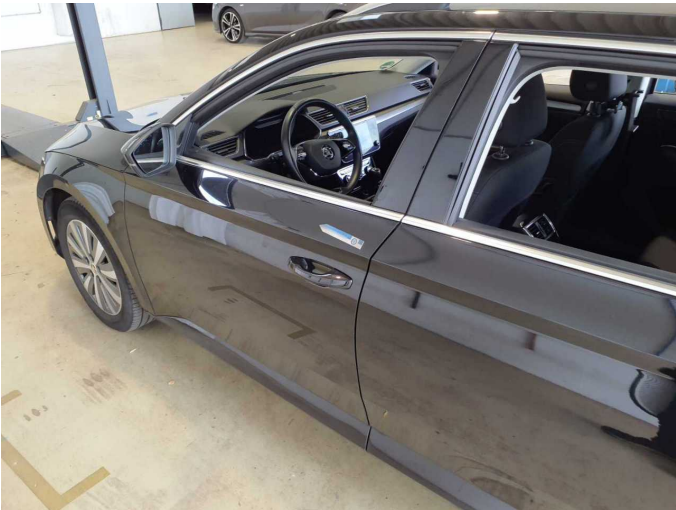
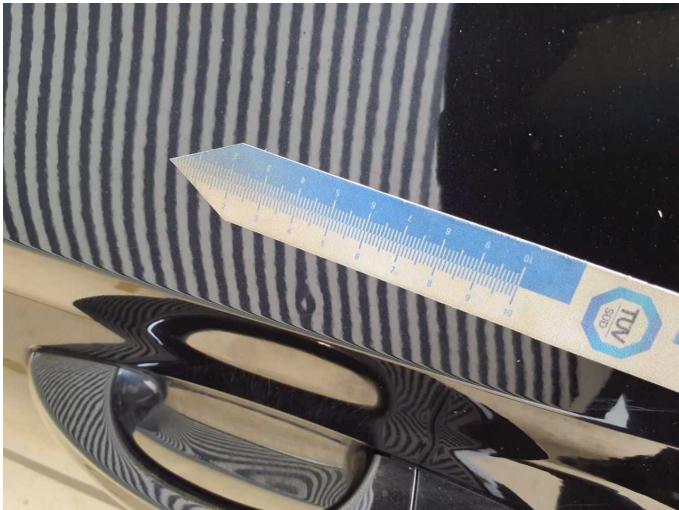
| No. | Component group | Description |
|---|---|---|
| 2 | Door - front left side | Door - dent(s) - Smooth repair work |

Damage 2: Door - front left side: Door - dent(s) - Smooth repair work

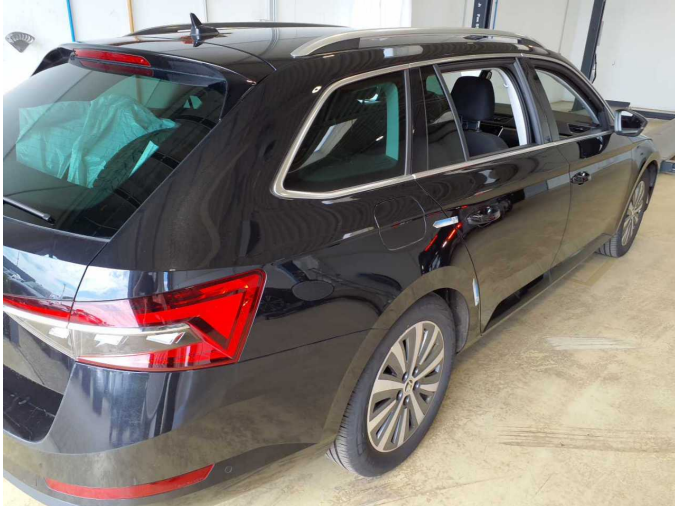
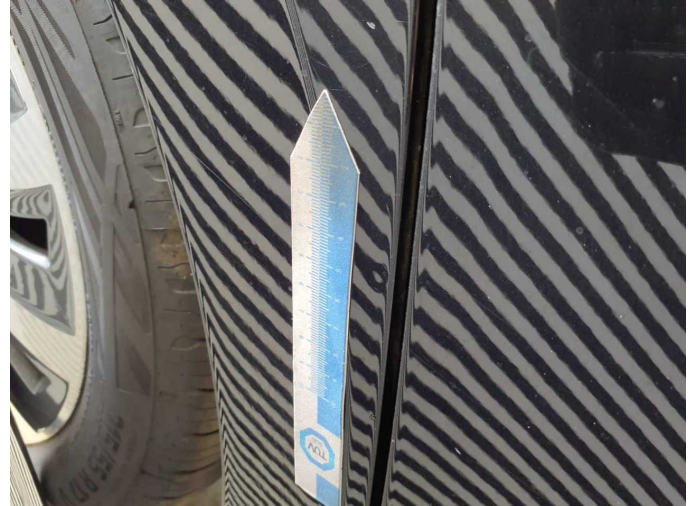
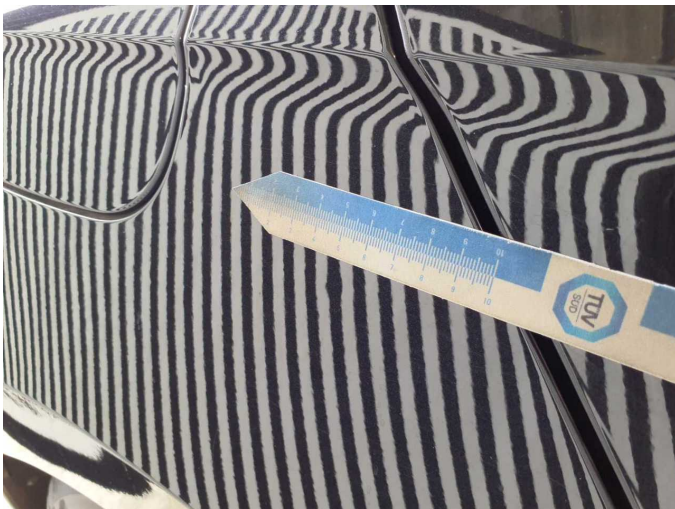
| No. | Component group | Description |
|---|---|---|
| 3 | Side panel - rear right side | Side panel - dent(s) - Smart repair |

**Damage 3:** Side panel - rear right side: Side panel - dent(s) - Smart repair

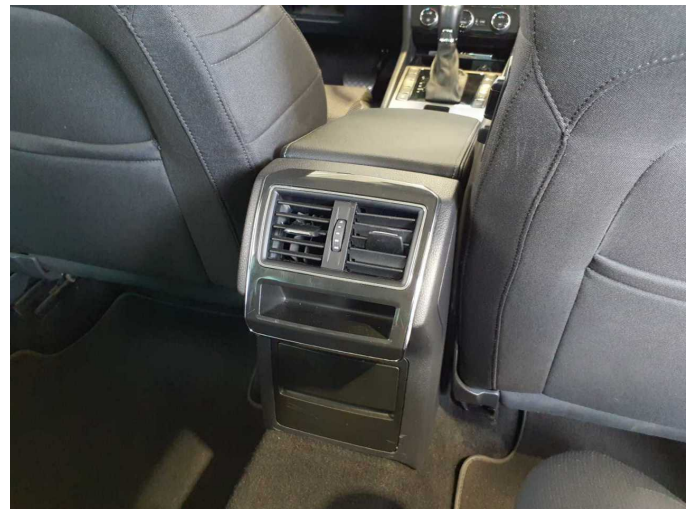
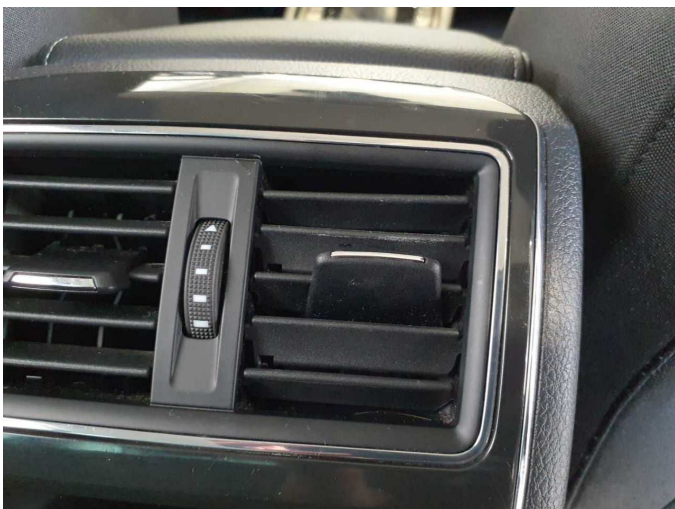
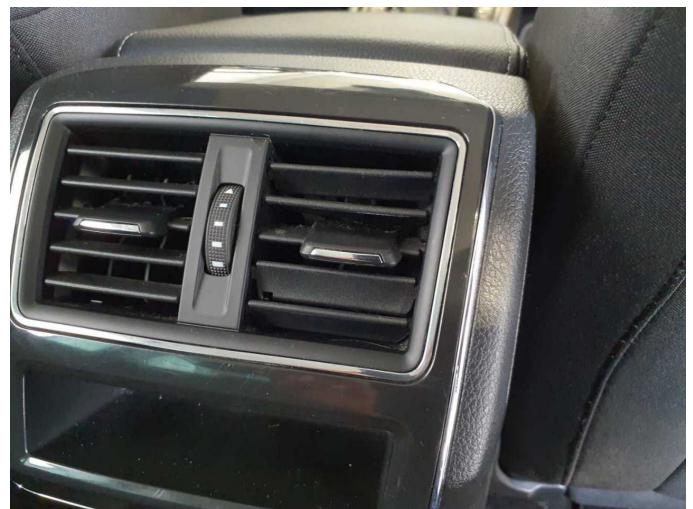
| No. | Component group | Description |
|---|---|---|
| 4 | Instrument panel | Air nozzle - centre (Hinten) - Broken / torn - Replace |

**Damage 4:** Instrument panel: Air nozzle - centre (Hinten) - Broken / torn - Replace

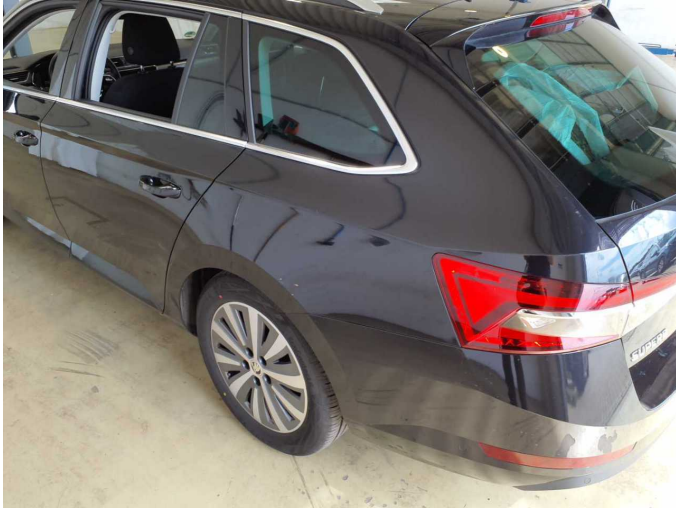
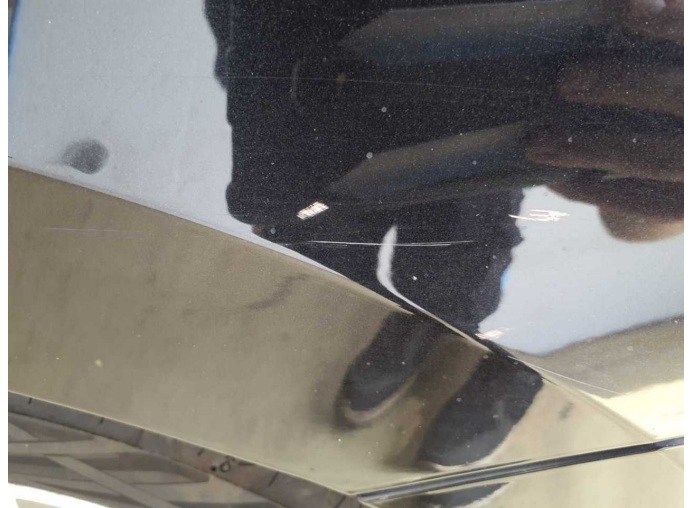
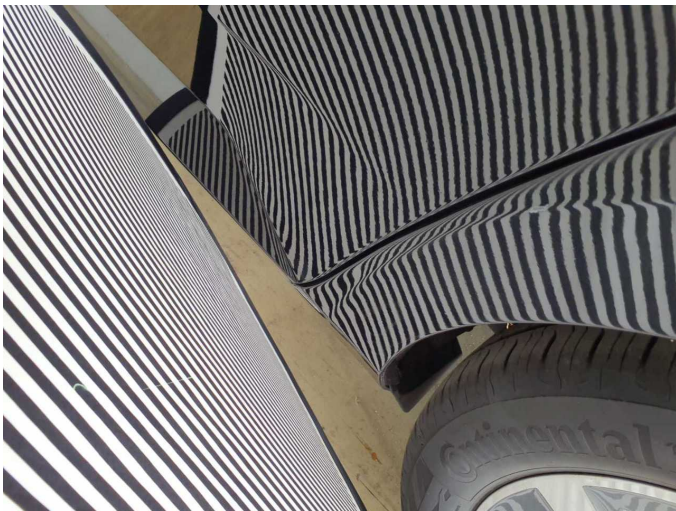
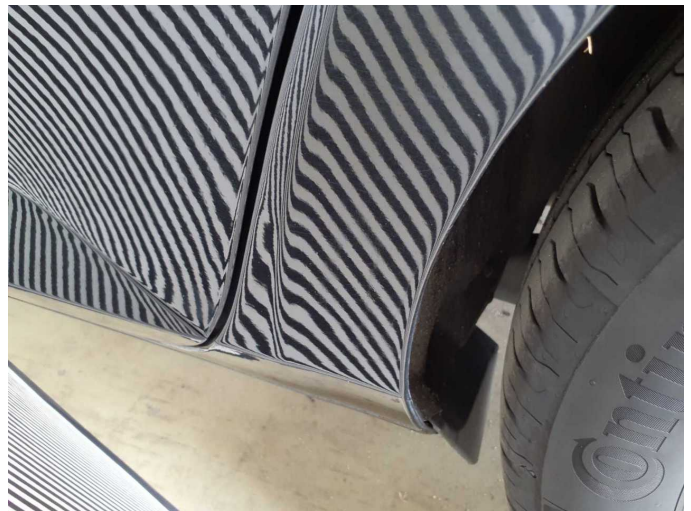
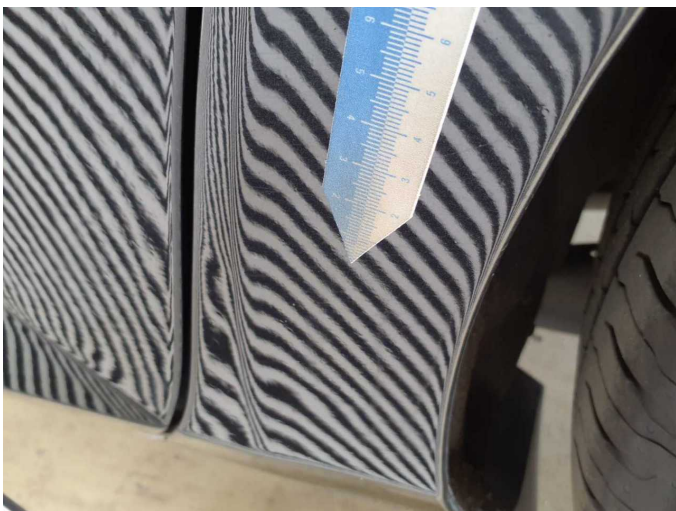
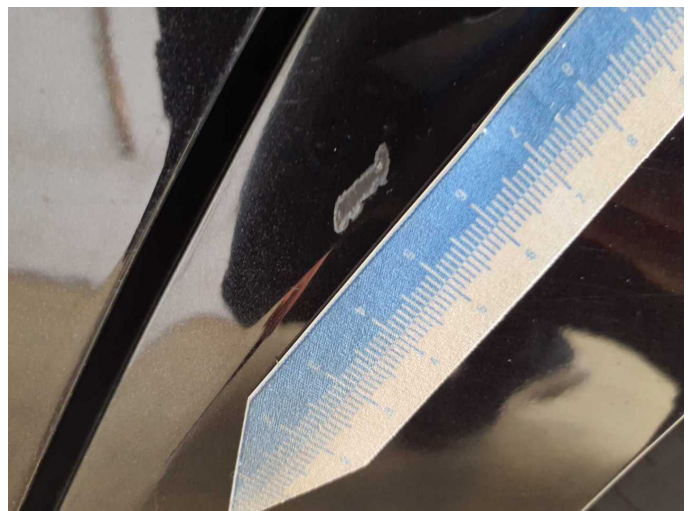
| No. | Component group | Description |
|---|---|---|
| 5 | Side panel - rear left side | Side panel (Wellig) - Unprofessionally repaired - Repair and paint |

| Side panel - rear left side | 234 µm |

**Damage 5:** Side panel - rear left side: Side panel (Wellig) - Unprofessionally repaired - Repair and paint

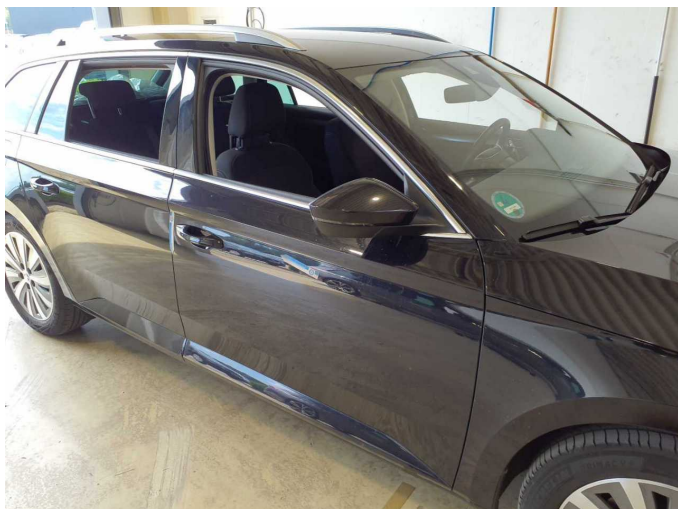
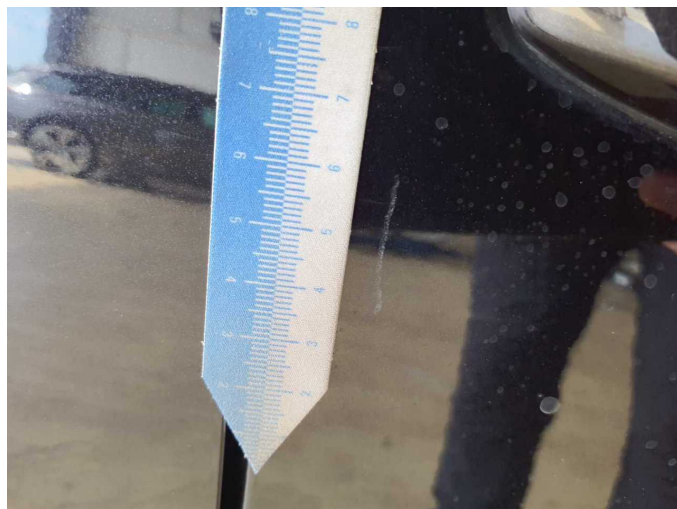
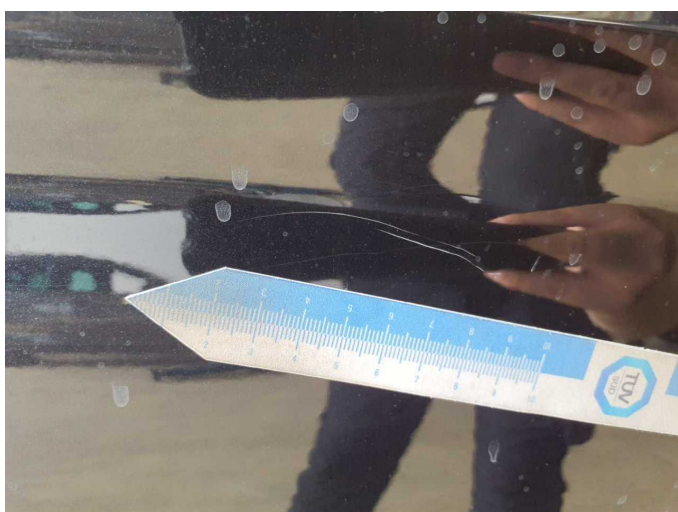
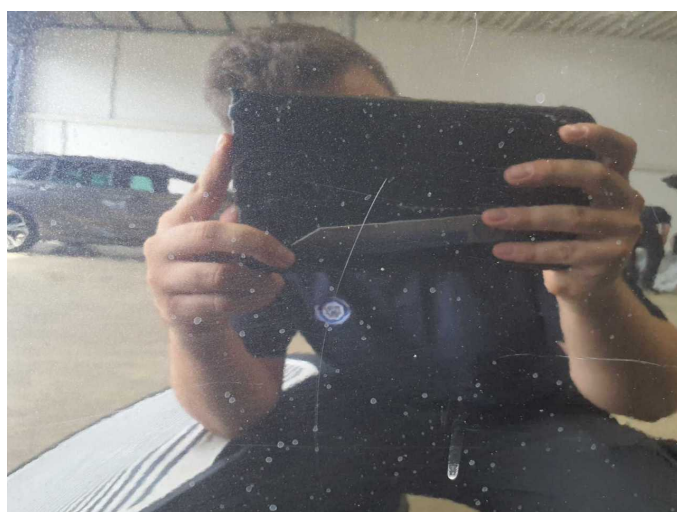
| No. | Component group | Description |
|---|---|---|
| 6 | Door - front right side | Door - Scratch(es) - Paint |

**Damage 6:** Door - front right side: Door - Scratch(es) - Paint

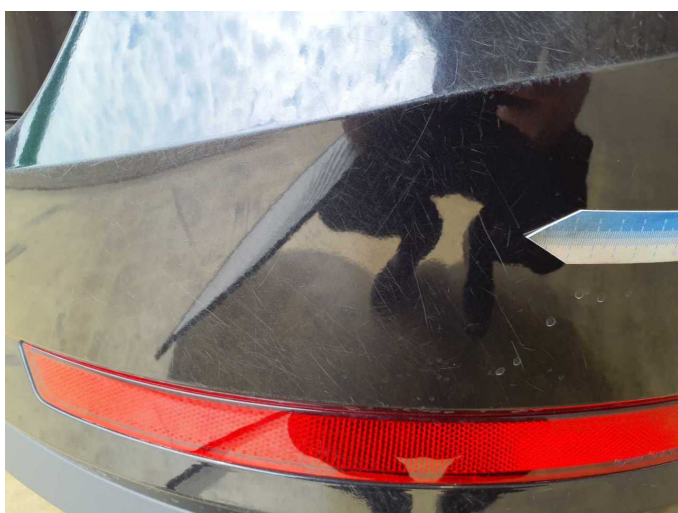
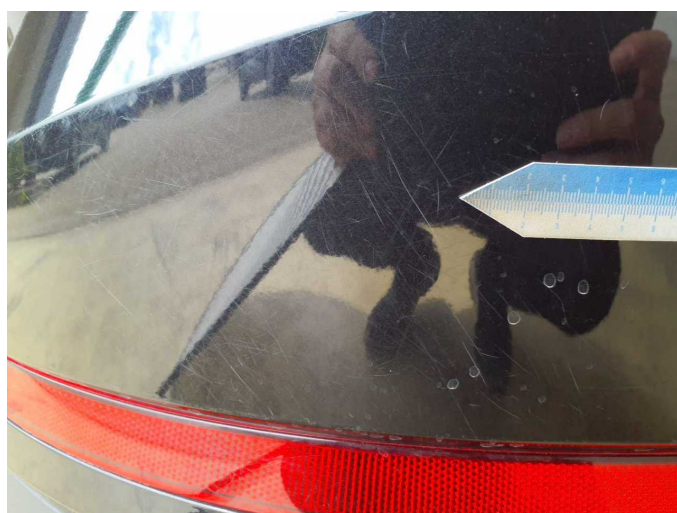
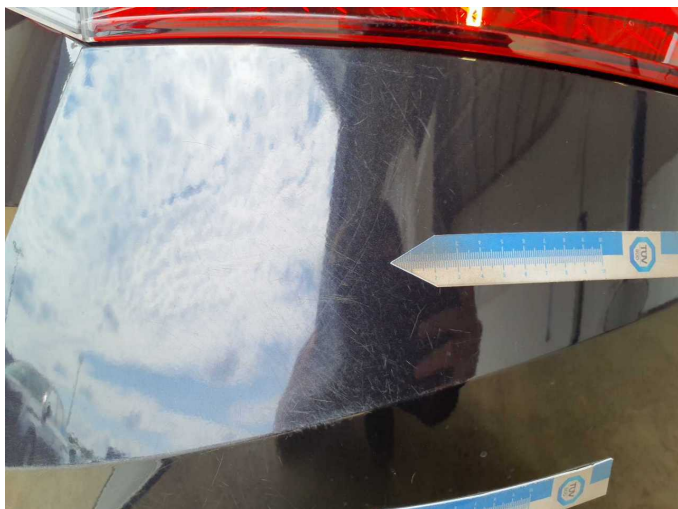
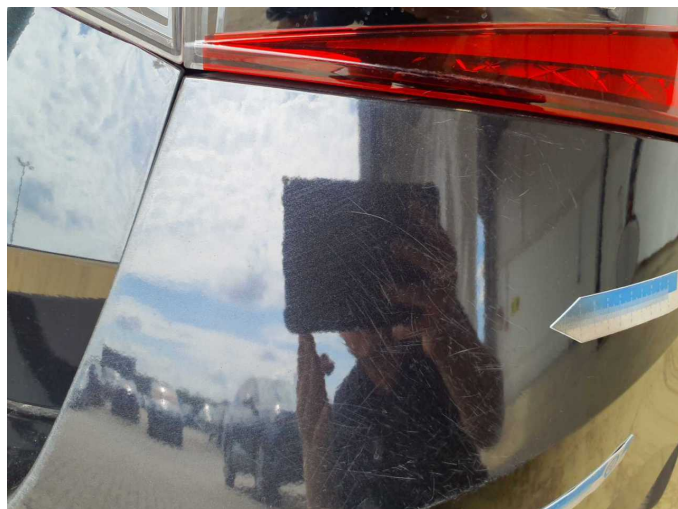
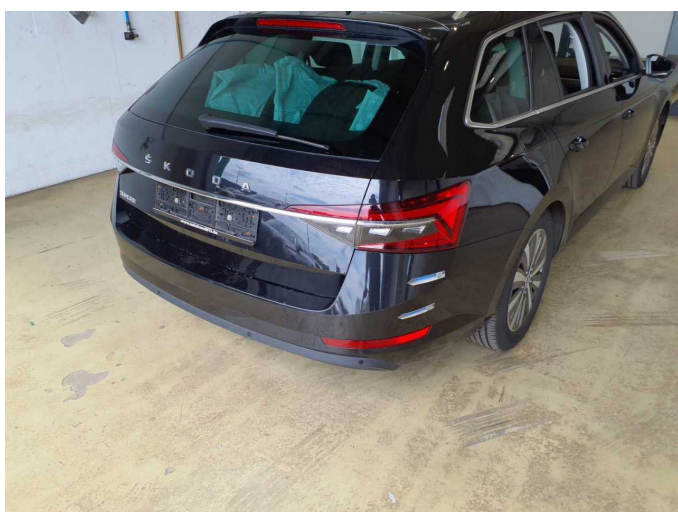
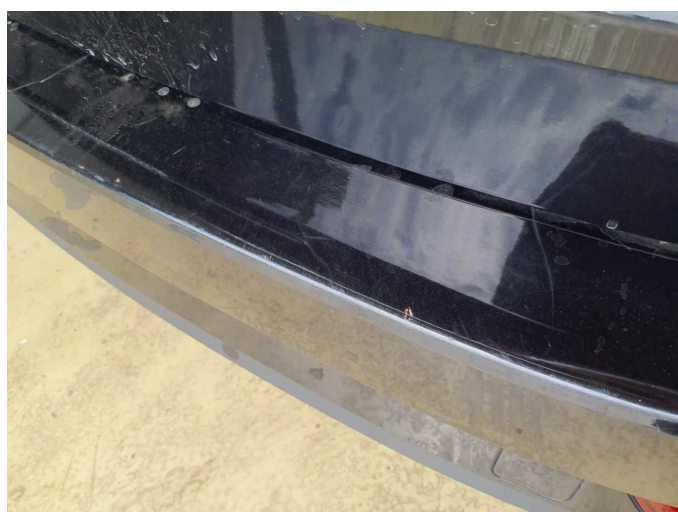
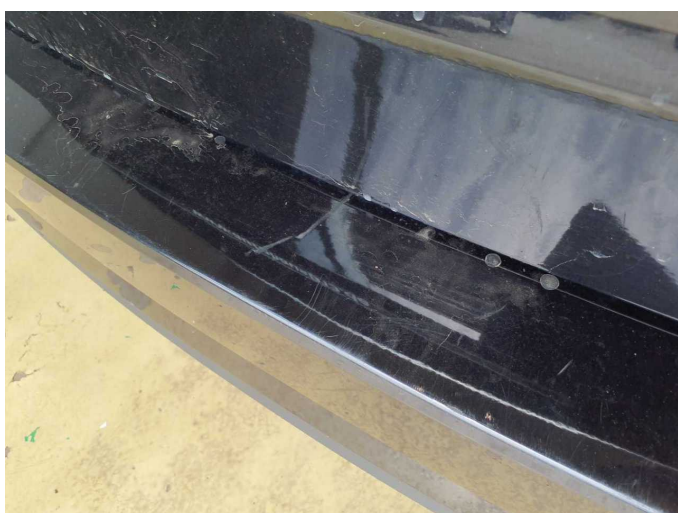
| No. | Component group | Description |
|---|---|---|
| 7 | Rear bumper | Rear bumper - Scratch(es) - Paint |

**Damage 7:** Rear bumper: Rear bumper - Scratch(es) - Paint

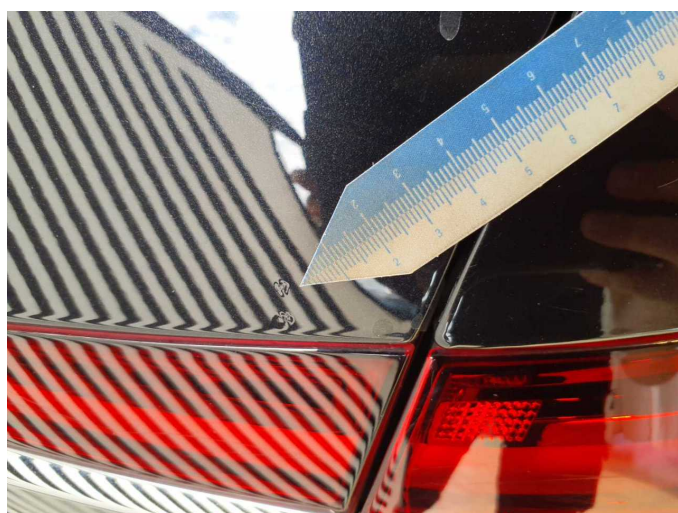
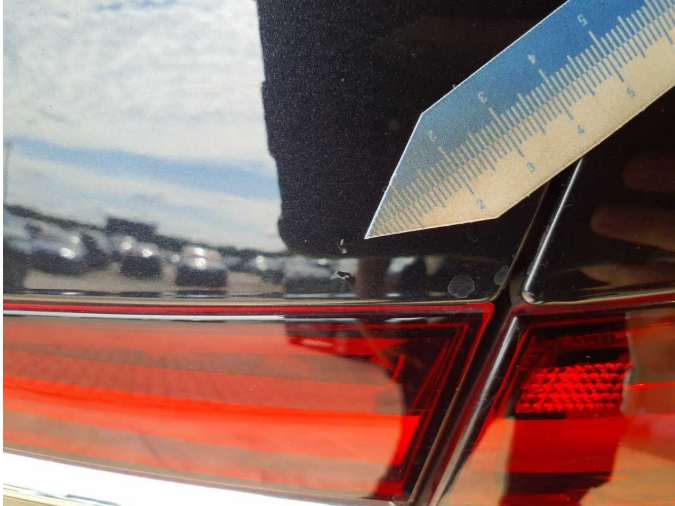
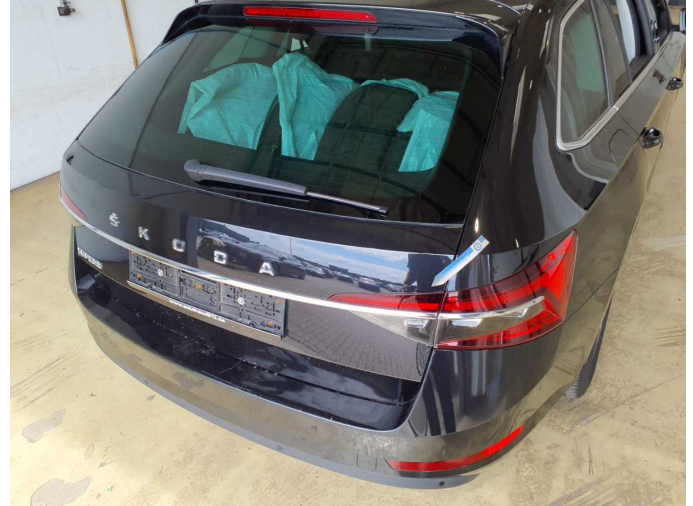
| No. | Component group | Description |
|---|---|---|
| 8 | Boot lid / rear door | Boot lid - Corrosion - Repair and paint |

**Damage 8:** Boot lid / rear door: Boot lid - Corrosion - Repair and paint

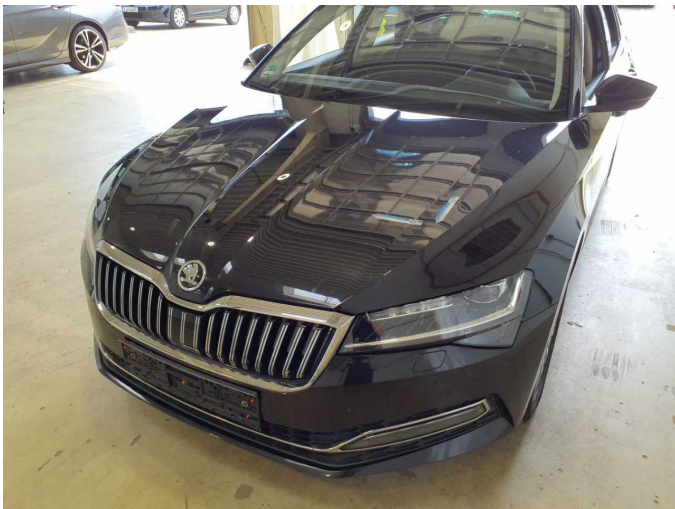
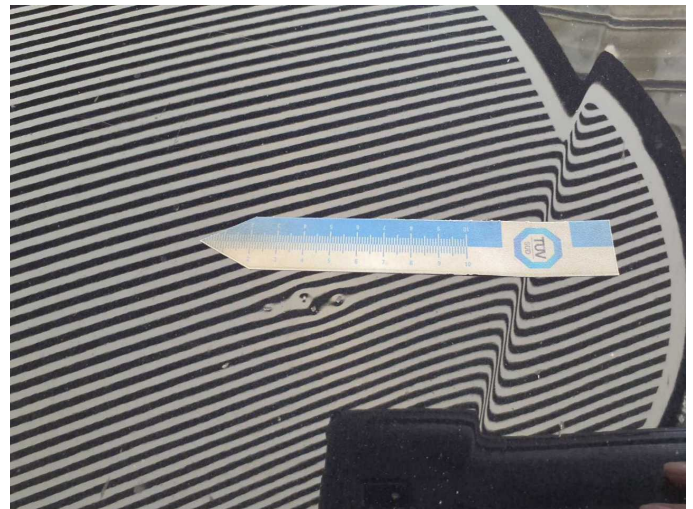
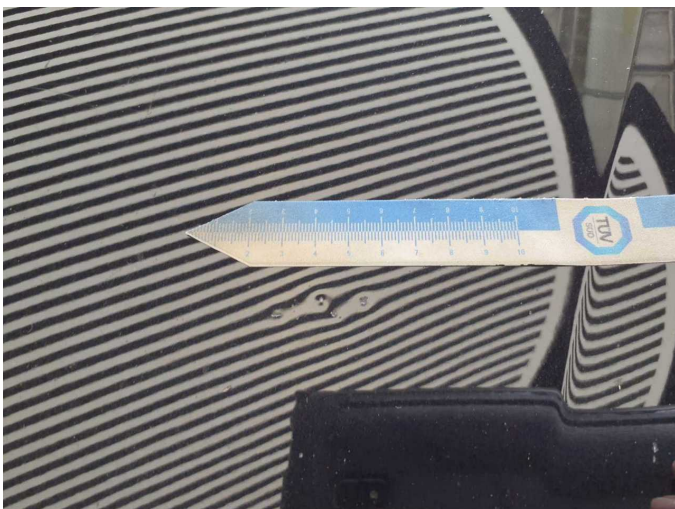
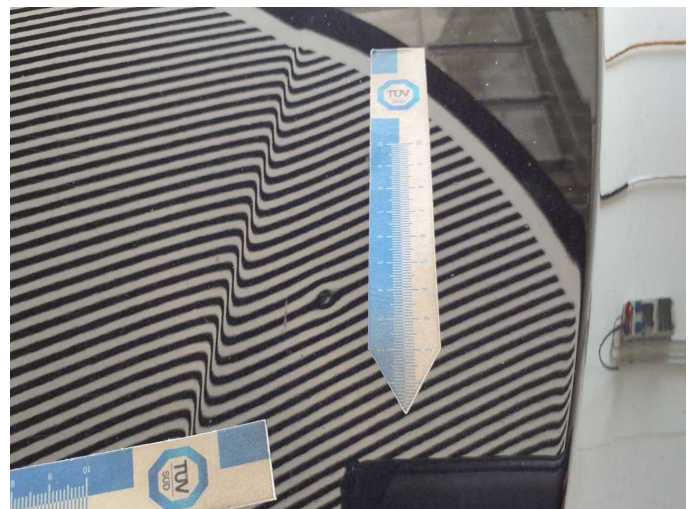
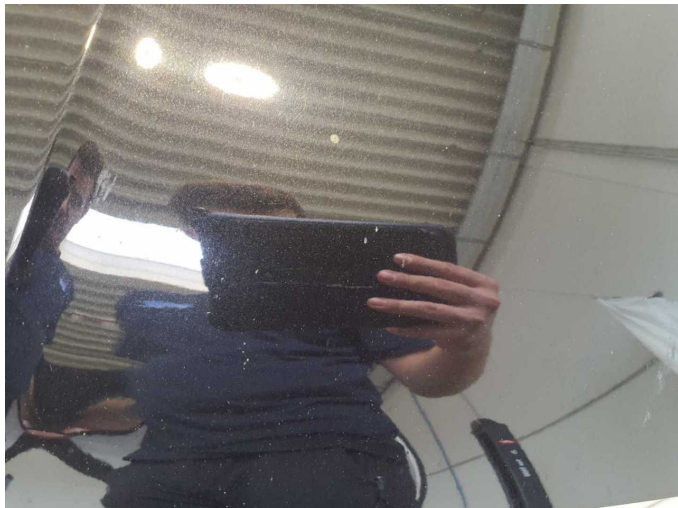
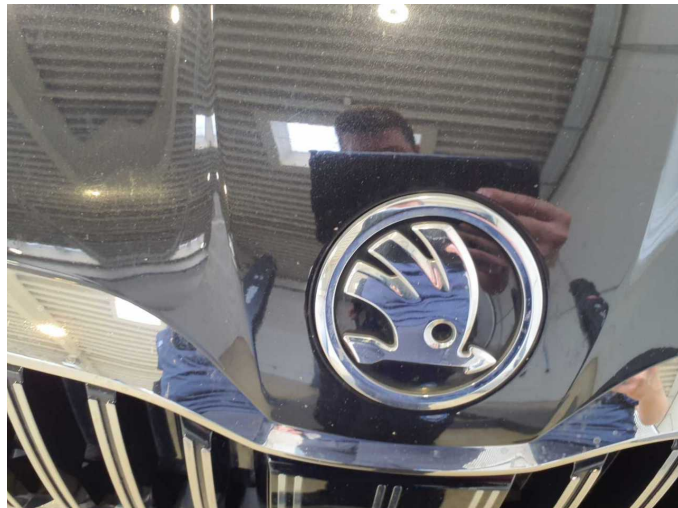
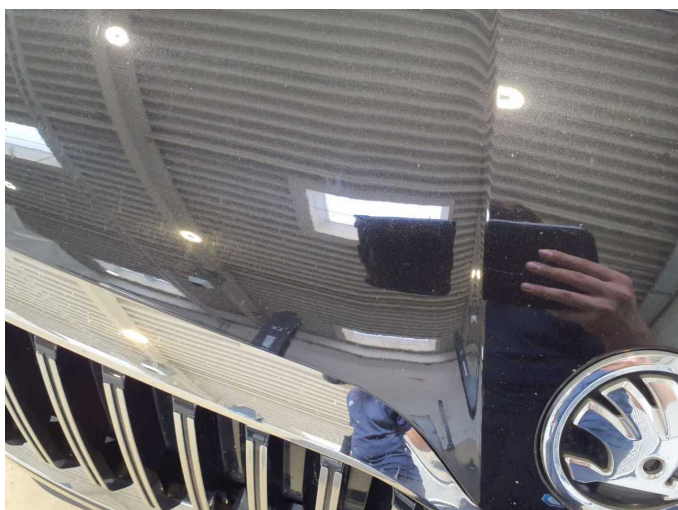
| No. | Component group | Description |
|---|---|---|
| 9 | Bonnet | Bonnet - Dent / paintcoat damage - Repair and paint |

**Damage 9:** Bonnet: Bonnet - Dent / paintcoat damage - Repair and paint

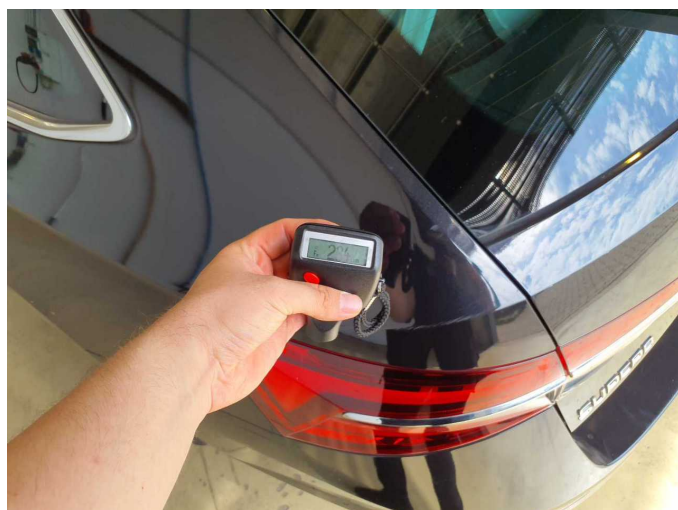
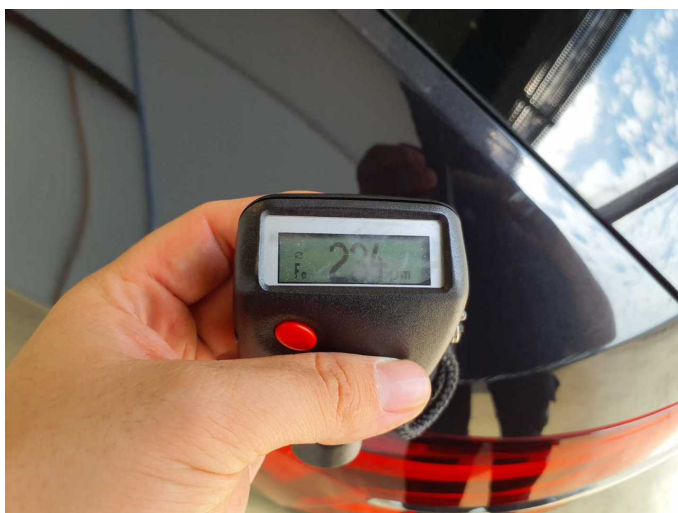
| No. | Repainting |
|---|---|
| 1 | Side panel - rear left side, Unprofessionally carried out |

**Repainting 1:** Side panel - rear left side
