Expertise

Protocol number: 46606761  
Order No. / Reference: 26725818  
Inspection date: 20 Jul 2026

| Manufacturer: Opel | Model: Astra Sports Tourer 1.5 D Automatik Business Elegance |
| VIN: VVKFCYHZTP1100925 | |

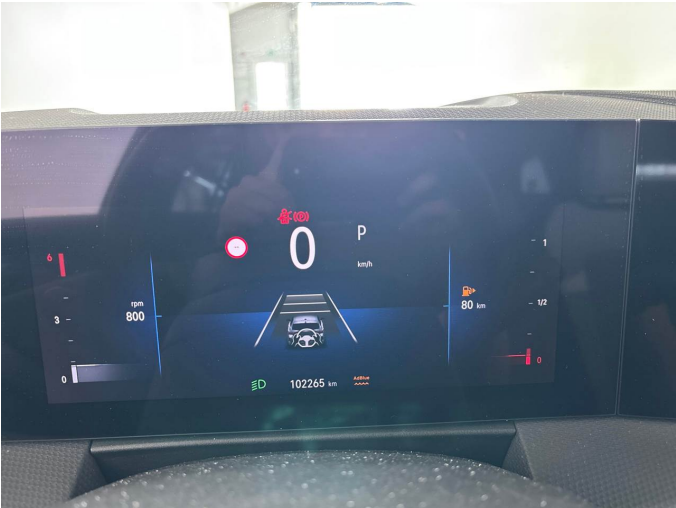
Figure 7: Instrument cluster

| Vehicle details | |
|---|---|
| Mileage (Read) | 102,265 km |

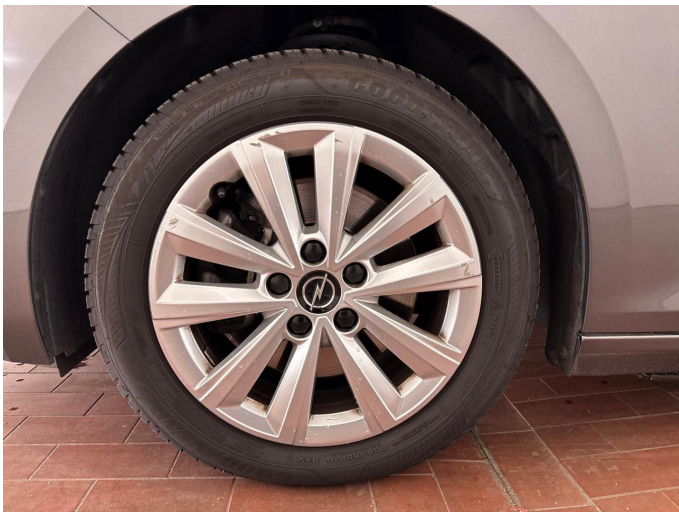
Figure 12: Mounted tyres

| # | Tyre size | Type of tyre | Manufacturer | Tread depth |
|---|---|---|---|---|
| 1) | 205/55 R16 94V | All-season tyres on Light alloy | Goodyear | 6mm / 6mm |
| 2) | 205/55 R16 94V | All-season tyres on Light alloy | Goodyear | 6mm / 6mm |

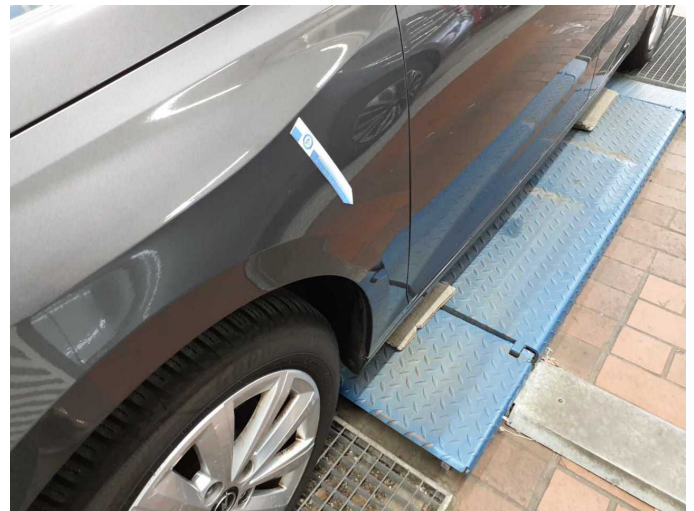
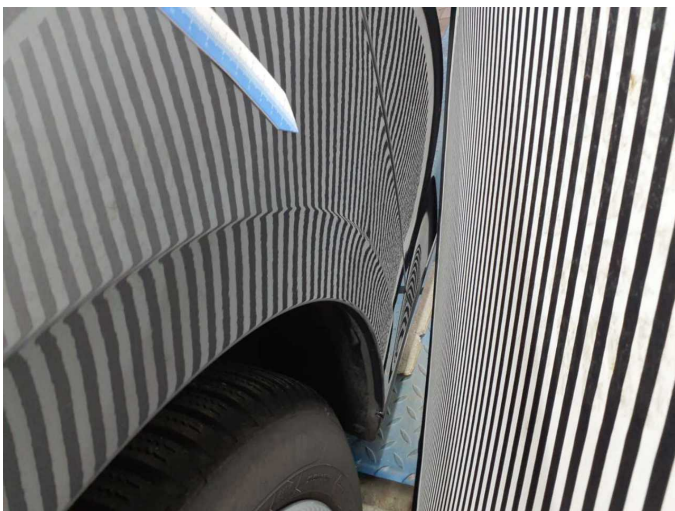
**Damage 1:** Mudguard - left side: Mudguard - left side - dent(s) - Smooth repair work

| No. | Component group | Description |
|---|---|---|
| 1 | Mudguard - left side | Mudguard - left side - dent(s) - Smooth repair work |

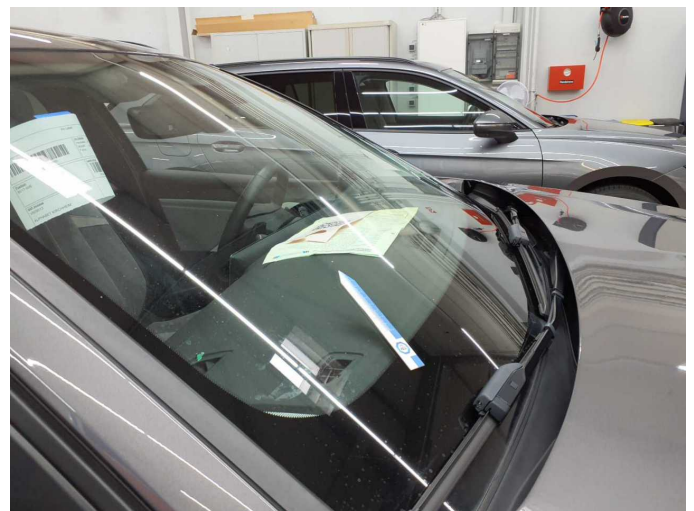
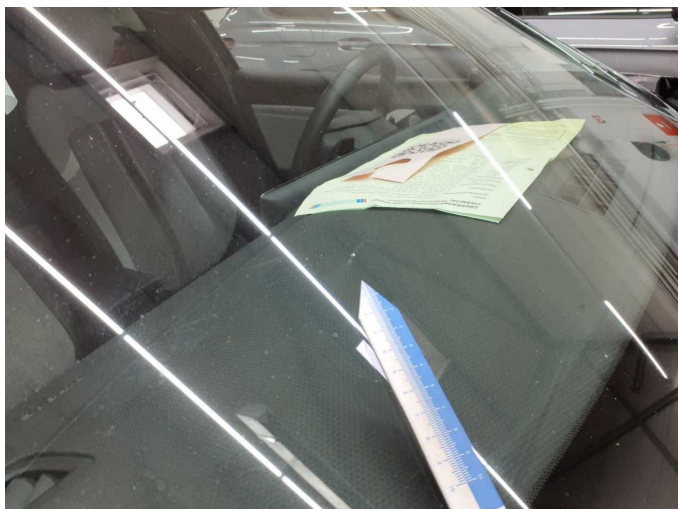
**Damage 2:** Vehicle glazing: Windscreen with lane departure assistant - Stone chips - Smart repair

| No. | Component group | Description |
|---|---|---|
| 2 | Vehicle glazing | Windscreen with lane departure assistant - Stone chips - Smart repair |

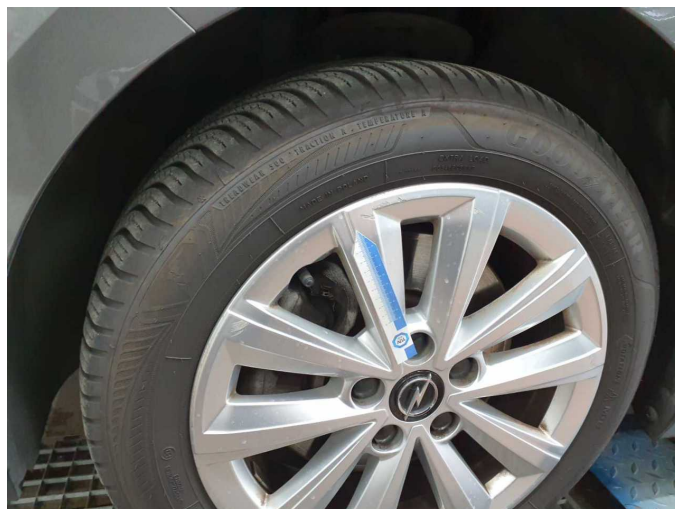
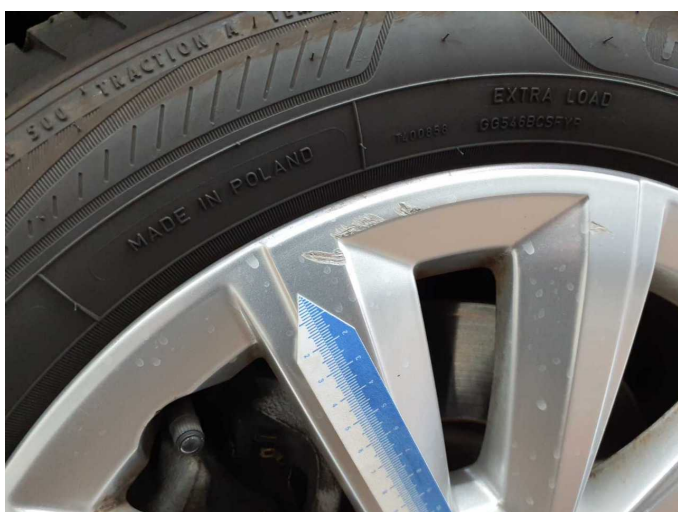
**Damage 3:** Wheel / tyres: Alloy rim - front left side - Scratch(es) - Loss in value

| No. | Component group | Description |
|---|---|---|
| 3 | Wheel / tyres | Alloy rim - front left side - Scratch(es) - Loss in value |

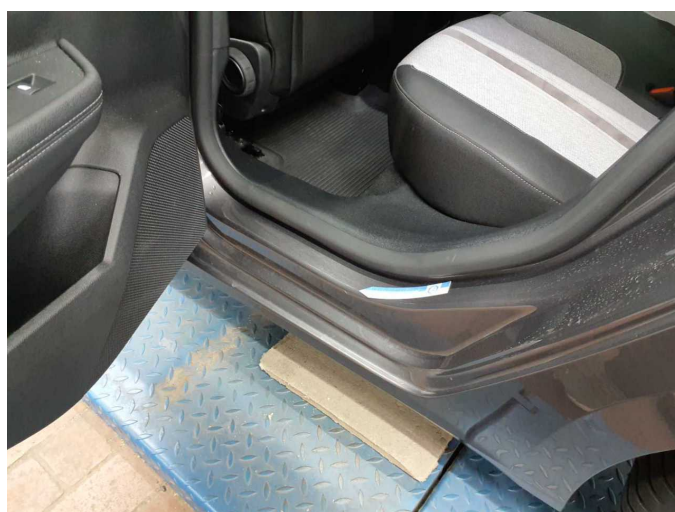
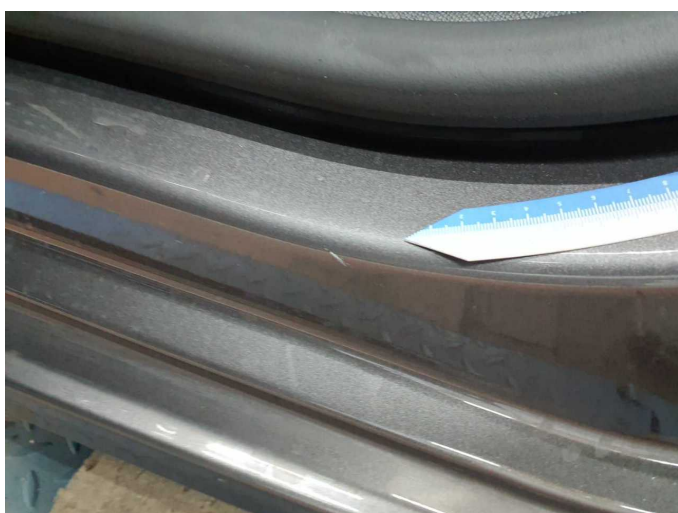
**Damage 4:** Side panel - rear left side: Sill - Scratch(es) - Smart repair

| No. | Component group | Description |
|---|---|---|
| 4 | Side panel - rear left side | Sill - Scratch(es) - Smart repair |

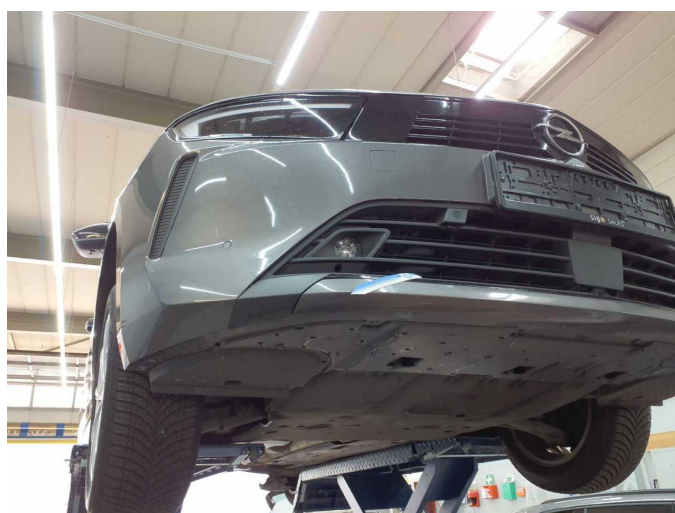
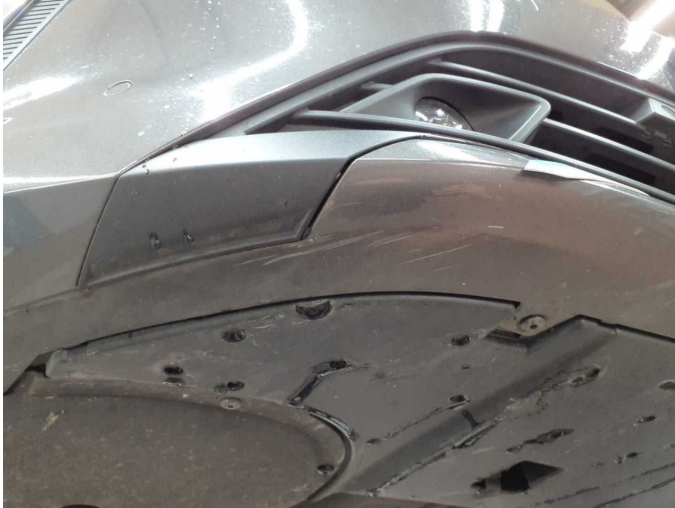
**Damage 5:** Front bumper: Front bumper - Scratch(es) - Smart repair

| No. | Component group | Description |
|---|---|---|
| 5 | Front bumper | Front bumper - Scratch(es) - Smart repair |

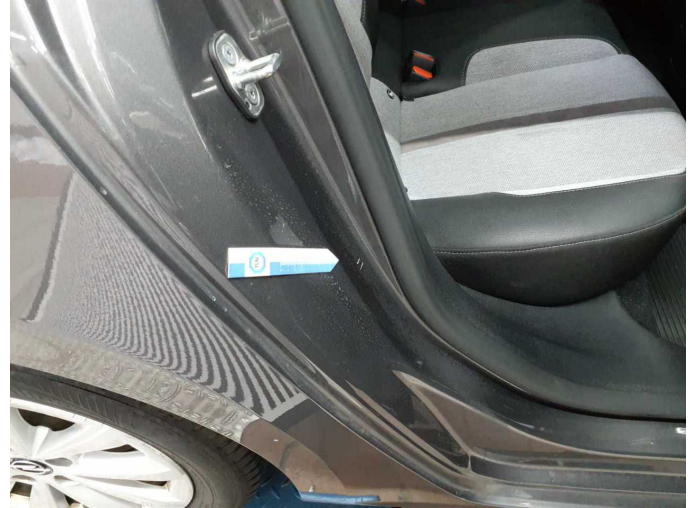
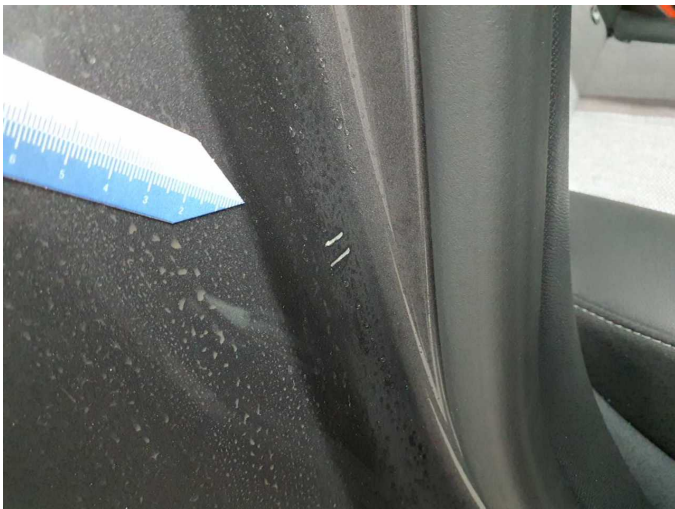
**Damage 6:** Side panel - rear right side: Sill - Scratch(es) - Smart repair

| No. | Component group | Description |
|---|---|---|
| 6 | Side panel - rear right side | Sill - Scratch(es) - Smart repair |

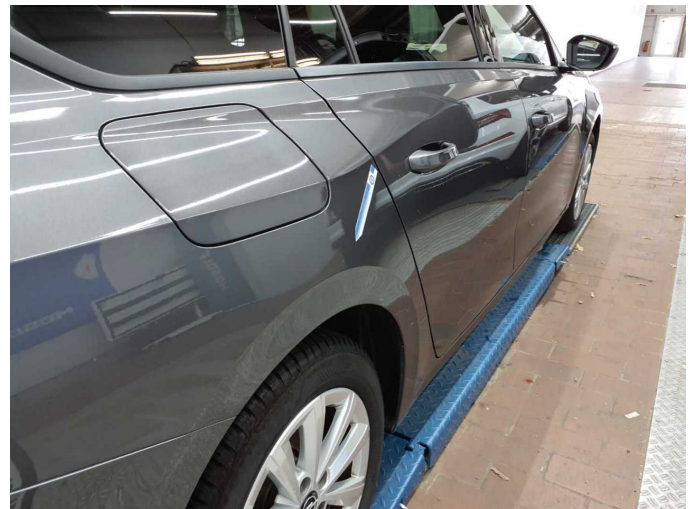
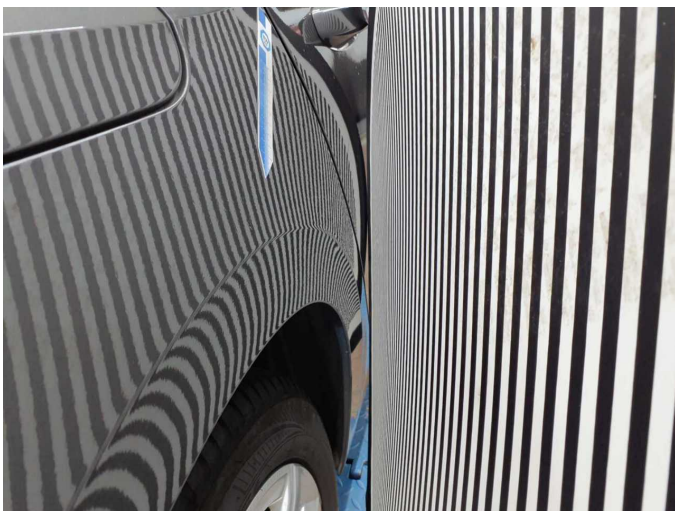
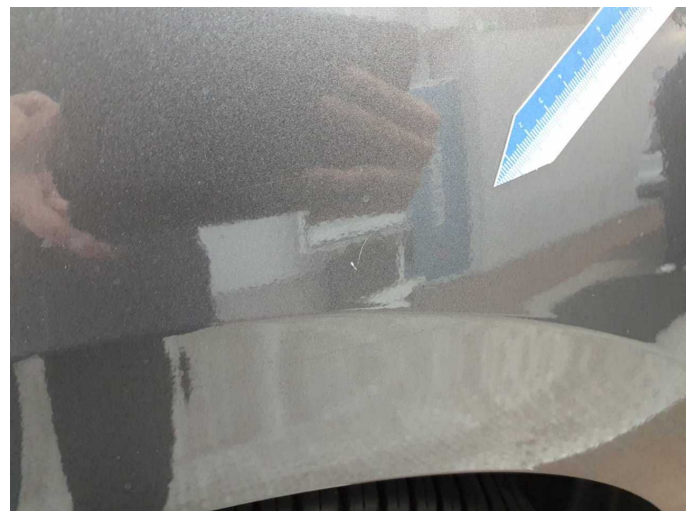
**Damage 7:** Side panel - rear right side: Side panel (& Kratzer) - dent(s) - Smart repair

| No. | Component group | Description |
|---|---|---|
| 7 | Side panel - rear right side | Side panel (& Kratzer) - dent(s) - Smart repair |

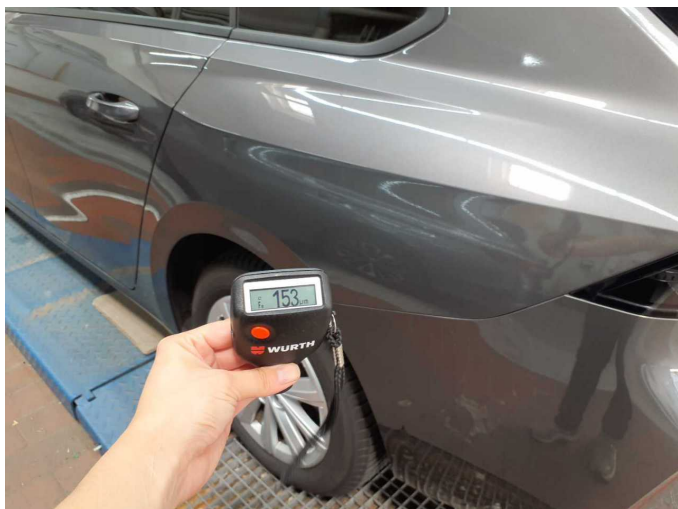
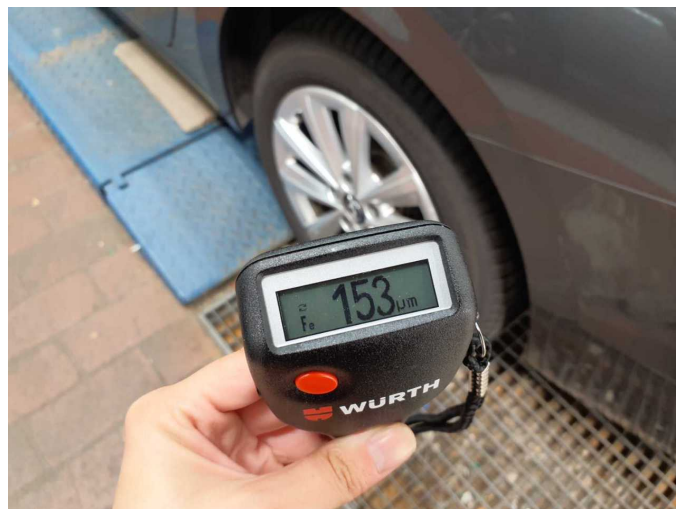
| 1 | Side panel - rear left side, Professionally carried out, Invoice of repair done Non-existent |

| Side panel - rear left side | 153 µm | Side panel - rear right side | 85 µm |

**Repainting 1:** Side panel - rear left side
