Expertise

Protocol number: 46670643  
Order No. / Reference: 26646318  
Inspection date: 23 Jul 2026

Manufacturer: Mercedes-Benz

Model: E 220 d 4Matic 9G-TRONIC Avantgarde

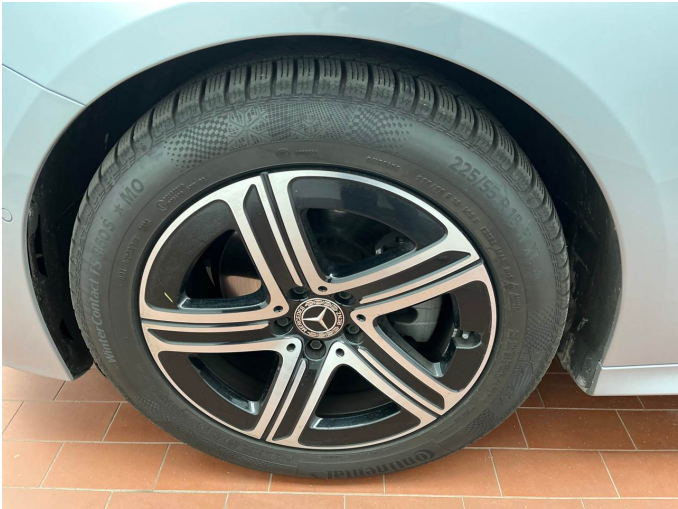
Figure 12: Mounted tyres

| # | Tyre size | Type of tyre | Manufacturer | Tread depth |
|---|---|---|---|---|
| 1) | 225/55 R18 102H | Winter tyres on Light alloy | Continental | 6mm / 6mm |
| 2) | 225/55 R18 102H | Winter tyres on Light alloy | Continental | 6mm / 6mm |

- Für den montierten Radsatz wurde kein Nachweis erbracht.
- Winterradsatz ist kein Bestandteil des Auslieferungsumfangs.

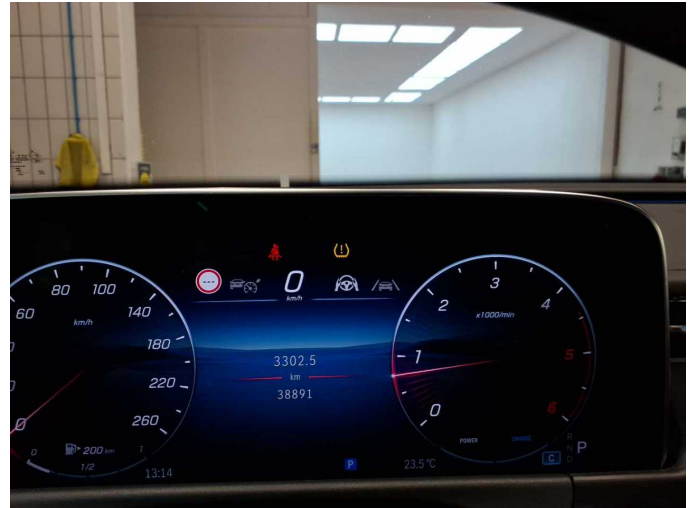
| No. | Component group | Description |
|---|---|---|
| 1 | Instrument panel | Indicator light (RDKS) - on - Diagnosed and repair if necessary |

**Damage 1:** Instrument panel: Indicator light (RDKS) - on - Diagnosed and repair if necessary

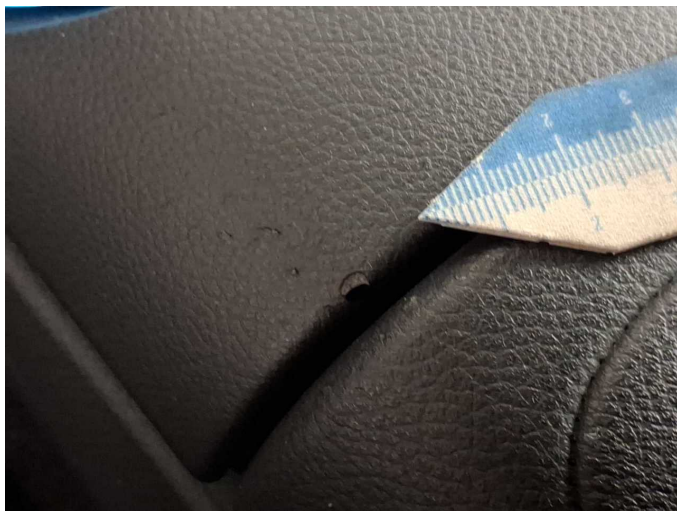
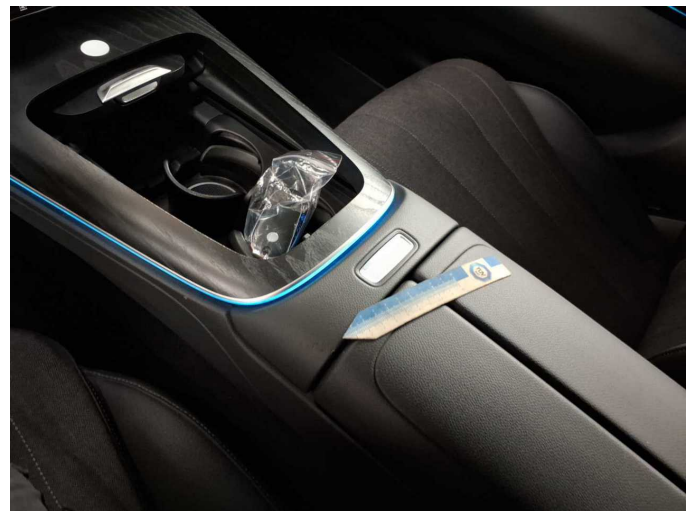
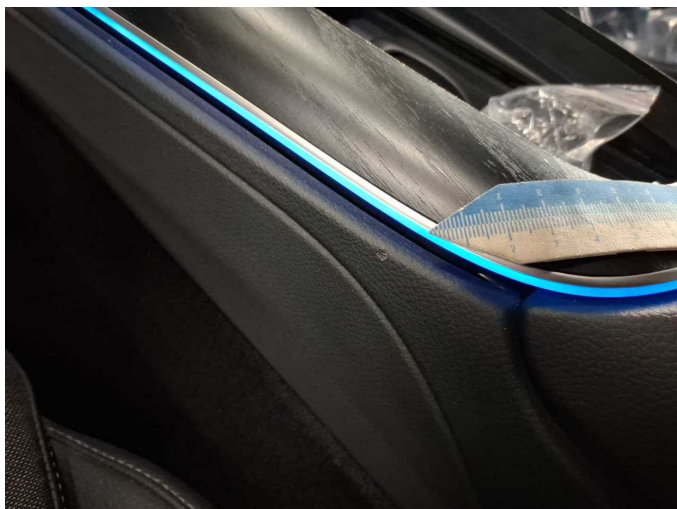
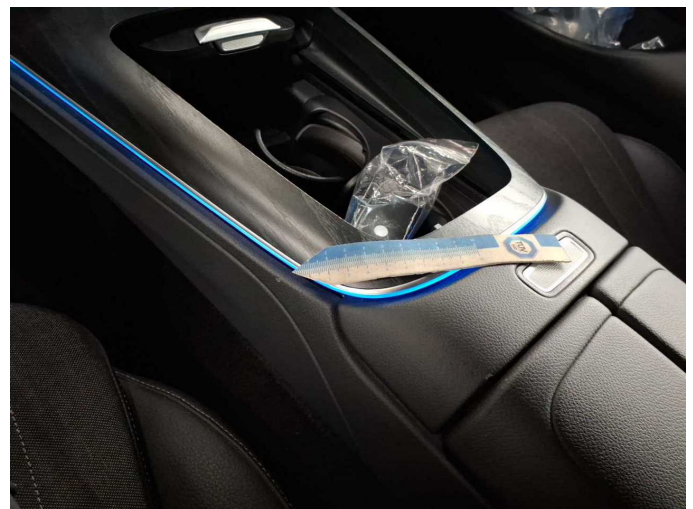
| No. | Component group | Description |
|---|---|---|
| 2 | Interior | Interior - Broken / torn - Smart repair |

**Damage 2:** Interior: Interior - Broken / torn - Smart repair

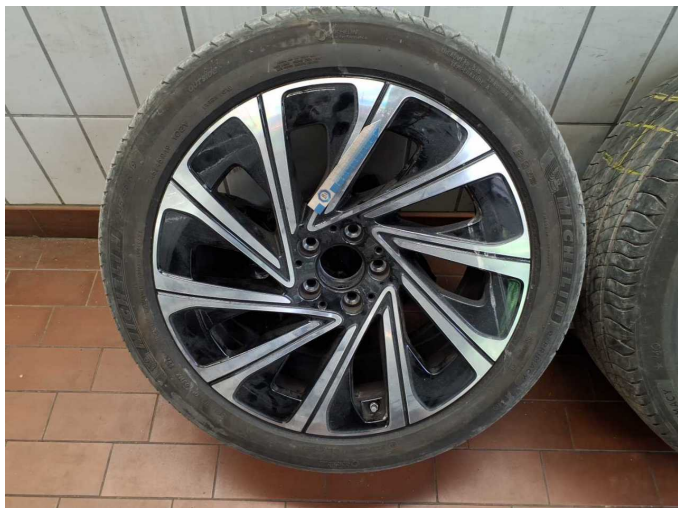
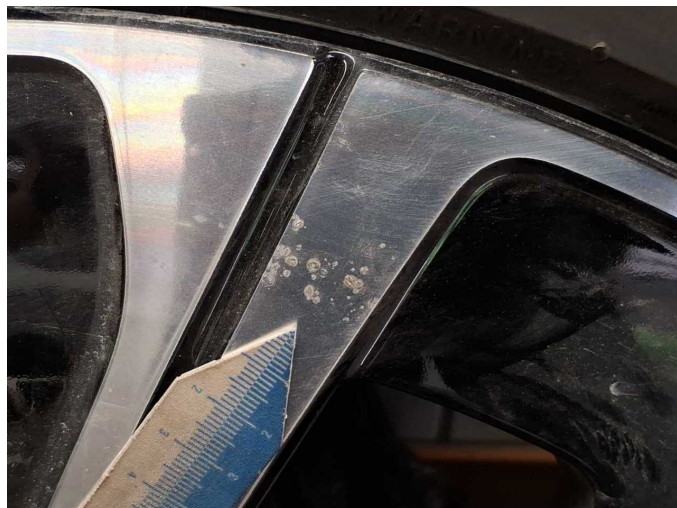
| No. | Component group | Description |
|---|---|---|
| 3 | 2nd wheel set | 1 alloy rim - Scratch(es) - Loss in value |

**Damage 3:** 2nd wheel set: 1 alloy rim - Scratch(es) - Loss in value

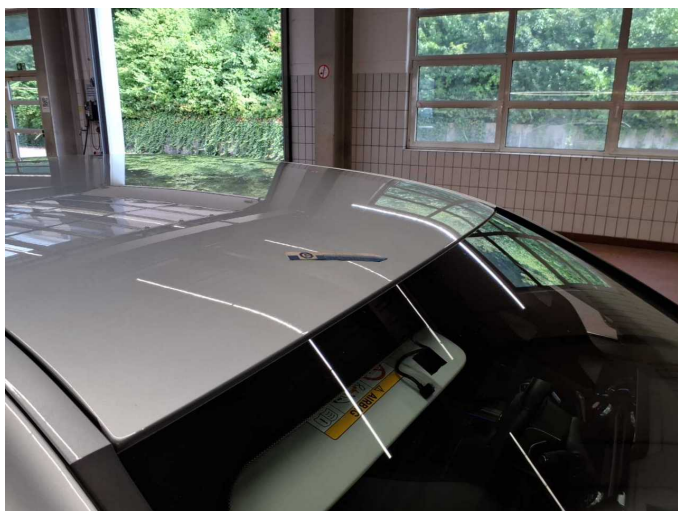
| No. | Component group | Description |
|---|---|---|
| 1 | Roof | Roof (Steinschlag mit kleiner Delle) - Stone chips - No deduction |

**Wear and tear 1:** Roof: Roof (Steinschlag mit kleiner Delle) - Stone chips - No deduction

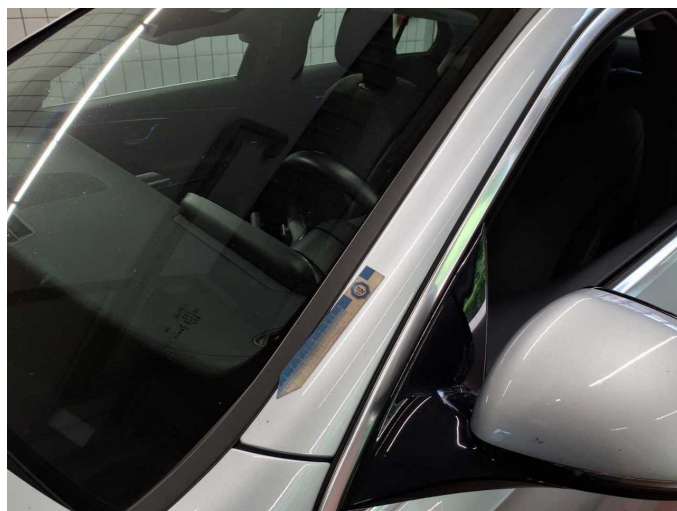
| No. | Component group | Description |
|---|---|---|
| 2 | Roof | Roof rail - left side - Stone chips - No deduction |

**Wear and tear 2:** Roof: Roof rail - left side - Stone chips - No deduction

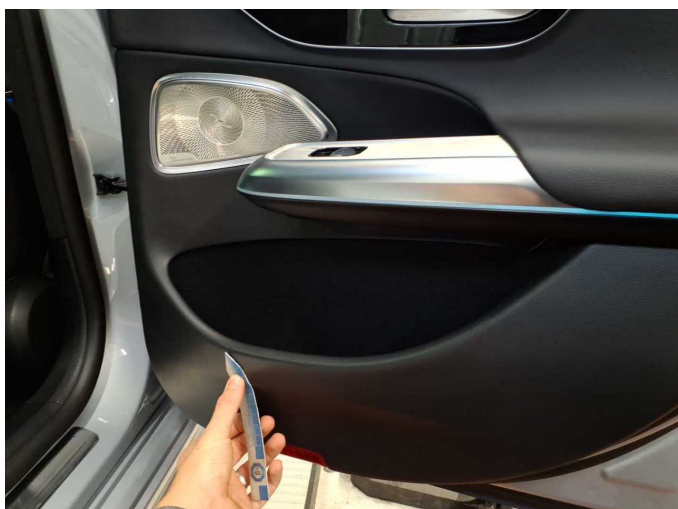
| No. | Component group | Description |
|---|---|---|
| 3 | Trim / covers | Door trim - rear right side - Scratch(es) - No deduction |

**Wear and tear 3:** Trim / covers: Door trim - rear right side - Scratch(es) - No deduction

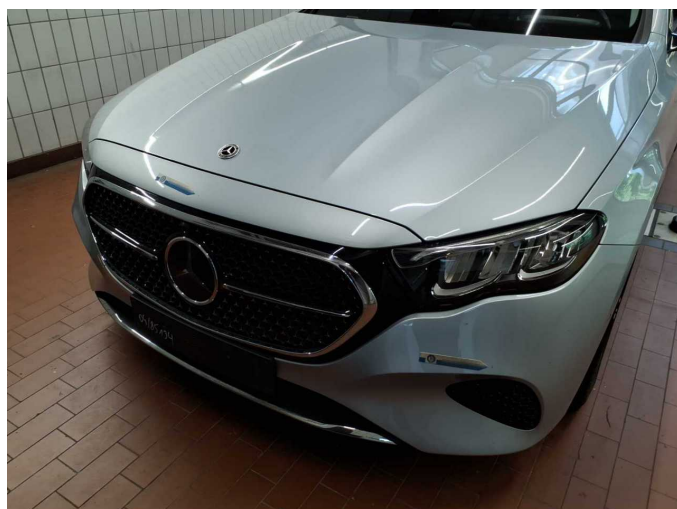
| No. | Component group | Description |
|---|---|---|
| 4 | Front bumper | Front bumper - Stone chips - No deduction |

**Wear and tear 4:** Front bumper: Front bumper - Stone chips - No deduction
