Expertise

Protocol number: 46626838  
Order No. / Reference: 26528916  
Inspection date: 15 Jul 2026

| Manufacturer: Opel | Model: Insignia Sports Tourer 2.0 Diesel Aut. Business |

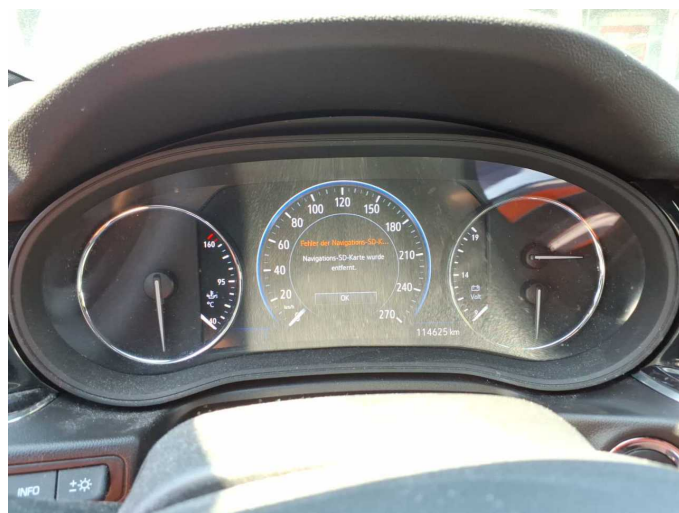
| Vehicle details | |
|---|---|
| Mileage (Read) | 114,625 km |

**Figure 4:** Instrument cluster

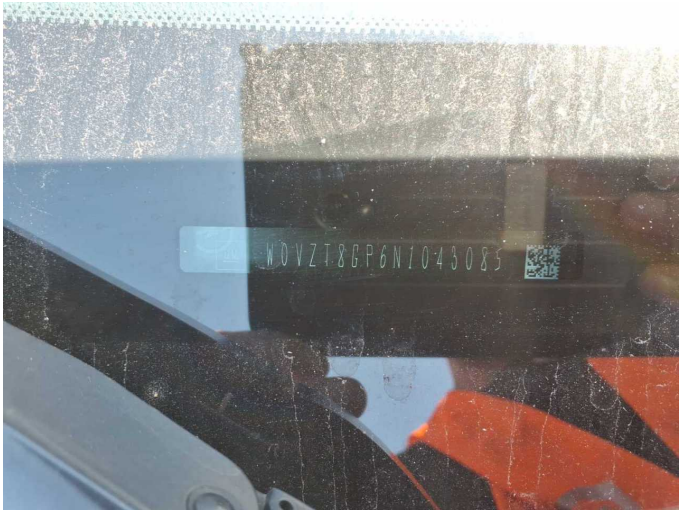
Figure 8: VIN

| VIN comparison | The vehicle identification number (VIN) was read from the vehicle and its conformity with the submitted documents was confirmed by the undersigned during the inspection. |

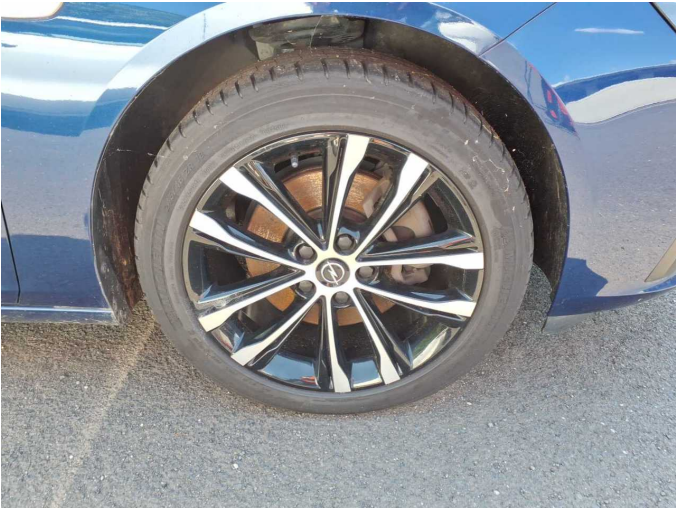
| Tyres | | | |
|---|---|---|---|
| 1) | 245/45 R18 100Y | Summer tyres on Light alloy | 5mm / 5mm |
| 2) | 245/45 R18 100Y | Summer tyres on Light alloy | 5mm / 5mm |

Figure 9: Mounted tyres

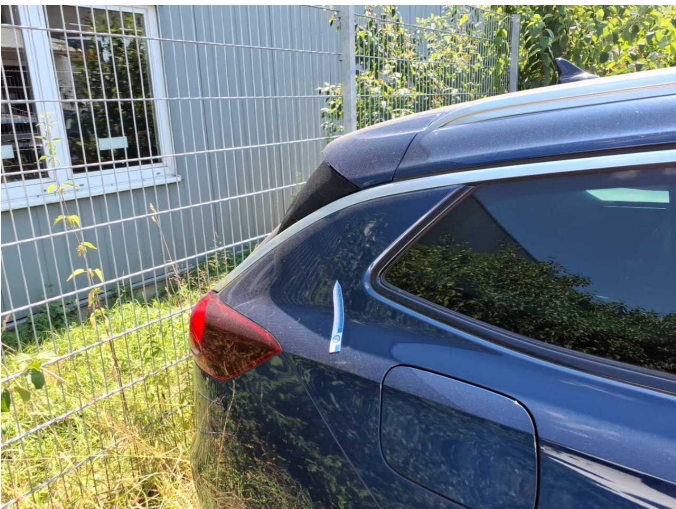
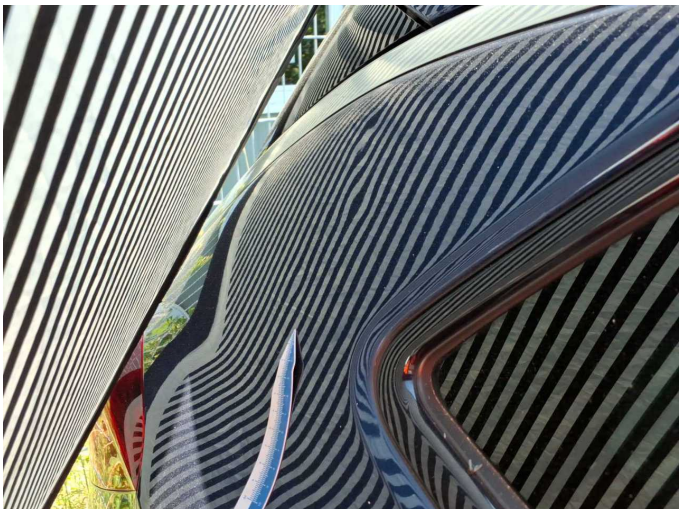
Damage 1: Side panel - rear right side: Side panel - dent(s) - Smooth repair work

| No. | Component group | Description |
|---|---|---|
| 1 | Side panel - rear right side | Side panel - dent(s) - Smooth repair work |

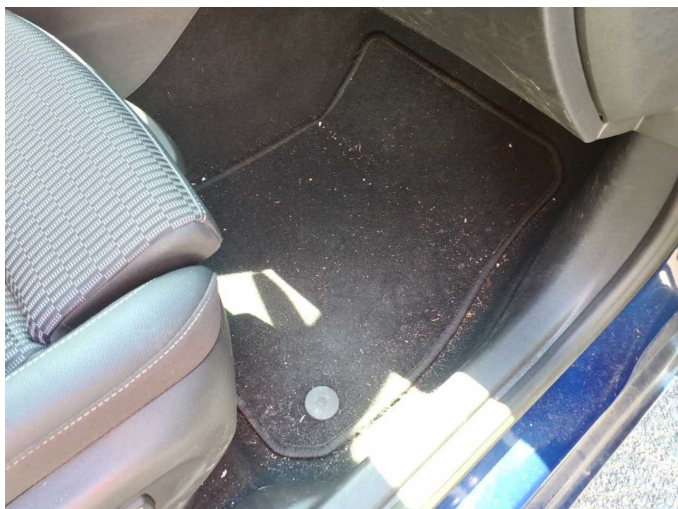
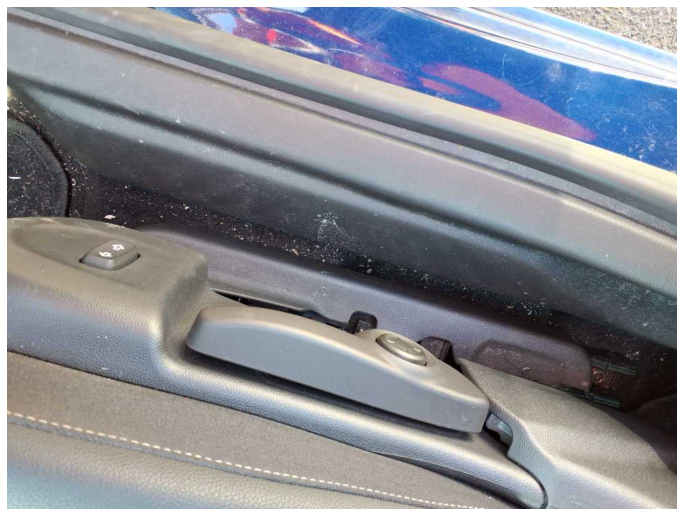
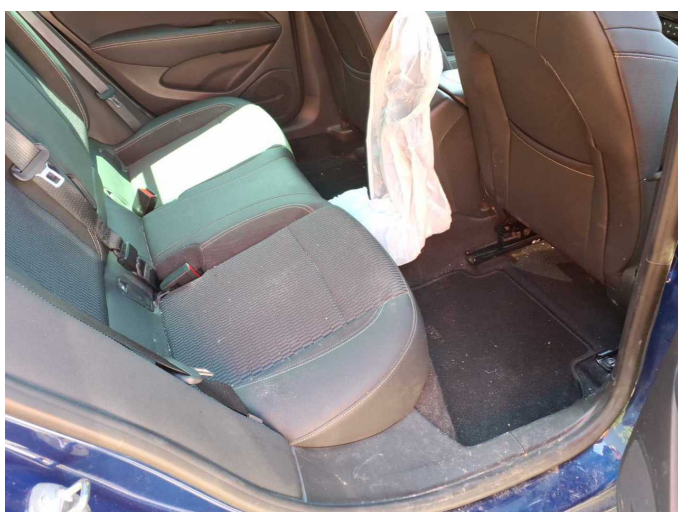
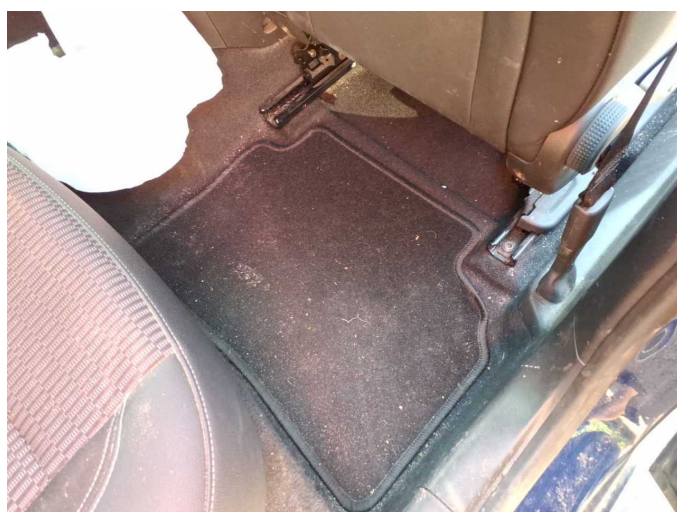
**Damage 2:** Interior: Interior - Soiled - Paint

| No. | Component group | Description |
|---|---|---|
| 2 | Interior | Interior - Soiled - Paint |

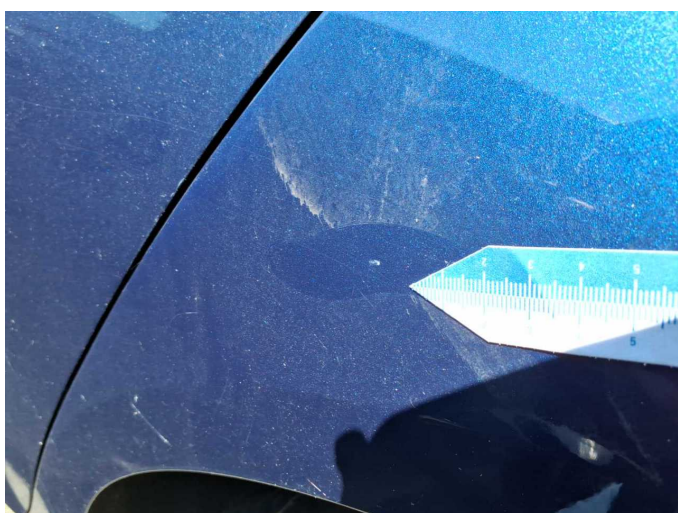
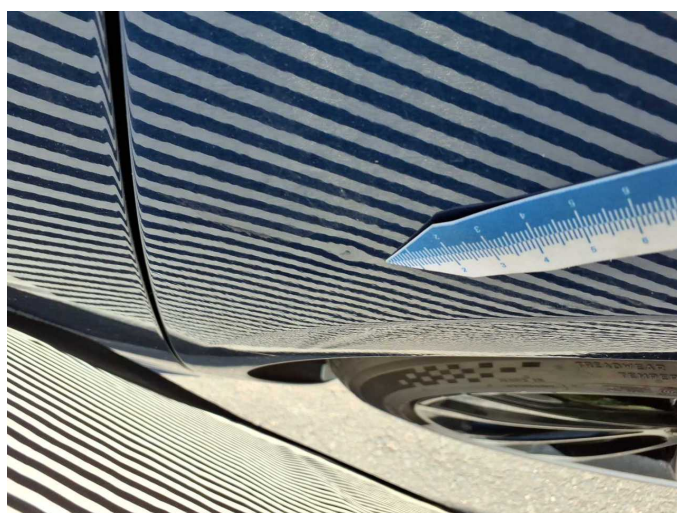
**Damage 3:** Side panel - rear left side: Side panel - Dent / paintcoat damage - Smart repair

| No. | Component group | Description |
|---|---|---|
| 3 | Side panel - rear left side | Side panel - Dent / paintcoat damage - Smart repair |

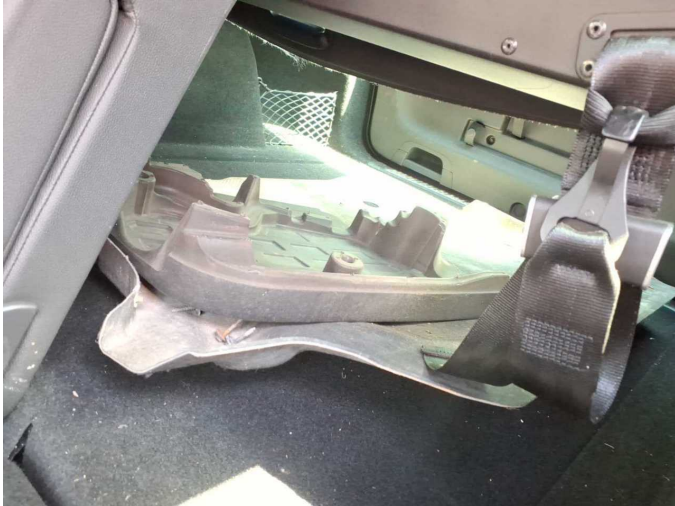
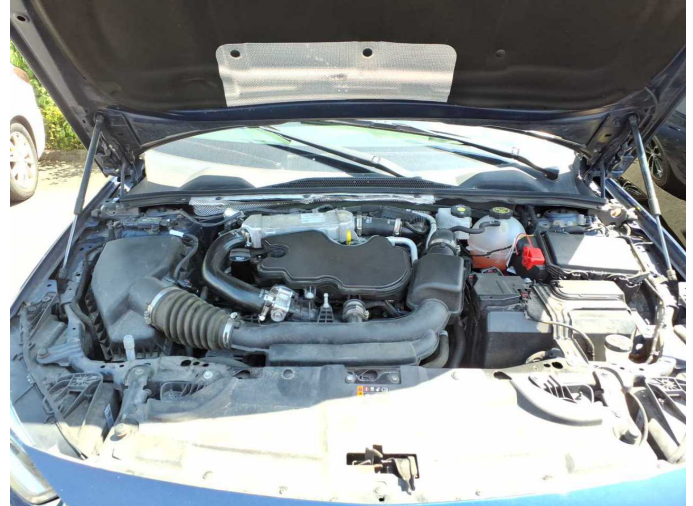
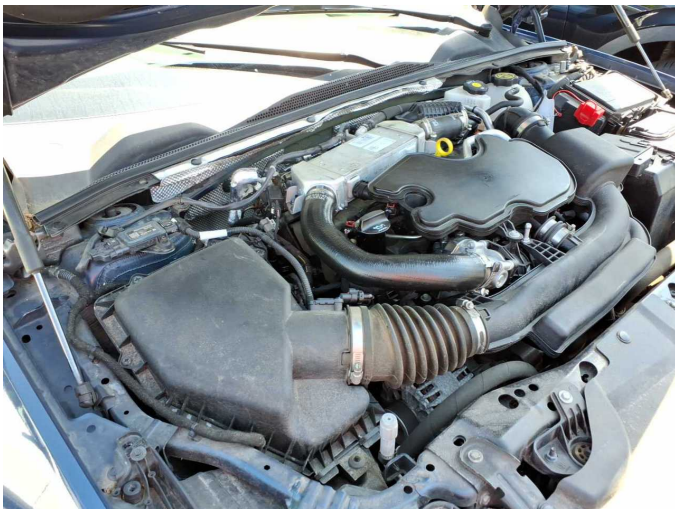
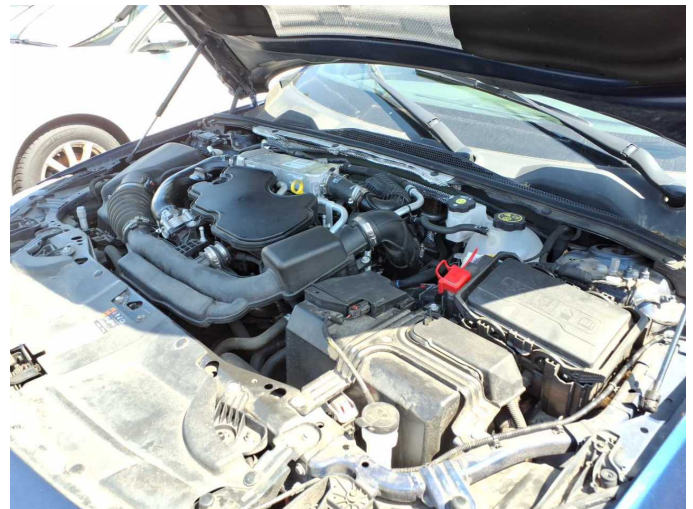
| Engine function test | An engine test run could not be performed.<br>This is due to the following reason.:<br>Motorschaden |

**Damage 4:** Engine: Engine - Defective - repair according to calculation

| No. | Component group | Description |
|---|---|---|
| 4 | Engine | Engine - Defective - repair according to calculation |

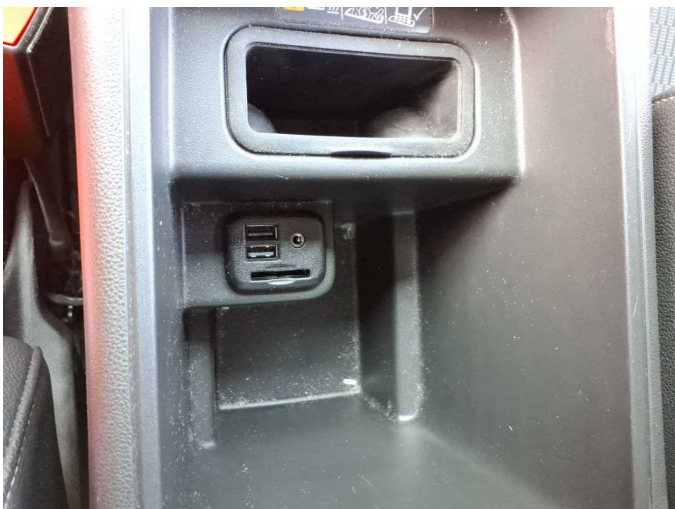
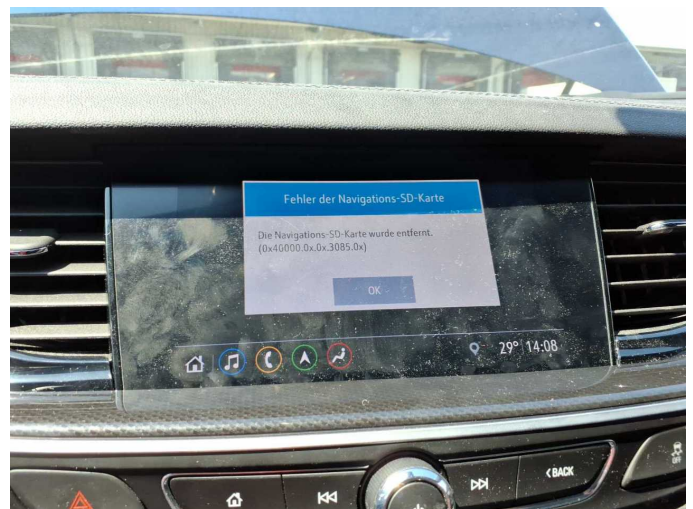
Multimedia system - Navigation data storage

**Missing part 1:** Multimedia system: Navigation data storage - Missing - Replace
