Expertise

Protocol number: 46714232  
Order No. / Reference: 26787734  
Inspection date: 24 Jul 2026

Manufacturer: Volkswagen

Model: Passat Variant 2.0 TDI SCR DSG Elegance

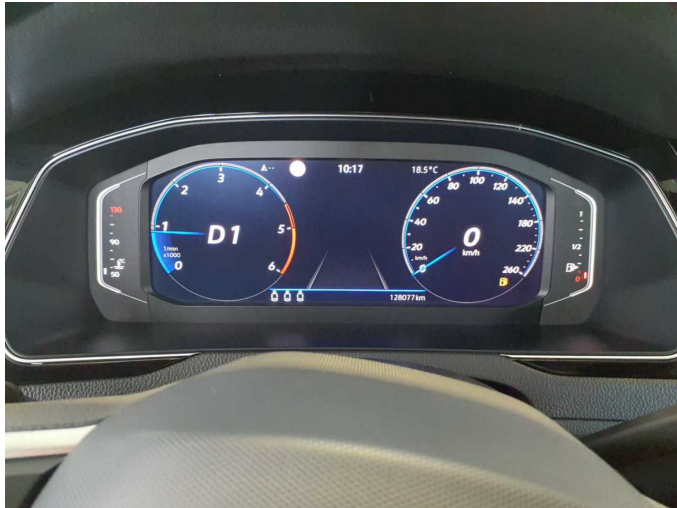
| Vehicle details | |
|---|---|
| Mileage (Read) | 128,077 km |

Figure 7: Instrument cluster

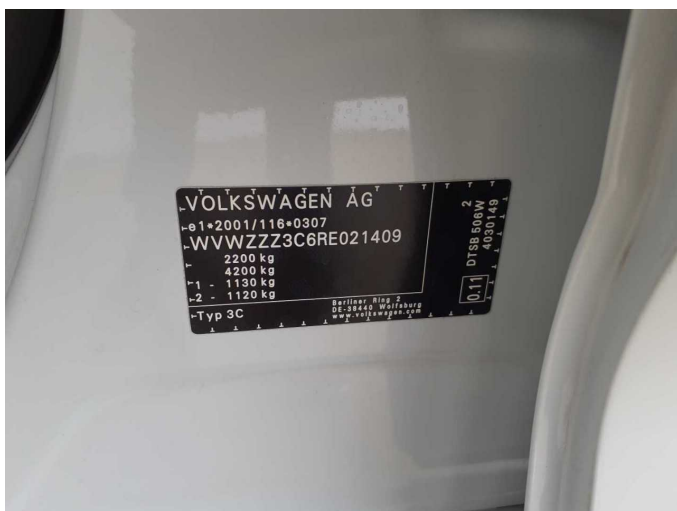
| VIN comparison | The vehicle identification number (VIN) was read from the vehicle and its conformity with the submitted documents was confirmed by the undersigned during the inspection. |

Figure 11: VIN

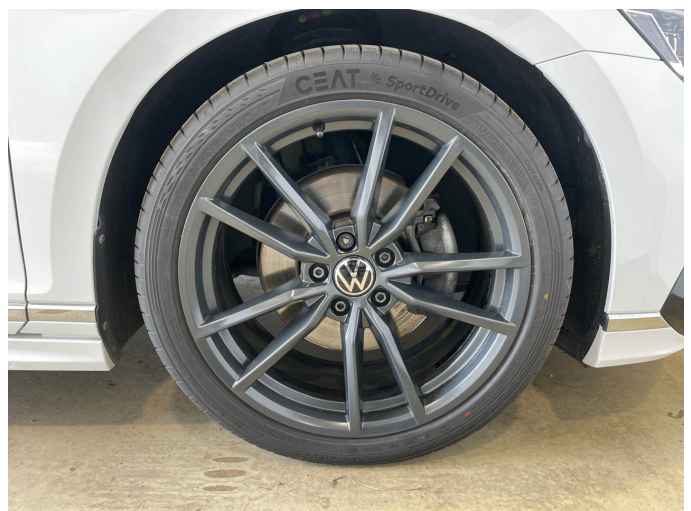
| # | Tyre size | Type of tyre | Manufacturer | Tread depth |
|---|---|---|---|---|
| 1) | 235/40 R19 96Y | Summer tyres on Light alloy | Sonstige | 7mm / 7mm |
| 2) | 235/40 R19 96W | Summer tires (with run-flat tires) on Light alloy | Pirelli | 5mm / 5mm |

Figure 12: Mounted tyres

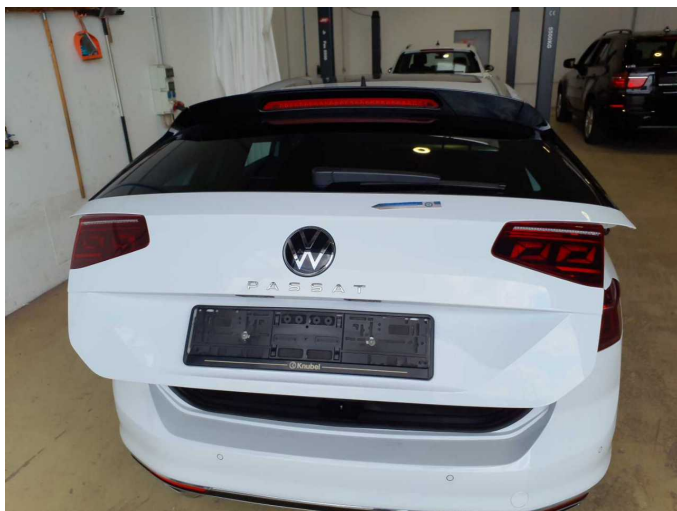
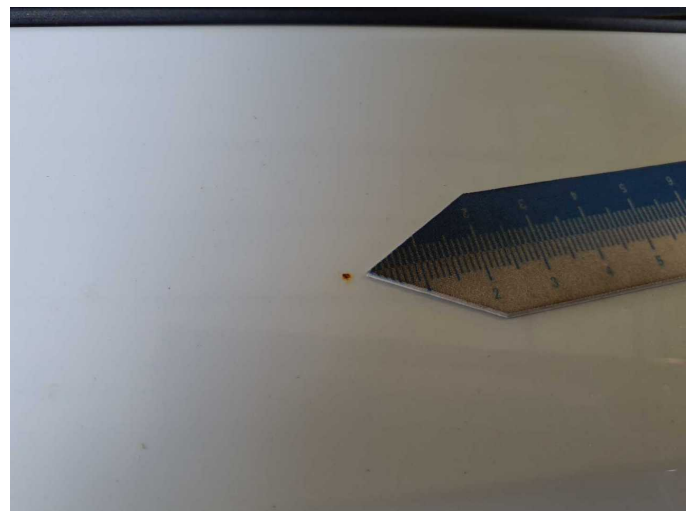
| No. | Component group | Description |
|---|---|---|
| 2 | Boot lid / rear door | Boot lid - Corrosion - Smart repair |

Damage 2: Boot lid / rear door: Boot lid - Corrosion - Smart repair

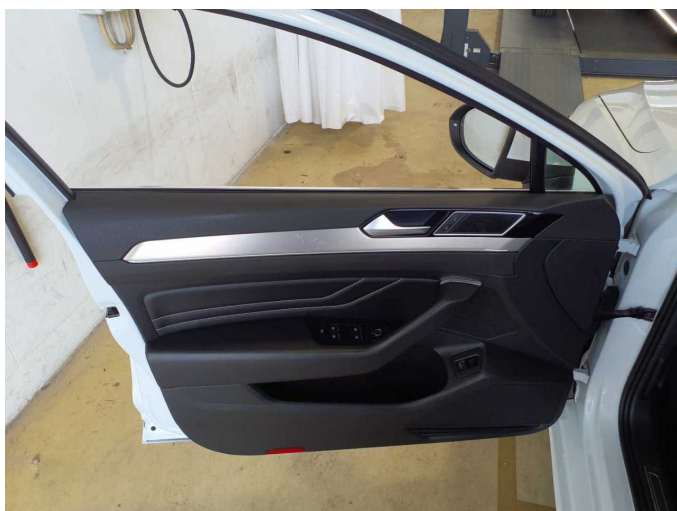
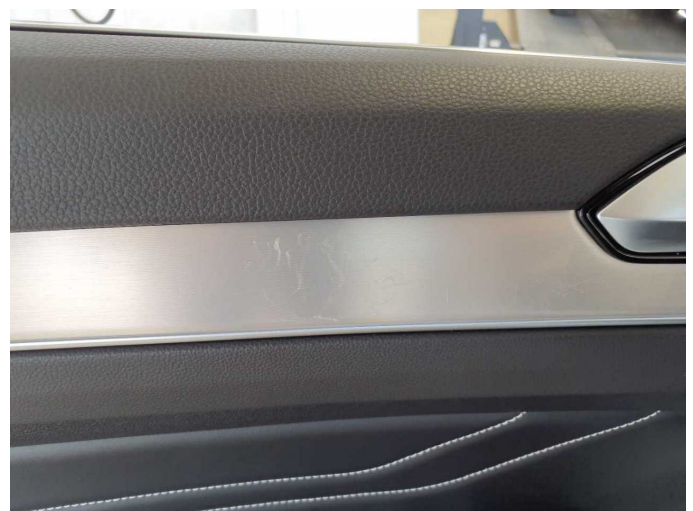
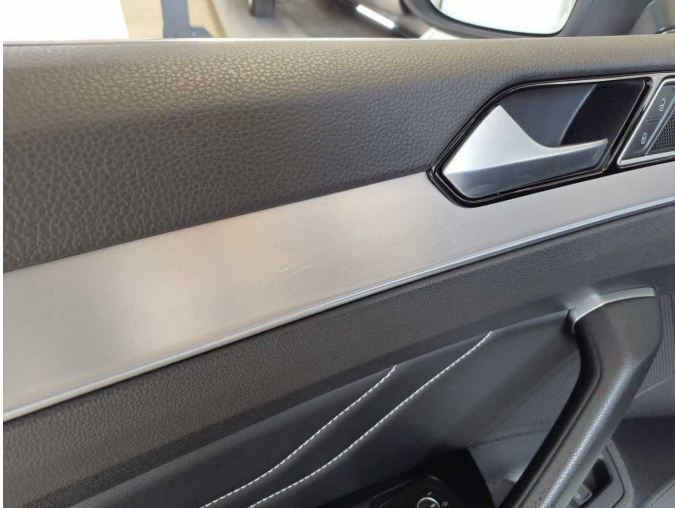
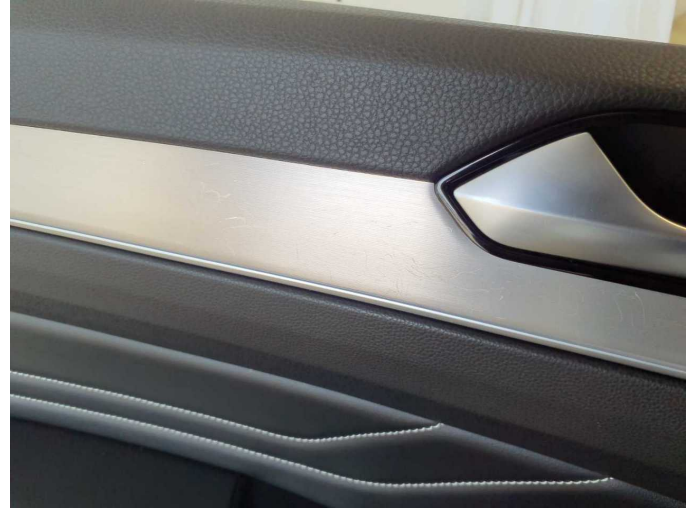
| No. | Component group | Description |
|---|---|---|
| 3 | Trim / covers | Door trim - front left side (Zierleiste) - Scratch(es) - Loss in value |

Damage 3: Trim / covers: Door trim - front left side (Zierleiste) - Scratch(es) - Loss in value

**Damage 3:** Trim / covers: Door trim - front left side (Zierleiste) - Scratch(es) - Loss in value

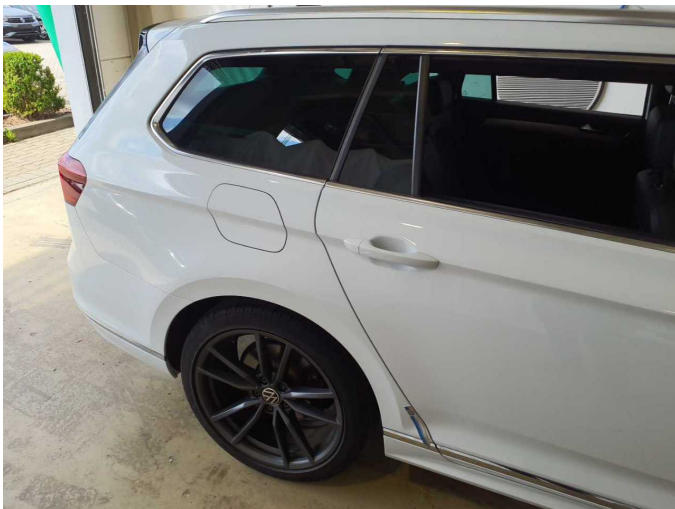
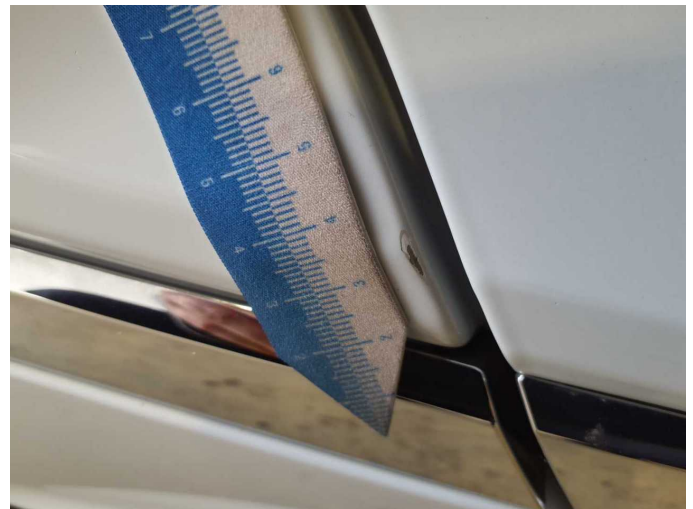
| No. | Component group | Description |
|---|---|---|
| 4 | Side panel - rear right side | Sill - Scratch(es) - Smart repair |

**Damage 4:** Side panel - rear right side: Sill - Scratch(es) - Smart repair

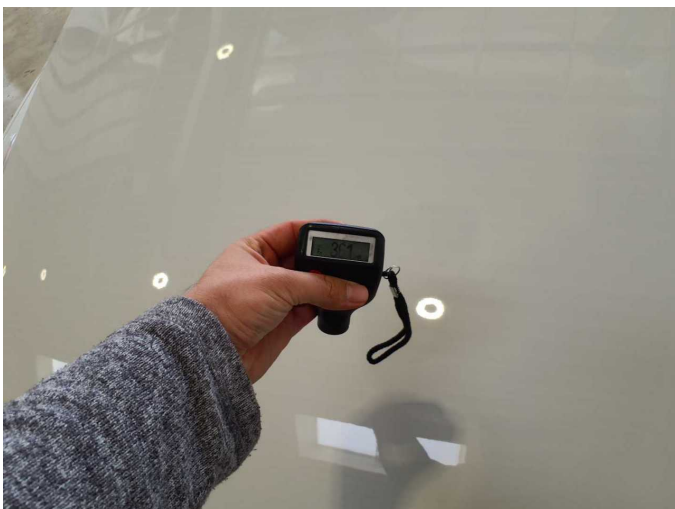
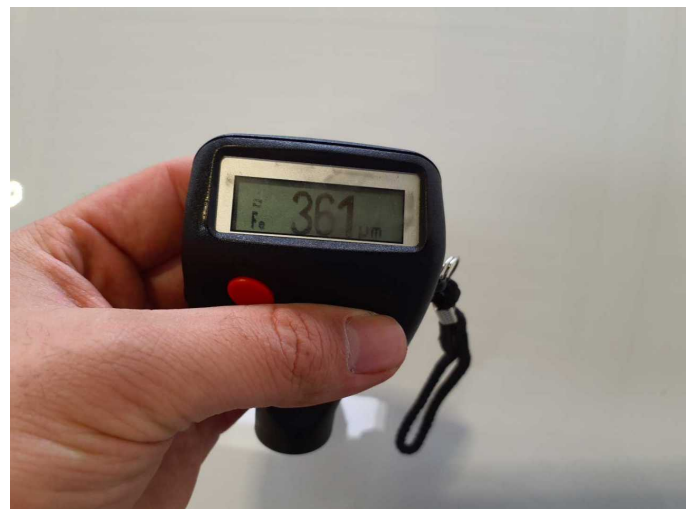
| No. | Repainting |
|---|---|
| 1 | Bonnet, Professionally carried out |

| Bonnet | 361 µm | Side panel - rear left side | 1,730 µm |

**Repainting 1:** Bonnet

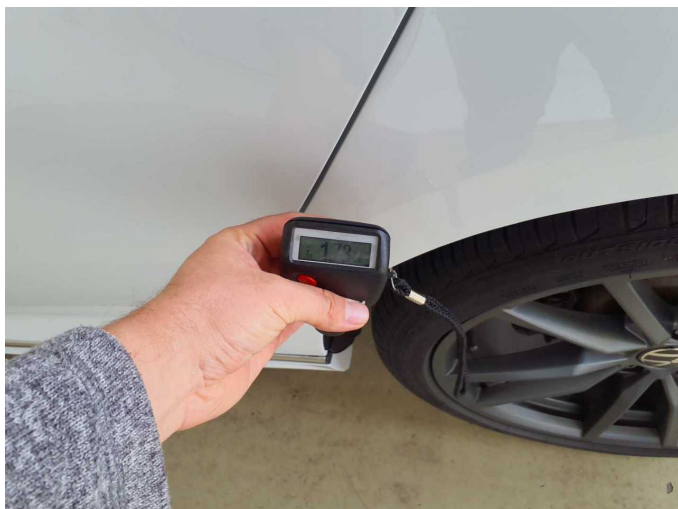
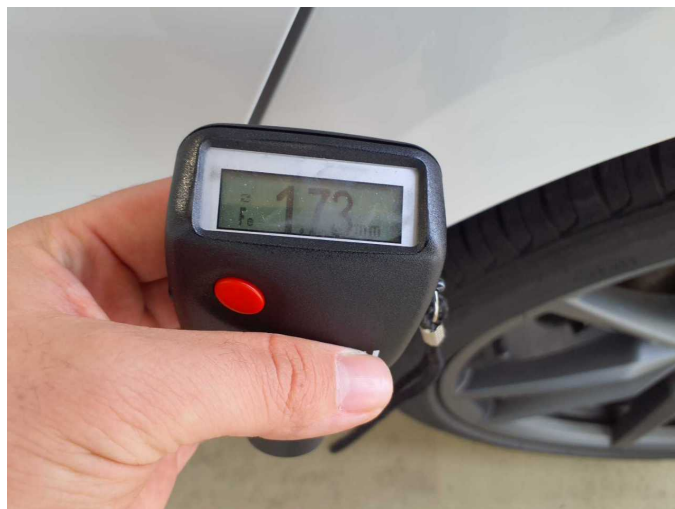
| No. | Repainting |
|---|---|
| 2 | Side panel - rear left side, Professionally carried out |

**Repainting 2:** Side panel - rear left side
