Expertise

Protocol number: 46557511  
Order No. / Reference: 26560237  
Inspection date: 16 Jul 2026

Manufacturer: Ford

Model: Focus Turnier 1.5 EcoBlue Start-Stopp-System TITANIUM

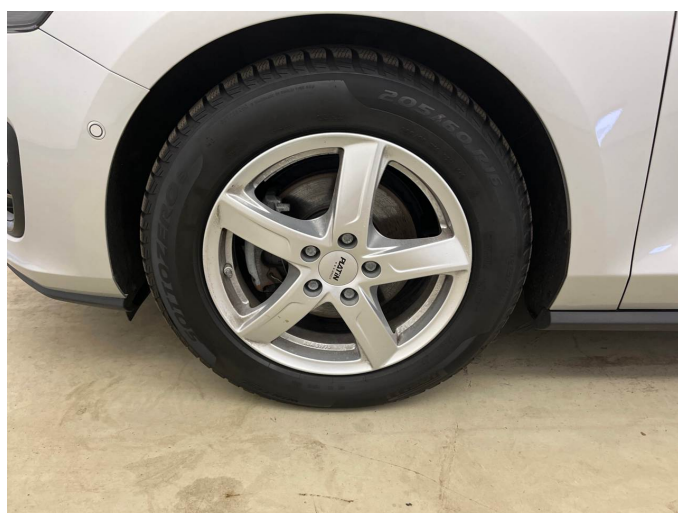
| Tyres | | | | |
|---|---|---|---|---|
| 1) | 205/60 R16 92H | Winter tyres on Light alloy | Goodyear | 5mm / 5mm |
| 2) | 205/60 R16 92H | Winter tyres on Light alloy | Goodyear | 5mm / 5mm |

Figure 12: Mounted tyres

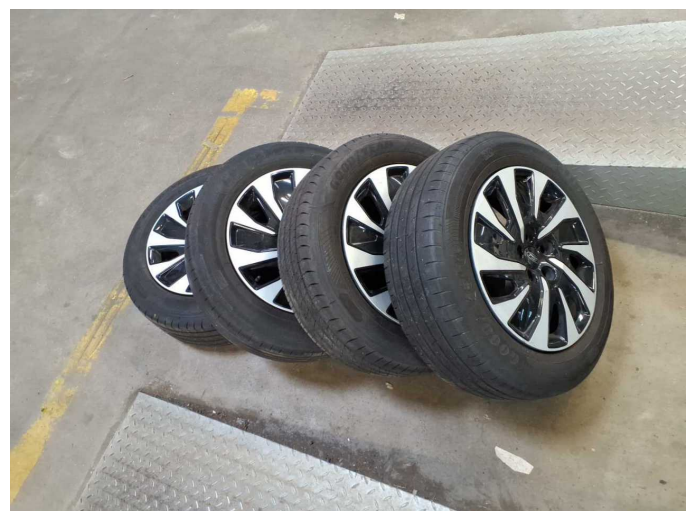
| Tyres | | | | |
|---|---|---|---|---|
| 1) | 205/60 R16 92V | Summer tyres on Steel rim with wheel cover | Goodyear | 4mm / 4mm |
| 2) | 205/60 R16 92V | Summer tyres on Steel rim with wheel cover | Goodyear | 5mm / 5mm |

Figure 18: Additional tyres

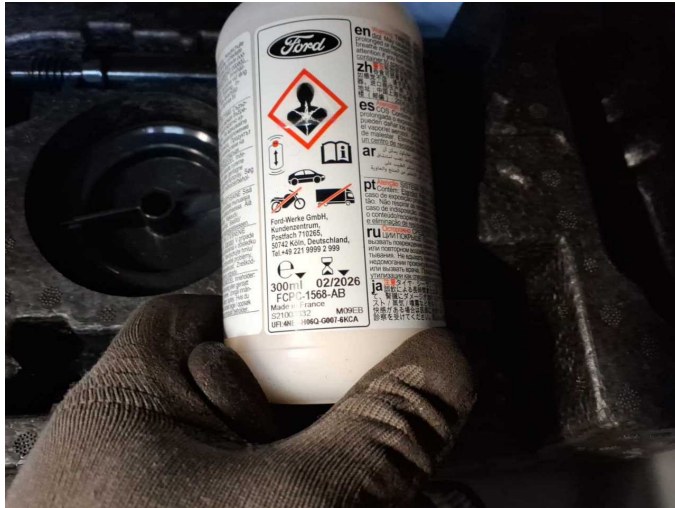
**Damage 1:** Equipment: Tirefit filler - Expired - Replace

| No. | Component group | Description |
|---|---|---|
| 1 | Equipment | Tirefit filler - Expired - Replace |

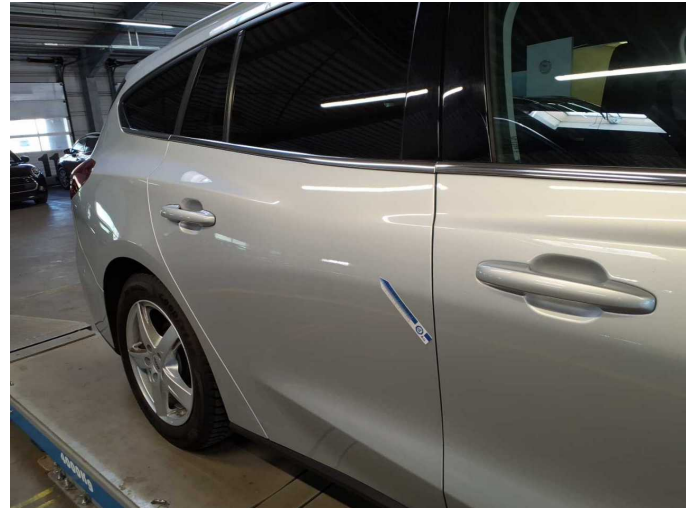
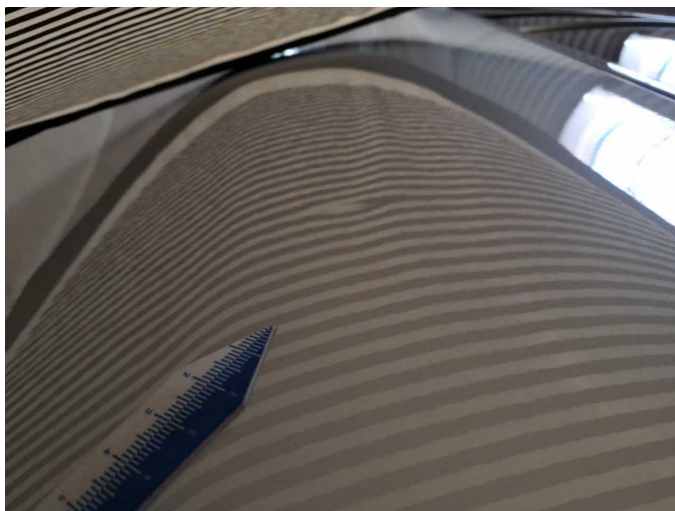
**Damage 2:** Door - front right side: Door - dent(s) - Smooth repair work

| No. | Component group | Description |
|---|---|---|
| 2 | Door - front right side | Door - dent(s) - Smooth repair work |

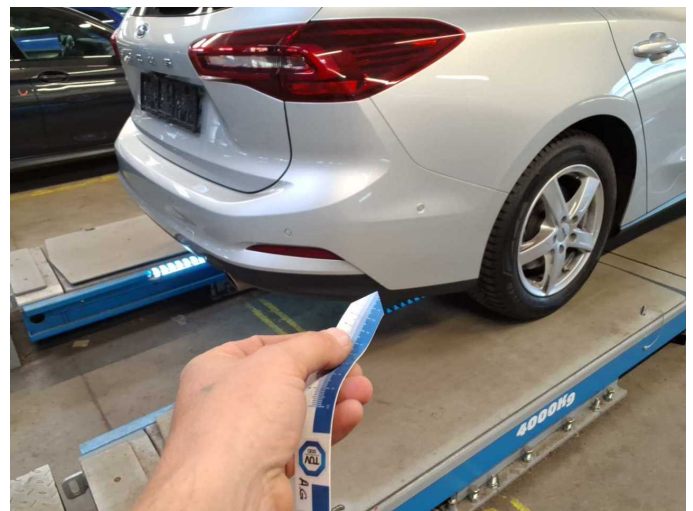
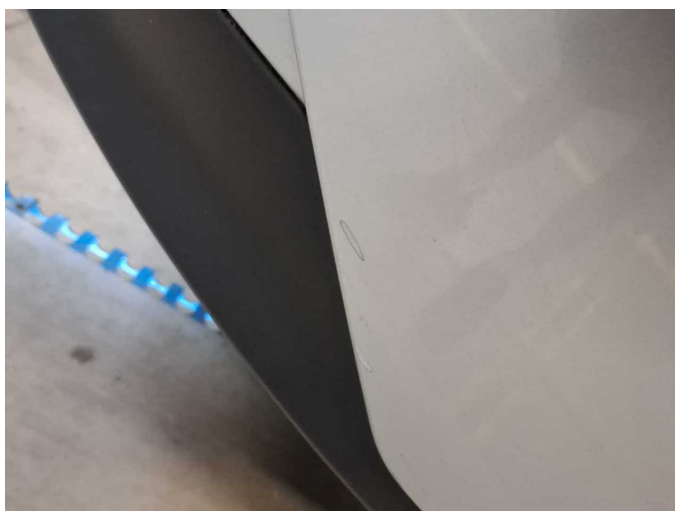
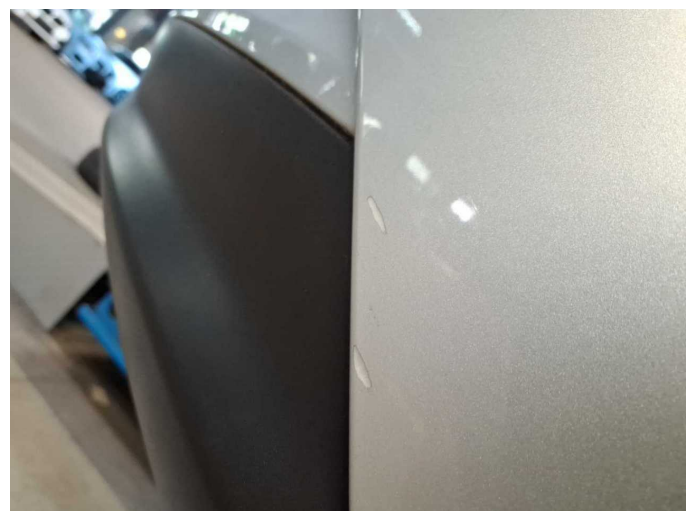
**Damage 3:** Rear bumper: Rear bumper - Scratch(es) - Smart repair

| No. | Component group | Description |
|---|---|---|
| 3 | Rear bumper | Rear bumper - Scratch(es) - Smart repair |

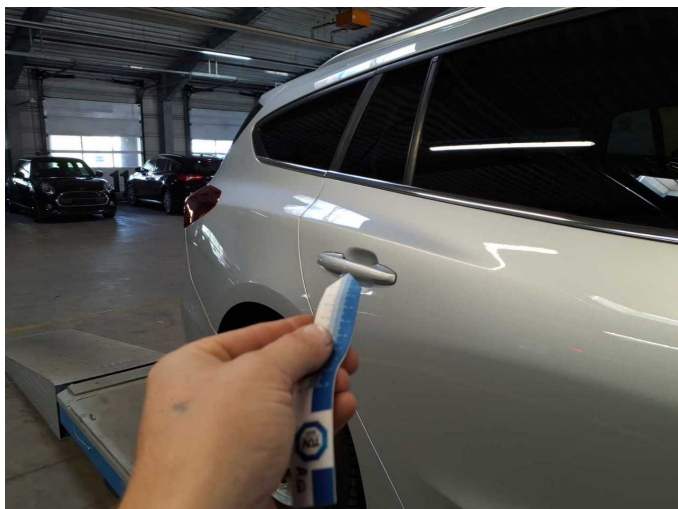
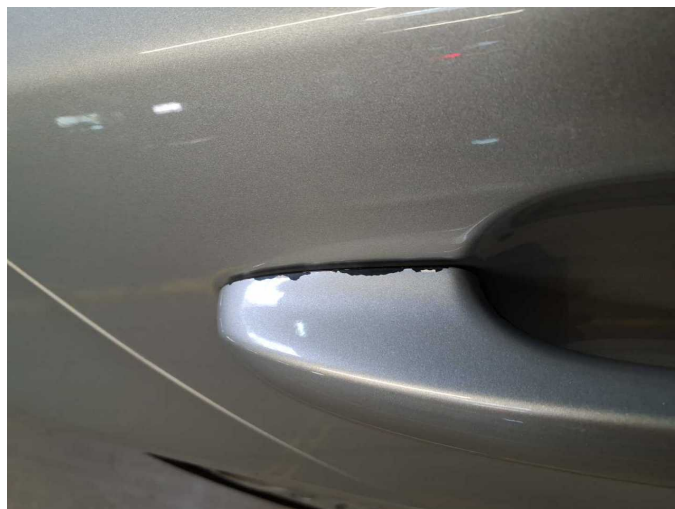
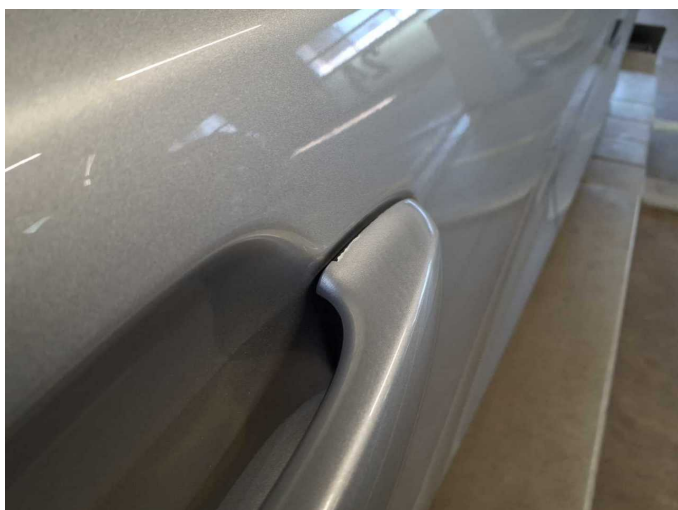
**Damage 4:** Door - rear right side: Door handle - outside - Paint defect - Smart repair

| No. | Component group | Description |
|---|---|---|
| 4 | Door - rear right side | Door handle - outside - Paint defect - Smart repair |

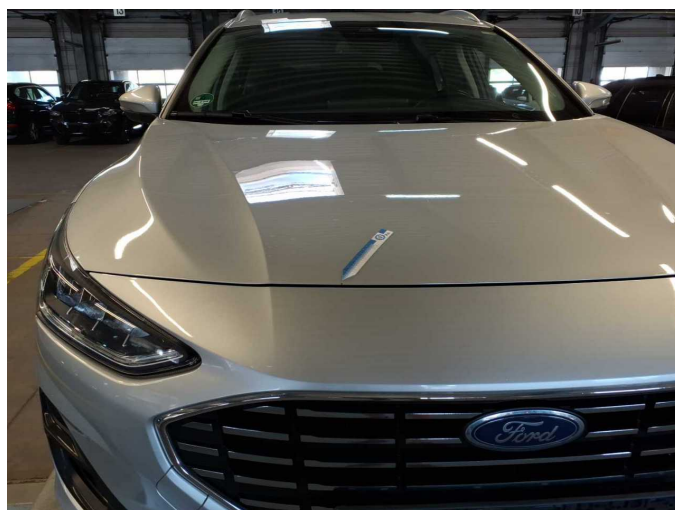
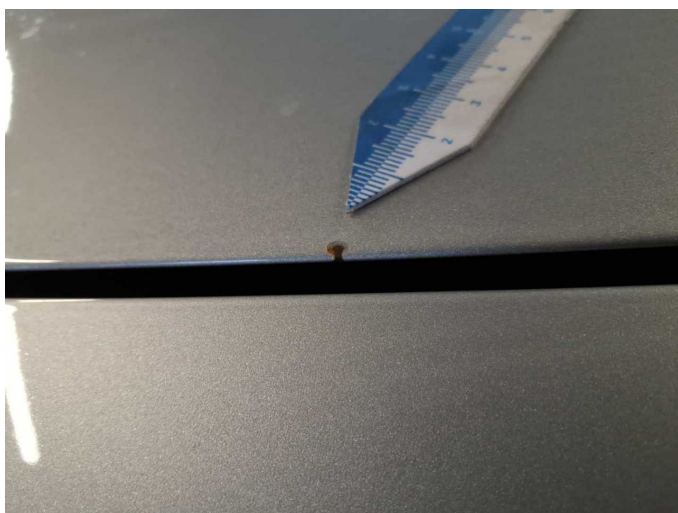
**Damage 5:** Bonnet: Bonnet (Korrosion) - Stone chips - Paint

| No. | Component group | Description |
|---|---|---|
| 5 | Bonnet | Bonnet (Korrosion) - Stone chips - Paint |

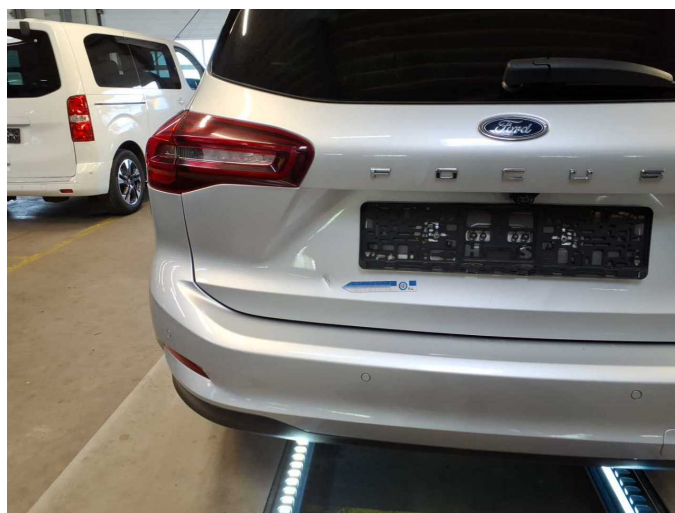
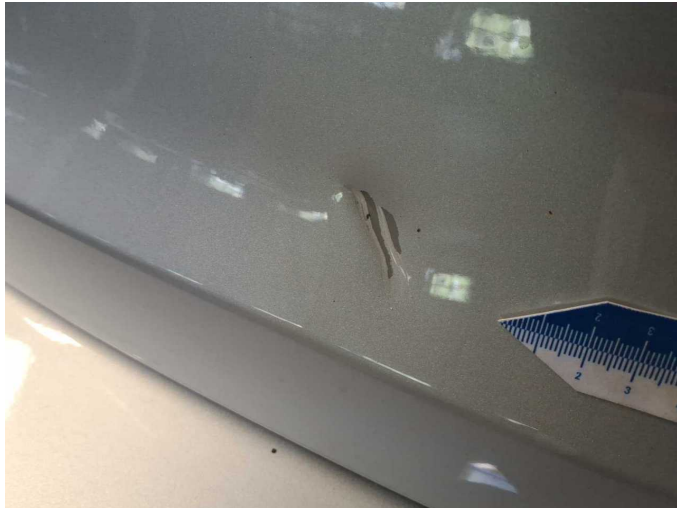
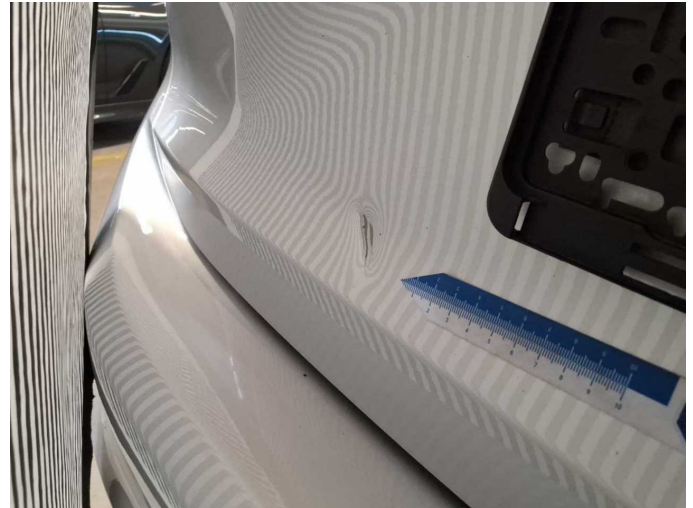
**Damage 6:** Boot lid / rear door: Boot lid - Deformed - Repair and paint

| No. | Component group | Description |
|---|---|---|
| 6 | Boot lid / rear door | Boot lid - Deformed - Repair and paint |

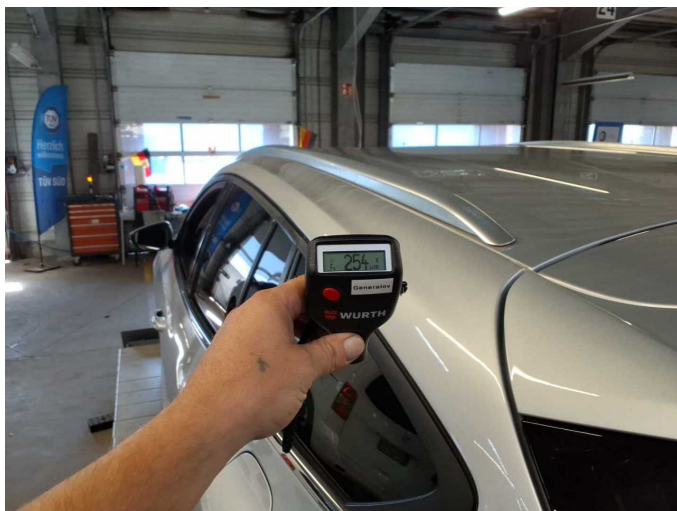
| No. | Repainting |
|---|---|
| 1 | Roof rail - left side, Professionally carried out, Invoice of repair done Non-existent |

| Roof rail - left side | 254 µm | Side panel - rear left side | 163 µm |

**Repainting 1:** Roof rail - left side

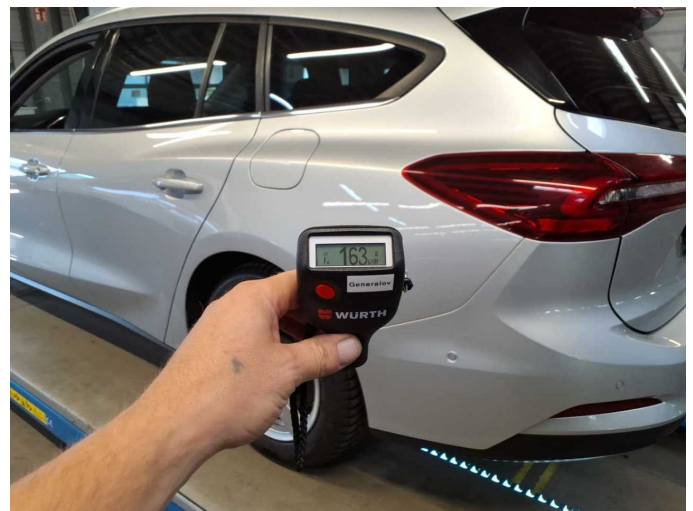
| No. | Repainting |
|---|---|
| 2 | Side panel - rear left side, Professionally carried out, Invoice of repair done Non-existent |

**Repainting 2:** Side panel - rear left side

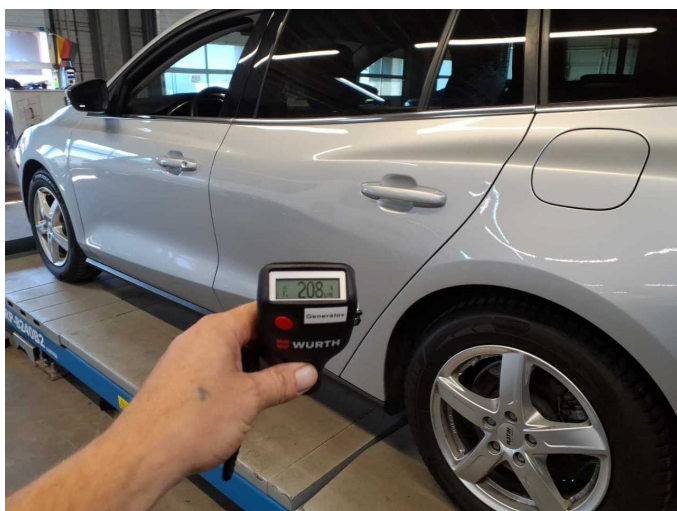
| No. | Repainting |
|---|---|
| 3 | Door - rear left side, Professionally carried out, Invoice of repair done Non-existent |

| Door - rear left side | 208 µm | | |

**Repainting 3:** Door - rear left side
