Expertise

Protocol number: 46583478  
Order No. / Reference: 26733410  
Inspection date: 16 Jul 2026

Manufacturer: Skoda  
VIN: TMBJR7NU8PC205721

Model: Karoq 1.5 TSI DSG Style

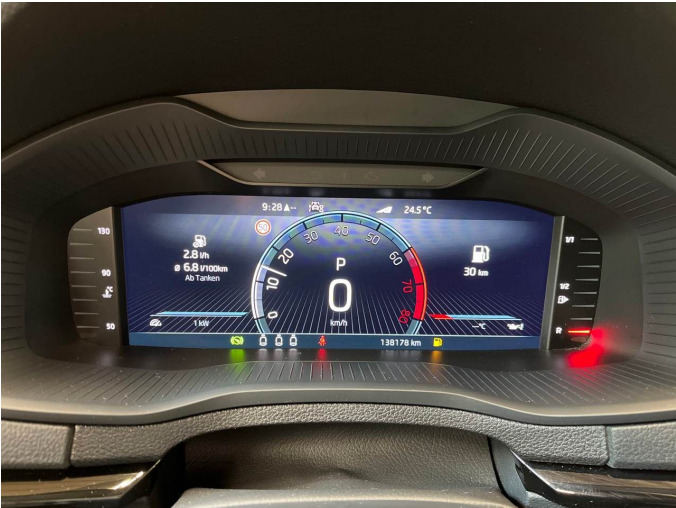
Figure 7: Instrument cluster

| Vehicle details | |
|---|---|
| Mileage (Read) | 138,178 km |

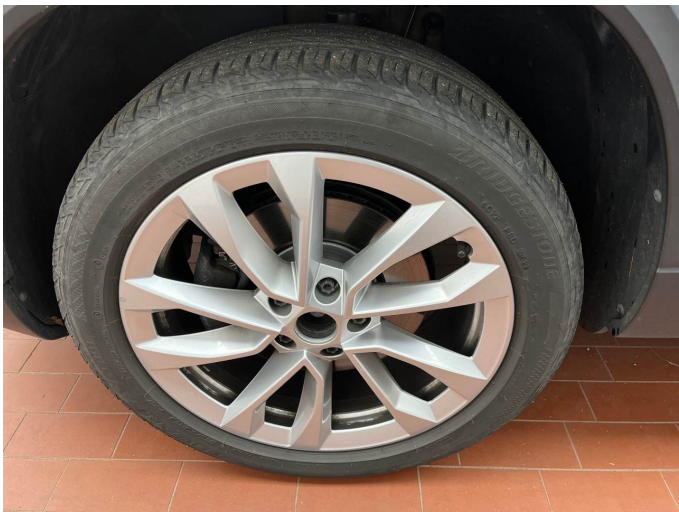
Figure 12: Mounted tyres

| # | Tyre size | Type of tyre | Manufacturer | Tread depth |
|---|---|---|---|---|
| 1) | 215/50 R18 92W | Summer tyres on Light alloy | Bridgestone | 5mm / 5mm |
| 2) | 215/50 R18 92W | Summer tyres on Light alloy | Pirelli | 5mm / 5mm |

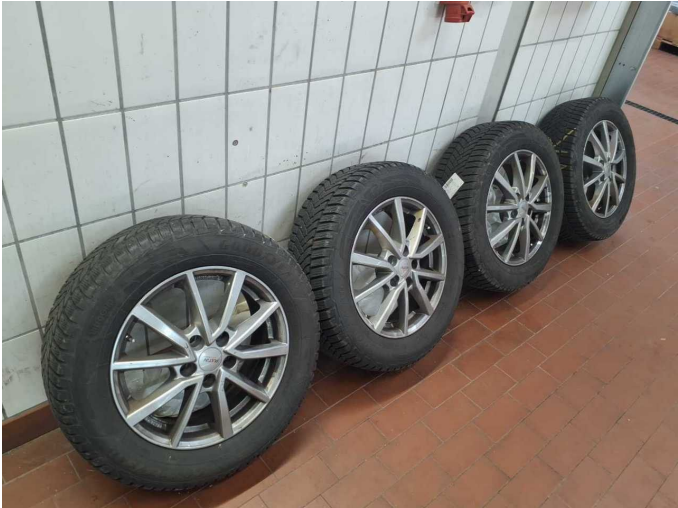
Figure 16: Additional tyres

| # | Tyre size | Type of tyre | Manufacturer | Tread depth |
|---|---|---|---|---|
| 1) | 215/60 R16 99H | Winter tyres on Light alloy | Goodyear | 6mm / 6mm |
| 2) | 215/60 R16 99H | Winter tyres on Light alloy | Goodyear | 6mm / 6mm |

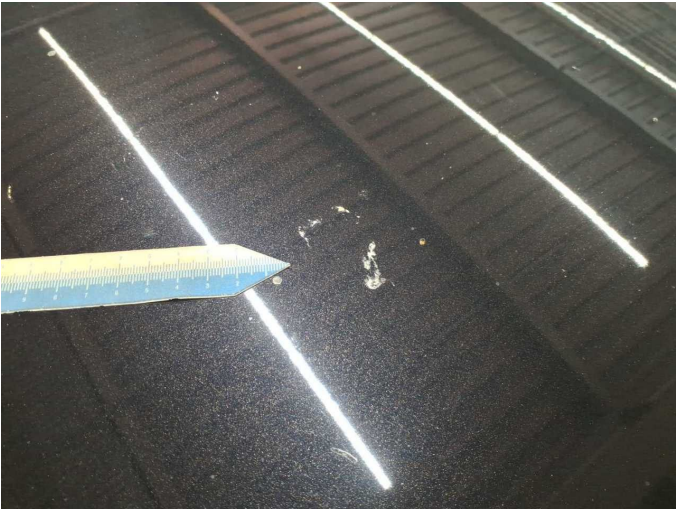
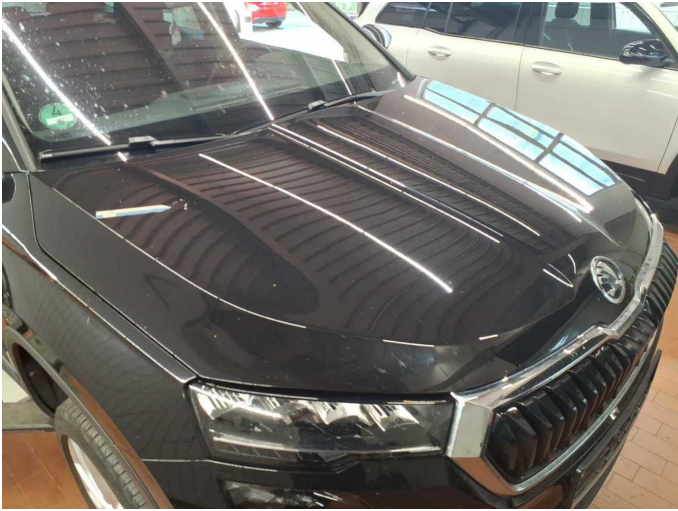
| No. | Component group | Description |
|---|---|---|
| 1 | Bonnet | Bonnet - Soiled - Conditioning |

Damage 1: Bonnet: Bonnet - Soiled - Conditioning

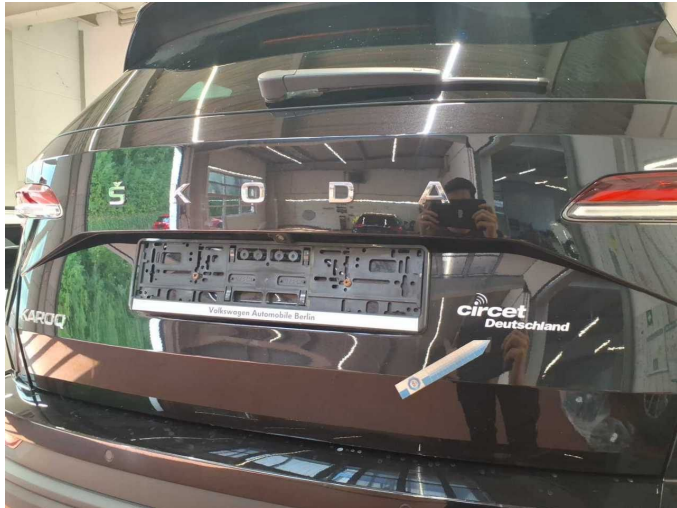
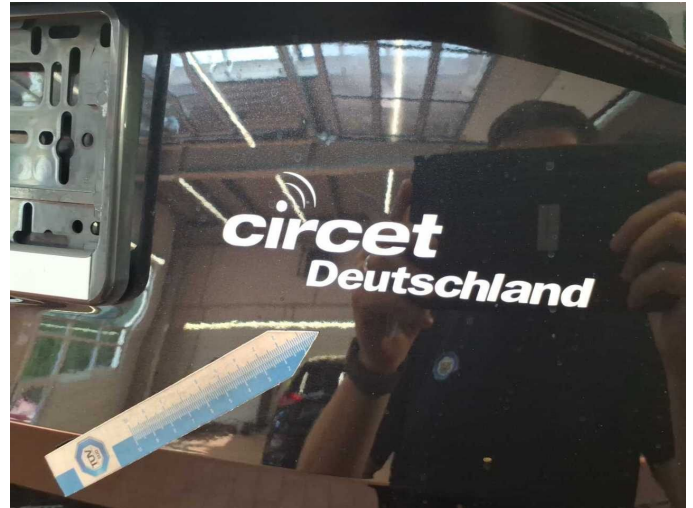
| No. | Component group | Description |
|---|---|---|
| 2 | Boot lid / rear door | Boot lid - Glued / labelled - De-glue / neutralise |

**Damage 2:** Boot lid / rear door: Boot lid - Glued / labelled - De-glue / neutralise

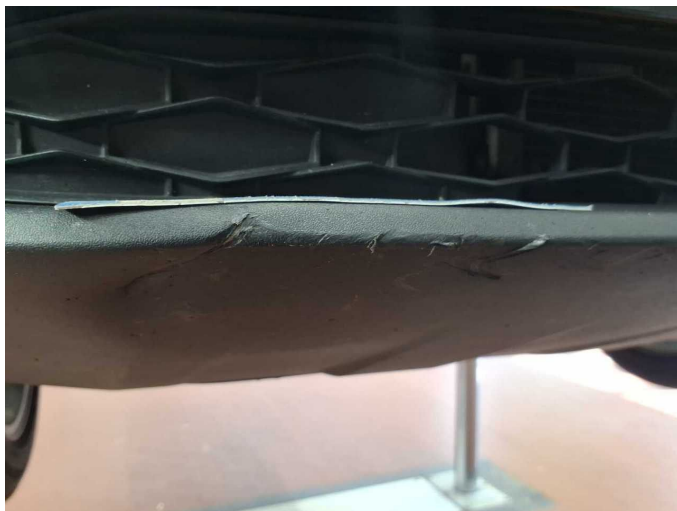
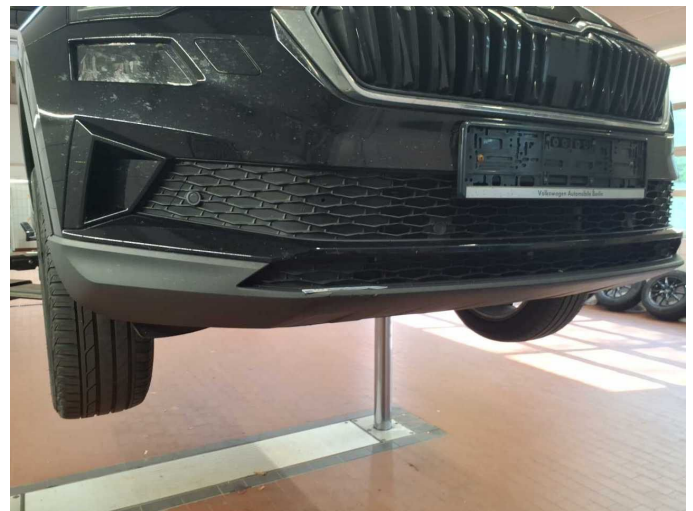
| No. | Component group | Description |
|---|---|---|
| 3 | Front bumper | Spoiler - Scratched - Replace |

**Damage 3:** Front bumper: Spoiler - Scratched - Replace

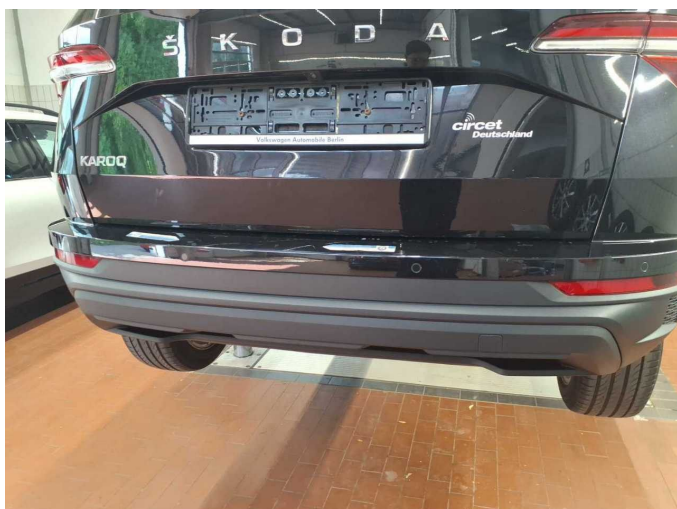
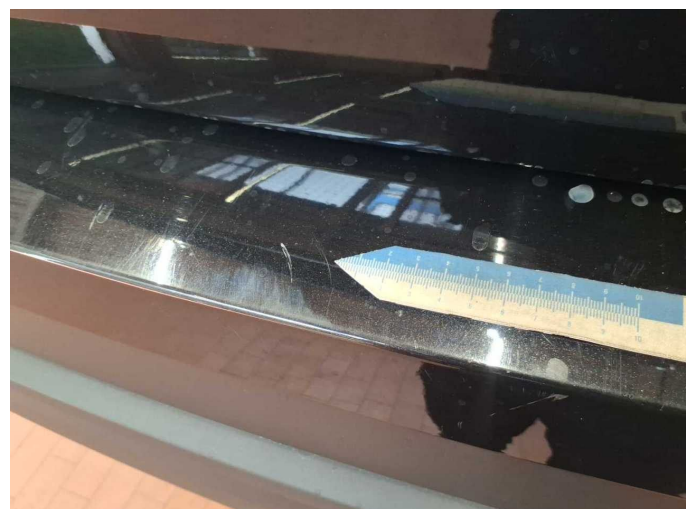
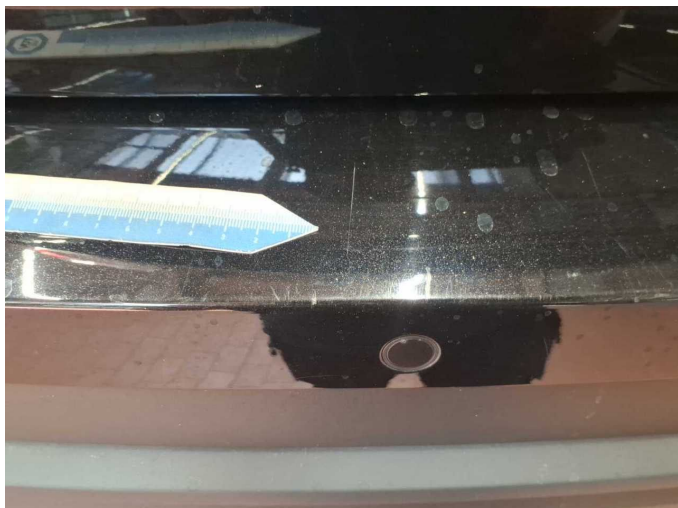
| No. | Component group | Description |
|---|---|---|
| 4 | Rear bumper | Rear bumper - Scratch(es) - Paint |

**Damage 4:** Rear bumper: Rear bumper - Scratch(es) - Paint

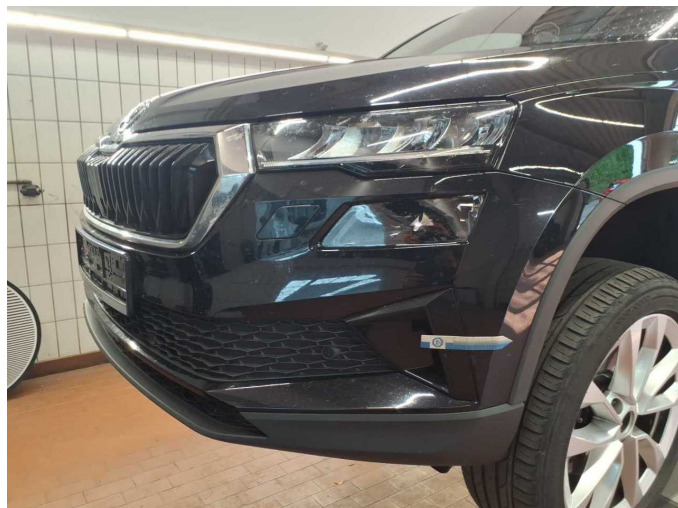
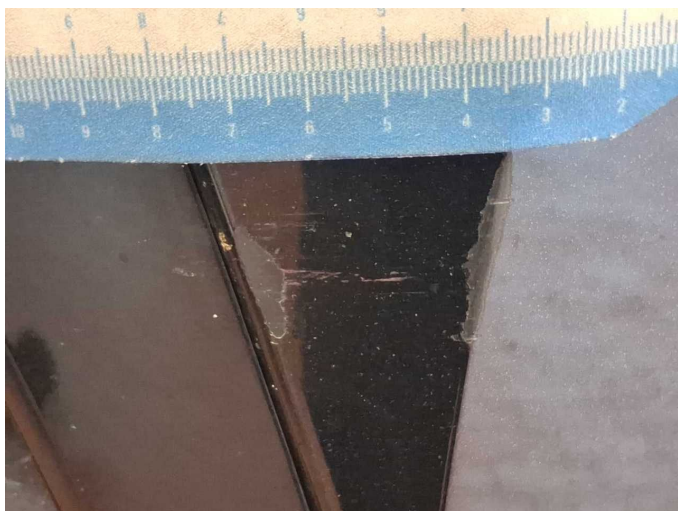
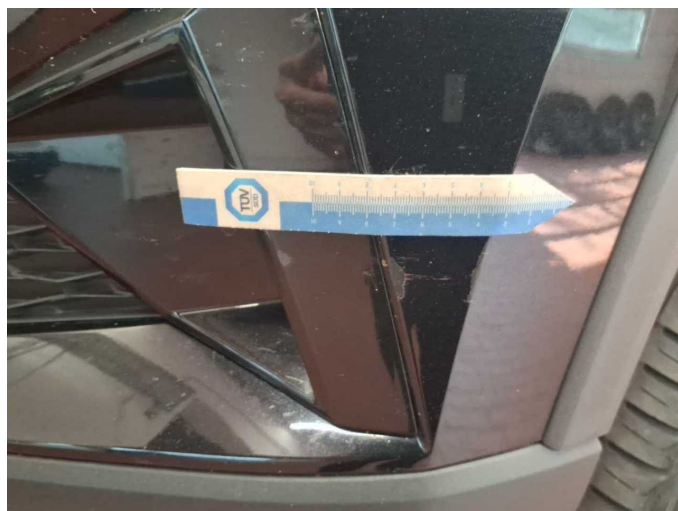
| No. | Component group | Description |
|---|---|---|
| 5 | Front bumper | Front bumper - Scratched - Paint |

**Damage 5:** Front bumper: Front bumper - Scratched - Paint

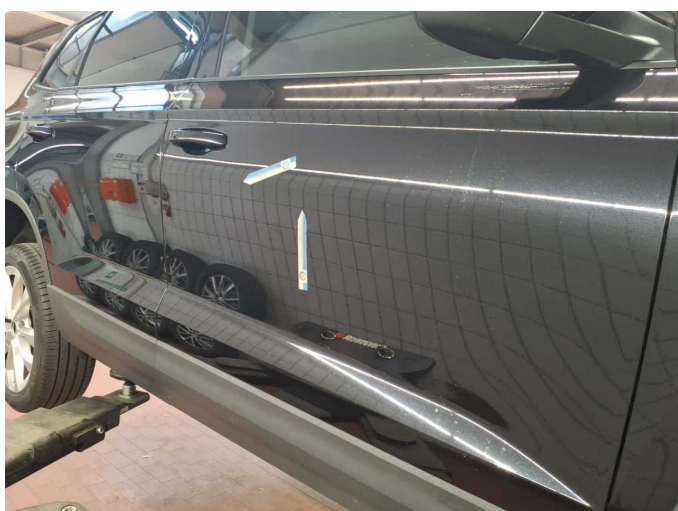
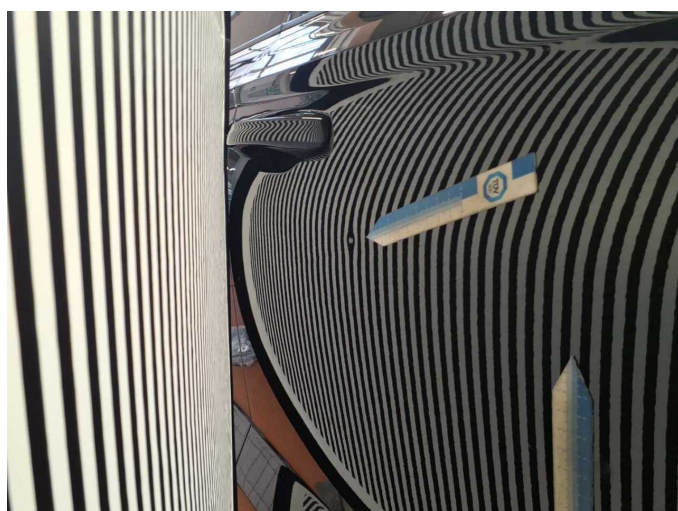
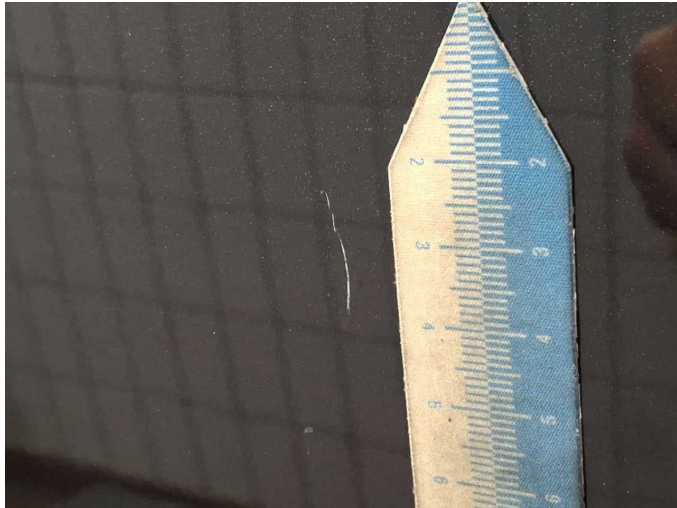
| No. | Component group | Description |
|---|---|---|
| 2 | Door - front right side | Door - Dent / paintcoat damage - No deduction |

**Wear and tear 2:** Door - front right side: Door - Dent / paintcoat damage - No deduction

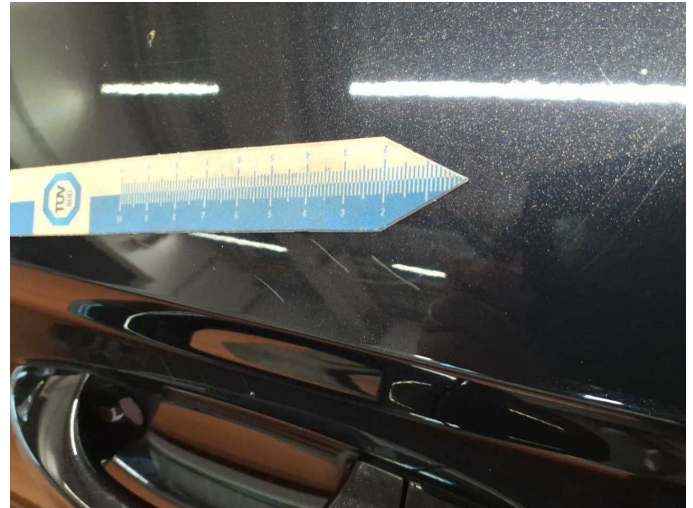
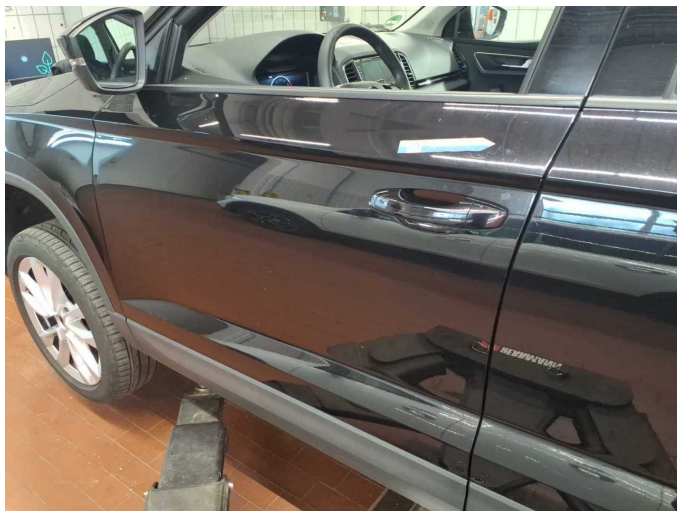
| No. | Component group | Description |
|---|---|---|
| 4 | Door - front left side | Door - Scratch(es) - No deduction |

**Wear and tear 4:** Door - front left side: Door - Scratch(es) - No deduction
