Expertise

Protocol number: 46364654  
Order No. / Reference: 26646295  
Inspection date: 3 Jul 2026

Model: Passat Variant 1.4 TSI Plug-In-Hybrid DSG GTE

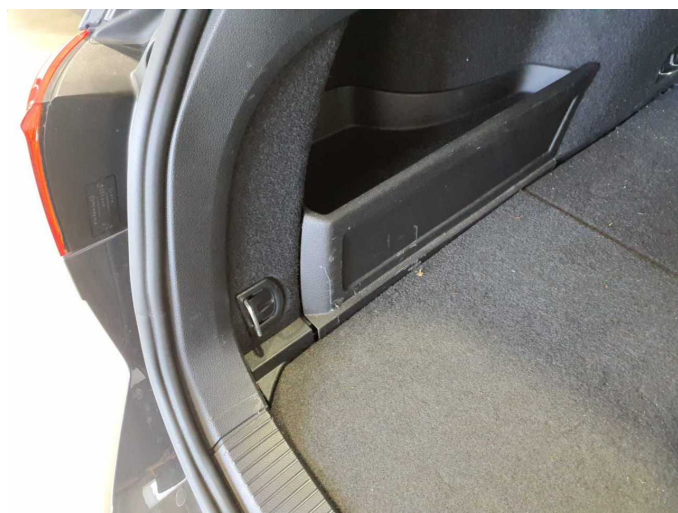
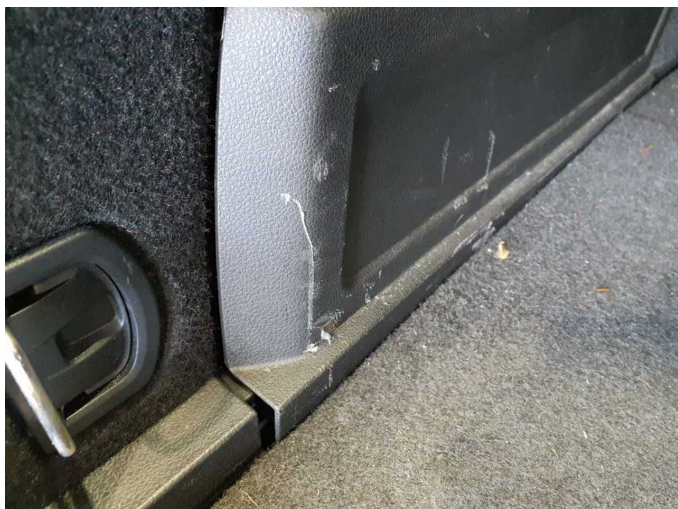
| No. | Component group | Description |
|---|---|---|
| 1 | Trim / covers | Boot lining - Scratch(es) - Replace |

Damage 1: Trim / covers: Boot lining - Scratch(es) - Replace

**Damage 1:** Trim / covers: Boot lining - Scratch(es) - Replace

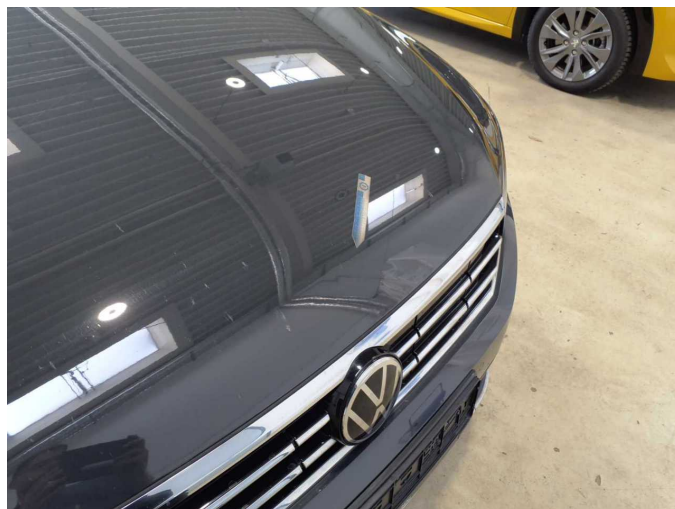
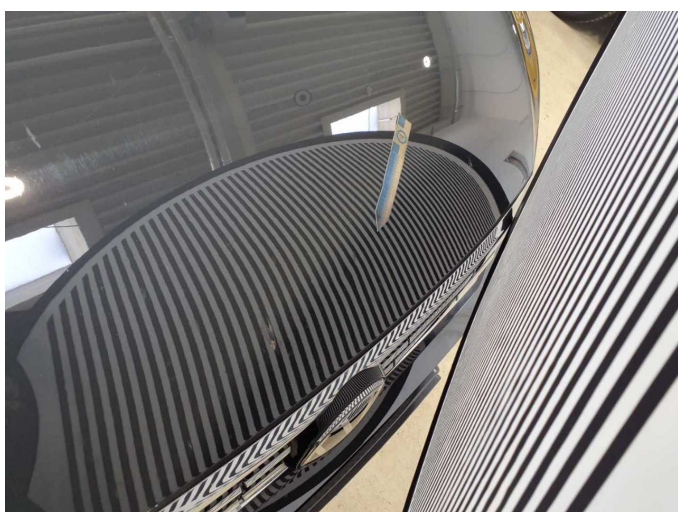
| No. | Component group | Description |
|---|---|---|
| 2 | Bonnet | Bonnet - dent(s) - Smooth repair work |

**Damage 2:** Bonnet: Bonnet - dent(s) - Smooth repair work

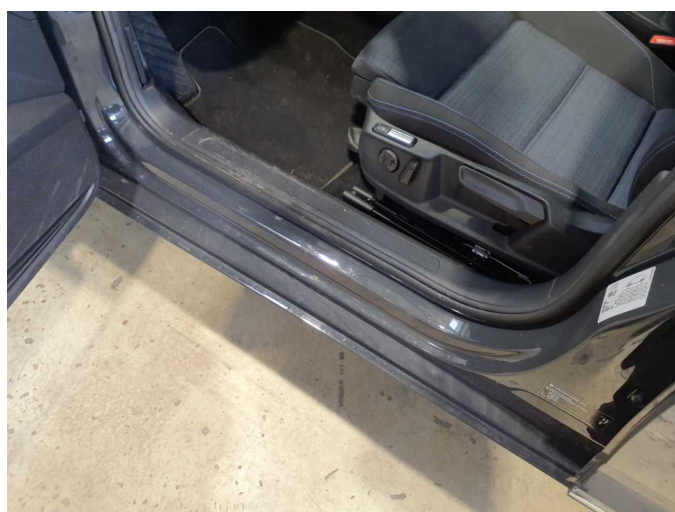
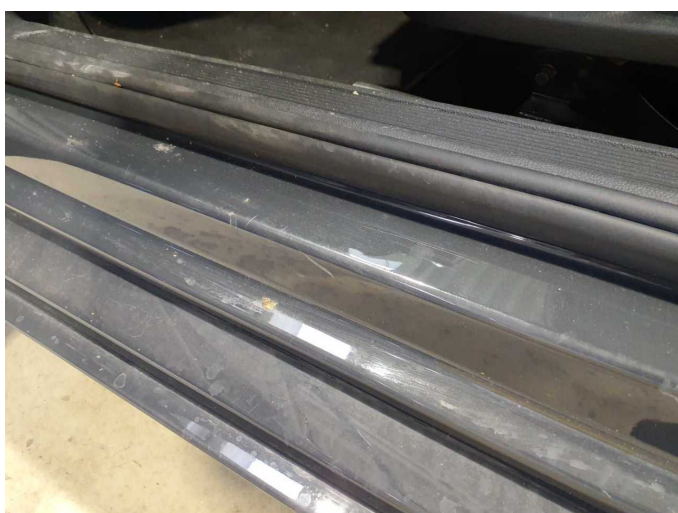
| No. | Component group | Description |
|---|---|---|
| 3 | Sill - left side | Sill - Dent / paintcoat damage - Smart repair |

**Damage 3:** Sill - left side: Sill - Dent / paintcoat damage - Smart repair

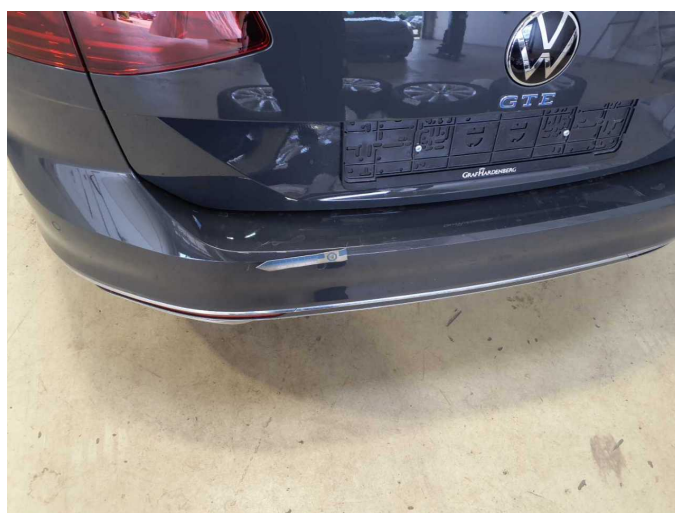
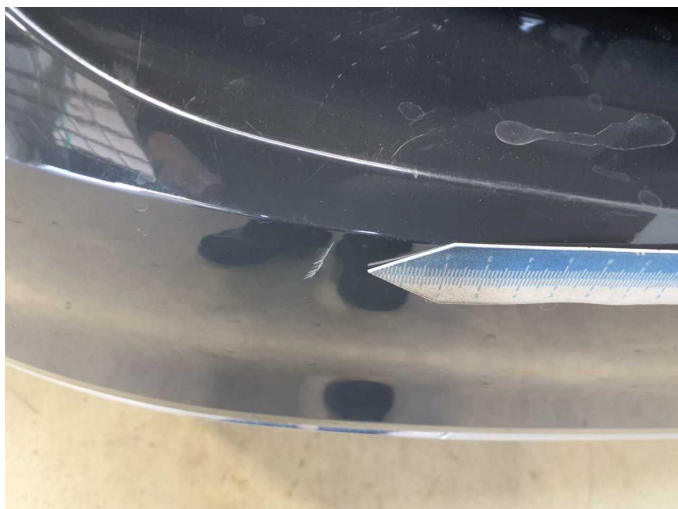
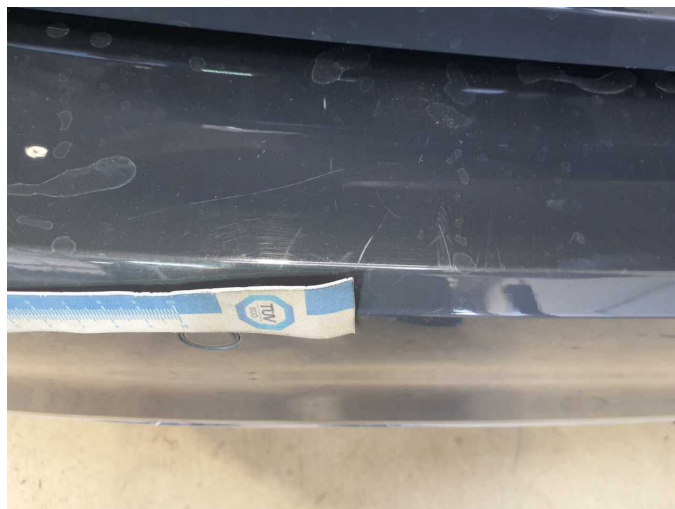
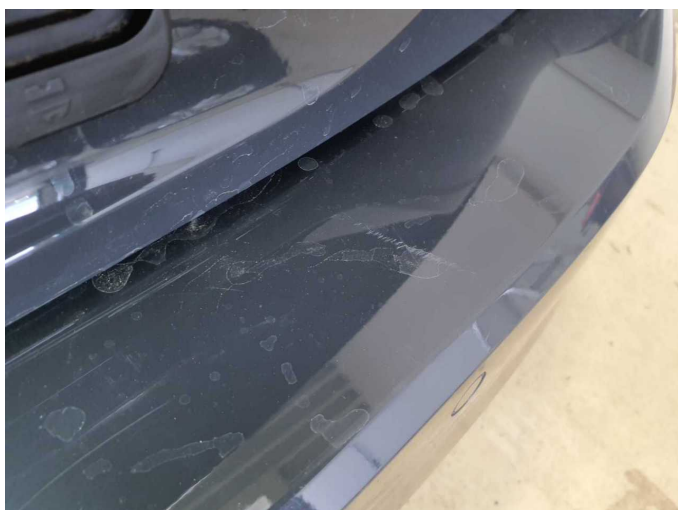
| No. | Component group | Description |
|---|---|---|
| 4 | Rear bumper | Rear bumper - Scratch(es) - Smart repair |

**Damage 4:** Rear bumper: Rear bumper - Scratch(es) - Smart repair

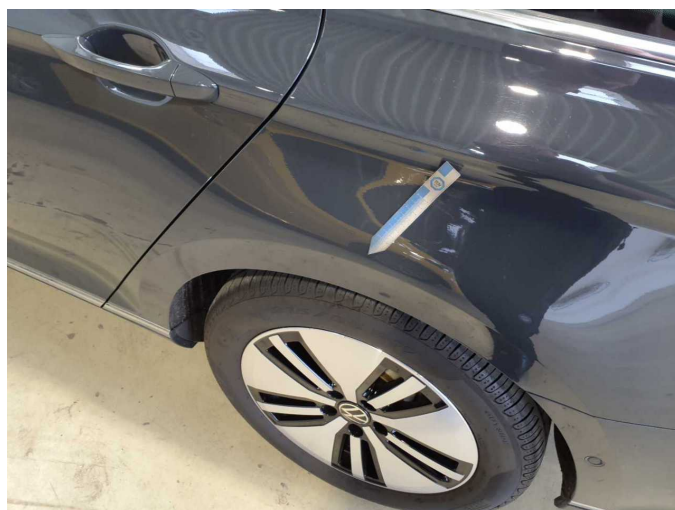
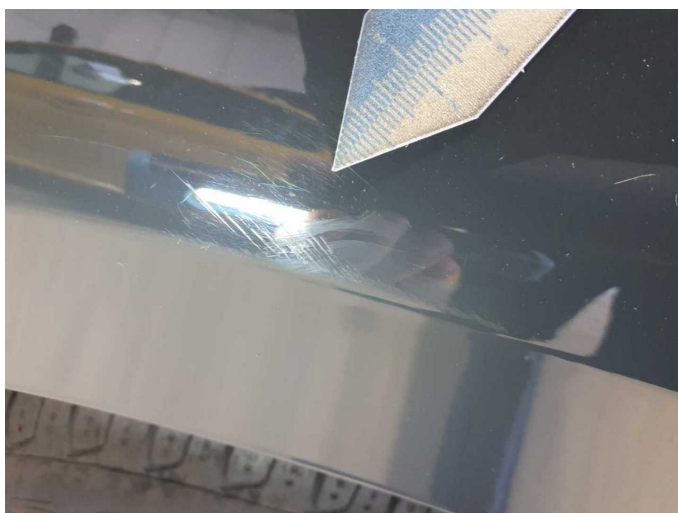
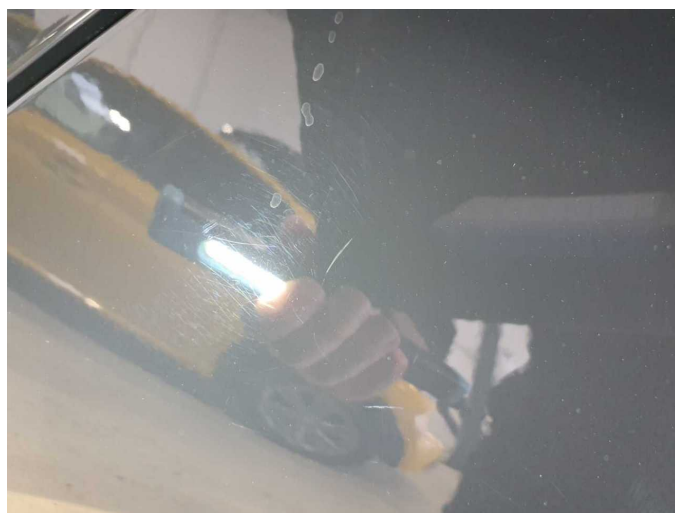
| No. | Component group | Description |
|---|---|---|
| 5 | Side panel - rear left side | Side panel - Scratch(es) - Smart repair |

**Damage 5:** Side panel - rear left side: Side panel - Scratch(es) - Smart repair

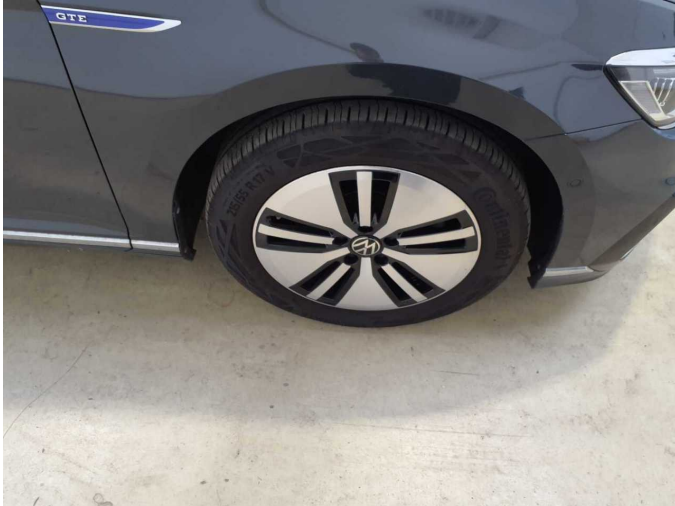
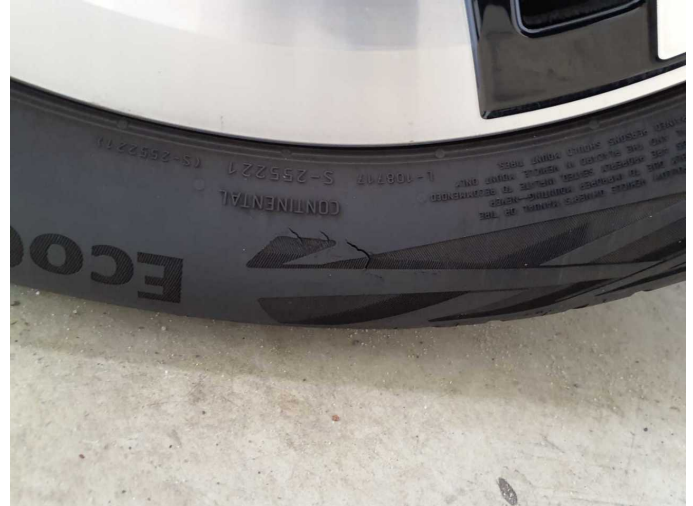
| No. | Component group | Description |
|---|---|---|
| 7 | Wheel / tyres | Tyre - front right side - Broken / torn - Replace |

**Damage 7:** Wheel / tyres: Tyre - front right side - Broken / torn - Replace

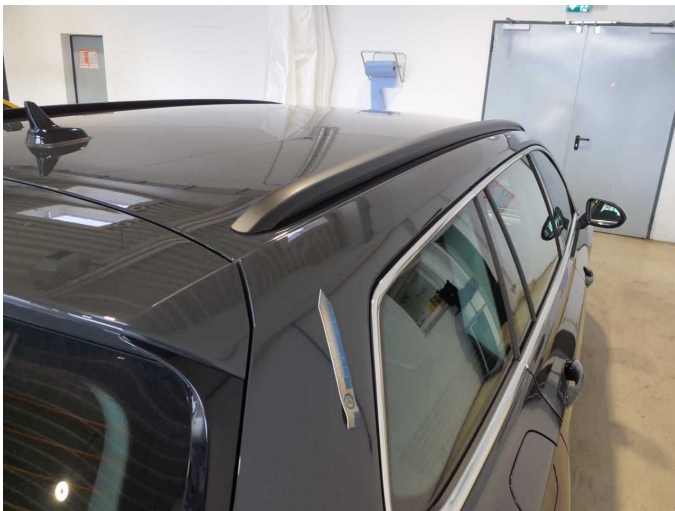
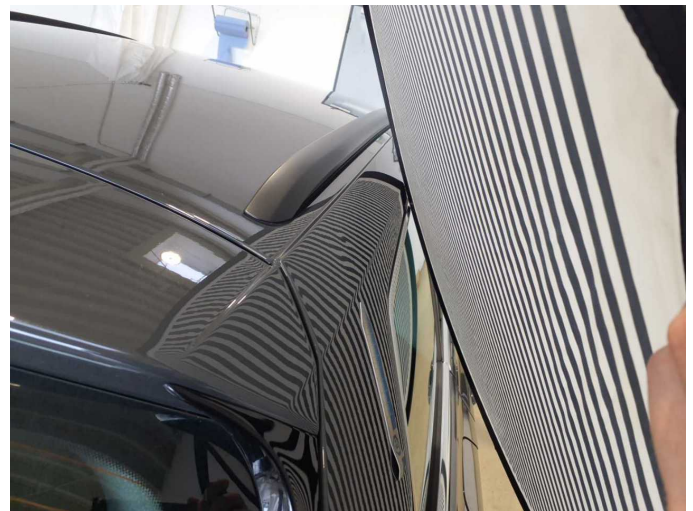
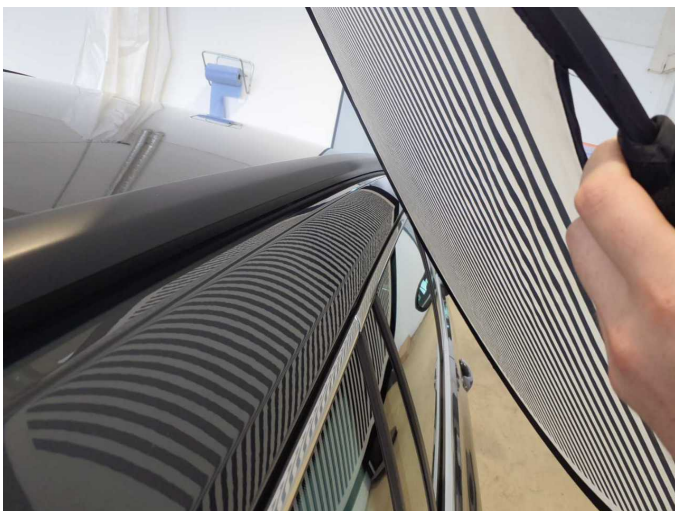
| No. | Component group | Description |
|---|---|---|
| 8 | Roof | Roof rail - right side - dent(s) - Smart repair |

**Damage 8:** Roof: Roof rail - right side - dent(s) - Smart repair

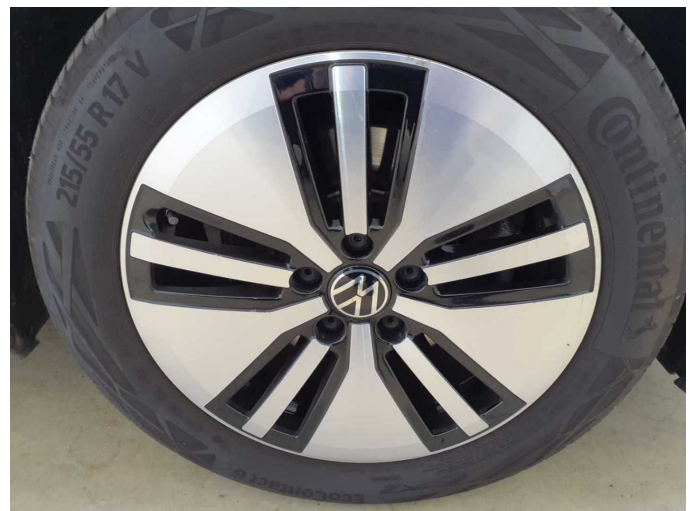
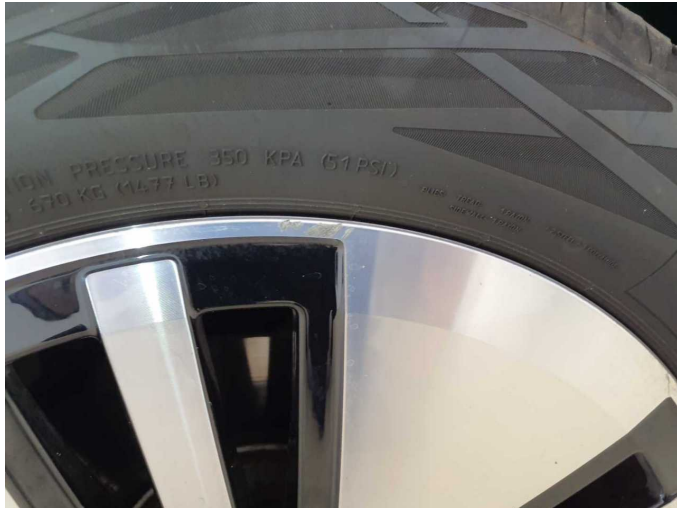
| No. | Component group | Description |
|---|---|---|
| 9 | Wheel / tyres | Alloy rim - front right side - Scratch(es) - Loss in value |

**Damage 9:** Wheel / tyres: Alloy rim - front right side - Scratch(es) - Loss in value

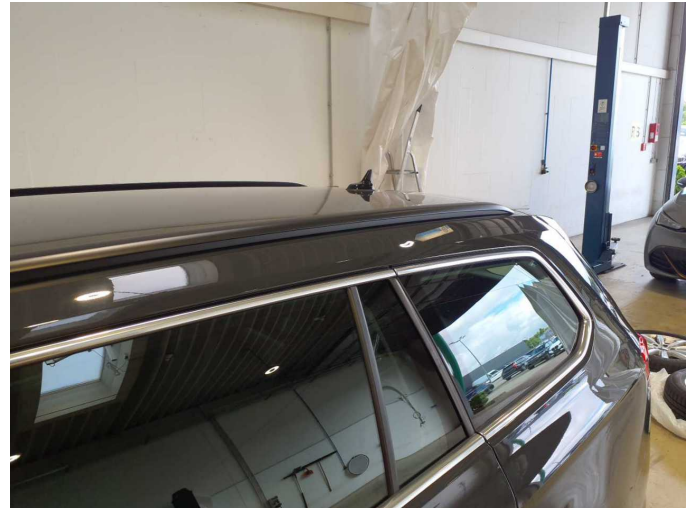
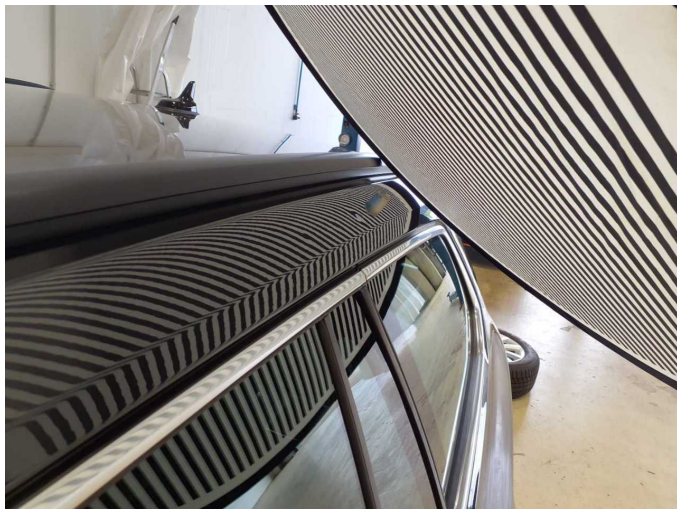
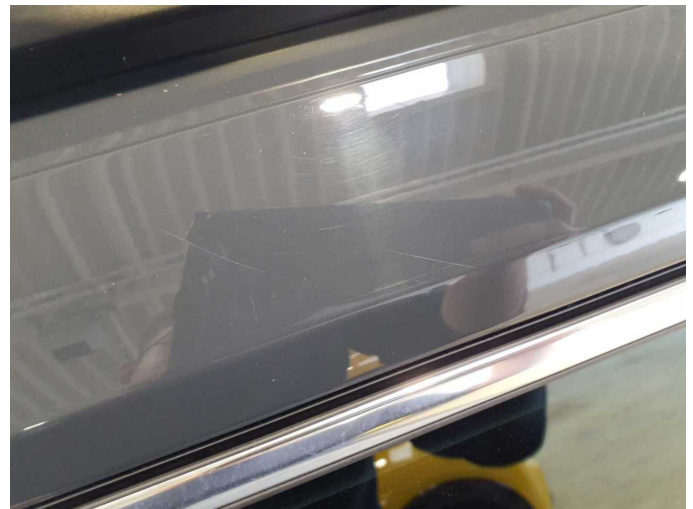
| No. | Component group | Description |
|---|---|---|
| 10 | Roof | Roof rail - left side - Dent / paintcoat damage - Repair and paint |

**Damage 10:** Roof: Roof rail - left side - Dent / paintcoat damage - Repair and paint

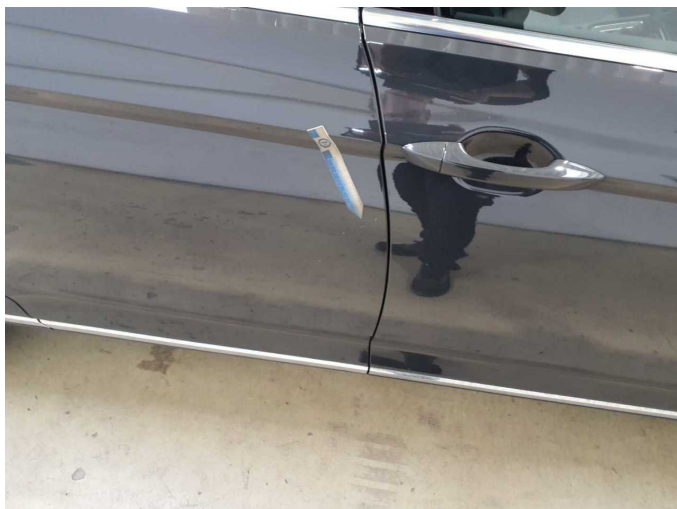
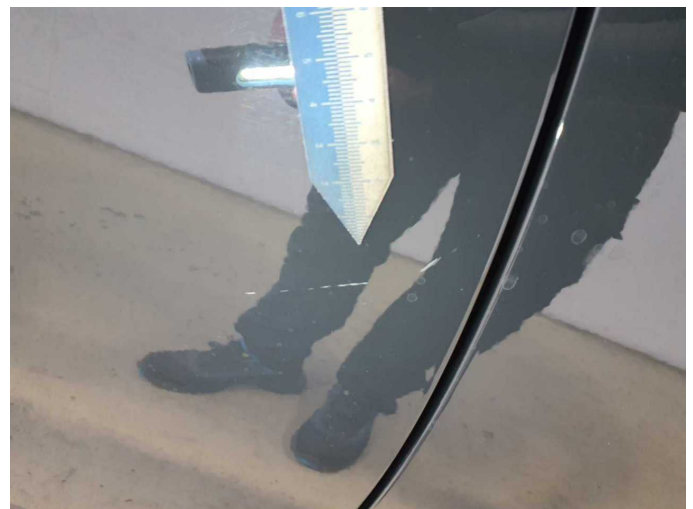
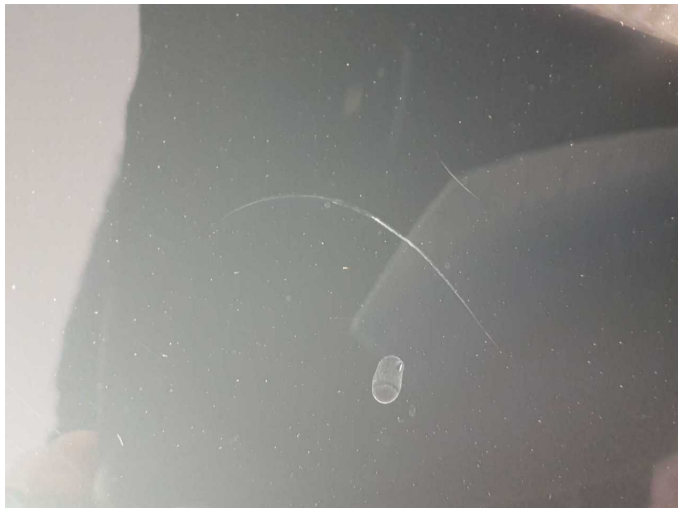
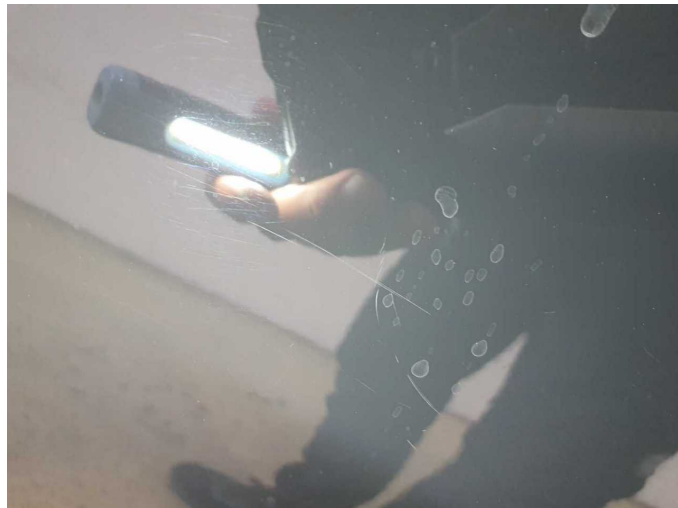
| No. | Component group | Description |
|---|---|---|
| 11 | Door - rear right side | Door - Scratch(es) - Paint |

**Damage 11:** Door - rear right side: Door - Scratch(es) - Paint

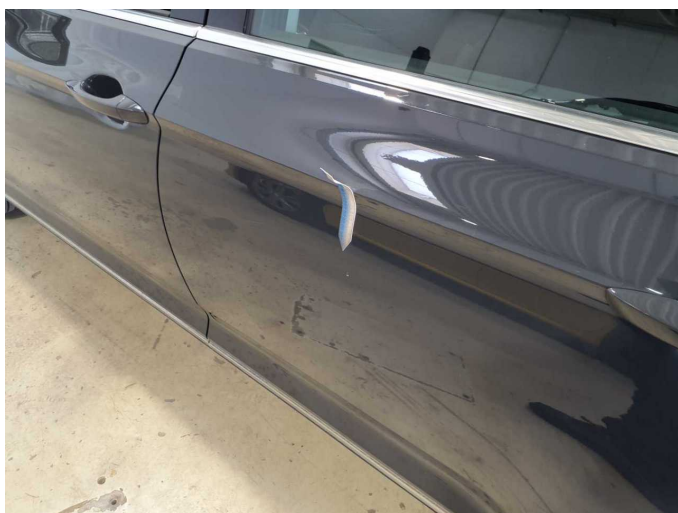
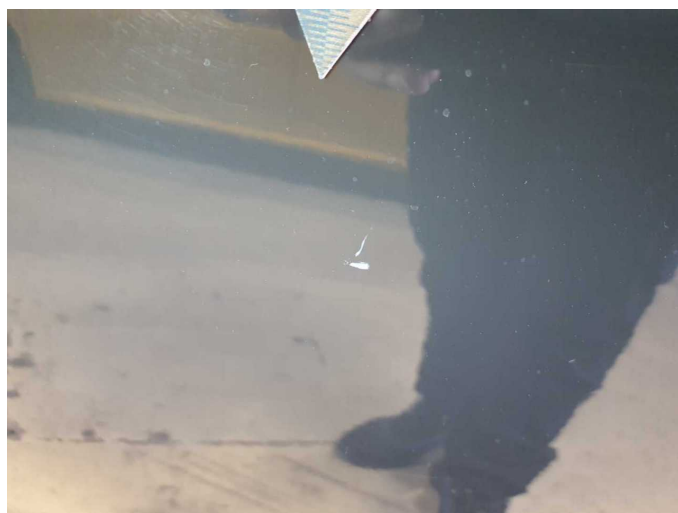
| No. | Component group | Description |
|---|---|---|
| 12 | Door - rear left side | Door - Scratch(es) - Paint |

**Damage 12:** Door - rear left side: Door - Scratch(es) - Paint

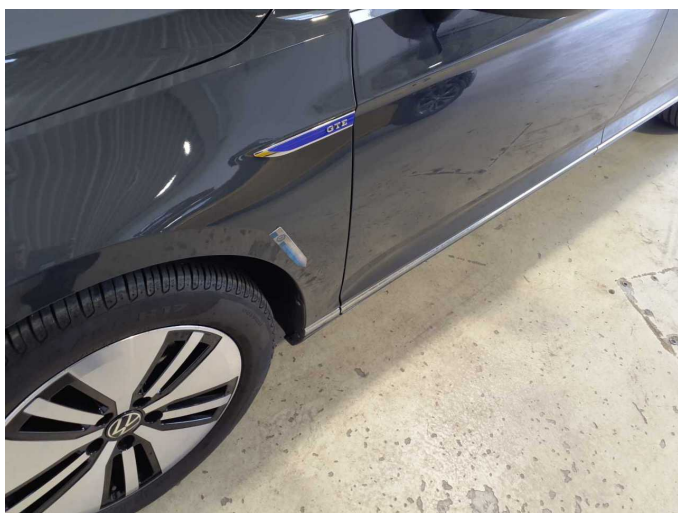
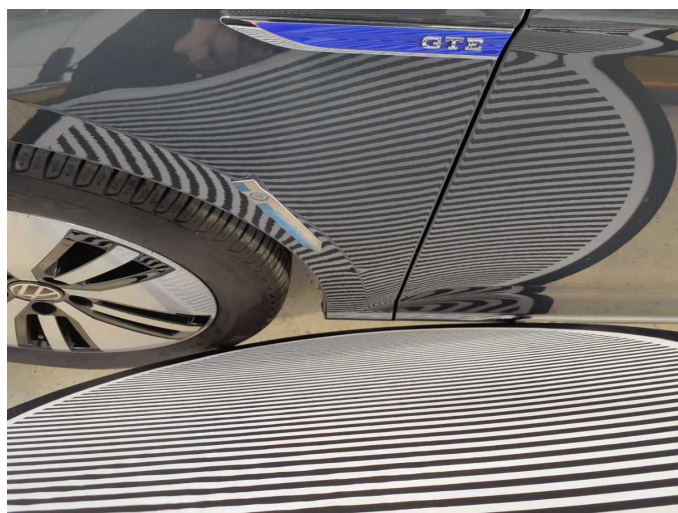
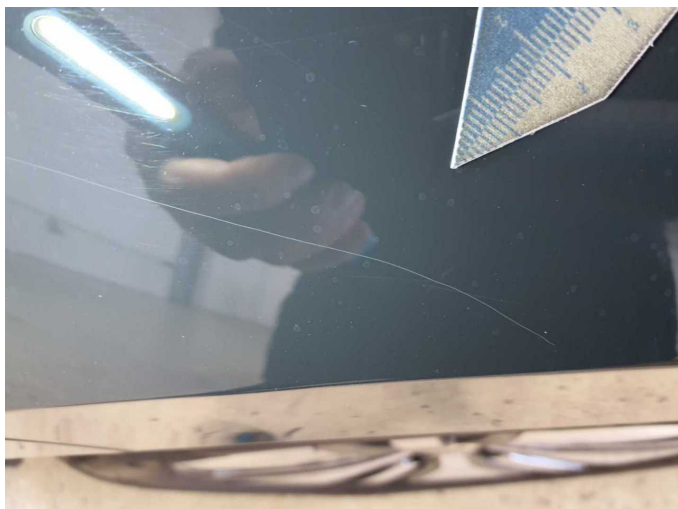
| No. | Component group | Description |
|---|---|---|
| 13 | Mudguard - left side | Mudguard - left side - Dent / paintcoat damage - Repair and paint |

**Damage 13:** Mudguard - left side: Mudguard - left side - Dent / paintcoat damage - Repair and paint
