Expertise

Protocol number: 46653717  
Order No. / Reference: 26628489  
Inspection date: 22 Jul 2026

Manufacturer: Mercedes-Benz

Model: GLC 300 d 4Matic 9G-TRONIC AMG Line

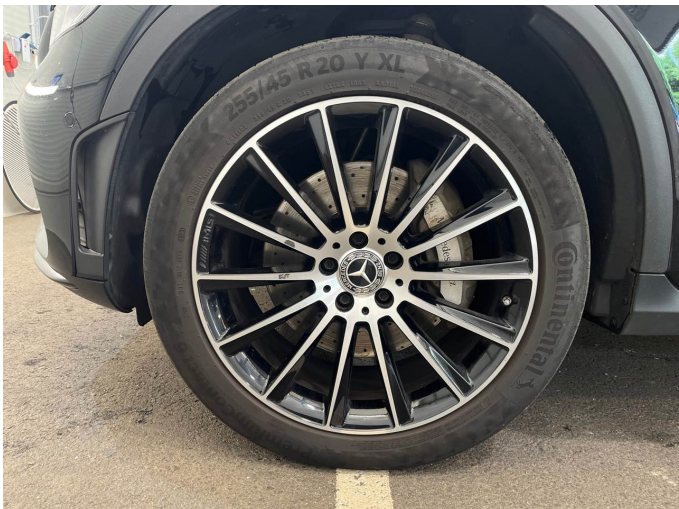
Figure 12: Mounted tyres

| # | Tyre size | Type of tyre | Manufacturer | Tread depth |
|---|---|---|---|---|
| 1) | 225/45 R20 105Y | Summer tyres on Light alloy | Continental | 4mm / 4mm |
| 2) | 225/45 R20 105Y | Summer tyres on Light alloy | Continental | 4mm / 4mm |

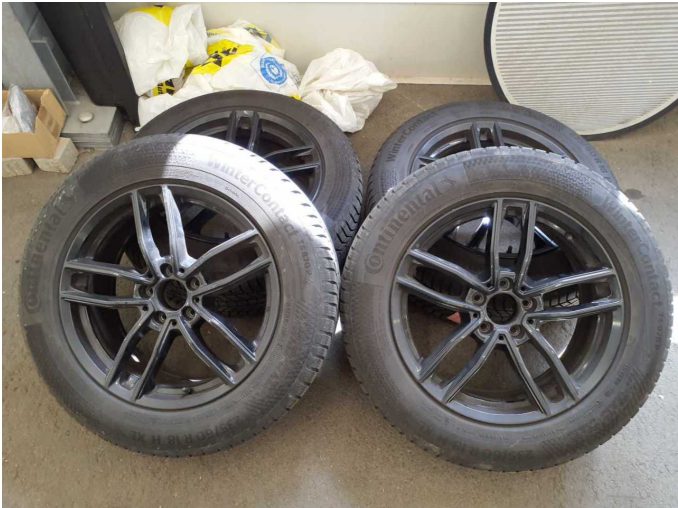
Figure 16: Additional tyres

| # | Tyre size | Type of tyre | Manufacturer | Tread depth |
|---|---|---|---|---|
| 1) | 235/60 R18 107H | Winter tyres on Light alloy | Continental | 7mm / 7mm |
| 2) | 235/60 R18 107H | Winter tyres on Light alloy | Continental | 6mm / 6mm |

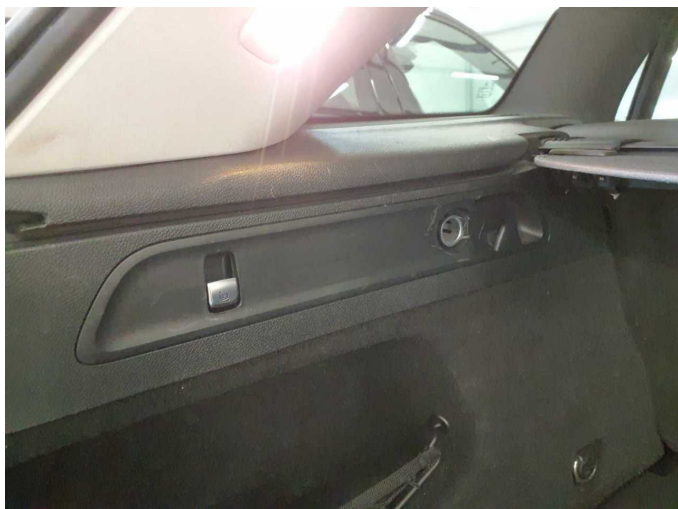
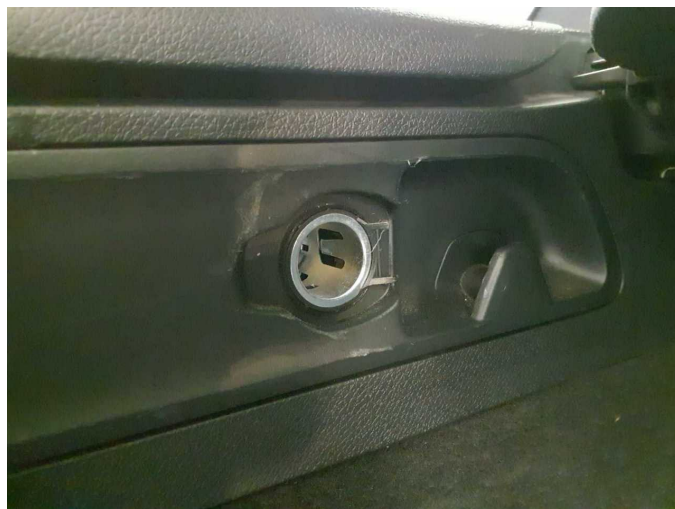
| No. | Component group | Description |
|---|---|---|
| 1 | Interior | Cigarette lighter (Abdeckung) - Broken / torn - Replace |

**Damage 1:** Interior: Cigarette lighter (Abdeckung) - Broken / torn - Replace

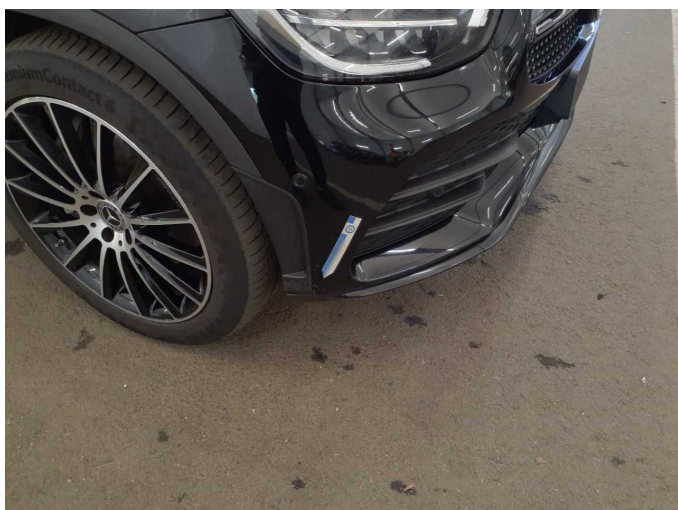
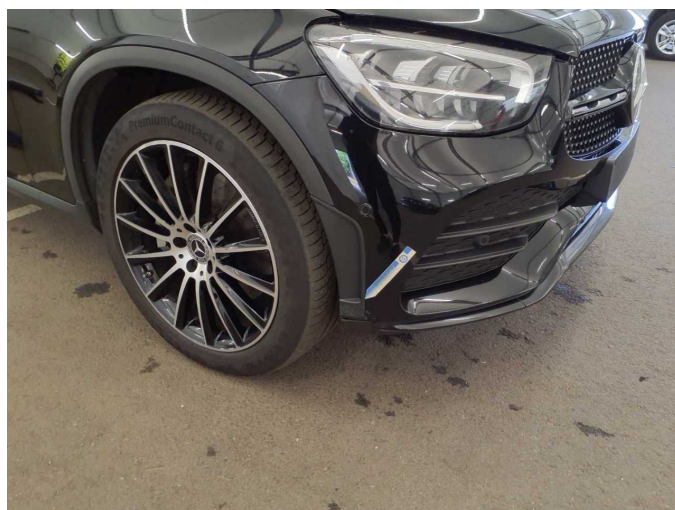
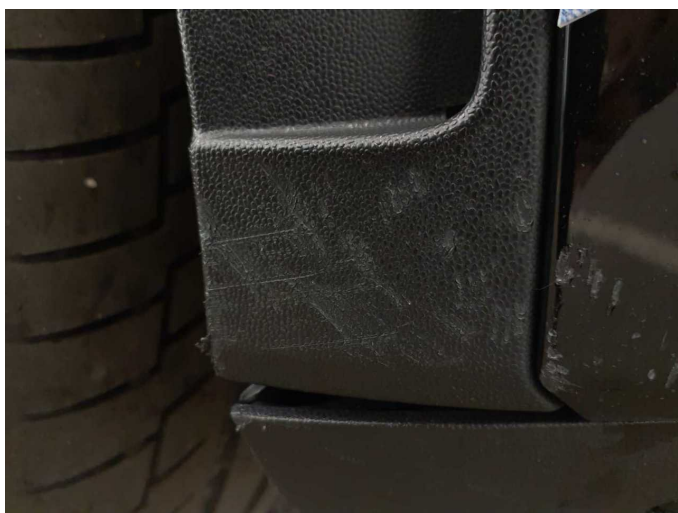
| No. | Component group | Description |
|---|---|---|
| 2 | Front bumper | Bumper - front right side (Zierleiste) - Scratched - Replace |

**Damage 2:** Front bumper: Bumper - front right side (Zierleiste) - Scratched - Replace

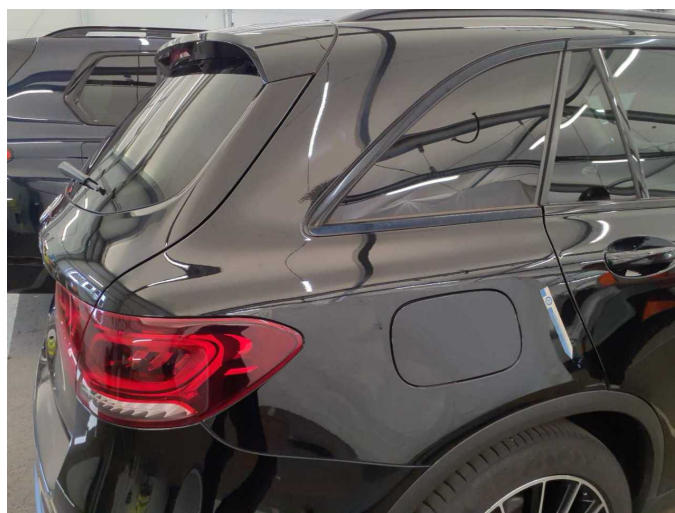
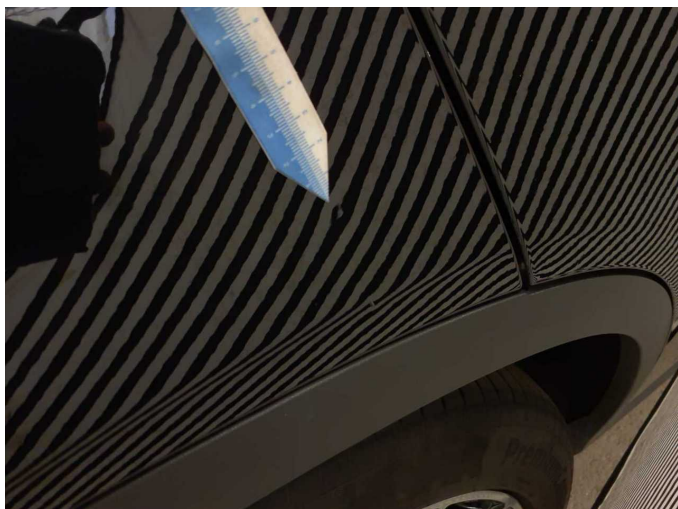
| No. | Component group | Description |
|---|---|---|
| 3 | Side panel - rear right side | Side panel - dent(s) - Smart repair |

**Damage 3:** Side panel - rear right side: Side panel - dent(s) - Smart repair

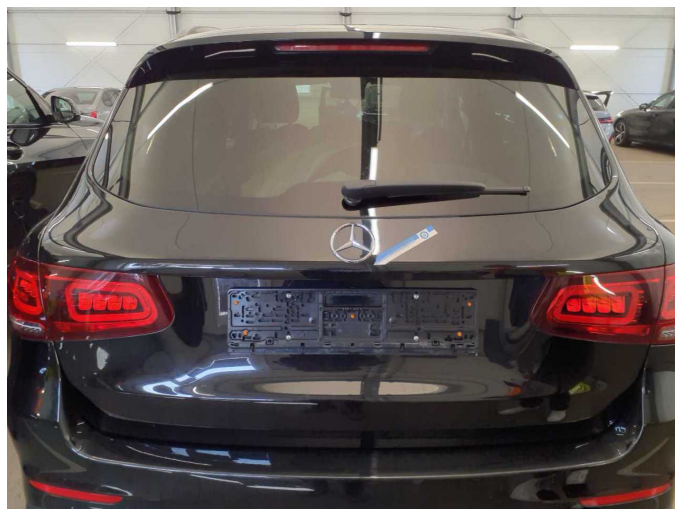
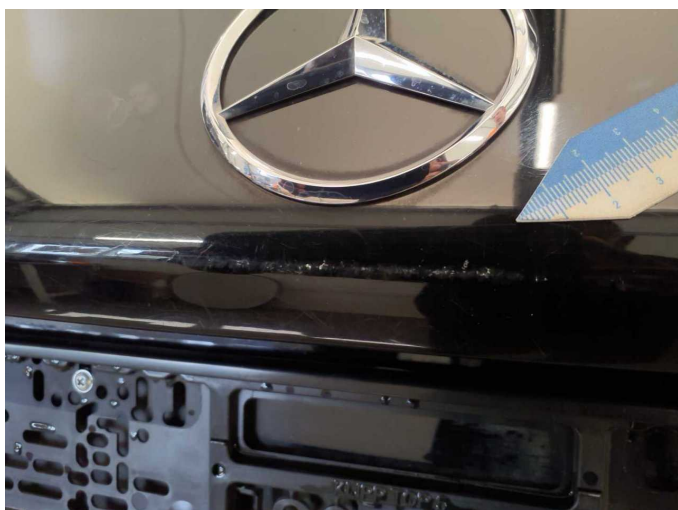
| No. | Component group | Description |
|---|---|---|
| 4 | Boot lid / rear door | Boot lid - Scratch(es) - Smart repair |

**Damage 4:** Boot lid / rear door: Boot lid - Scratch(es) - Smart repair

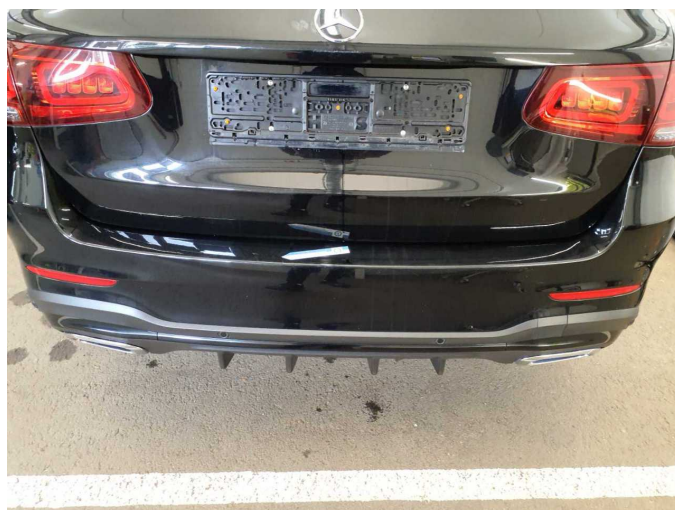
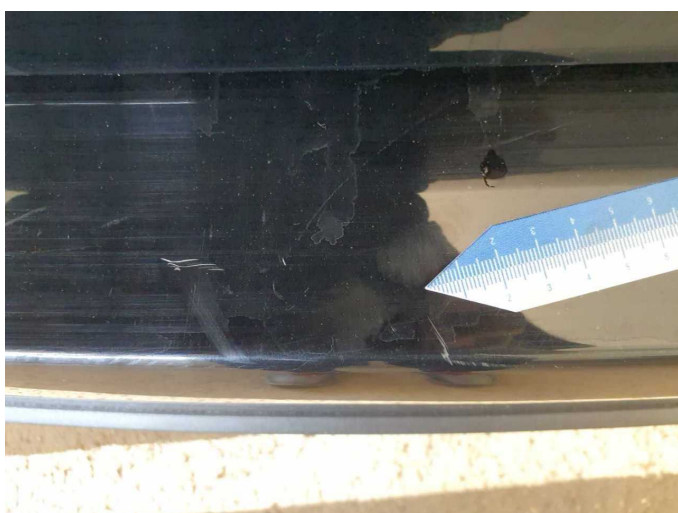
| No. | Component group | Description |
|---|---|---|
| 5 | Rear bumper | Rear bumper - Scratch(es) - Smart repair |

**Damage 5:** Rear bumper: Rear bumper - Scratch(es) - Smart repair

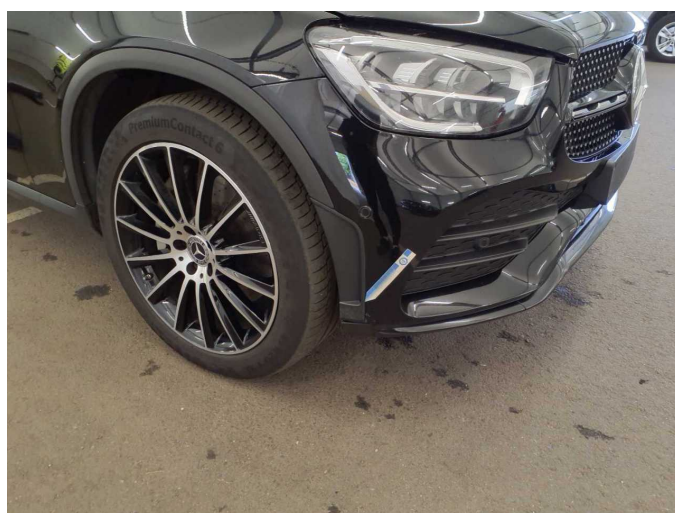
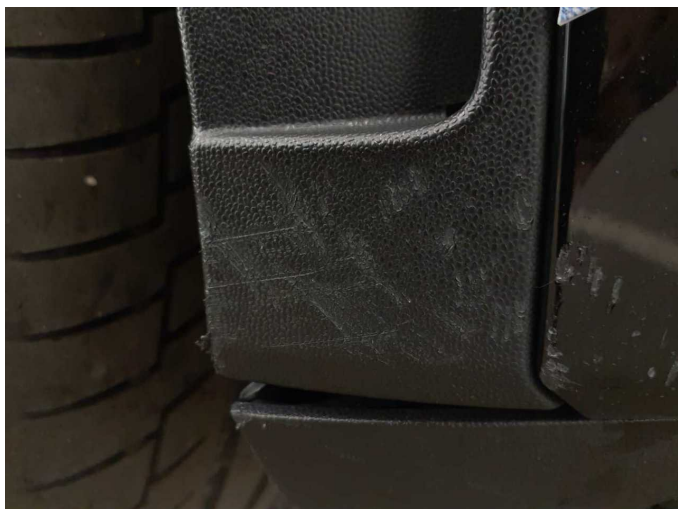
| No. | Component group | Description |
|---|---|---|
| 6 | Mudguard - right side | Wheel arch - Scratched - Replace |

**Damage 6:** Mudguard - right side: Wheel arch - Scratched - Replace

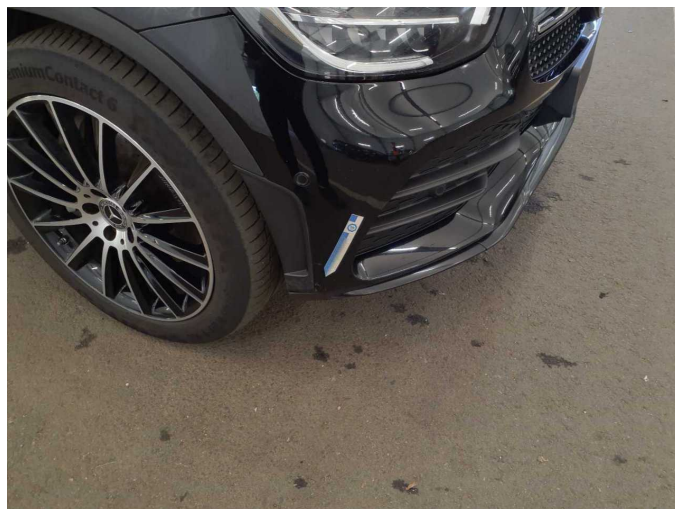
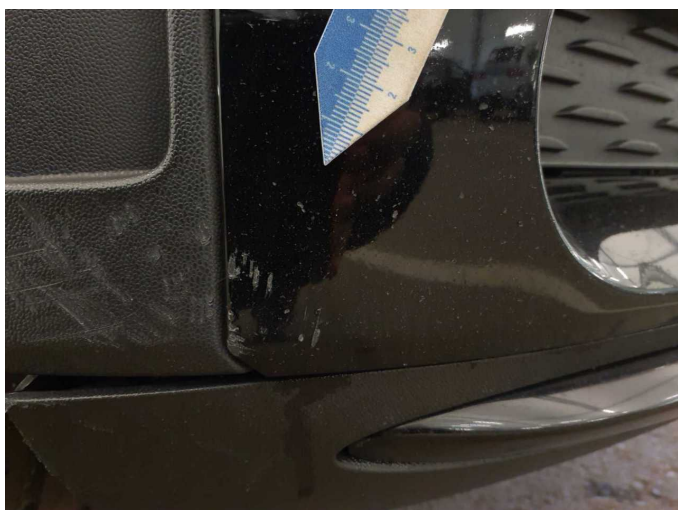
| No. | Component group | Description |
|---|---|---|
| 7 | Front bumper | Front bumper - Scratch(es) - Paint |

**Damage 7:** Front bumper: Front bumper - Scratch(es) - Paint

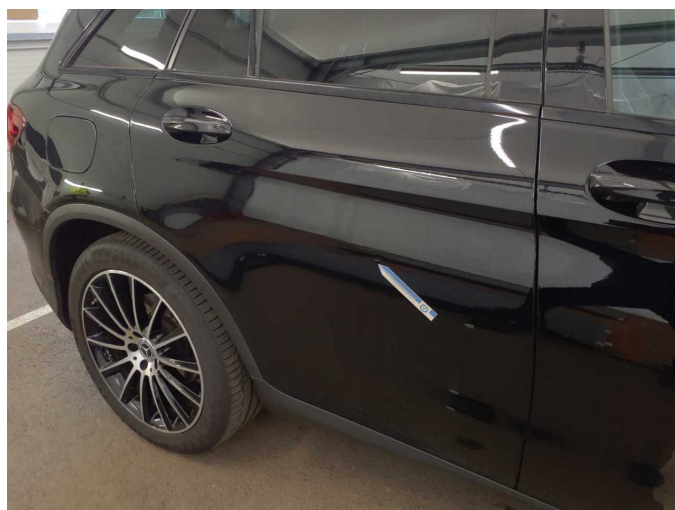
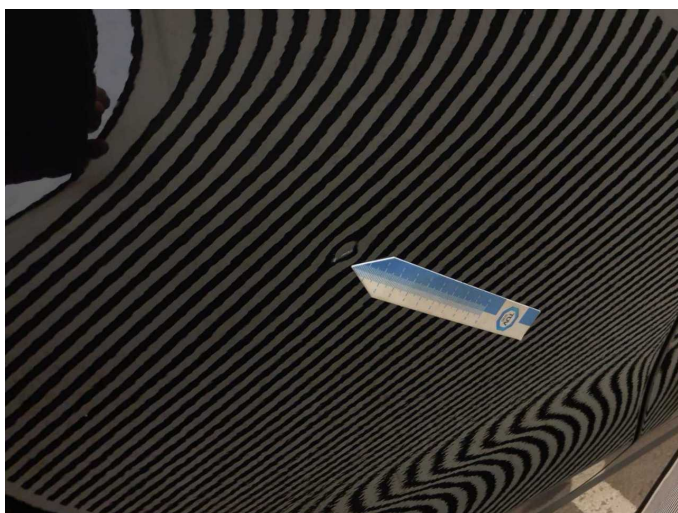
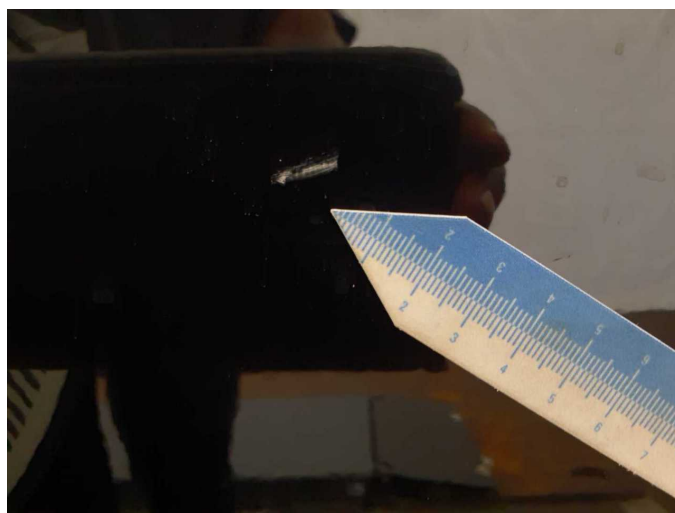
| No. | Component group | Description |
|---|---|---|
| 8 | Door - rear right side | Door - Dent / paintcoat damage - Paint |

**Damage 8:** Door - rear right side: Door - Dent / paintcoat damage - Paint

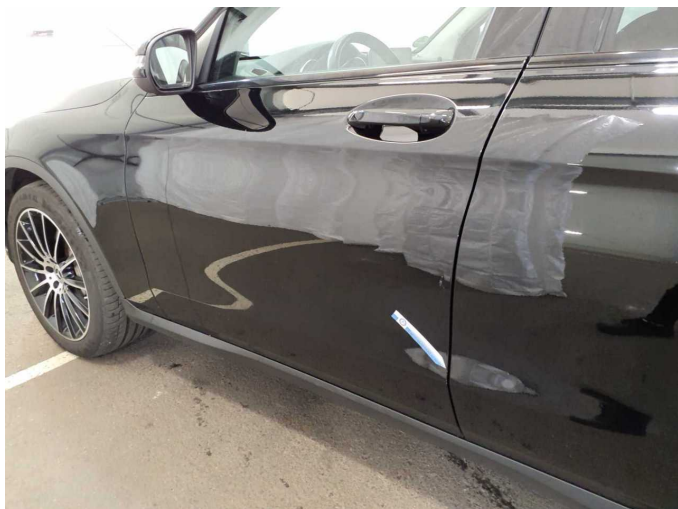
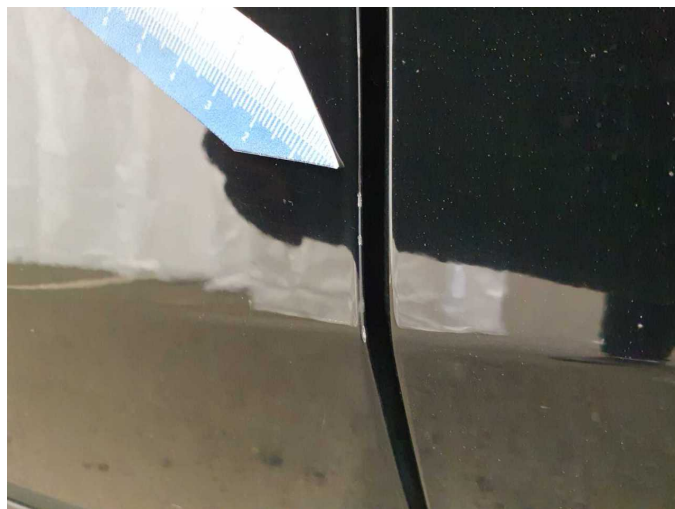
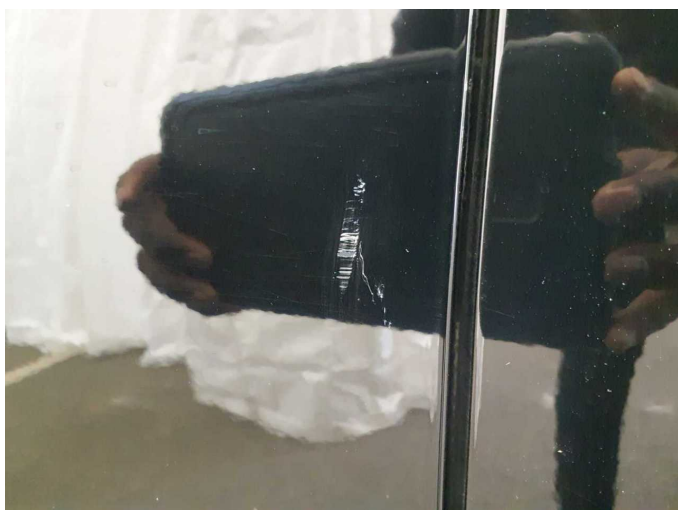
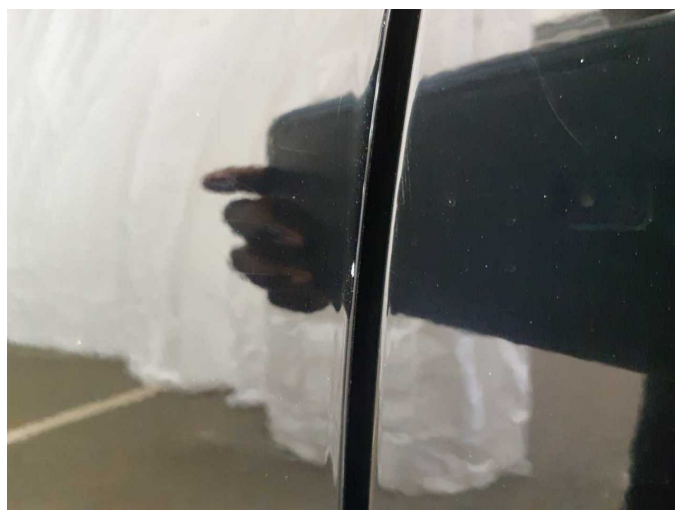
| No. | Component group | Description |
|---|---|---|
| 9 | Door - front left side | Door edge - Scratch(es) - Paint |

**Damage 9:** Door - front left side: Door edge - Scratch(es) - Paint

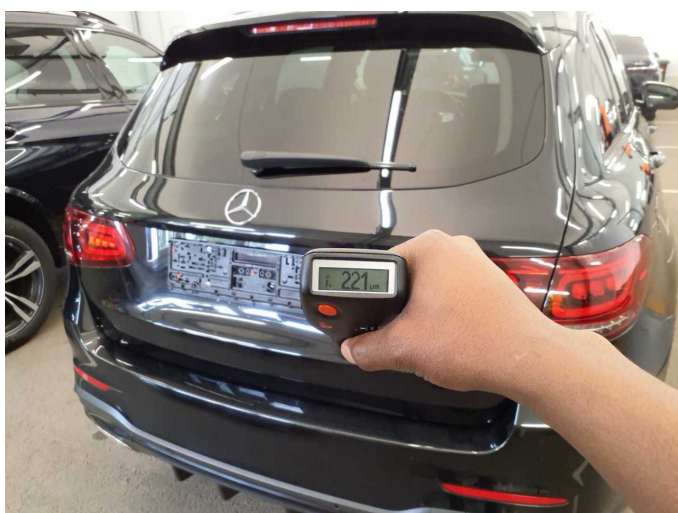
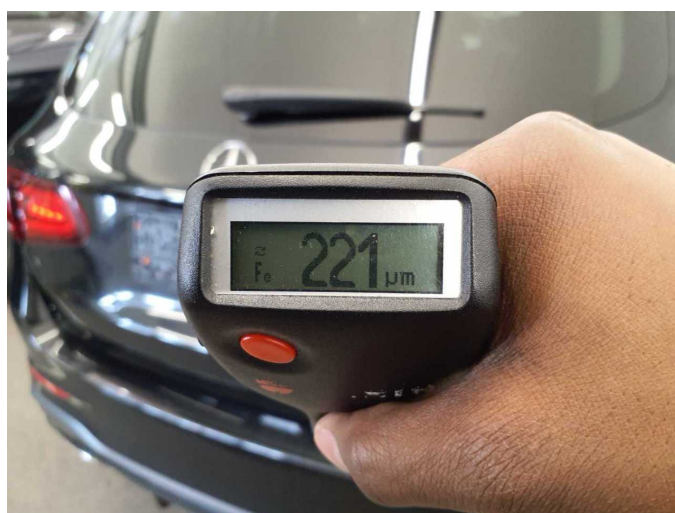
| 1 | Boot lid / rear door, Professionally carried out, Invoice of repair done Non-existent |

| Boot lid / rear door | 221 µm |

**Repainting 1:** Boot lid / rear door
