Expertise

Protocol number: 46392076  
Order No. / Reference: 26562156  
Inspection date: 8 Jul 2026

| Manufacturer: Volvo | Model: XC60 B4 D Plus Bright |
| VIN: YV1UZZK5V8P1282670 | |

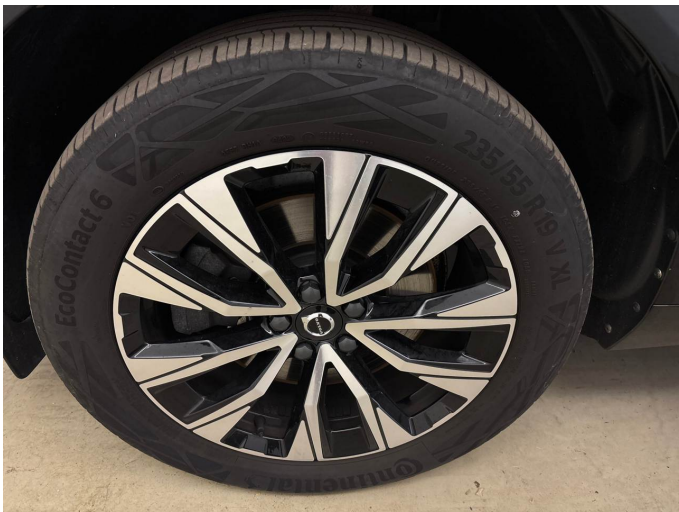
| # | Tyre size | Type of tyre | Manufacturer | Tread depth |
|---|---|---|---|---|
| 1) | 235/55 R19 105V | Summer tyres on Light alloy | Continental | 3mm / 3mm |
| 2) | 235/55 R19 105V | Summer tyres on Light alloy | Continental | 4mm / 4mm |

Figure 12: Mounted tyres

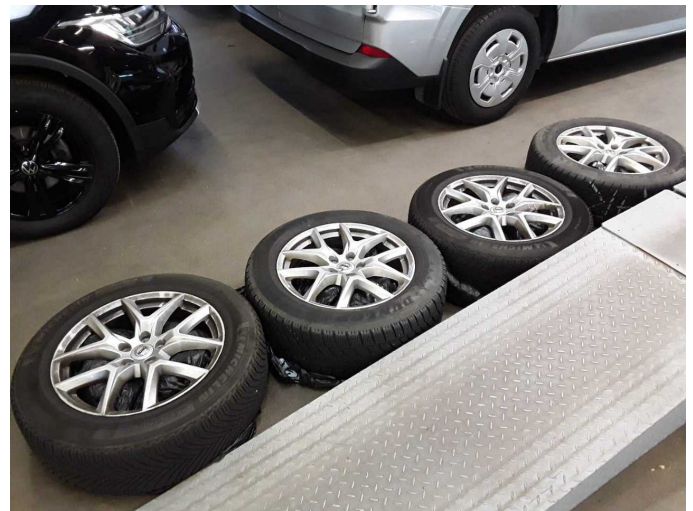
| # | Tyre size | Type of tyre | Manufacturer | Tread depth |
|---|---|---|---|---|
| 1) | 235/60 R18 107H | Winter tyres on Light alloy | Michelin | 5mm / 5mm |
| 2) | 235/60 R18 107H | Winter tyres on Light alloy | Dunlop | 5mm / 5mm |

Figure 16: Additional tyres

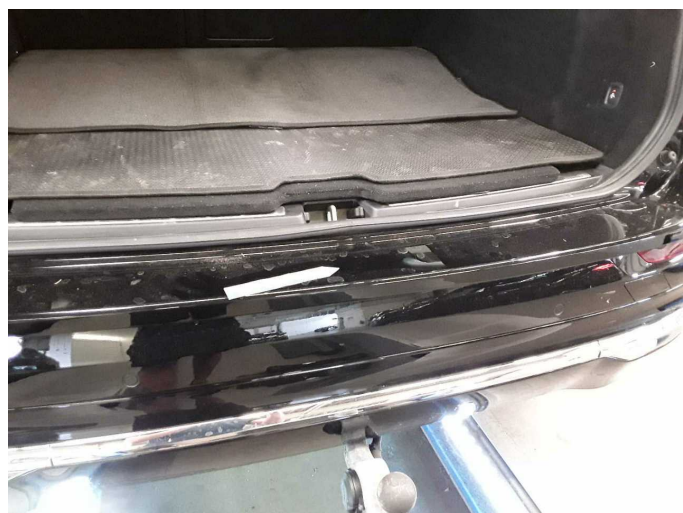
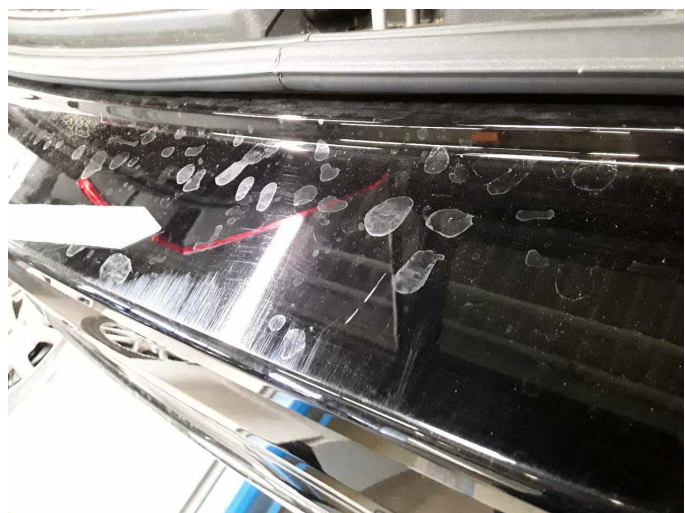
Damage 1: Rear bumper: Rear bumper - Scratch(es) - Smart repair

| No. | Component group | Description |
|---|---|---|
| 1 | Rear bumper | Rear bumper - Scratch(es) - Smart repair |

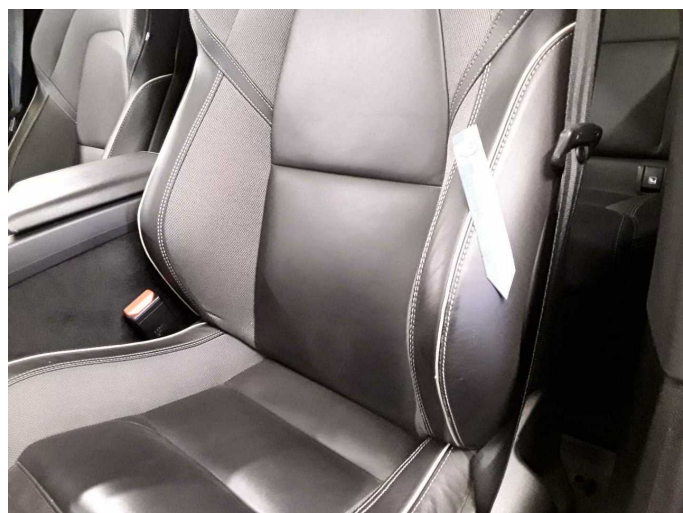
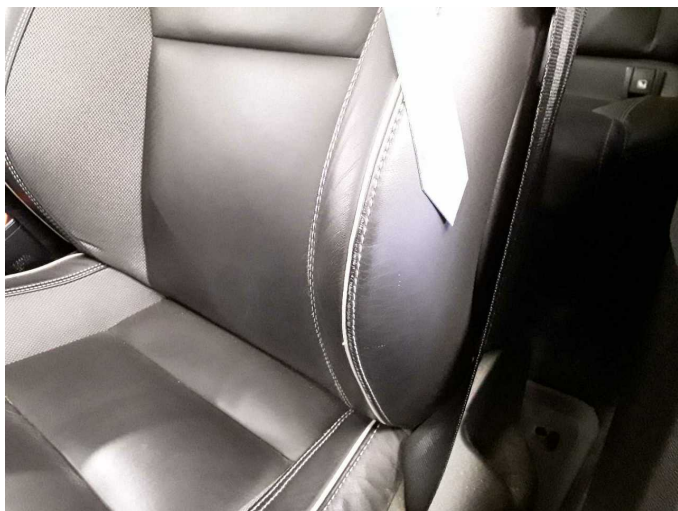
Damage 2: Seat - front: Backrest cover - left side - Scratch(es) - Smart repair

**Damage 2:** Seat - front: Backrest cover - left side - Scratch(es) - Smart repair

| No. | Component group | Description |
|---|---|---|
| 2 | Seat - front | Backrest cover - left side - Scratch(es) - Smart repair |

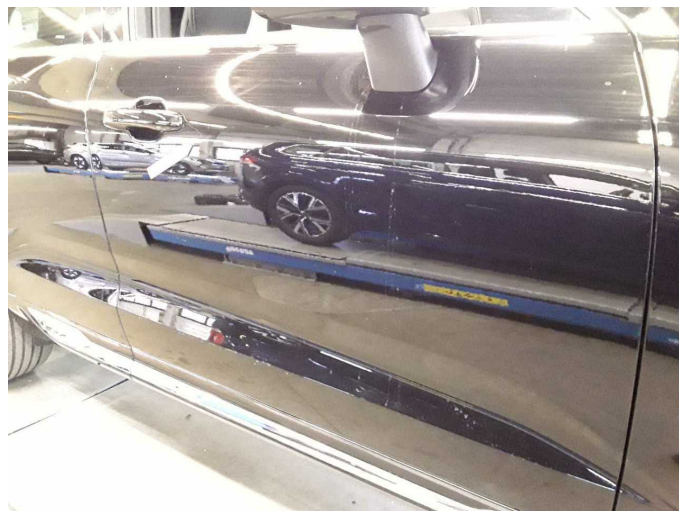
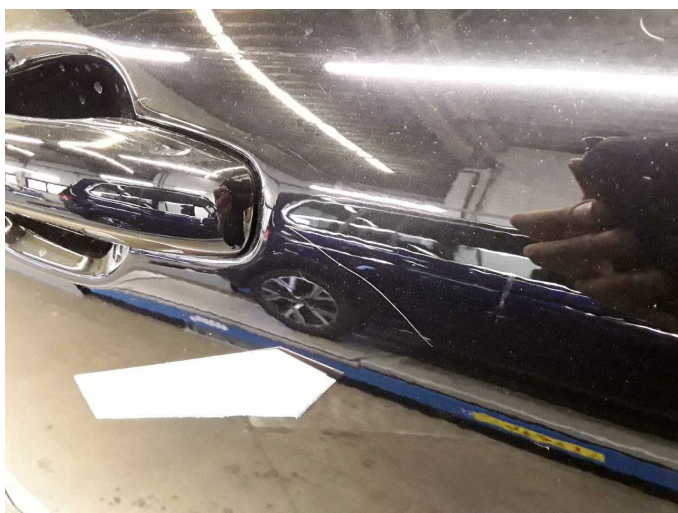
**Damage 3:** Door - front right side: Door - Scratch(es) - Paint

| No. | Component group | Description |
|---|---|---|
| 3 | Door - front right side | Door - Scratch(es) - Paint |

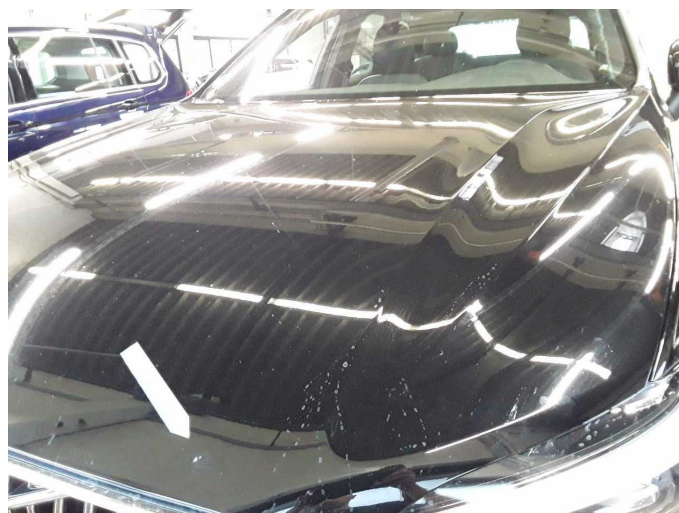
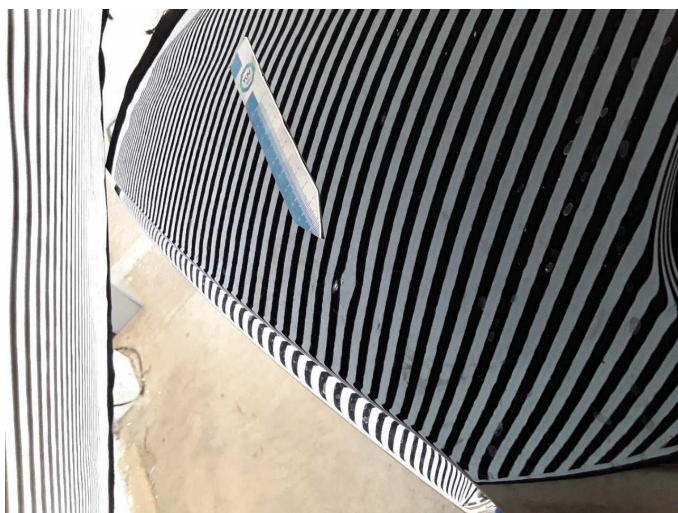
**Damage 4:** Bonnet: Bonnet - Dent / paintcoat damage - Repair and paint

| No. | Component group | Description |
|---|---|---|
| 4 | Bonnet | Bonnet - Dent / paintcoat damage - Repair and paint |

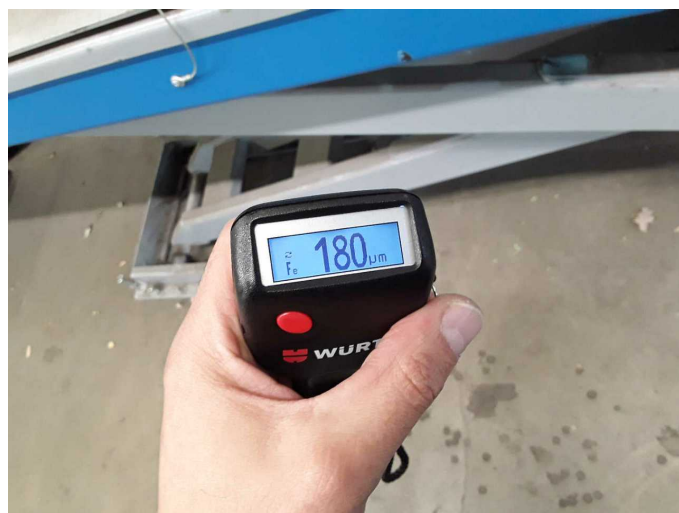
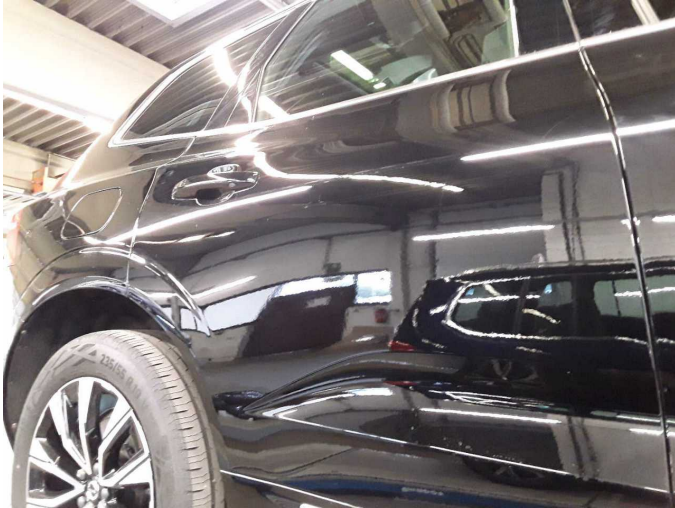
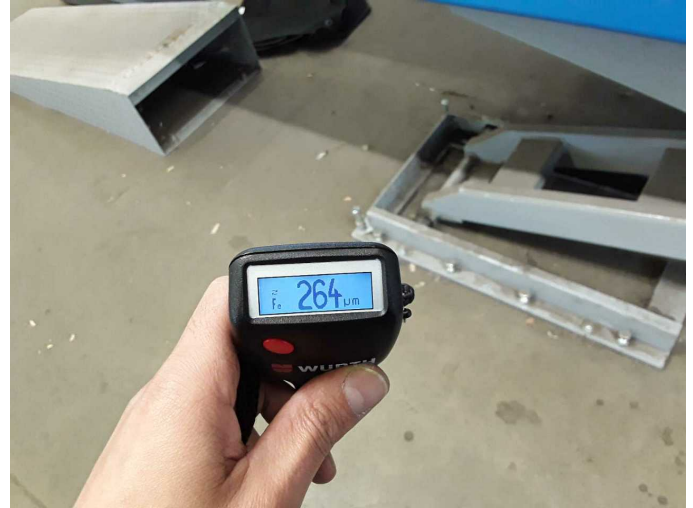
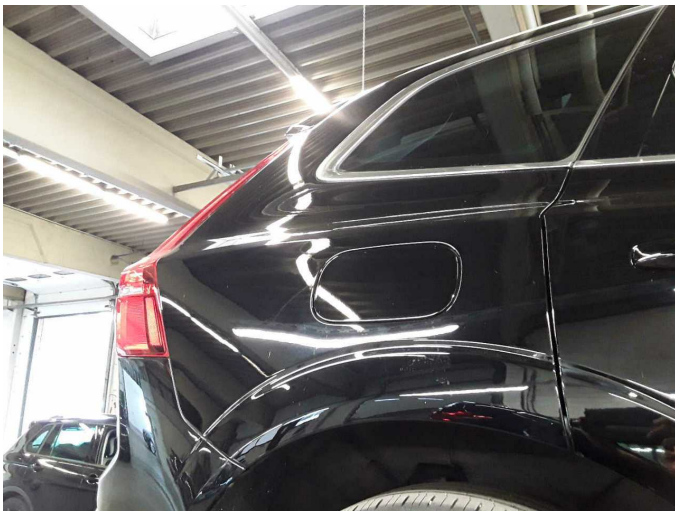
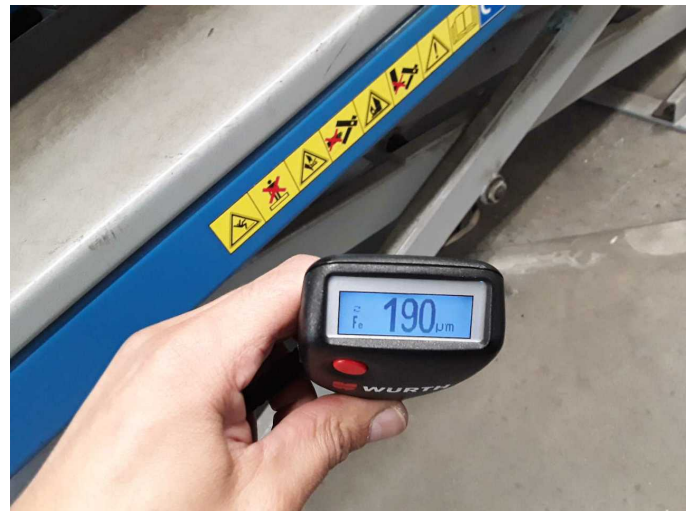
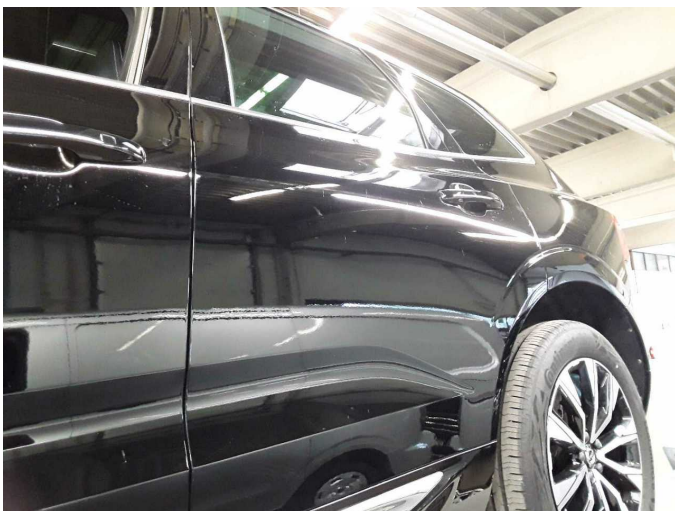
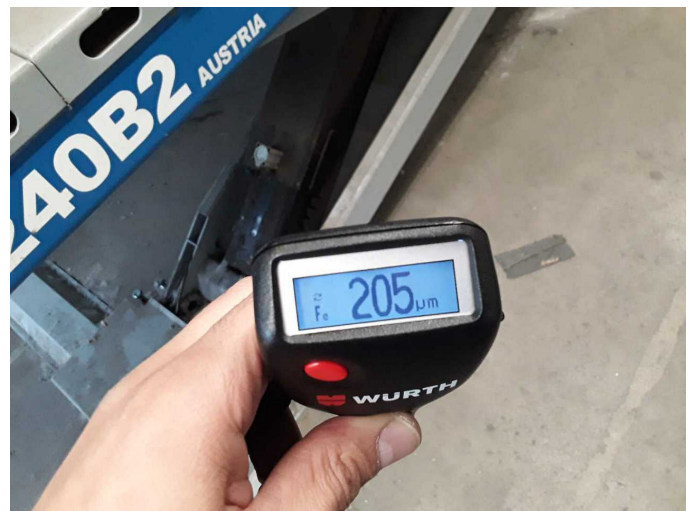
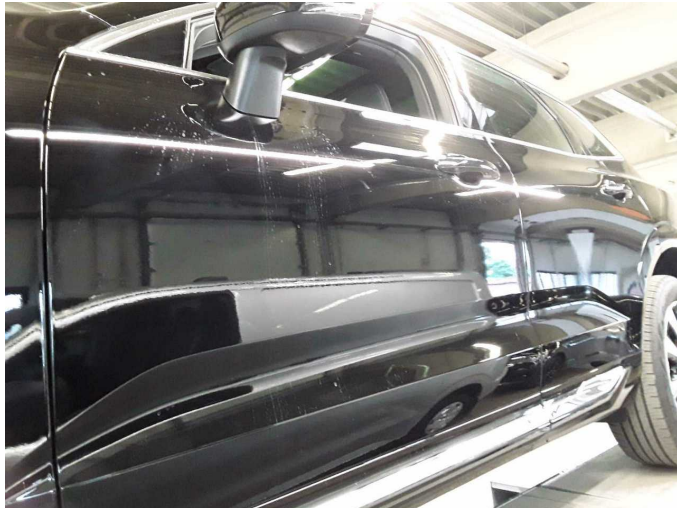
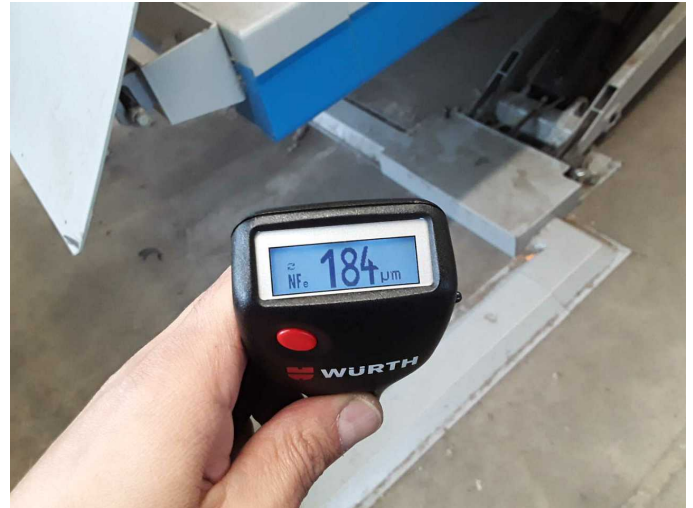
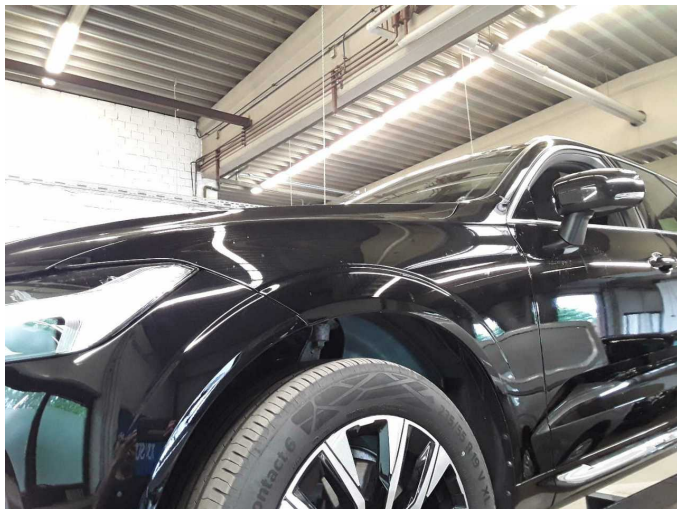
| No. | Repainting |
|---|---|
| 1 | Mudguard - left side, Side panel - rear right side, Door - rear left side, Door - rear right side, Door - front left side, Professionally carried out, Invoice of repair done Non-existent |

**Repainting 1:** Mudguard - left side, Side panel - rear right side, Door - rear left side, Door - rear right side, Door - front left side
