Expertise

Protocol number: 46211566  
Order No. / Reference: 26588886  
Inspection date: 26 Jun 2026

Manufacturer: Volkswagen

Model: Golf Variant 2.0 TDI SCR Life

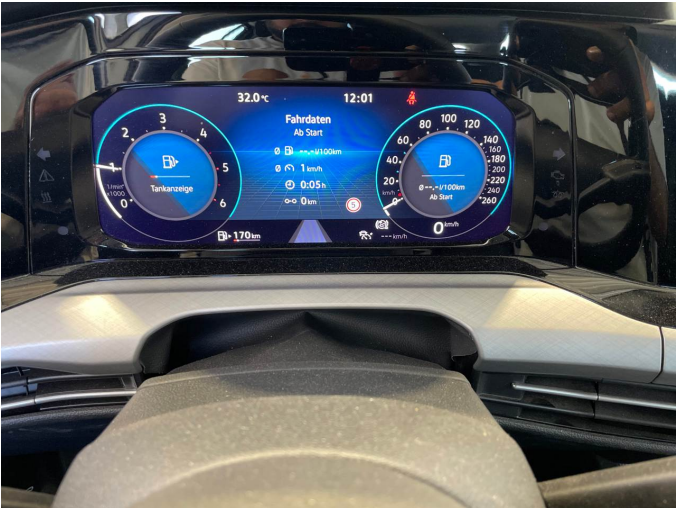
| Vehicle details | |
|---|---|
| Mileage (Read) | 45,117 km |

Figure 7: Instrument cluster

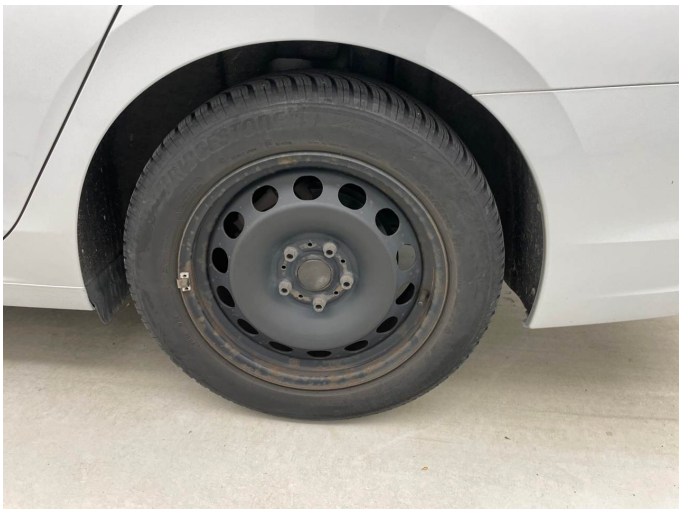
| Tyres | | | | |
|---|---|---|---|---|
| 1) | 205/55 R16 91H | Winter tyres on Steel | Bridgestone | 7mm / 7mm |
| 2) | 205/55 R16 91H | Winter tyres on Steel | Bridgestone | 6mm / 6mm |

Figure 12: Mounted tyres

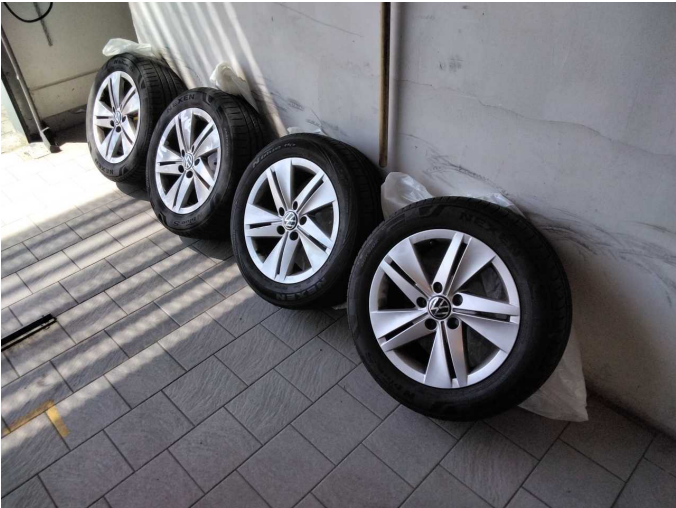
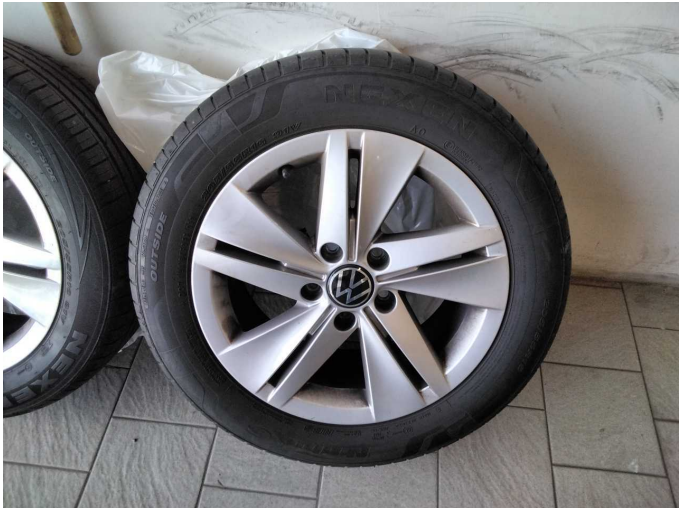
| Tyres | | | | |
|---|---|---|---|---|
| 1) | 205/55 R16 91V | Summer tyres on Light alloy | Nexen | 6mm / 6mm |
| 2) | 205/55 R16 91V | Summer tyres on Light alloy | Nexen | 7mm / 7mm |

Figure 15: Additional tyres

Figure 16: Additional tyres

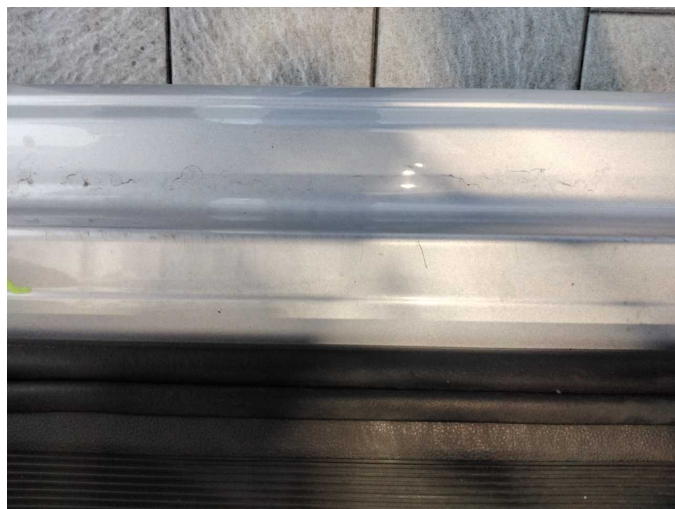
**Damage 2:** Sill - left side: Sill - Scratch(es) - Smart repair

| No. | Component group | Description |
|---|---|---|
| 2 | Sill - left side | Sill - Scratch(es) - Smart repair |

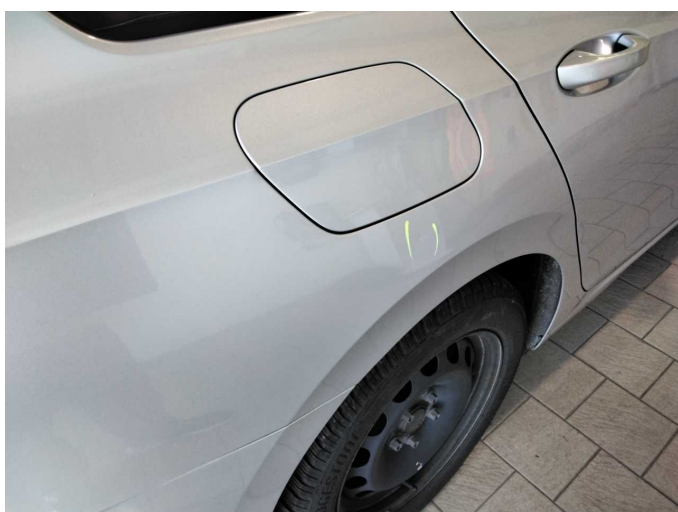
**Damage 3:** Side panel - rear right side: Side panel - Dent / paintcoat damage - Smart repair

| No. | Component group | Description |
|---|---|---|
| 3 | Side panel - rear right side | Side panel - Dent / paintcoat damage - Smart repair |

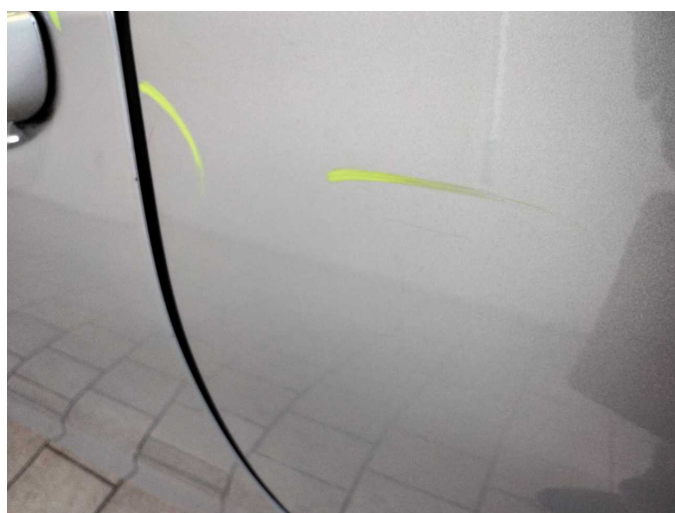
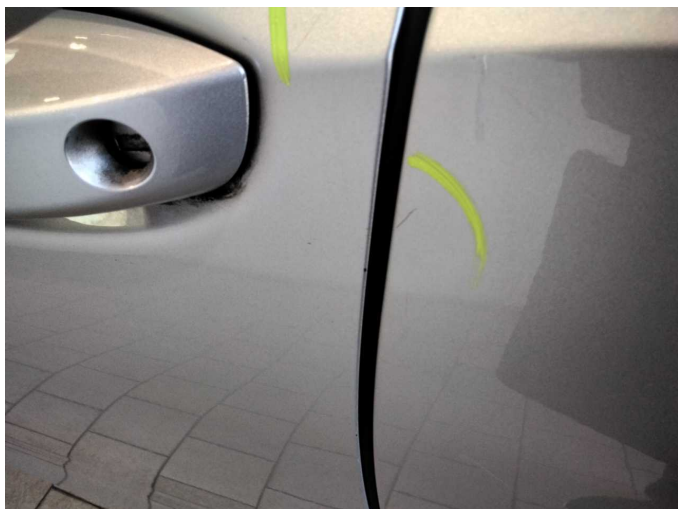
**Damage 4:** Door - rear left side: Door - Scratch(es) - Smart repair

| No. | Component group | Description |
|---|---|---|
| 4 | Door - rear left side | Door - Scratch(es) - Smart repair |

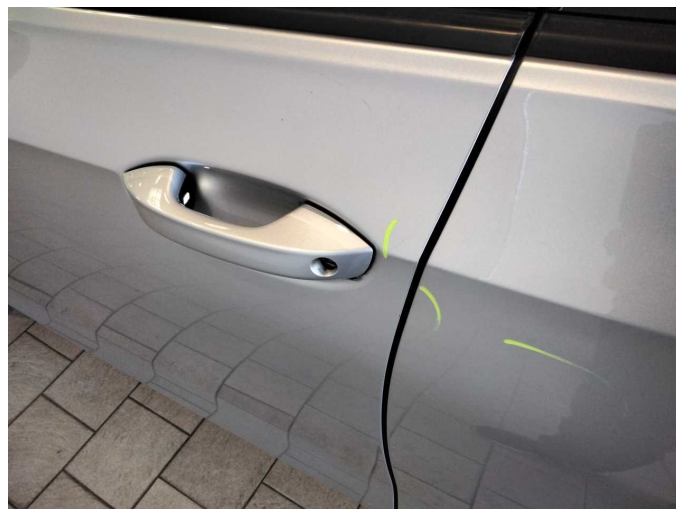
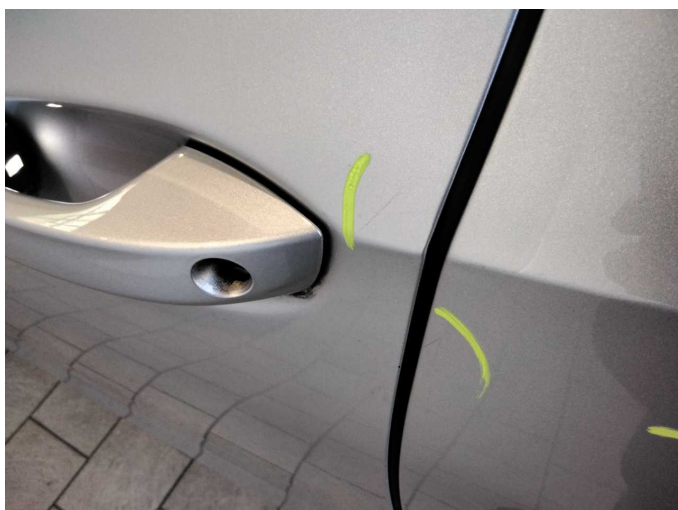
**Damage 5:** Door - front left side: Door - Scratch(es) - Smart repair

| No. | Component group | Description |
|---|---|---|
| 5 | Door - front left side | Door - Scratch(es) - Smart repair |

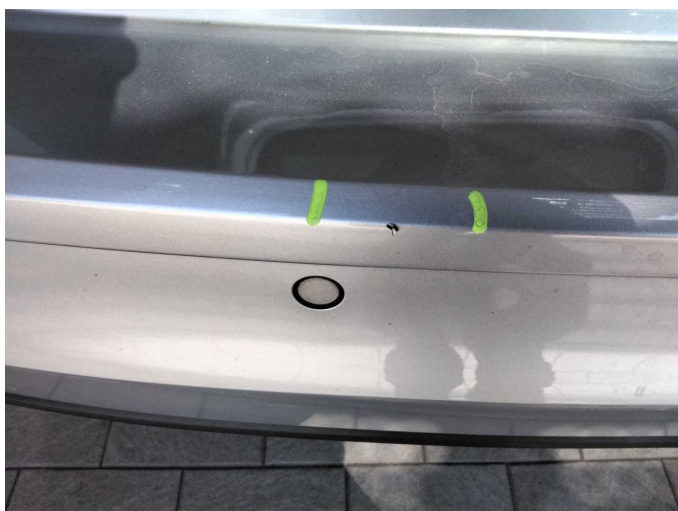
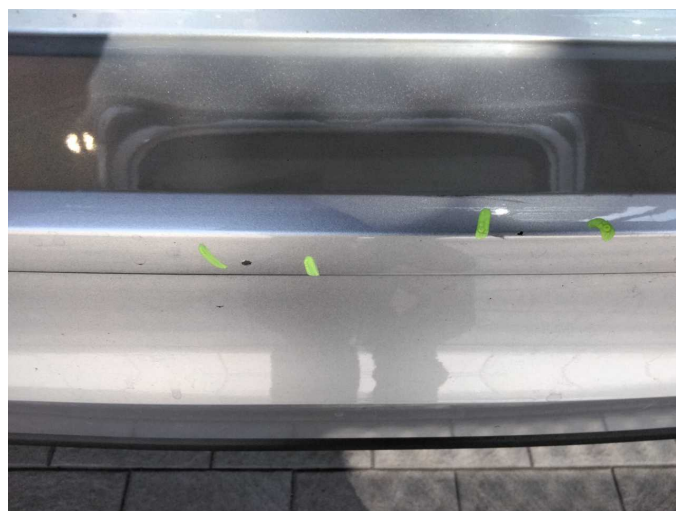
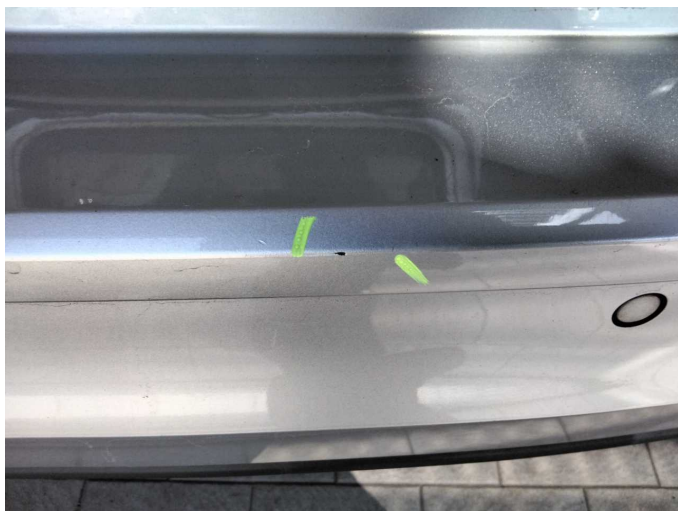
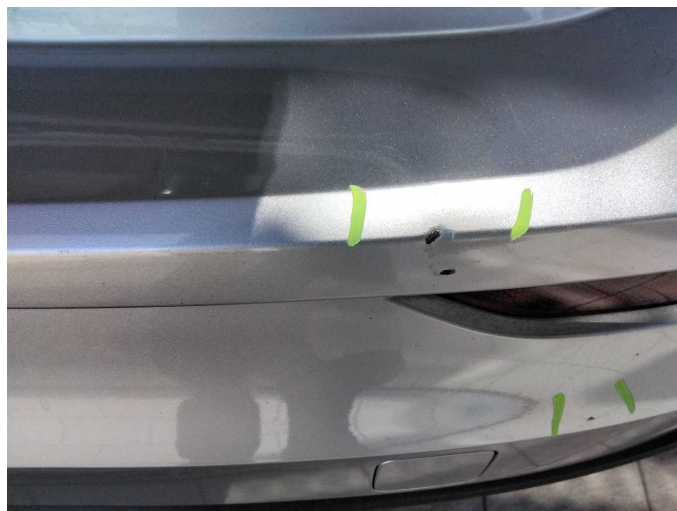
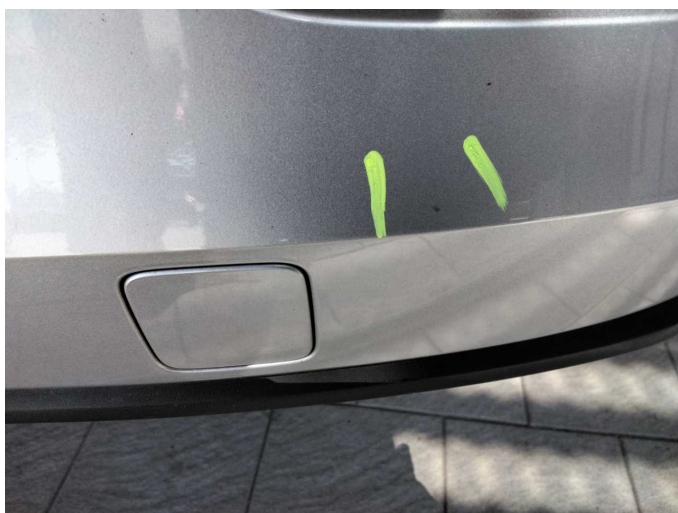
**Damage 6:** Rear bumper: Rear bumper - Scratch(es) - Paint

| No. | Component group | Description |
|---|---|---|
| 6 | Rear bumper | Rear bumper - Scratch(es) - Paint |

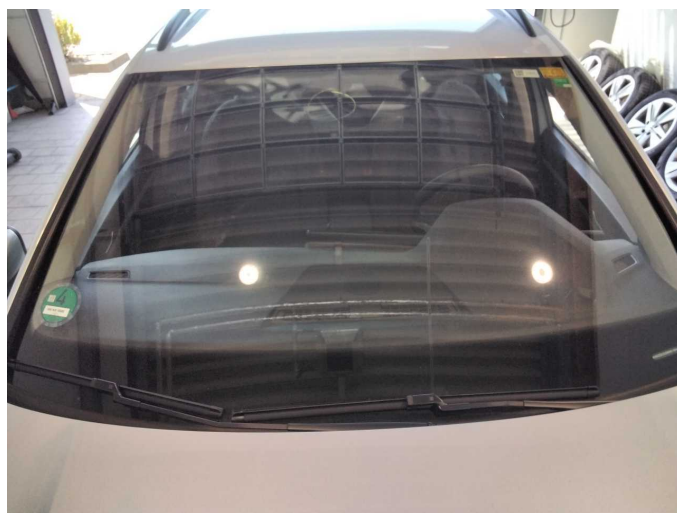
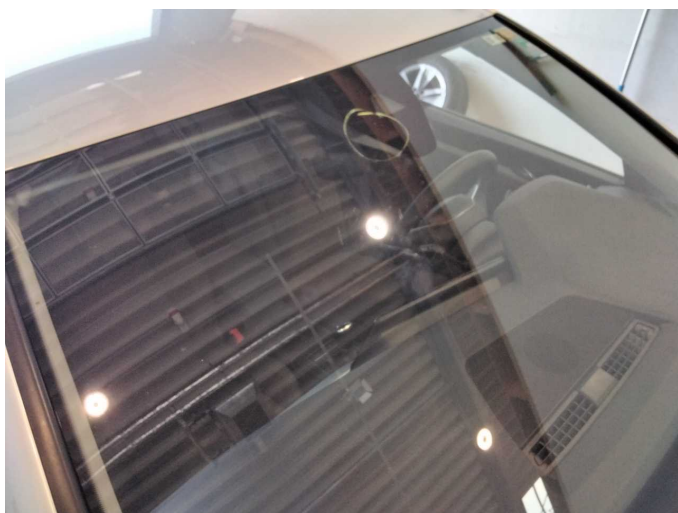
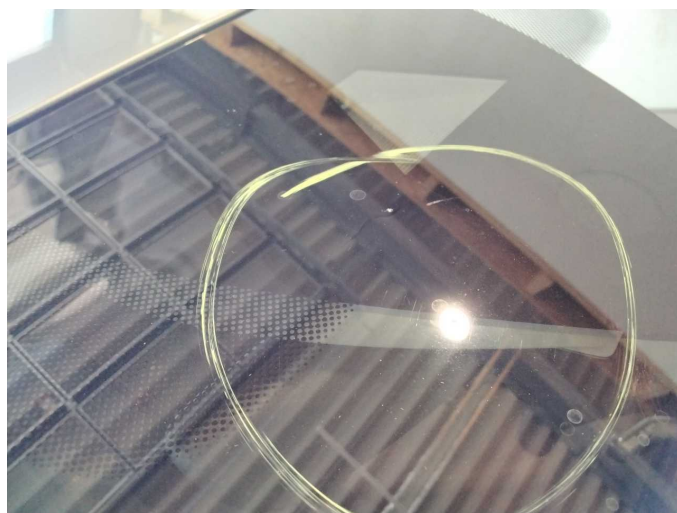
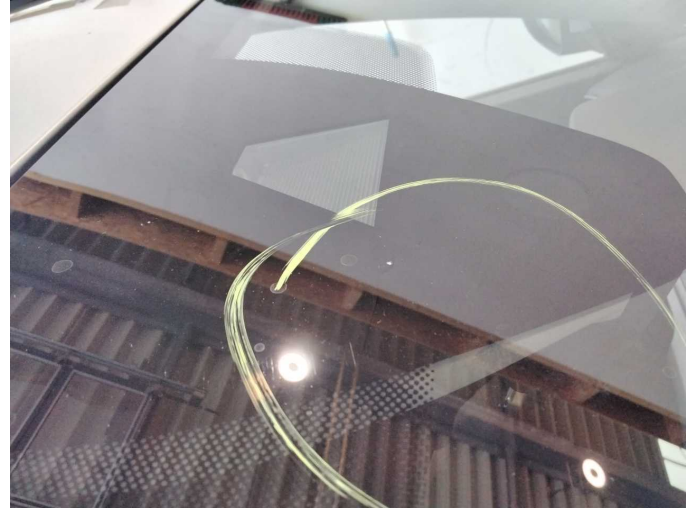
**Damage 7:** Vehicle glazing: Windscreen - Stone chips - Replace

| No. | Component group | Description |
|---|---|---|
| 7 | Vehicle glazing | Windscreen - Stone chips - Replace |
