Expertise

Protocol number: 46103810  
Order No. / Reference: 26478976  
Inspection date: 18 Jun 2026

Manufacturer: Skoda  
VIN: TMBJJ9NS7P8021469

Model: Kodiaq 2.0 TDI DSG Sportline

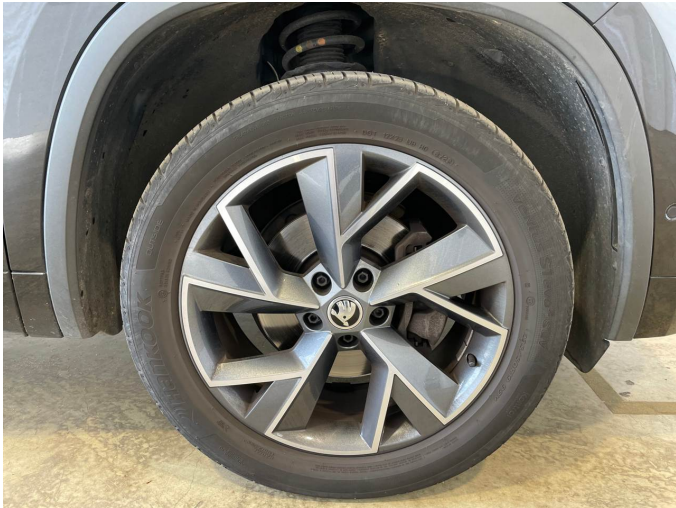
| # | Tyre size | Type of tyre | Manufacturer | Tread depth |
|---|---|---|---|---|
| 1) | 235/50 R19 99V | Summer tyres on Light alloy | Hankook | 4mm / 4mm |
| 2) | 235/50 R19 99V | Summer tyres on Light alloy | Hankook | 3mm / 2mm |

Figure 13: Mounted tyres

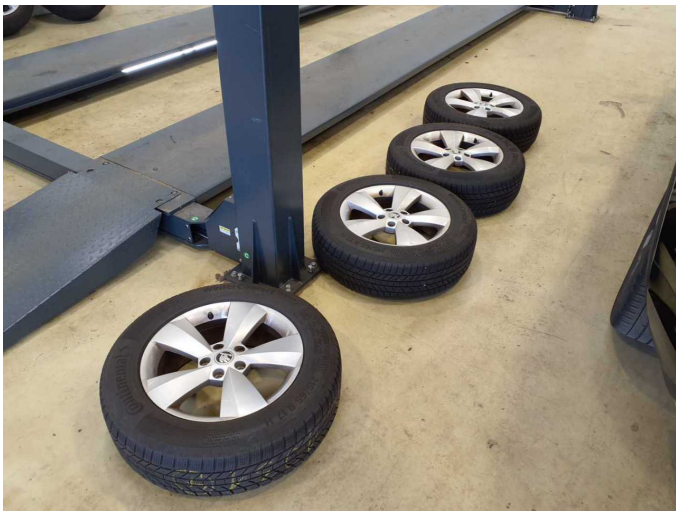
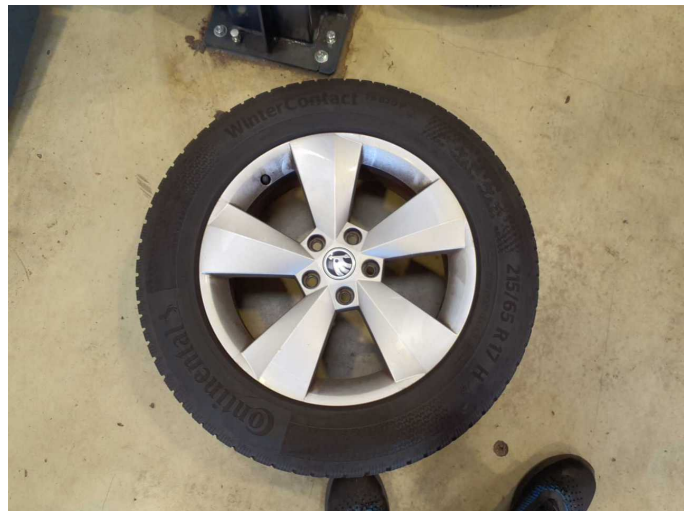
| # | Tyre size | Type of tyre | Manufacturer | Tread depth |
|---|---|---|---|---|
| 1) | 215/65 R17 99H | Winter tyres on Light alloy | Continental | 6mm / 6mm |
| 2) | 215/65 R17 99H | Winter tyres on Light alloy | Continental | 7mm / 7mm |

Figure 15: Additional tyres

Figure 16: Additional tyres

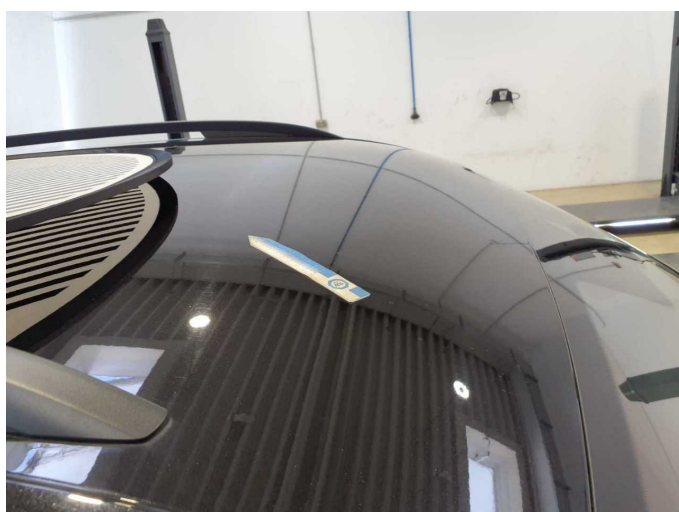
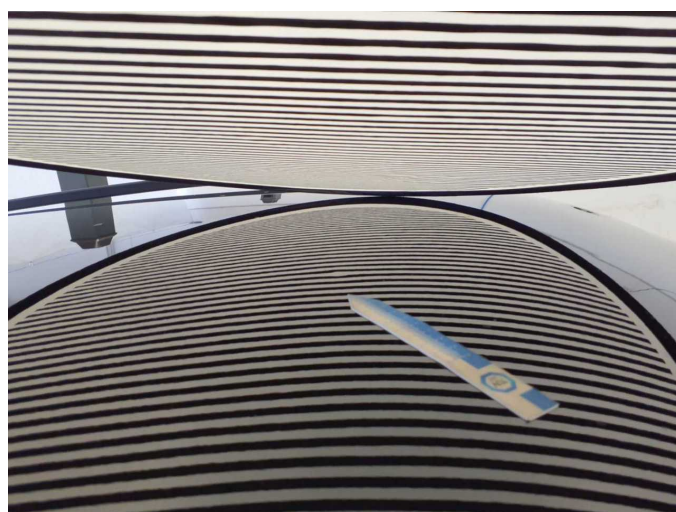
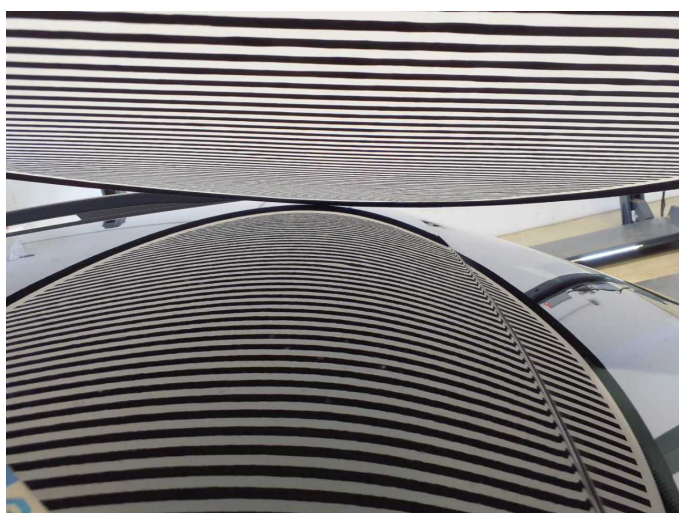
| No. | Component group | Description |
|---|---|---|
| 1 | Roof | Roof - dent(s) - Smooth repair work |

**Damage 1:** Roof: Roof - dent(s) - Smooth repair work

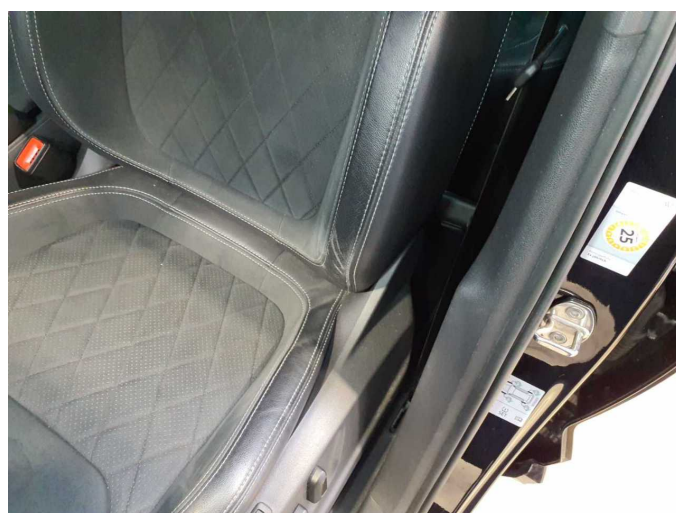
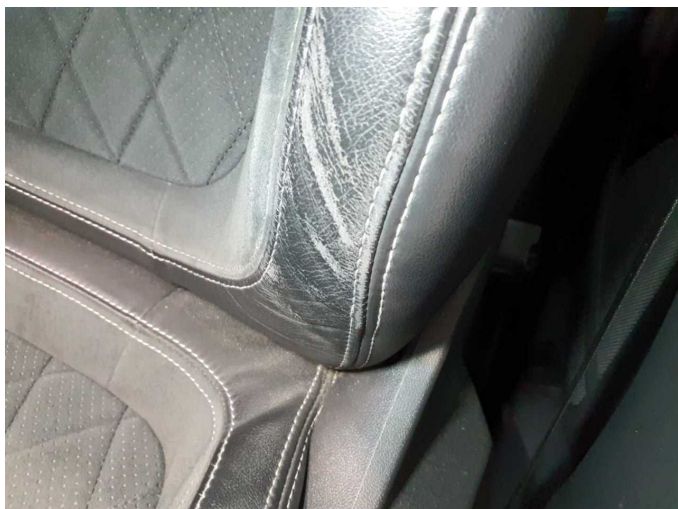
| No. | Component group | Description |
|---|---|---|
| 2 | Seat - front | Seat cover - left side - Scratch(es) - Smart repair |

**Damage 2:** Seat - front: Seat cover - left side - Scratch(es) - Smart repair

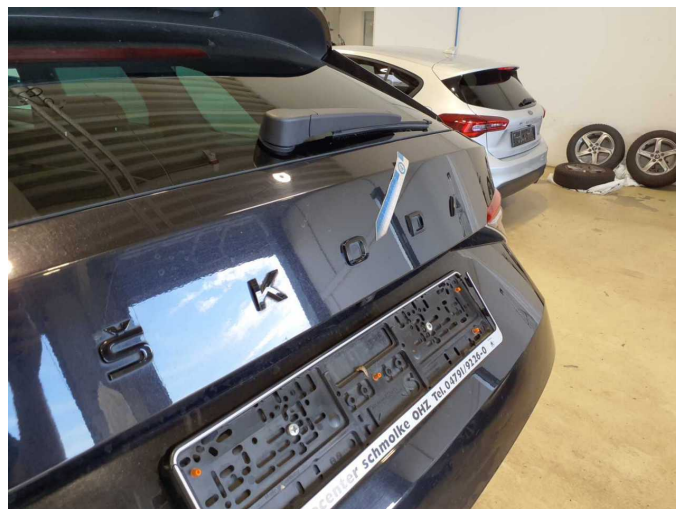
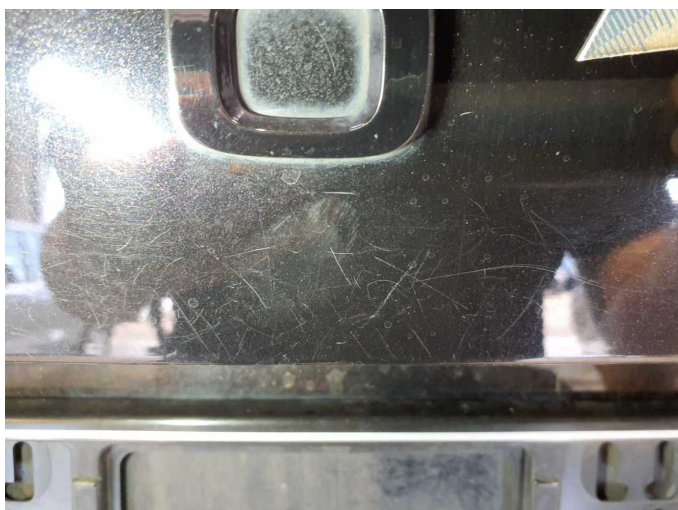
| No. | Component group | Description |
|---|---|---|
| 3 | Boot lid / rear door | Boot lid - Scratch(es) - Smart repair |

**Damage 3:** Boot lid / rear door: Boot lid - Scratch(es) - Smart repair

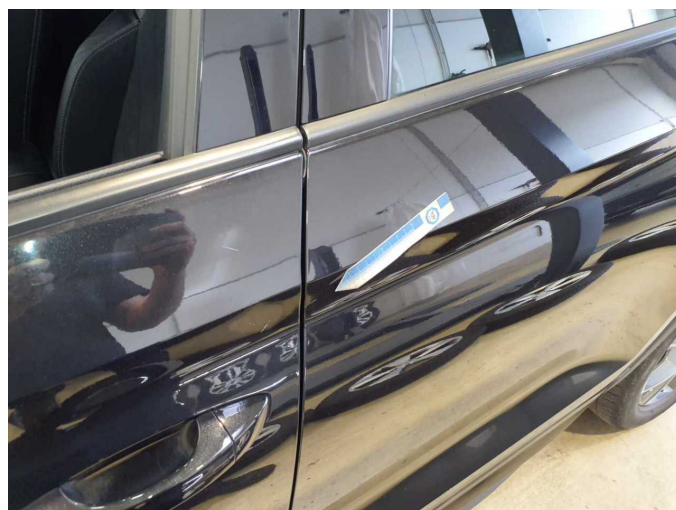
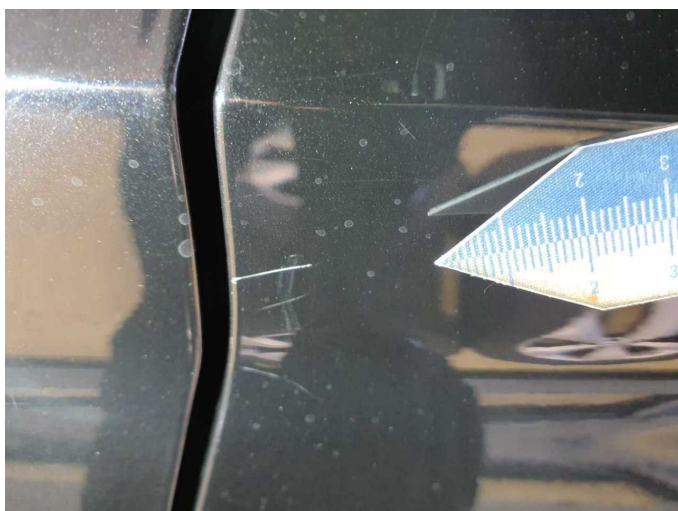
| No. | Component group | Description |
|---|---|---|
| 4 | Door - rear left side | Door - Scratch(es) - Smart repair |

**Damage 4:** Door - rear left side: Door - Scratch(es) - Smart repair

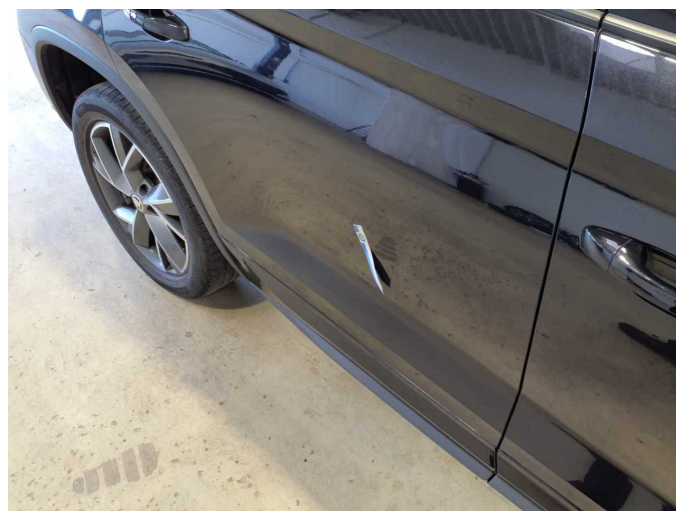
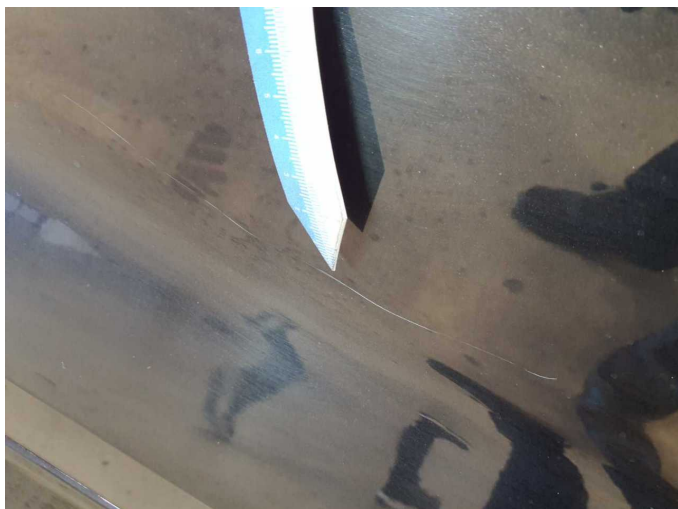
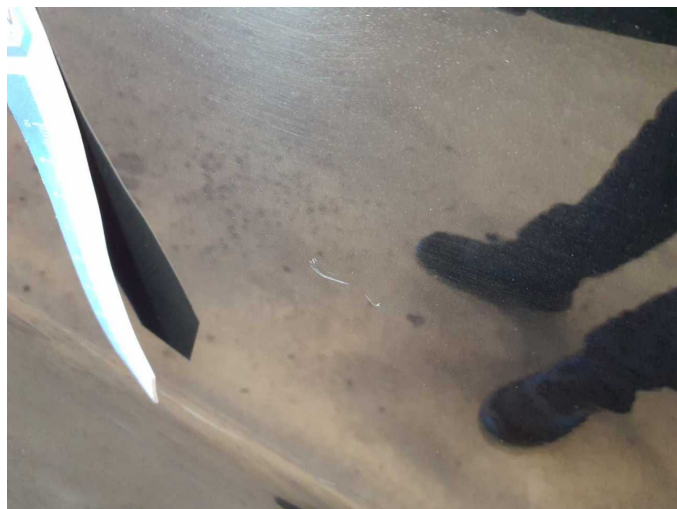
| No. | Component group | Description |
|---|---|---|
| 5 | Door - rear right side | Door - Scratch(es) - Paint |

**Damage 5:** Door - rear right side: Door - Scratch(es) - Paint

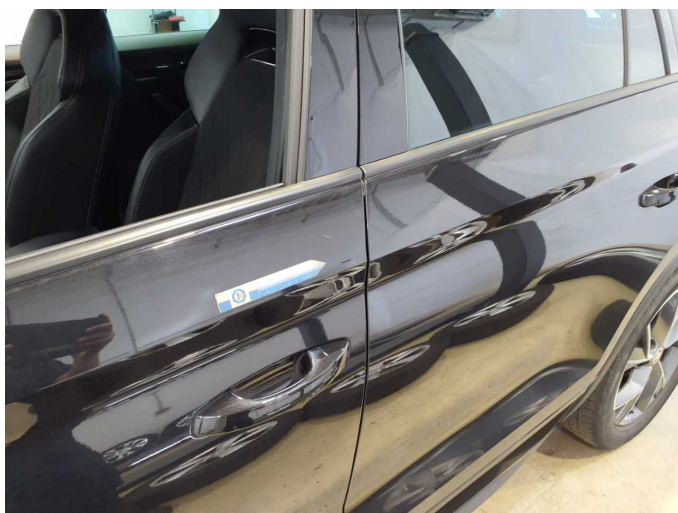
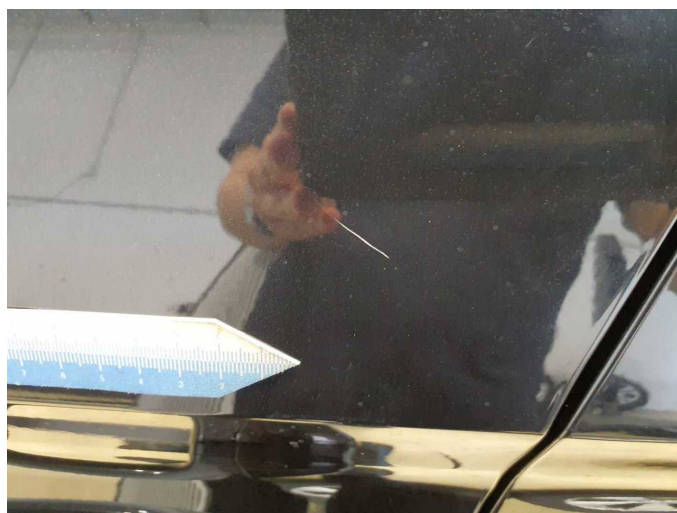
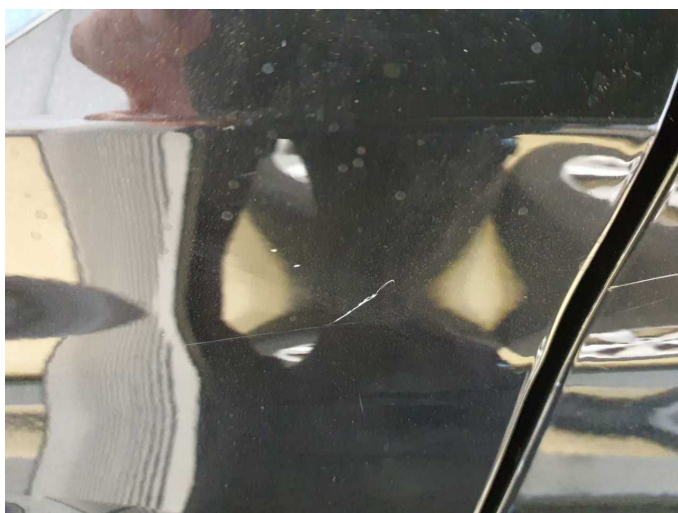
| No. | Component group | Description |
|---|---|---|
| 6 | Door - front left side | Door - Scratch(es) - Paint |

**Damage 6:** Door - front left side: Door - Scratch(es) - Paint
