Protocol number: 46079959
Order No. / Reference: 26512085
Inspection date: 18 Jun 2026

Manufacturer: Volkswagen

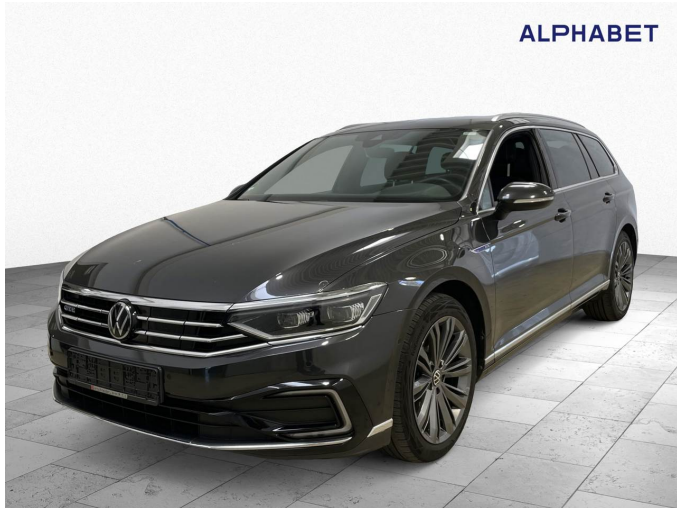
Figure 1: Diagonal front (left)

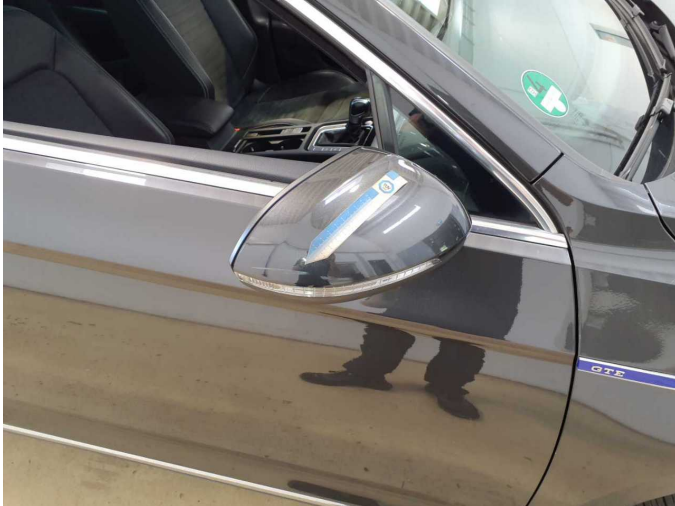
Damage 1: Wing mirror - right side: Cap - Scratch(es) - Smart repair

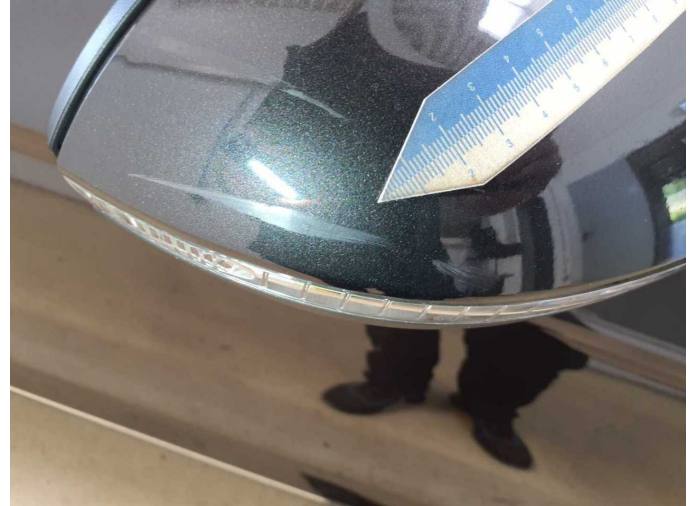
Damage 1: Wing mirror - right side: Cap - Scratch(es) - Smart repair

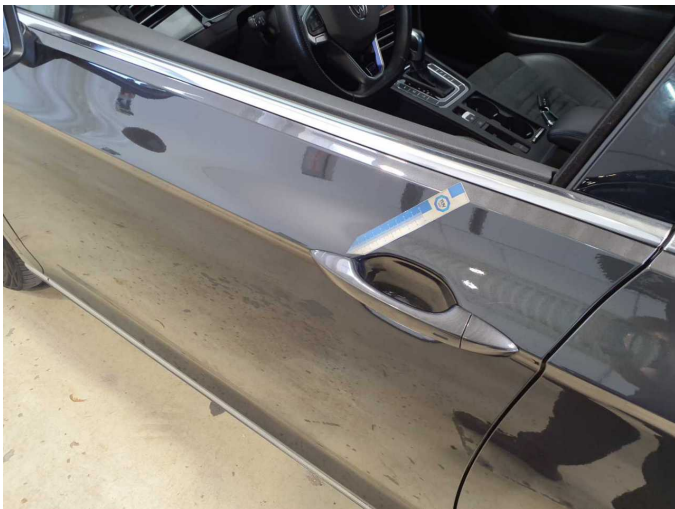
Damage 2: Door - front left side: Door handle - outside - Scratch(es) - Smart repair

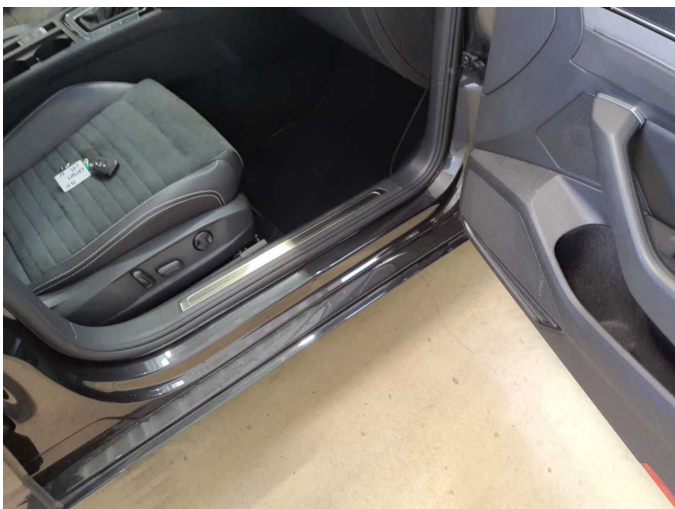
Damage 3: Sill - right side: Sill - dent(s) - Smooth repair work

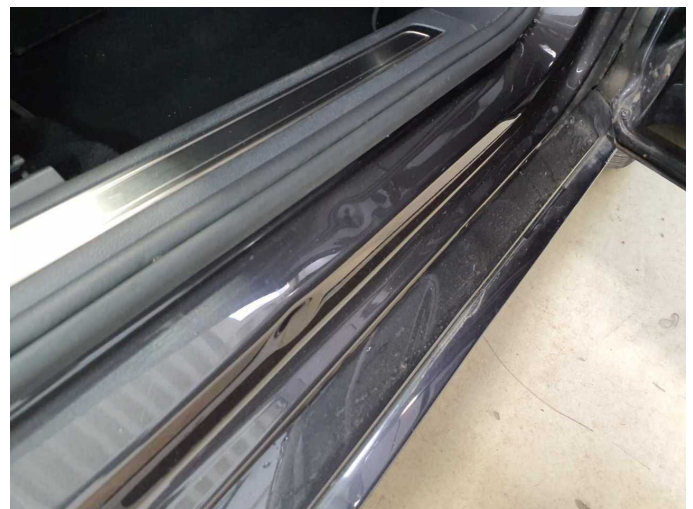
Damage 3: Sill - right side: Sill - dent(s) - Smooth repair work

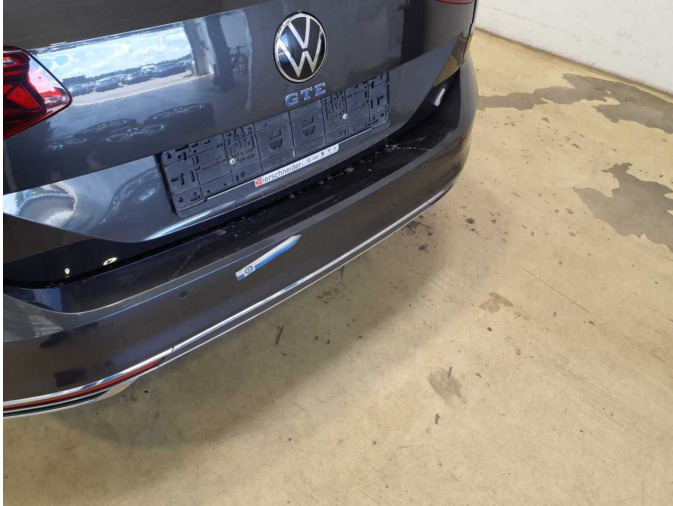
Damage 4: Rear bumper: Rear bumper - Scratch(es) - Smart repair

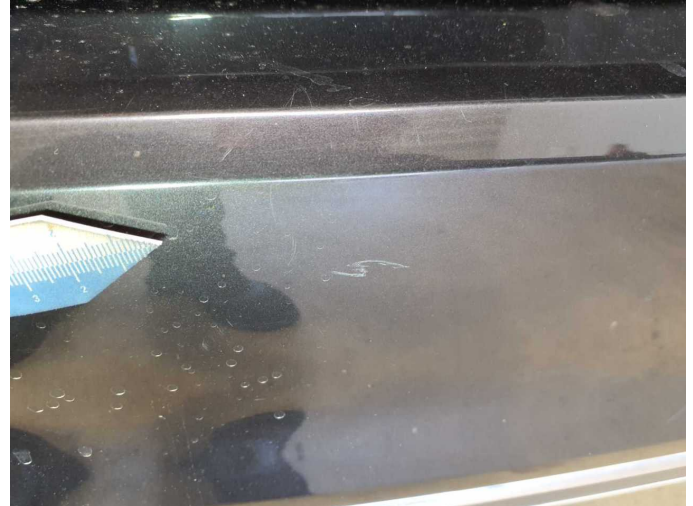
Damage 4: Rear bumper: Rear bumper - Scratch(es) - Smart repair

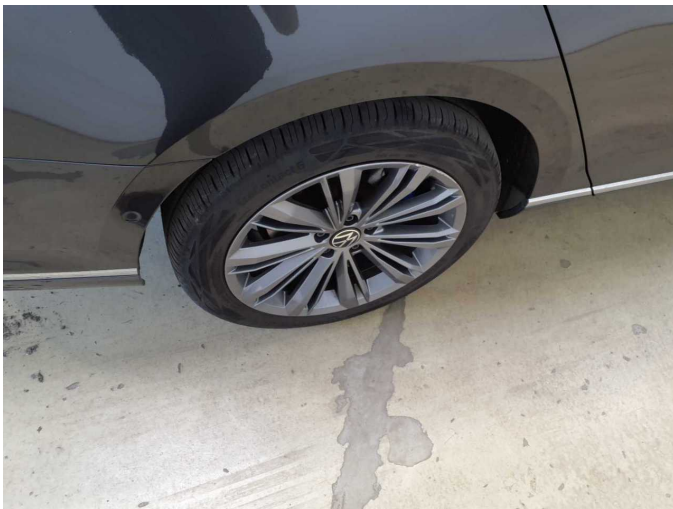
Damage 5: Wheel / tyres: Tyre - rear right side (nicht fahrbereit) - Broken / torn - Replace

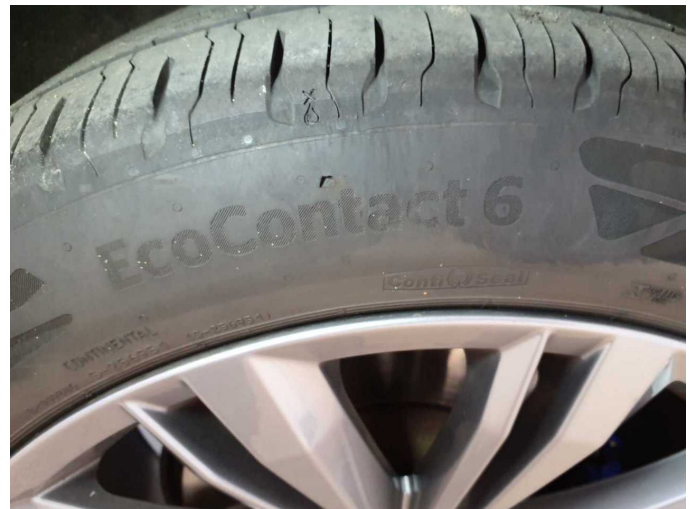
Damage 5: Wheel / tyres: Tyre - rear right side (nicht fahrbereit) - Broken / torn - Replace

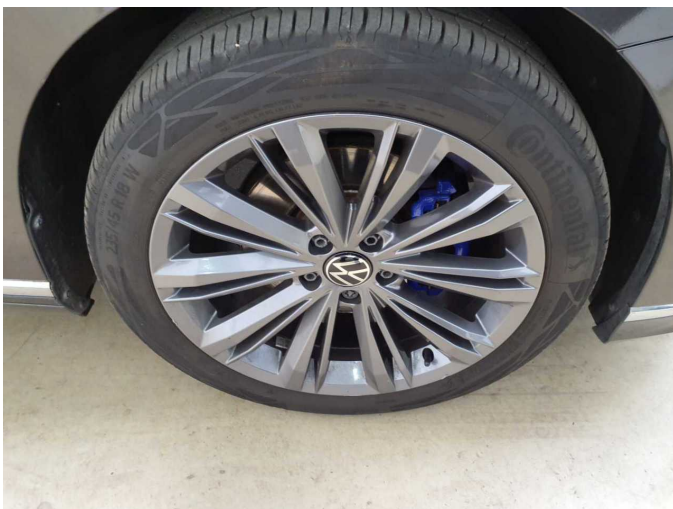
Damage 6: Wheel / tyres: Tyre - front right side (nicht fahrbereit) - Damaged - Replace

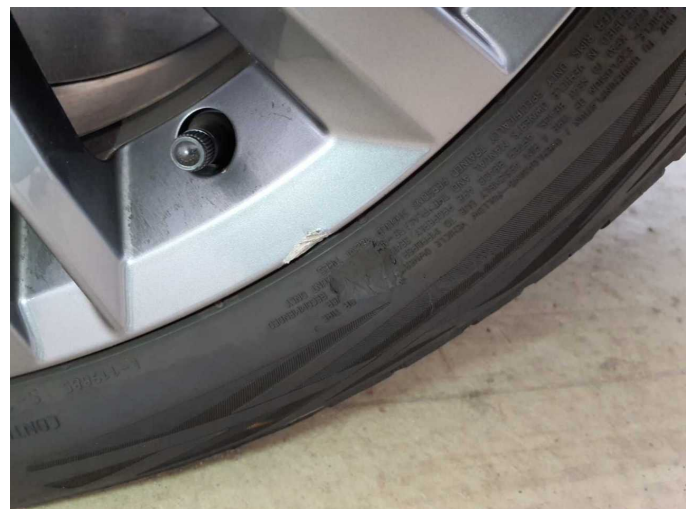
Damage 6: Wheel / tyres: Tyre - front right side (nicht fahrbereit) - Damaged - Replace

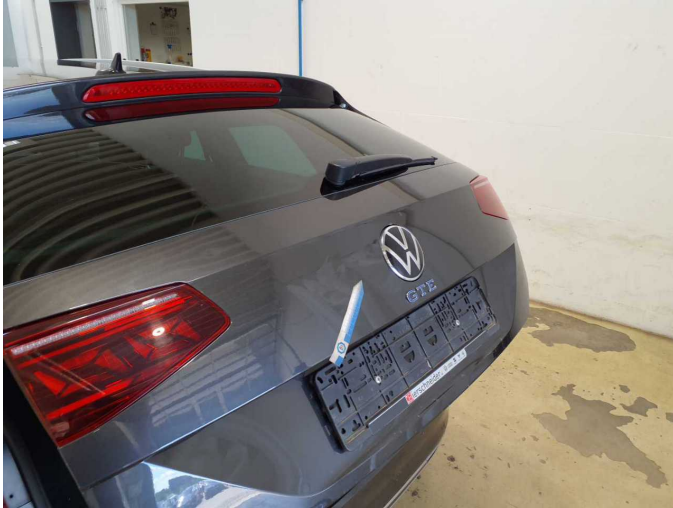
Damage 7: Boot lid / rear door: Boot lid - dent(s) - Smooth repair work

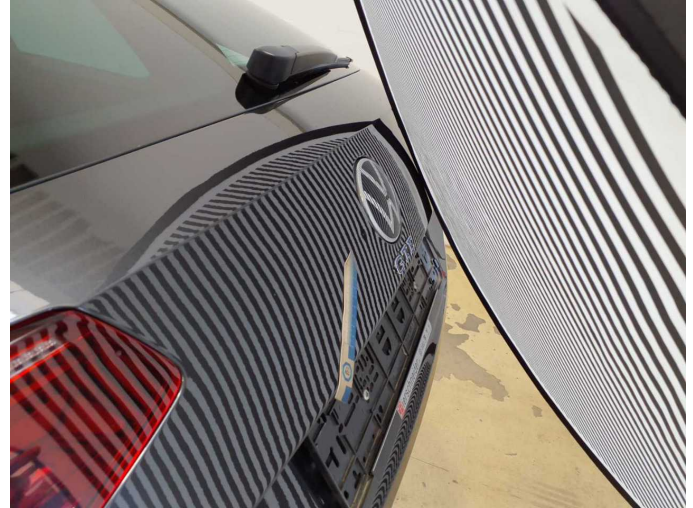
Damage 7: Boot lid / rear door: Boot lid - dent(s) - Smooth repair work

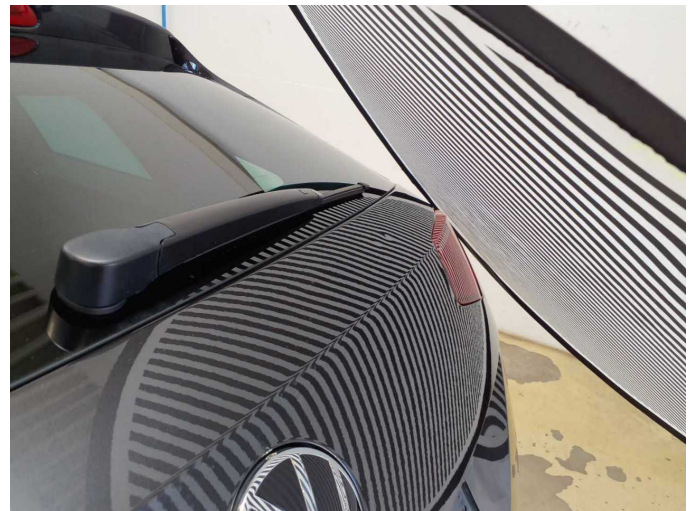
Damage 7: Boot lid / rear door: Boot lid - dent(s) - Smooth repair work

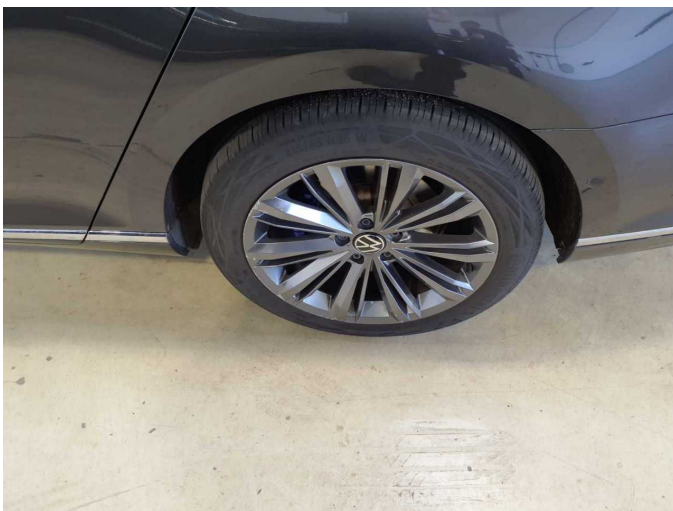
Damage 8: Wheel / tyres: Alloy rim - rear left side - Scratch(es) - Loss in value

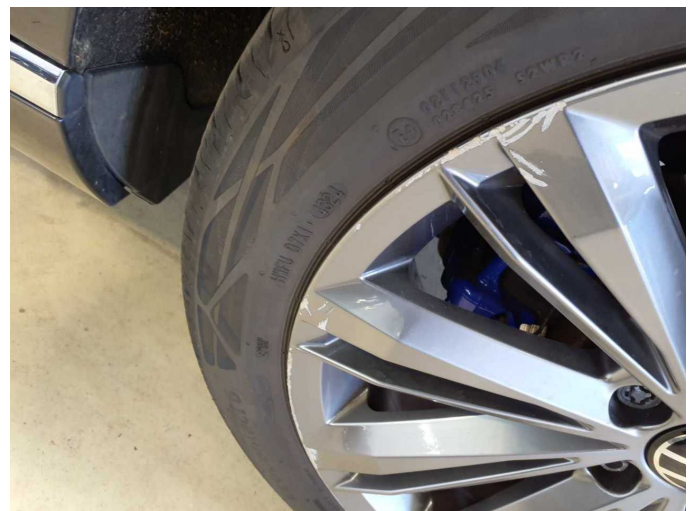
Damage 8: Wheel / tyres: Alloy rim - rear left side - Scratch(es) - Loss in value

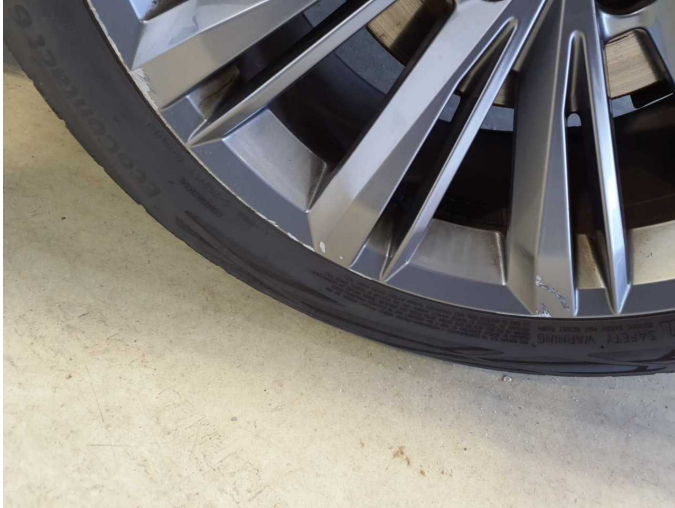
Damage 8: Wheel / tyres: Alloy rim - rear left side - Scratch(es) - Loss in value

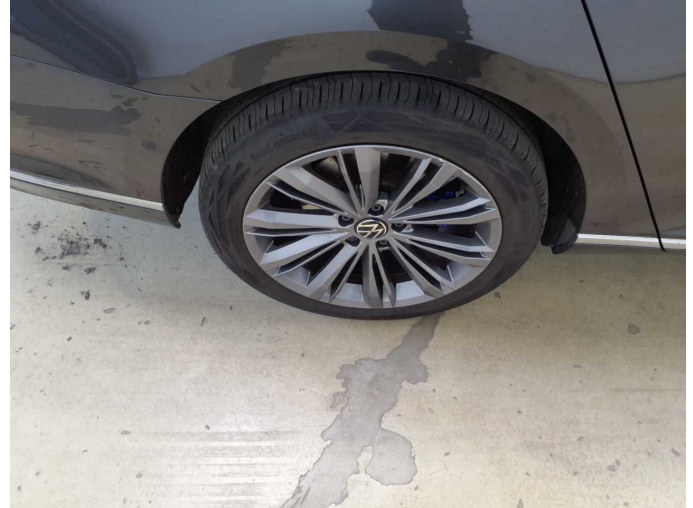
Damage 9: Wheel / tyres: Alloy rim - rear right side - Scratch(es) - Loss in value

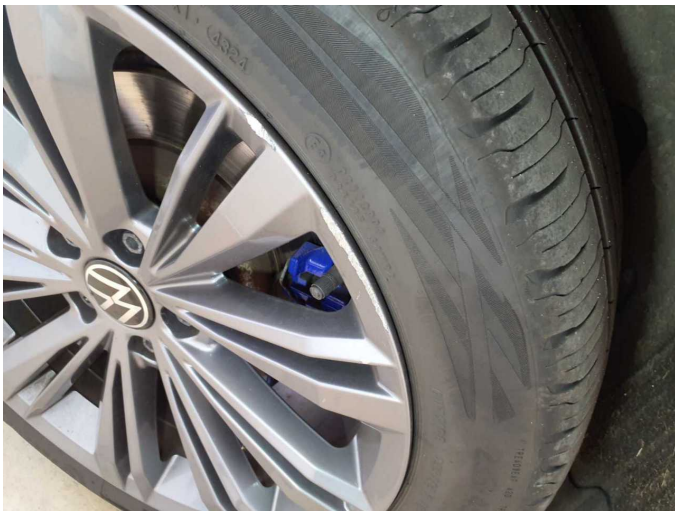
Damage 9: Wheel / tyres: Alloy rim - rear right side - Scratch(es) - Loss in value

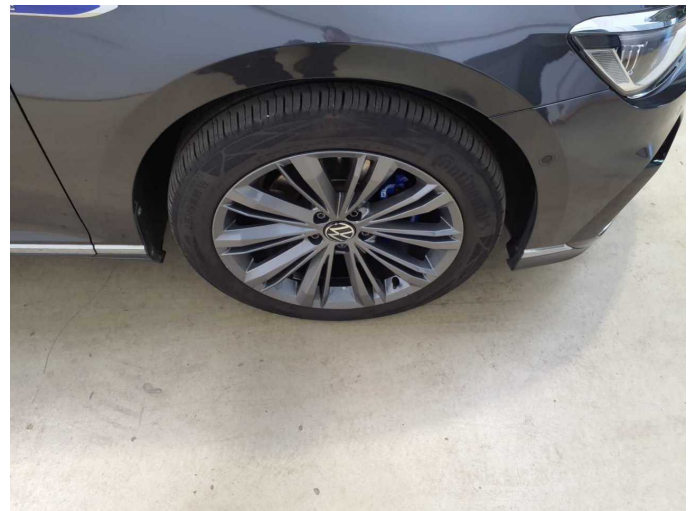
Damage 10: Wheel / tyres: Alloy rim - front right side - Scratch(es) - Loss in value

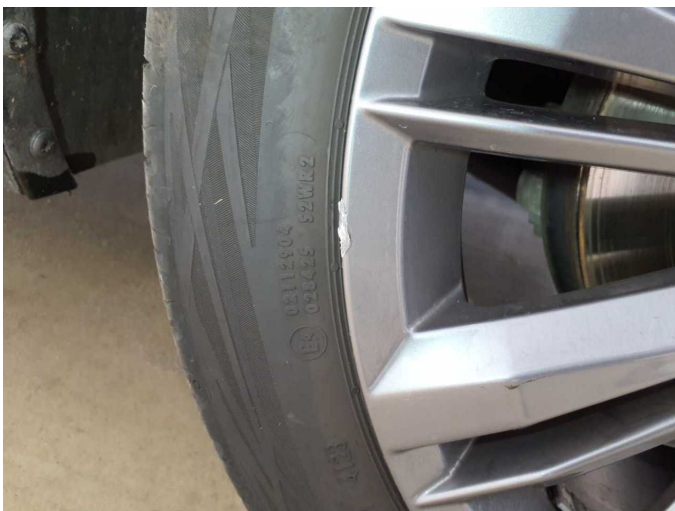
Damage 10: Wheel / tyres: Alloy rim - front right side - Scratch(es) - Loss in value

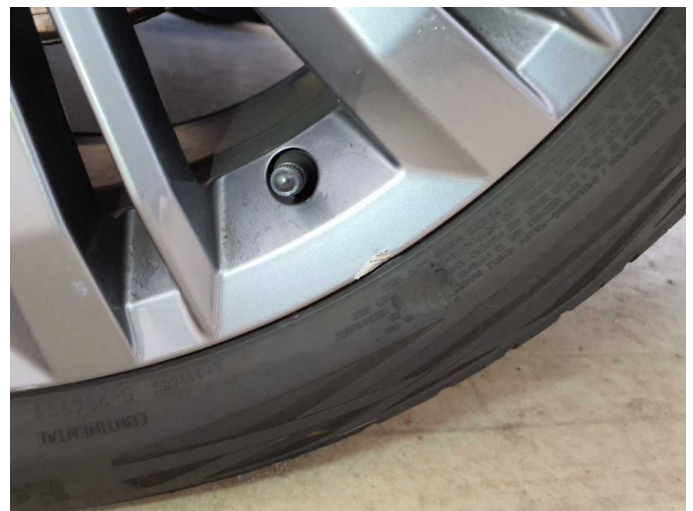
Damage 10: Wheel / tyres: Alloy rim - front right side - Scratch(es) - Loss in value

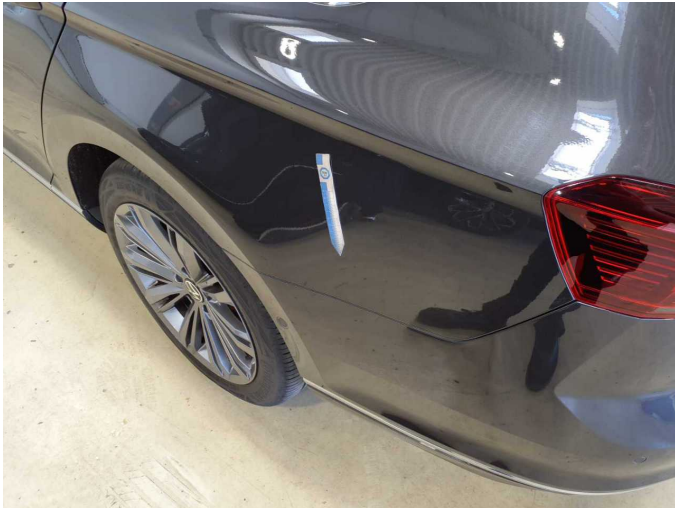
Damage 11: Side panel - rear left side: Side panel - Scratch(es) - Paint

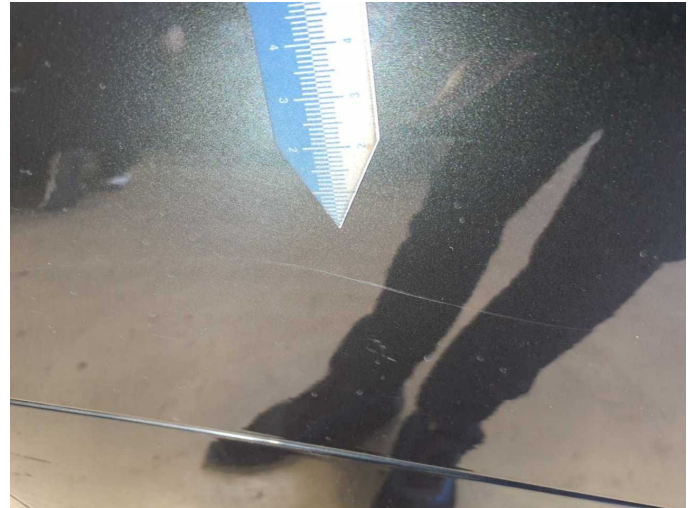
Damage 11: Side panel - rear left side: Side panel - Scratch(es) - Paint

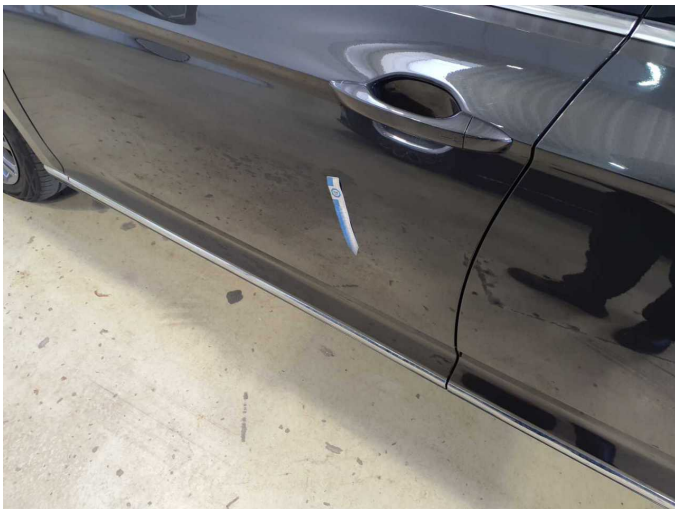
Damage 12: Door - front left side: Door - Scratch(es) - Paint

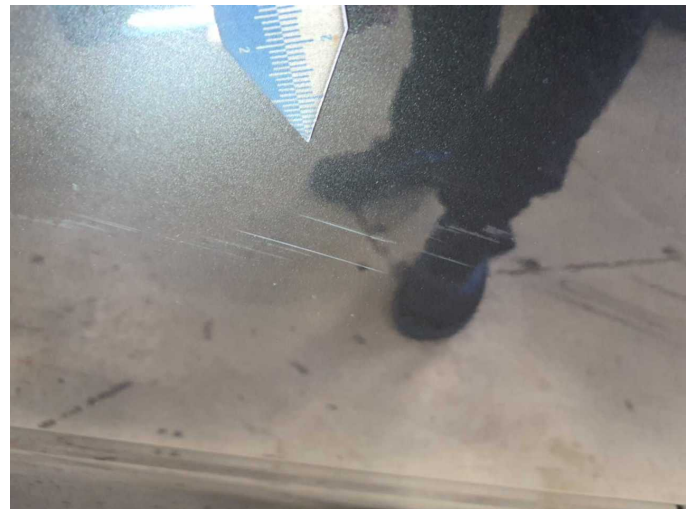
Damage 12: Door - front left side: Door - Scratch(es) - Paint

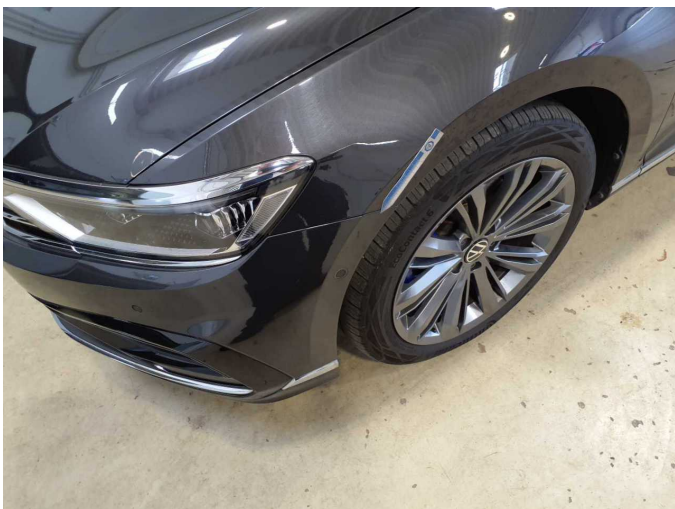
Damage 13: Front bumper: Front bumper (Orangenhaut) - Unprofessionally repaired - Repair and paint

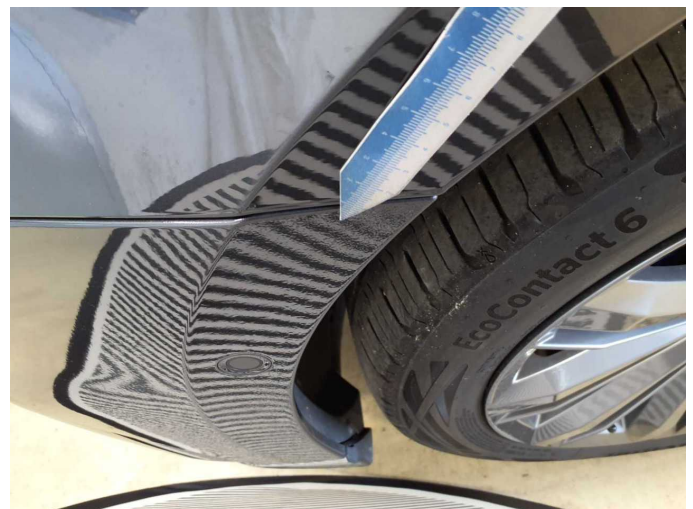
Damage 13: Front bumper: Front bumper (Orangenhaut) - Unprofessionally repaired - Repair and paint

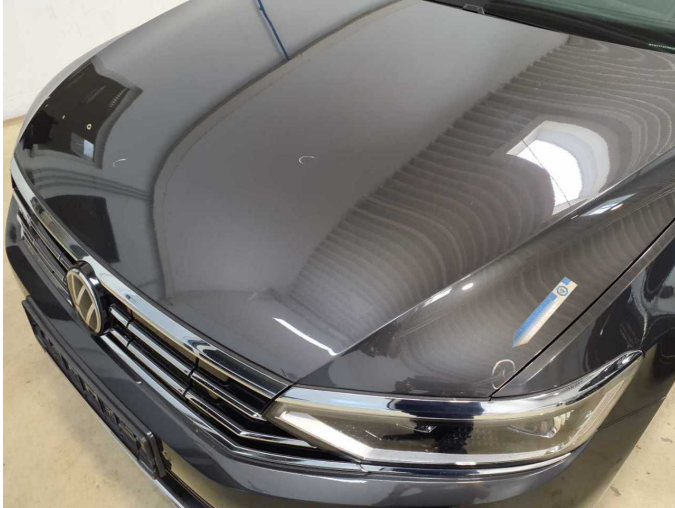
Damage 14: Bonnet: Bonnet - Dent / paintcoat damage - Repair and paint

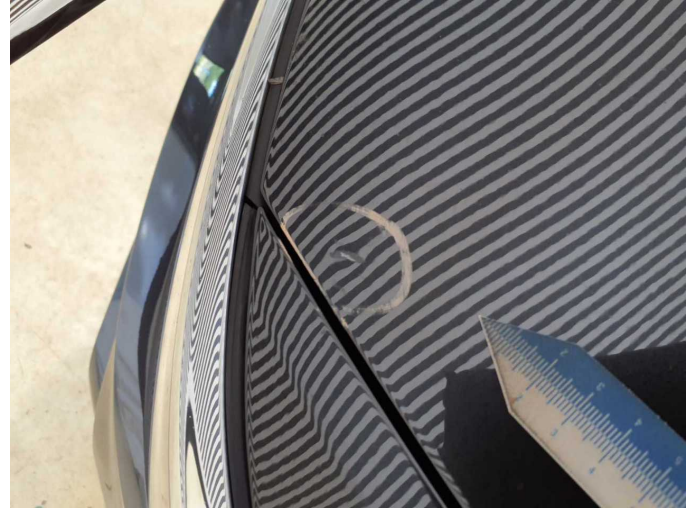
Damage 14: Bonnet: Bonnet - Dent / paintcoat damage - Repair and paint

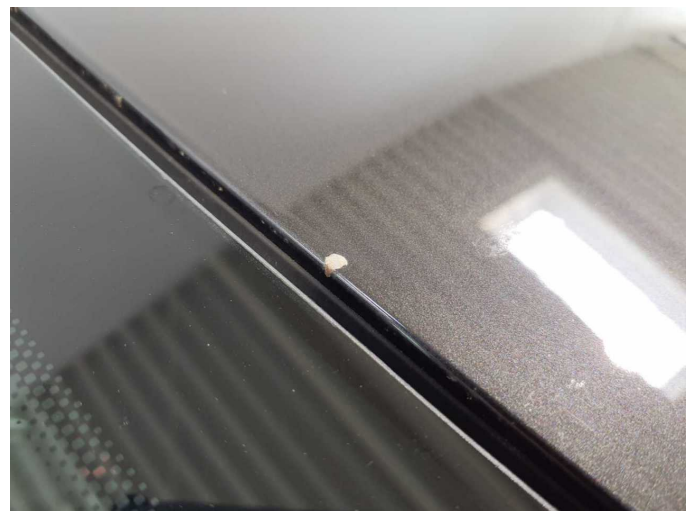
Damage 15: Roof: Roof - Corrosion - Repair and paint

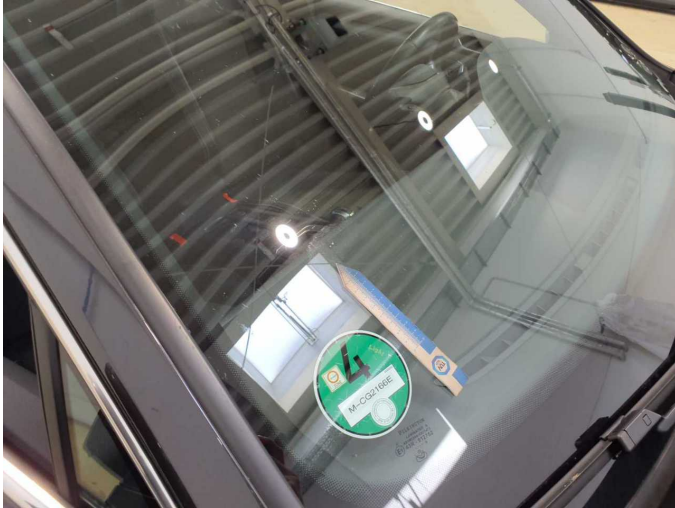
Damage 16: Vehicle glazing: Windscreen - Broken / torn - repair according to calculation

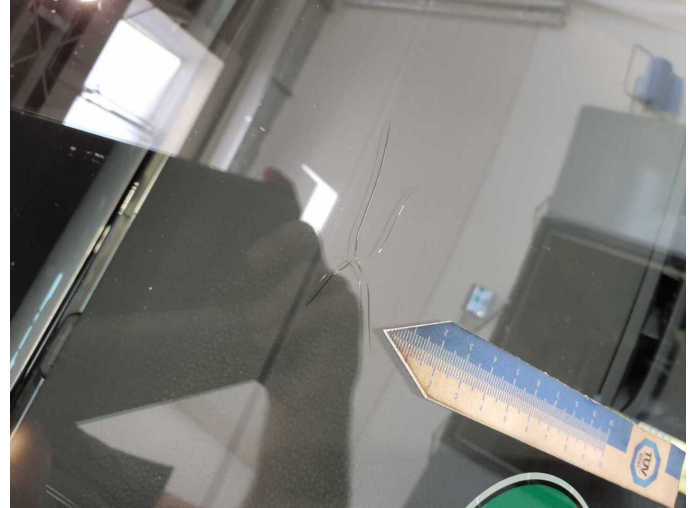
Damage 16: Vehicle glazing: Windscreen - Broken / torn - repair according to calculation

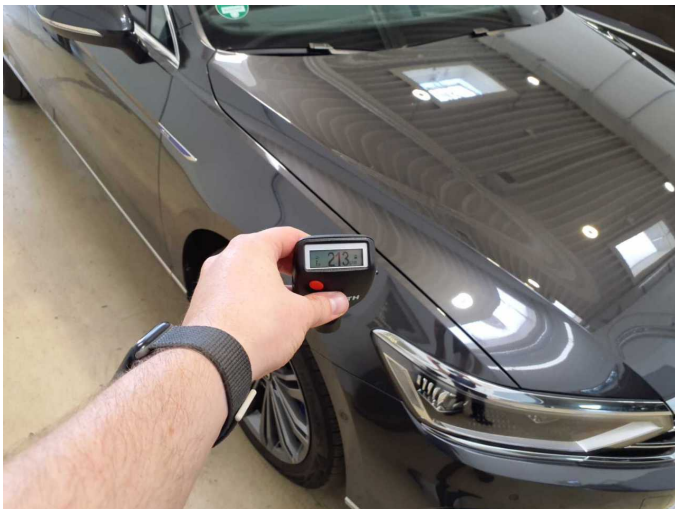
Repainting 1: Mudguard - right side
