Expertise

Protocol number: 46533569  
Order No. / Reference: 26637620  
Inspection date: 13 Jul 2026

Manufacturer: Volvo

Model: XC40 T5 Recharge DKG RDesign

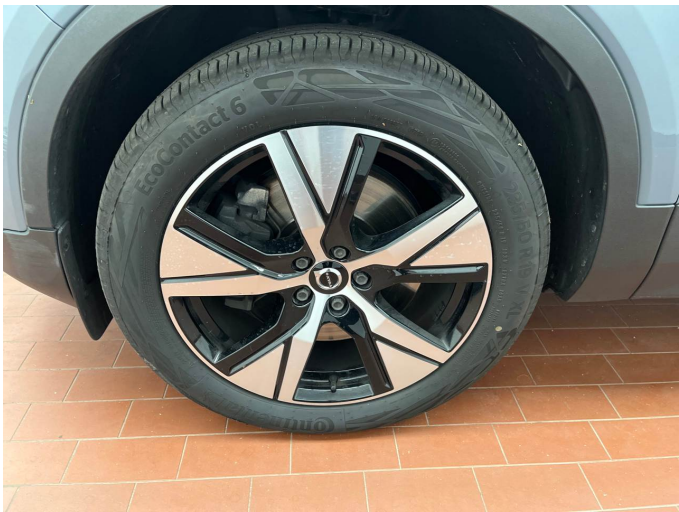
Figure 12: Mounted tyres

| # | Tyre size | Type of tyre | Manufacturer | Tread depth |
|---|---|---|---|---|
| 1) | 235/50 R19 103V | Summer tyres on Light alloy | Continental | 5mm / 5mm |
| 2) | 235/50 R19 103V | Summer tyres on Light alloy | Continental | 6mm / 6mm |

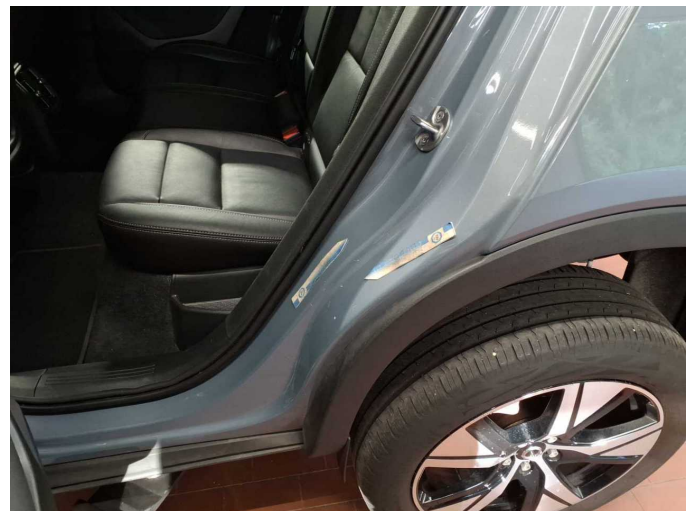
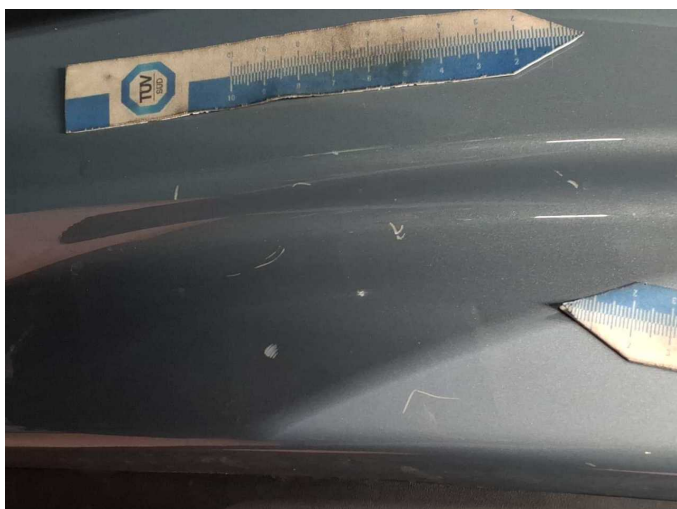
| No. | Component group | Description |
|---|---|---|
| 1 | Side panel - rear left side | Sill - Scratch(es) - Smart repair |

**Damage 1:** Side panel - rear left side: Sill - Scratch(es) - Smart repair

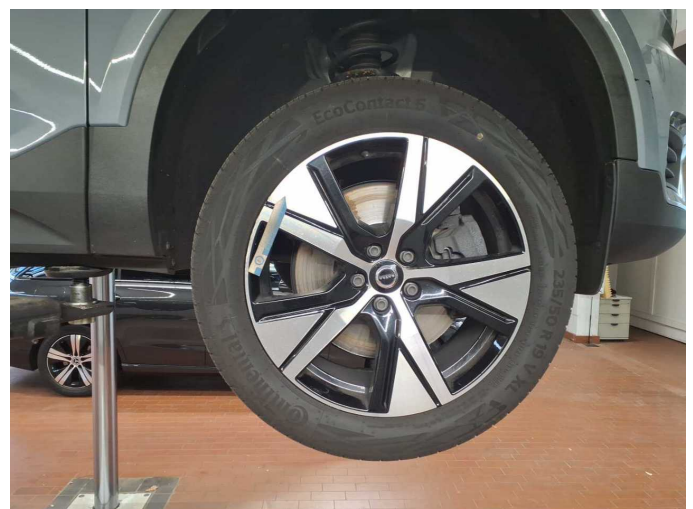
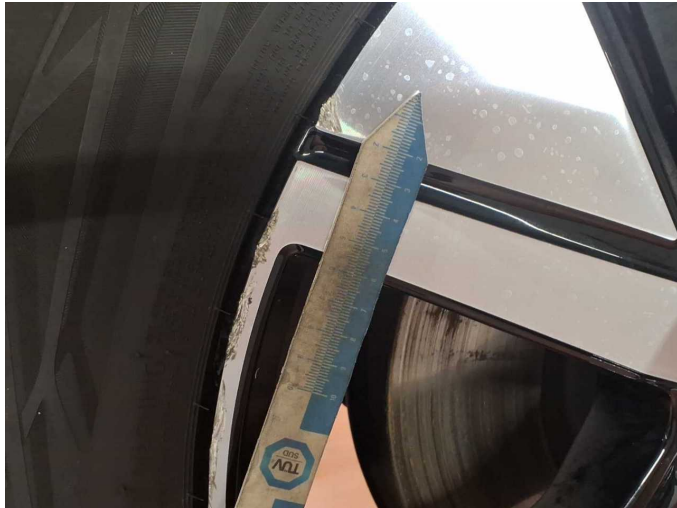
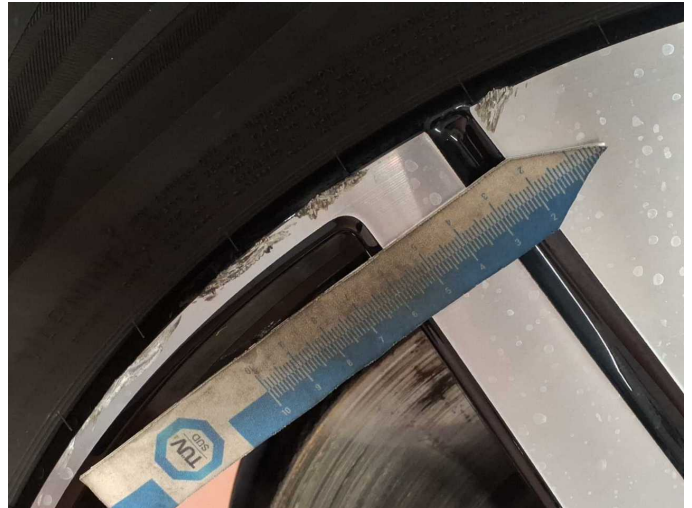
| No. | Component group | Description |
|---|---|---|
| 2 | Wheel / tyres | Alloy rim - front right side - Scratched - Loss in value |

**Damage 2:** Wheel / tyres: Alloy rim - front right side - Scratched - Loss in value

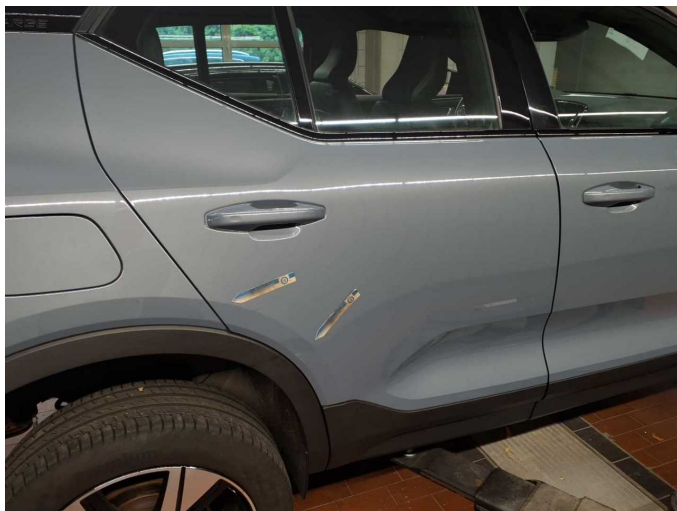
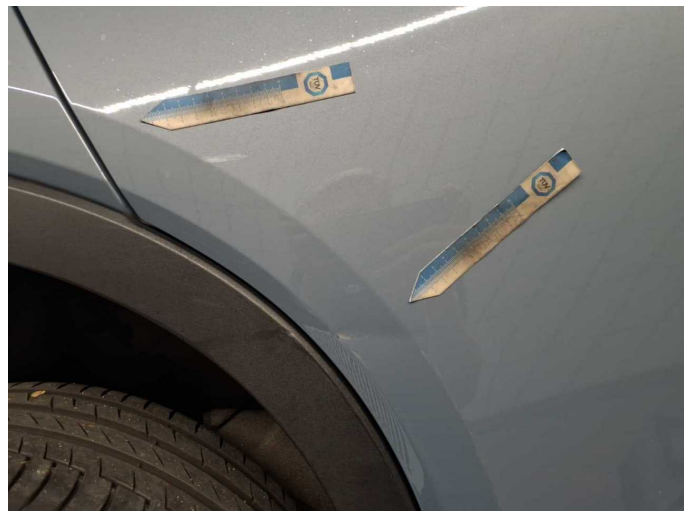
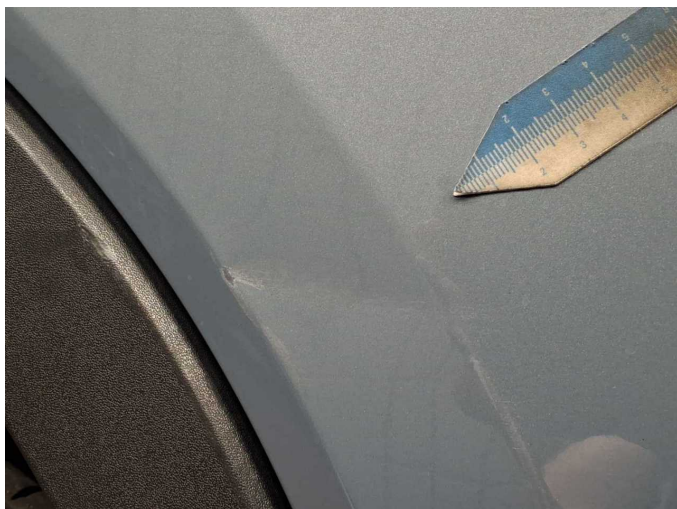
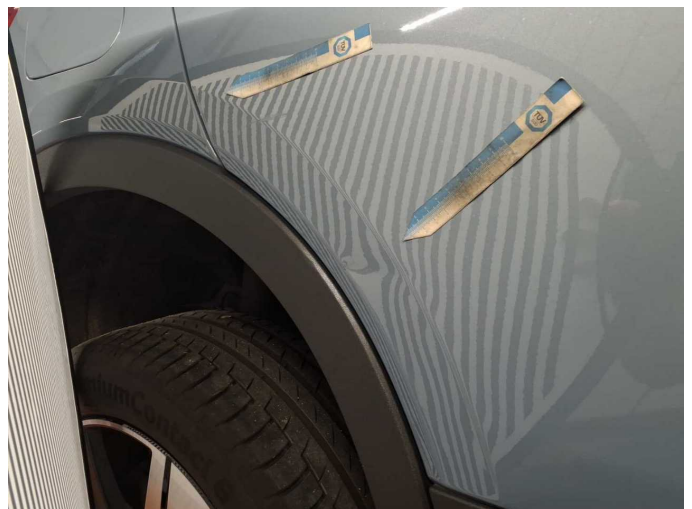
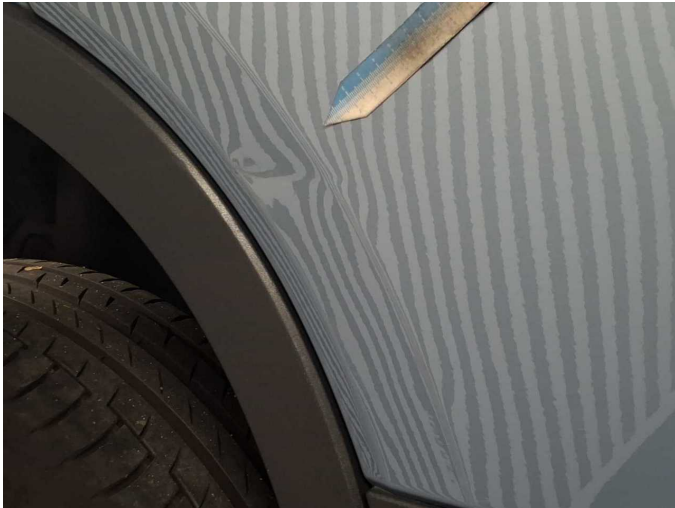
| No. | Component group | Description |
|---|---|---|
| 3 | Door - rear right side | Door - Dent / paintcoat damage - Repair and paint |

**Damage 3:** Door - rear right side: Door - Dent / paintcoat damage - Repair and paint

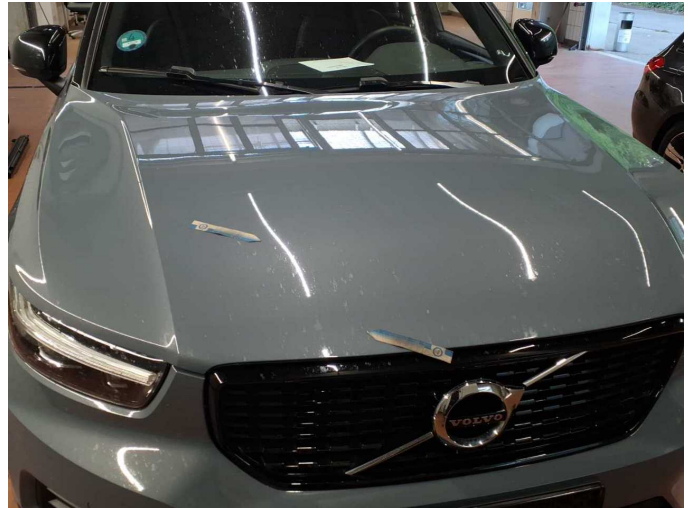
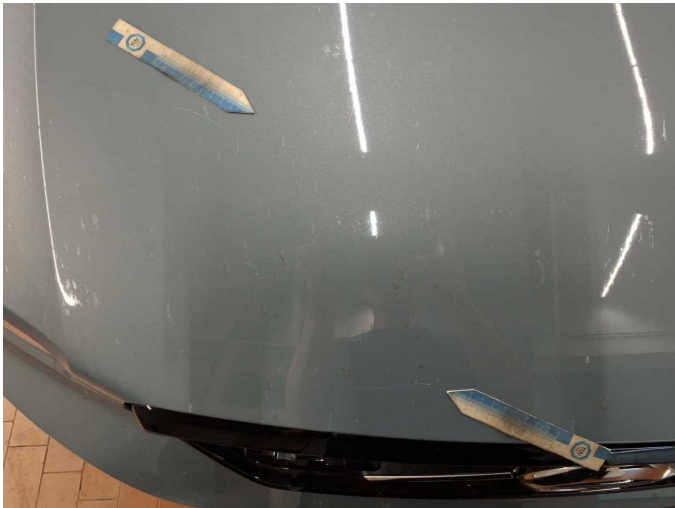
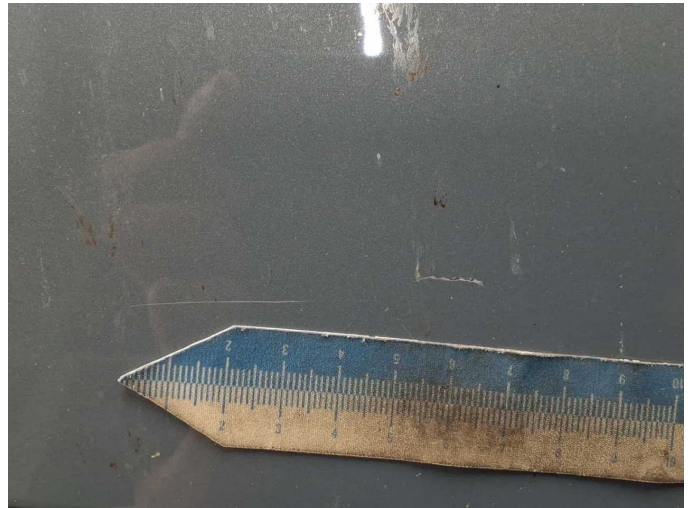
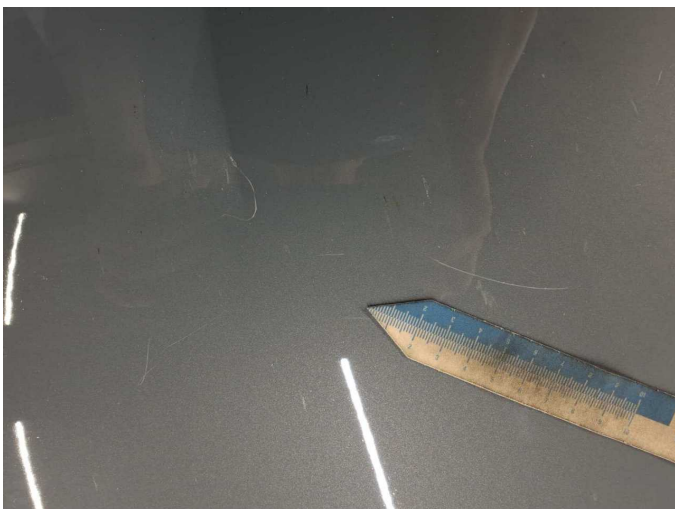
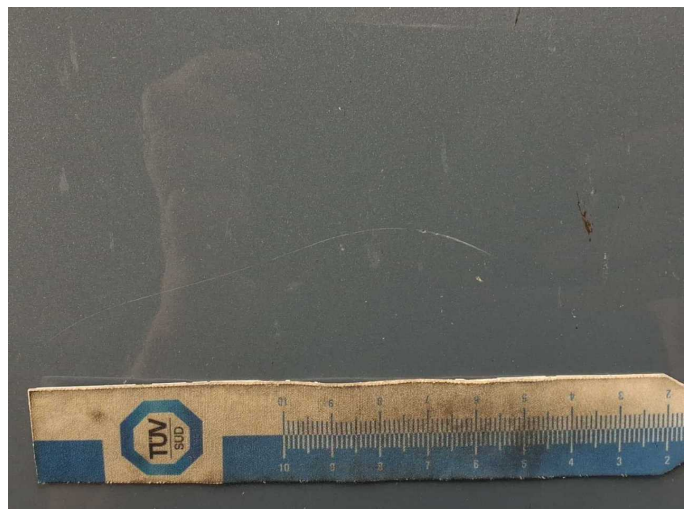
| No. | Component group | Description |
|---|---|---|
| 4 | Bonnet | Bonnet - Scratch(es) - Paint |

**Damage 4:** Bonnet: Bonnet - Scratch(es) - Paint

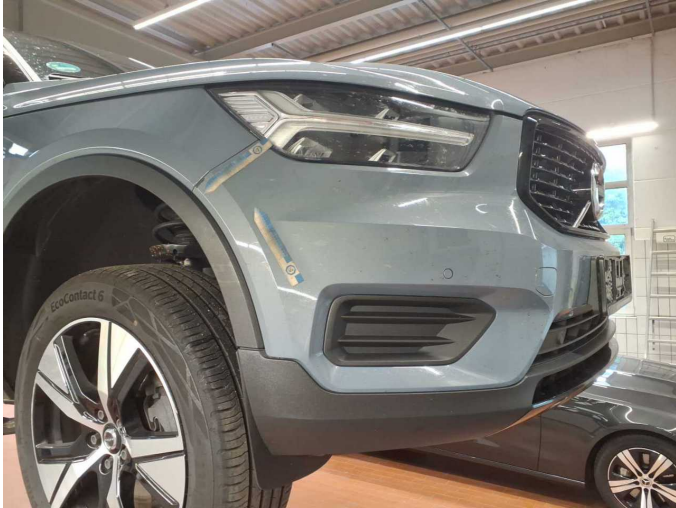
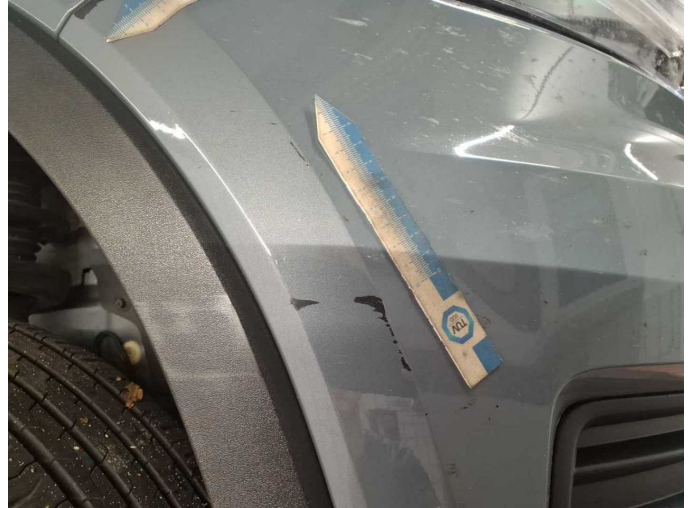
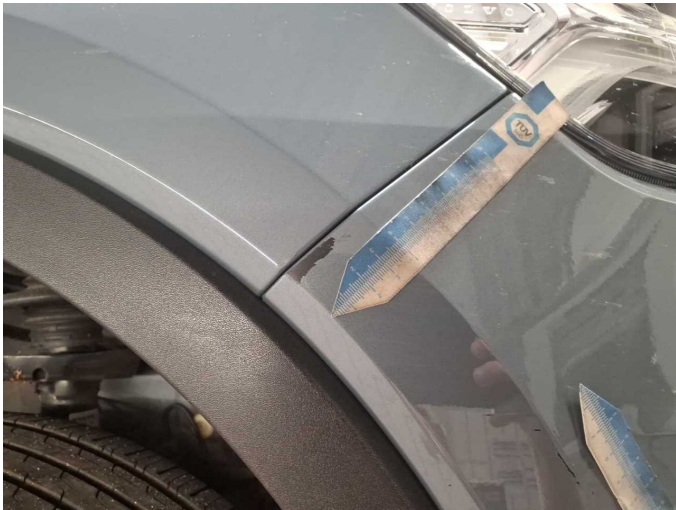
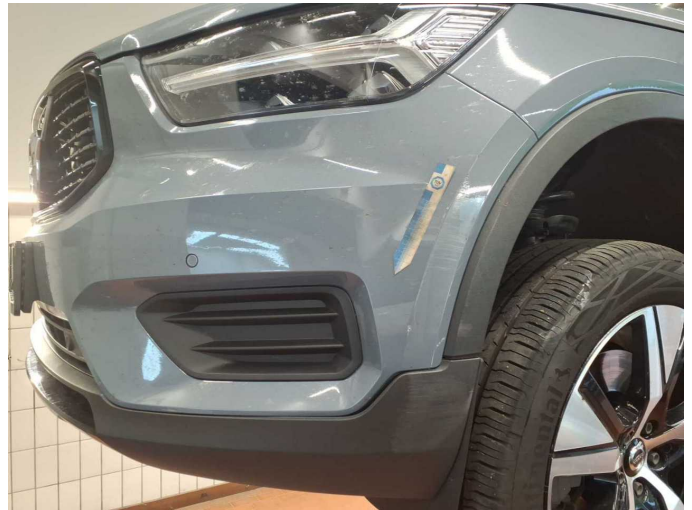
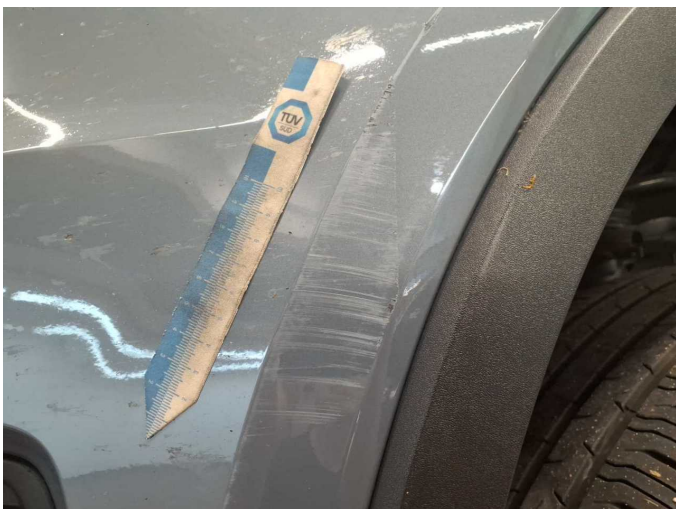
| No. | Component group | Description |
|---|---|---|
| 5 | Front bumper | Front bumper - Scratched - Paint |

**Damage 5:** Front bumper: Front bumper - Scratched - Paint

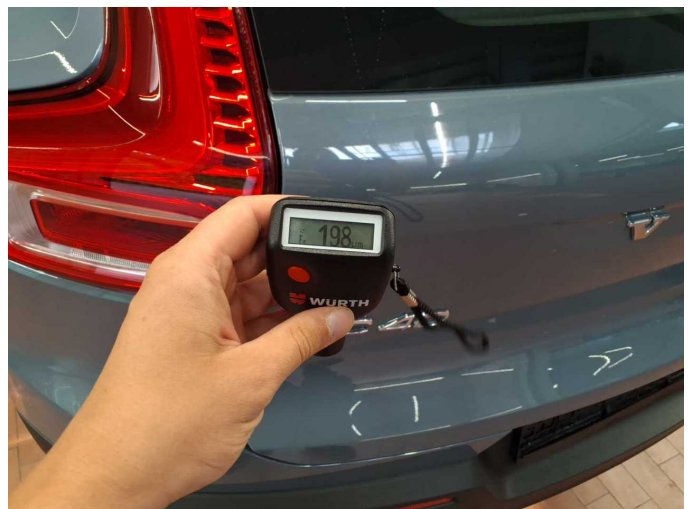
- 1 Boot lid / rear door, Professionally carried out, Invoice of repair done Non-existent

Boot lid / rear door 198 µm |

**Repainting 1:** Boot lid / rear door
