Expertise

Protocol number: 46179455  
Order No. / Reference: 26461395  
Inspection date: 24 Jun 2026

Manufacturer: Volkswagen  
VIN: WVVZZZCD7PW305129

Model: Golf 1.4 eHybrid OPF DSG GTE

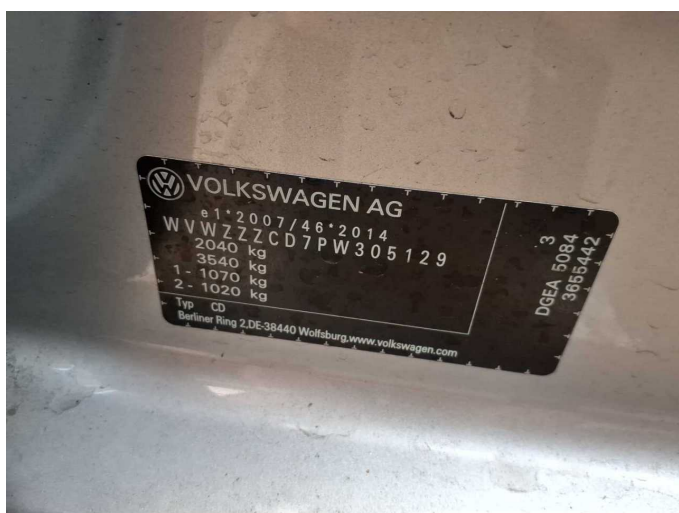
| VIN comparison | The vehicle identification number (VIN) was read from the vehicle and its conformity with the submitted documents was confirmed by the undersigned during the inspection. |

Figure 11: VIN

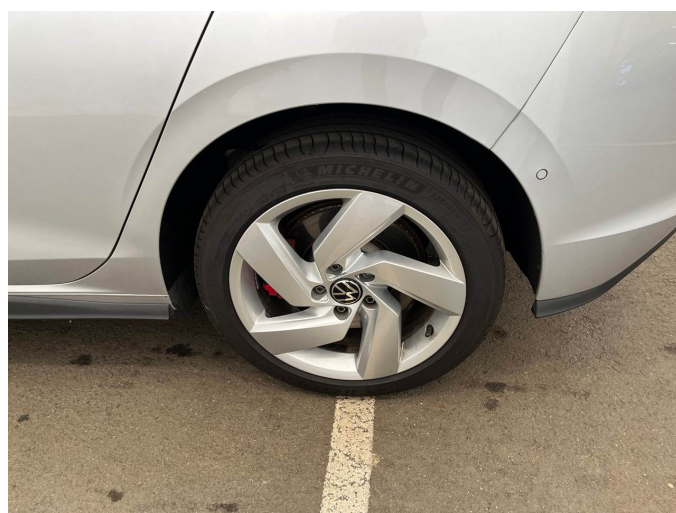
| # | Tyre size | Type of tyre | Manufacturer | Tread depth |
|---|---|---|---|---|
| 1) | 225/45 R17 91W | Summer tyres on Light alloy | Michelin | 5mm / 5mm |
| 2) | 225/45 R17 91W | Summer tyres on Light alloy | Michelin | 6mm / 6mm |

Figure 12: Mounted tyres

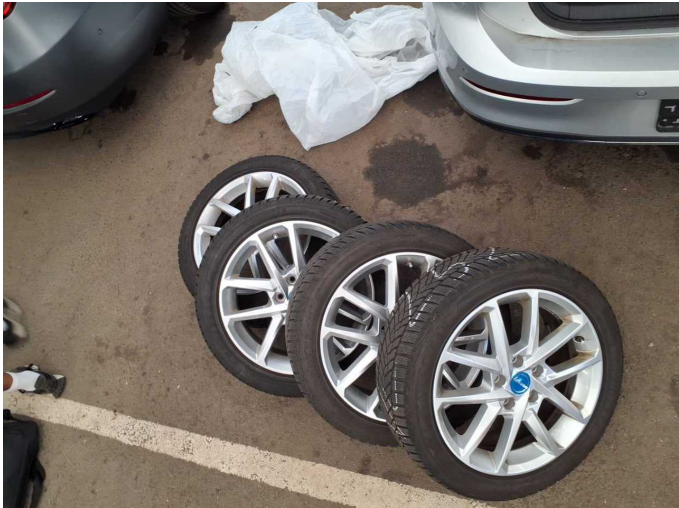
| # | Tyre size | Type of tyre | Manufacturer | Tread depth |
|---|---|---|---|---|
| 1) | 205/50 R17 93V | Winter tyres on Light alloy | Goodyear | 6mm / 6mm |
| 2) | 205/50 R17 93V | Winter tyres on Light alloy | Goodyear | 6mm / 6mm |

Figure 16: Additional tyres

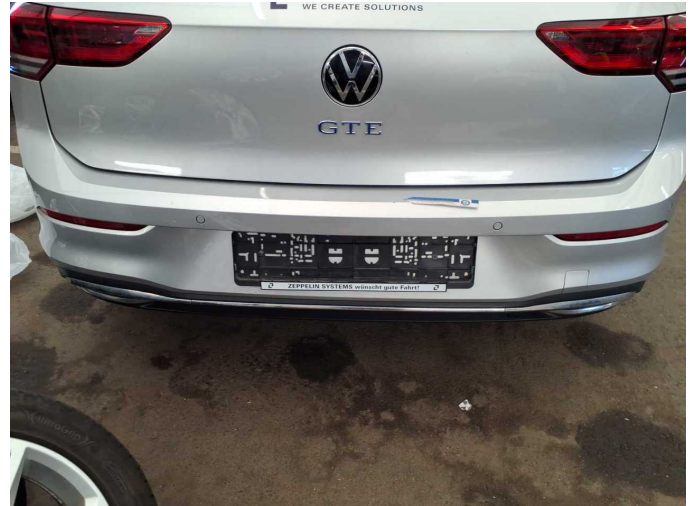
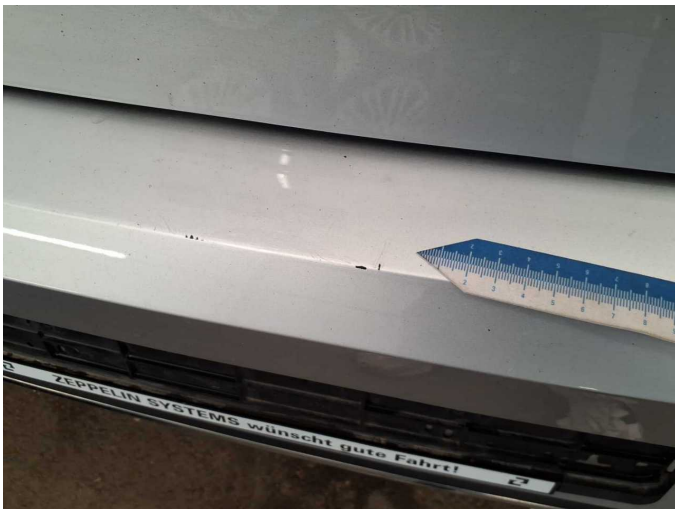
| No. | Component group | Description |
|---|---|---|
| 1 | Rear bumper | Rear bumper - Scratched - Smart repair |

**Damage 1:** Rear bumper: Rear bumper - Scratched - Smart repair

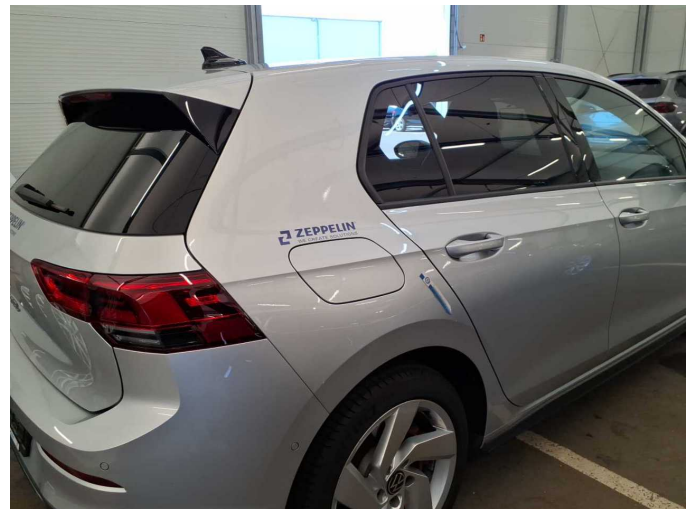
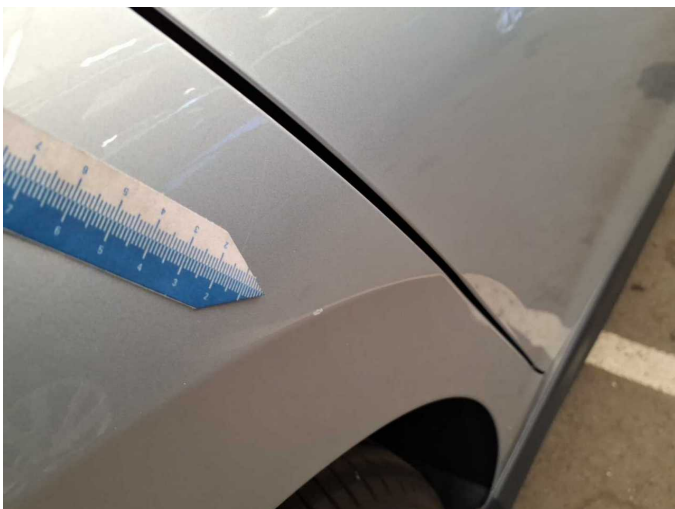
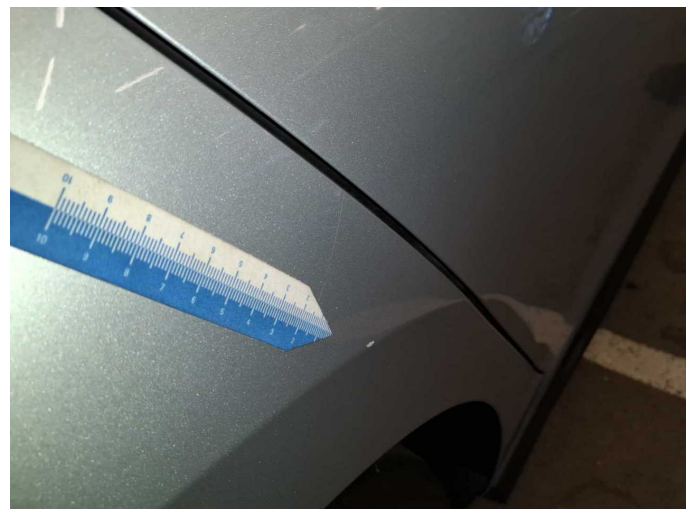
| No. | Component group | Description |
|---|---|---|
| 2 | Side panel - rear right side | Side panel - Scratch(es) - Smart repair |

**Damage 2:** Side panel - rear right side: Side panel - Scratch(es) - Smart repair

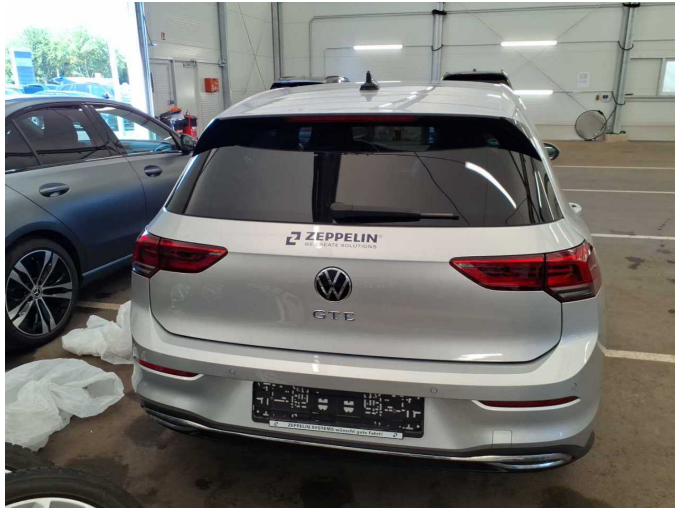
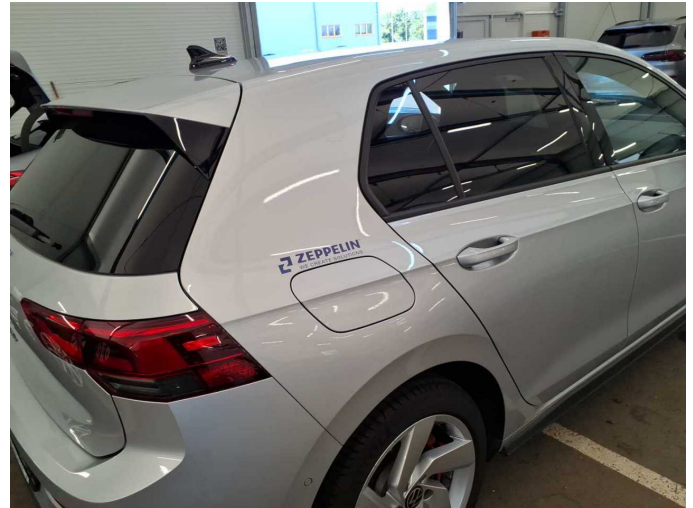
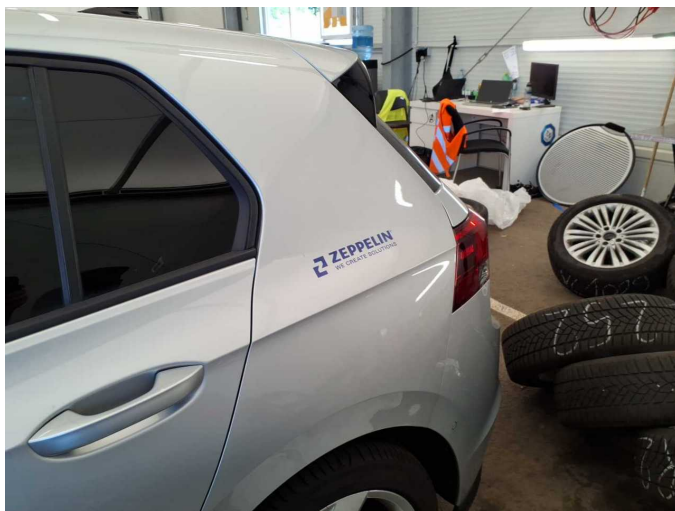
| No. | Component group | Description |
|---|---|---|
| 3 | Body | Body - Glued / labelled - De-glue / neutralise |

**Damage 3:** Body: Body - Glued / labelled - De-glue / neutralise

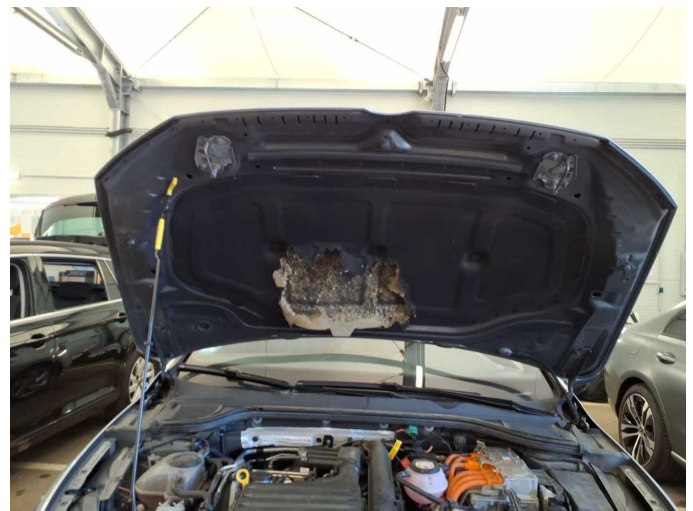
| No. | Component group | Description |
|---|---|---|
| 4 | Bonnet | Insulation lining - Damage caused by marten / rodent - Replace |

**Damage 4:** Bonnet: Insulation lining - Damage caused by marten / rodent  
- Replace
