Expertise

Protocol number: 46043215  
Order No. / Reference: 26587648  
Inspection date: 19 Jun 2026

Manufacturer: Skoda  
VIN: TMBJH7NP1N7050822

Model: Superb Combi 2.0 TDI DSG Ambition

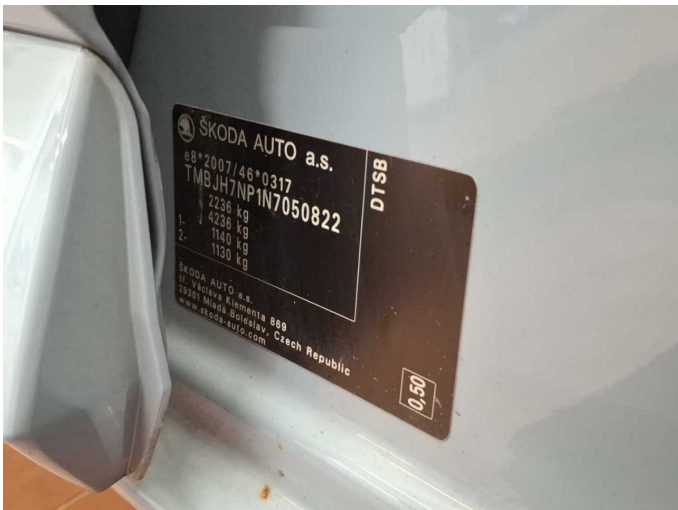
| VIN comparison | The vehicle identification number (VIN) was read from the vehicle and its conformity with the submitted documents was confirmed by the undersigned during the inspection. |

Figure 11: VIN

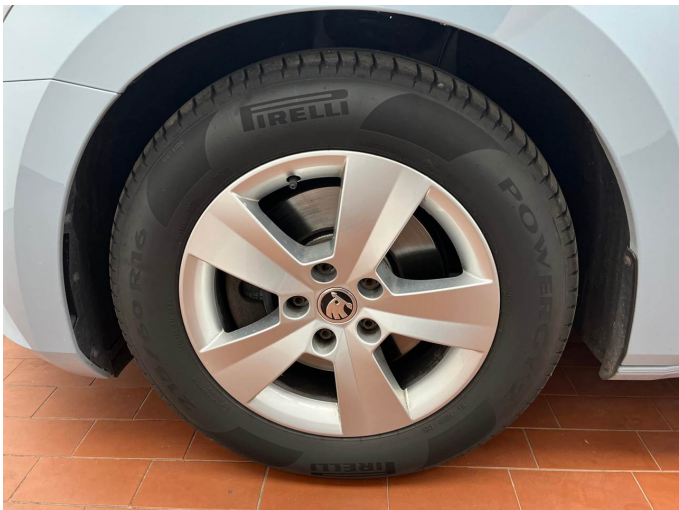
| # | Tyre size | Type of tyre | Manufacturer | Tread depth |
|---|---|---|---|---|
| 1) | 215/60 R16 99V | Summer tyres on Light alloy | Pirelli | 5mm / 5mm |
| 2) | 215/60 R16 99V | Summer tyres on Light alloy | Pirelli | 6mm / 6mm |

Figure 12: Mounted tyres

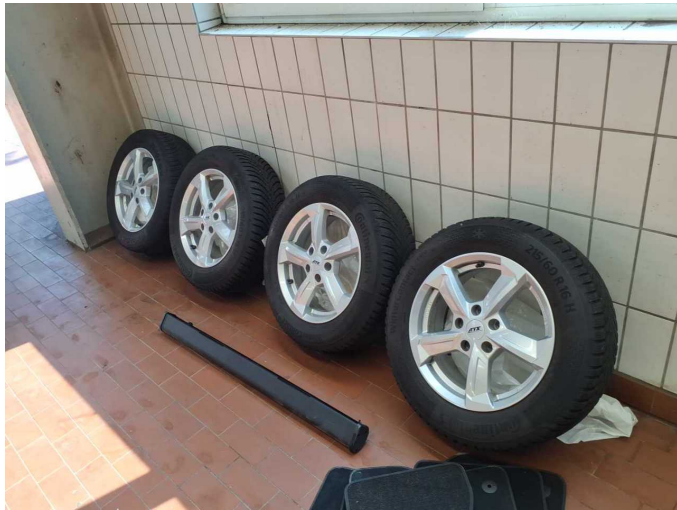
| # | Tyre size | Type of tyre | Manufacturer | Tread depth |
|---|---|---|---|---|
| 1) | 215/60 R16 95H | Winter tyres on Light alloy | Continental | 5mm / 5mm |
| 2) | 215/60 R16 95H | Winter tyres on Light alloy | Continental | 5mm / 5mm |

Figure 15: Additional tyres

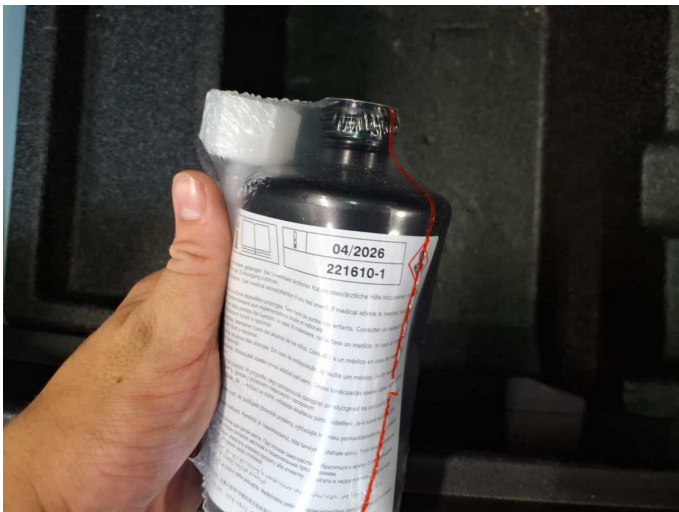
Damage 1: Equipment: Tirefit filler - Due - Replace

| No. | Component group | Description |
|---|---|---|
| 1 | Equipment | Tirefit filler - Due - Replace |

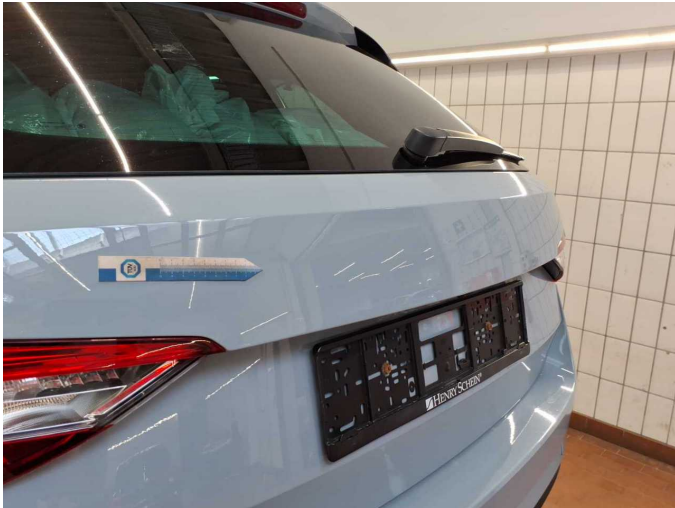
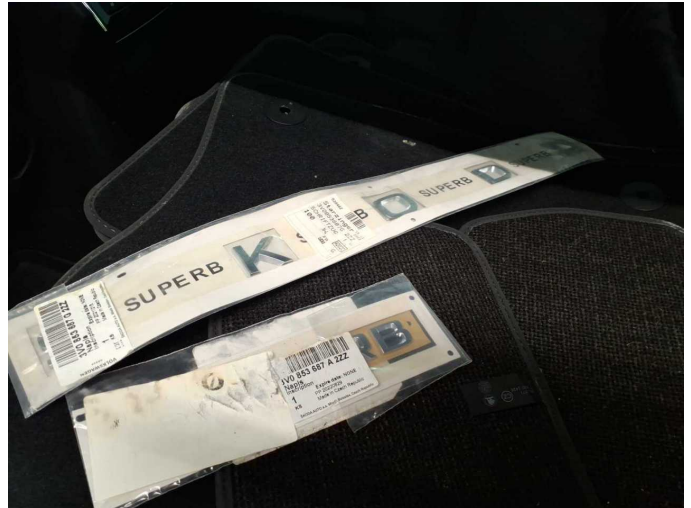
**Damage 2:** Boot lid / rear door: Lettering (Liegt im Auto) - Missing - Un- / install

| No. | Component group | Description |
|---|---|---|
| 2 | Boot lid / rear door | Lettering (Liegt im Auto) - Missing - Un- / install |

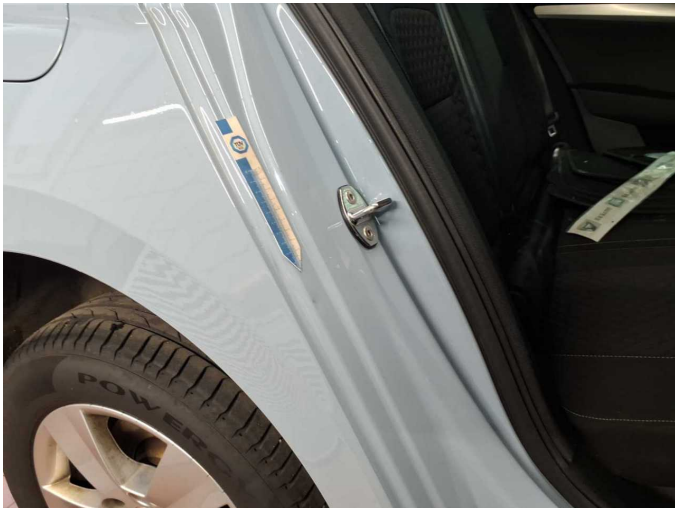
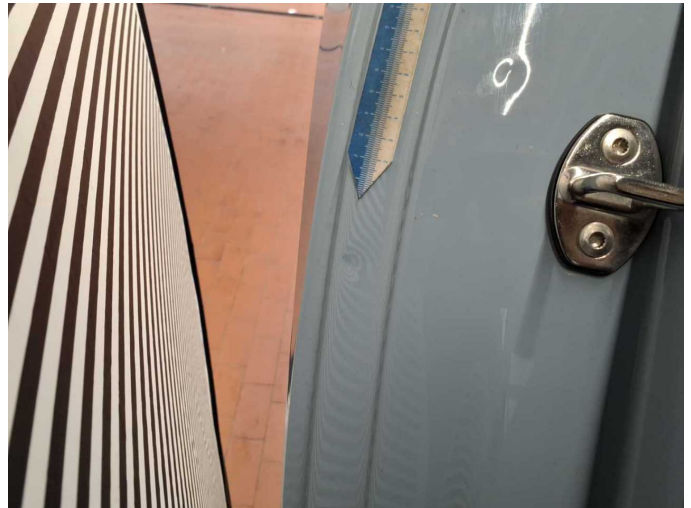
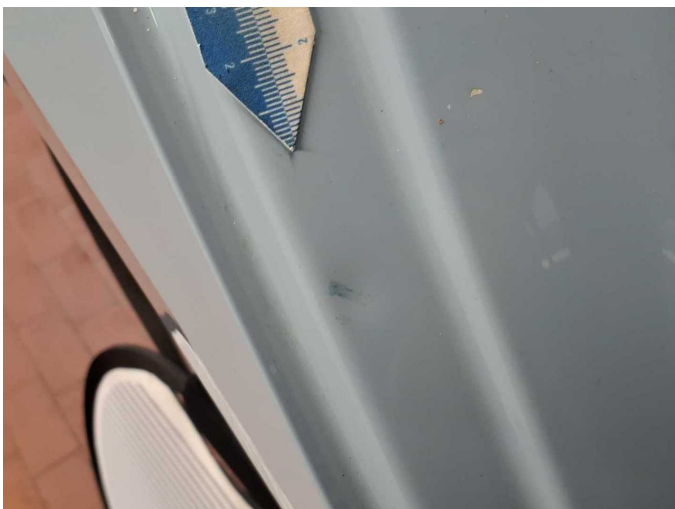
**Damage 3:** Side panel - rear right side: Sill - Dent / paintcoat damage - Smart repair

| No. | Component group | Description |
|---|---|---|
| 3 | Side panel - rear right side | Sill - Dent / paintcoat damage - Smart repair |

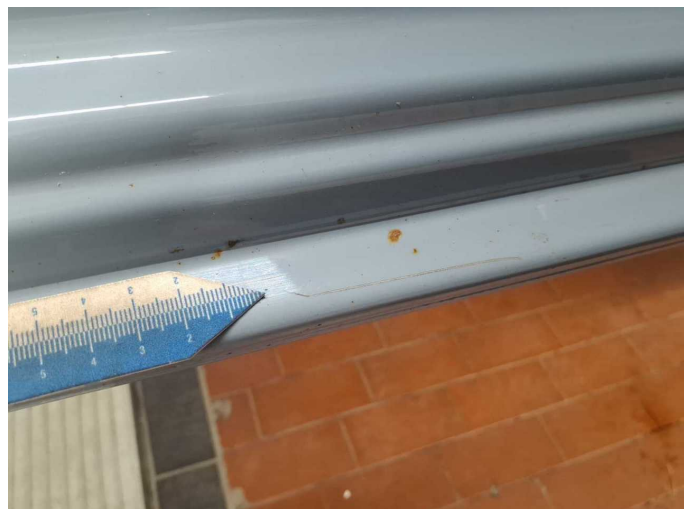
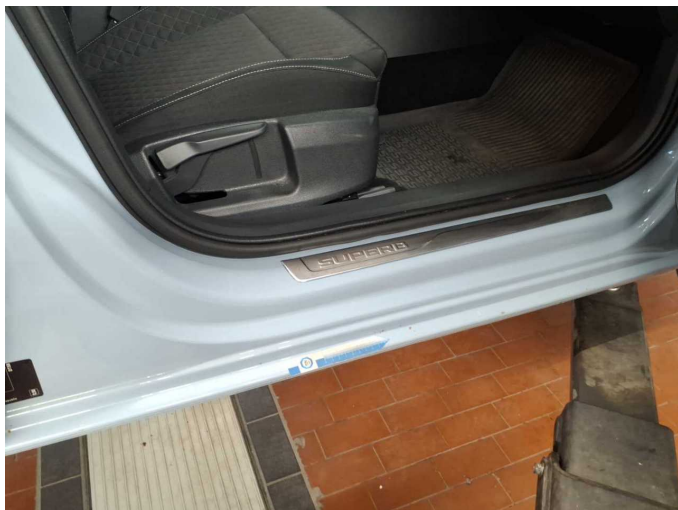
**Damage 4:** Sill - right side: Sill - Corrosion - Smart repair

| No. | Component group | Description |
|---|---|---|
| 4 | Sill - right side | Sill - Corrosion - Smart repair |

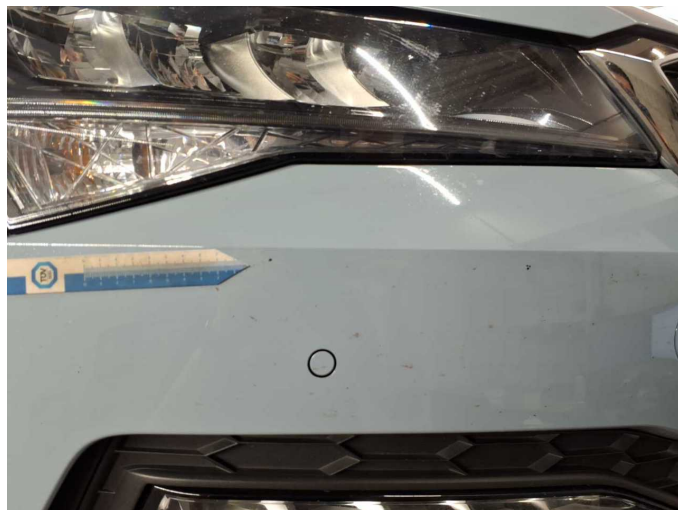
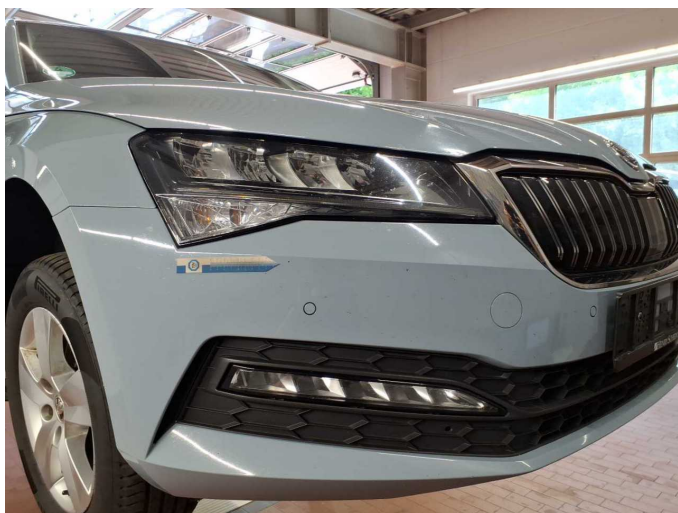
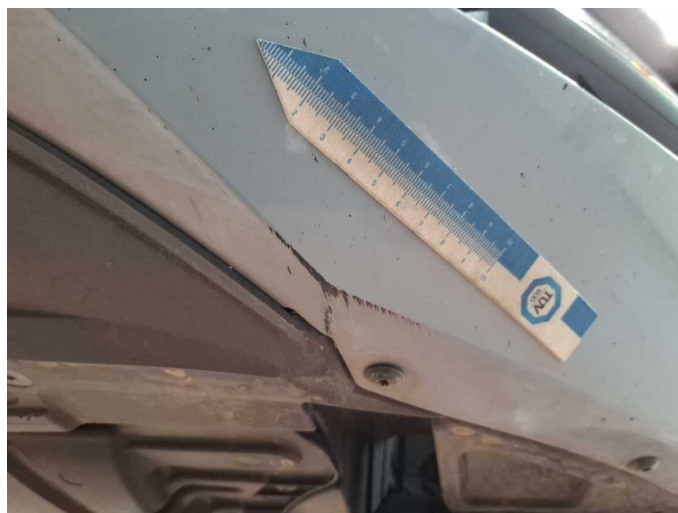
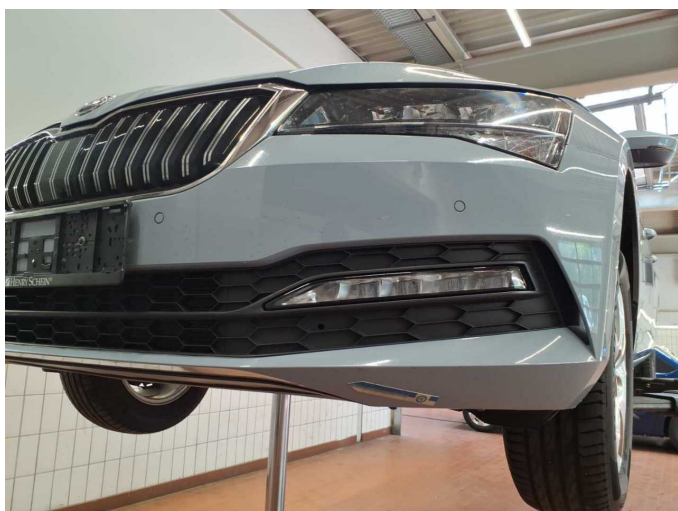
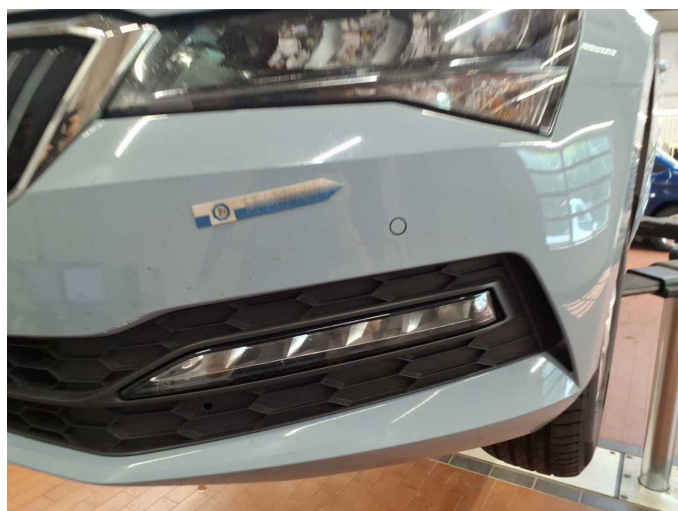
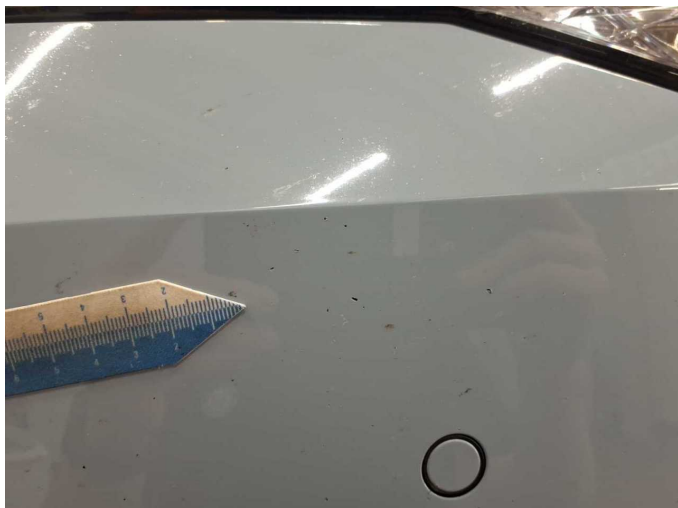
**Damage 5:** Front bumper: Front bumper - Scratched - Paint

| No. | Component group | Description |
|---|---|---|
| 5 | Front bumper | Front bumper - Scratched - Paint |

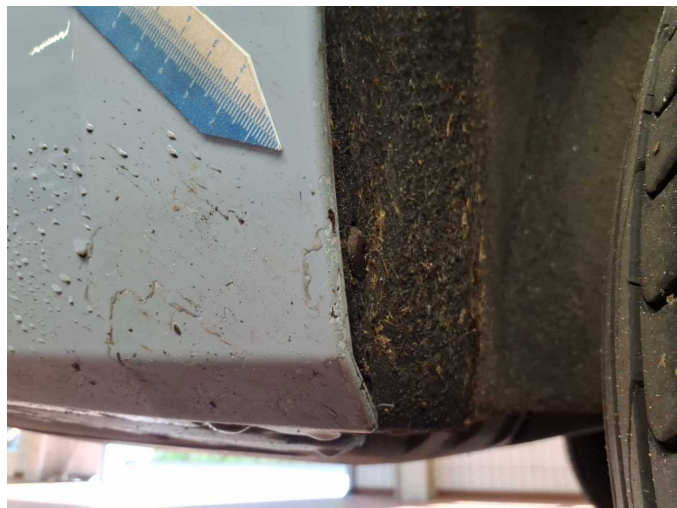
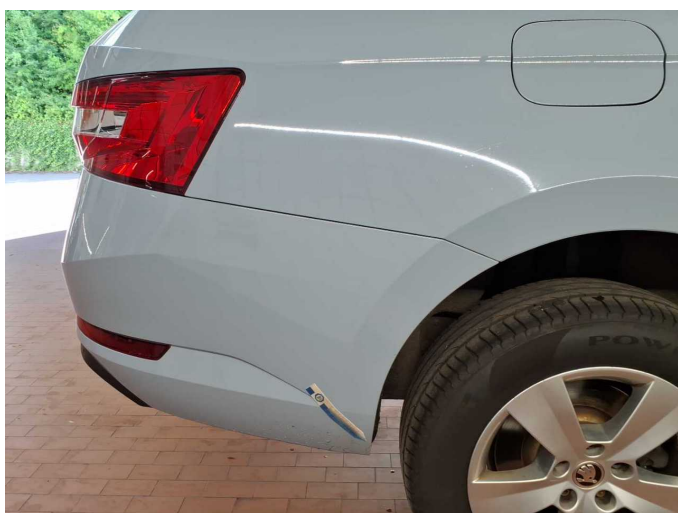
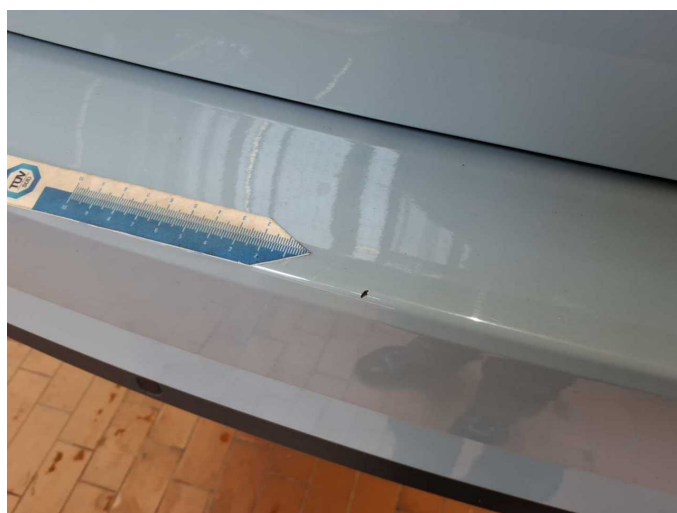
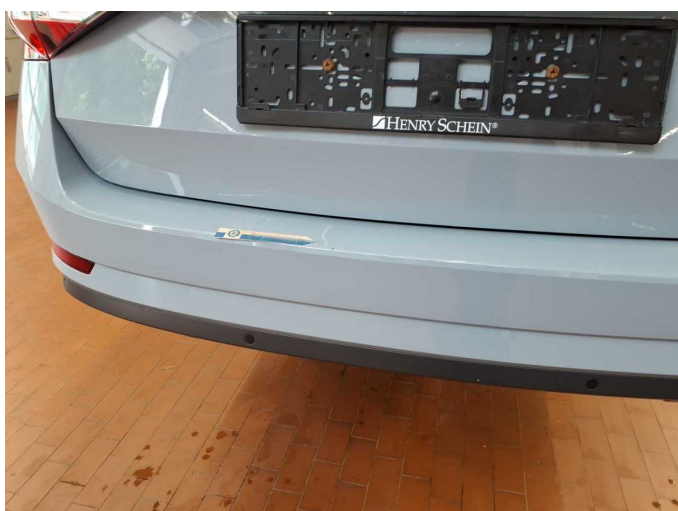
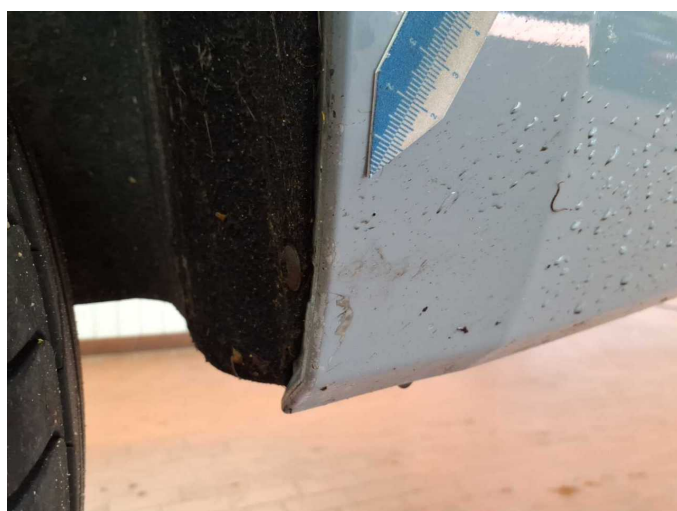
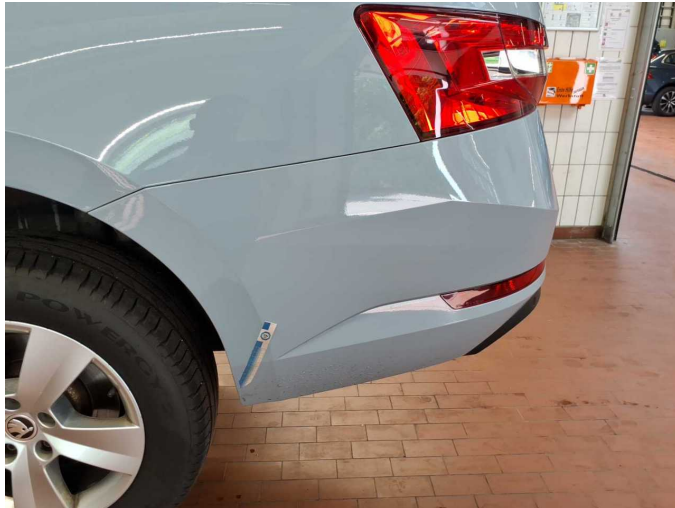
**Damage 6:** Rear bumper: Rear bumper - Unprofessionally repaired - Paint

| No. | Component group | Description |
|---|---|---|
| 6 | Rear bumper | Rear bumper - Unprofessionally repaired - Paint |

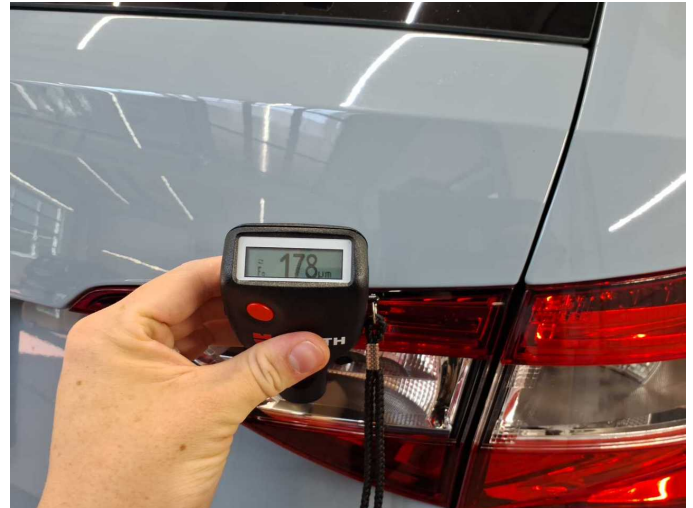
| No. | Repainting |
|---|---|
| 1 | Boot lid / rear door, Professionally carried out, Invoice of repair done Non-existent |

| Boot lid / rear door | 178 µm |

**Repainting 1:** Boot lid / rear door
