Expertise

Protocol number: 46661723  
Order No. / Reference: 26644686  
Inspection date: 22 Jul 2026

Manufacturer: Mercedes-Benz  
VIN: W1NKM5GB4PF035593

Model: GLC 300 e 4Matic 9G-TRONIC AMG Line Advanced

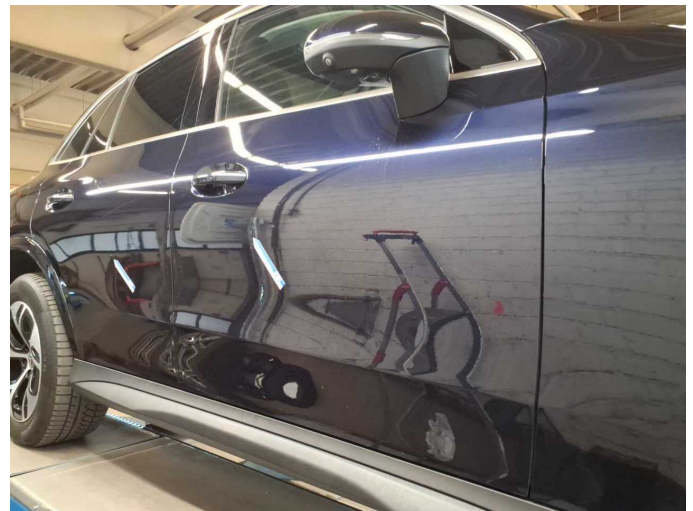
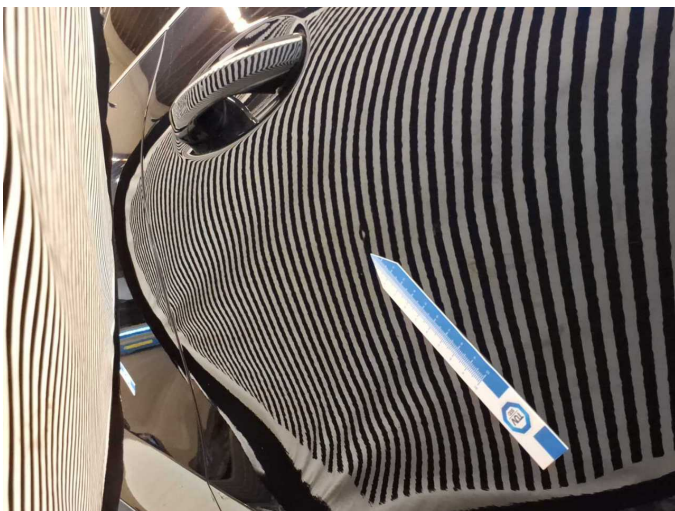
| No. | Component group | Description |
|---|---|---|
| 1 | Door - front right side | Door - dent(s) - Smooth repair work |

Damage 1: Door - front right side: Door - dent(s) - Smooth repair work

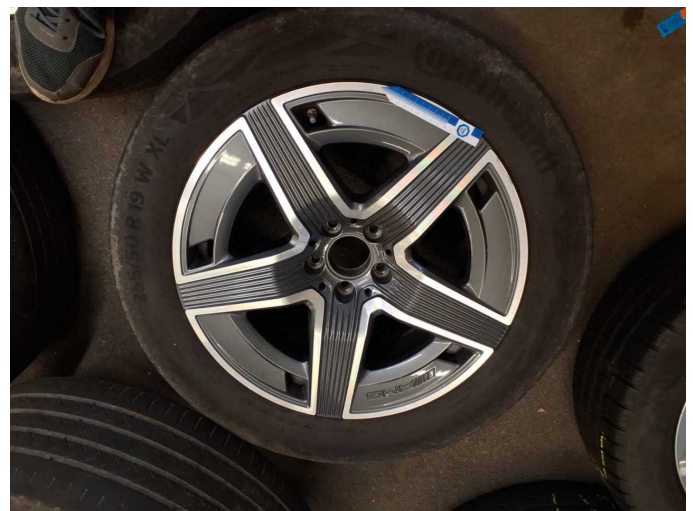
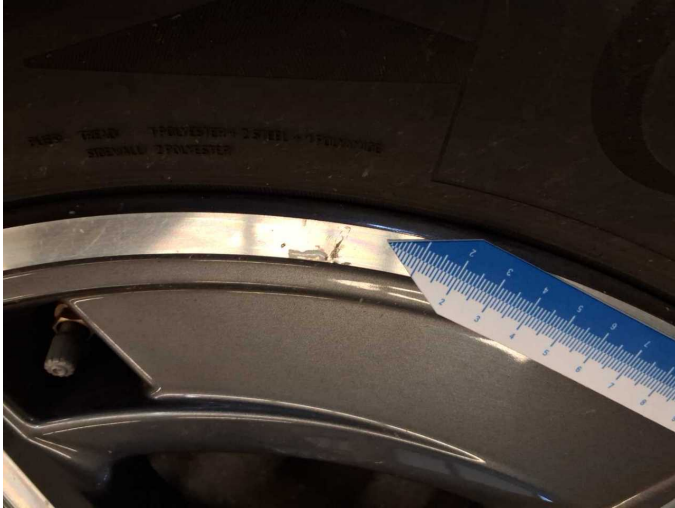
| No. | Component group | Description |
|---|---|---|
| 3 | 2nd wheel set | 1 alloy rim - Scratched - Loss in value |

Damage 3: 2nd wheel set: 1 alloy rim - Scratched - Loss in value

**Damage 3:** 2nd wheel set: 1 alloy rim - Scratched - Loss in value

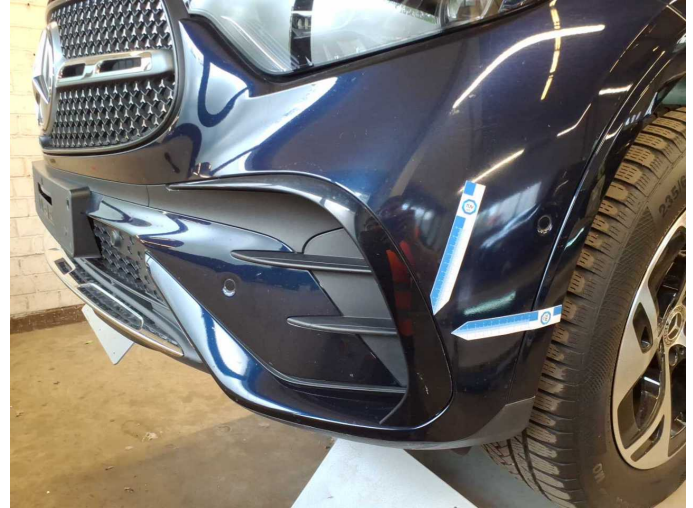
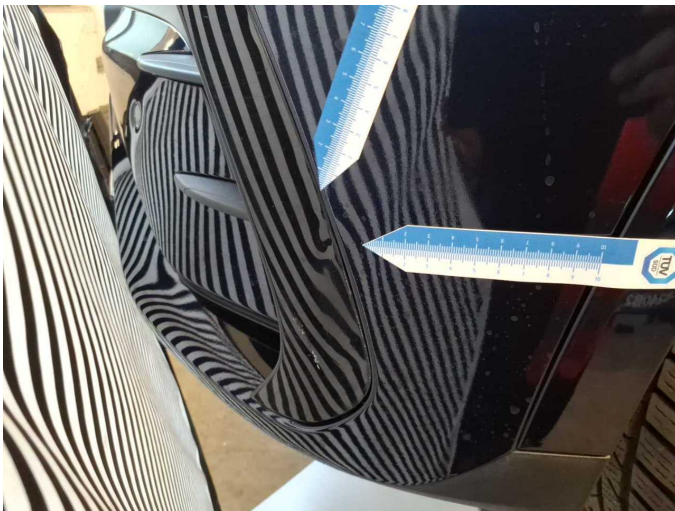
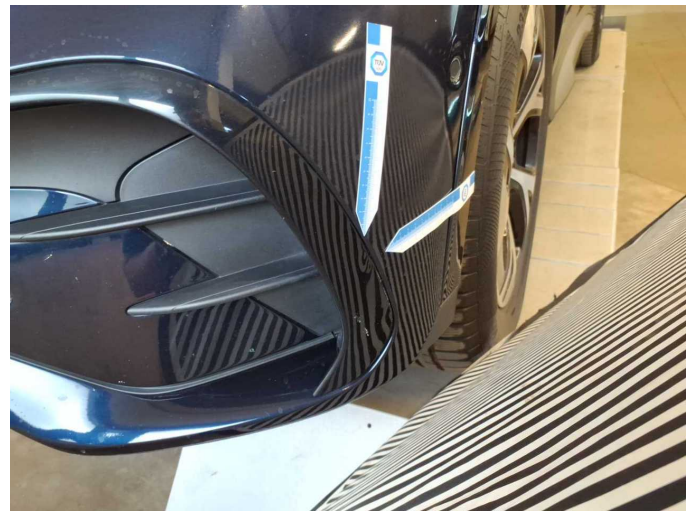
| No. | Component group | Description |
|---|---|---|
| 4 | Front bumper | Cover bumper - front - Deformed - Replace |

**Damage 4:** Front bumper: Cover bumper - front - Deformed - Replace

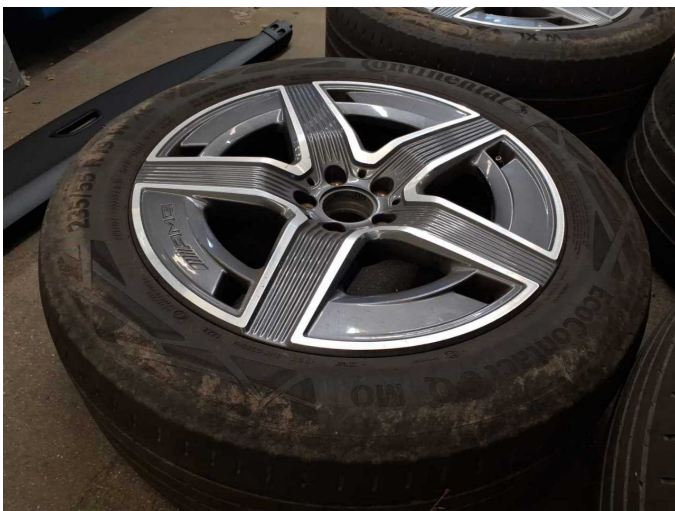
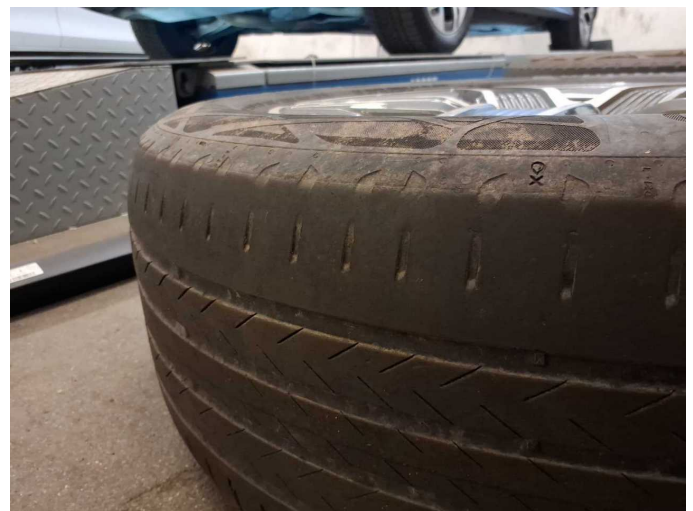
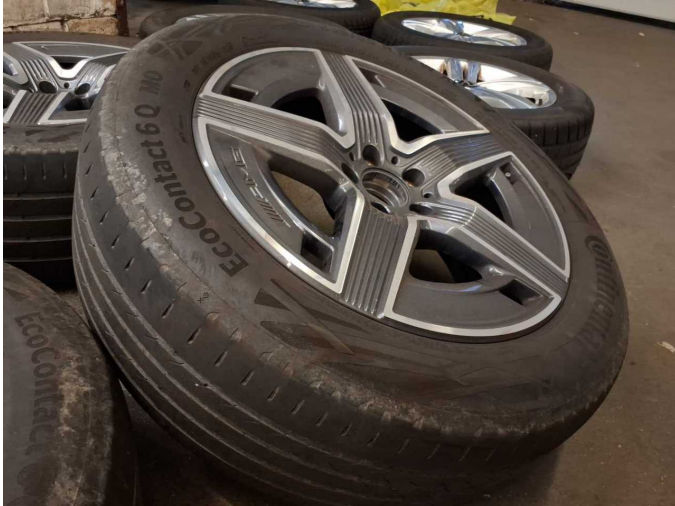
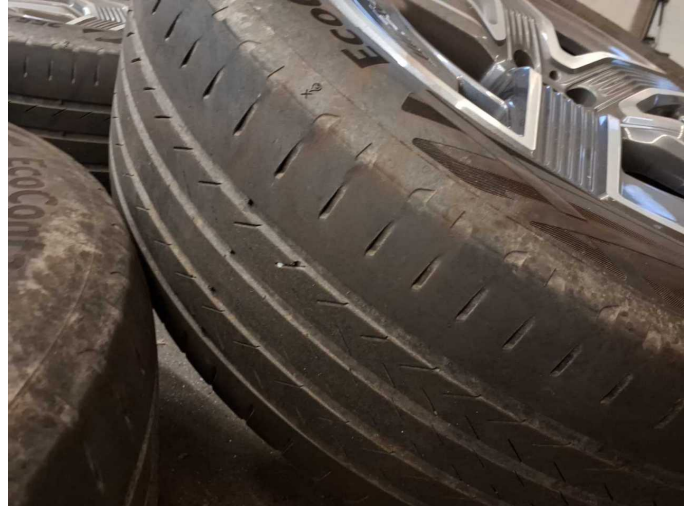
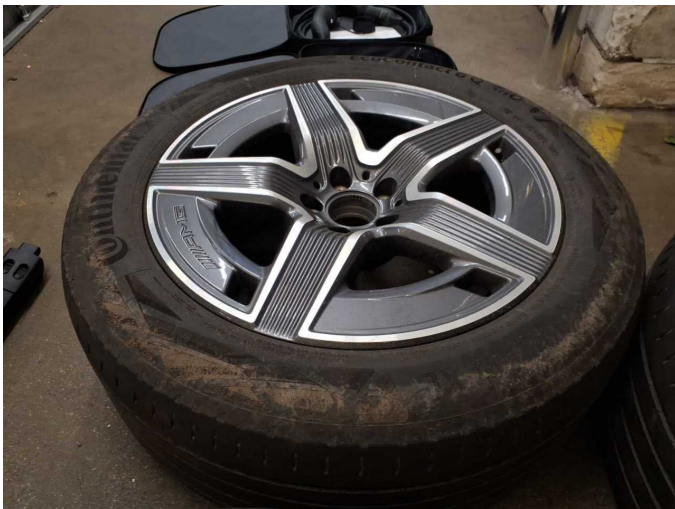
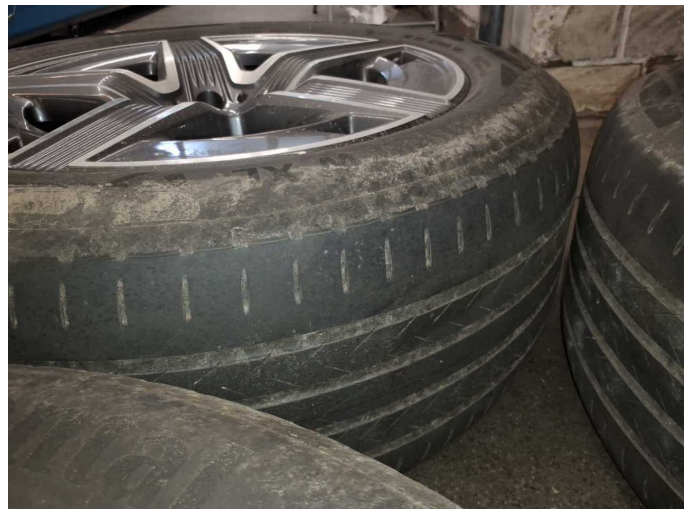
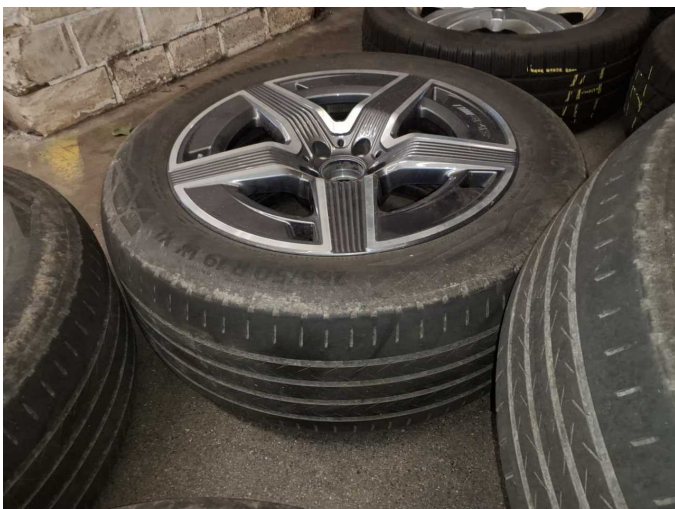
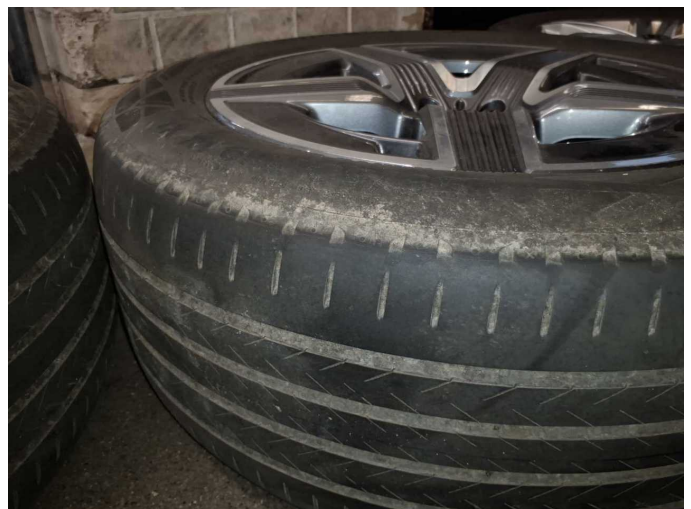
| No. | Component group | Description |
|---|---|---|
| 5 | 2nd wheel set | Tyres - complete set (Sommerreifen einseitig abgefahren) - Rough engine running - Replace |

**Damage 5:** 2nd wheel set: Tyres - complete set (Sommerreifen einseitig abgefahren) - Rough engine running - Replace

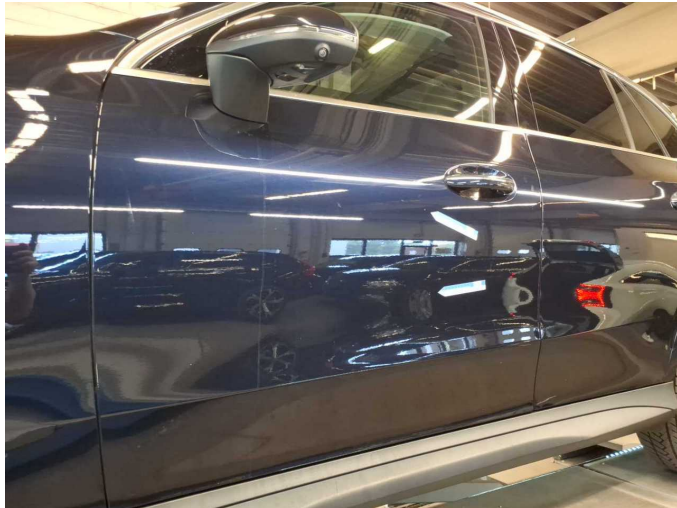
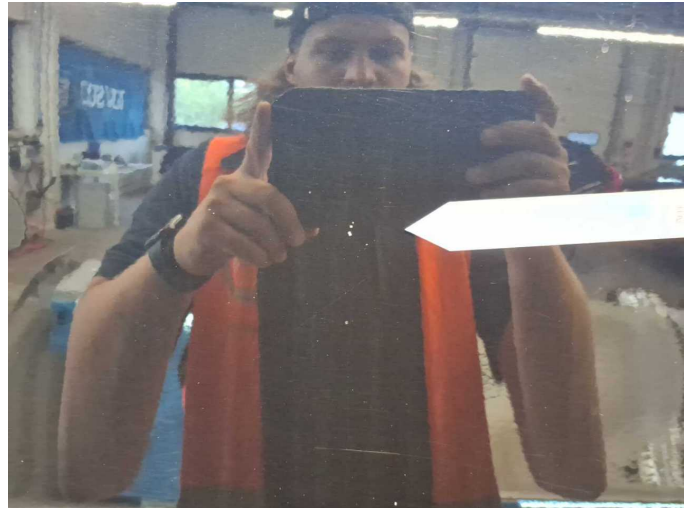
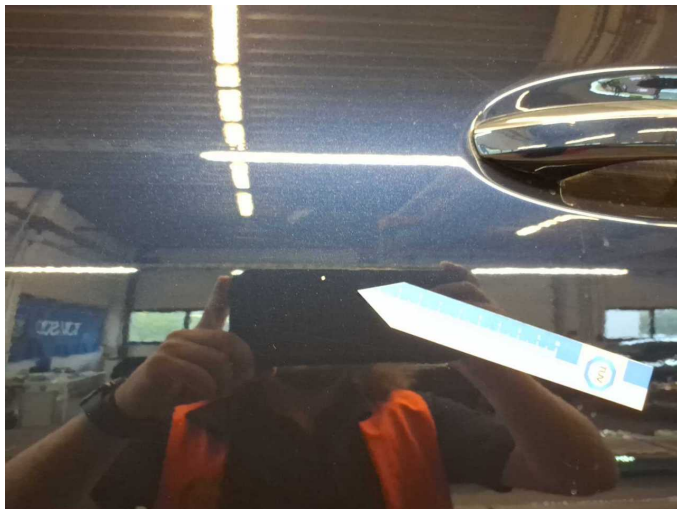
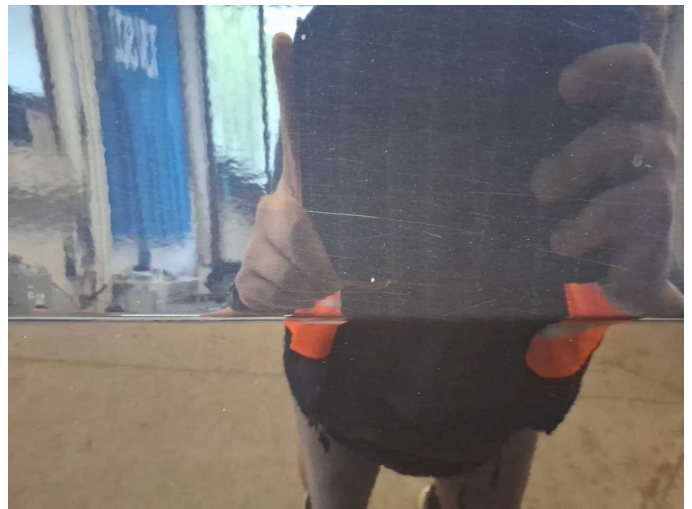
| No. | Component group | Description |
|---|---|---|
| 6 | Door - front left side | Door - Scratched - Paint |

**Damage 6:** Door - front left side: Door - Scratched - Paint

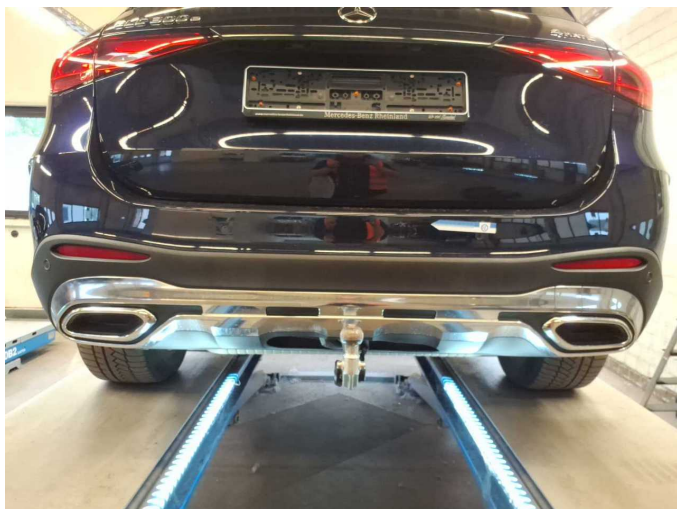
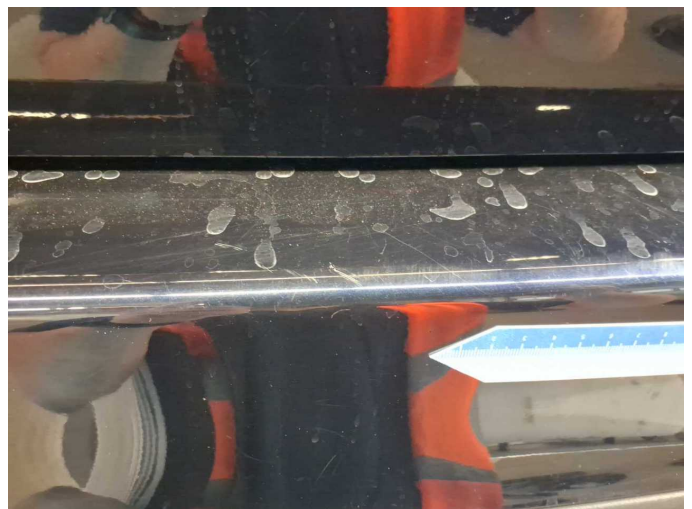
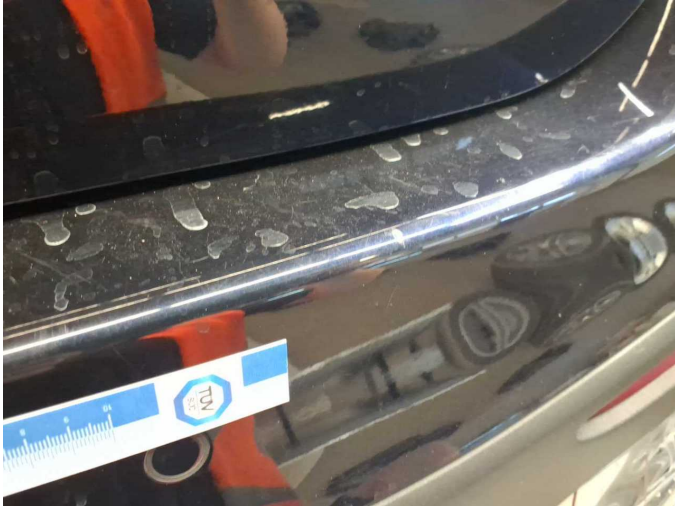
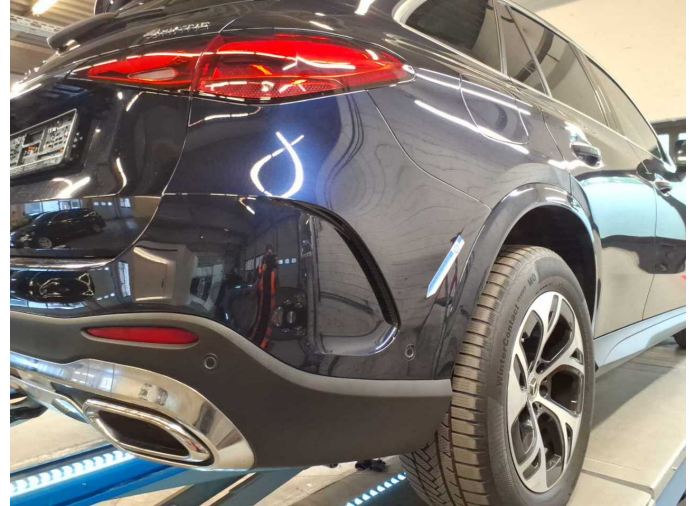
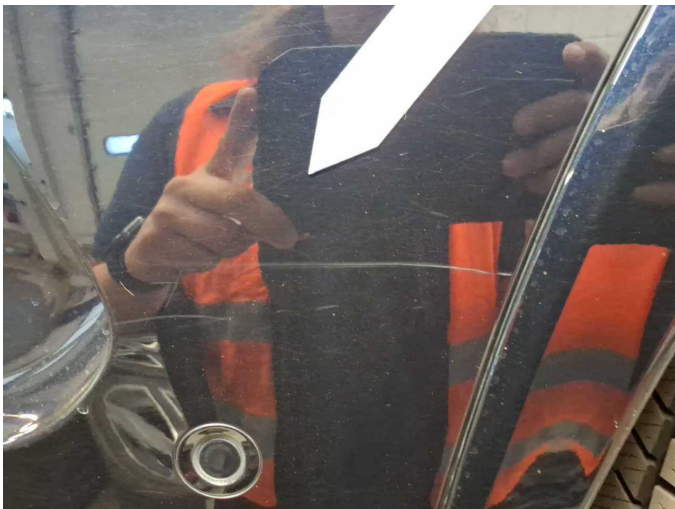
| No. | Component group | Description |
|---|---|---|
| 7 | Rear bumper | Rear bumper - Scratched - Paint |

**Damage 7:** Rear bumper: Rear bumper - Scratched - Paint

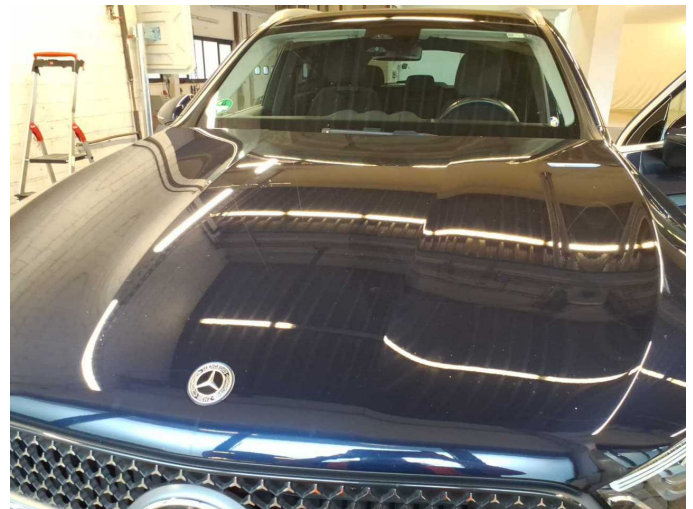
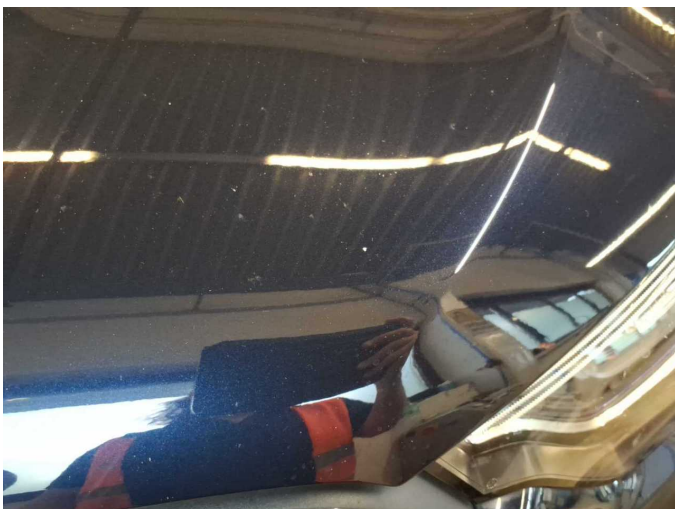
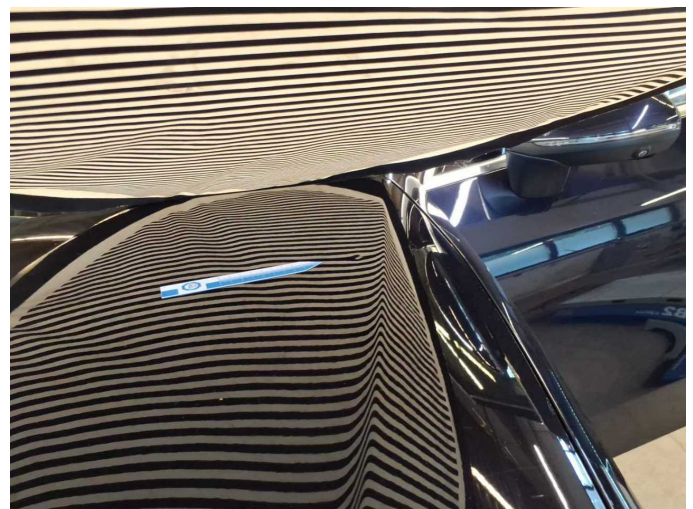
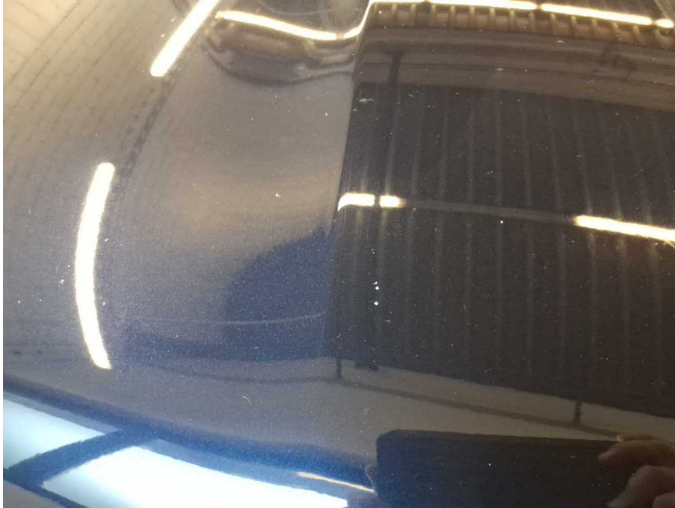
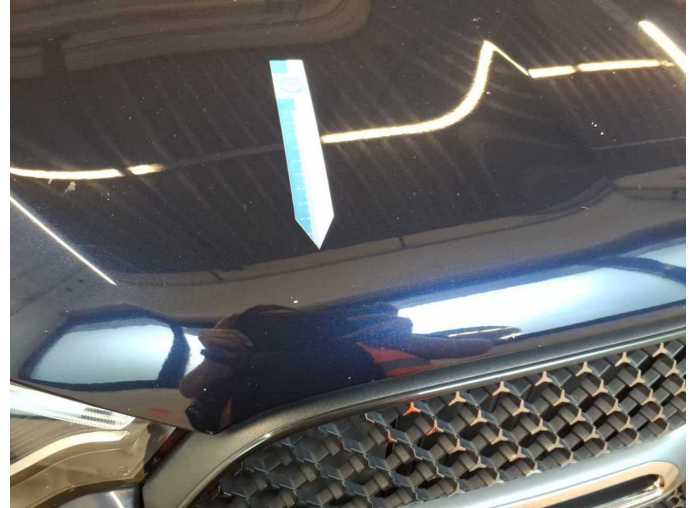
| No. | Component group | Description |
|---|---|---|
| 8 | Bonnet | Bonnet - Dent / paintcoat damage - Repair and paint |

**Damage 8:** Bonnet: Bonnet - Dent / paintcoat damage - Repair and paint

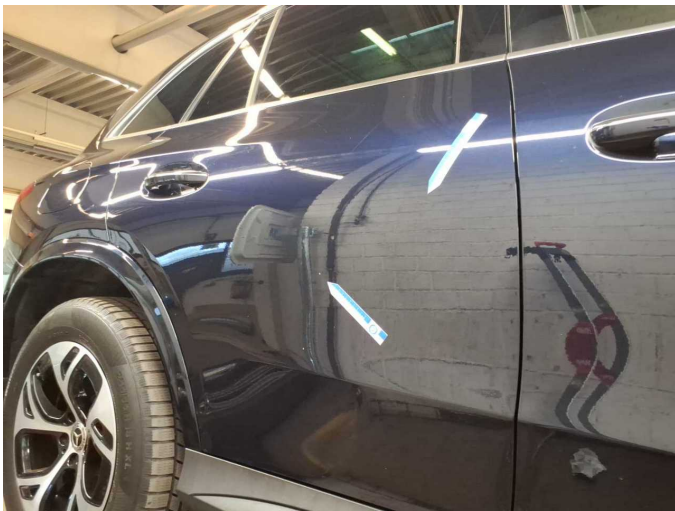
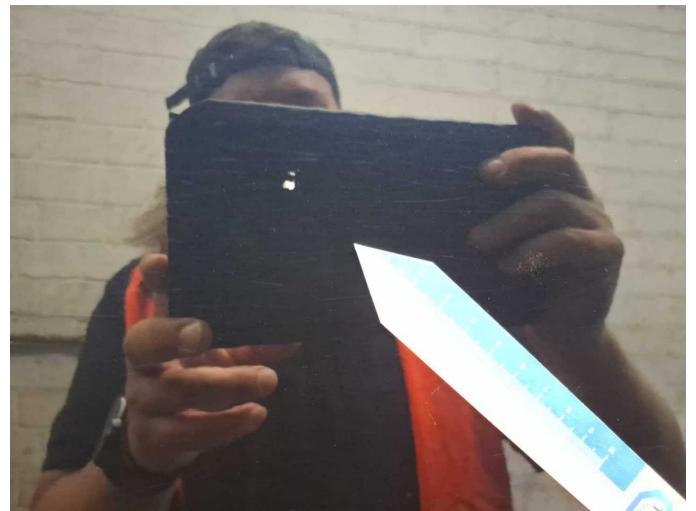
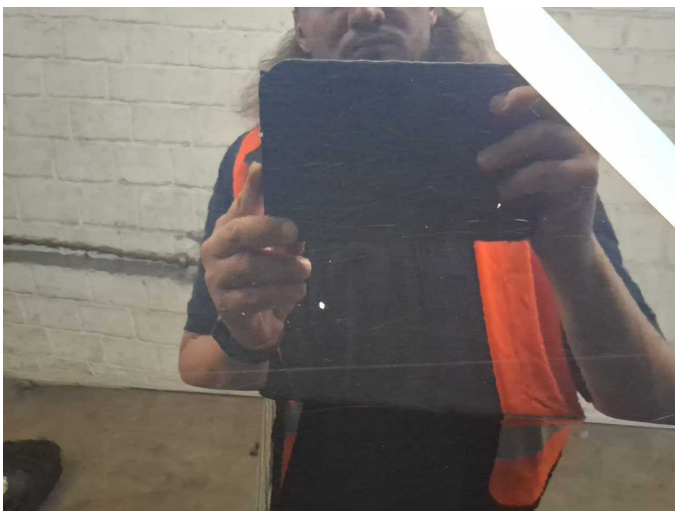
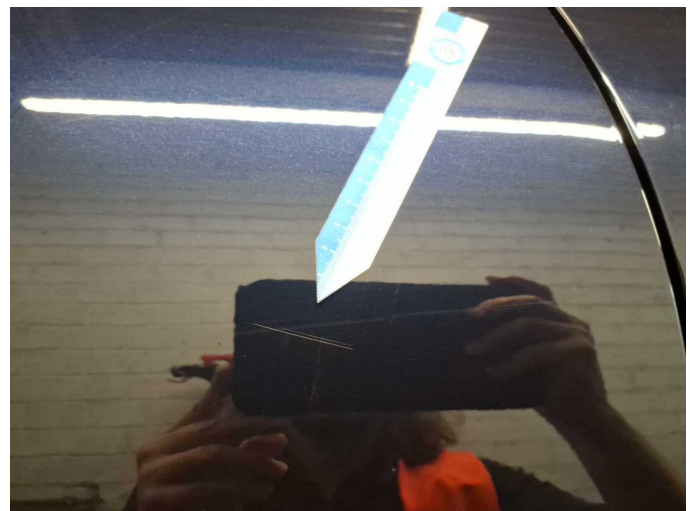
| No. | Component group | Description |
|---|---|---|
| 9 | Door - rear right side | Door - Scratched - Paint |

**Damage 9:** Door - rear right side: Door - Scratched - Paint

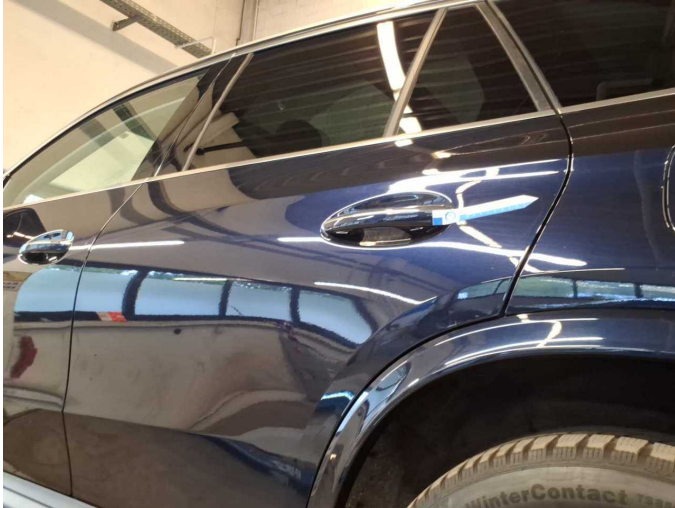
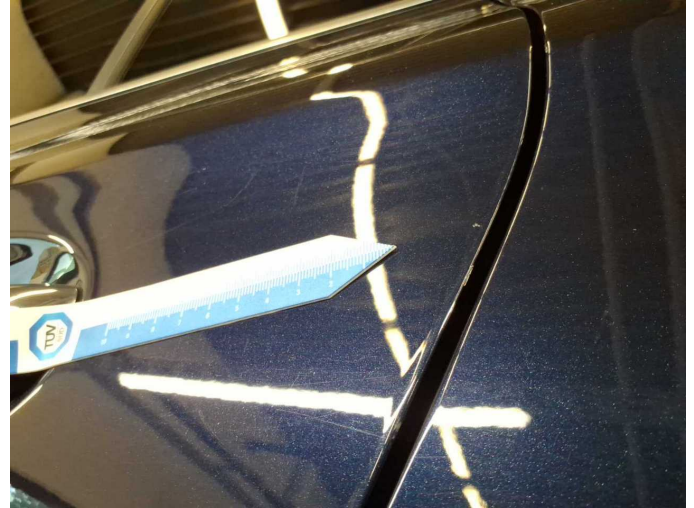
| No. | Component group | Description |
|---|---|---|
| 1 | Door - rear left side | Door edge - Scratched - No deduction |

**Wear and tear 1:** Door - rear left side: Door edge - Scratched - No deduction
