Expertise

Protocol number: 46689729  
Order No. / Reference: 26559353  
Inspection date: 23 Jul 2026

| Manufacturer: Volvo | Model: XC60 T8 AWD Recharge Ultimate Dark |

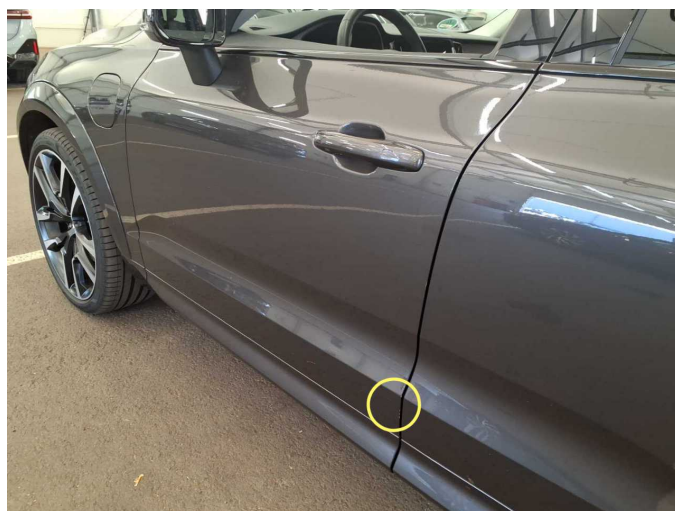
Damage 1: Door - front left side: Door edge - Scratch(es) - Smart repair

| No. | Component group | Description |
|---|---|---|
| 1 | Door - front left side | Door edge - Scratch(es) - Smart repair |

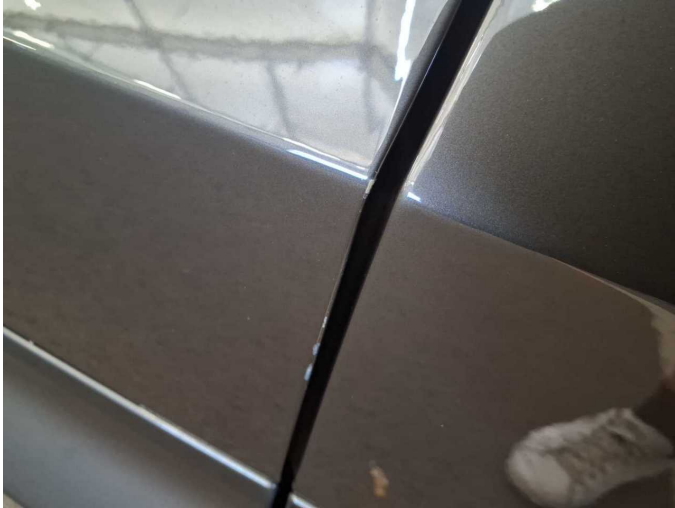
**Damage 1:** Door - front left side: Door edge - Scratch(es) - Smart repair

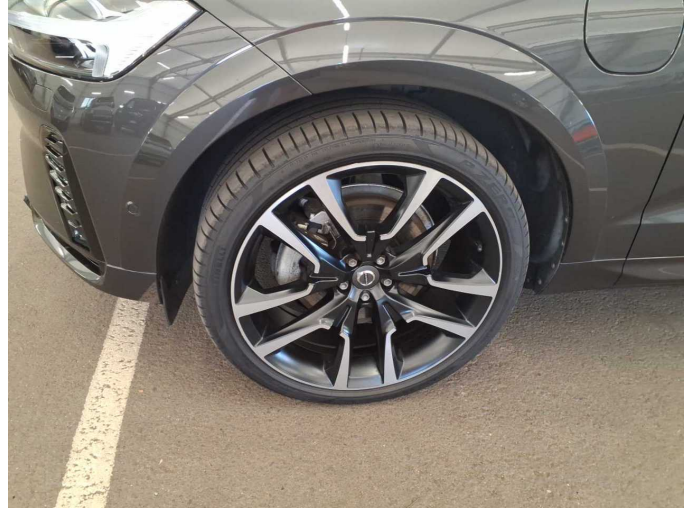
**Damage 2:** Wheel / tyres: Alloy rim - front left side - Scratched - Loss in value

| No. | Component group | Description |
|---|---|---|
| 2 | Wheel / tyres | Alloy rim - front left side - Scratched - Loss in value |

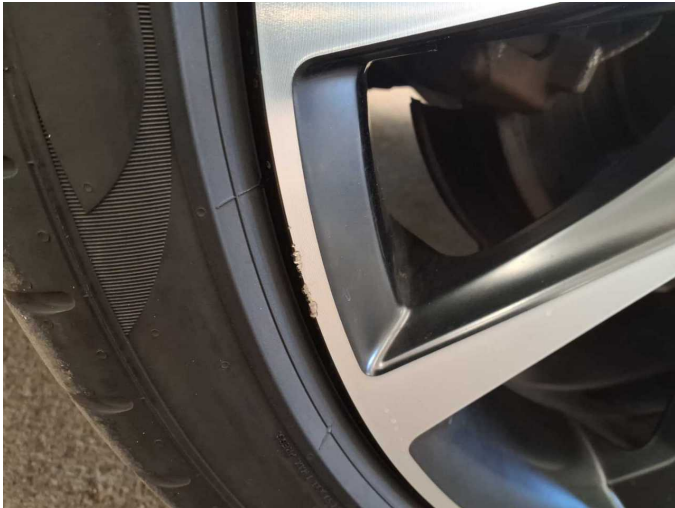
**Damage 2:** Wheel / tyres: Alloy rim - front left side - Scratched - Loss in value

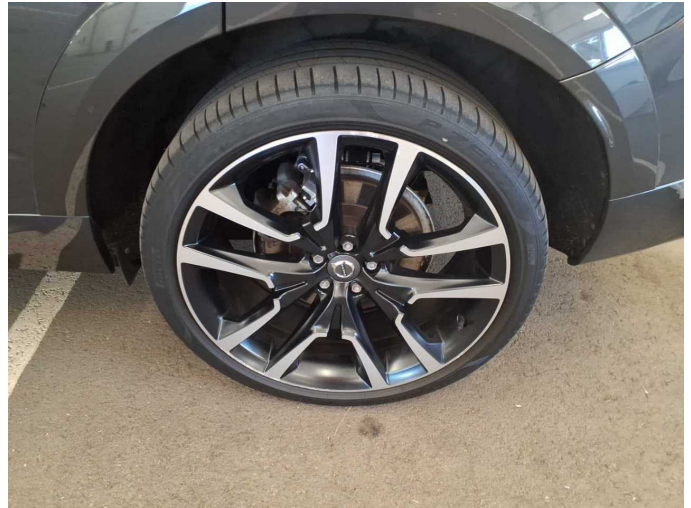
**Damage 3:** Wheel / tyres: Alloy rim - rear left side - Scratched - Loss in value

| No. | Component group | Description |
|---|---|---|
| 3 | Wheel / tyres | Alloy rim - rear left side - Scratched - Loss in value |

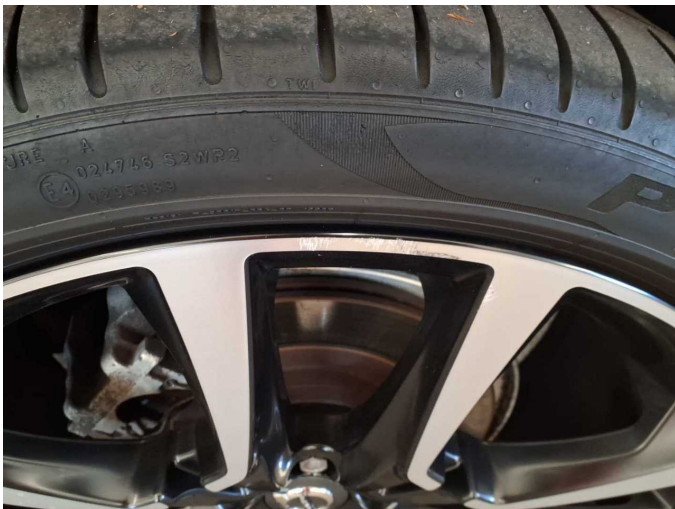
**Damage 3:** Wheel / tyres: Alloy rim - rear left side - Scratched - Loss in value

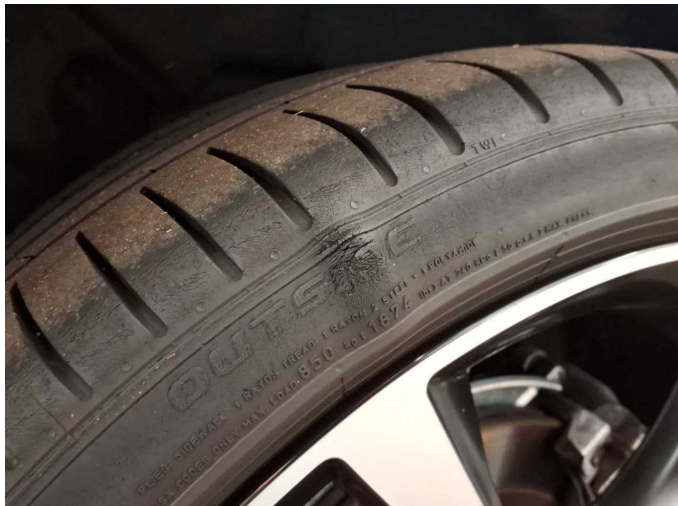
**Damage 4:** Wheel / tyres: Tyre - rear right side (Beule in der Seitenwand)  
- Damaged - Replace

| No. | Component group | Description |
|---|---|---|
| 4 | Wheel / tyres | Tyre - rear right side (Beule in der Seitenwand) - Damaged - Replace |

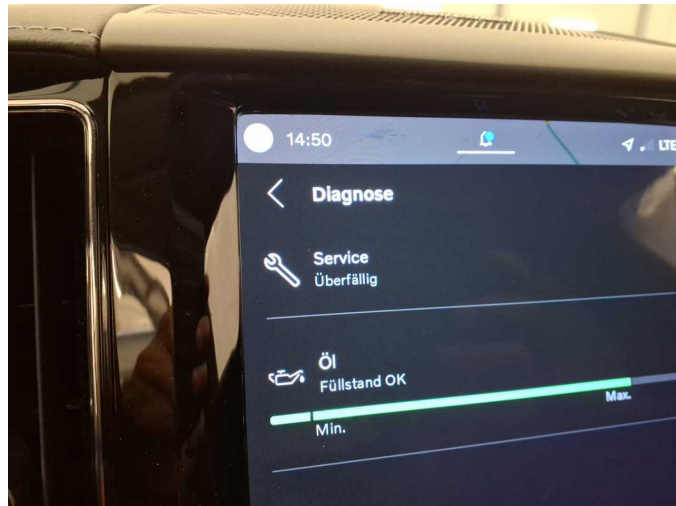
**Damage 5:** Misc.: Inspection / maintenance - Due - Perform

| No. | Component group | Description |
|---|---|---|
| 5 | Misc. | Inspection / maintenance - Due - Perform |

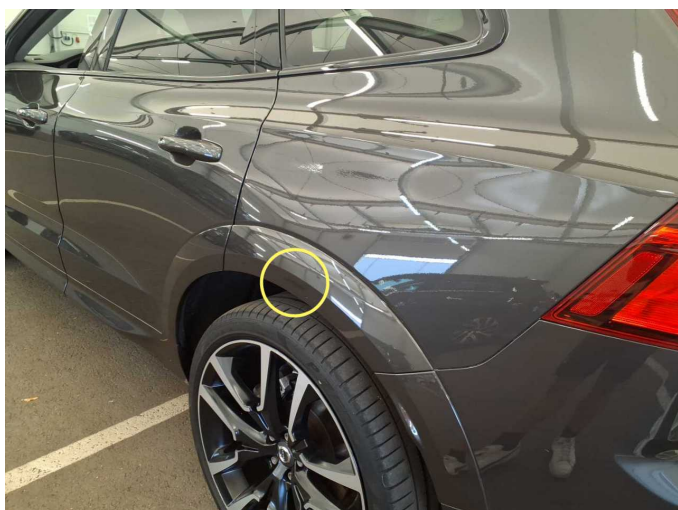
**Damage 6:** Side panel - rear left side: Wheel well extension - Scratch(es)  
- Paint

| No. | Component group | Description |
|---|---|---|
| 6 | Side panel - rear left side | Wheel well extension - Scratch(es) - Paint |

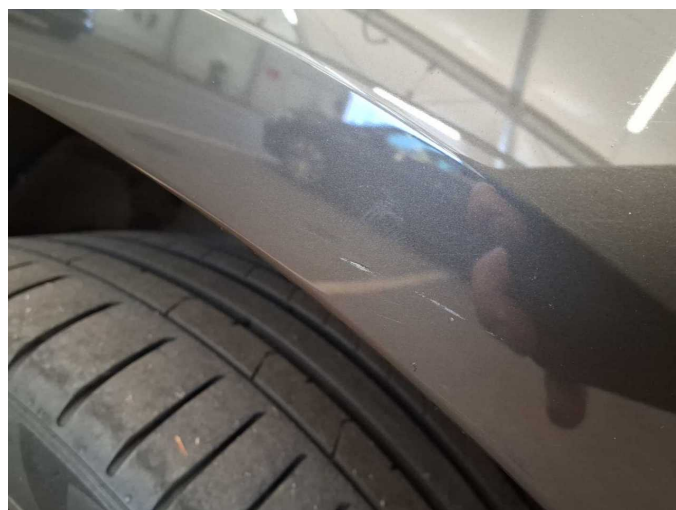
**Damage 6:** Side panel - rear left side: Wheel well extension - Scratch(es)  
- Paint
