Expertise

Protocol number: 46462018  
Order No. / Reference: 26649858  
Inspection date: 7 Jul 2026

Manufacturer: Skoda  
VIN: TMBJJ8NX5PY066917

Model: Octavia Combi 2.0 TDI DSG Style

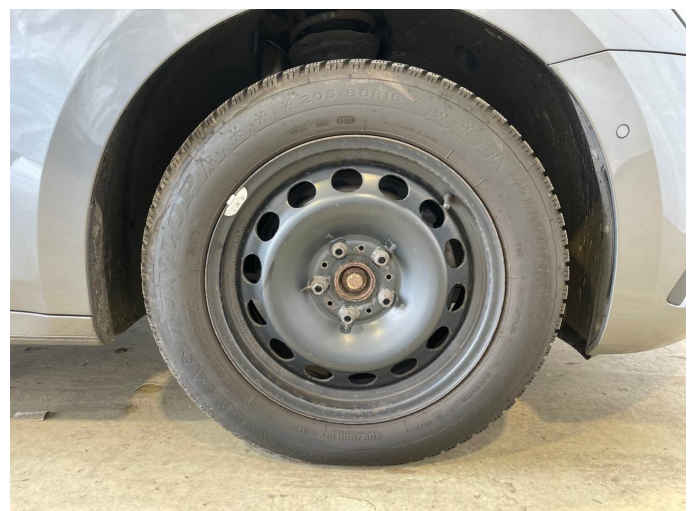
Figure 12: Mounted tyres

| # | Tyre size | Type of tyre | Manufacturer | Tread depth |
|---|---|---|---|---|
| 1) | 205/60 R16 92H | Winter tyres on Steel | Dunlop | 5mm / 5mm |
| 2) | 205/60 R16 92H | Winter tyres on Steel | Dunlop | 6mm / 6mm |

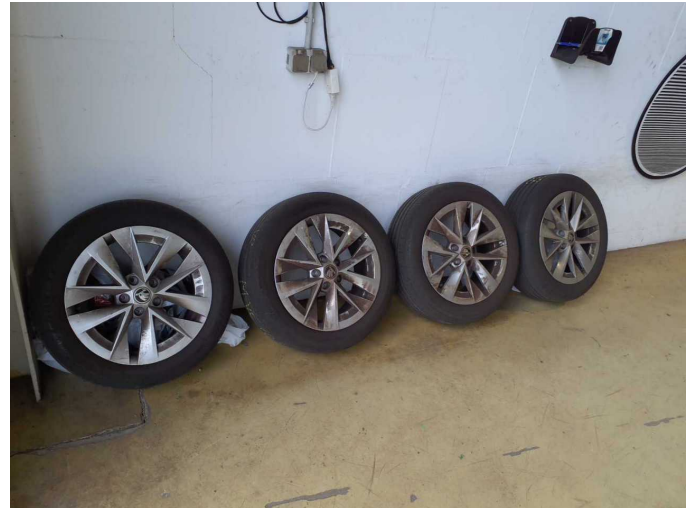
Figure 14: Additional tyres

| # | Tyre size | Type of tyre | Manufacturer | Tread depth |
|---|---|---|---|---|
| 1) | 205/55 R17 91V | Summer tyres on Light alloy | Goodyear | 1mm / 1mm |
| 2) | 205/55 R17 91V | Summer tyres on Light alloy | Goodyear | 5mm / 5mm |

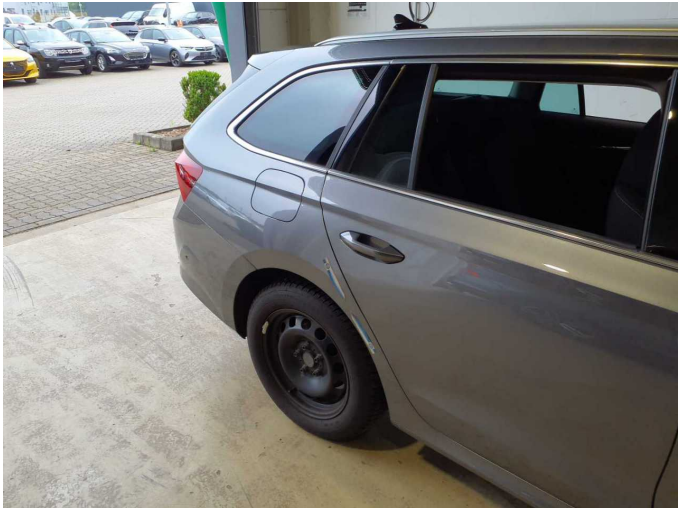
| No. | Component group | Description |
|---|---|---|
| 2 | Side panel - rear right side | Side panel - dent(s) - Smooth repair work |

Damage 2: Side panel - rear right side: Side panel - dent(s) - Smooth repair work

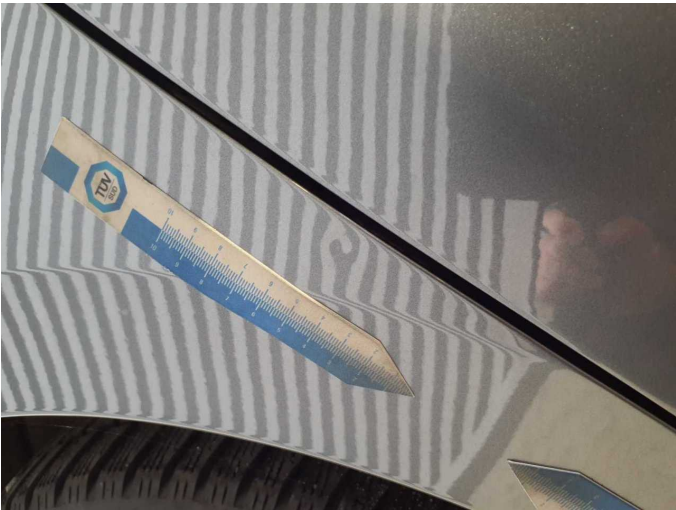
Damage 2: Side panel - rear right side: Side panel - dent(s) - Smooth repair work

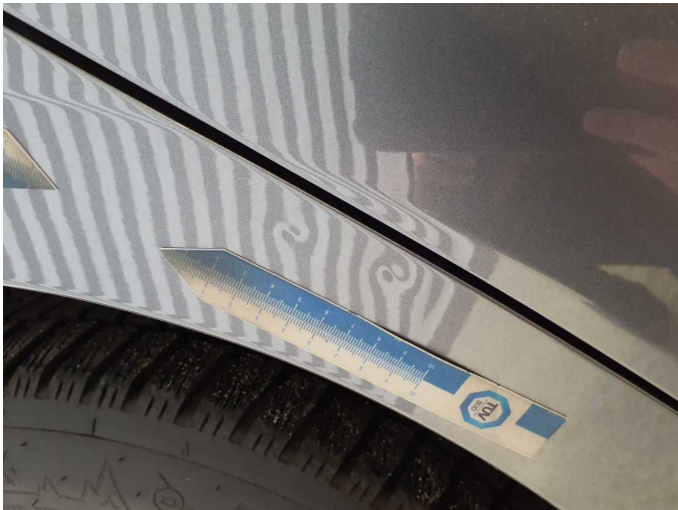
Damage 2: Side panel - rear right side: Side panel - dent(s) - Smooth repair work

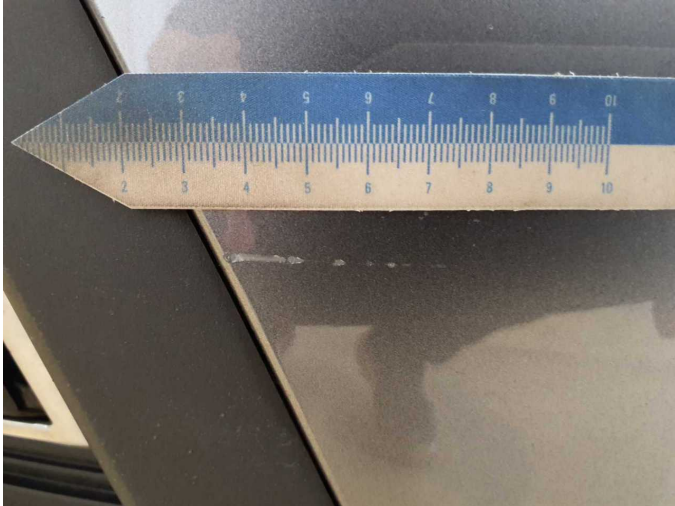
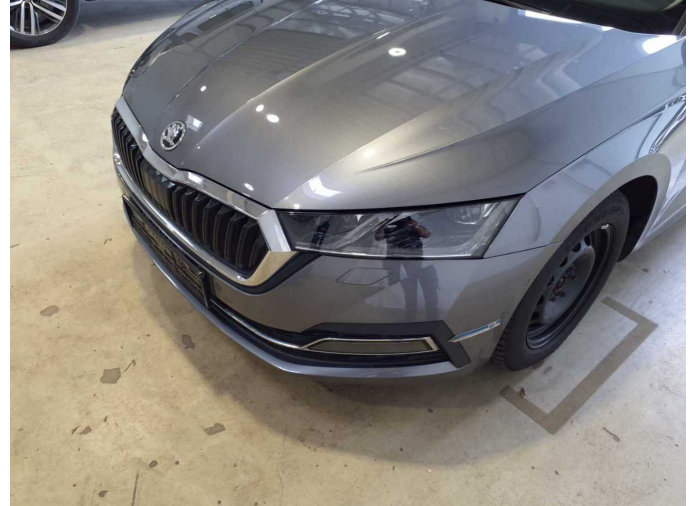
| No. | Component group | Description |
|---|---|---|
| 3 | Front bumper | Front bumper - Scratch(es) - Smart repair |

**Damage 3:** Front bumper: Front bumper - Scratch(es) - Smart repair

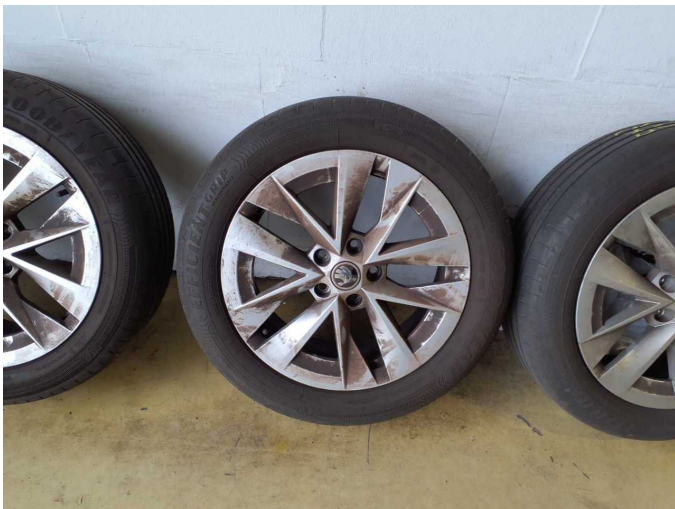
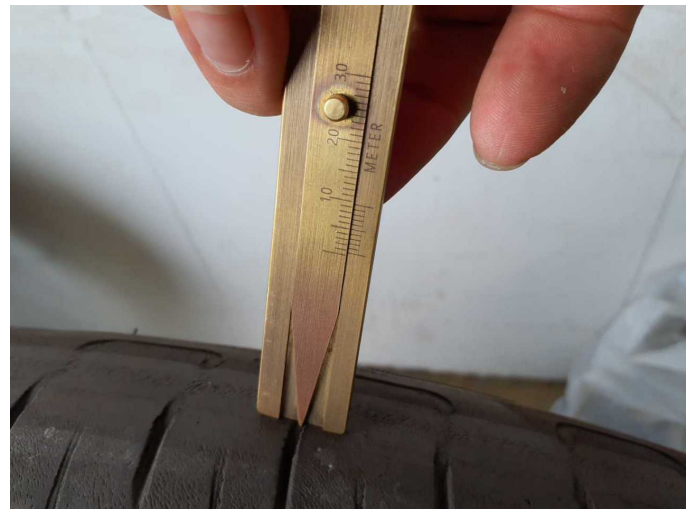
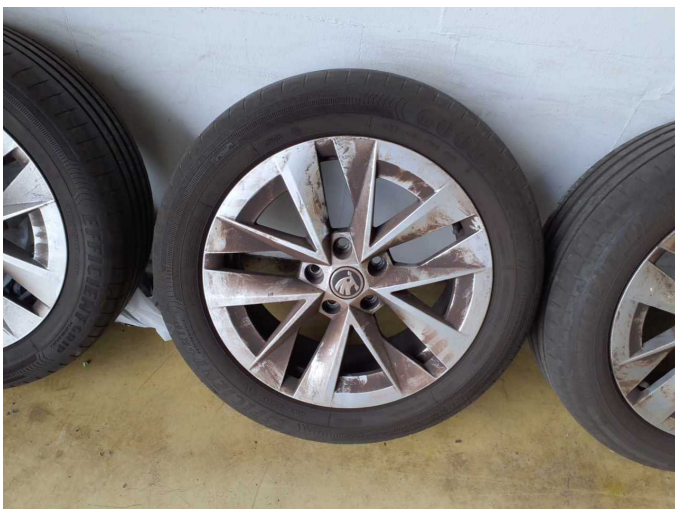
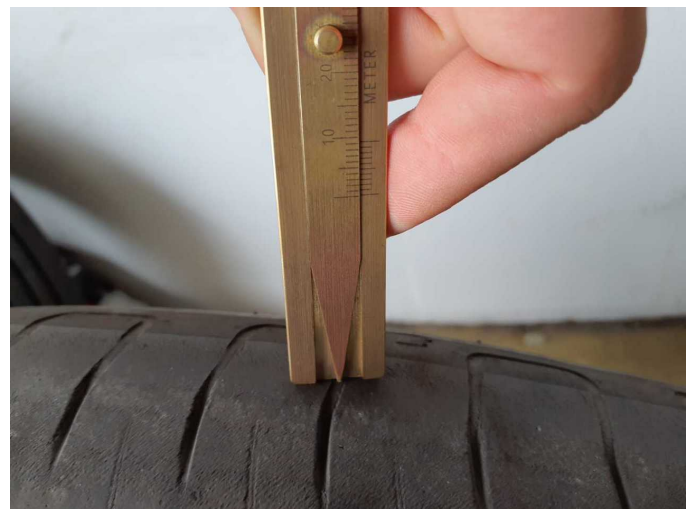
| No. | Component group | Description |
|---|---|---|
| 4 | 2nd wheel set | 2 tyres - Worn - Replace |

**Damage 4:** 2nd wheel set: 2 tyres - Worn - Replace

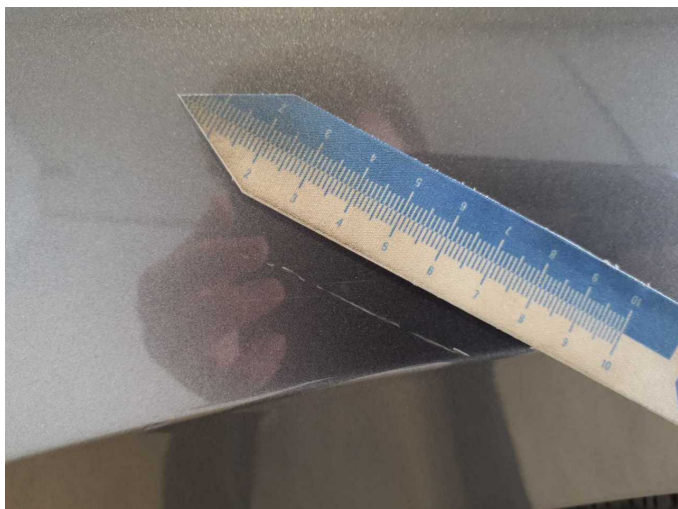
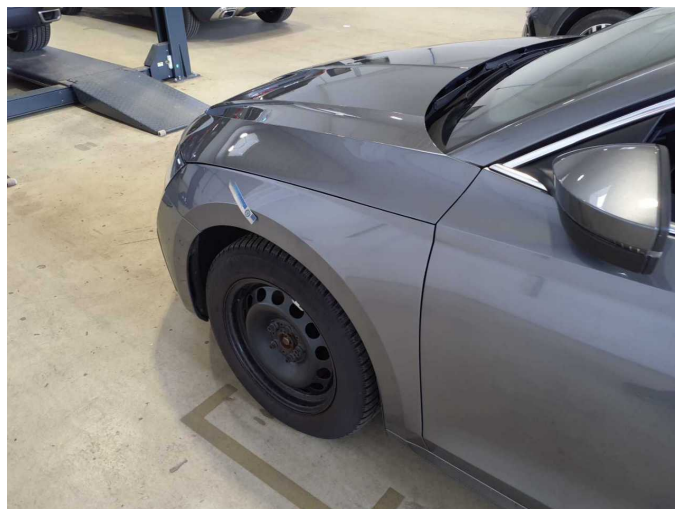
| No. | Component group | Description |
|---|---|---|
| 5 | Mudguard - left side | Mudguard - left side - Scratch(es) - Paint |

**Damage 5:** Mudguard - left side: Mudguard - left side - Scratch(es) - Paint

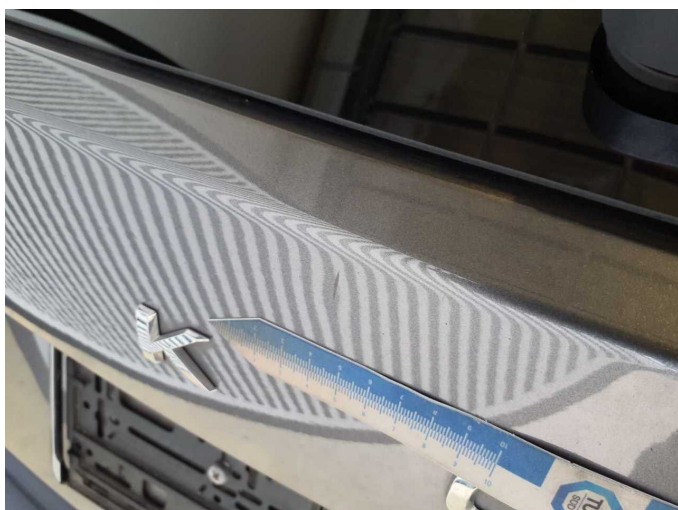
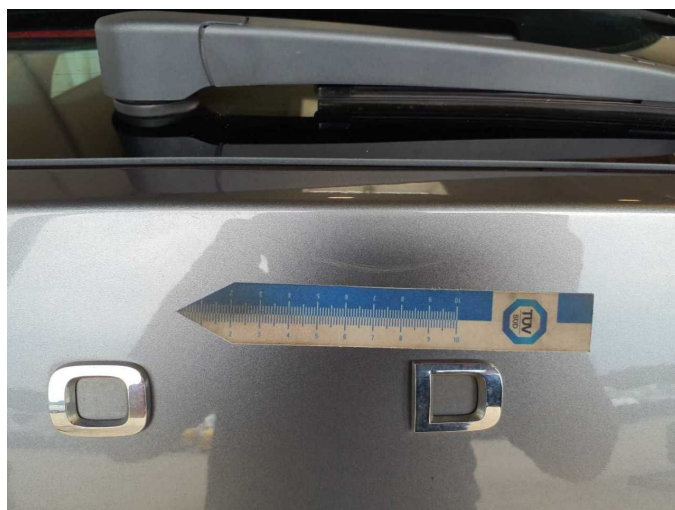
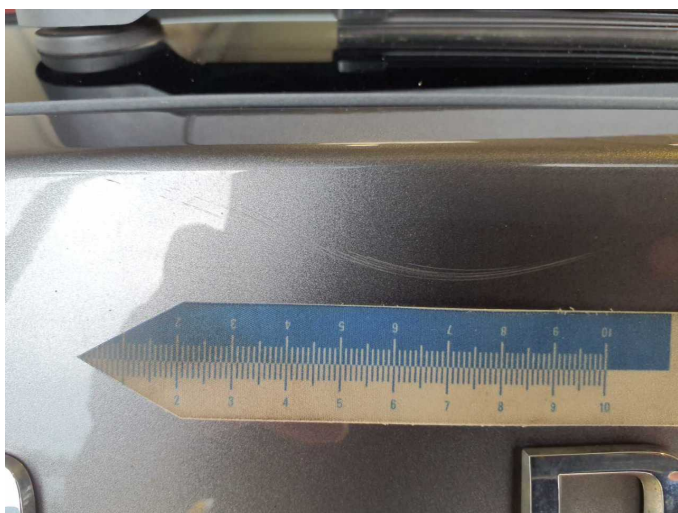
| No. | Component group | Description |
|---|---|---|
| 6 | Boot lid / rear door | Boot lid (+ Delle) - Scratch(es) - Paint |

**Damage 6:** Boot lid / rear door: Boot lid (+ Delle) - Scratch(es) - Paint

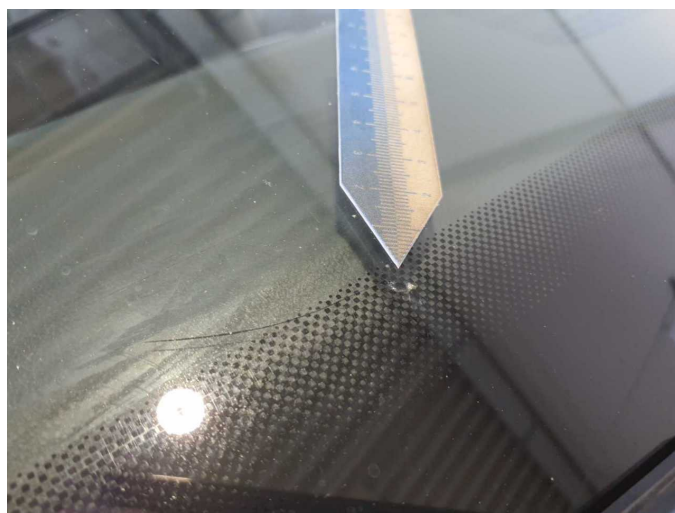
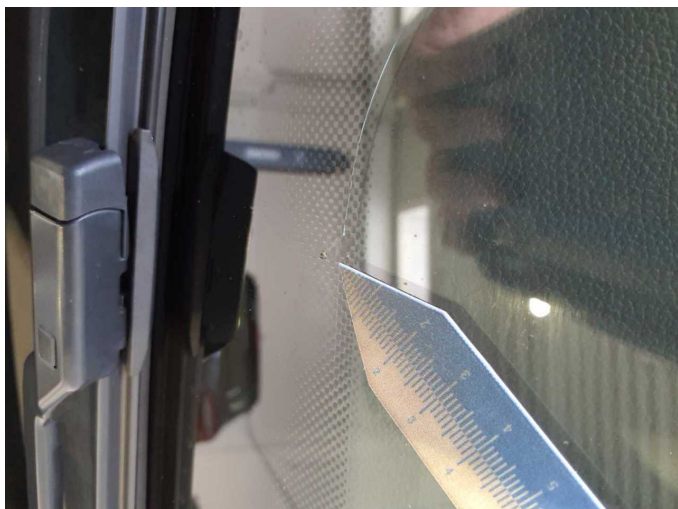
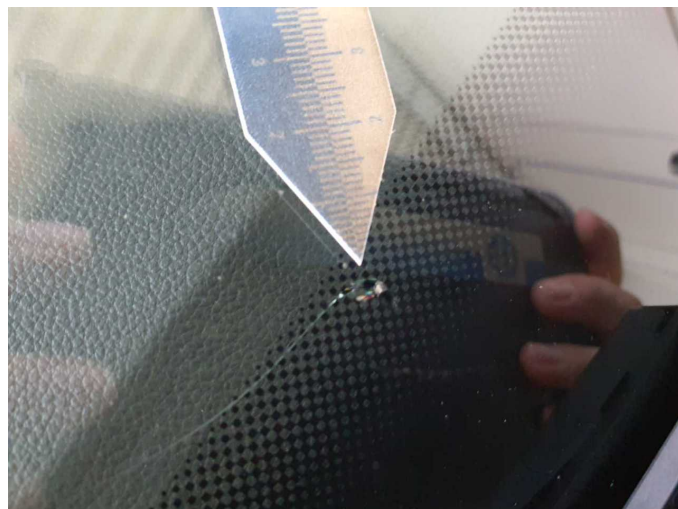
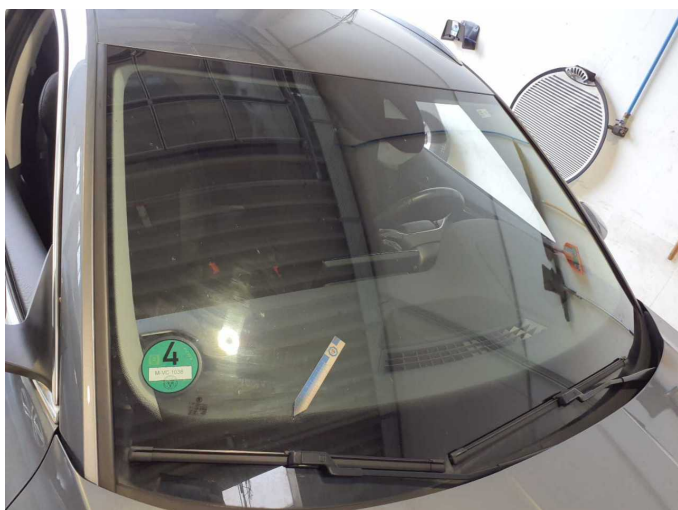
| No. | Component group | Description |
|---|---|---|
| 7 | Vehicle glazing | Windscreen - Broken / torn - Replace |

**Damage 7:** Vehicle glazing: Windscreen - Broken / torn - Replace

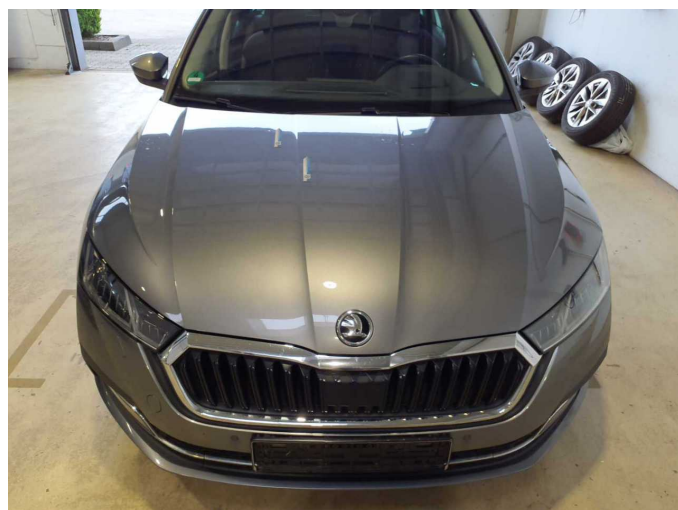
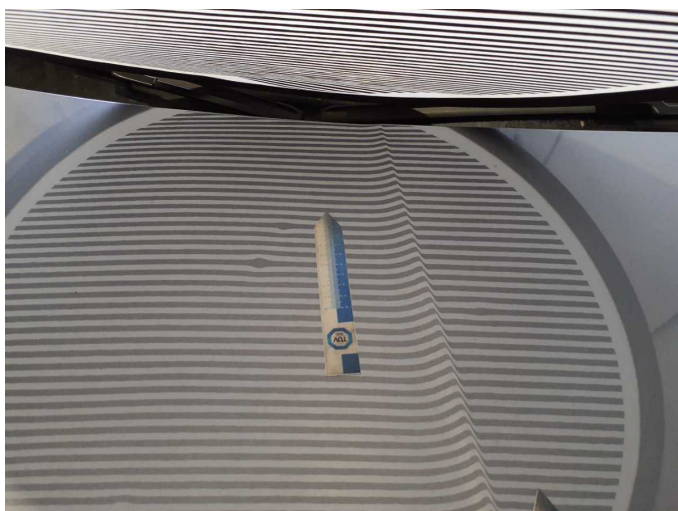
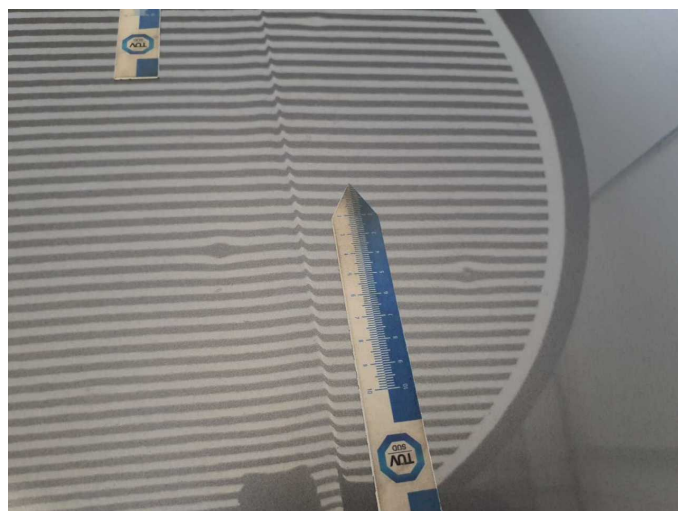
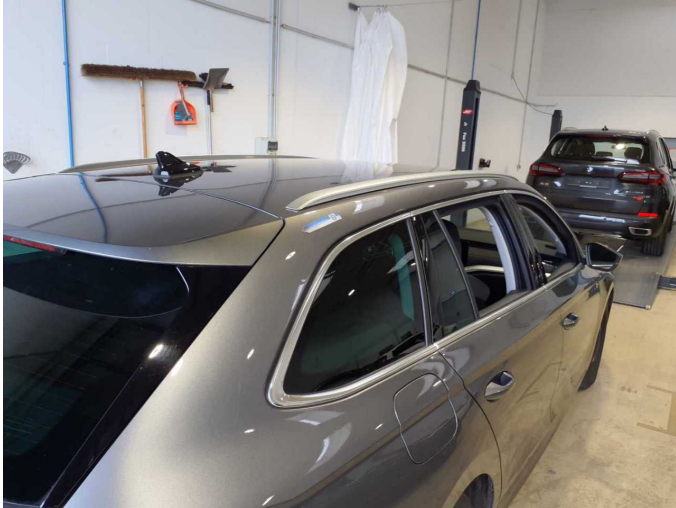
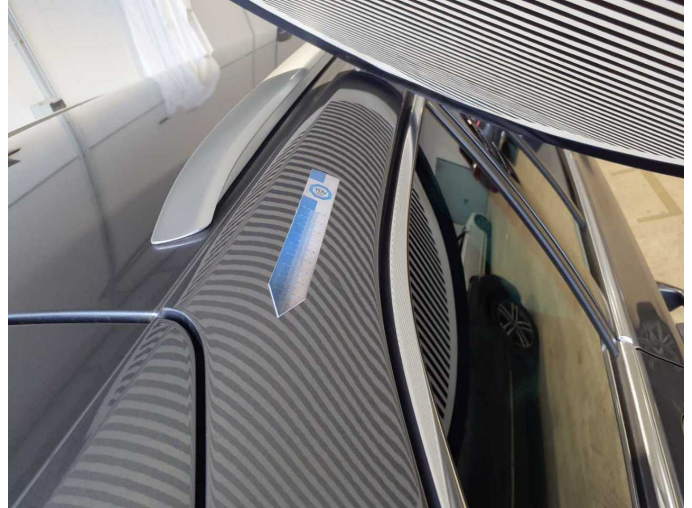
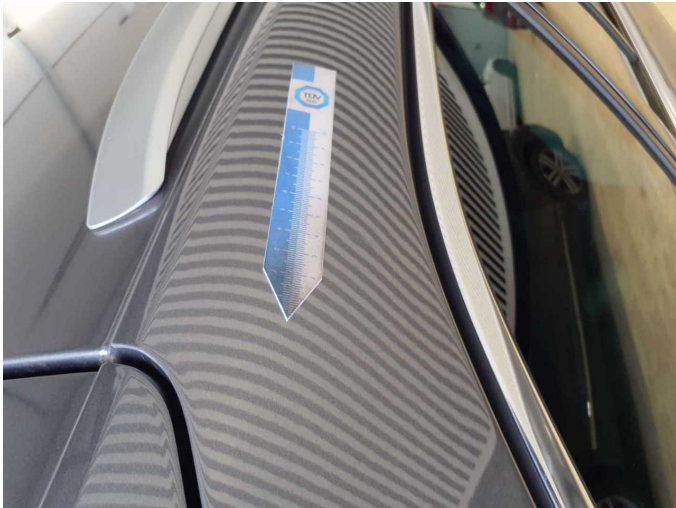
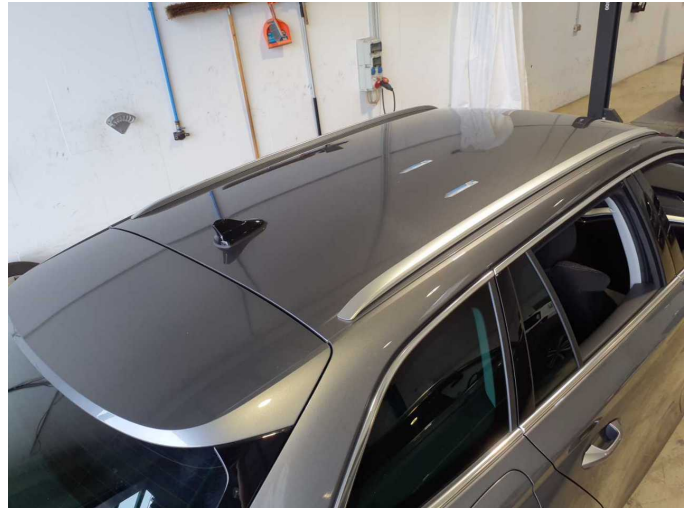
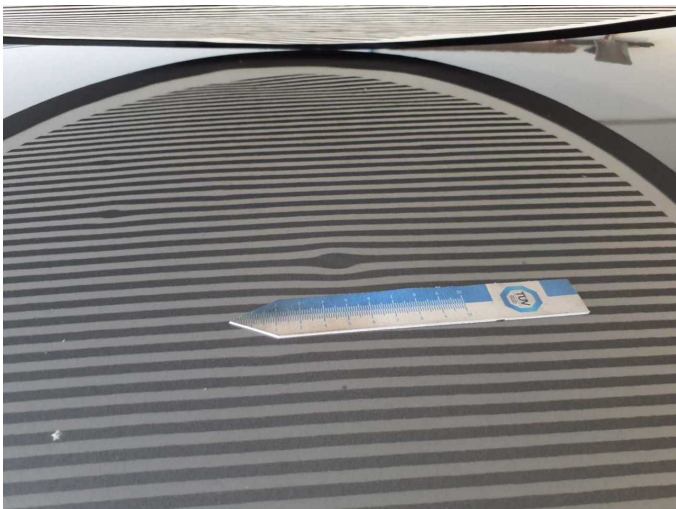
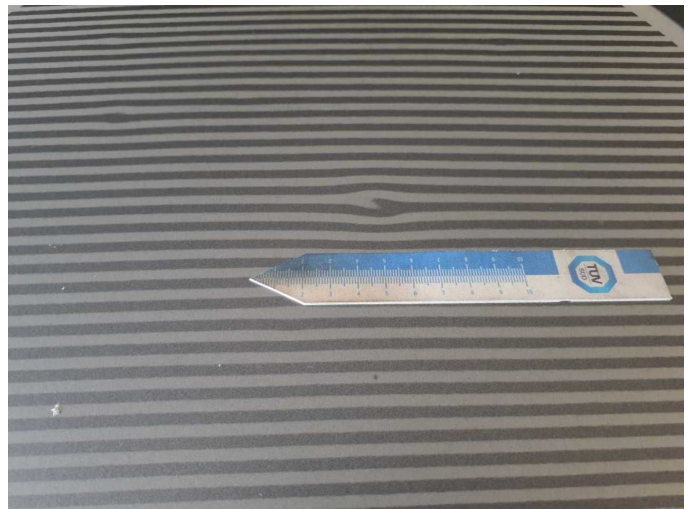
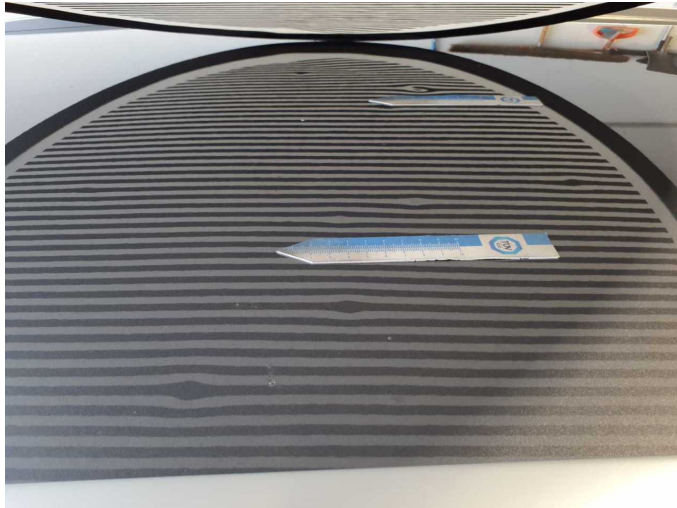
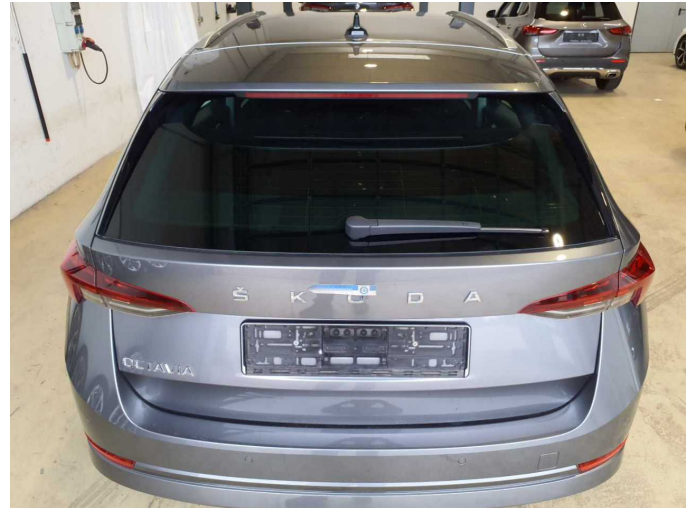
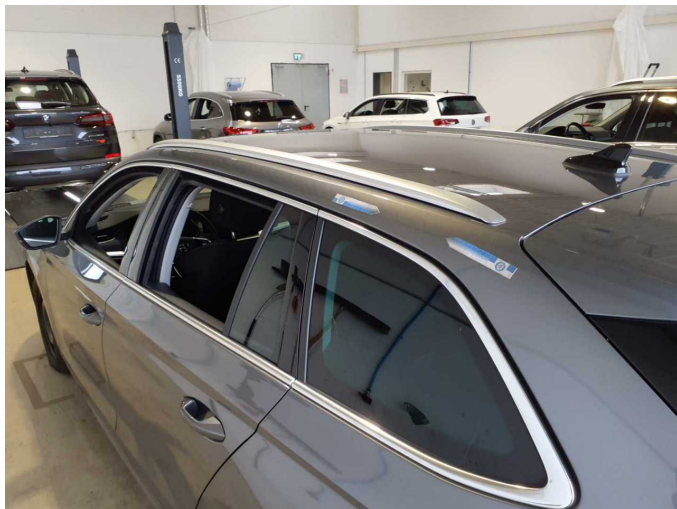
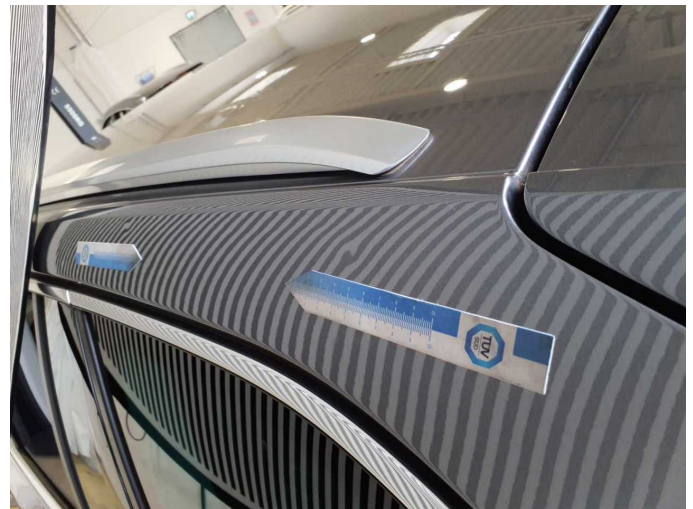
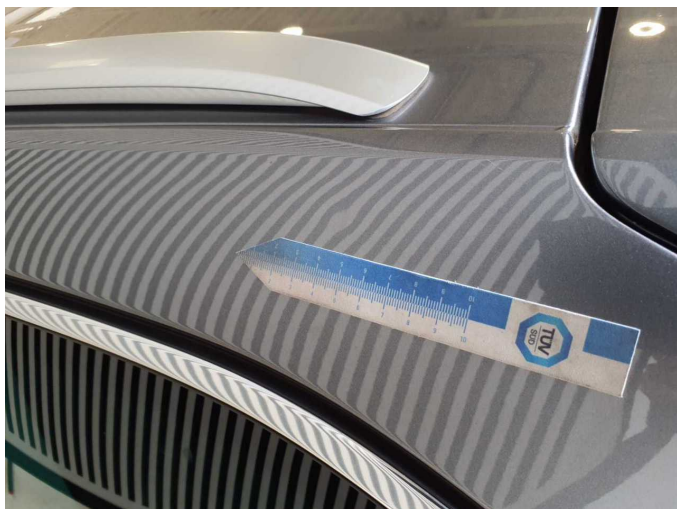
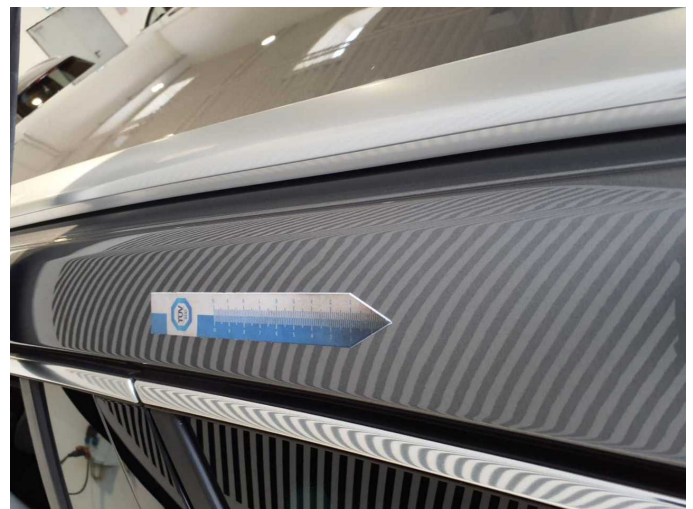
| No. | Component group | Description |
|---|---|---|
| 8 | Body | Body - Damage by hail - repair according to calculation |

**Damage 8:** Body: Body - Damage by hail - repair according to calculation

Damage 8: Body: Body - Damage by hail - repair according to calculation

Der kalkulierte Hagelschaden wurde nach bestem Wissen und Gewissen unter eingeschränkten Besichtigungsbedingung im demontagefreien Zustand erstellt. Es können aufgrund verdeckter Beschädigung, Mehrkosten und somit Abweichung der für den Schaden ausgewiesenen Reparaturkosten nicht ausgeschlossen werden.
