Expertise

Manufacturer: Ford

Model: Focus Turnier 2.0 EcoBlue Start-Stopp-System Aut.  
COOL&CONNECT

VIN: WF0PXXGCHPLS78306

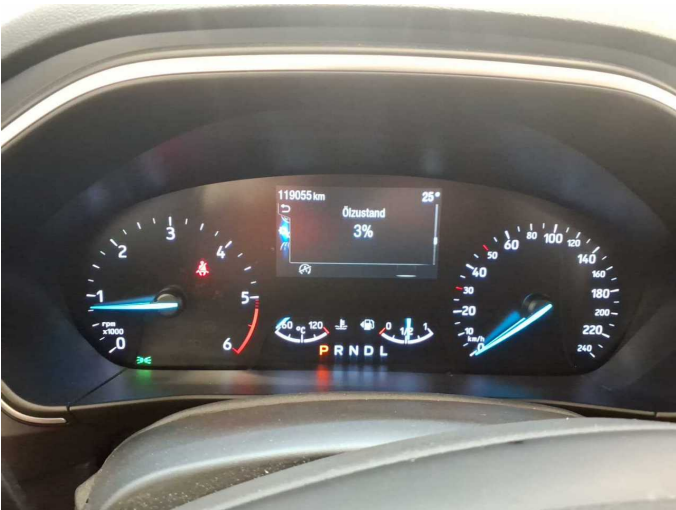
Figure 7: Instrument cluster

| Vehicle details | |
|---|---|
| <b>Mileage (Read)</b> | 119,055 km |

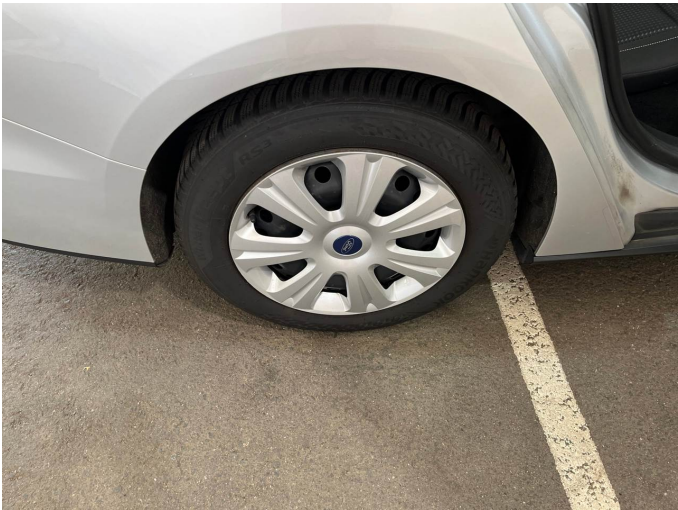
Figure 12: Mounted tyres

| # | Tyre size | Type of tyre | Manufacturer | Tread depth |
|---|---|---|---|---|
| 1) | 205/60 R16 96H | Winter tyres on Steel rim with wheel cover | Hankook | 5mm / 5mm |
| 2) | 205/60 R16 96H | Winter tyres on Steel rim with wheel cover | Hankook | 5mm / 5mm |

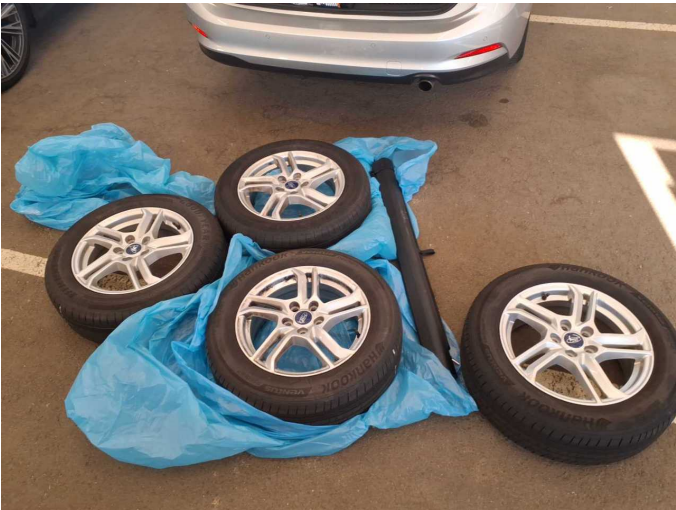
Figure 17: Additional tyres

| # | Tyre size | Type of tyre | Manufacturer | Tread depth |
|---|---|---|---|---|
| 1) | 205/60 R16 92V | Summer tyres on Light alloy | Goodyear | 5mm / 5mm |
| 2) | 205/60 R16 92V | Summer tyres on Light alloy | Goodyear | 6mm / 6mm |

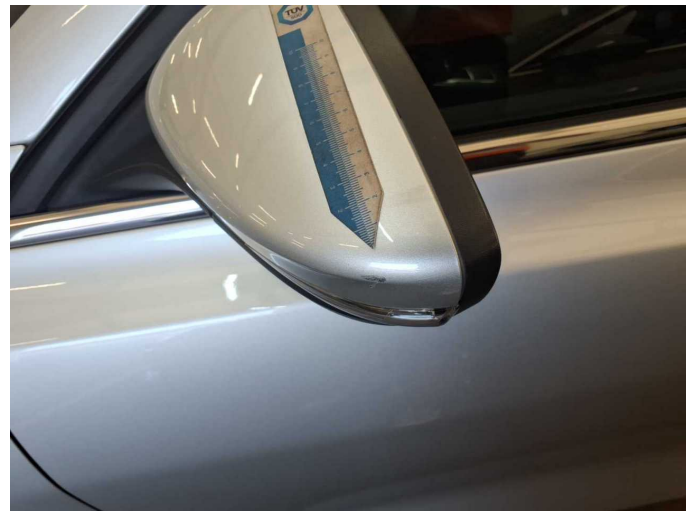
| No. | Component group | Description |
|---|---|---|
| 2 | Wing mirror - left side | Cap - Scratch(es) - Smart repair |

**Damage 2:** Wing mirror - left side: Cap - Scratch(es) - Smart repair

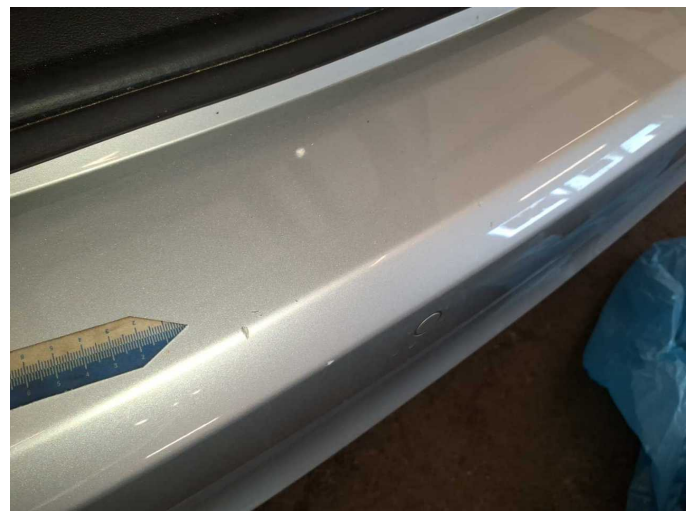
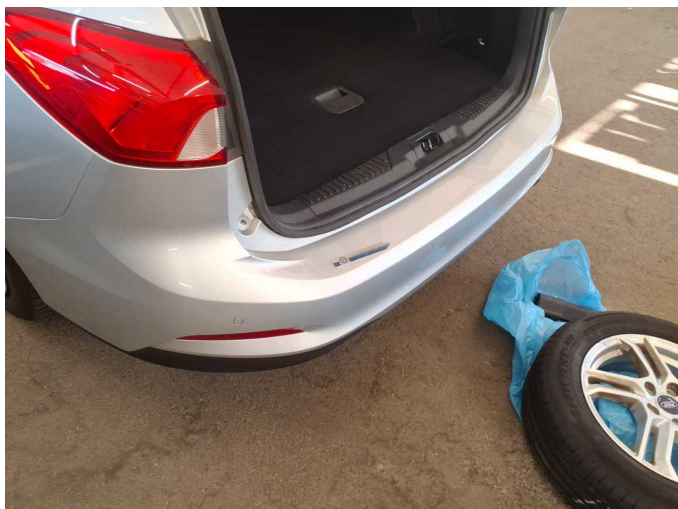
| No. | Component group | Description |
|---|---|---|
| 3 | Rear bumper | Rear bumper - Scratched - Paint |

**Damage 3:** Rear bumper: Rear bumper - Scratched - Paint

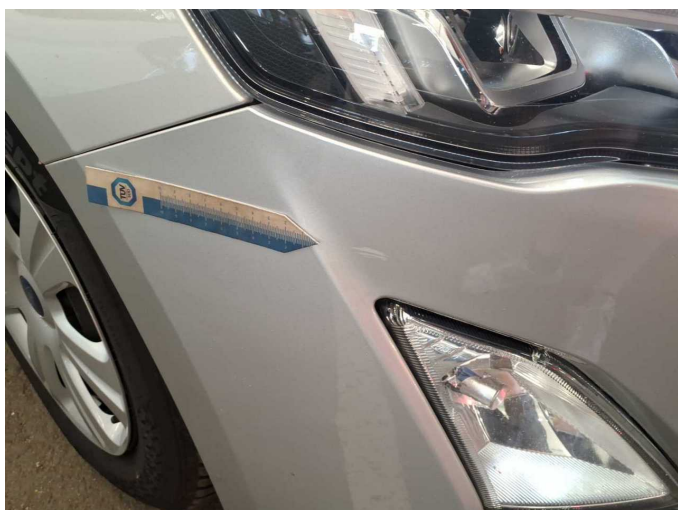
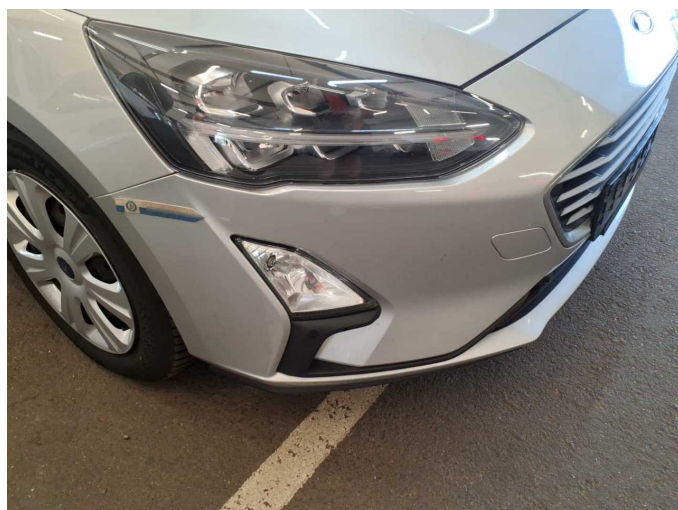
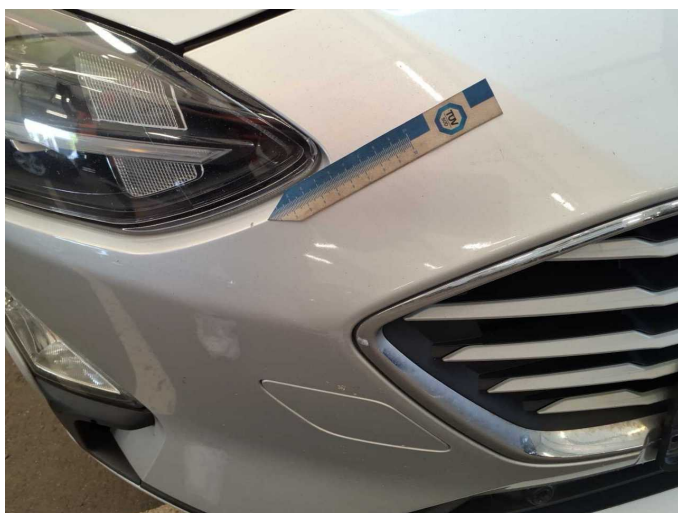
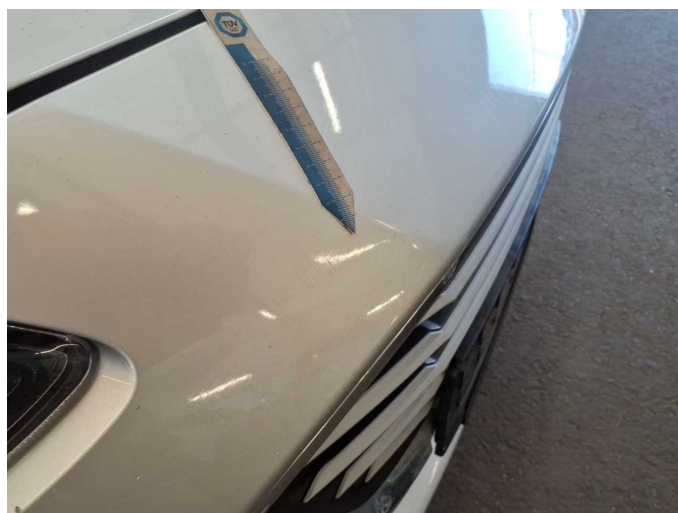
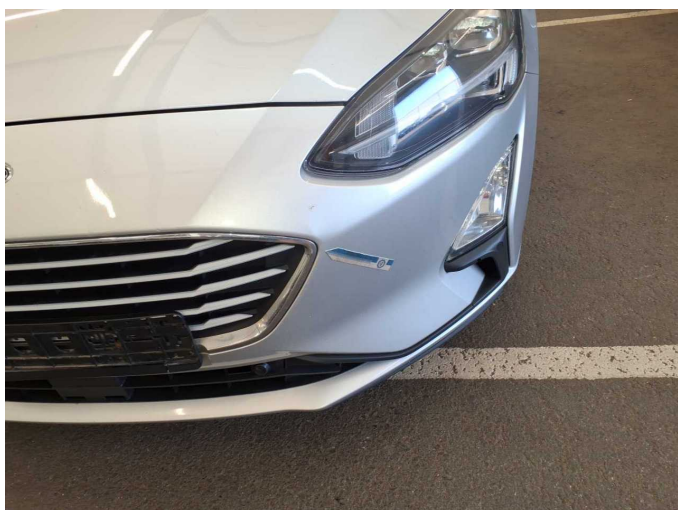
| No. | Component group | Description |
|---|---|---|
| 4 | Front bumper | Front bumper - Scratch(es) - Paint |

**Damage 4:** Front bumper: Front bumper - Scratch(es) - Paint

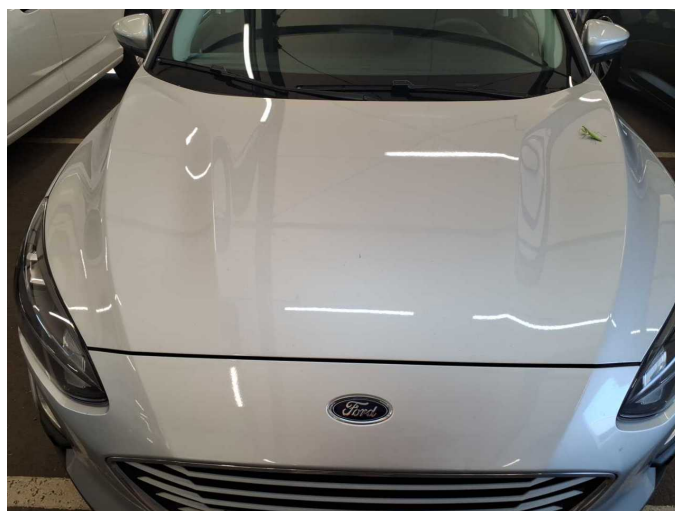
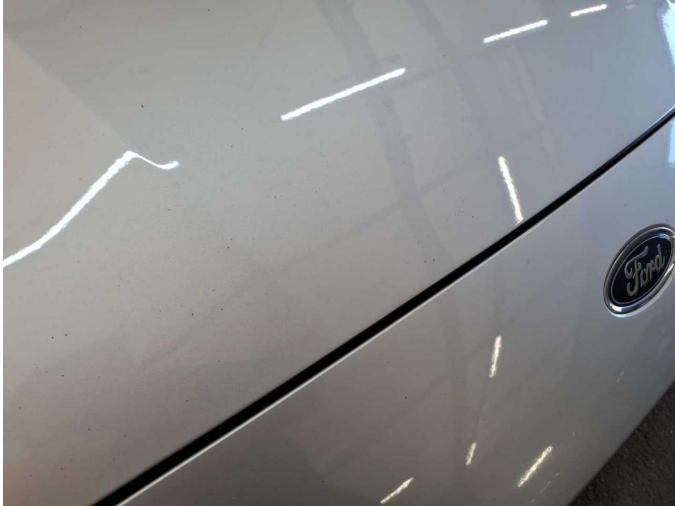
| No. | Component group | Description |
|---|---|---|
| 2 | Bonnet | Bonnet - Stone chips - No deduction |

**Wear and tear 2:** Bonnet: Bonnet - Stone chips - No deduction

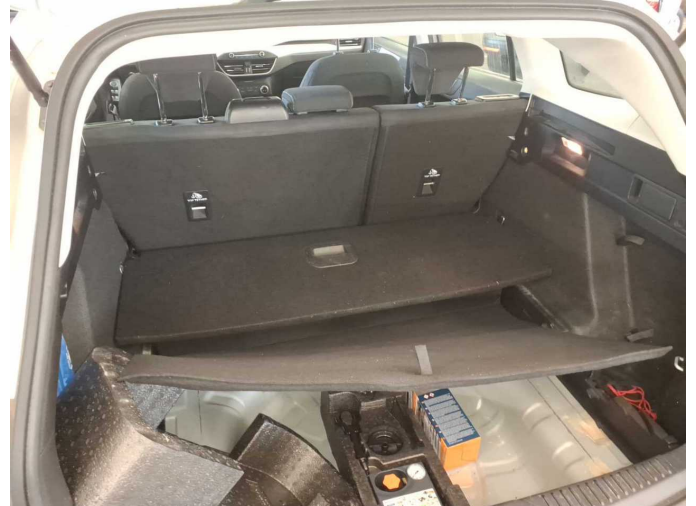
Interior - Rear shelf

**Missing part 1:** Interior: Rear shelf - Missing - Replace
