Expertise

Protocol number: 46894114  
Order No. / Reference: 26826907  
Inspection date: 5 Aug 2026

Manufacturer: Volkswagen

Model: ID.3 Pro S (5-Sitzer)

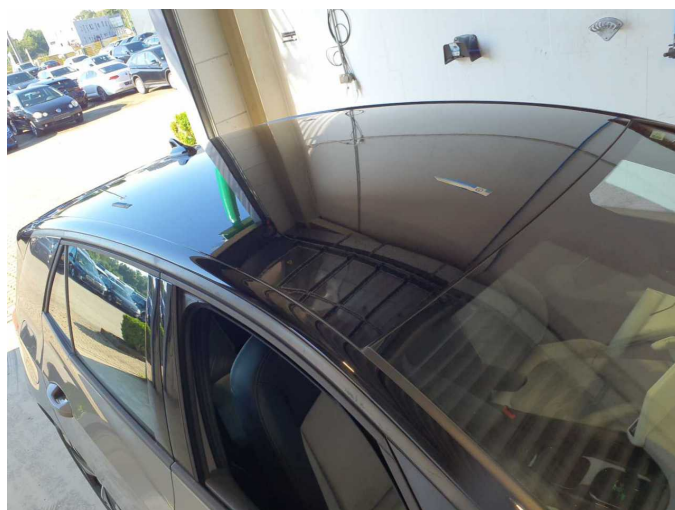
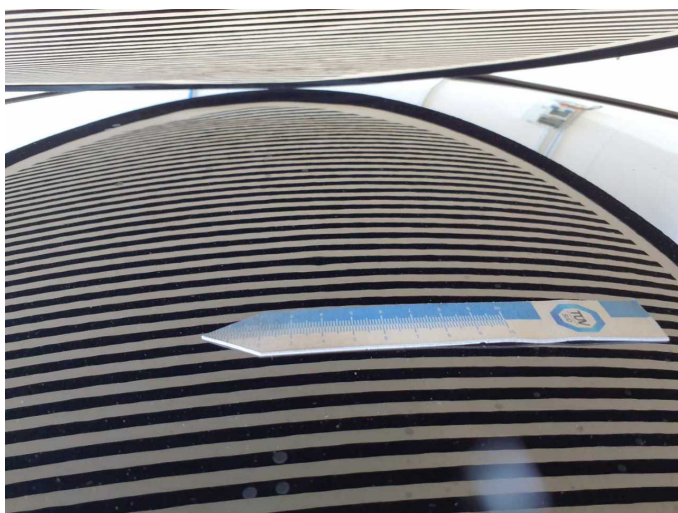
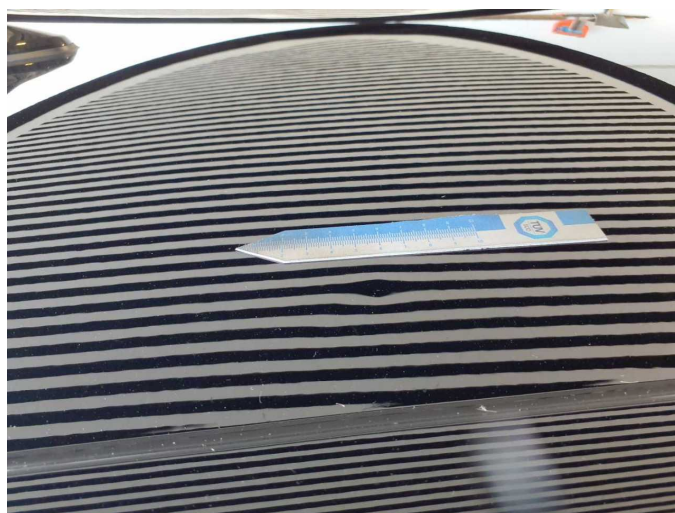
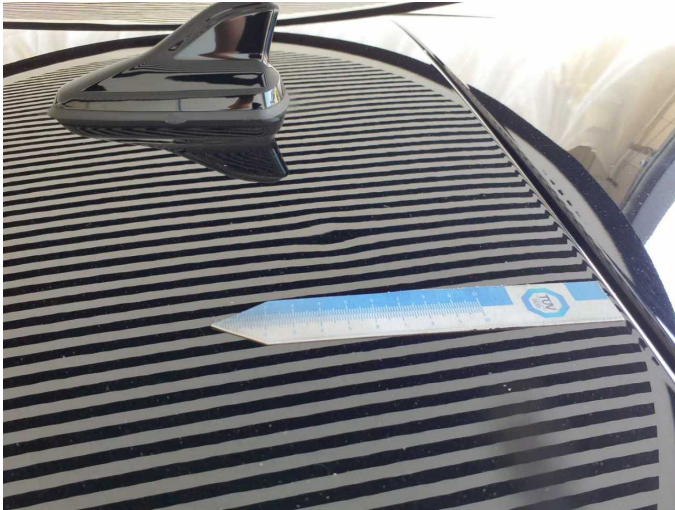
| No. | Component group | Description |
|---|---|---|
| 1 | Roof | Roof - dent(s) - Smooth repair work |

Damage 1: Roof: Roof - dent(s) - Smooth repair work

**Damage 1:** Roof: Roof - dent(s) - Smooth repair work

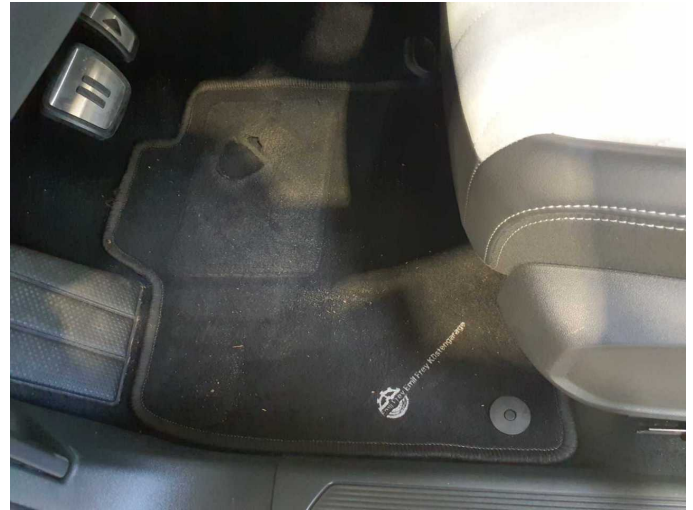
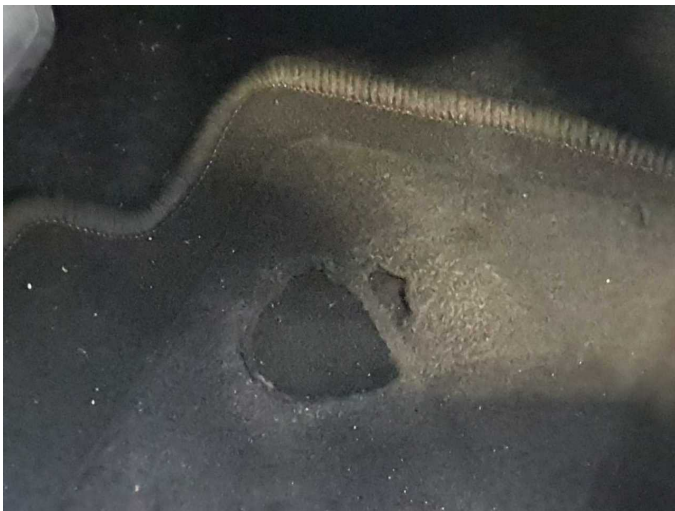
| No. | Component group | Description |
|---|---|---|
| 2 | Trim / covers | Floor mats (VL) - Holes - Replace |

**Damage 2:** Trim / covers: Floor mats (VL) - Holes - Replace

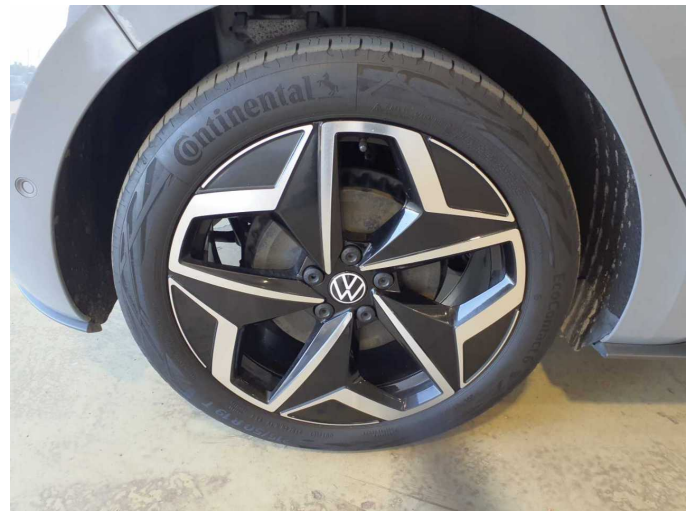
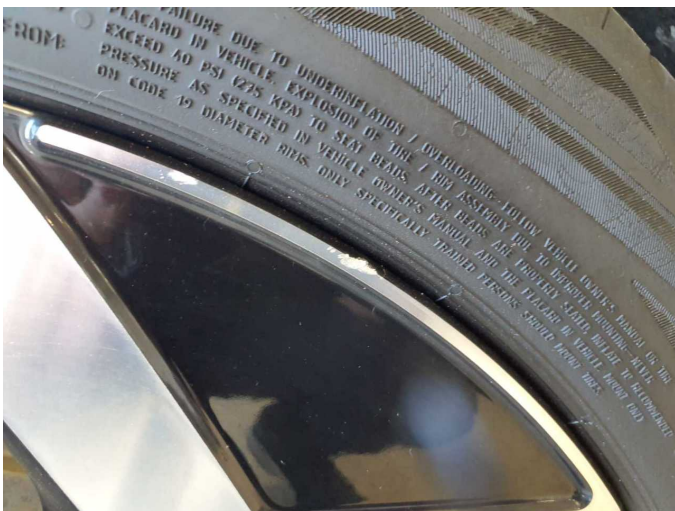
| No. | Component group | Description |
|---|---|---|
| 3 | Wheel / tyres | Alloy rim - rear right side - Scratch(es) - Loss in value |

**Damage 3:** Wheel / tyres: Alloy rim - rear right side - Scratch(es) - Loss in value

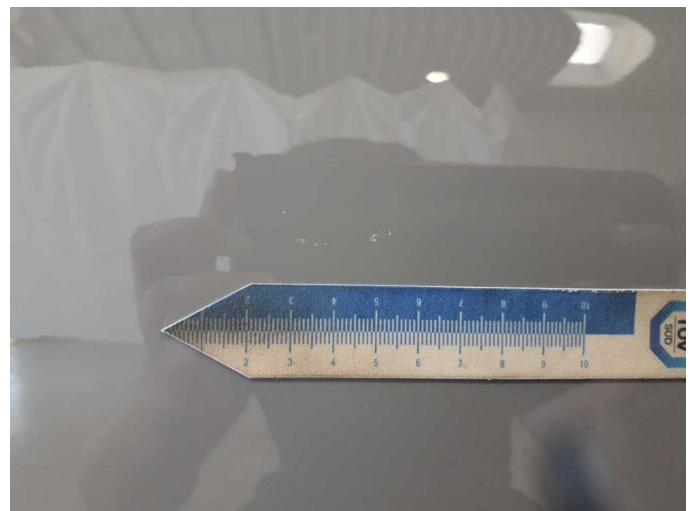
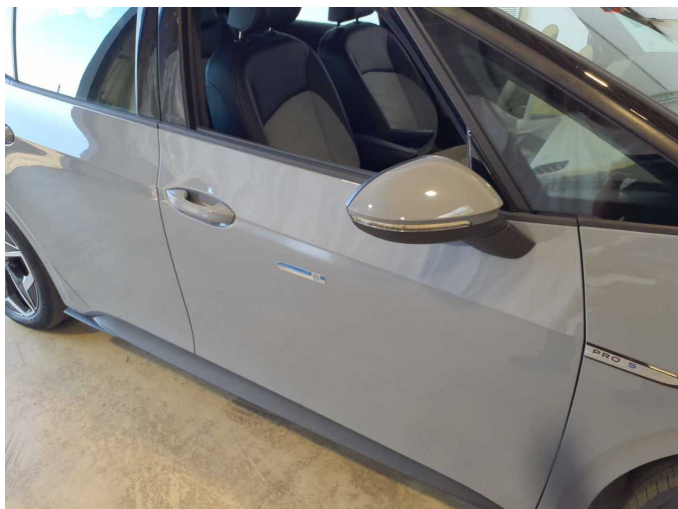
| No. | Component group | Description |
|---|---|---|
| 4 | Door - front right side | Door - Scratch(es) - Smart repair |

**Damage 4:** Door - front right side: Door - Scratch(es) - Smart repair

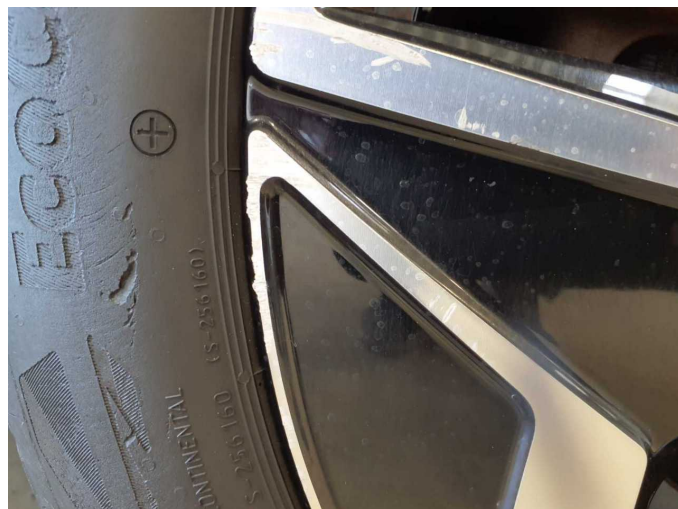
| No. | Component group | Description |
|---|---|---|
| 5 | Wheel / tyres | Tyre - front right side - Broken / torn - Replace |

**Damage 5:** Wheel / tyres: Tyre - front right side - Broken / torn - Replace

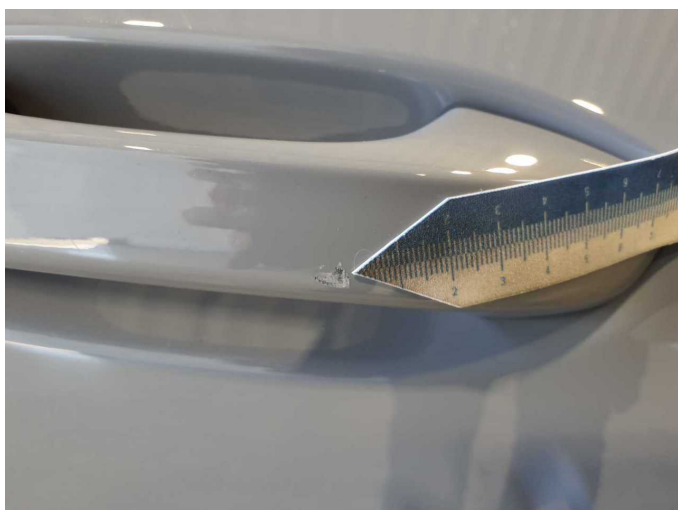
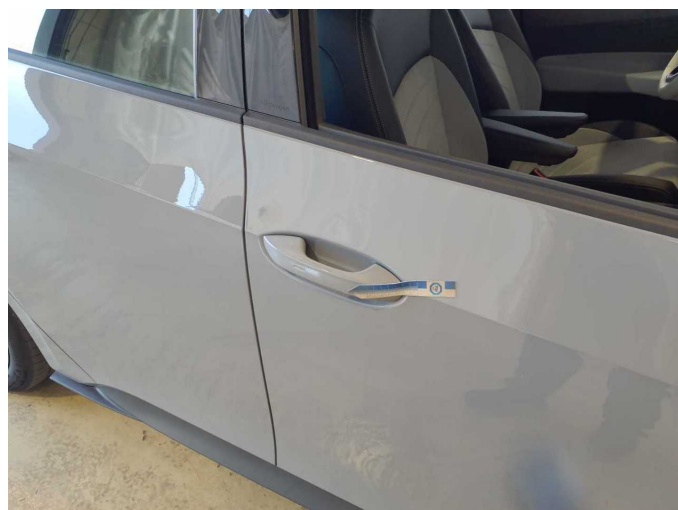
| No. | Component group | Description |
|---|---|---|
| 6 | Door - front right side | Door handle - outside - Scratch(es) - Paint |

**Damage 6:** Door - front right side: Door handle - outside - Scratch(es) - Paint

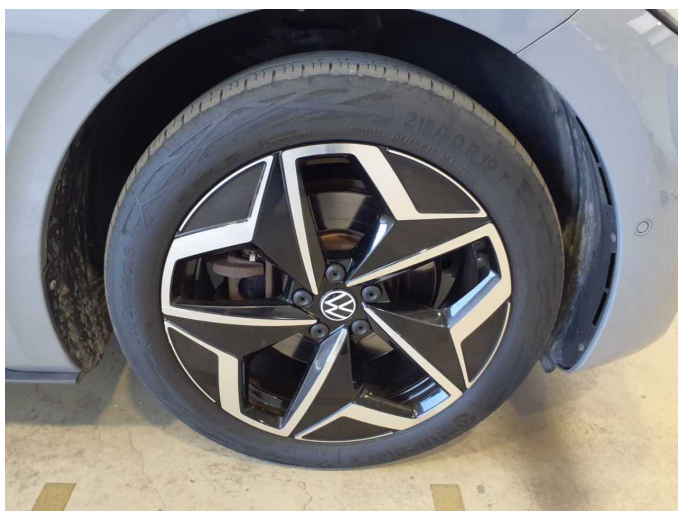
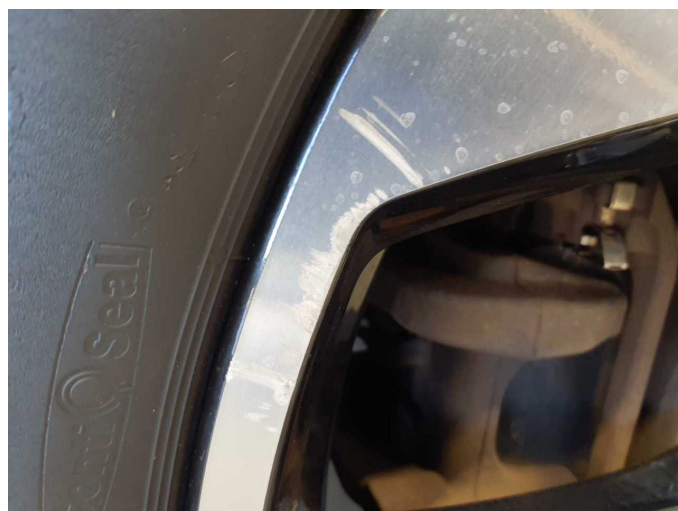
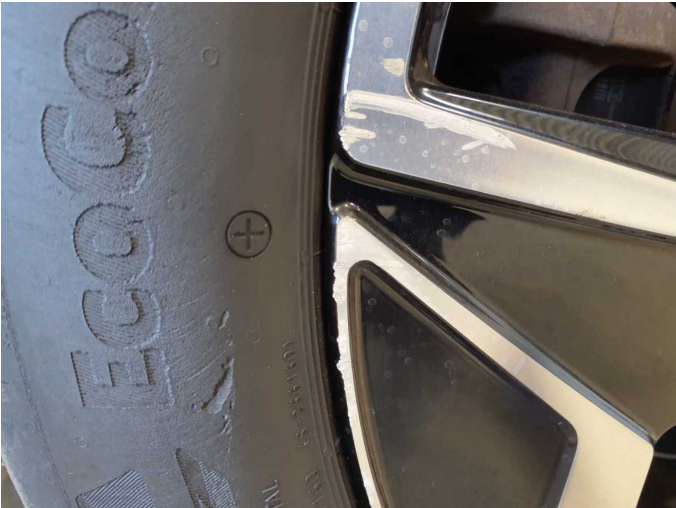
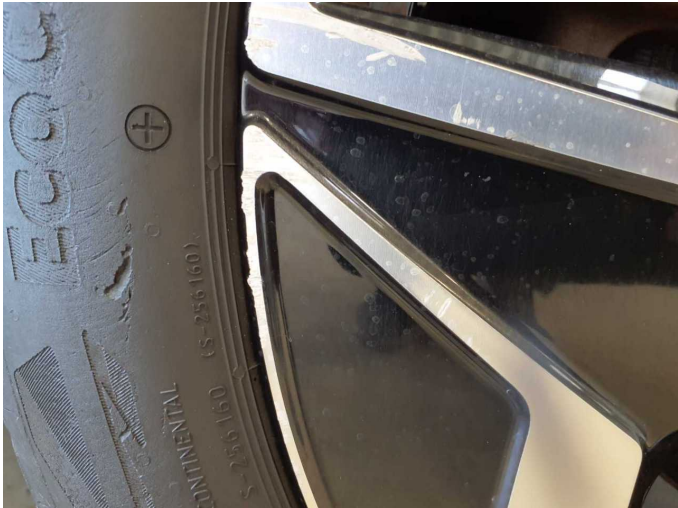
| No. | Component group | Description |
|---|---|---|
| 7 | Wheel / tyres | Alloy rim - front right side - Scratch(es) - Replace |

**Damage 7:** Wheel / tyres: Alloy rim - front right side - Scratch(es) - Replace

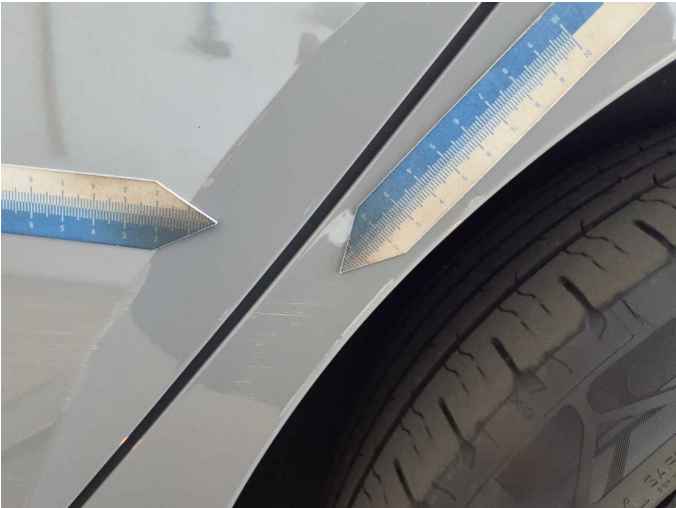
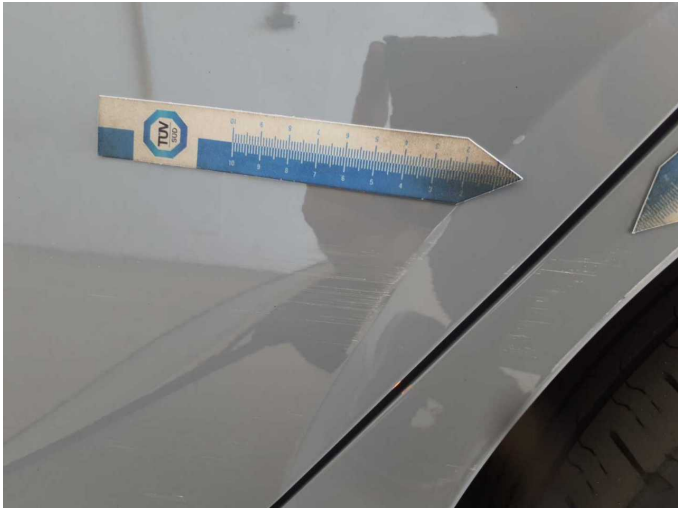
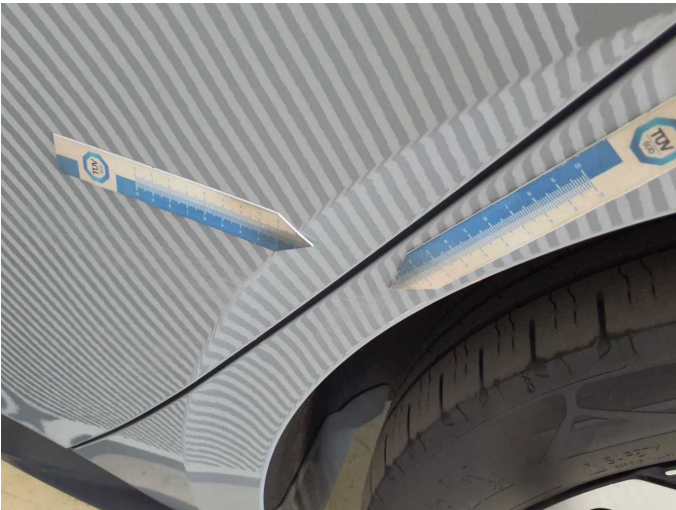
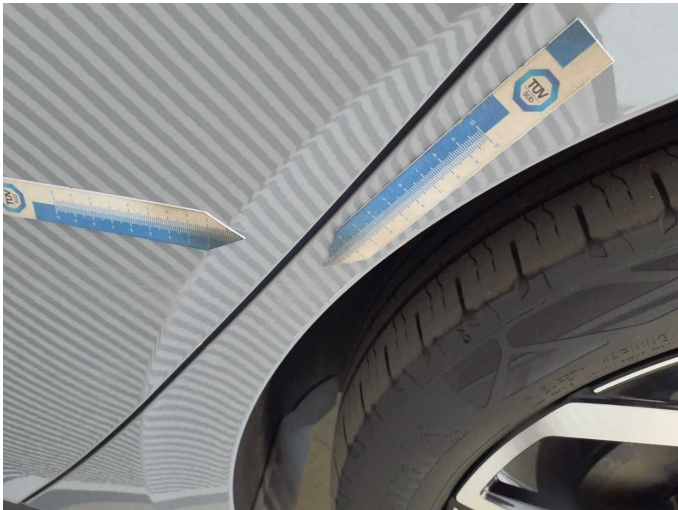
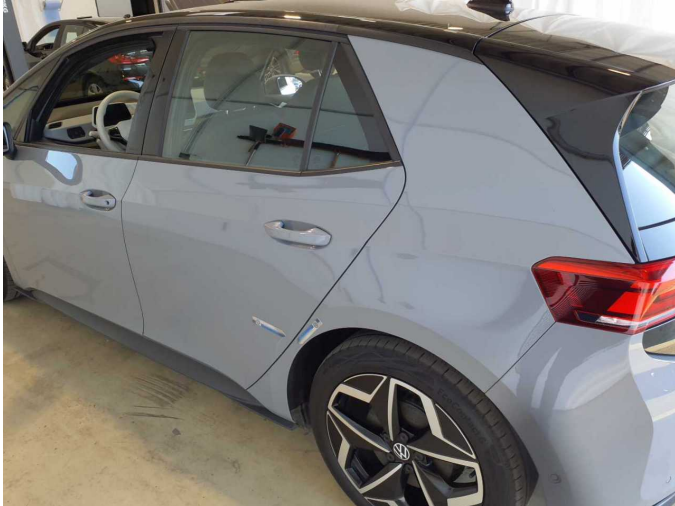
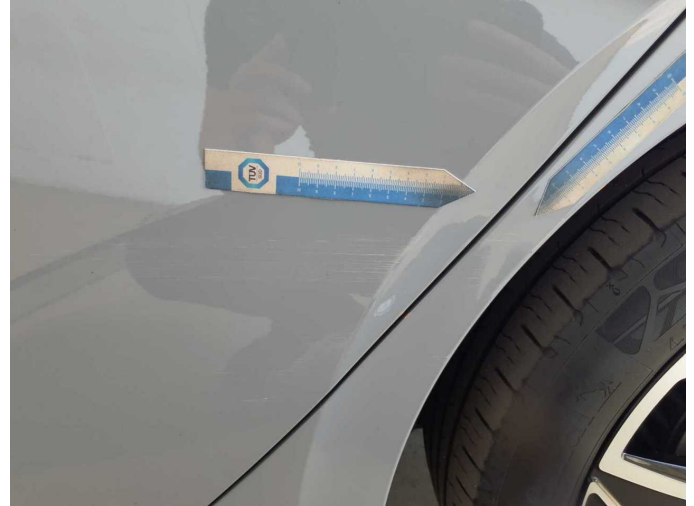
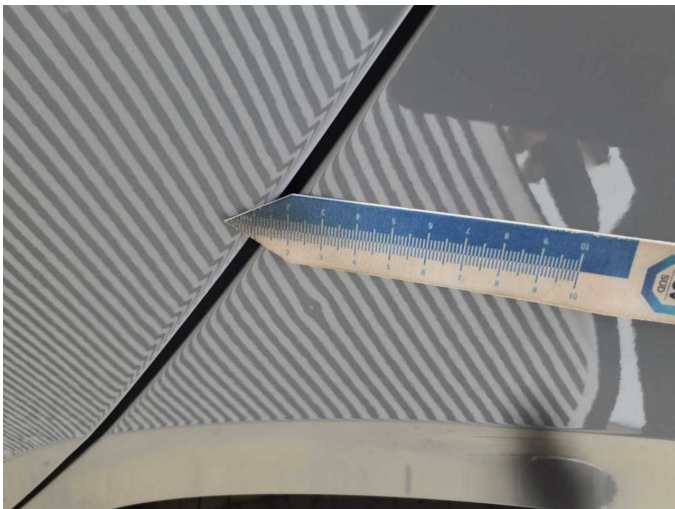
| No. | Accident |
|---|---|
| 1 | Side - left |

Non-repaired previous damages were found at the vehicle. The necessary repair costs are listed in the expert report or if necessary, are listed in detail in a separately enclosed repair cost calculation.

**Accident 1:** Side - left

**Accident 1: Side - left**
