Expertise

Protocol number: 45439904
Order No. / Reference: 26165348
Inspection date: 13 May 2026

Manufacturer: Seat

Model: Ateca 2.0 TDI DSG Style

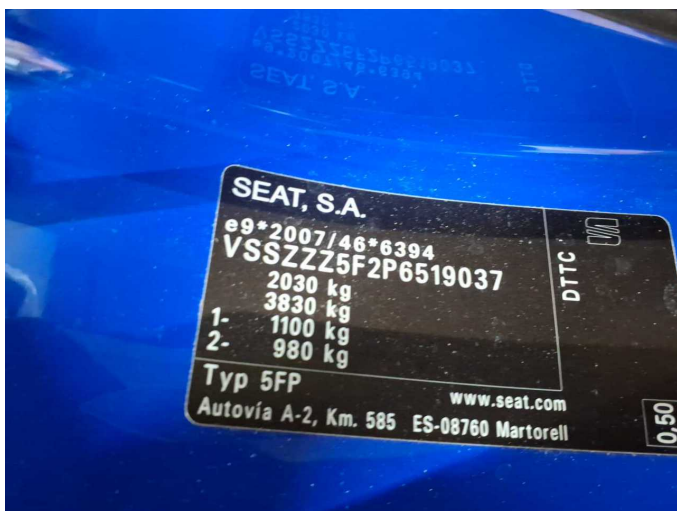
Figure 11: VIN

Documents submitted	At the time of the inspection, the vehicle registration certificate Part 2 (title) was available, but the vehicle registration certificate Part 1 (document) was not. (Copy)
VIN comparison	The vehicle identification number (VIN) was read from the vehicle and its conformity with the submitted documents was confirmed by the undersigned during the inspection.
Inspection	The inspection conditions were sufficient for the assessment of the vehicle. Lifting equipment and/or a pit were available for examining the vehicle.
Test drive	No test drive/shunting maneuver was carried out during the inspection of the vehicle.
Engine function test	An engine test run was performed.

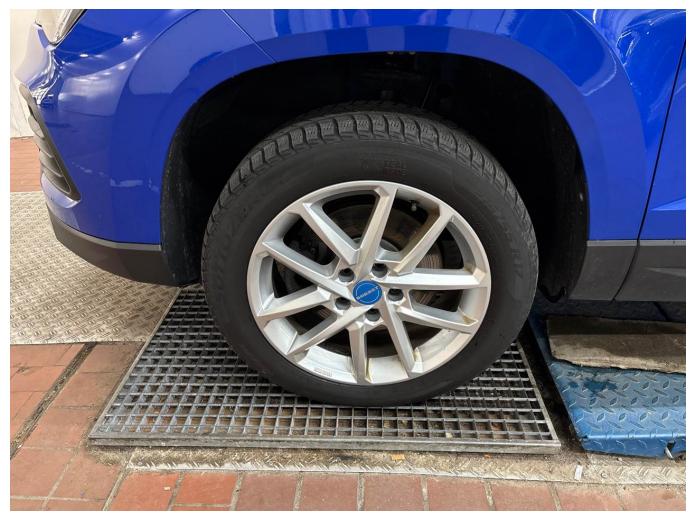
Figure 12: Mounted tyres

#	Tyre size	Type of tyre	Manufacturer	Tread depth
1)	215/55 R17 94H	Winter tyres on Light alloy	Pirelli	4mm / 4mm
2)	215/55 R17 94H	Winter tyres on Light alloy	Pirelli	7mm / 7mm

No.	Component group	Description
1	Wheel / tyres	Tyre - front - Does not meet the leasing specifications - No deduction
2	Bonnet	Bonnet - dent(s) - No deduction
3	Body	Body - Scratch(es) - No deduction

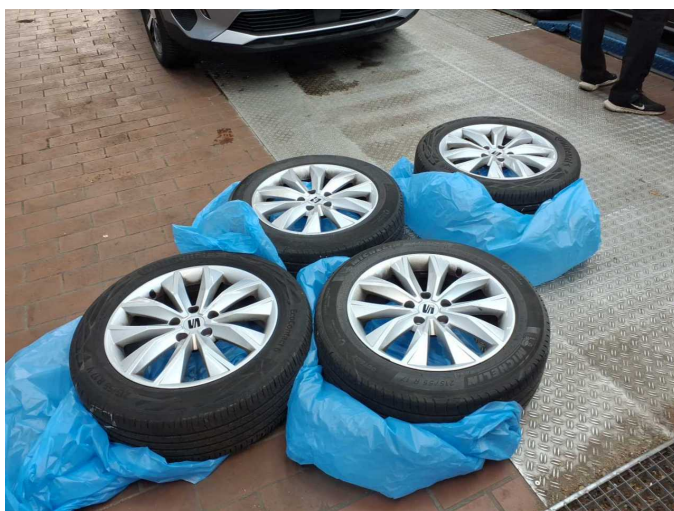
Figure 17: Additional tyres

#	Tyre size	Type of tyre	Manufacturer	Tread depth
1)	215/55 R17 94V	Summer tyres on Light alloy	Continental	6mm / 6mm
2)	215/55 R17 94V	Summer tyres on Light alloy	Continental	6mm / 6mm

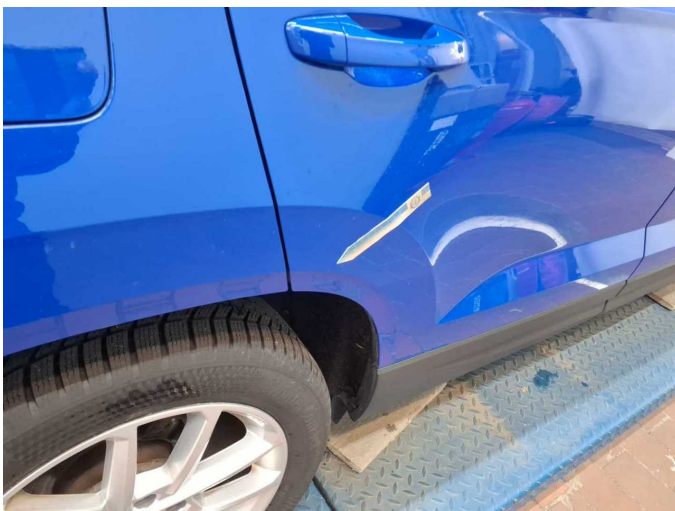
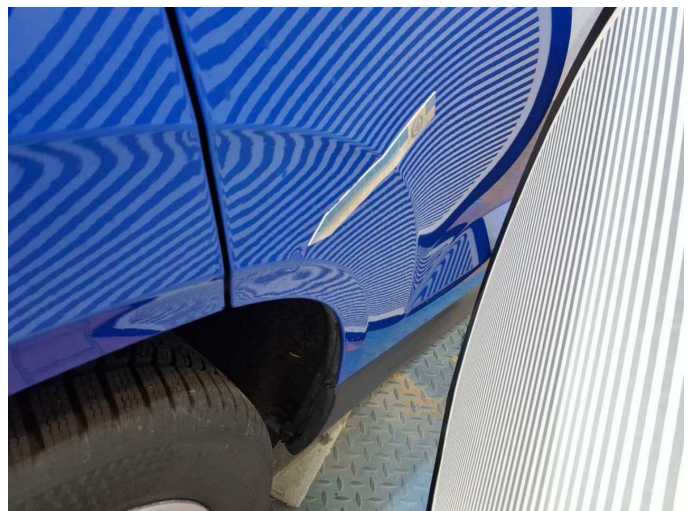
Damage 3: Door - rear right side: Door - dent(s) - Smart repair

No.	Component group	Description
1	Braking system	Brake fluid - No evidence - No deduction
2	Misc.	Inspection / maintenance - No evidence - No deduction
3	Door - rear right side	Door - dent(s) - Smart repair
4	Front bumper	Front bumper (Blende) - Deformed - Replace
5	Roof	Roof (Verätzungen) - Paint defect - Paint

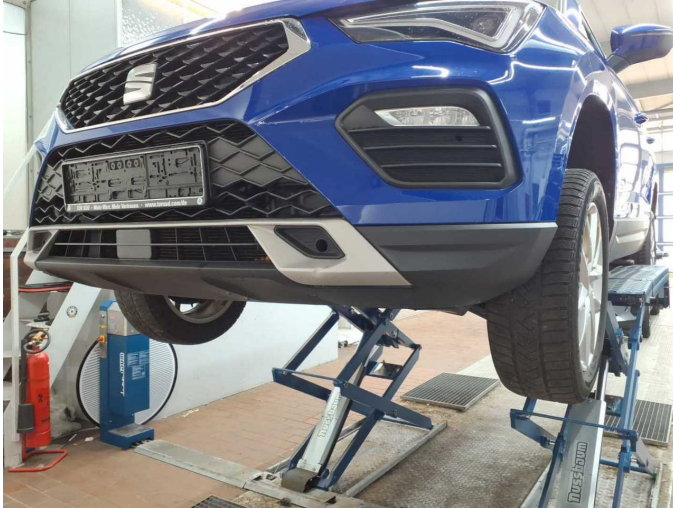
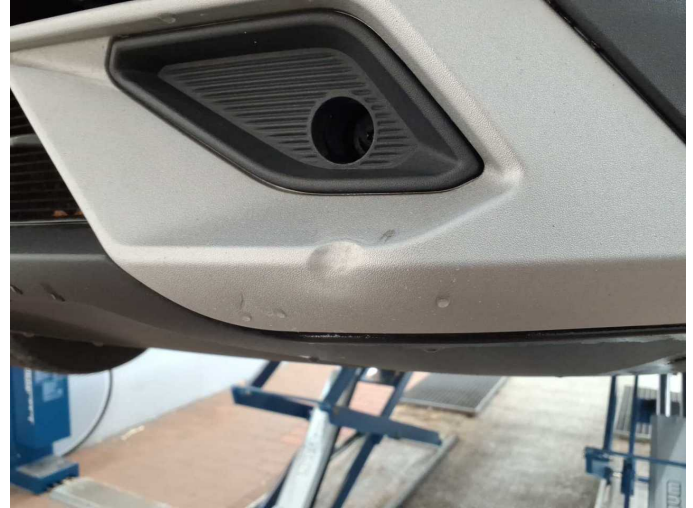
Damage 4: Front bumper: Front bumper (Blende) - Deformed - Replace

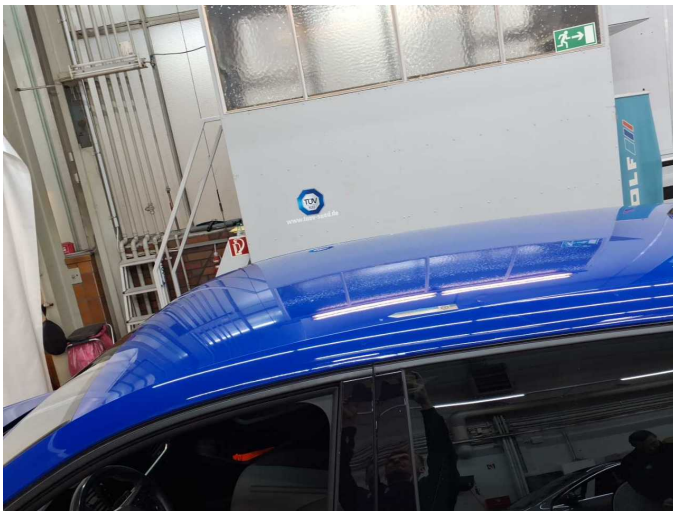
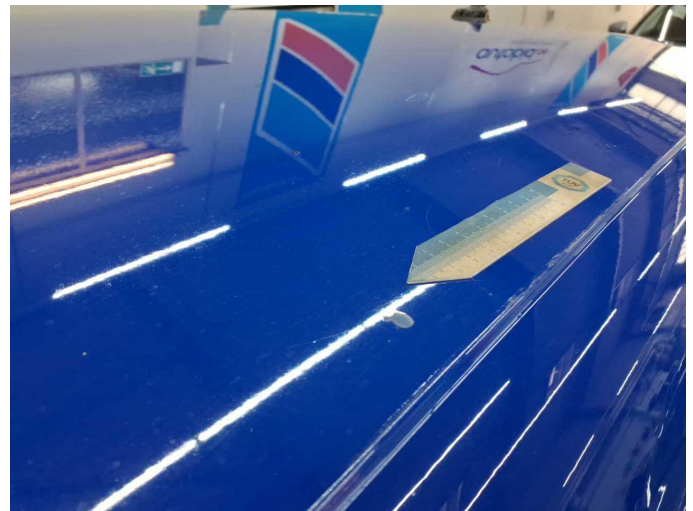
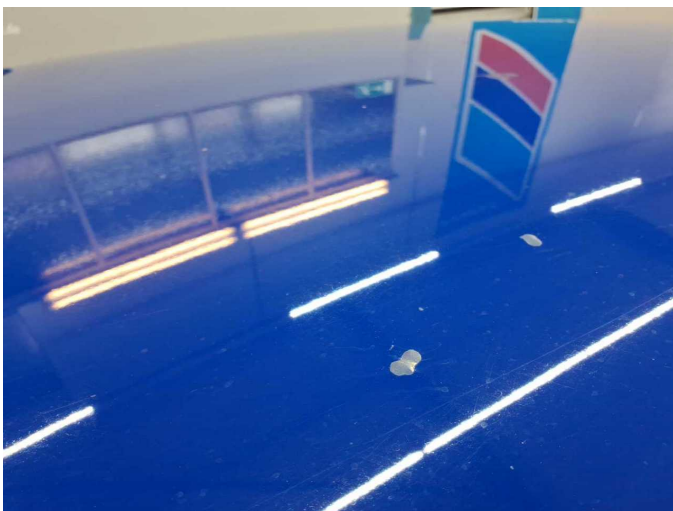
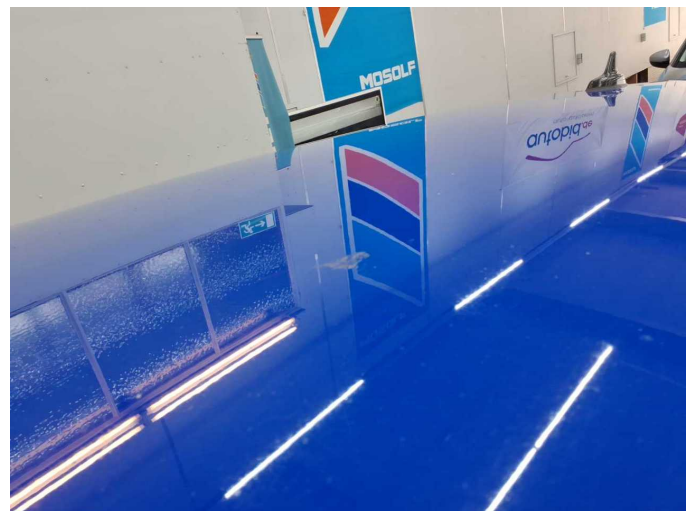
Damage 5: Roof: Roof (Verätzungen) - Paint defect - Paint
