Expertise

Protocol number: 46712766  
Order No. / Reference: 26512528  
Inspection date: 17 Jul 2026

Manufacturer: Volvo

Model: XC90 B5 D AWD Plus Dark

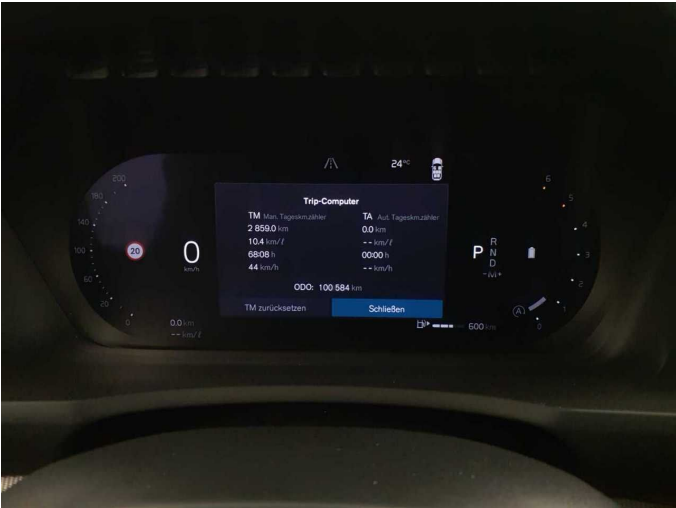
Figure 7: Instrument cluster

| Vehicle details | |
|---|---|
| Mileage (Read) | 100,584 km |

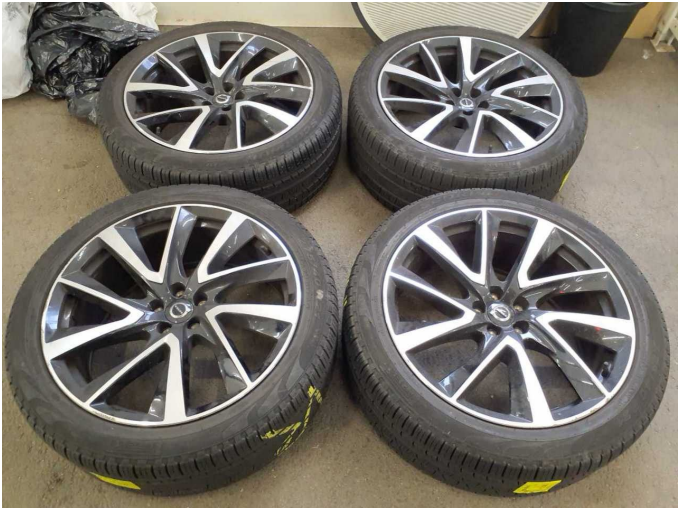
Figure 16: Additional tyres

| No. | Component group | Description |
|---|---|---|
| 9 | 2nd wheel set | 1 tyre - Broken / torn - Replace |

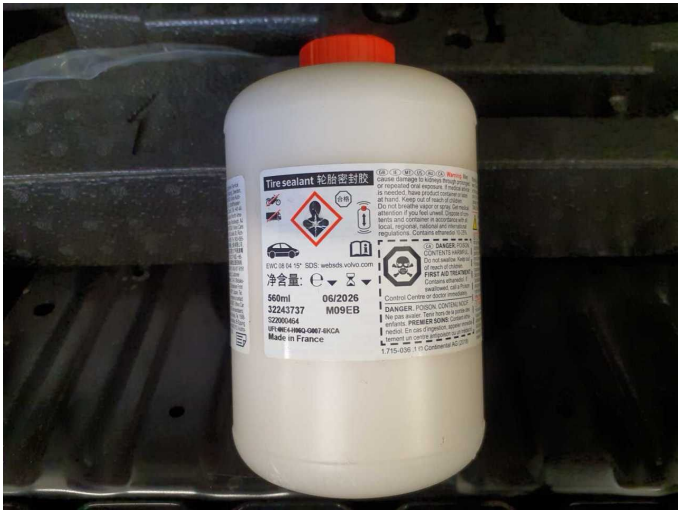
| No. | Component group | Description |
|---|---|---|
| 1 | Equipment | Tirefit filler - Expired - Replace |

Damage 1: Equipment: Tirefit filler - Expired - Replace

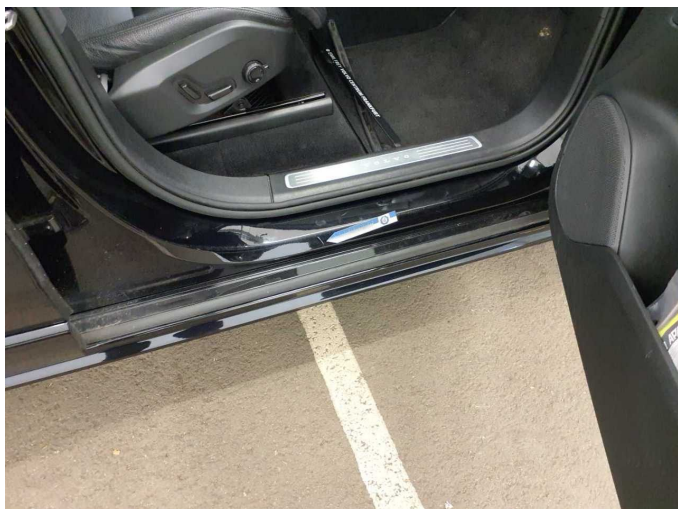
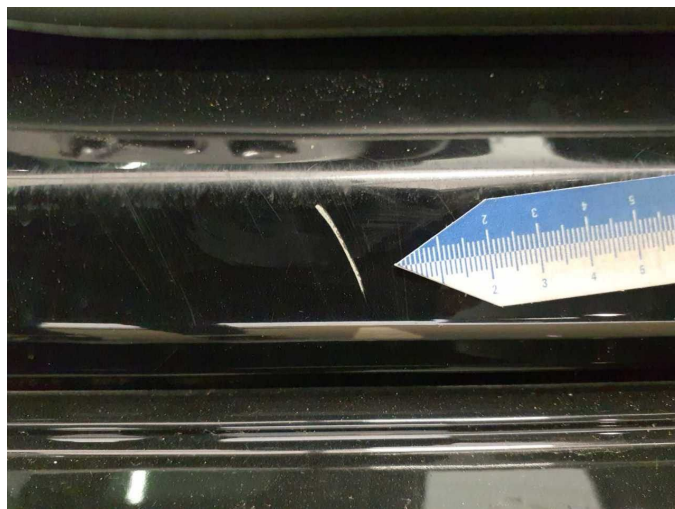
| No. | Component group | Description |
|---|---|---|
| 2 | Sill - right side | Sill - Scratch(es) - Smart repair |

**Damage 2:** Sill - right side: Sill - Scratch(es) - Smart repair

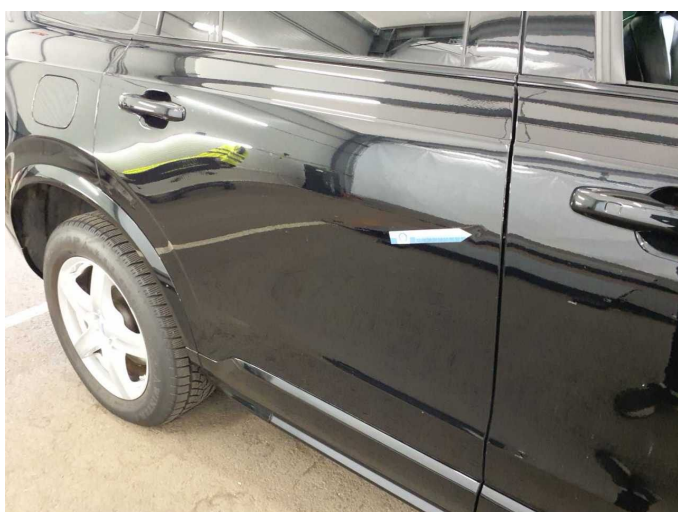
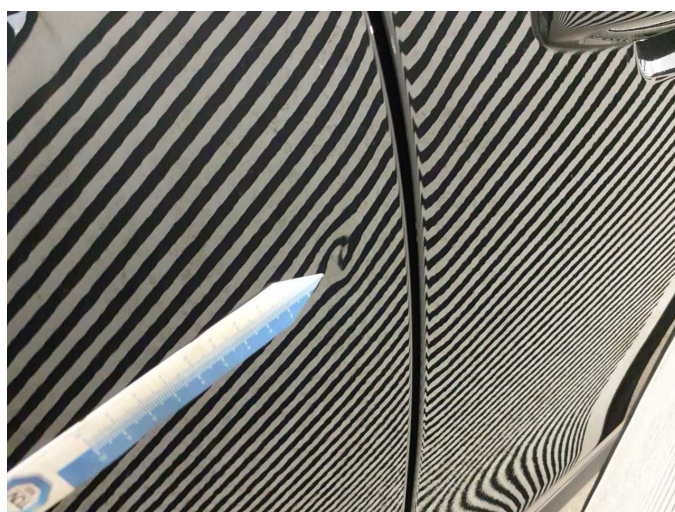
| No. | Component group | Description |
|---|---|---|
| 3 | Door - rear right side | Door - dent(s) - Smart repair |

**Damage 3:** Door - rear right side: Door - dent(s) - Smart repair

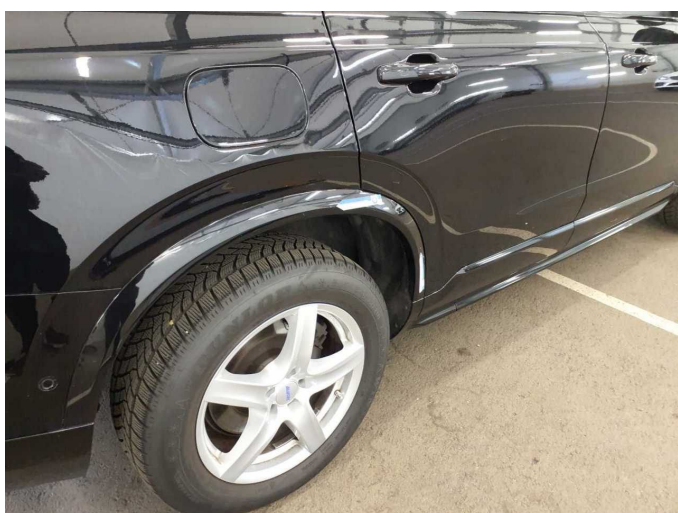
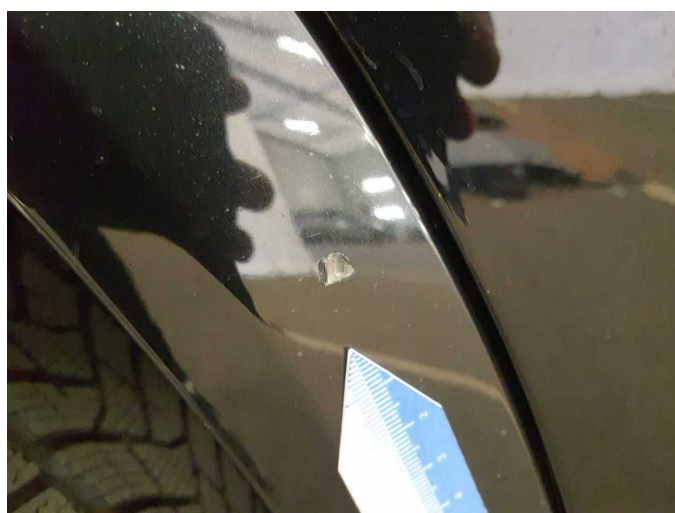
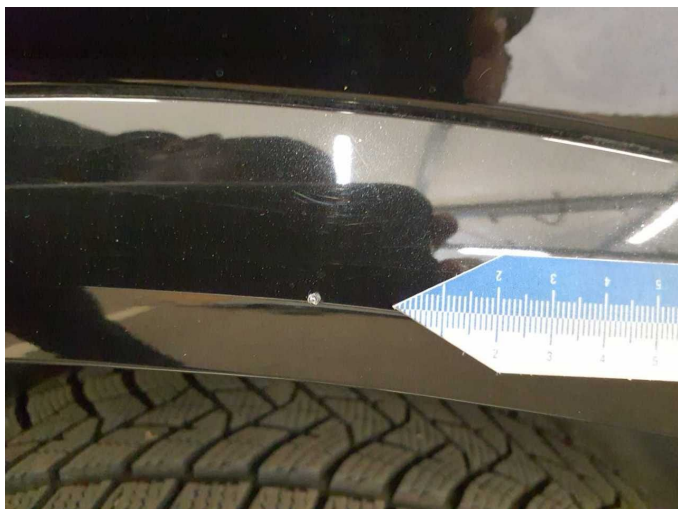
| No. | Component group | Description |
|---|---|---|
| 4 | Side panel - rear right side | Wheel well extension - Stone chips - Smart repair |

**Damage 4:** Side panel - rear right side: Wheel well extension - Stone chips - Smart repair

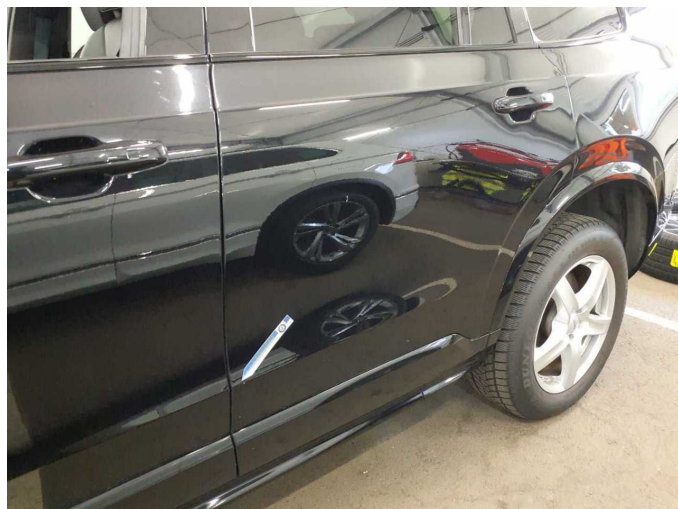
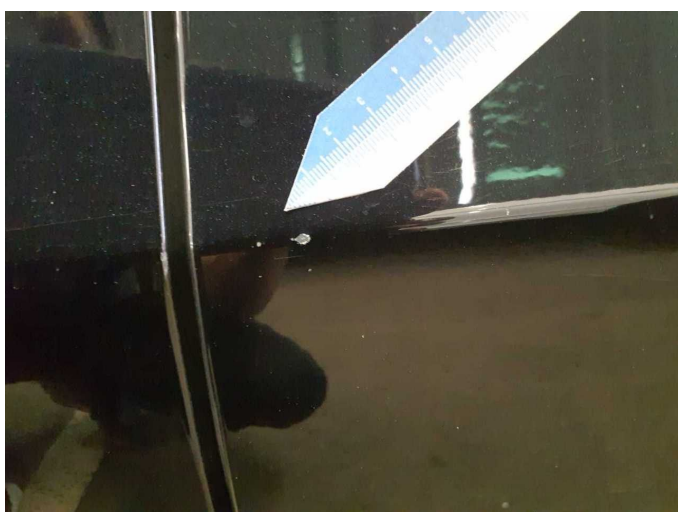
| No. | Component group | Description |
|---|---|---|
| 5 | Door - rear left side | Door - Stone chips - Smart repair |

**Damage 5:** Door - rear left side: Door - Stone chips - Smart repair

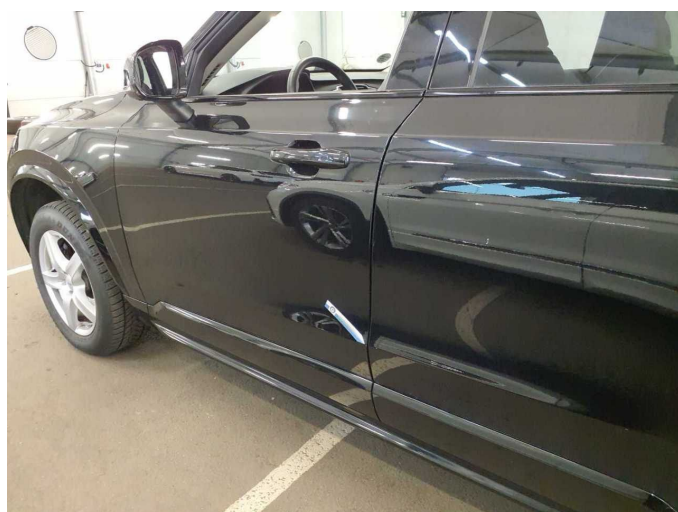
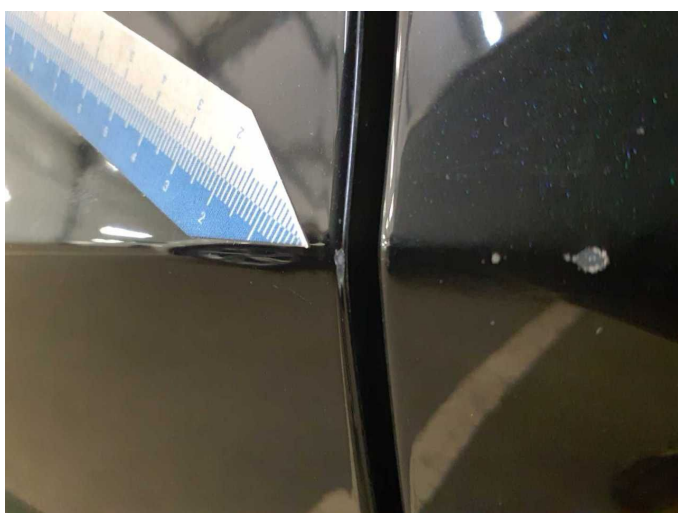
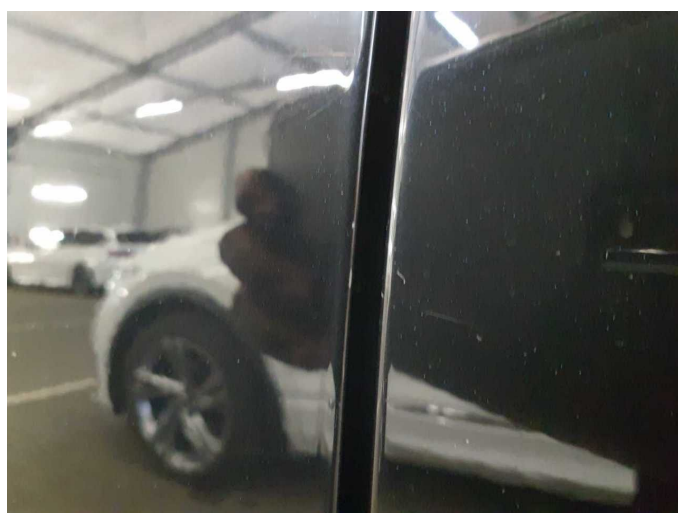
| No. | Component group | Description |
|---|---|---|
| 6 | Door - front left side | Door edge - Scratch(es) - Smart repair |

**Damage 6:** Door - front left side: Door edge - Scratch(es) - Smart repair

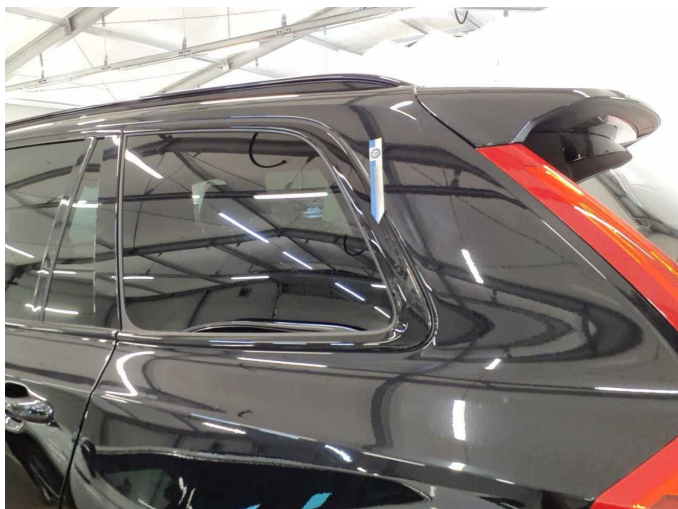
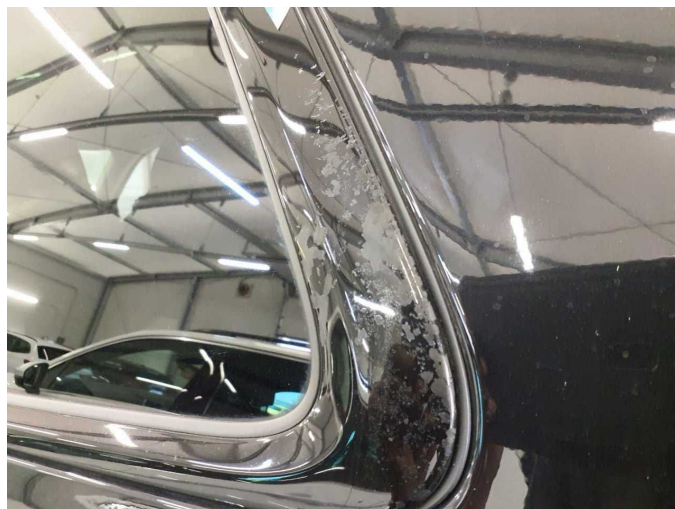
| No. | Component group | Description |
|---|---|---|
| 7 | Trim / covers | Brightware / decorative strip - Paint defect - Replace |

**Damage 7:** Trim / covers: Brightware / decorative strip - Paint defect - Replace

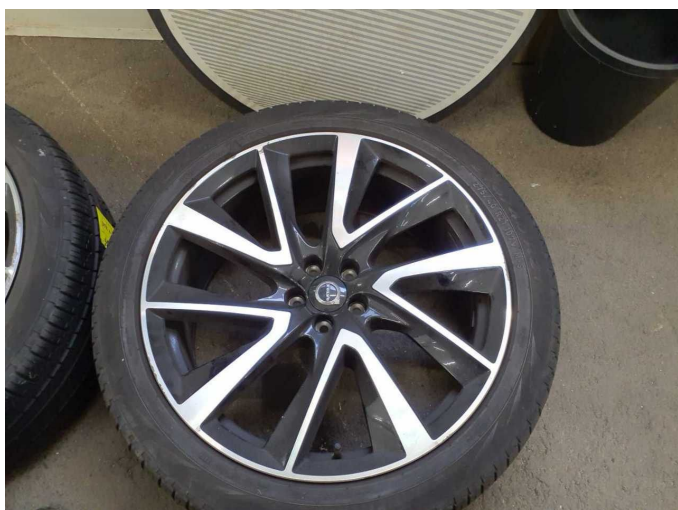
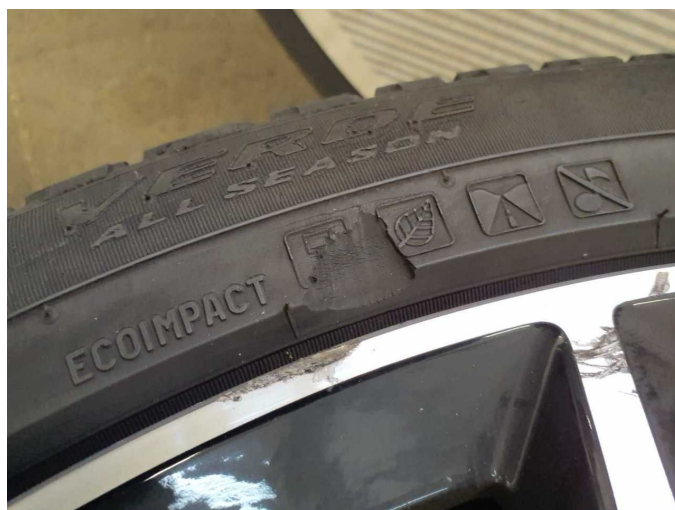
**Damage 9:** 2nd wheel set: 1 tyre - Broken / torn - Replace

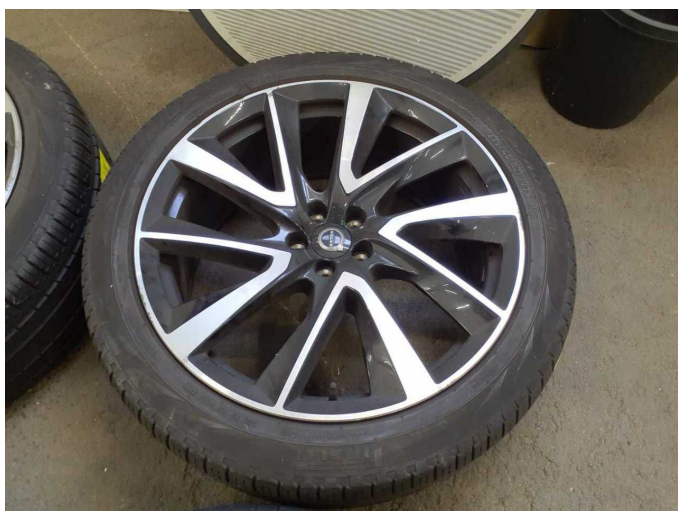
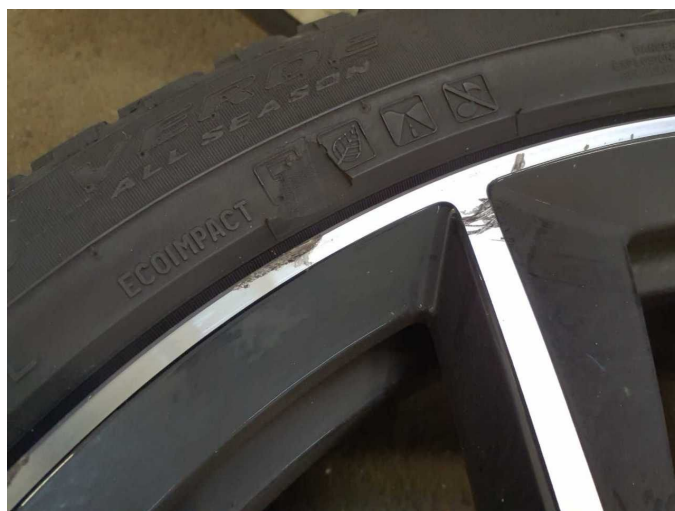
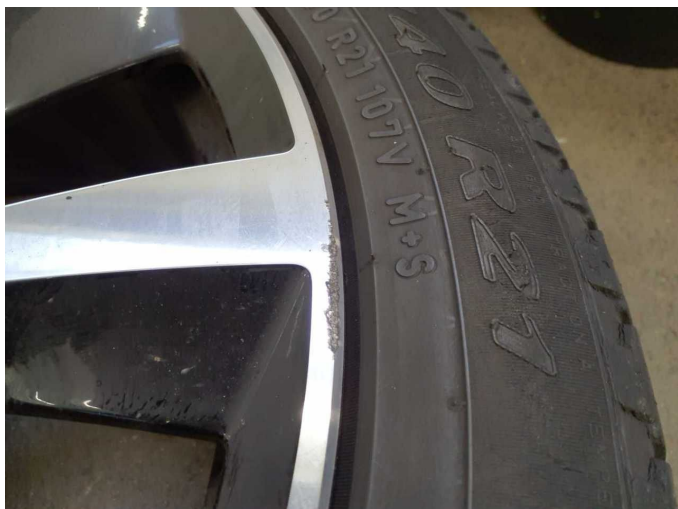
| No. | Component group | Description |
|---|---|---|
| 10 | 2nd wheel set | 1 alloy rim - Scratched - Loss in value |

Die Felgen wurden aufgrund der Laufleistung gemindert.

**Damage 10:** 2nd wheel set: 1 alloy rim - Scratched - Loss in value

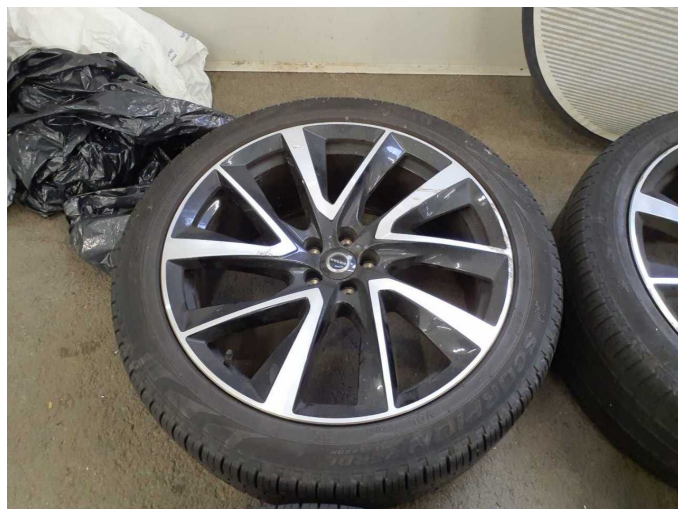
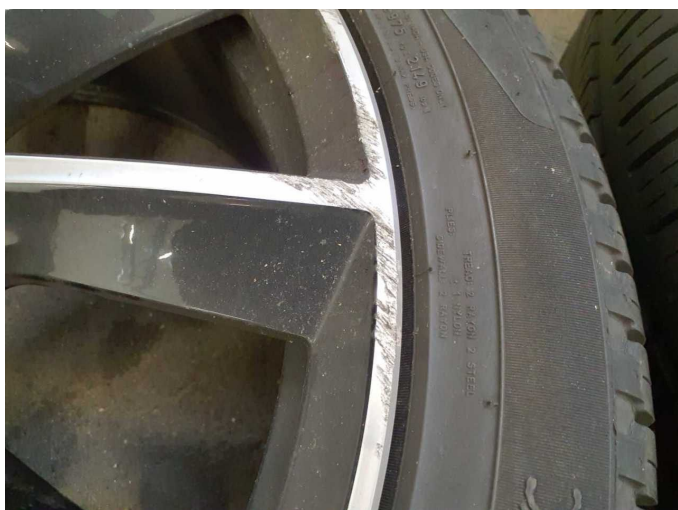
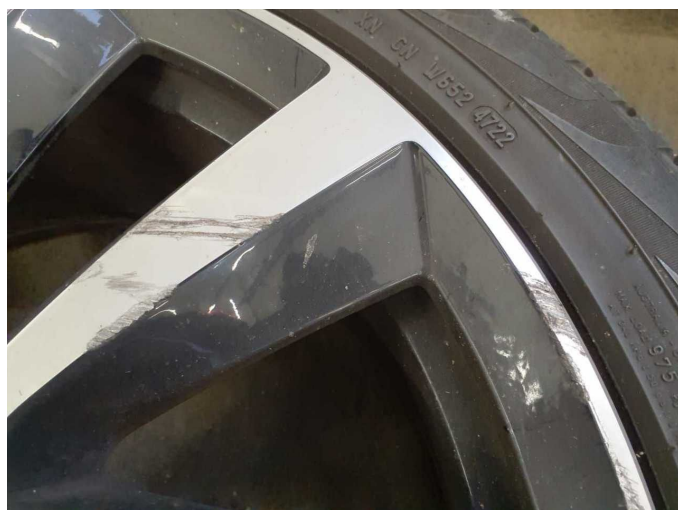
| No. | Component group | Description |
|---|---|---|
| 11 | 2nd wheel set | 1 alloy rim - Scratched - Loss in value |

**Damage 11:** 2nd wheel set: 1 alloy rim - Scratched - Loss in value

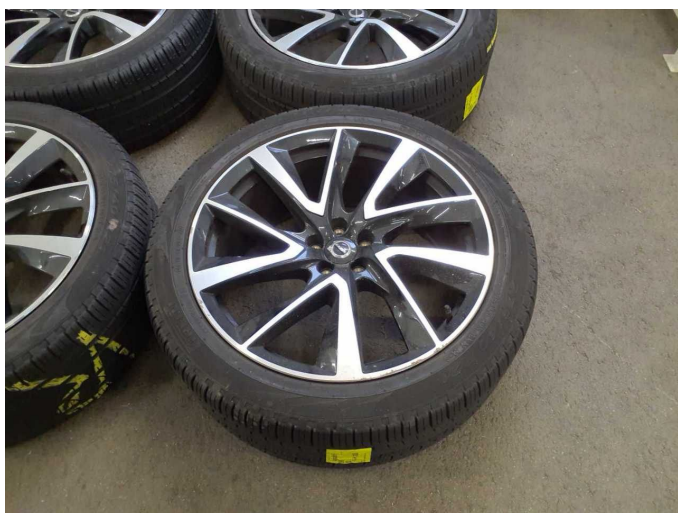
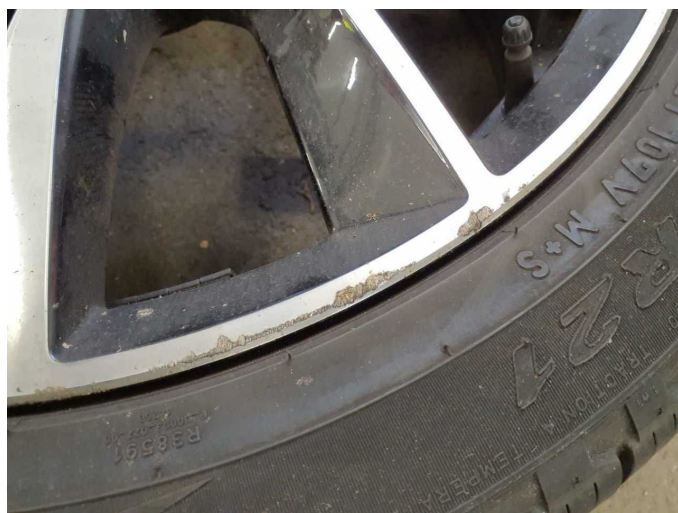
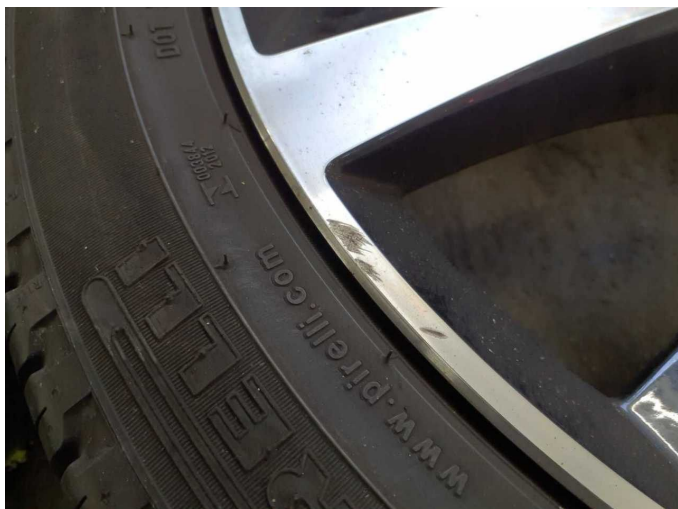
| No. | Component group | Description |
|---|---|---|
| 12 | 2nd wheel set | 1 alloy rim - Scratched - Loss in value |

**Damage 12:** 2nd wheel set: 1 alloy rim - Scratched - Loss in value

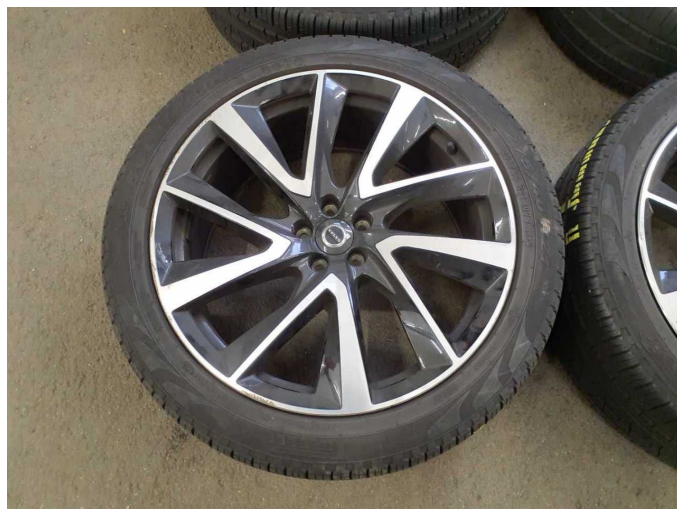
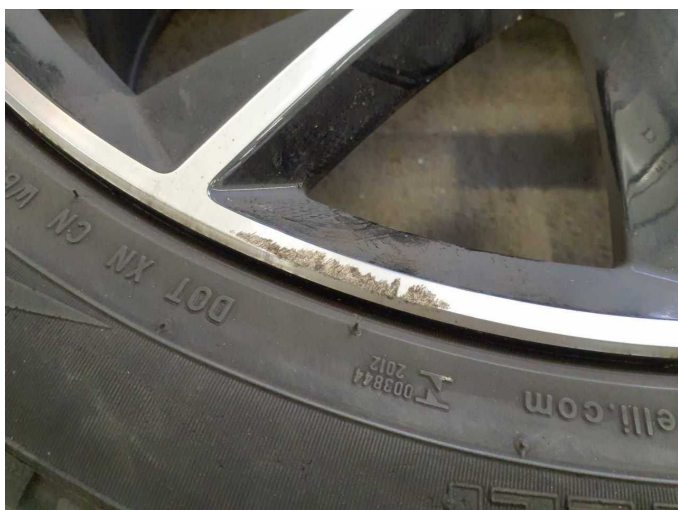
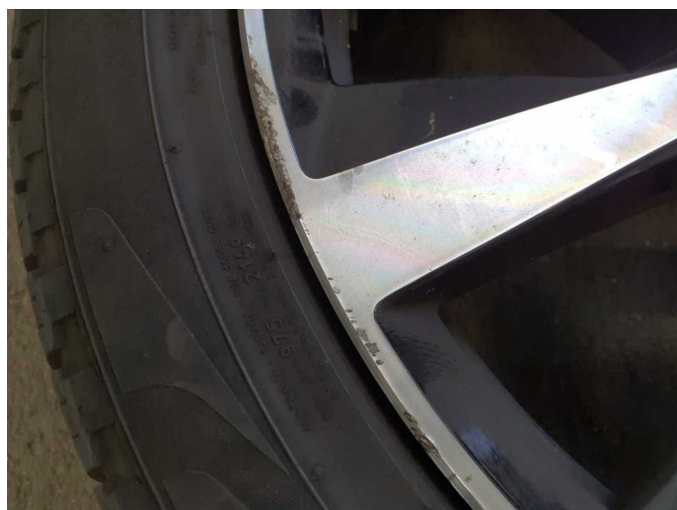
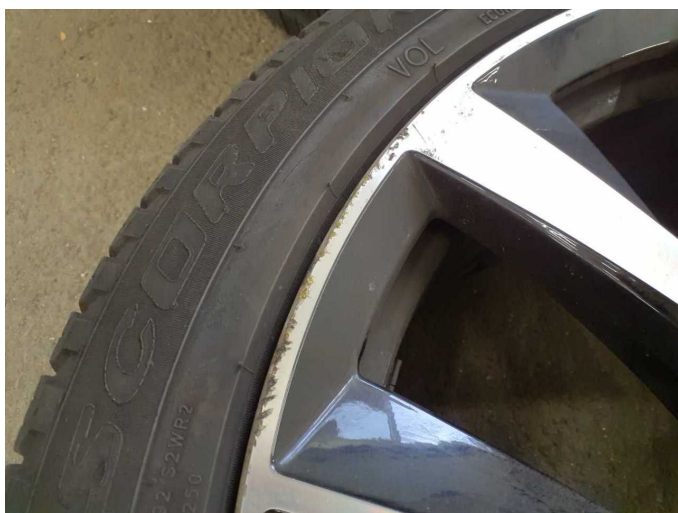
| No. | Component group | Description |
|---|---|---|
| 13 | 2nd wheel set | 1 alloy rim - Scratched - Loss in value |

**Damage 13:** 2nd wheel set: 1 alloy rim - Scratched - Loss in value
