Expertise

Protocol number: 46343658
Order No. / Reference: 26500933
Inspection date: 6 Jul 2026

Manufacturer: DS

Model: 7 Crossback BlueHDI 130 Aut. PERFORMANCE LINE +

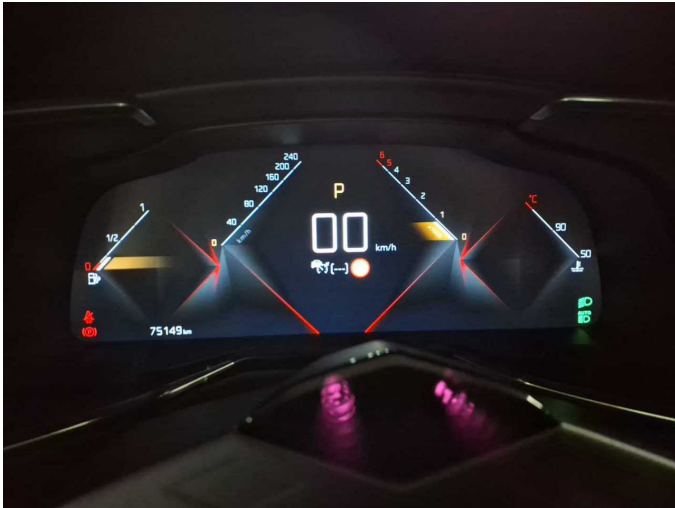
Figure 7: Instrument cluster

Mileage (Read) 75,149 km

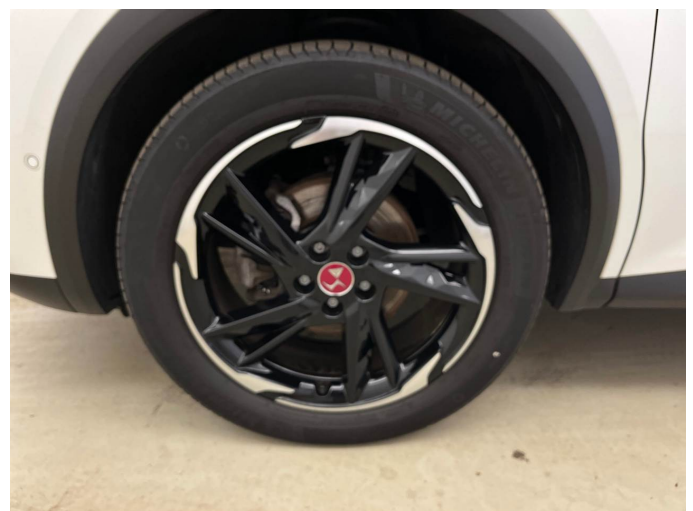
Figure 12: Mounted tyres

#	Tyre size	Type of tyre	Manufacturer	Tread depth
1)	235/50 R19 103V	Summer tyres on Light alloy	Michelin	5mm / 5mm
2)	235/50 R19 103V	Summer tyres on Light alloy	Michelin	5mm / 5mm

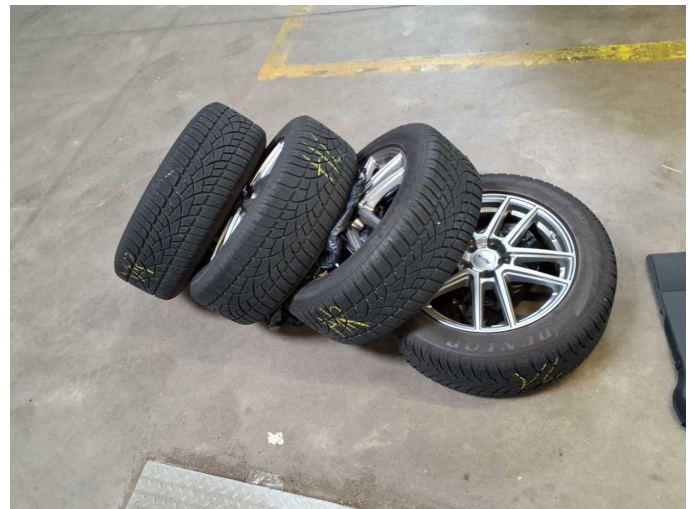
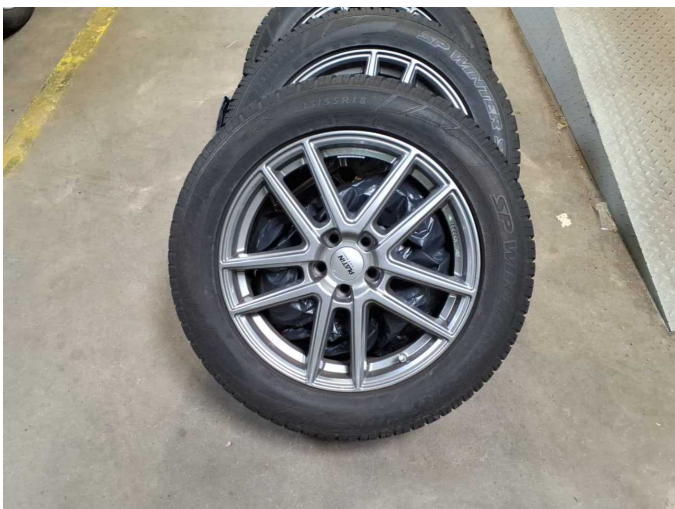
#	Tyre size	Type of tyre	Manufacturer	Tread depth
1)	235/55 R18 100H	Winter tyres on Light alloy	Dunlop	5mm / 5mm
2)	235/55 R18 100H	Winter tyres on Light alloy	Dunlop	5mm / 5mm

Figure 16: Additional tyres

Figure 17: Additional tyres

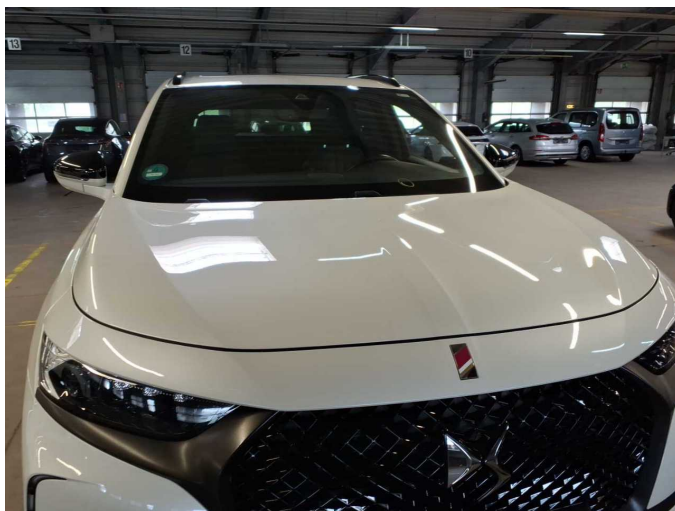
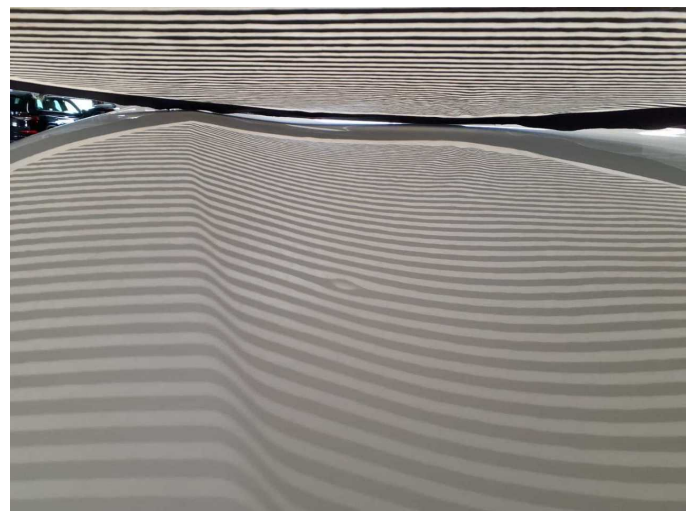
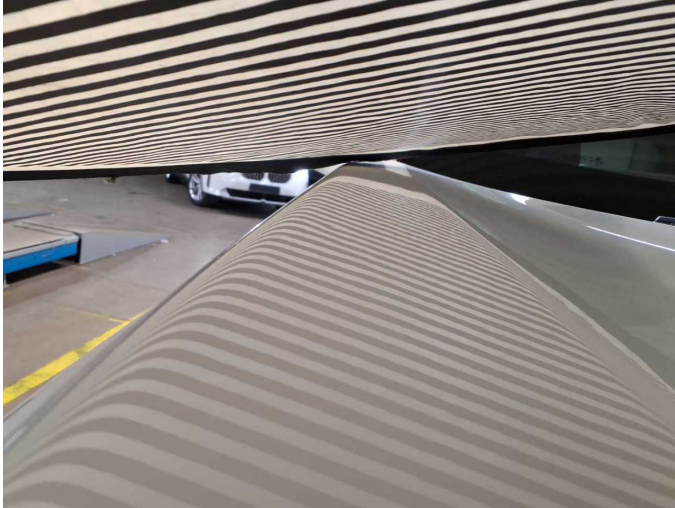
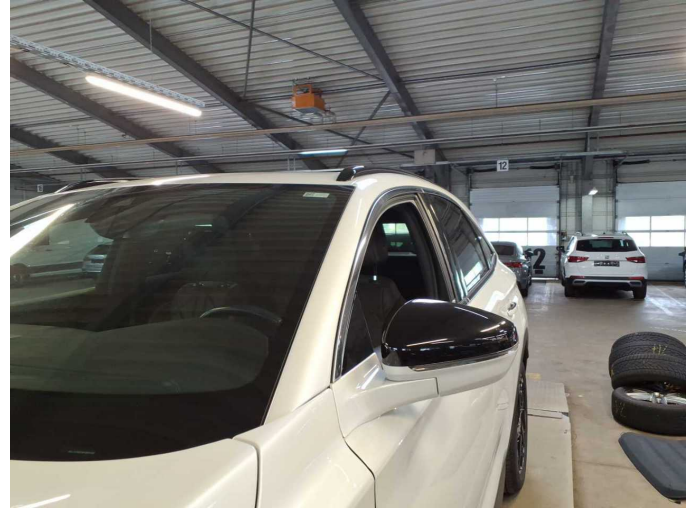
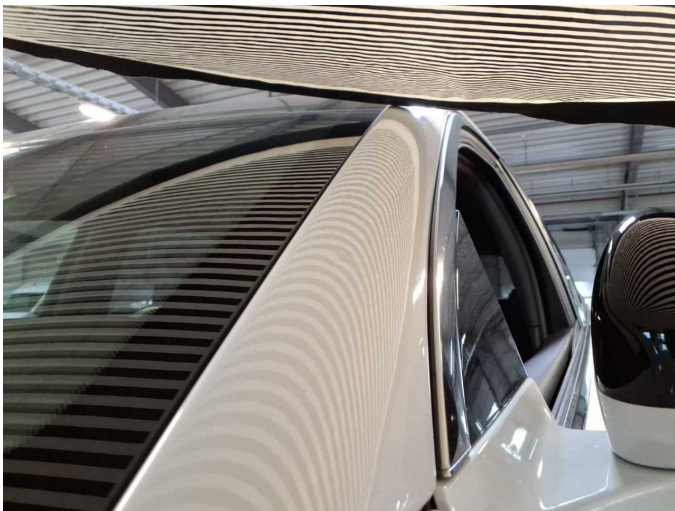
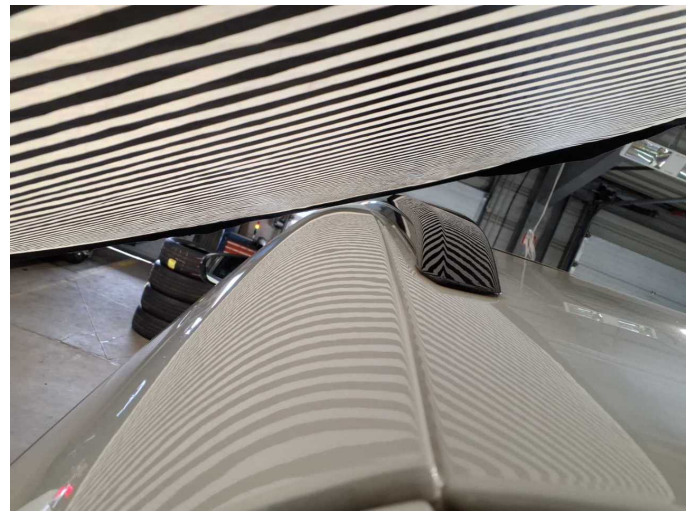
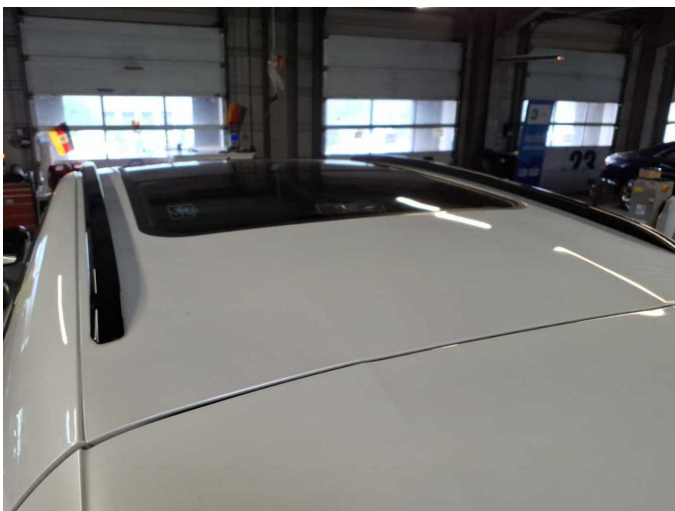
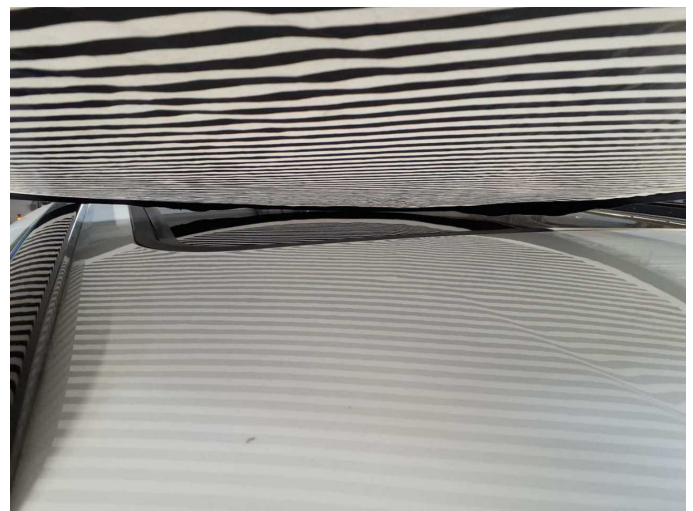
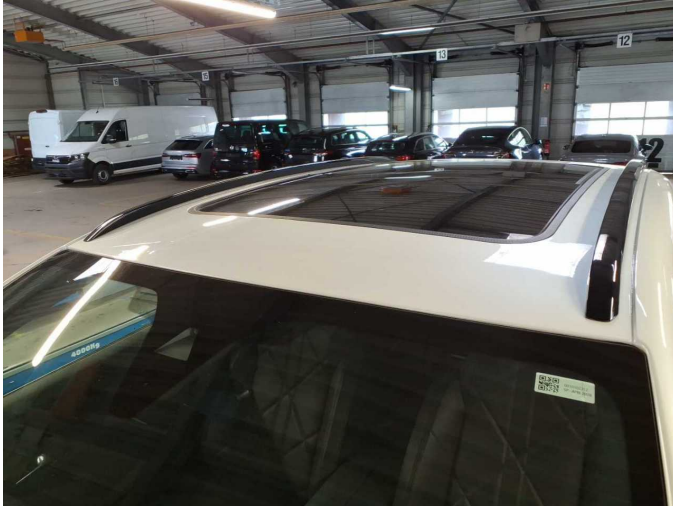
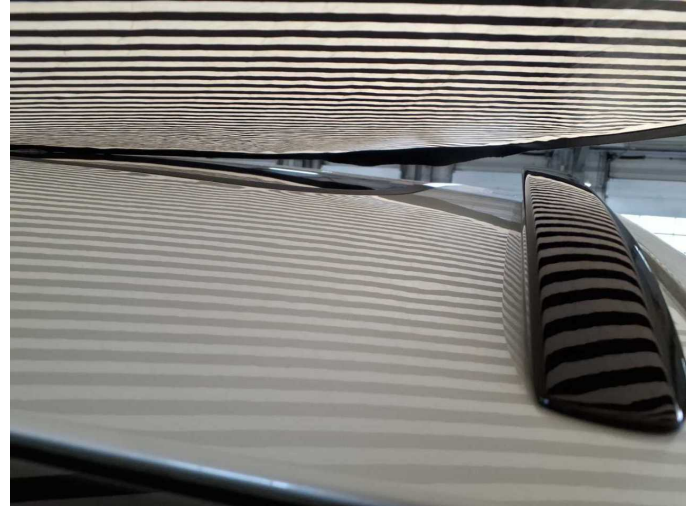
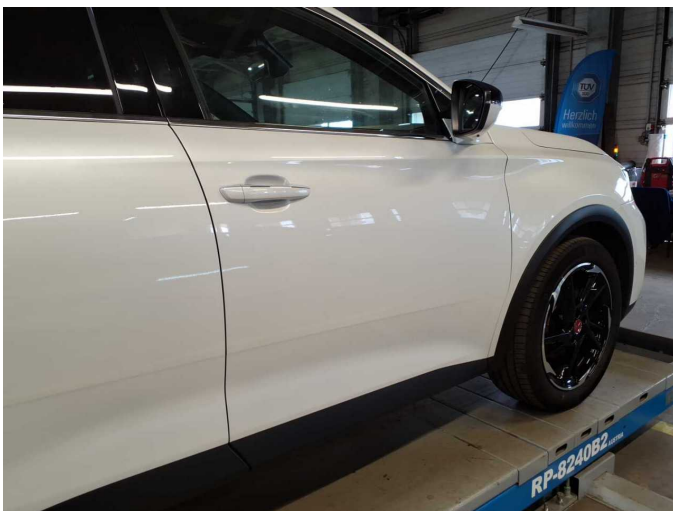
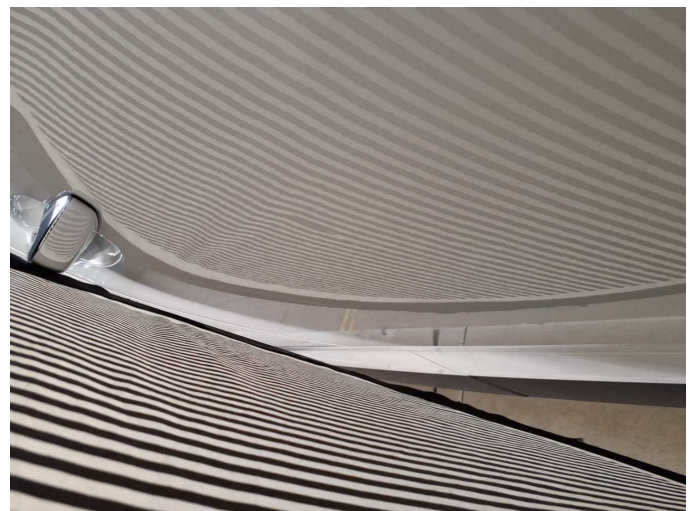
Damage 2: Body: Body - Damage by hail - Smooth repair work

No.	Component group	Description
1	Misc.	Main inspection - No evidence - No deduction
2	Body	Body - Damage by hail - Smooth repair work
3	Vehicle glazing	Windscreen (Rissbildung) - Stone chips - Replace

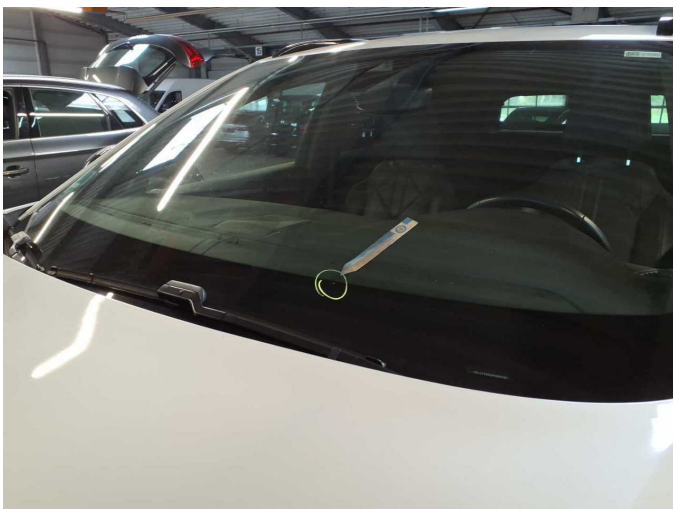
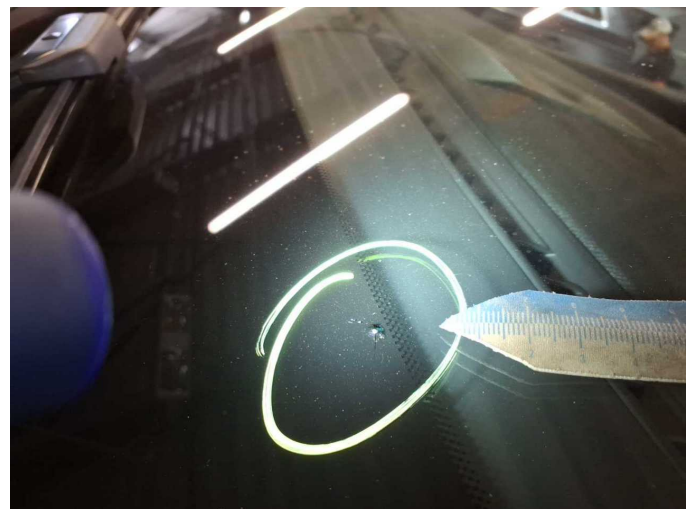
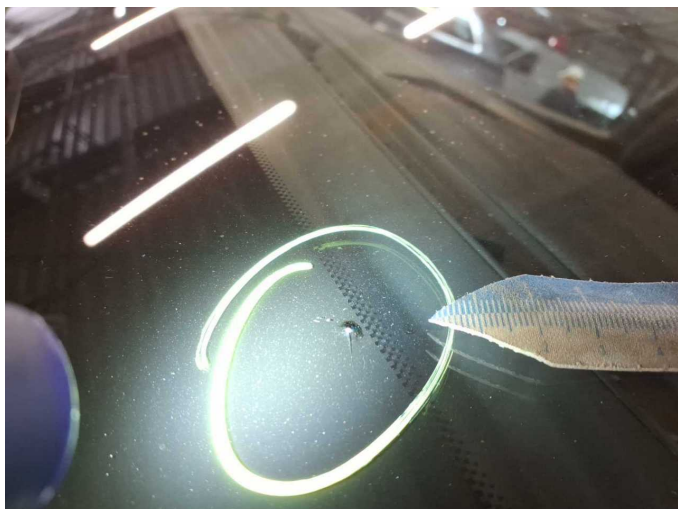
Damage 3: Vehicle glazing: Windscreen (Rissbildung) - Stone chips - Replace
