Expertise

Protocol number: 46790606  
Order No. / Reference: 26760511  
Inspection date: 29 Jul 2026

Manufacturer: Volvo

Model: XC90 B5 D AWD Geartronic Inscription

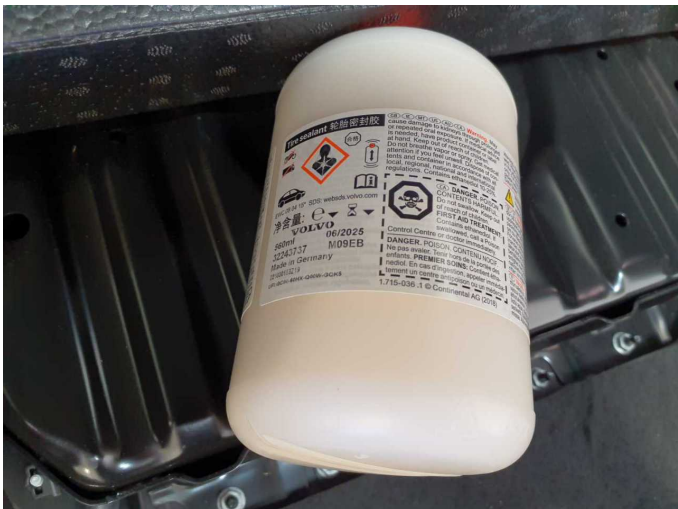
Damage 1: Equipment: Tirefit filler - Expired - Replace

| No. | Component group | Description |
|---|---|---|
| 1 | Equipment | Tirefit filler - Expired - Replace |

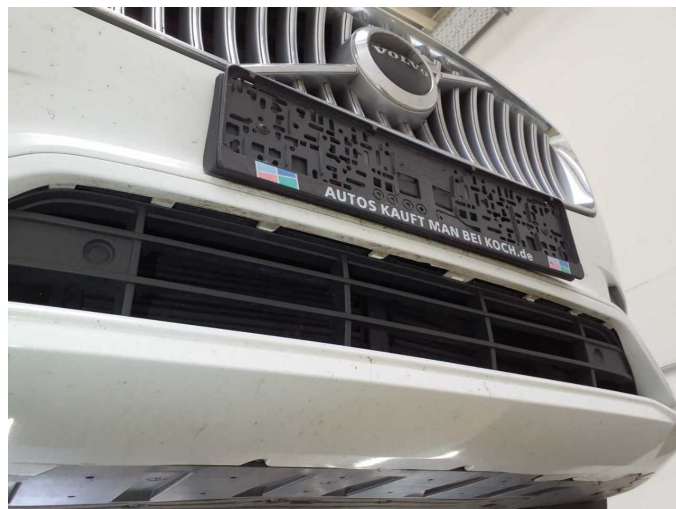
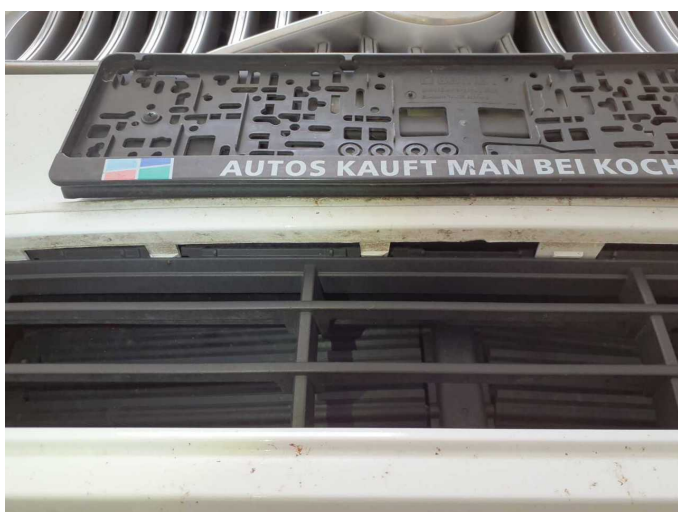
**Damage 3:** Front structure: Grille - Loose - Repair

| No. | Component group | Description |
|---|---|---|
| 3 | Front structure | Grille - Loose - Repair |

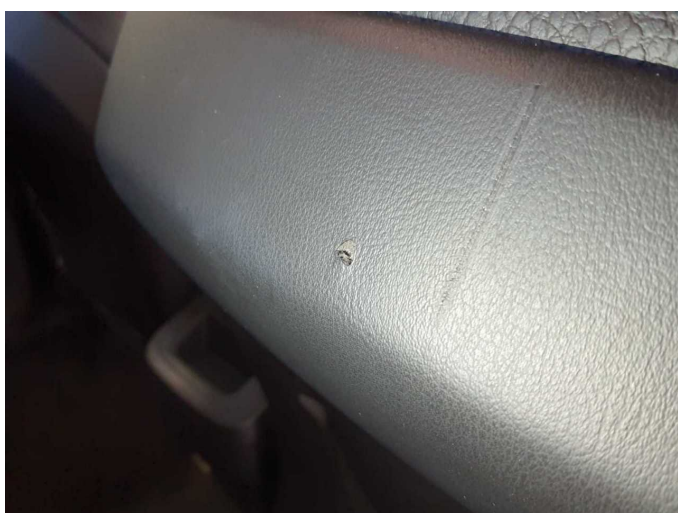
**Damage 4:** Seat - front: Backrest cover - right side - Scratch(es) - Smart repair

| No. | Component group | Description |
|---|---|---|
| 4 | Seat - front | Backrest cover - right side - Scratch(es) - Smart repair |

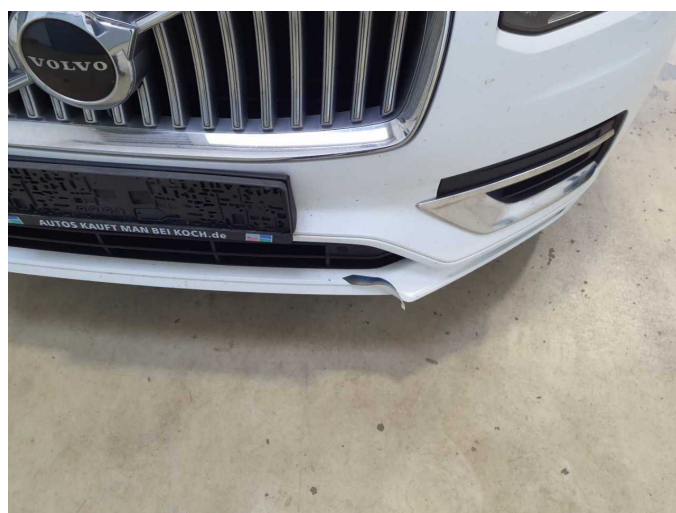
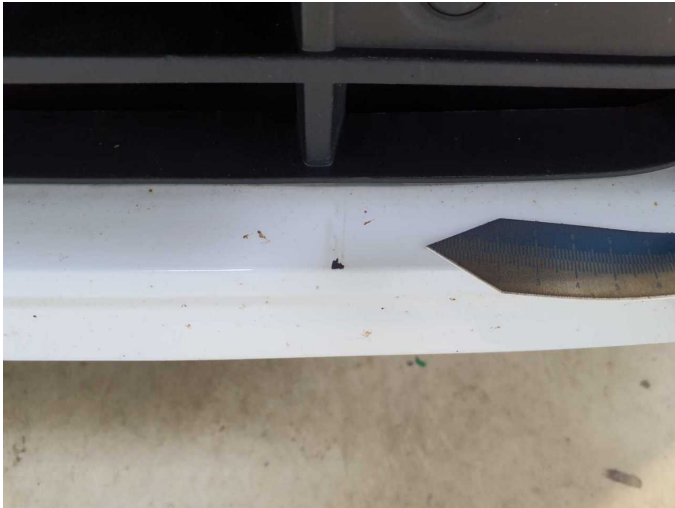
**Damage 5:** Front bumper: Front bumper - Scratch(es) - Smart repair

| No. | Component group | Description |
|---|---|---|
| 5 | Front bumper | Front bumper - Scratch(es) - Smart repair |

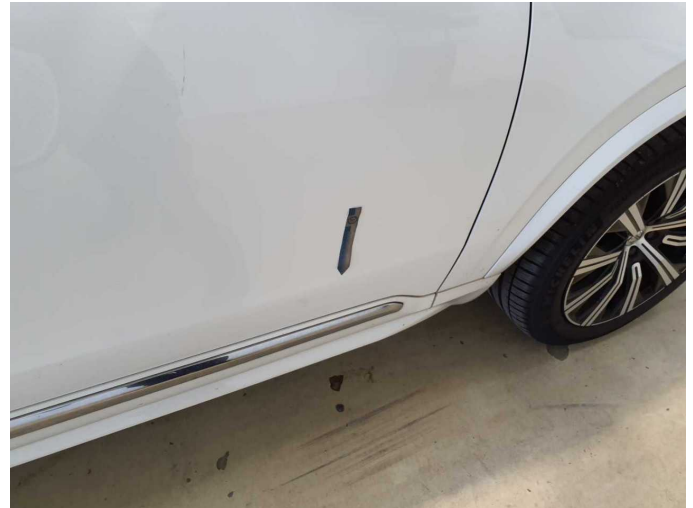
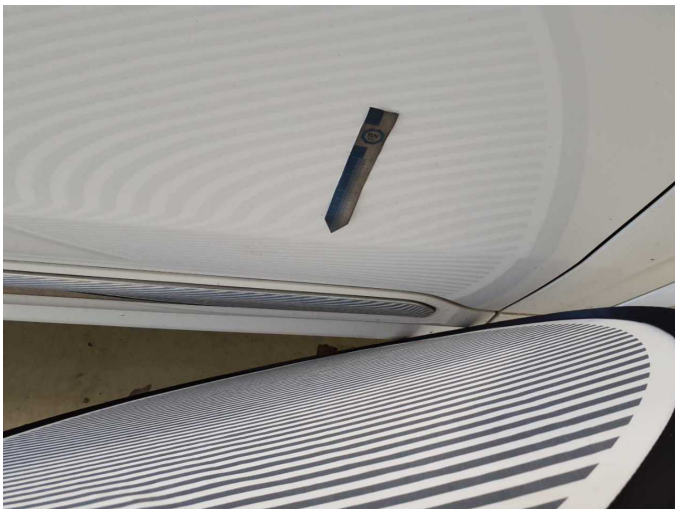
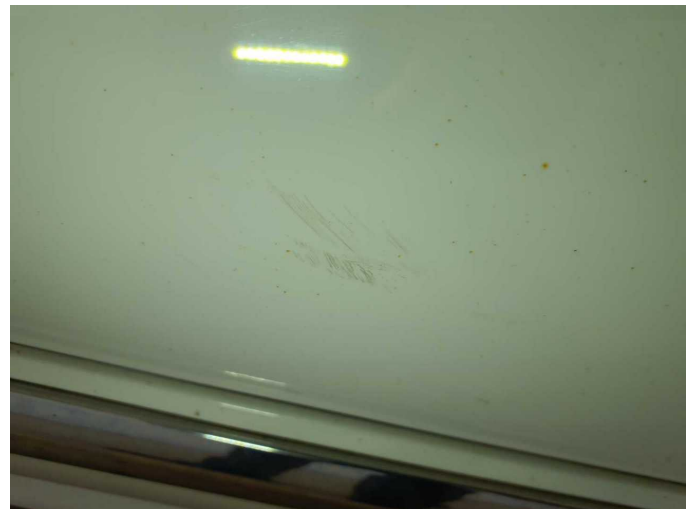
**Damage 6:** Door - front right side: Door - Dent / paintcoat damage - Smart repair

| No. | Component group | Description |
|---|---|---|
| 6 | Door - front right side | Door - Dent / paintcoat damage - Smart repair |

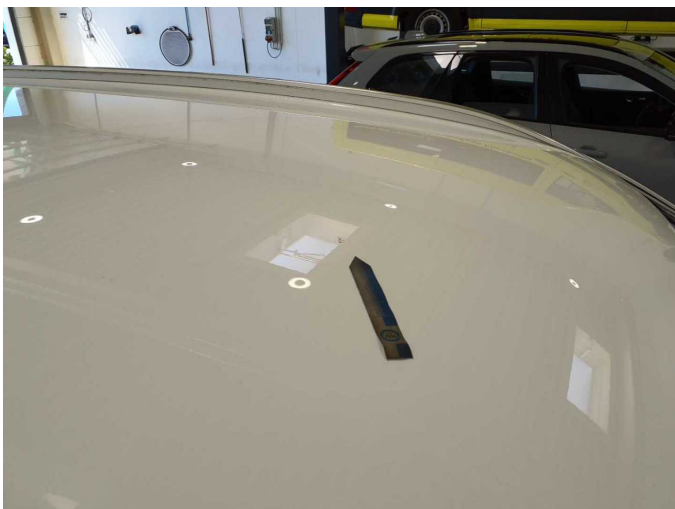
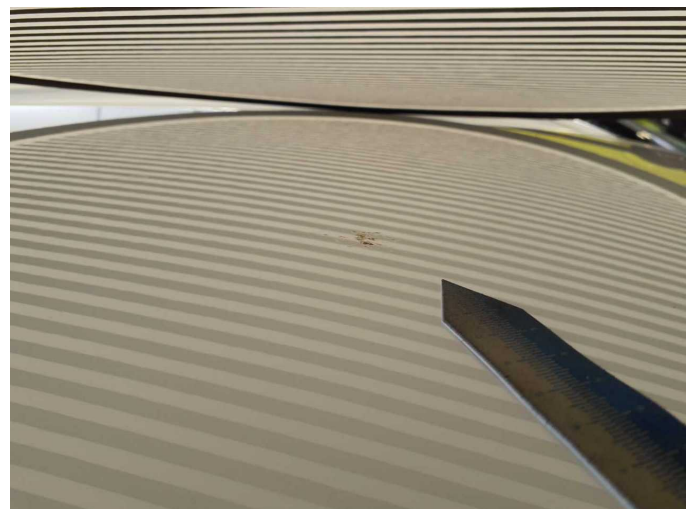
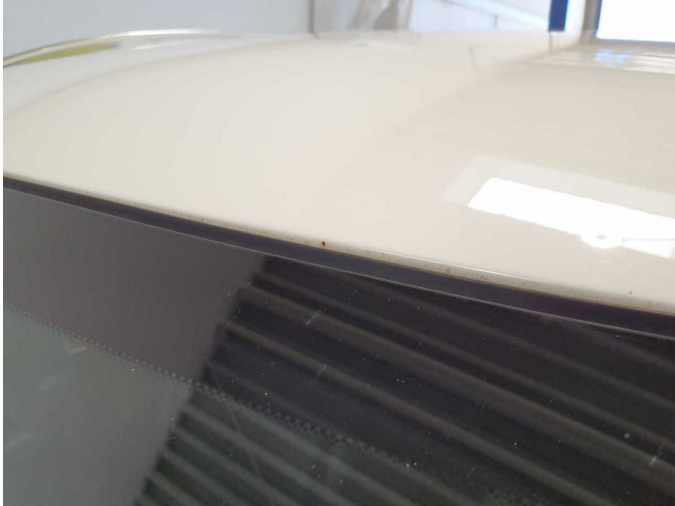
**Damage 7:** Roof: Roof (Anätzung-Mehrkosten möglich) - Paint defect - Conditioning

| No. | Component group | Description |
|---|---|---|
| 7 | Roof | Roof (Anätzung-Mehrkosten möglich) - Paint defect - Conditioning |

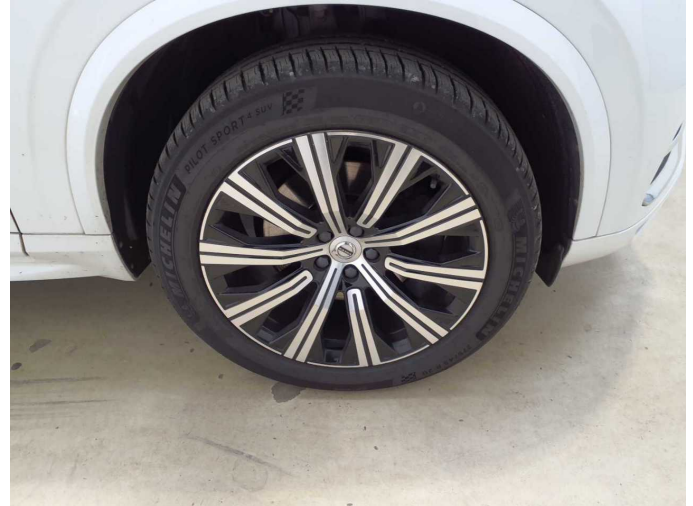
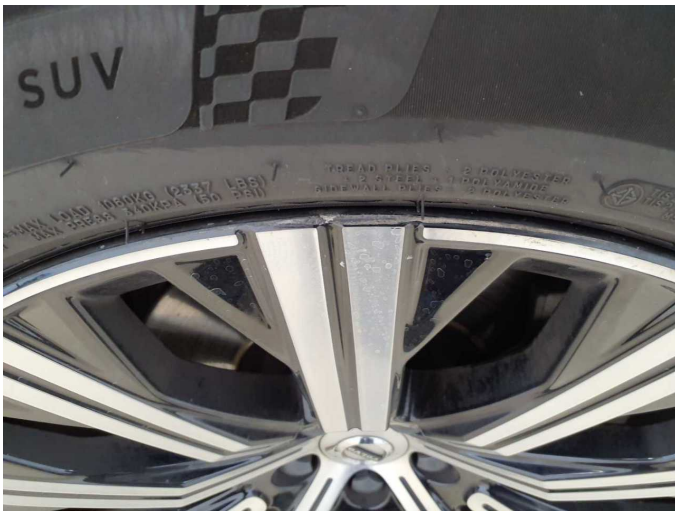
**Damage 8:** Wheel / tyres: Alloy rim - front right side - Scratch(es) - Loss in value

| No. | Component group | Description |
|---|---|---|
| 8 | Wheel / tyres | Alloy rim - front right side - Scratch(es) - Loss in value |

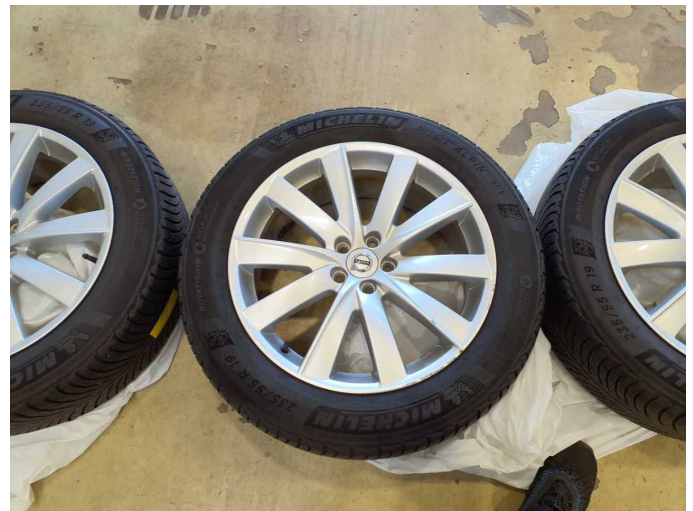
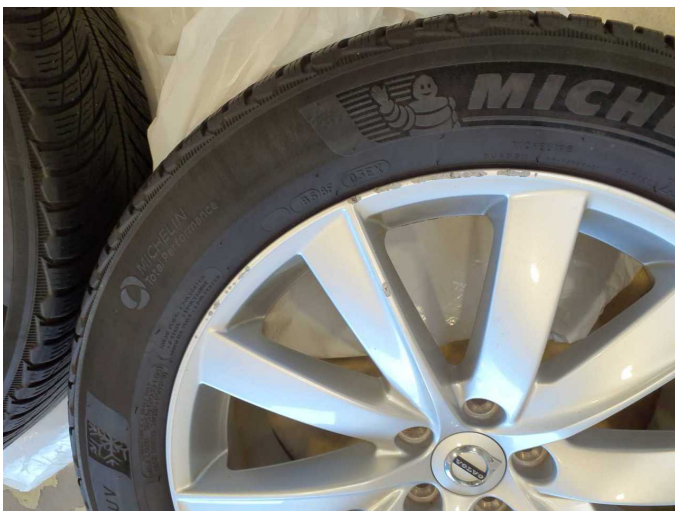
**Damage 9:** 2nd wheel set: 1 alloy rim - Scratch(es) - Loss in value

| No. | Component group | Description |
|---|---|---|
| 9 | 2nd wheel set | 1 alloy rim - Scratch(es) - Loss in value |

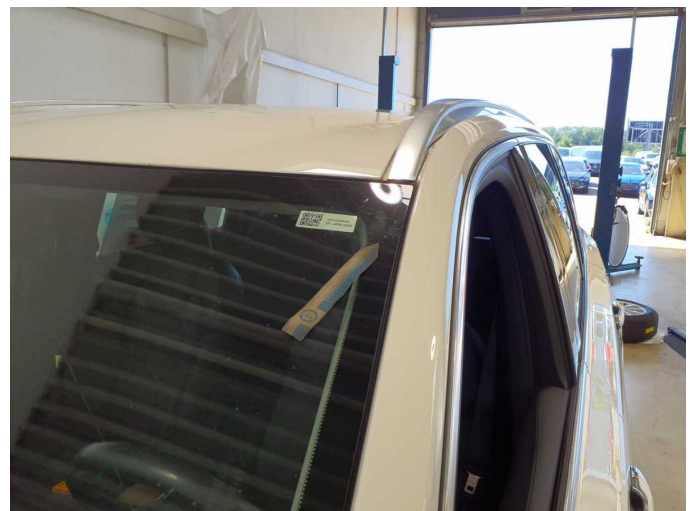
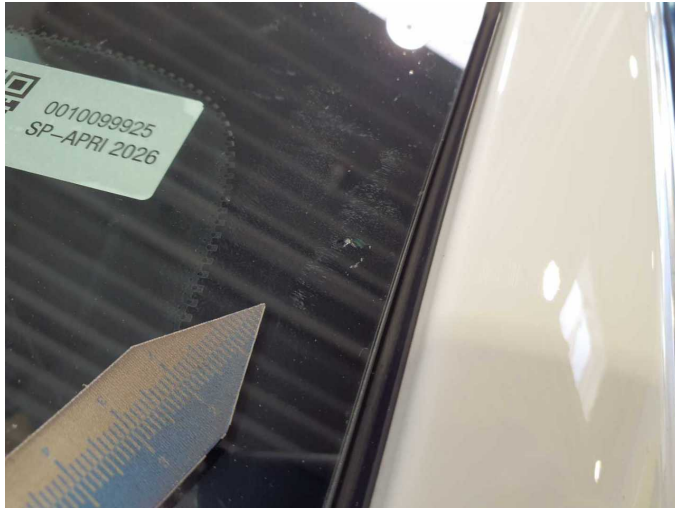
**Damage 10:** Vehicle glazing: Windscreen - Broken / torn - Replace

| No. | Component group | Description |
|---|---|---|
| 10 | Vehicle glazing | Windscreen - Broken / torn - Replace |

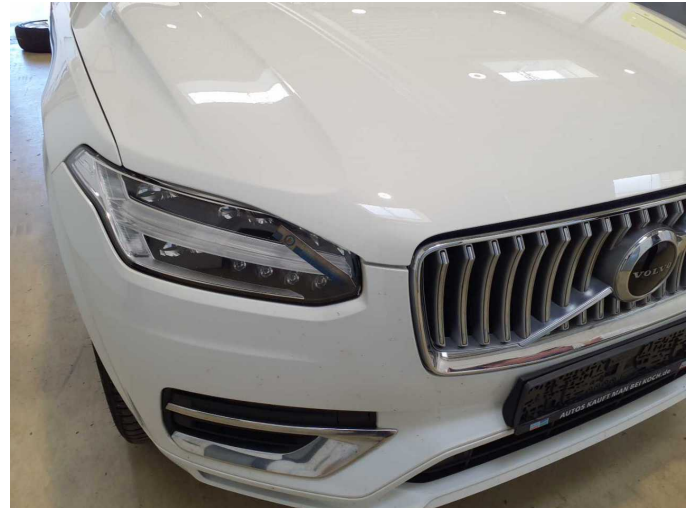
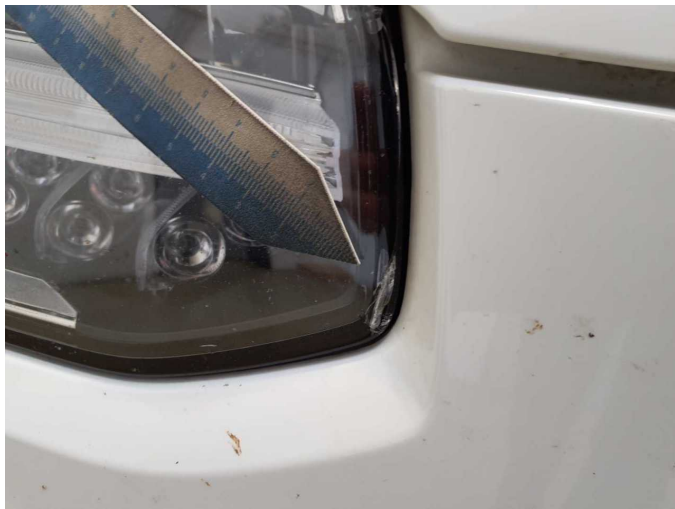
**Damage 11:** Headlight: Headlight - right side - Broken / torn - repair according to calculation

| No. | Component group | Description |
|---|---|---|
| 11 | Headlight | Headlight - right side - Broken / torn - repair according to calculation |
