## Expertise

Protocol number: 46130268  
Order No. / Reference: 26487995  
Inspection date: 24 Jun 2026

Model: Transit Custom 340 L1H1 LKW VA Autm. Trend

Ford Transit Custom 340 L1H1 LKW VA Autm. Trend

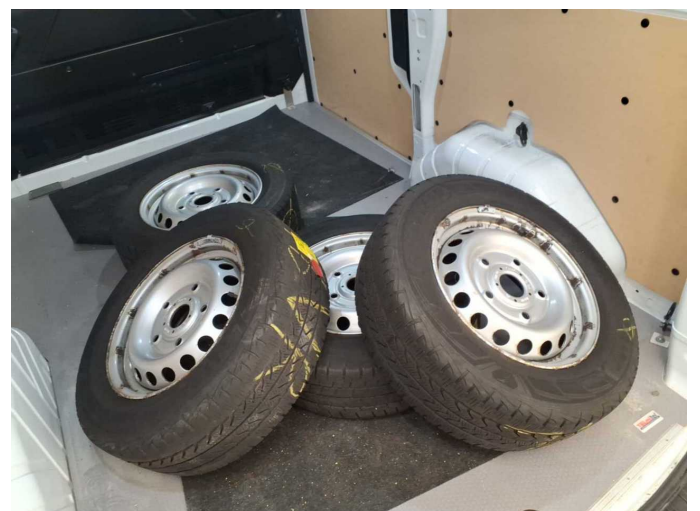
Figure 18: Additional tyres

#	Tyre size	Type of tyre	Manufacturer	Tread depth
1)	215/65 R16 109T	Winter tyres on Steel	Goodyear	6mm / 6mm
2)	215/65 R16 109T	Winter tyres on Steel	Goodyear	6mm / 6mm

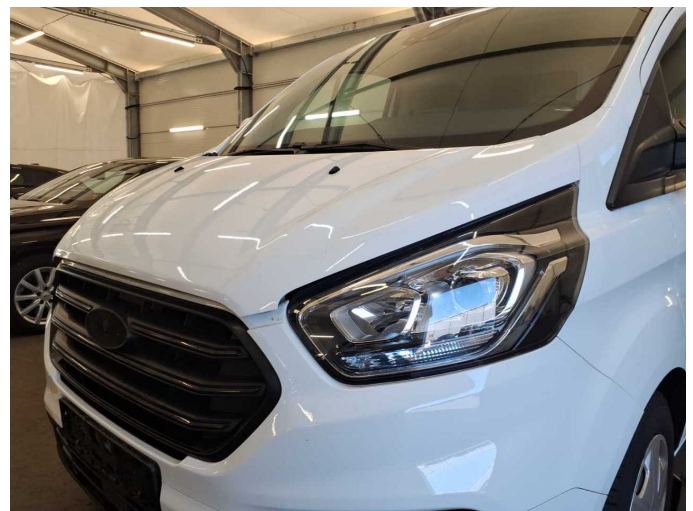
**Damage 2:** Bonnet: Bonnet bowden cable (Verriegelung nicht möglich, Motorhaube bleibt in Stellung 1) - Specify findings - Perform diagnosis

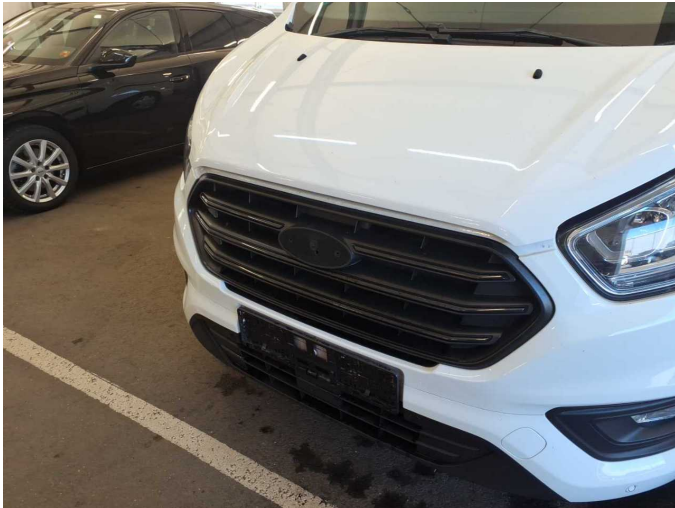
**Damage 3:** Front structure: Emblem - Missing - Replace

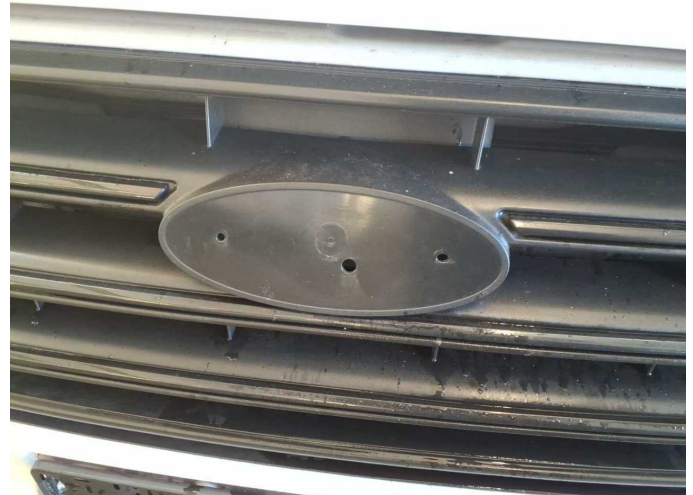
**Damage 3:** Front structure: Emblem - Missing - Replace
