Expertise

Manufacturer: Volvo

Model: XC90 T8 AWD Recharge Ultimate Dark

VIN: YV1LFH5V7P1913318

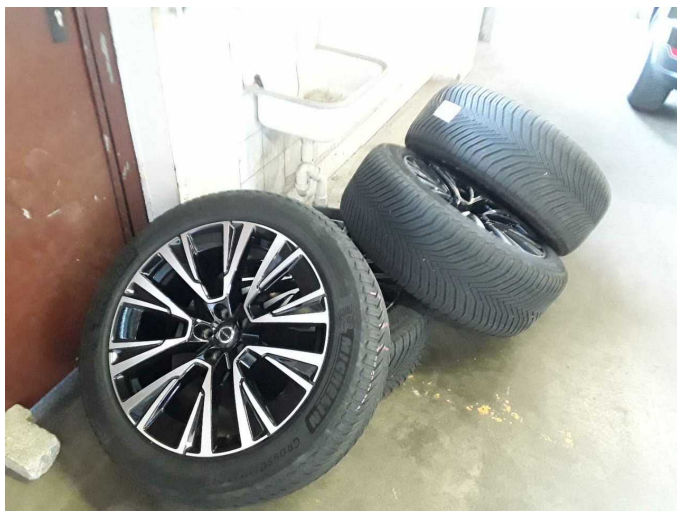
Figure 15: Additional tyres

#	Tyre size	Type of tyre	Manufacturer	Tread depth
1)	275/45 R20 110H	All-season tyres on Light alloy	Michelin	5mm / 5mm
2)	275/45 R20 110H	All-season tyres on Light alloy	Michelin	5mm / 5mm

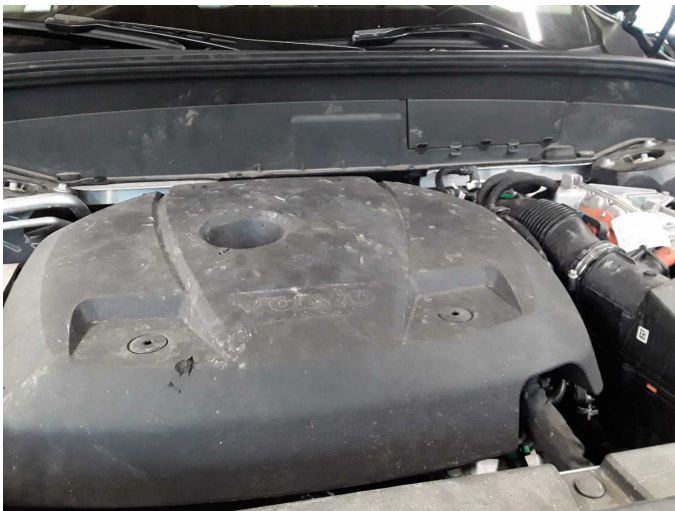
Damage 2: Engine: Engine cover - Damage caused by marten / rodent - Replace

No.	Component group	Description
1	Interior	Interior (Hundegeruch) - Odour - Ozone treatment
2	Engine	Engine cover - Damage caused by marten / rodent - Replace
3	Door - rear right side	Door - Scratch(es) - Paint
4	Door - front left side	Door - Dent / paintcoat damage - Repair and paint

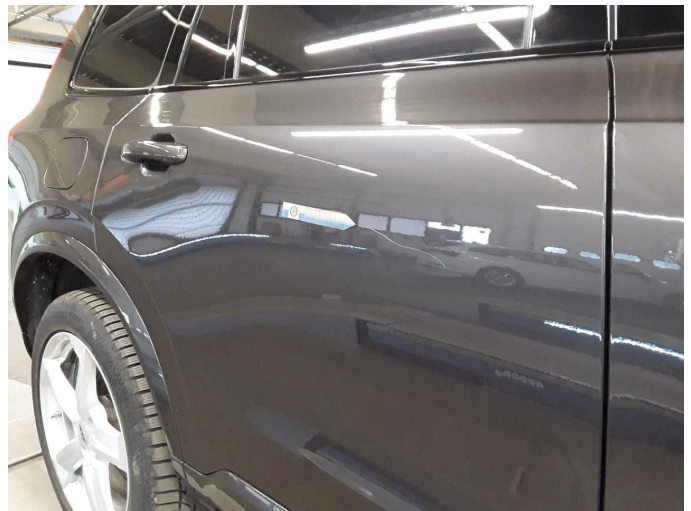
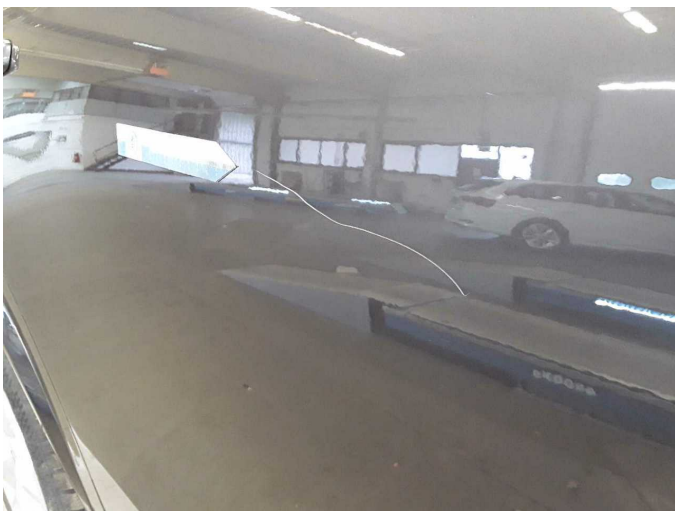
Damage 3: Door - rear right side: Door - Scratch(es) - Paint

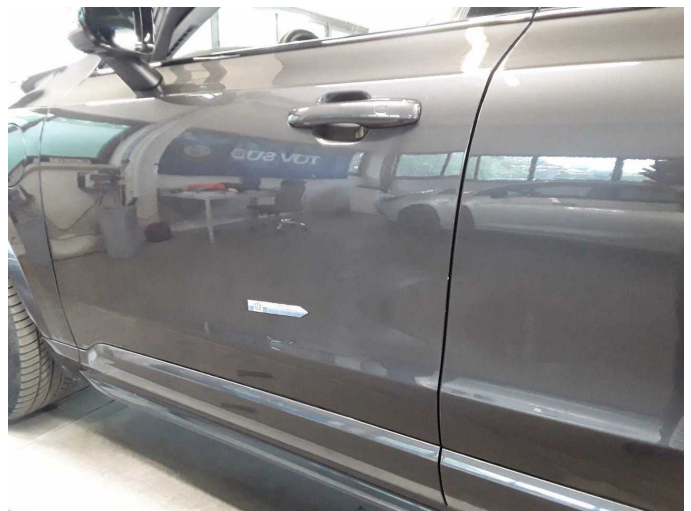
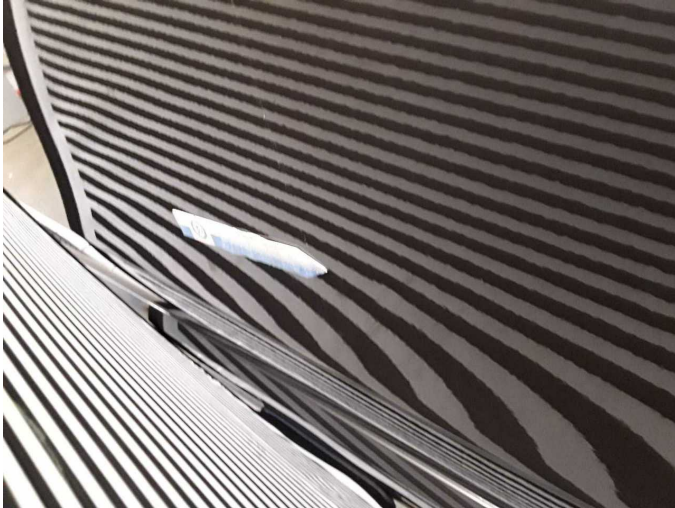
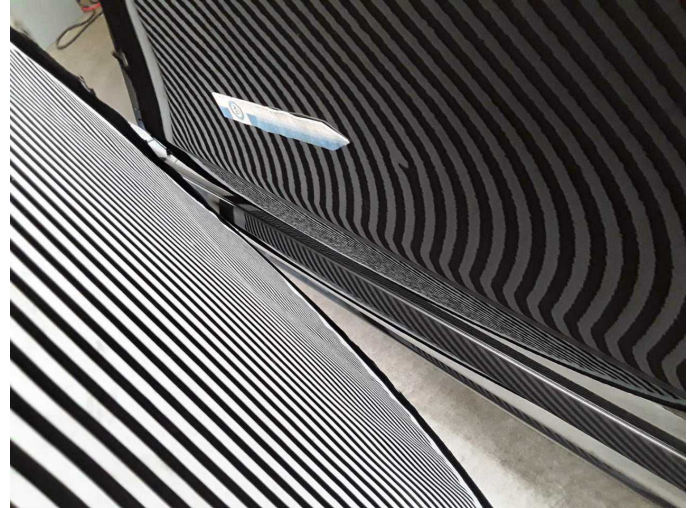
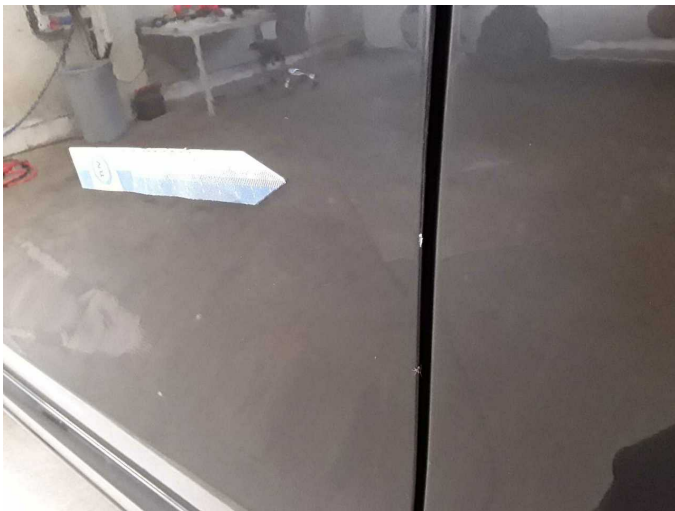
Damage 4: Door - front left side: Door - Dent / paintcoat damage - Repair and paint

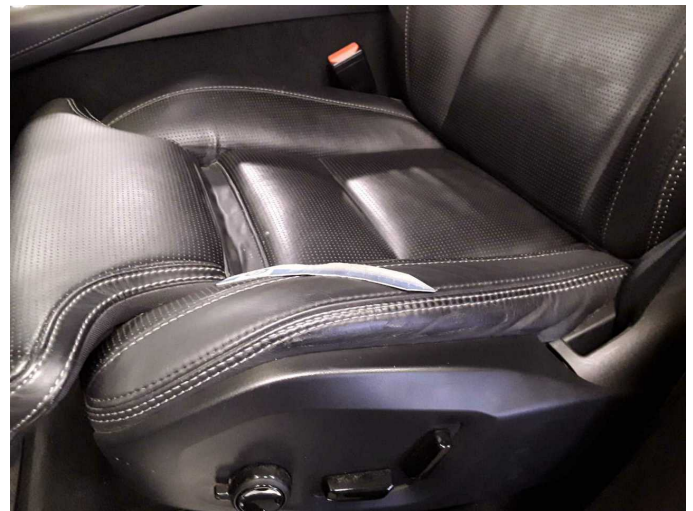
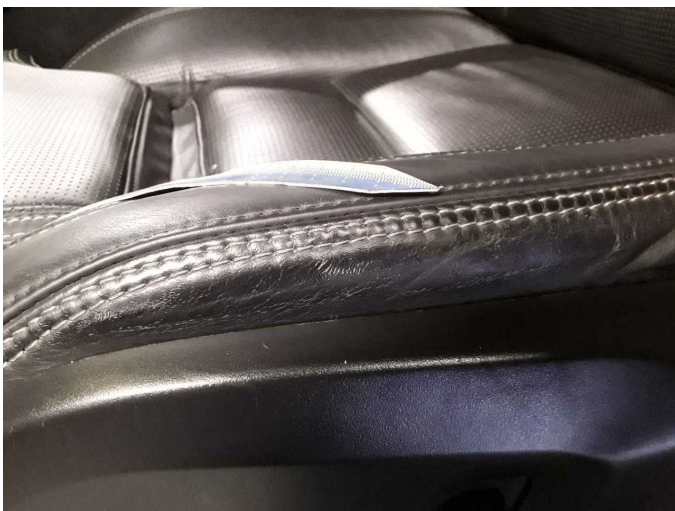
Wear and tear 6: Seat - front: Seat cover - left side - Scratch(es) - No deduction

No.	Component group	Description
1	Side panel - rear right side	Wheel arch - Scratch(es) - No deduction
2	Front bumper	Front bumper - Stone chips - No deduction
3	Bonnet	Bonnet - Stone chips - No deduction
4	Vehicle glazing	Windscreen - Stone chips - No deduction
5	Interior	Interior - Scratch(es) - No deduction
6	Seat - front	Seat cover - left side - Scratch(es) - No deduction
