Expertise

Protocol number: 46348057  
Order No. / Reference: 26360248  
Inspection date: 6 Jul 2026

Manufacturer: Mercedes-Benz  
VIN: W1KAH0DB4PF096527

Model: C 200 d T 9G-TRONIC Avantgarde

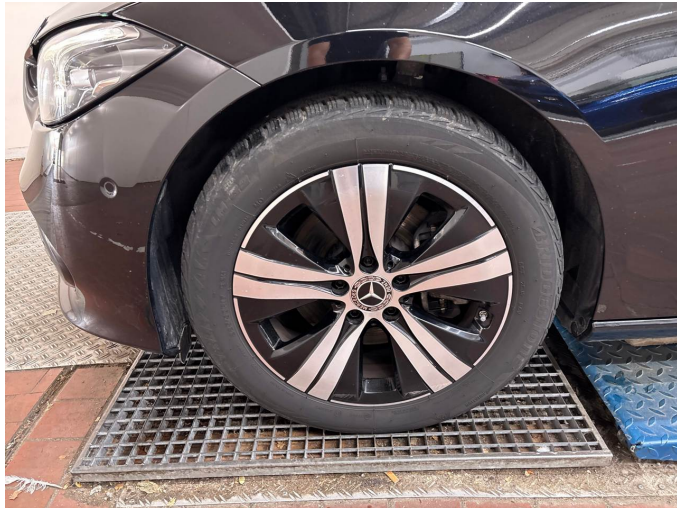
| # | Tyre size | Type of tyre | Manufacturer | Tread depth |
|---|---|---|---|---|
| 1) | 225/50 R17 94H | Winter tyres on Light alloy | Bridgestone | 7mm / 7mm |
| 2) | 225/50 R17 94H | Winter tyres on Light alloy | Bridgestone | 6mm / 6mm |

Figure 13: Mounted tyres

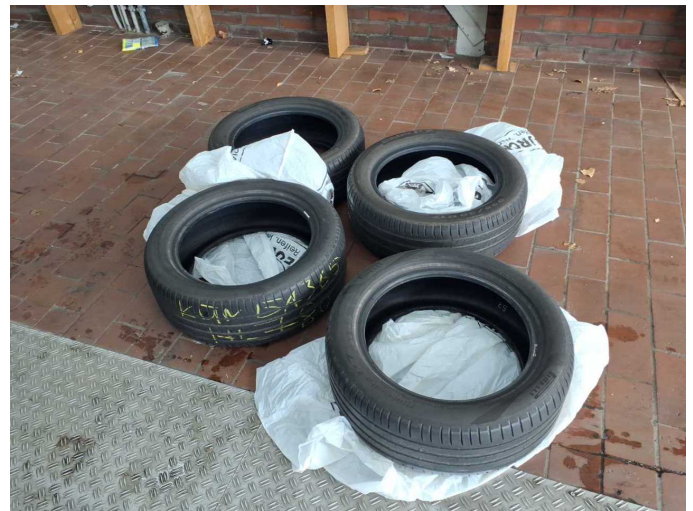
| # | Tyre size | Type of tyre | Manufacturer | Tread depth |
|---|---|---|---|---|
| 1) | 225/55 R17 94Y | Summer tyres (Without wheel rim) | Pirelli | 6mm / 6mm |
| 2) | 225/55 R17 94Y | Summer tyres (Without wheel rim) | Pirelli | 6mm / 6mm |

Figure 16: Additional tyres

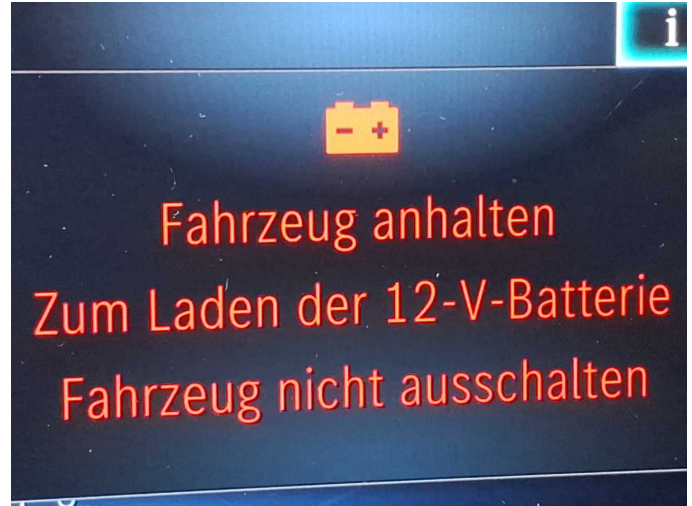
**Damage 2:** Electrical system: Battery - Empty - Perform diagnosis

| No. | Component group | Description |
|---|---|---|
| 2 | Electrical system | Battery - Empty - Perform diagnosis |

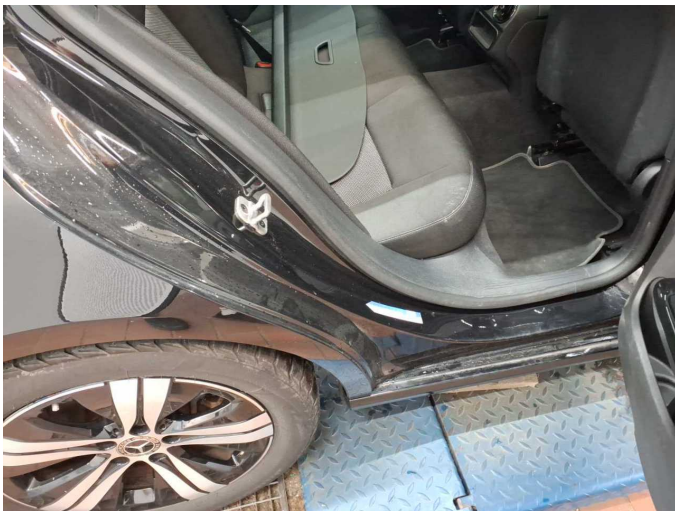
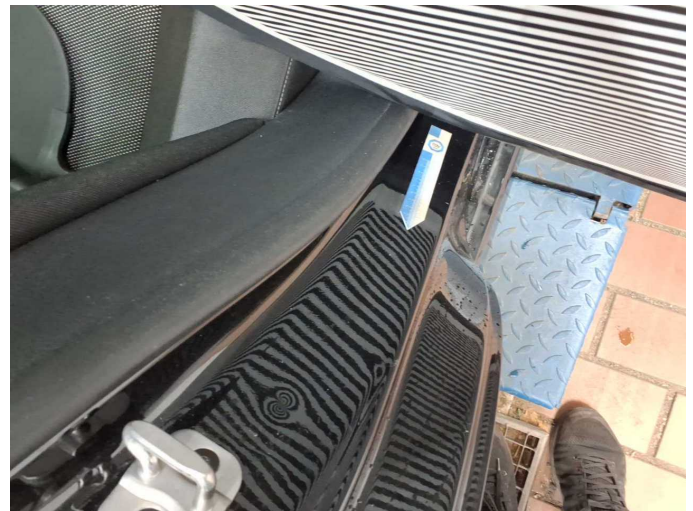
**Damage 3:** Side panel - rear right side: Sill - dent(s) - Smart repair

| No. | Component group | Description |
|---|---|---|
| 3 | Side panel - rear right side | Sill - dent(s) - Smart repair |

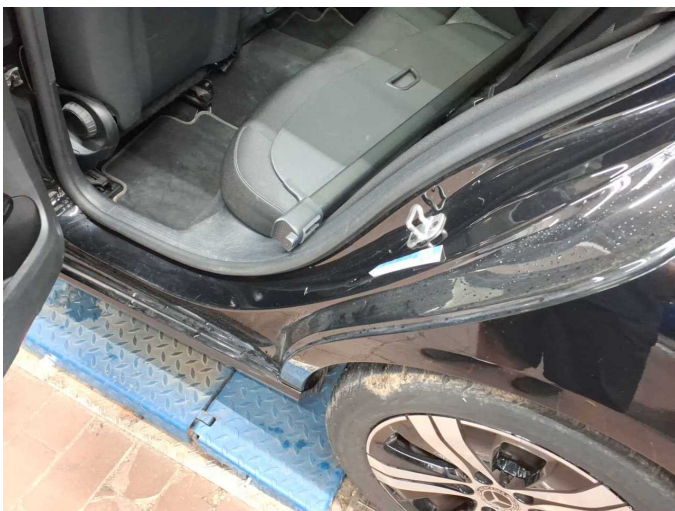
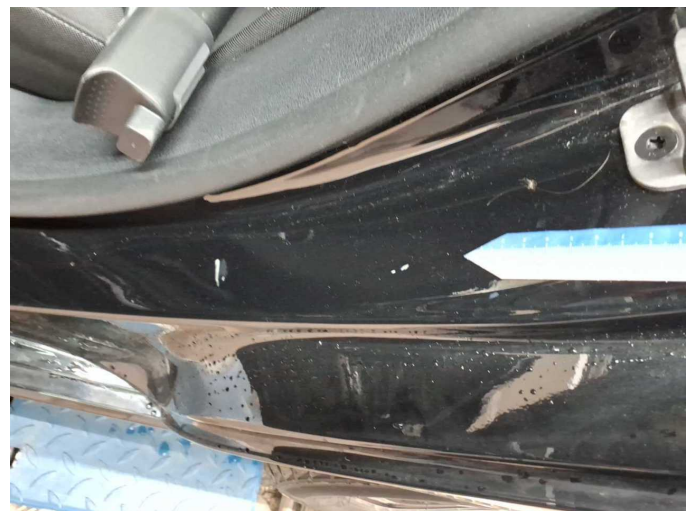
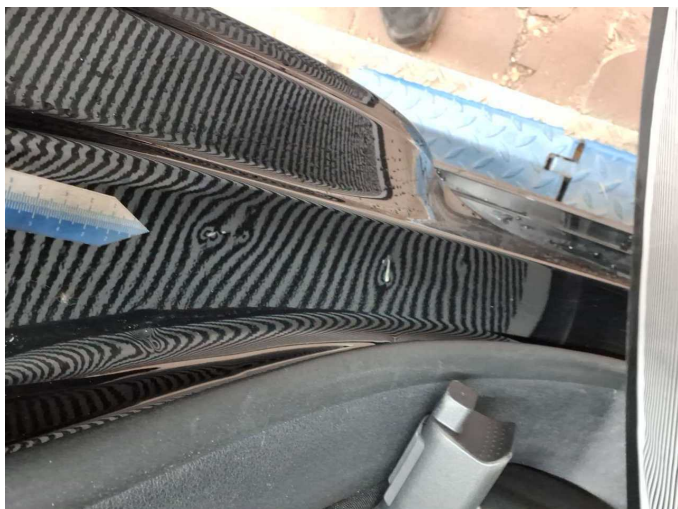
**Damage 4:** Side panel - rear left side: Sill - Dent / paintcoat damage - Smart repair

| No. | Component group | Description |
|---|---|---|
| 4 | Side panel - rear left side | Sill - Dent / paintcoat damage - Smart repair |

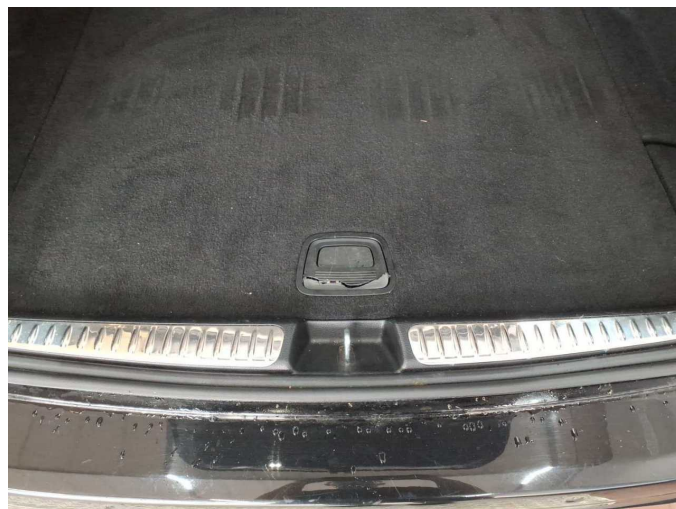
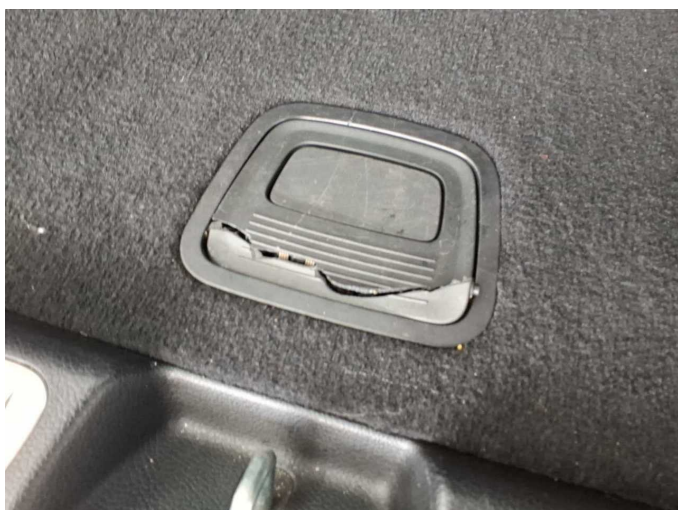
**Damage 5:** Interior: Cargo area floor (Griff) - Broken / torn - Replace

| No. | Component group | Description |
|---|---|---|
| 5 | Interior | Cargo area floor (Griff) - Broken / torn - Replace |

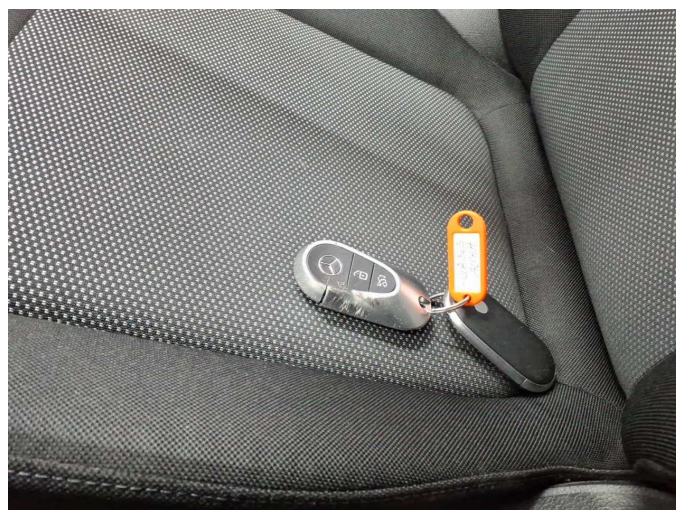
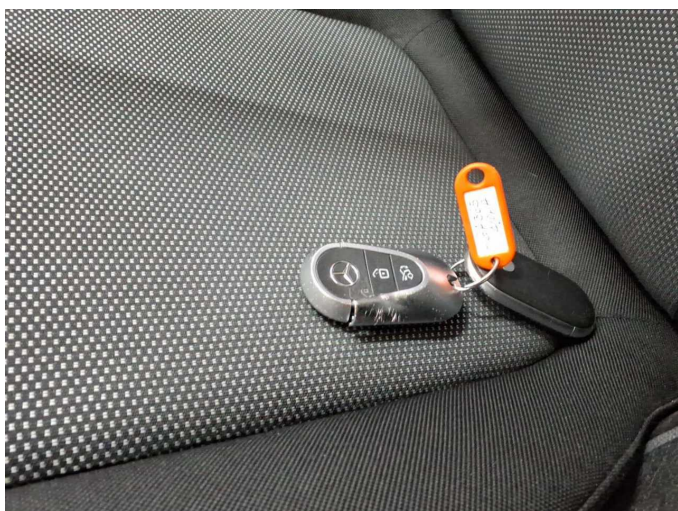
**Damage 6:** Equipment: Vehicle key with remote control - Deformed - Replace

| No. | Component group | Description |
|---|---|---|
| 6 | Equipment | Vehicle key with remote control - Deformed - Replace |

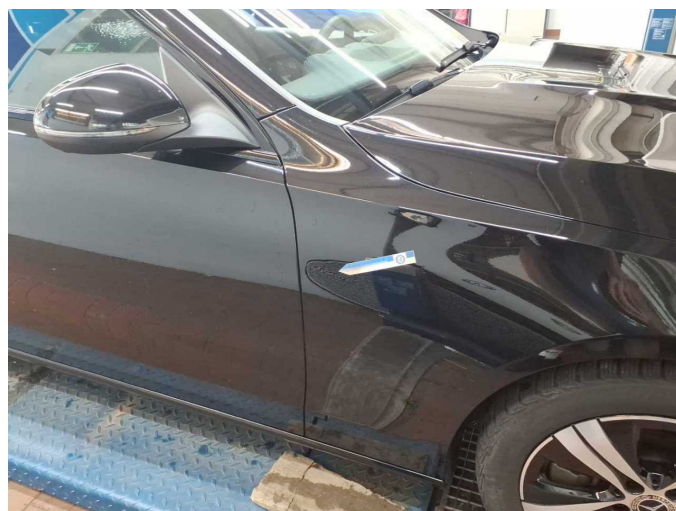
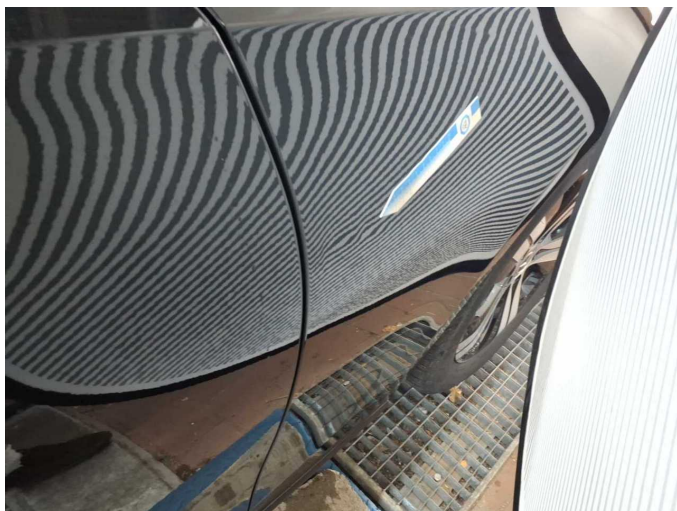
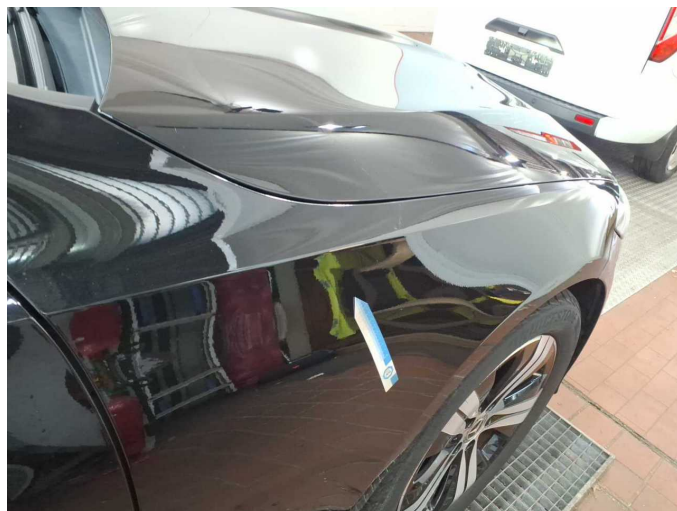
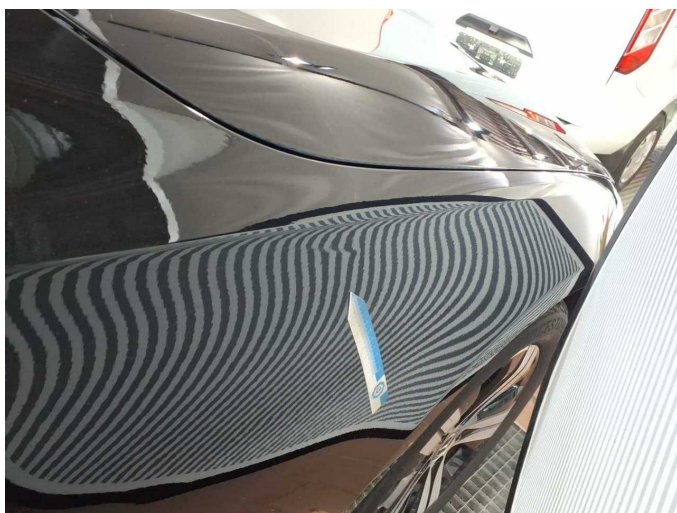
**Damage 7:** Mudguard - right side: Mudguard - right side - dent(s) - Repair and paint

| No. | Component group | Description |
|---|---|---|
| 7 | Mudguard - right side | Mudguard - right side - dent(s) - Repair and paint |

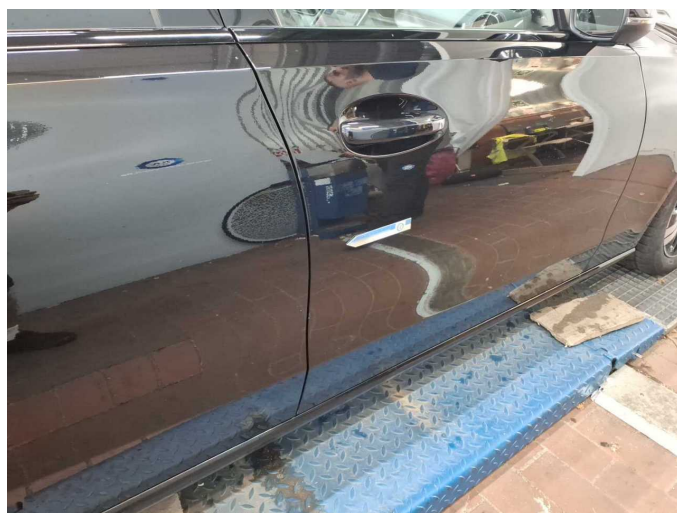
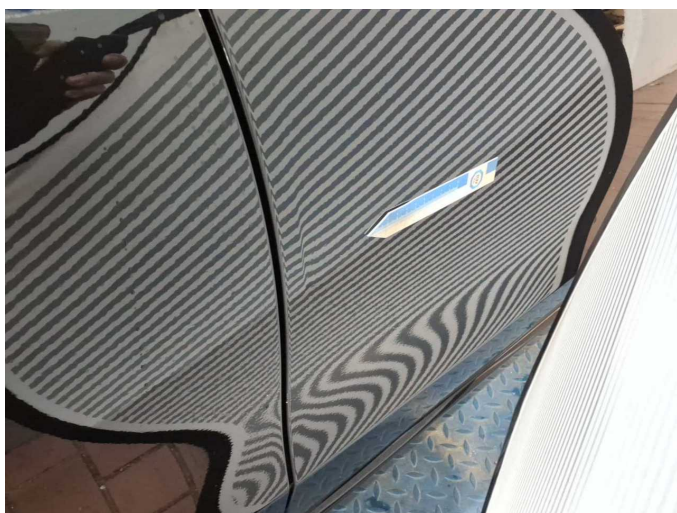
**Damage 8:** Door - front right side: Door - dent(s) - Repair and paint

| No. | Component group | Description |
|---|---|---|
| 8 | Door - front right side | Door - dent(s) - Repair and paint |

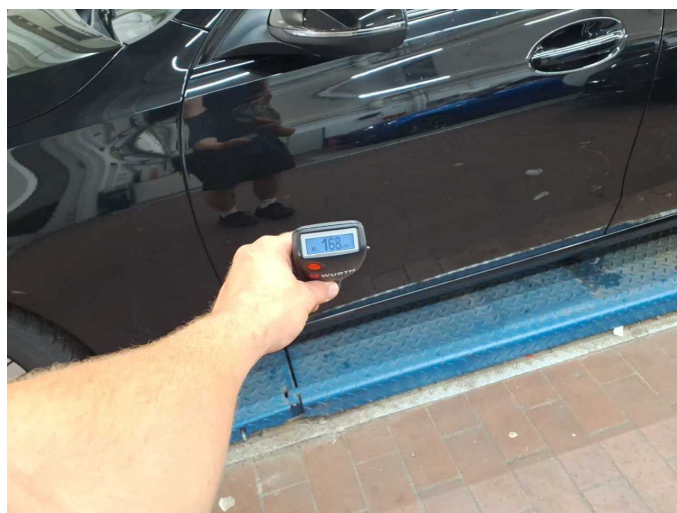
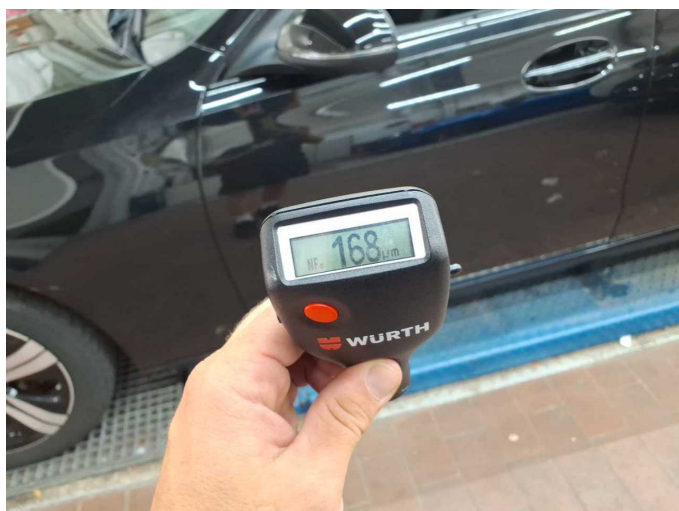
1 Door - front left side, Professionally carried out, Invoice of repair done Non-existent

Door - front left side 168 µm |

**Repainting 1:** Door - front left side
