Expertise

Protocol number: 46442726  
Order No. / Reference: 26605918-1  
Inspection date: 7 Jul 2026

Manufacturer: Skoda  
VIN: TMBJH7NP1P7034364

Model: Superb Combi 2.0 TDI Ambition

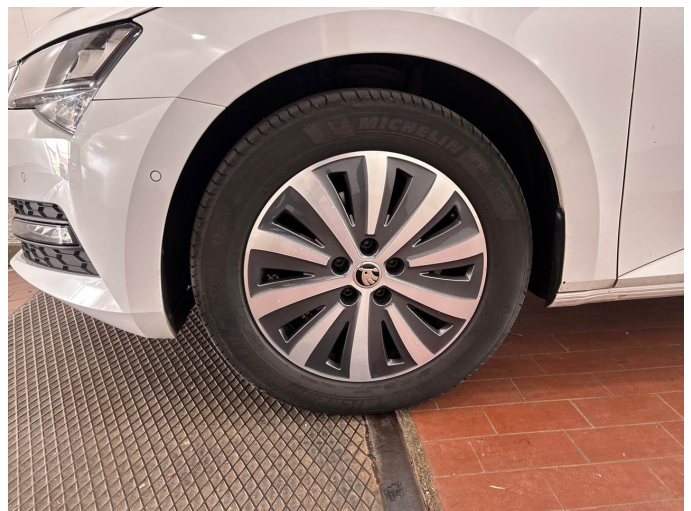
Figure 12: Mounted tyres

| # | Tyre size | Type of tyre | Manufacturer | Tread depth |
|---|---|---|---|---|
| 1) | 215/55 R17 94V | Summer tyres on Light alloy | Michelin | 4mm / 4mm |
| 2) | 215/55 R17 94V | Summer tyres on Light alloy | Michelin | 4mm / 4mm |

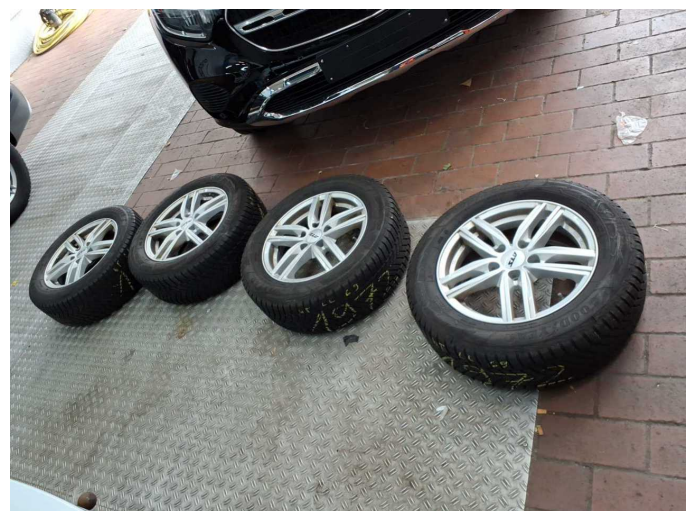
Figure 18: Additional tyres

| # | Tyre size | Type of tyre | Manufacturer | Tread depth |
|---|---|---|---|---|
| 1) | 215/60 R16 99H | Winter tyres on Light alloy | Goodyear | 7mm / 7mm |
| 2) | 215/60 R16 99H | Winter tyres on Light alloy | Goodyear | 7mm / 7mm |

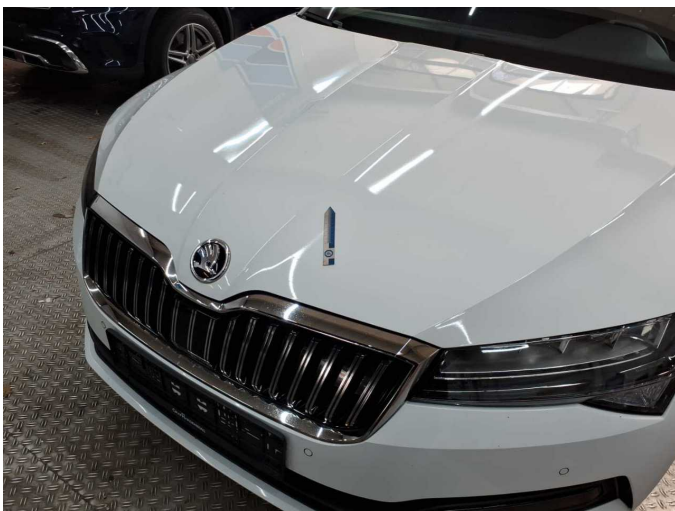
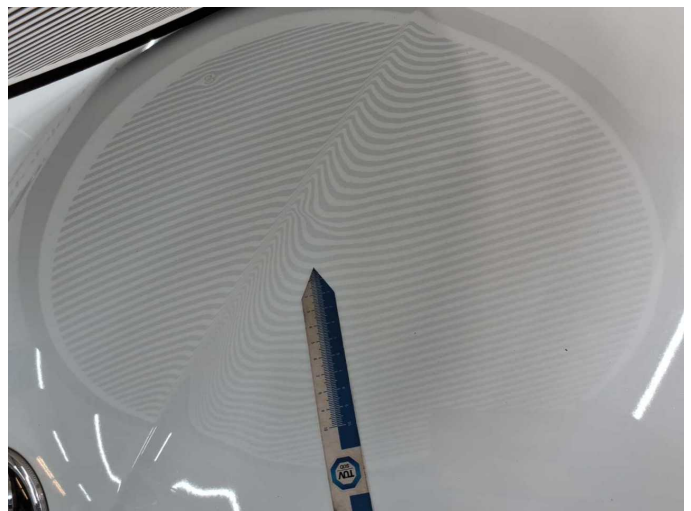
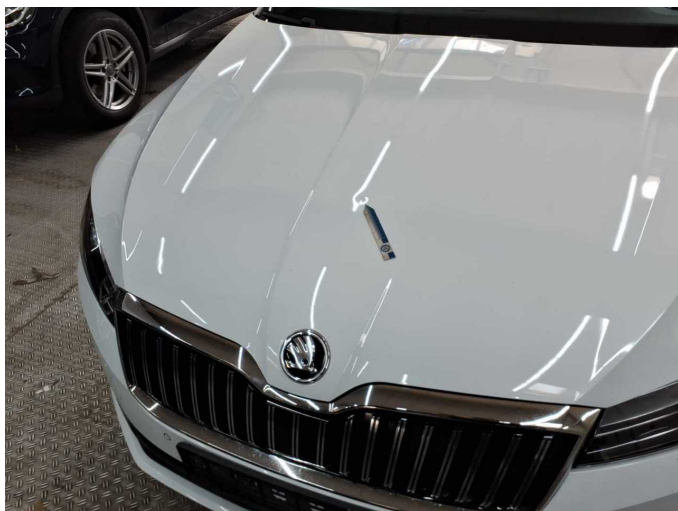
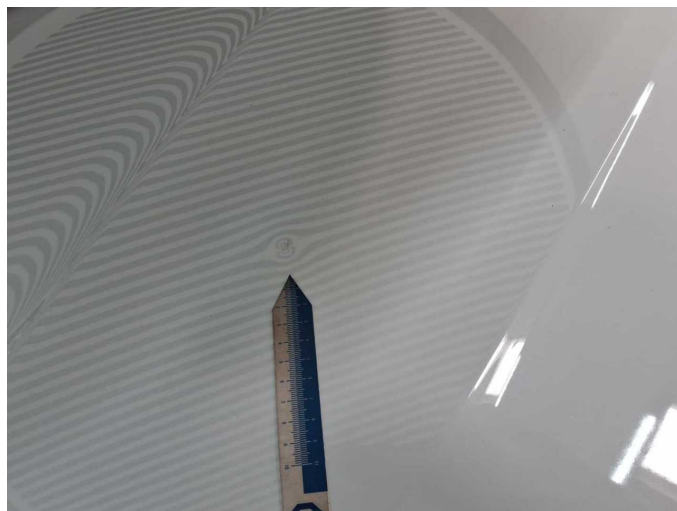
| No. | Component group | Description |
|---|---|---|
| 1 | Bonnet | Bonnet - dent(s) - Smooth repair work |

Damage 1: Bonnet: Bonnet - dent(s) - Smooth repair work

**Damage 1:** Bonnet: Bonnet - dent(s) - Smooth repair work

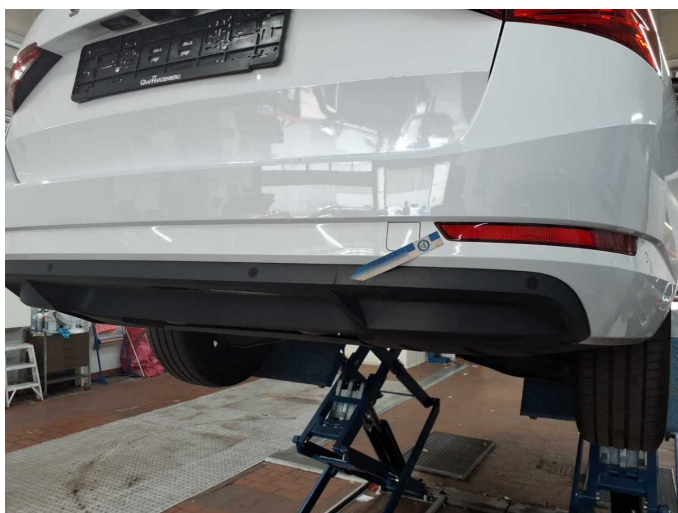
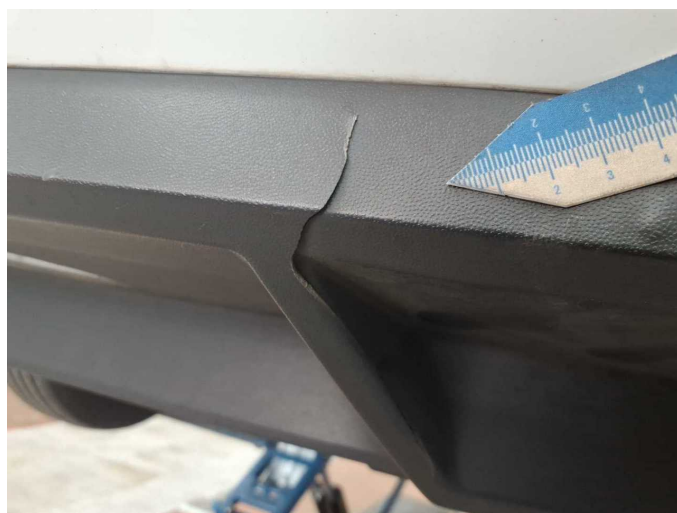
| No. | Component group | Description |
|---|---|---|
| 2 | Rear bumper | Spoiler - Broken / torn - Replace |

**Damage 2:** Rear bumper: Spoiler - Broken / torn - Replace

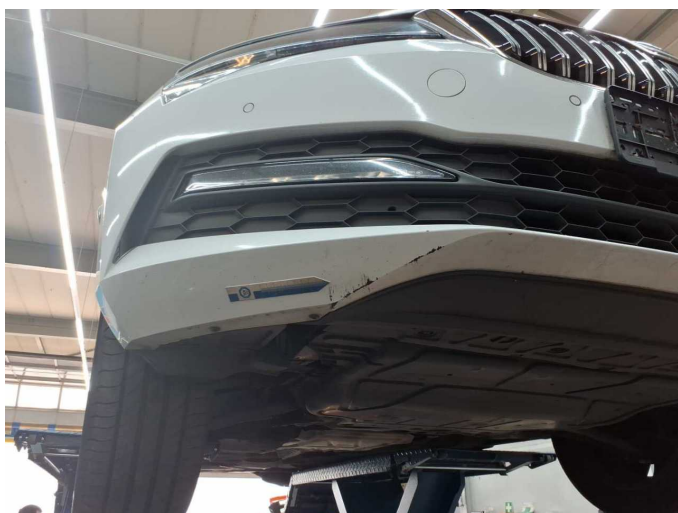
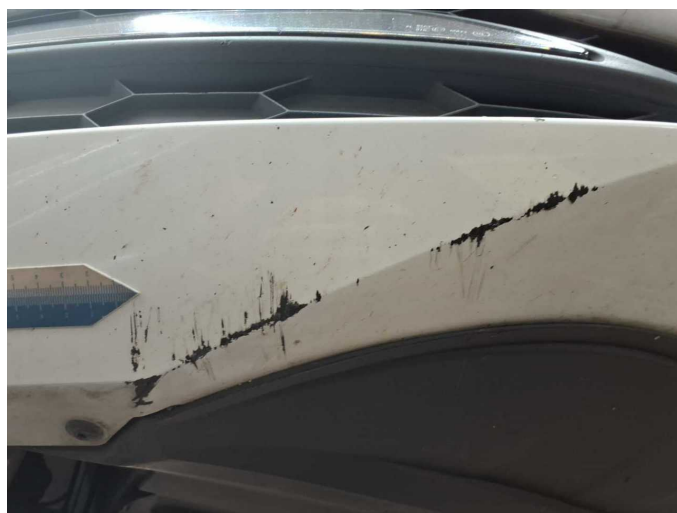
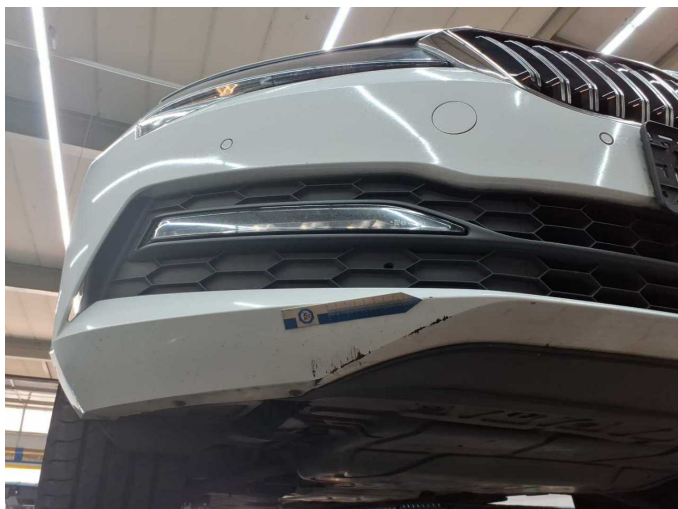
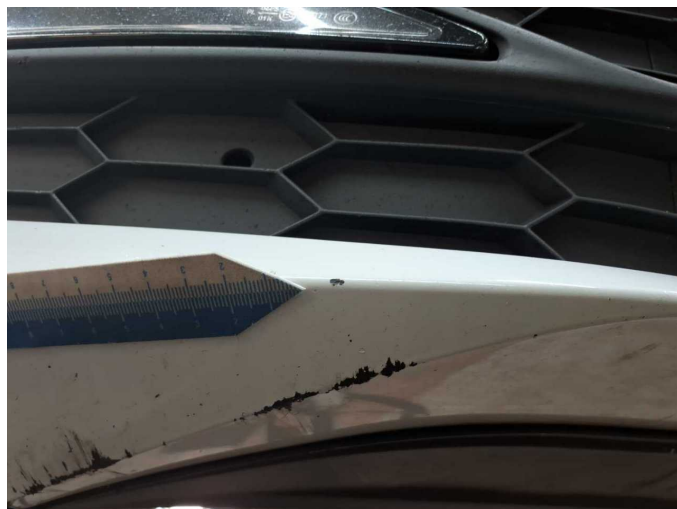
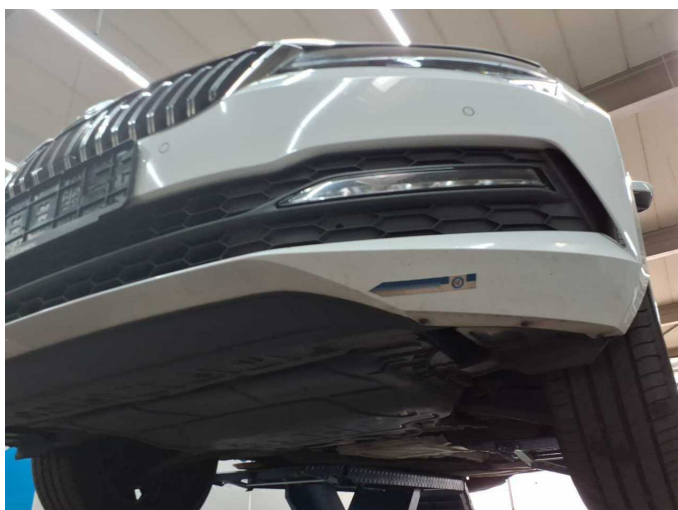
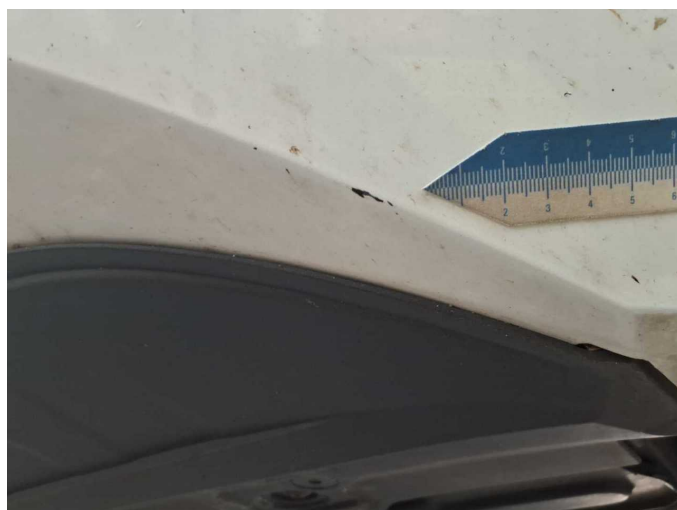
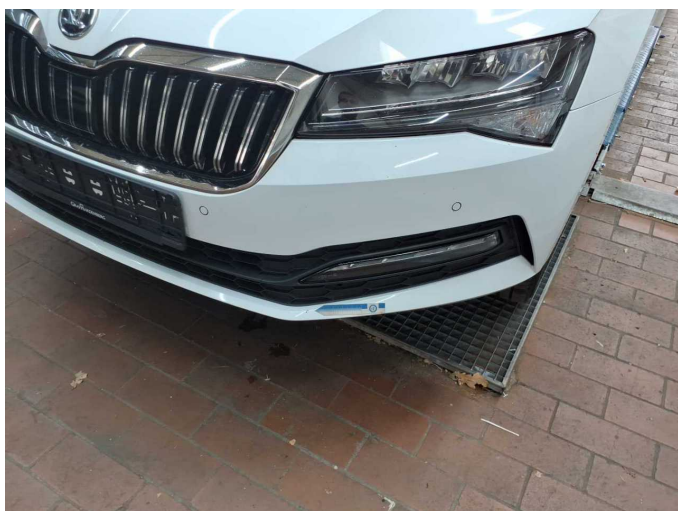
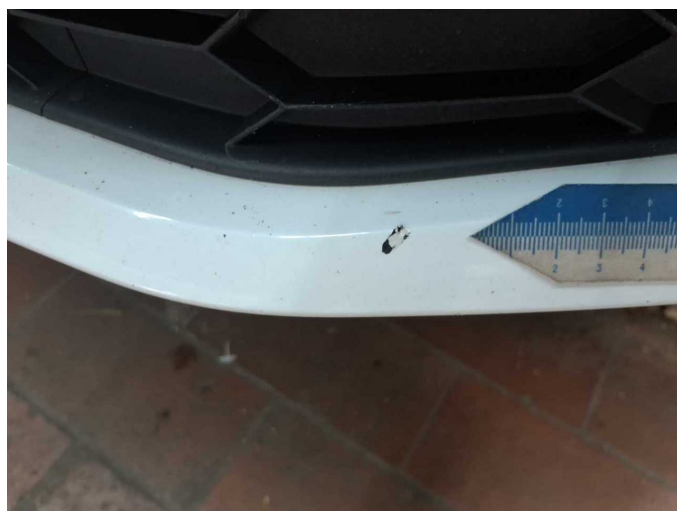
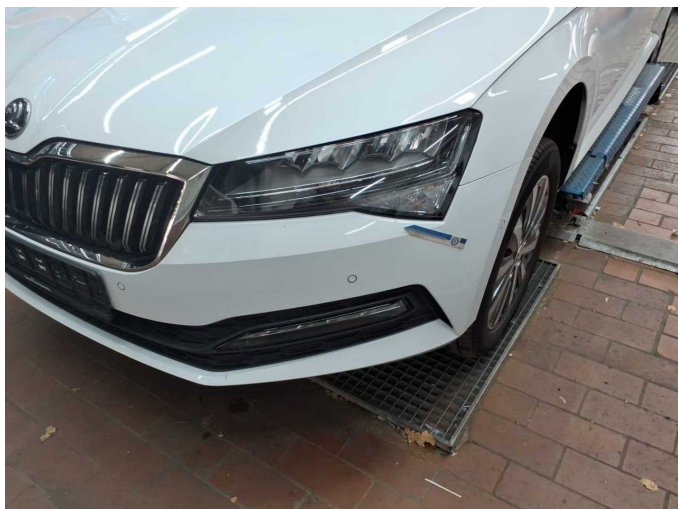
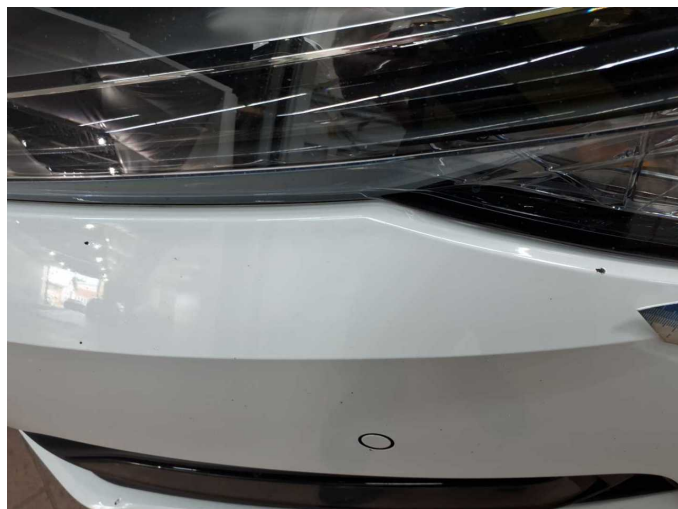
| No. | Component group | Description |
|---|---|---|
| 3 | Front bumper | Front bumper - Scratched - Paint |

**Damage 3:** Front bumper: Front bumper - Scratched - Paint
