Expertise

Protocol number: 45947833  
Order No. / Reference: 26434699  
Inspection date: 15 Jun 2026

Manufacturer: Volvo  
VIN: LYVUZH5V9PB309814

Model: XC60 T8 AWD Recharge Ultimate Dark

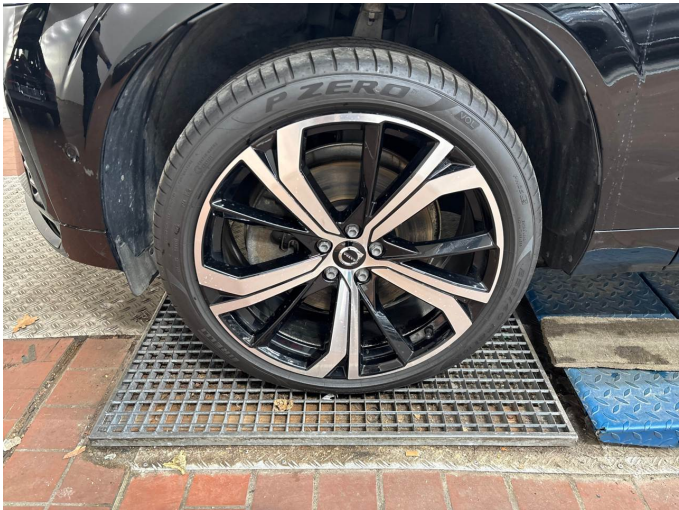
Figure 12: Mounted tyres

| # | Tyre size | Type of tyre | Manufacturer | Tread depth |
|---|---|---|---|---|
| 1) | 255/40 R21 102V | Summer tyres on Light alloy | Pirelli | 5mm / 5mm |
| 2) | 255/40 R21 102V | Summer tyres on Light alloy | Pirelli | 6mm / 6mm |

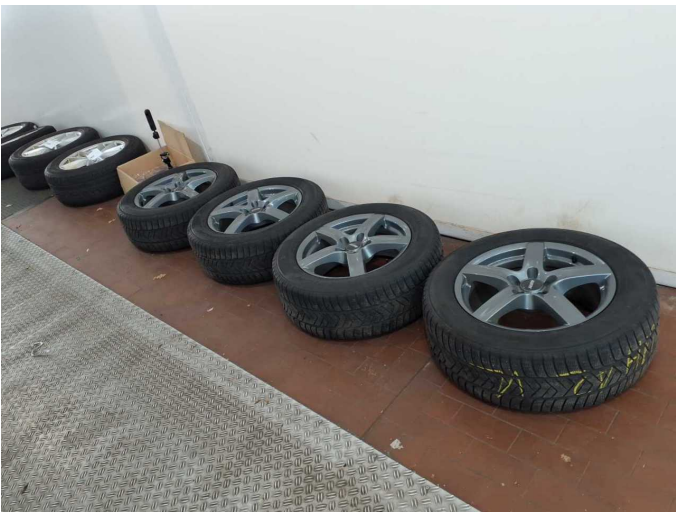
Figure 17: Additional tyres

| # | Tyre size | Type of tyre | Manufacturer | Tread depth |
|---|---|---|---|---|
| 1) | 235/60 R18 107H | Winter tyres on Light alloy | Pirelli | 3mm / 3mm |
| 2) | 235/60 R18 107H | Winter tyres on Light alloy | Pirelli | 3mm / 3mm |

| No. | Component group | Description |
|---|---|---|
| 3 | 2nd wheel set | Tyres - complete set - Worn - Replace |

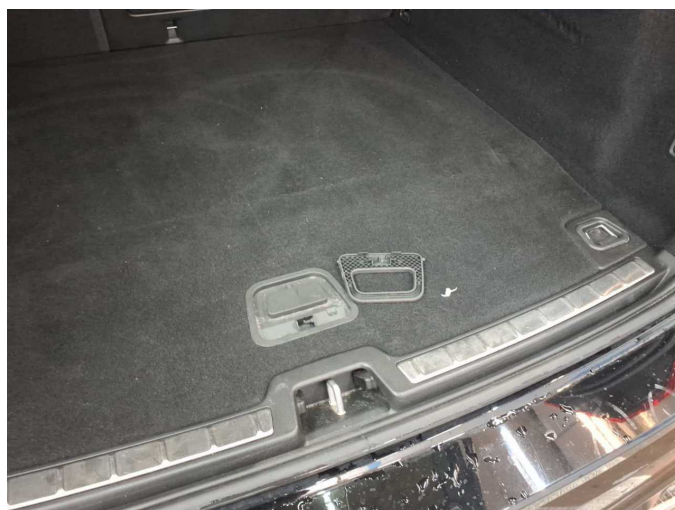
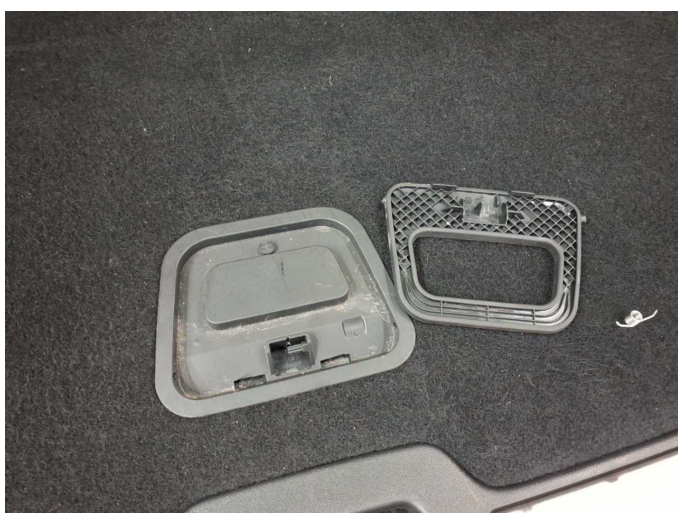
**Damage 1:** Interior: Cargo area floor (Griff) - Broken / torn - Replace

| No. | Component group | Description |
|---|---|---|
| 1 | Interior | Cargo area floor (Griff) - Broken / torn - Replace |

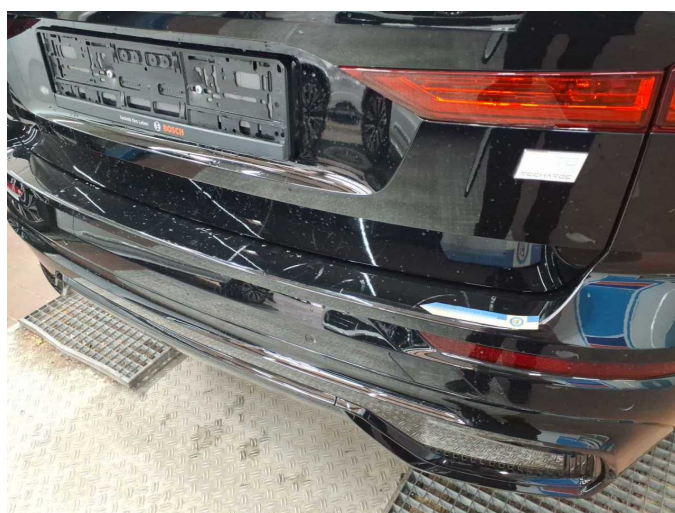
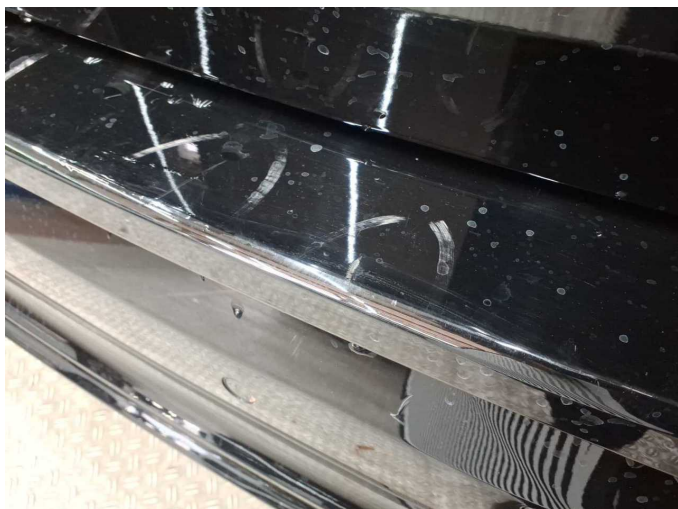
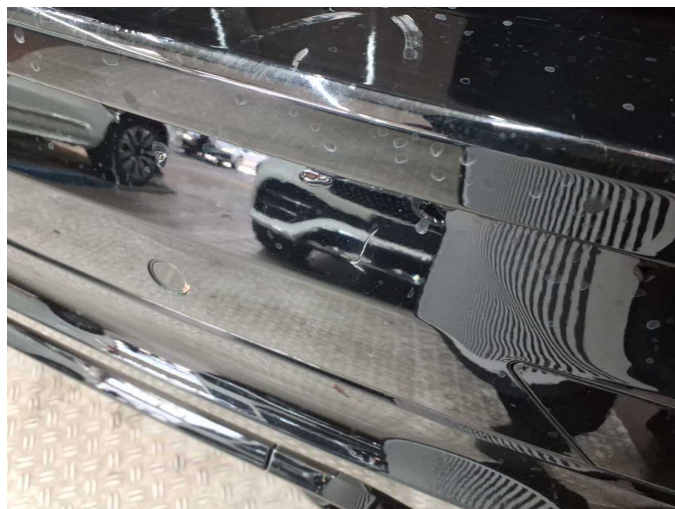
**Damage 2:** Rear bumper: Rear bumper - Scratch(es) - Smart repair

| No. | Component group | Description |
|---|---|---|
| 2 | Rear bumper | Rear bumper - Scratch(es) - Smart repair |

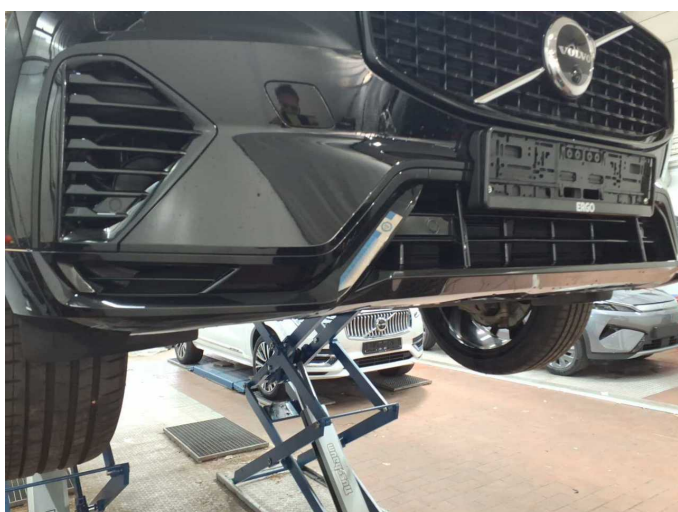
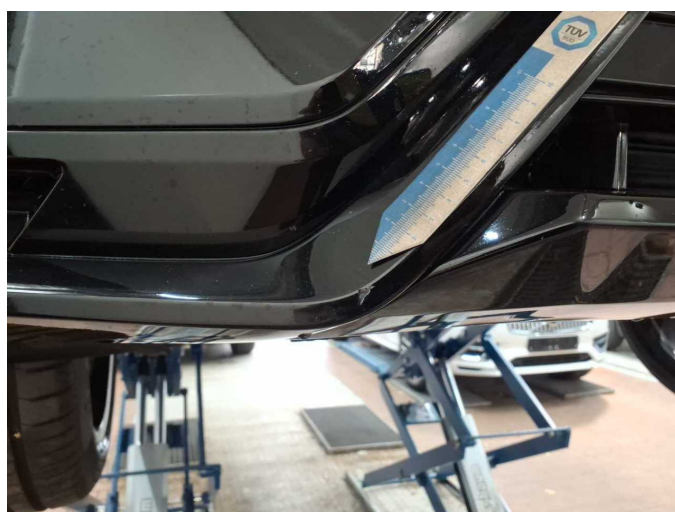
**Damage 3:** Front bumper: Spoiler - Scratch(es) - Smart repair

| No. | Component group | Description |
|---|---|---|
| 3 | Front bumper | Spoiler - Scratch(es) - Smart repair |

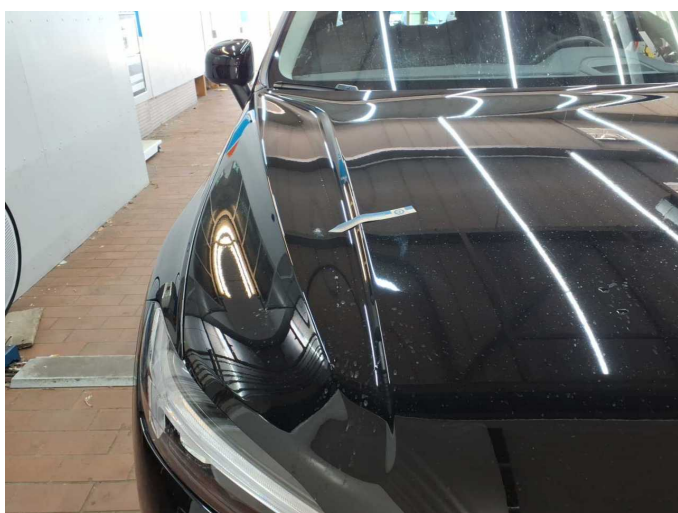
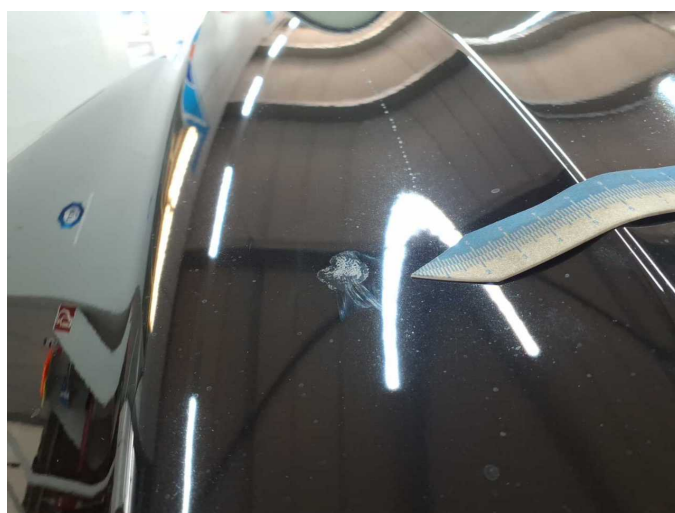
**Damage 4:** Bonnet: Bonnet (Verätzungen-Mehrkosten möglich) - Paint defect - Conditioning

| No. | Component group | Description |
|---|---|---|
| 4 | Bonnet | Bonnet (Verätzungen-Mehrkosten möglich) - Paint defect - Conditioning |

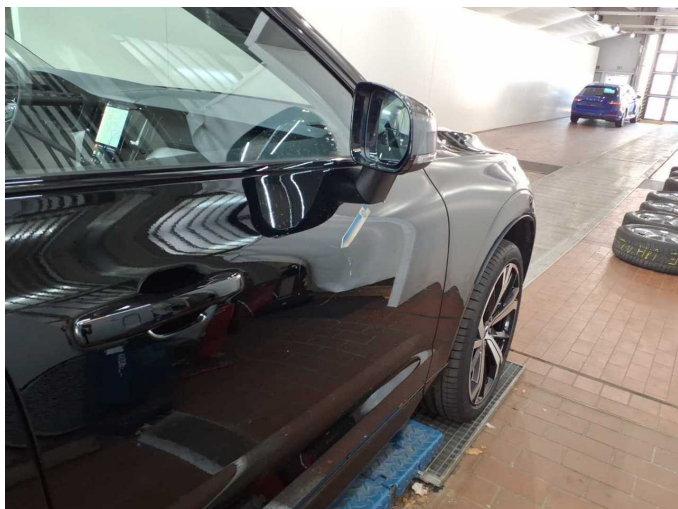
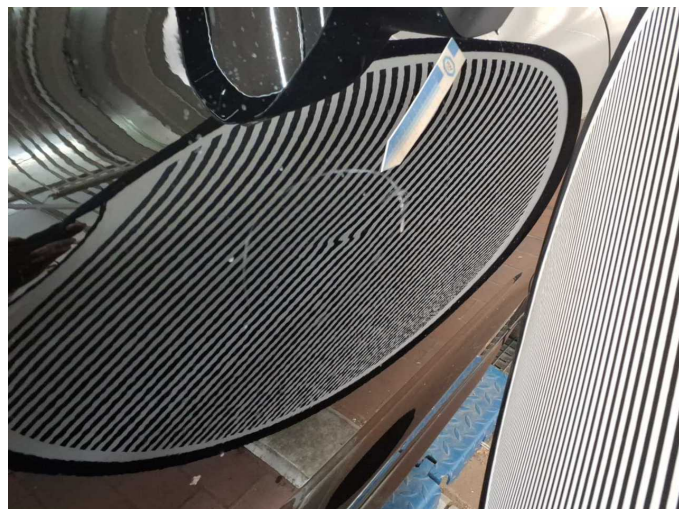
**Damage 5:** Door - front right side: Door - dent(s) - Smart repair

| No. | Component group | Description |
|---|---|---|
| 5 | Door - front right side | Door - dent(s) - Smart repair |

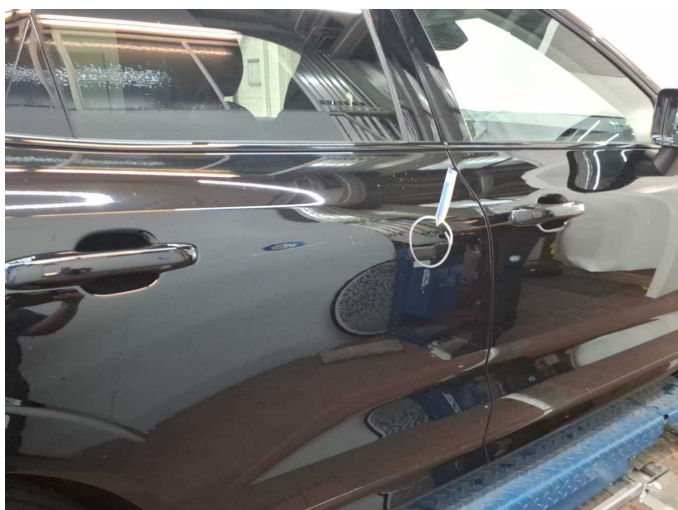
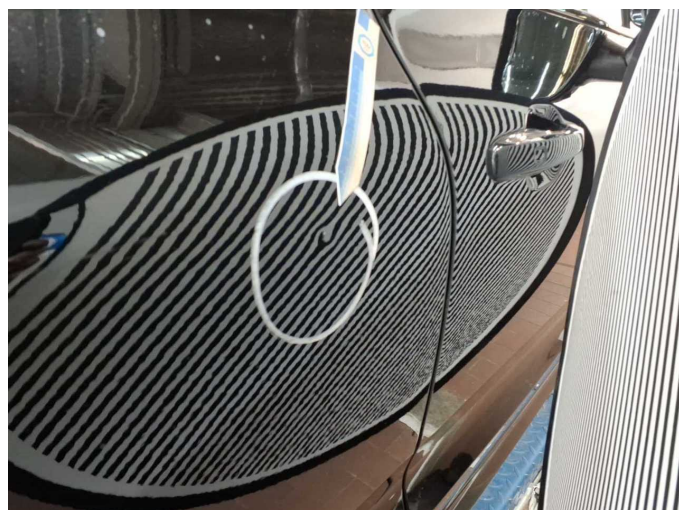
**Damage 6:** Door - rear right side: Door - Dent / paintcoat damage - Smart repair

| No. | Component group | Description |
|---|---|---|
| 6 | Door - rear right side | Door - Dent / paintcoat damage - Smart repair |

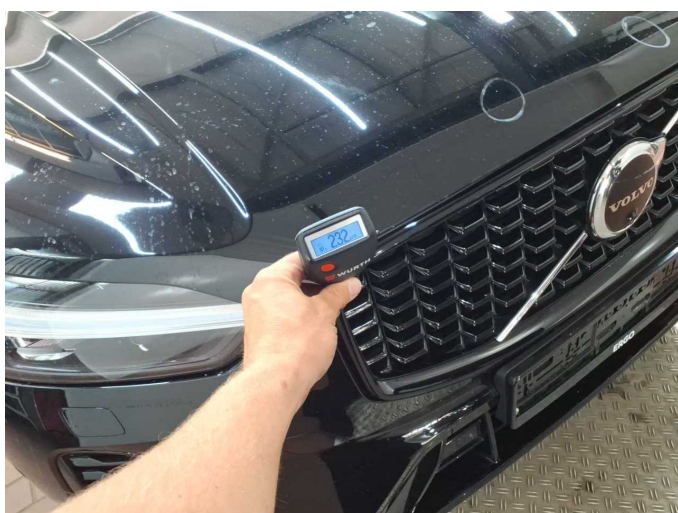
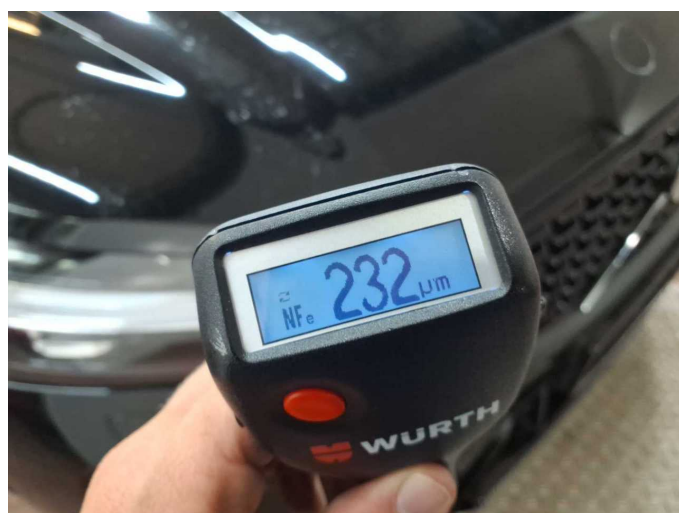
- 1 Bonnet, Door - front right side, Professionally carried out, Invoice of repair done Non-existent

| Bonnet | 232 µm |

**Repainting 1:** Bonnet, Door - front right side
