Expertise

Protocol number: 46210844  
Order No. / Reference: 26584646  
Inspection date: 26 Jun 2026

Manufacturer: Volkswagen

Model: Passat Variant 2.0 TDI SCR DSG Business

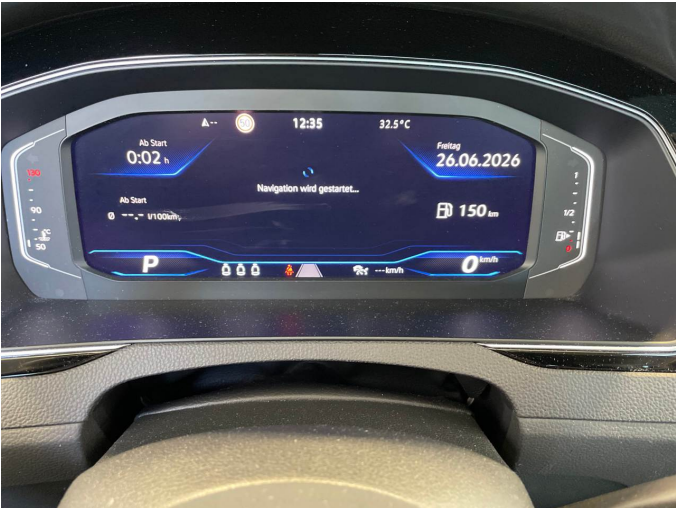
Figure 7: Instrument cluster

| Vehicle details | |
|---|---|
| Mileage (Read) | 85,775 km |

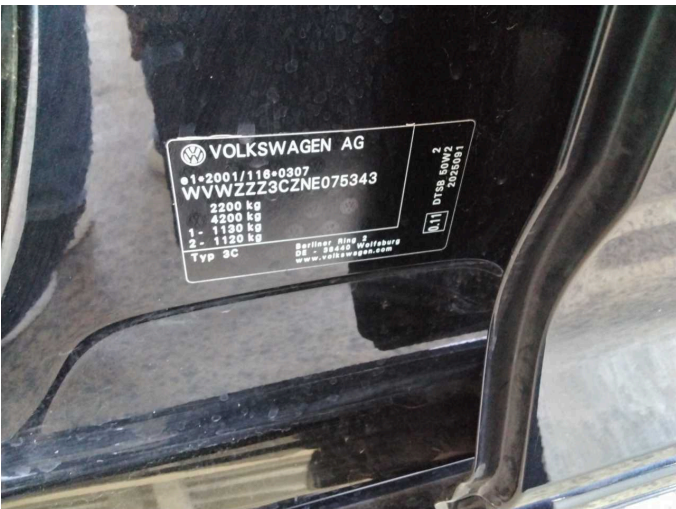
Figure 11: VIN

| VIN comparison | The vehicle identification number (VIN) was read from the vehicle and its conformity with the submitted documents was confirmed by the undersigned during the inspection. |

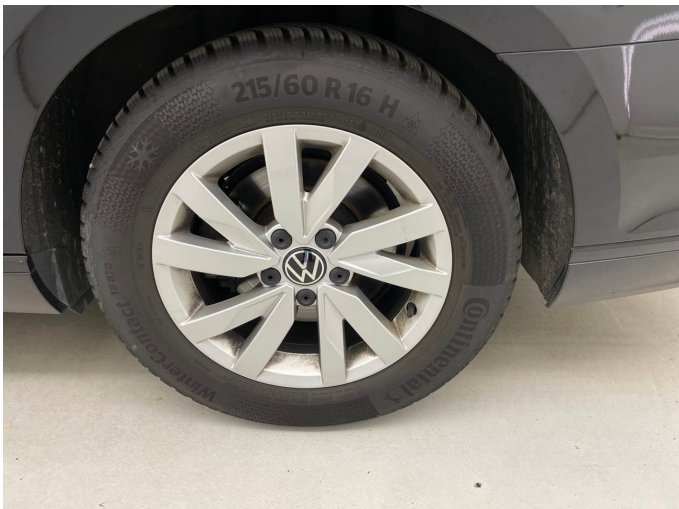
Figure 12: Mounted tyres

| # | Tyre size | Type of tyre | Manufacturer | Tread depth |
|---|---|---|---|---|
| 1) | 215/60 R16 95H | Winter tyres on Light alloy | Continental | 7mm / 7mm |
| 2) | 215/60 R16 95H | Winter tyres on Light alloy | Continental | 8mm / 8mm |

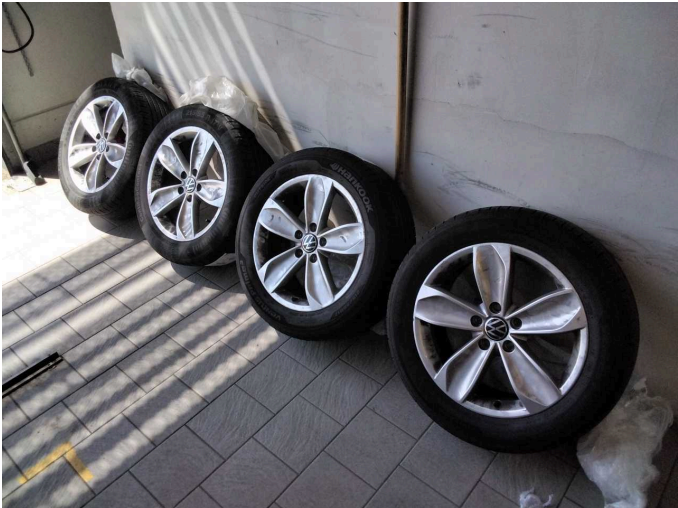
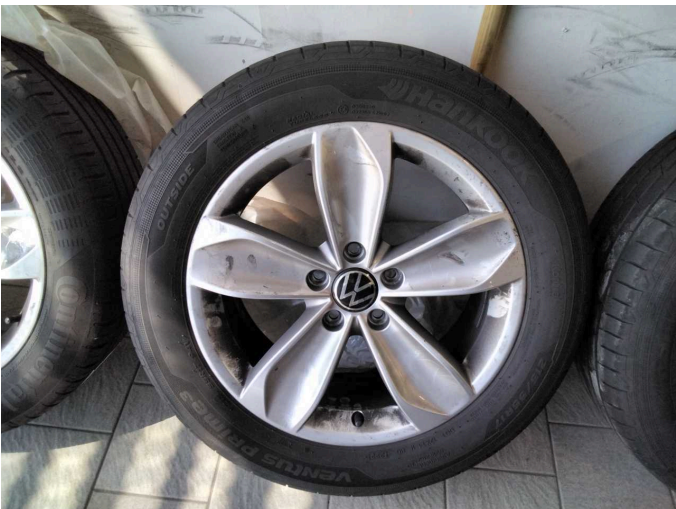
| # | Tyre size | Type of tyre | Manufacturer | Tread depth |
|---|---|---|---|---|
| 1) | 215/55 R17 94V | Summer tyres on Light alloy | Hankook | 5mm / 5mm |
| 2) | 215/55 R17 94V | Summer tyres on Light alloy | Hankook | 6mm / 6mm |

Figure 16: Additional tyres

Figure 17: Additional tyres

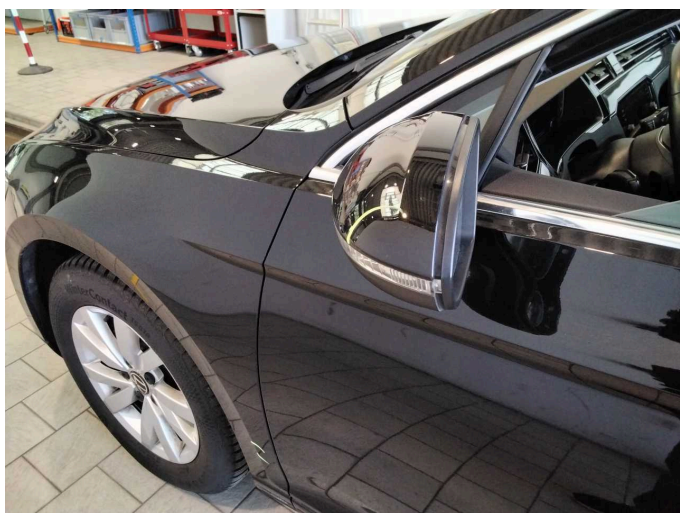
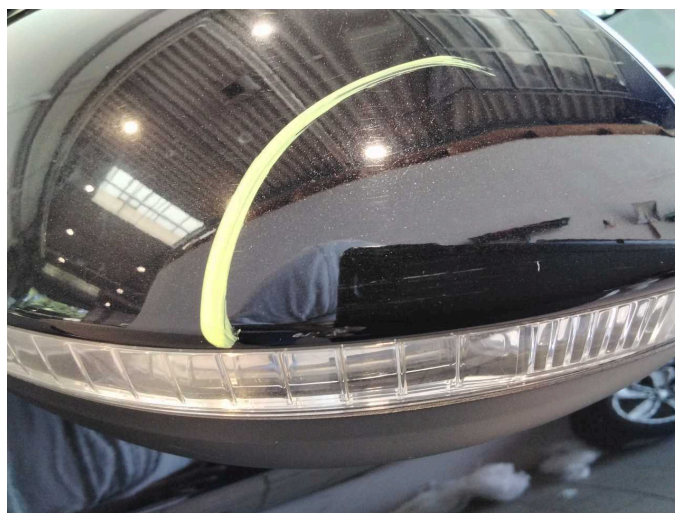
| No. | Component group | Description |
|---|---|---|
| 1 | Wing mirror - left side | Cap - Scratch(es) - Smart repair |

Damage 1: Wing mirror - left side: Cap - Scratch(es) - Smart repair

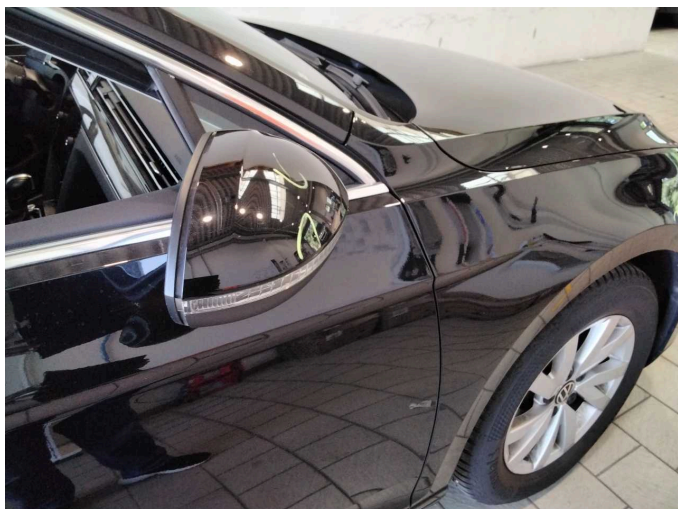
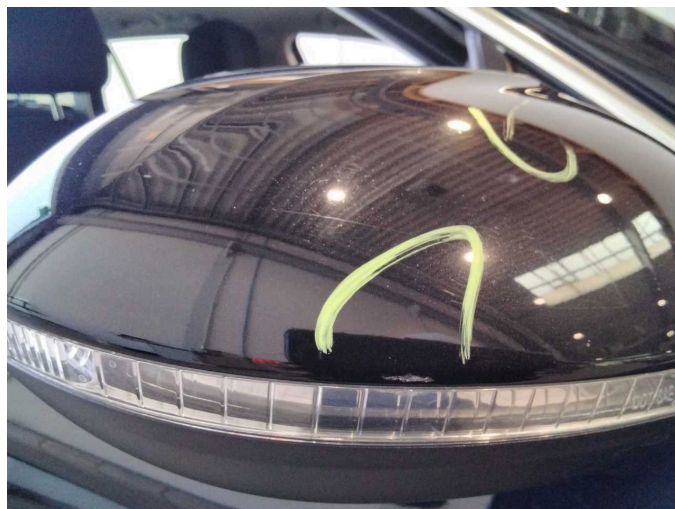
| No. | Component group | Description |
|---|---|---|
| 2 | Wing mirror - right side | Cap - Scratch(es) - Smart repair |

**Damage 2:** Wing mirror - right side: Cap - Scratch(es) - Smart repair

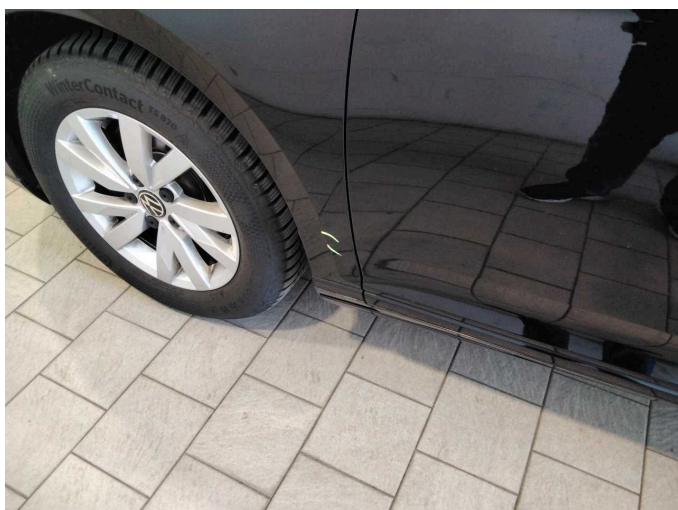
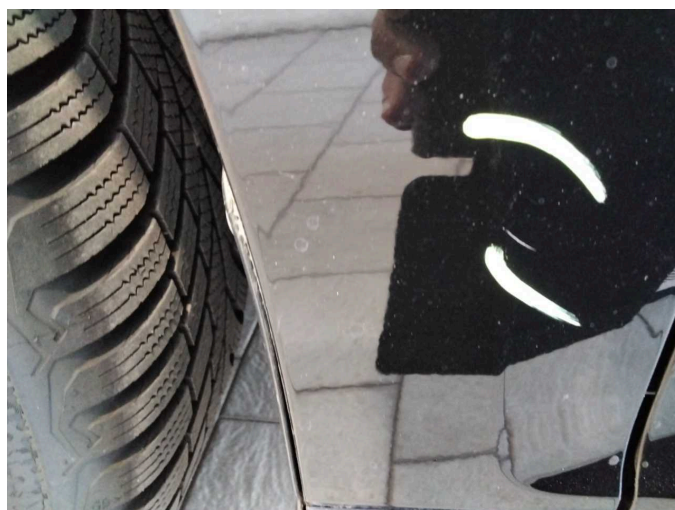
| No. | Component group | Description |
|---|---|---|
| 3 | Mudguard - left side | Mudguard - left side - Scratch(es) - Smart repair |

**Damage 3:** Mudguard - left side: Mudguard - left side - Scratch(es) - Smart repair

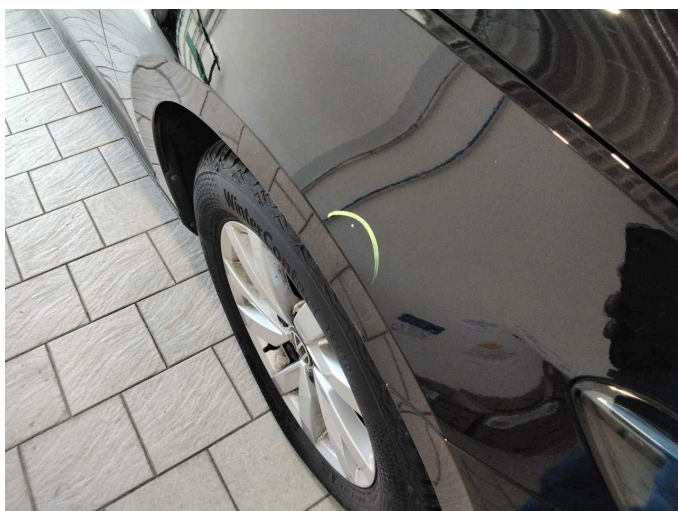
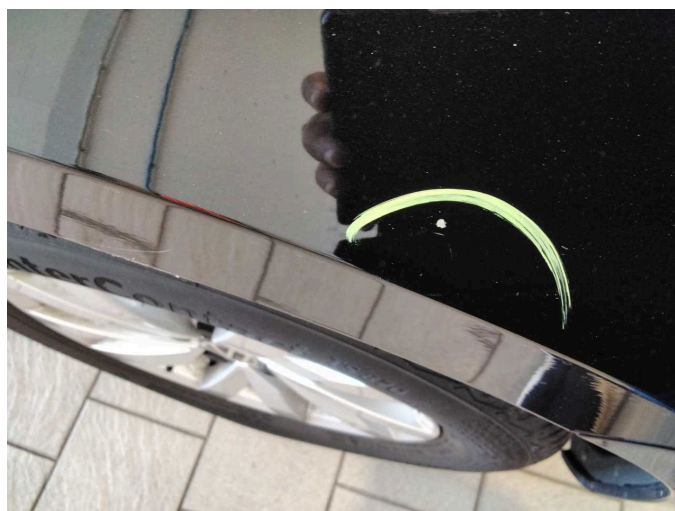
| No. | Component group | Description |
|---|---|---|
| 4 | Mudguard - right side | Mudguard - right side - Scratch(es) - Smart repair |

**Damage 4:** Mudguard - right side: Mudguard - right side - Scratch(es) - Smart repair

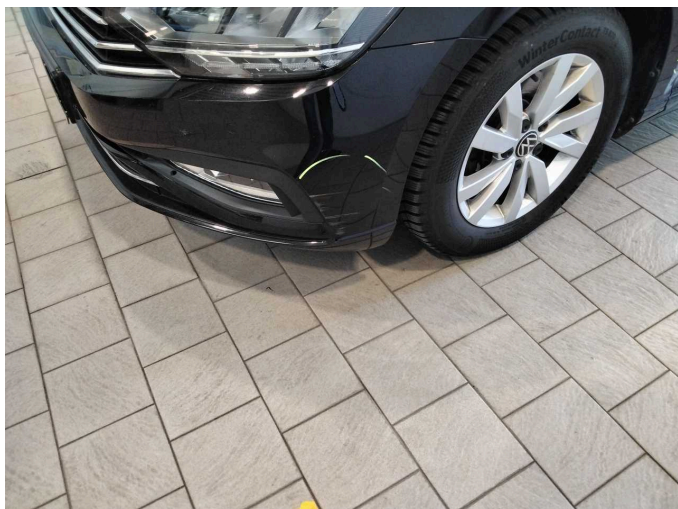
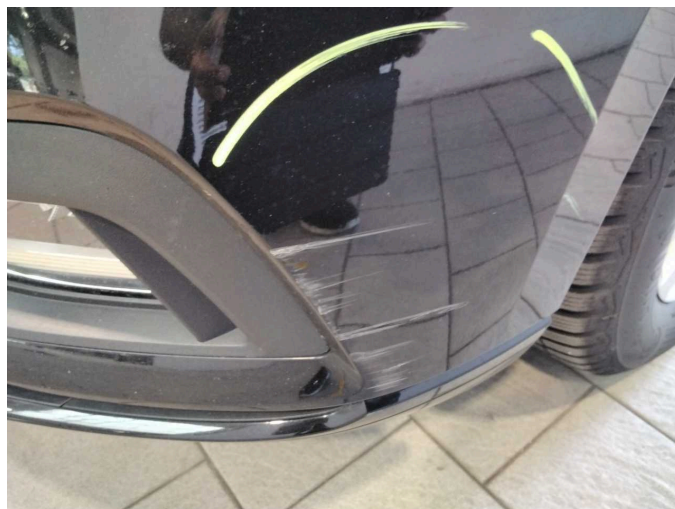
| No. | Component group | Description |
|---|---|---|
| 5 | Front bumper | Front bumper - Scratch(es) - Smart repair |

**Damage 5:** Front bumper: Front bumper - Scratch(es) - Smart repair

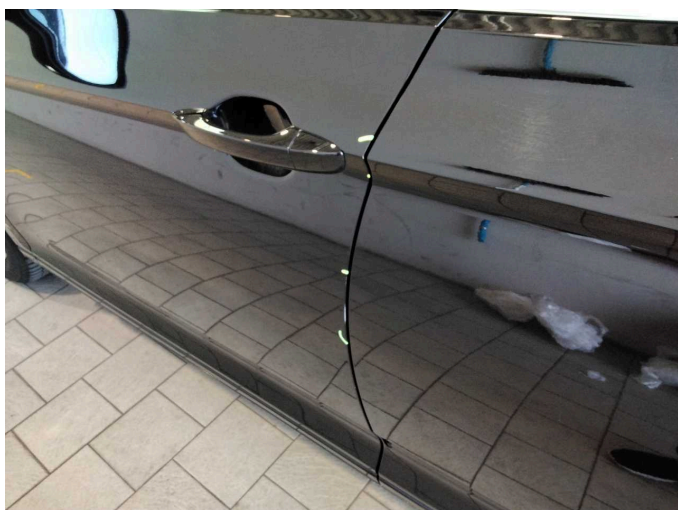
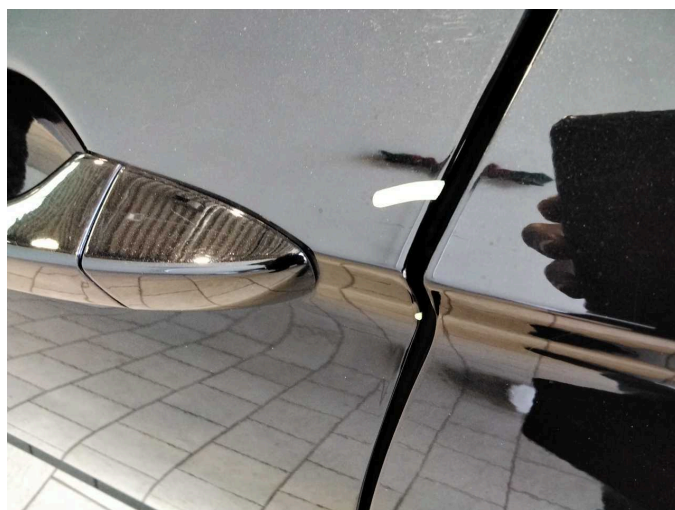
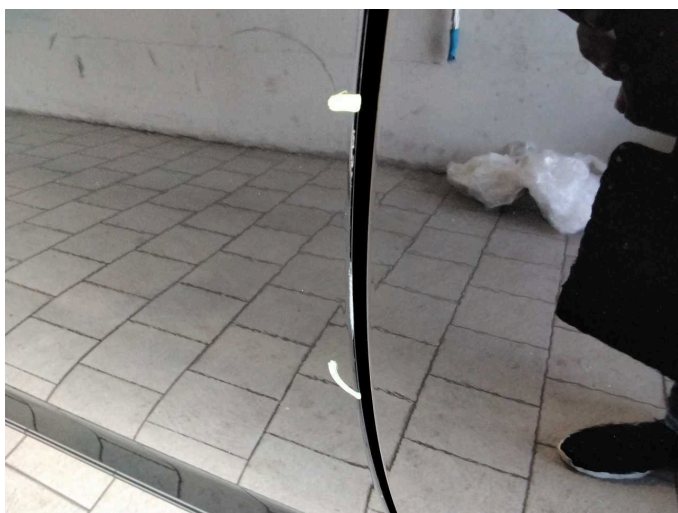
| No. | Component group | Description |
|---|---|---|
| 6 | Door - front left side | Door edge - Scratch(es) - Smart repair |

**Damage 6:** Door - front left side: Door edge - Scratch(es) - Smart repair

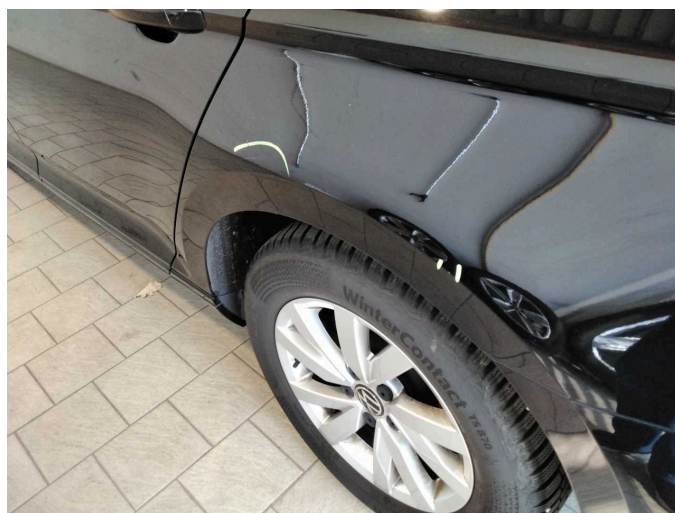
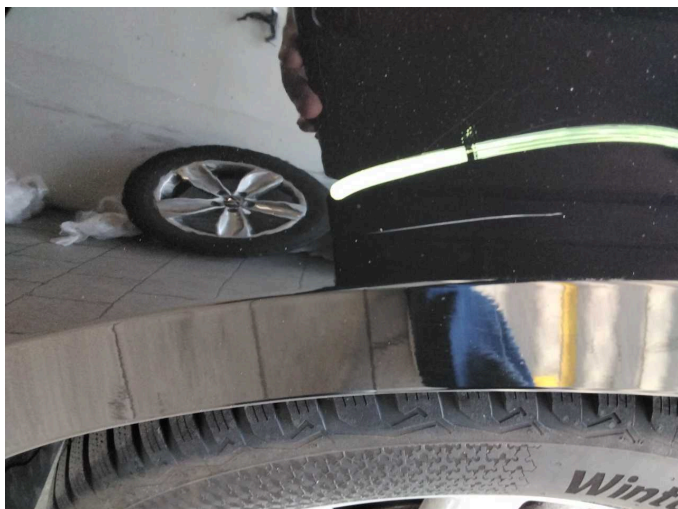
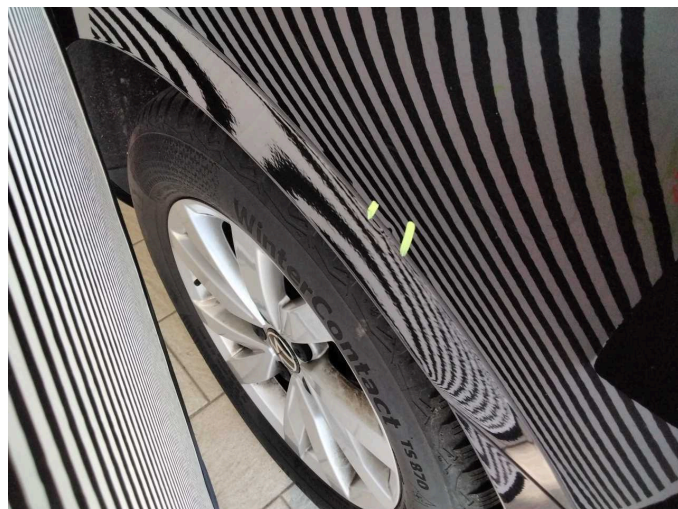
| No. | Component group | Description |
|---|---|---|
| 7 | Side panel - rear left side | Side panel - Dent / paintcoat damage - Smart repair |

**Damage 7:** Side panel - rear left side: Side panel - Dent / paintcoat damage - Smart repair

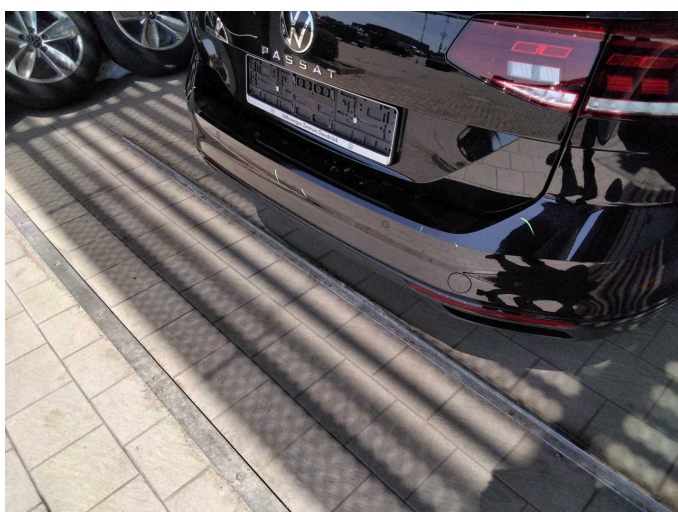
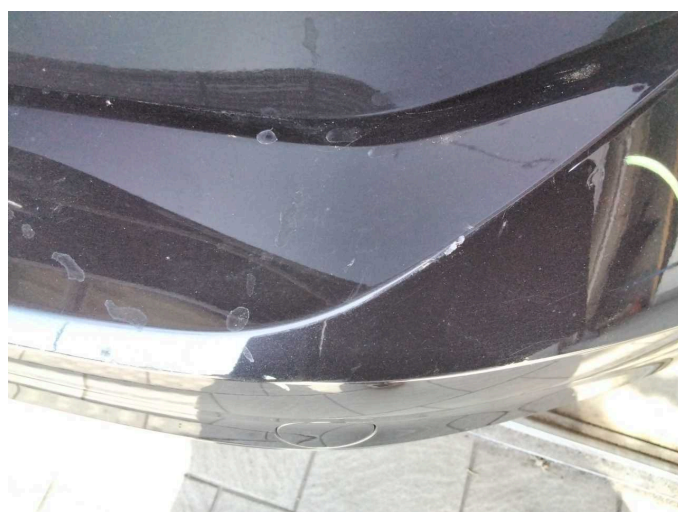
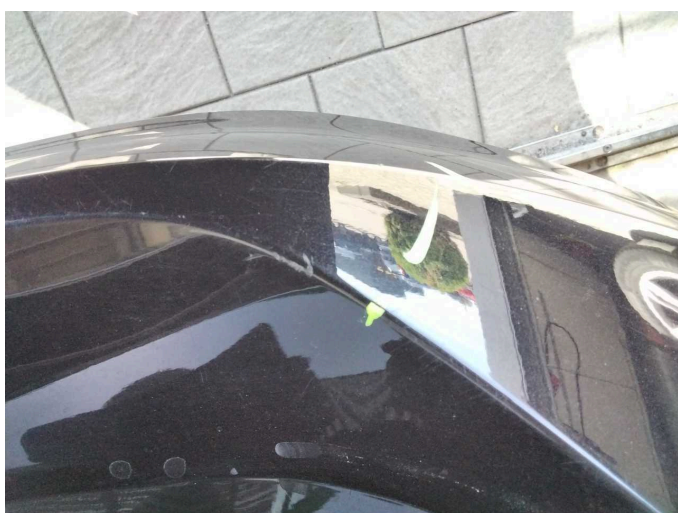
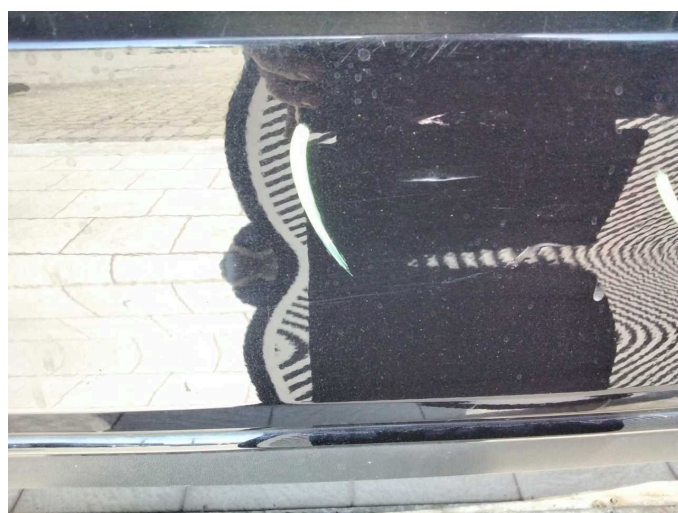
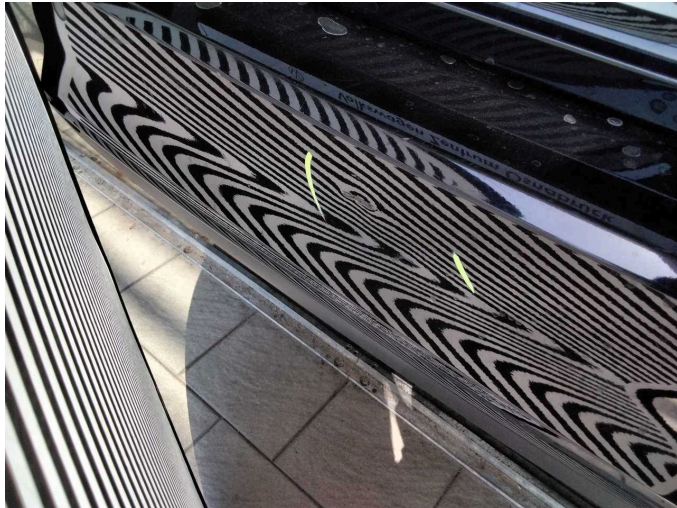
| No. | Component group | Description |
|---|---|---|
| 8 | Rear bumper | Rear bumper - Dent / paintcoat damage - Repair and paint |

**Damage 8:** Rear bumper: Rear bumper - Dent / paintcoat damage - Repair and paint

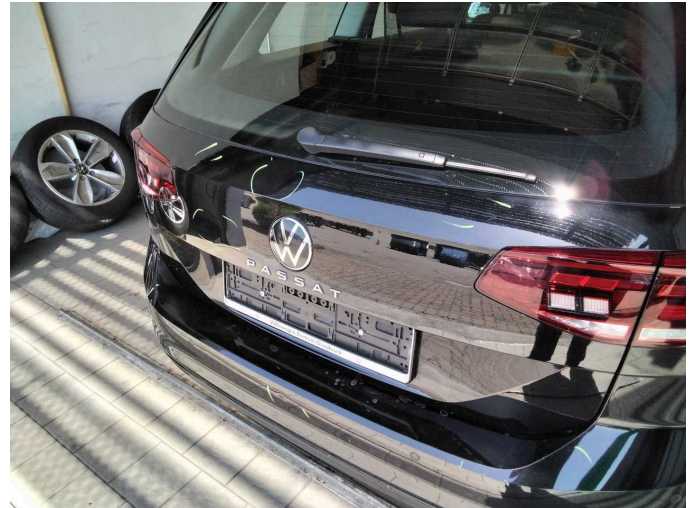
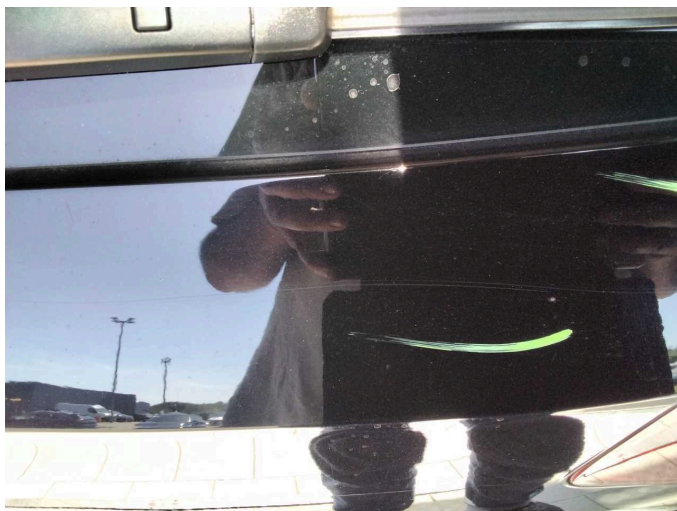
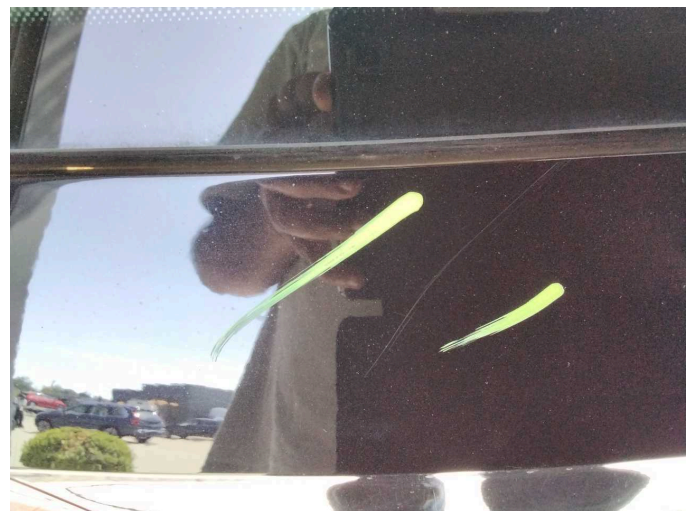
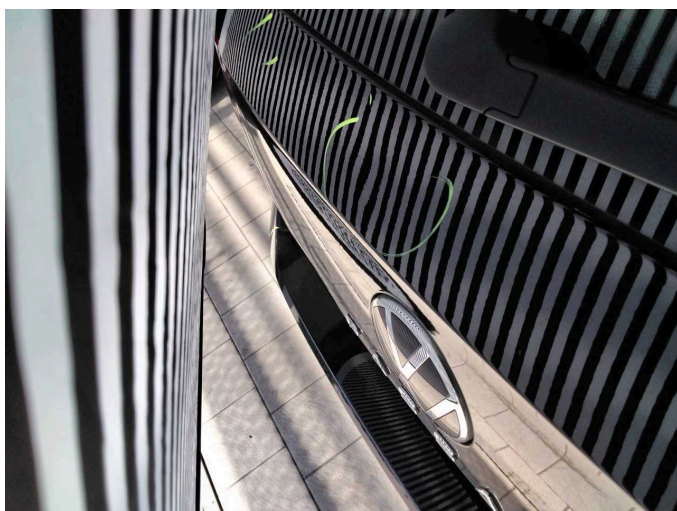
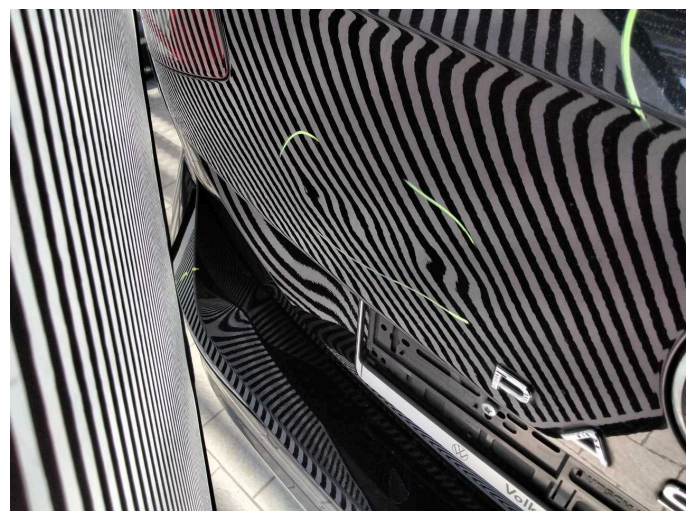
| No. | Component group | Description |
|---|---|---|
| 9 | Boot lid / rear door | Boot lid - Dent / paintcoat damage - Repair and paint |

**Damage 9:** Boot lid / rear door: Boot lid - Dent / paintcoat damage - Repair and paint

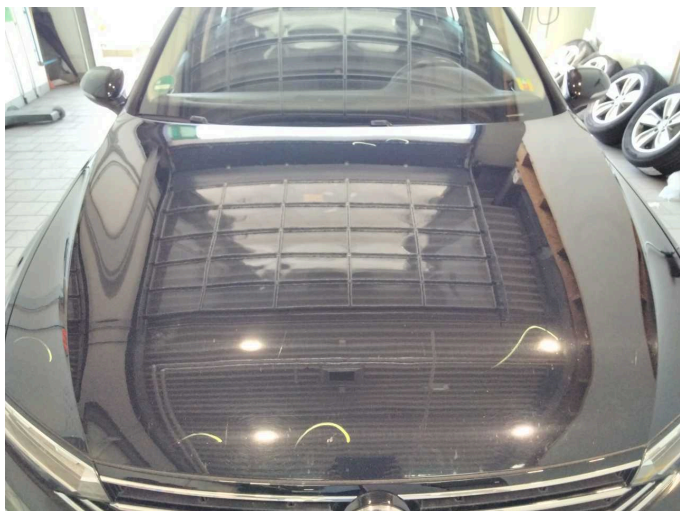
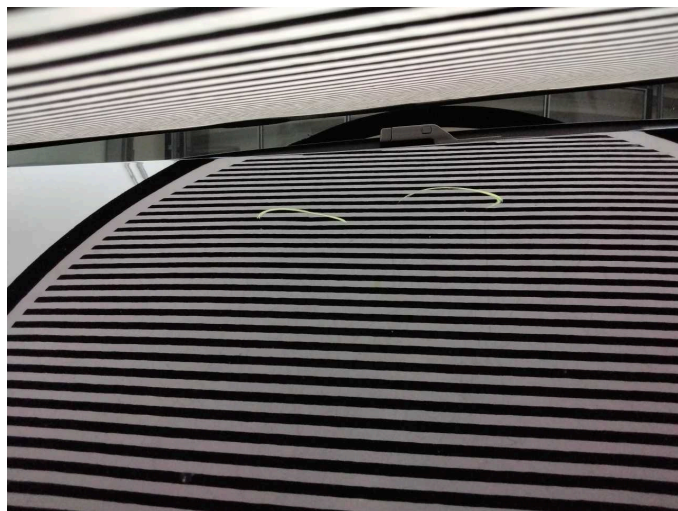
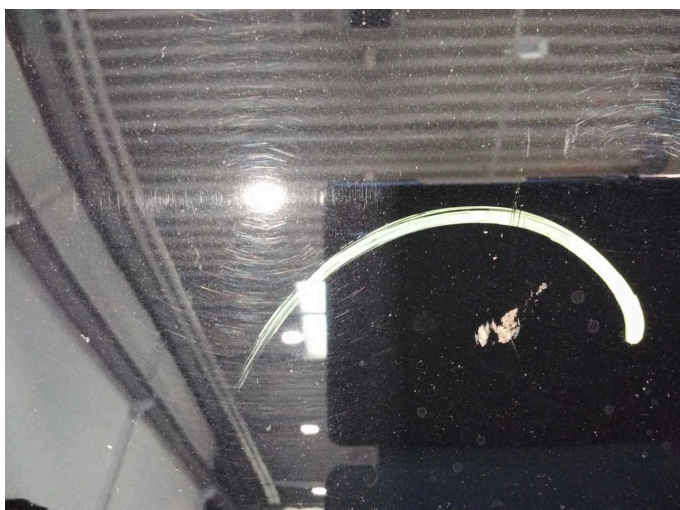
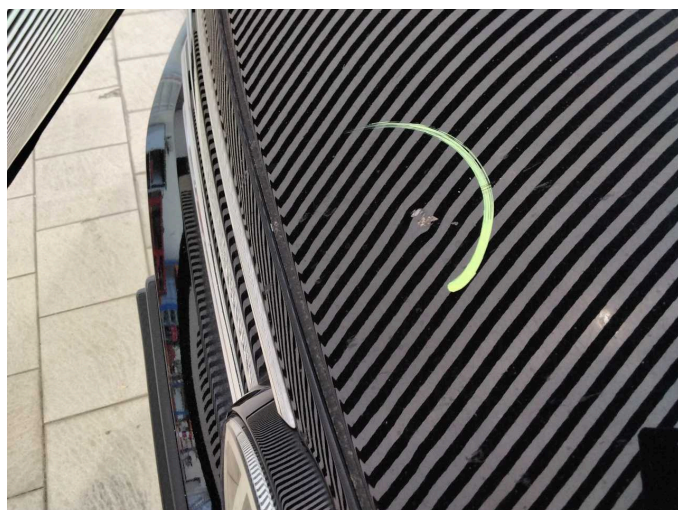
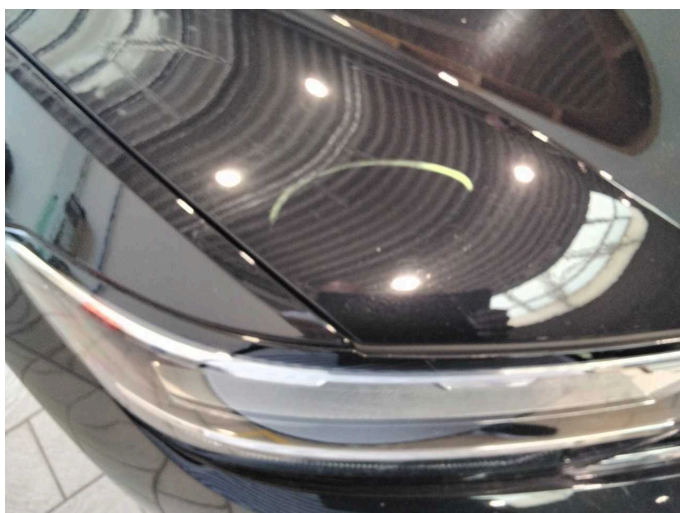
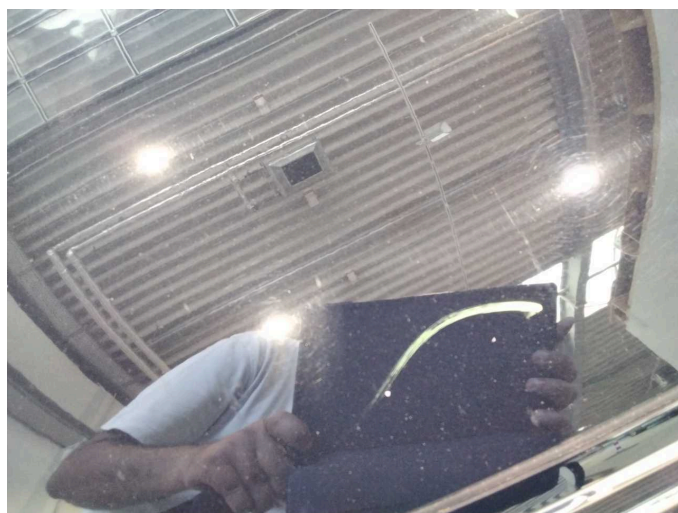
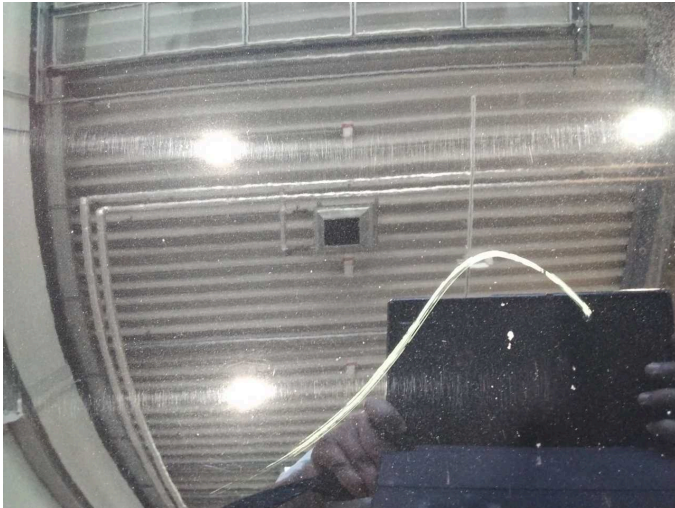
| No. | Component group | Description |
|---|---|---|
| 10 | Bonnet | Bonnet - Dent / paintcoat damage - Repair and paint |

**Damage 10:** Bonnet: Bonnet - Dent / paintcoat damage - Repair and paint

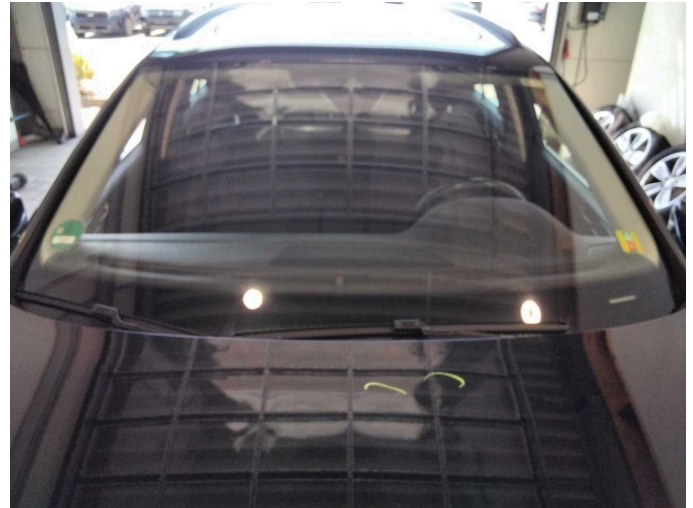
| 1 | Vehicle glazing | Windscreen - Stone chips - No deduction |

**Wear and tear 1:** Vehicle glazing: Windscreen - Stone chips - No deduction

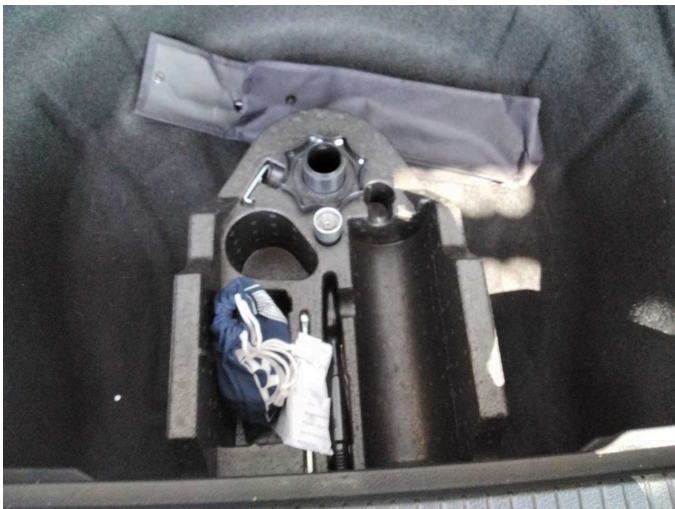
Equipment - Tirefit complete

**Missing part 1:** Equipment: Tirefit complete - Missing - Replace
