Expertise

Protocol number: 46731549  
Order No. / Reference: 26733429  
Inspection date: 27 Jul 2026

Manufacturer: Volvo

Model: XC60 B4 D Geartronic Momentum Pro

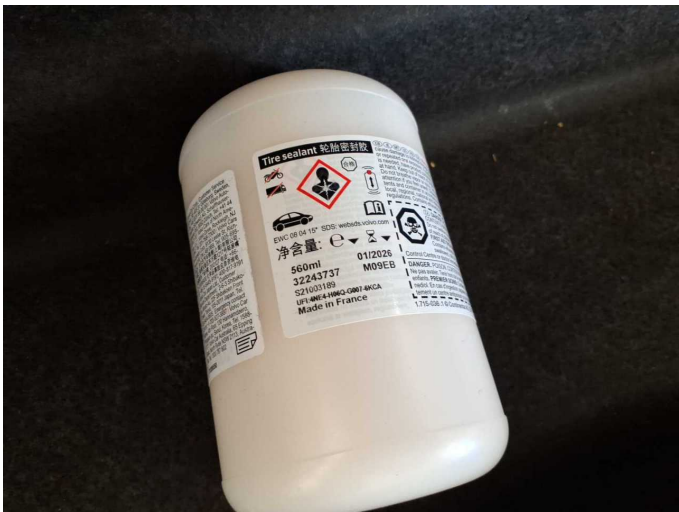
Damage 1: Equipment: Tirefit filler - Expired - Replace

| No. | Component group | Description |
|---|---|---|
| 1 | Equipment | Tirefit filler - Expired - Replace |

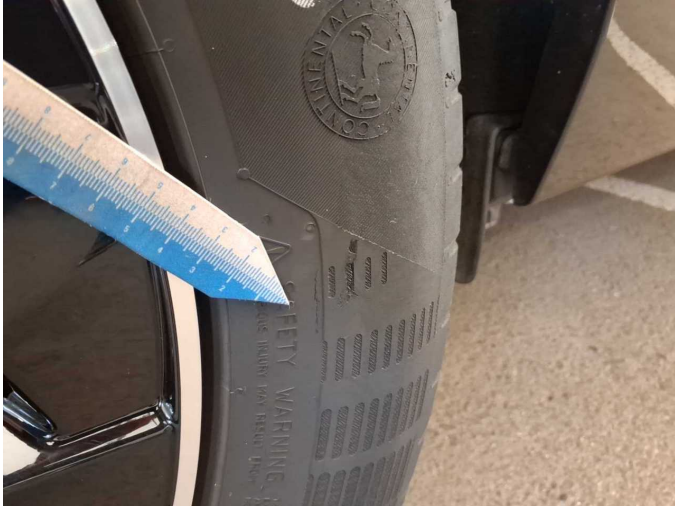
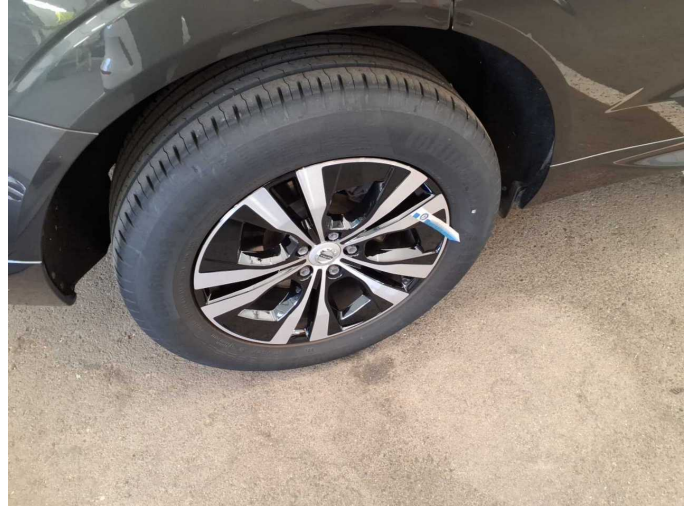
**Damage 2:** Wheel / tyres: Tyre - rear right side (nicht fahrbereit) - Broken / torn - Replace

| No. | Component group | Description |
|---|---|---|
| 2 | Wheel / tyres | Tyre - rear right side (nicht fahrbereit) - Broken / torn - Replace |

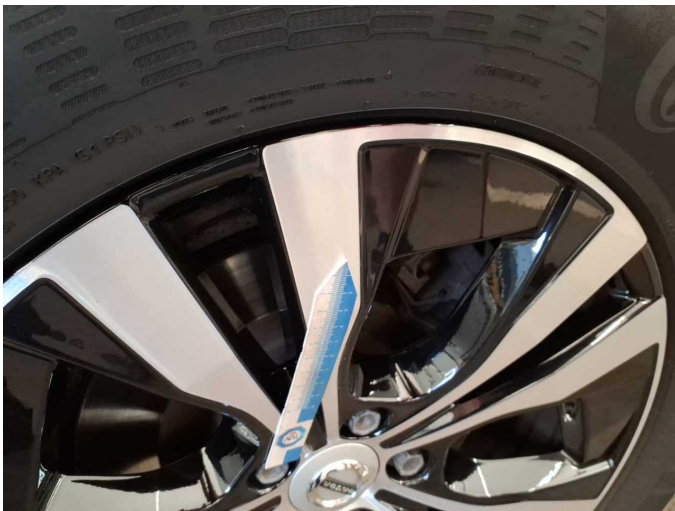
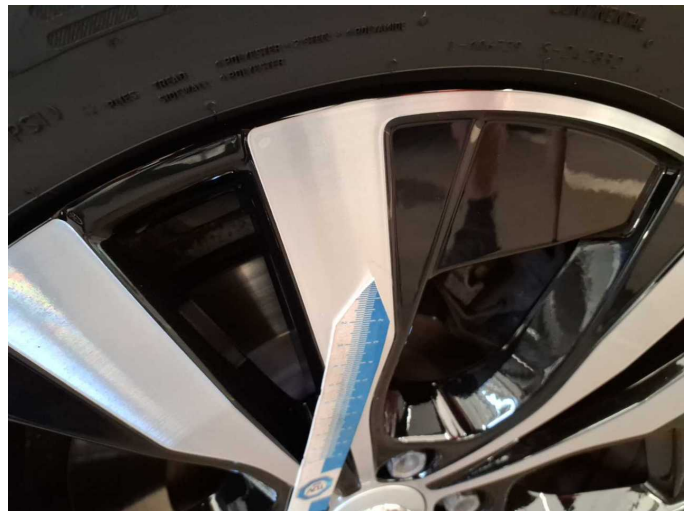
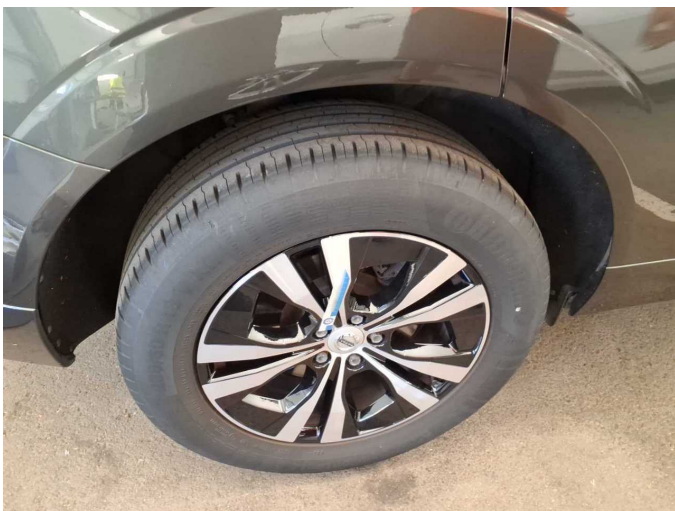
**Damage 3:** Wheel / tyres: Alloy rim - rear right side - Scratch(es) - Loss in value

| No. | Component group | Description |
|---|---|---|
| 3 | Wheel / tyres | Alloy rim - rear right side - Scratch(es) - Loss in value |

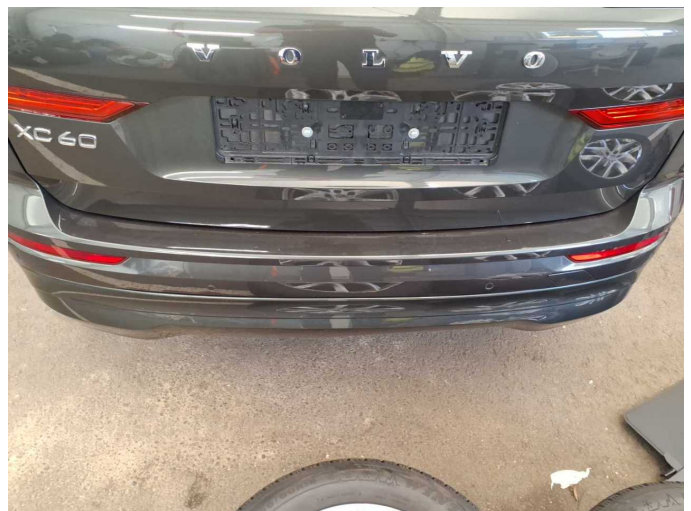
| No. | Component group | Description |
|---|---|---|
| 1 | Rear bumper | Rear bumper - Scratch(es) - No deduction |

**Wear and tear 1:** Rear bumper: Rear bumper - Scratch(es) - No deduction

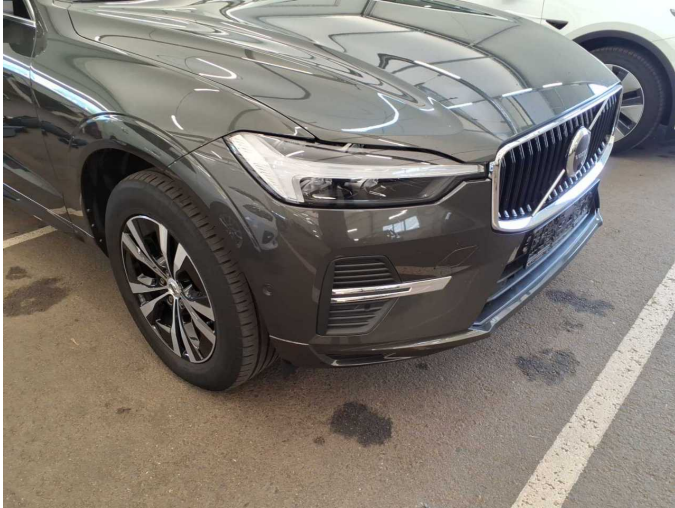
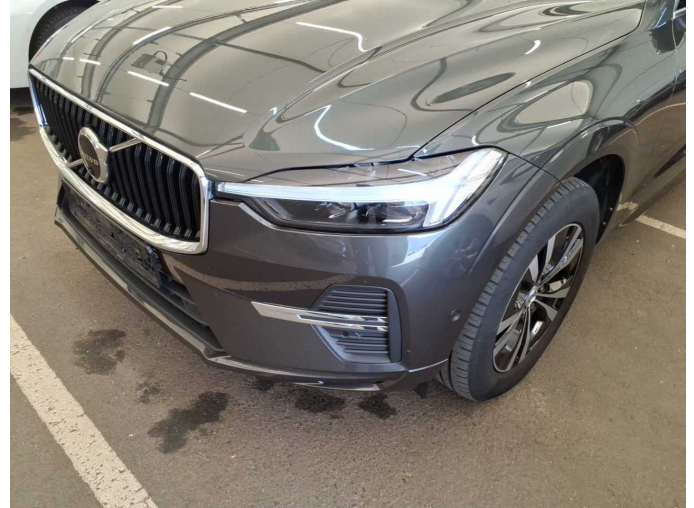
| No. | Component group | Description |
|---|---|---|
| 3 | Front bumper | Front bumper - Stone chips - No deduction |

**Wear and tear 3:** Front bumper: Front bumper - Stone chips - No deduction

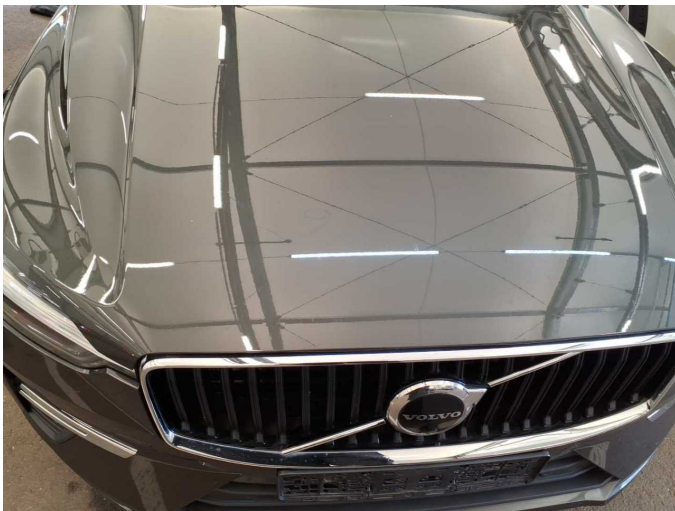
| No. | Component group | Description |
|---|---|---|
| 4 | Bonnet | Bonnet - Stone chips - No deduction |

**Wear and tear 4:** Bonnet: Bonnet - Stone chips - No deduction

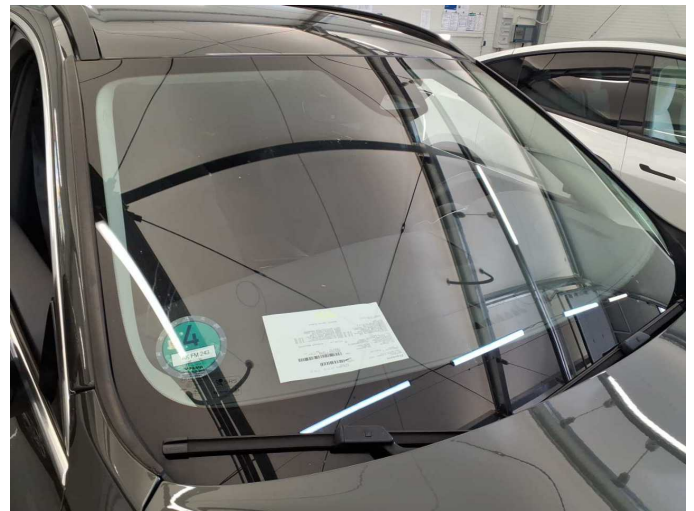
| No. | Component group | Description |
|---|---|---|
| 5 | Vehicle glazing | Windscreen - Stone chips - No deduction |

**Wear and tear 5:** Vehicle glazing: Windscreen - Stone chips - No deduction

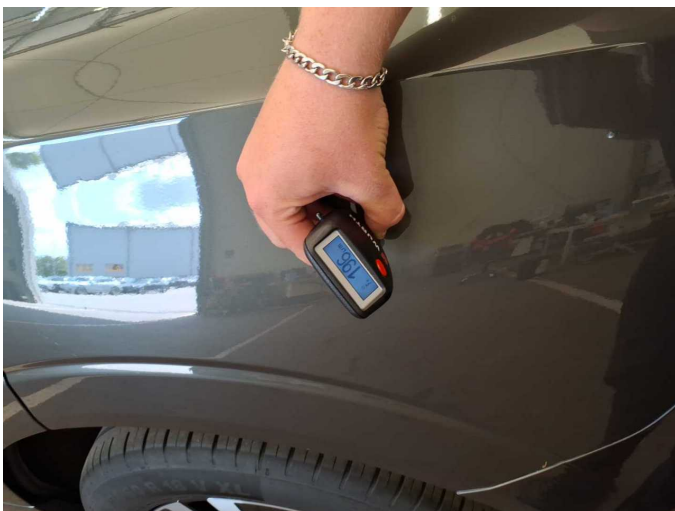
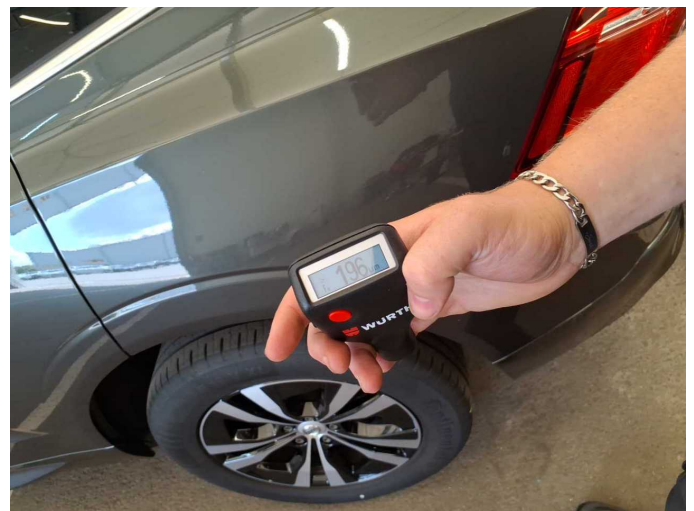
- 1 Side panel - rear left side, Professionally carried out, Invoice of repair done Non-existent
- 2 Door - rear left side, Professionally carried out, Invoice of repair done Non-existent

| Side panel - rear left side | 196 µm | Door - rear left side | 201 µm |

**Repainting 1:** Side panel - rear left side

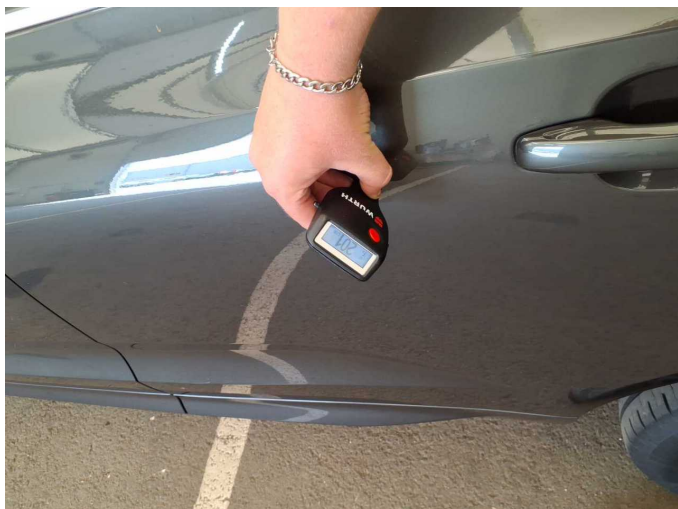
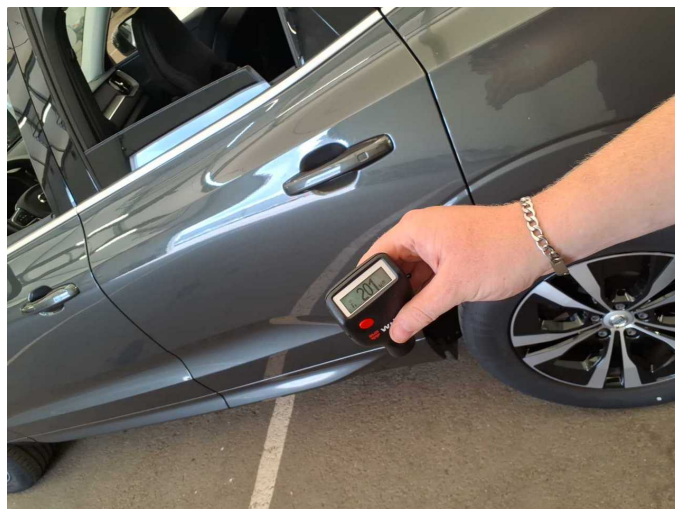
**Repainting 2:** Door - rear left side
