Expertise

Protocol number: 46714001  
Order No. / Reference: 26689084  
Inspection date: 23 Jul 2026

Manufacturer: Mercedes-Benz

Model: C 220 d T 9G-TRONIC AMG Line

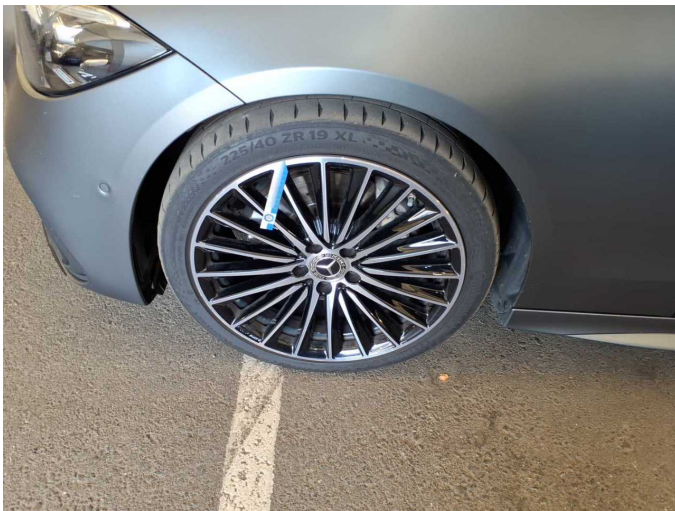
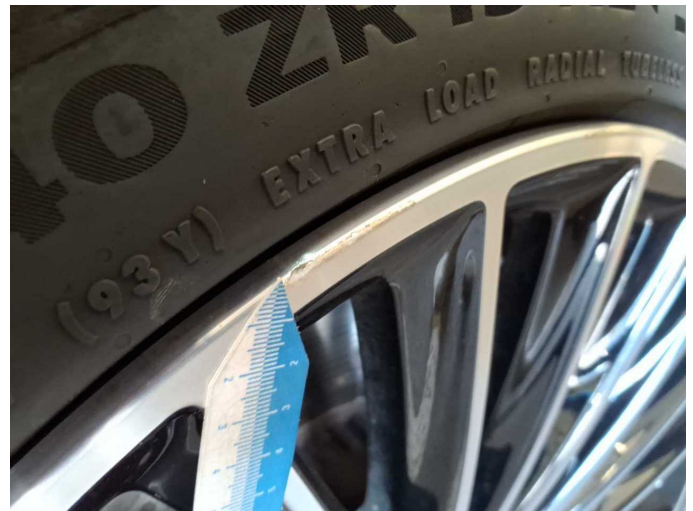
| No. | Component group | Description |
|---|---|---|
| 1 | Wheel / tyres | Alloy rim - front left side - Scratch(es) - Loss in value |

**Damage 1:** Wheel / tyres: Alloy rim - front left side - Scratch(es) - Loss in value

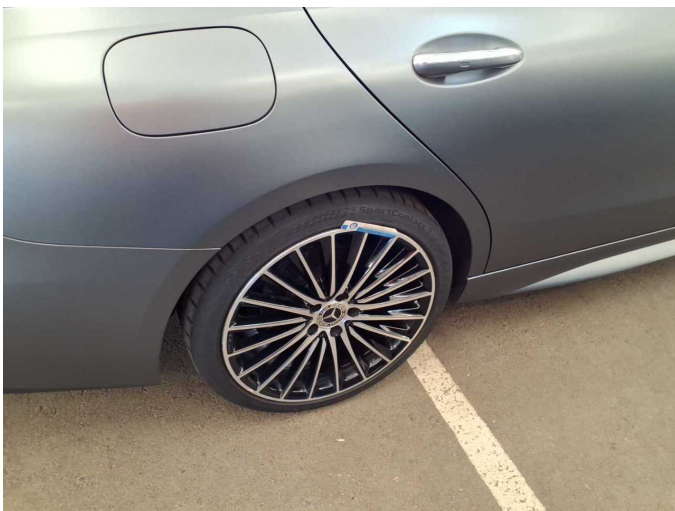
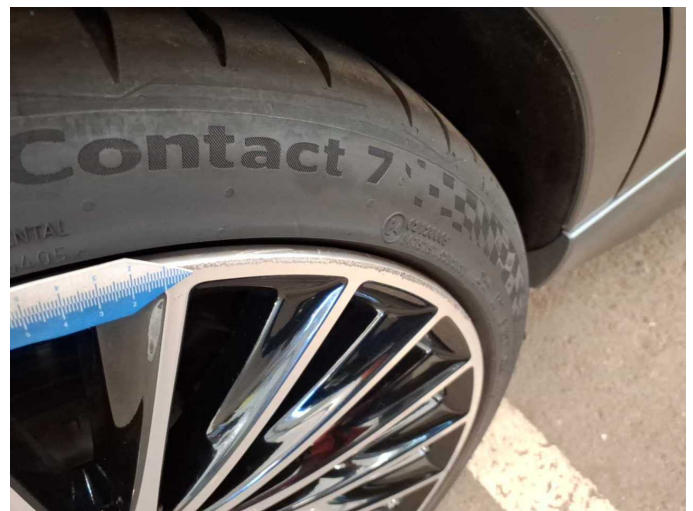
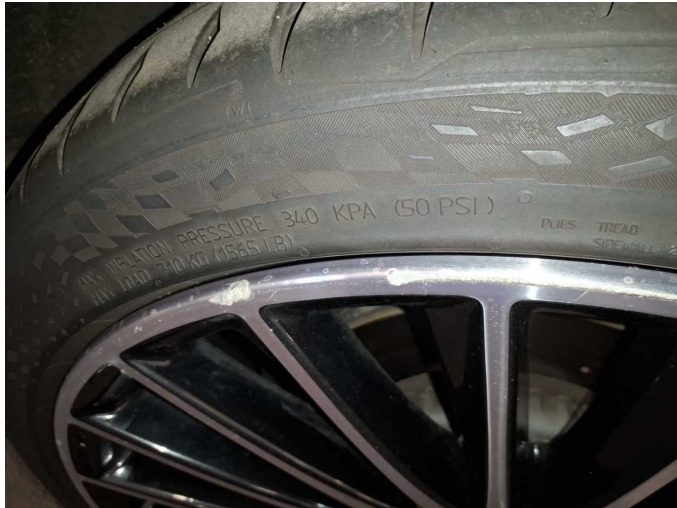
| No. | Component group | Description |
|---|---|---|
| 2 | Wheel / tyres | Alloy rim - rear right side (Mit Materialabtrag) - Scratched - Replace |

**Damage 2:** Wheel / tyres: Alloy rim - rear right side (Mit Materialabtrag) - Scratched - Replace

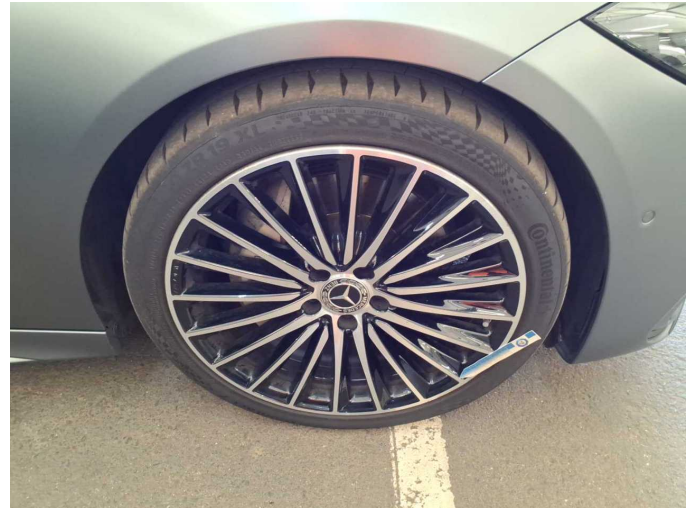
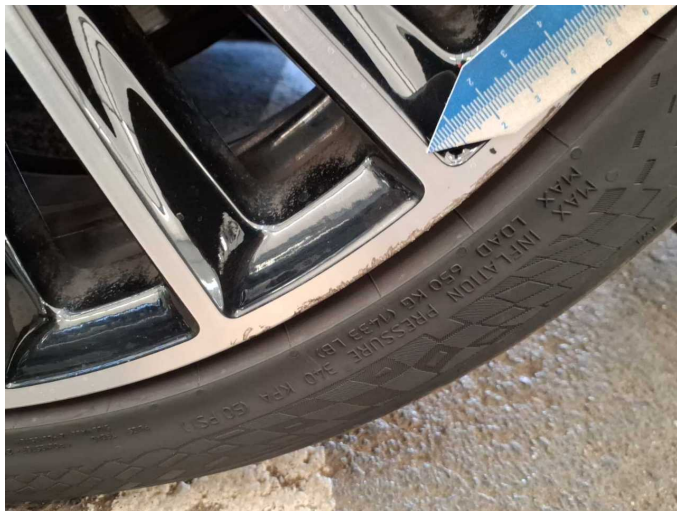
| No. | Component group | Description |
|---|---|---|
| 3 | Wheel / tyres | Alloy rim - front right side - Scratch(es) - Loss in value |

**Damage 3:** Wheel / tyres: Alloy rim - front right side - Scratch(es) - Loss in value

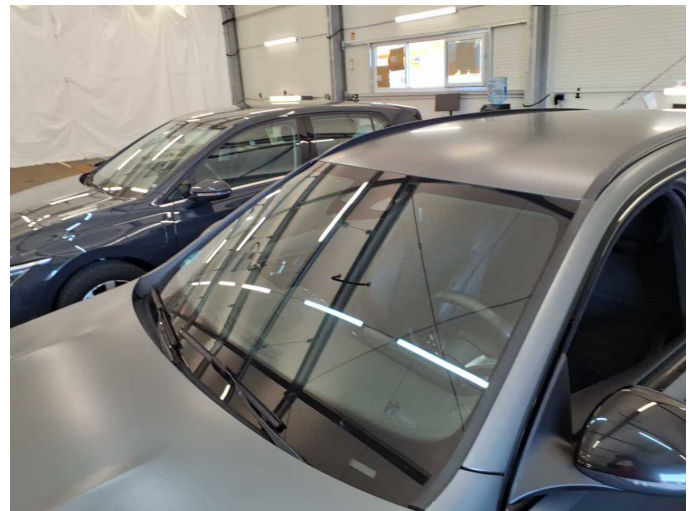
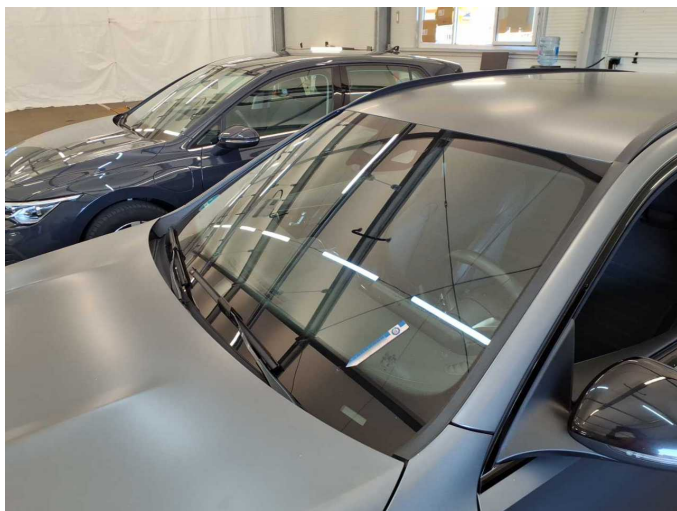
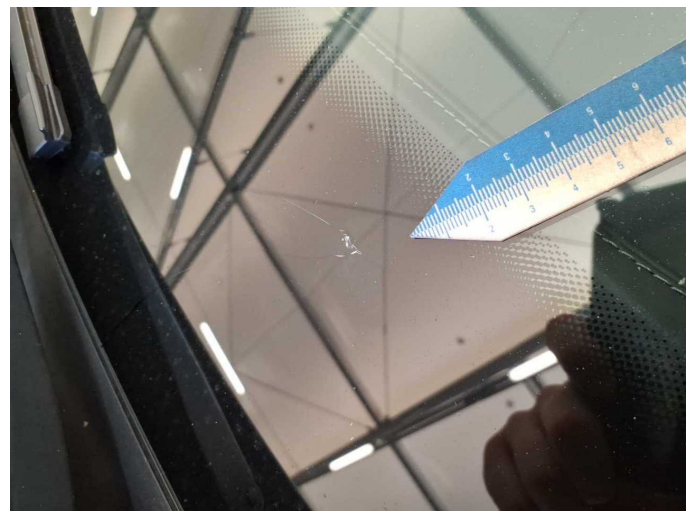
| No. | Component group | Description |
|---|---|---|
| 4 | Vehicle glazing | Windscreen (Im Randbereich mit Rissbildung) - Stone chips - Replace |

**Damage 4:** Vehicle glazing: Windscreen (Im Randbereich mit Rissbildung) - Stone chips - Replace

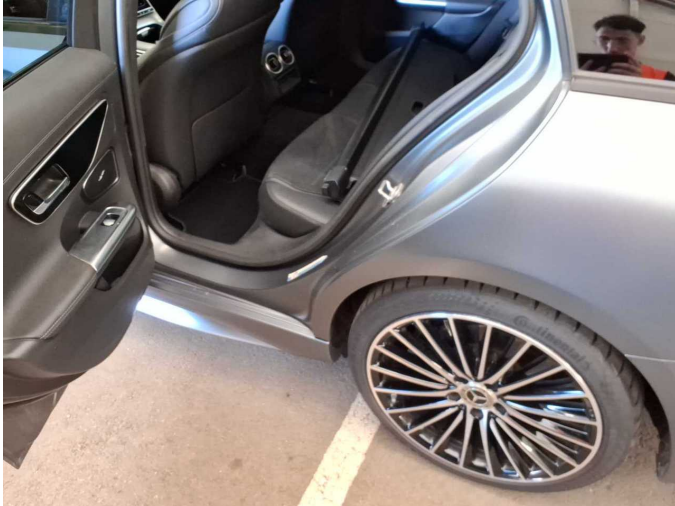
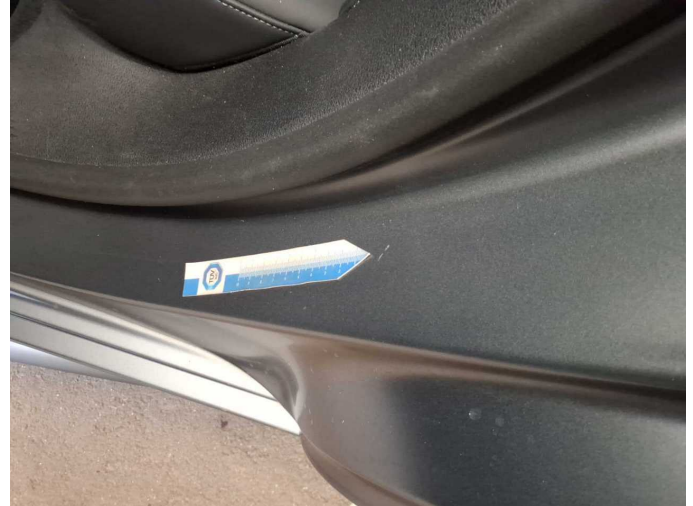
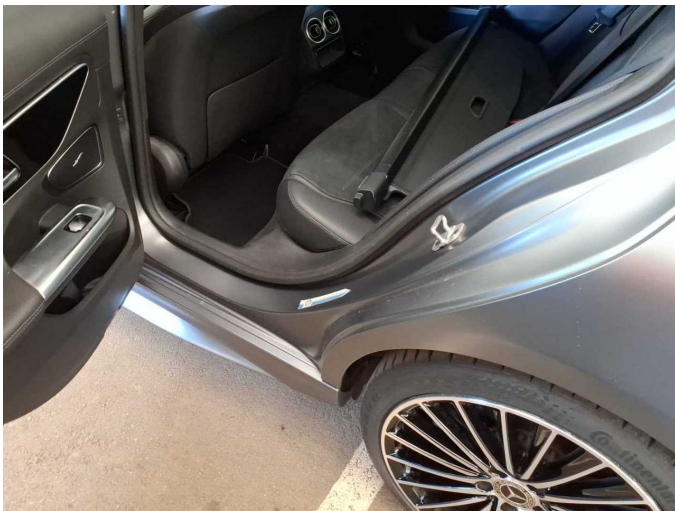
| No. | Component group | Description |
|---|---|---|
| 3 | Side panel - rear left side | Sill - Scratch(es) - No deduction |

**Wear and tear 3:** Side panel - rear left side: Sill - Scratch(es) - No deduction

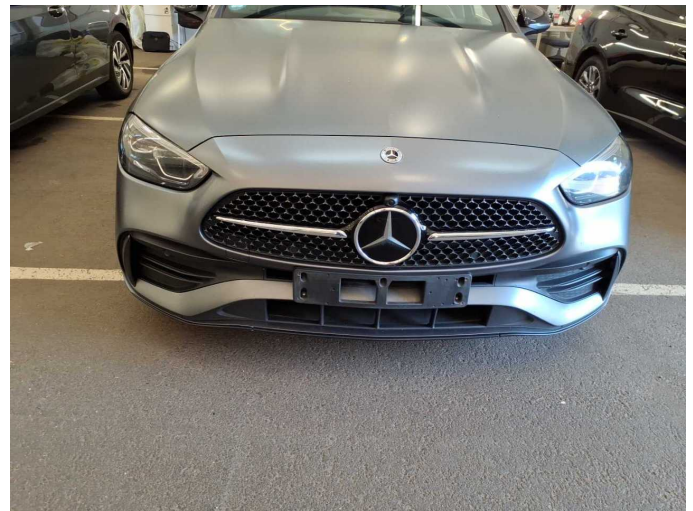
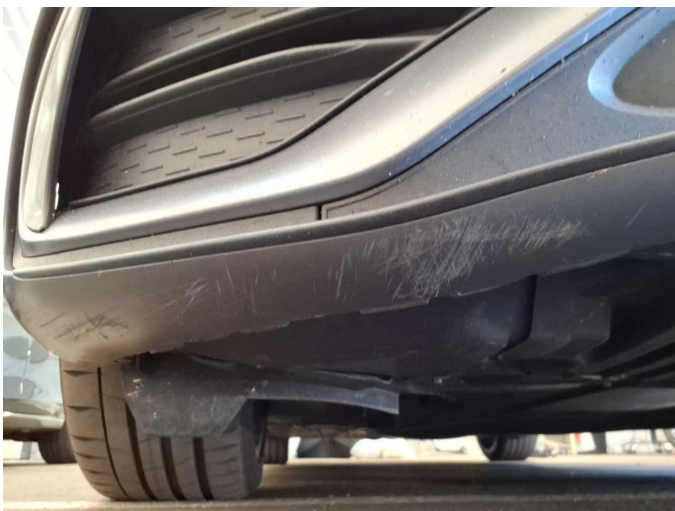
| No. | Component group | Description |
|---|---|---|
| 4 | Front bumper | Front bumper - Scratched - Paint |

**Wear and tear 4:** Front bumper: Front bumper - Scratched - Paint
