Expertise

Protocol number: 46435889  
Order No. / Reference: 26594933  
Inspection date: 10 Jul 2026

| Manufacturer: Opel | Model: Astra Sports Tourer 1.5 D Automatik Elegance |

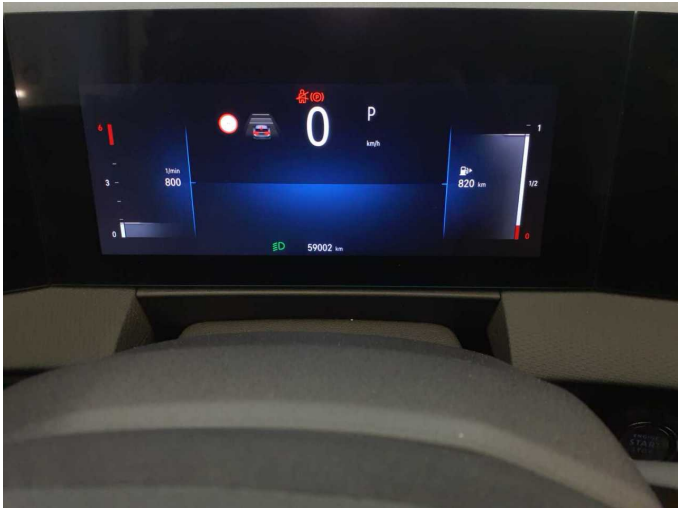
| Vehicle details | |
|---|---|
| Mileage (Read) | 59,002 km |

Figure 7: Instrument cluster

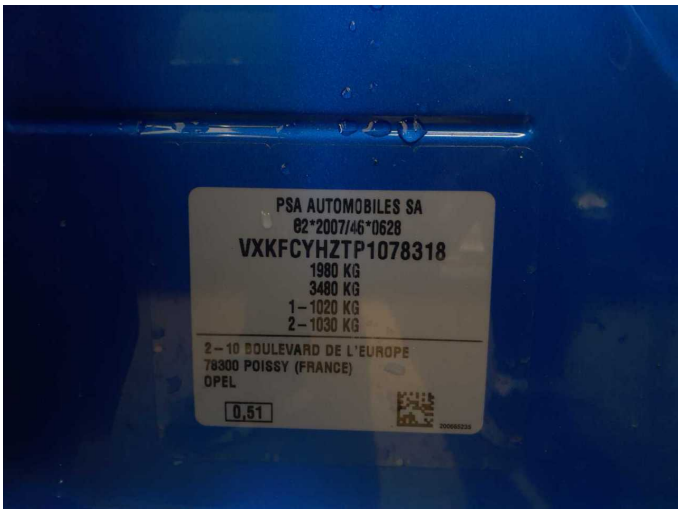
| VIN comparison | The vehicle identification number (VIN) was read from the vehicle and its conformity with the submitted documents was confirmed by the undersigned during the inspection. |

Figure 11: VIN

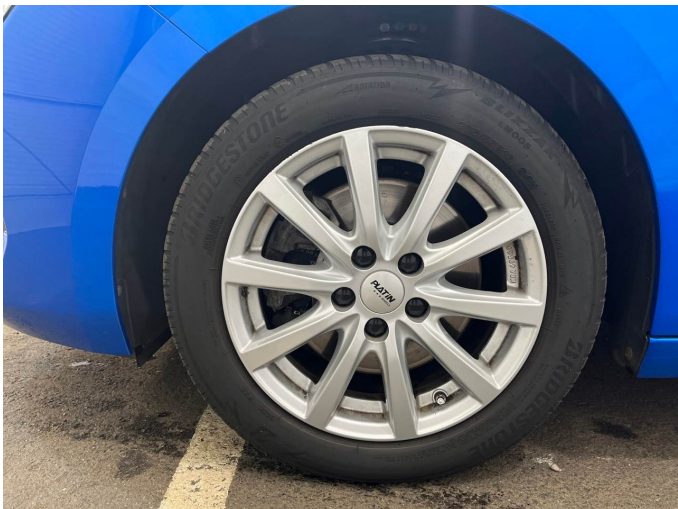
| # | Tyre size | Type of tyre | Manufacturer | Tread depth |
|---|---|---|---|---|
| 1) | 205/55 R16 94H | Winter tyres on Light alloy | Bridgestone | 4mm / 4mm |
| 2) | 205/55 R16 94H | Winter tyres on Light alloy | Bridgestone | 5mm / 5mm |

Figure 12: Mounted tyres

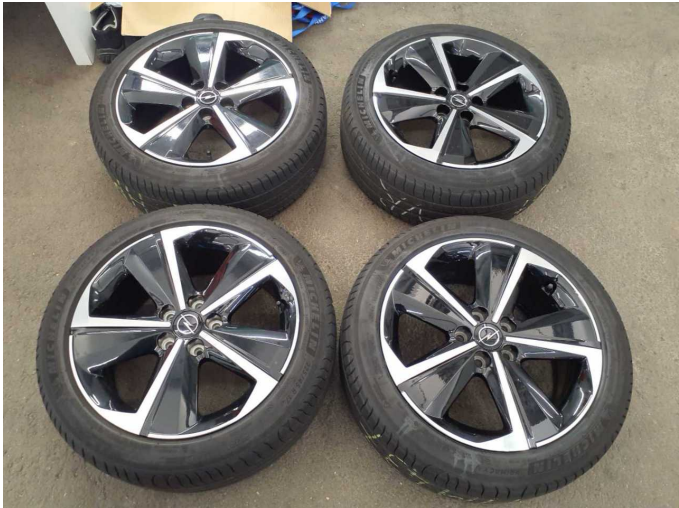
| # | Tyre size | Type of tyre | Manufacturer | Tread depth |
|---|---|---|---|---|
| 1) | 225/45 R17 94V | Summer tyres on Light alloy | Michelin | 6mm / 6mm |
| 2) | 225/45 R17 94V | Summer tyres on Light alloy | Michelin | 6mm / 6mm |

Figure 16: Additional tyres

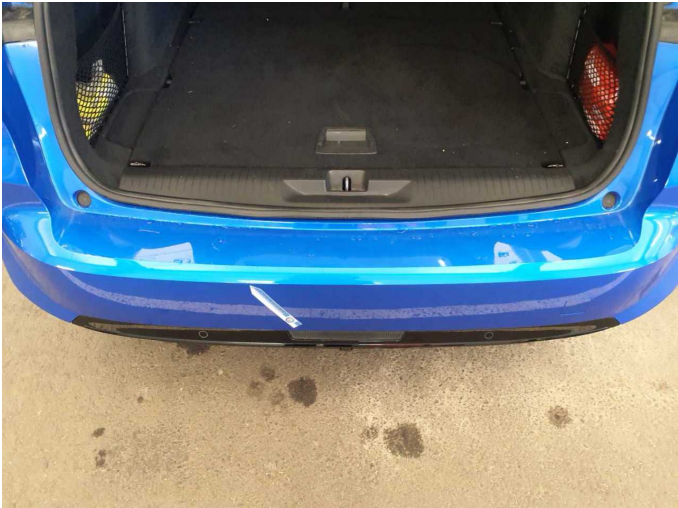
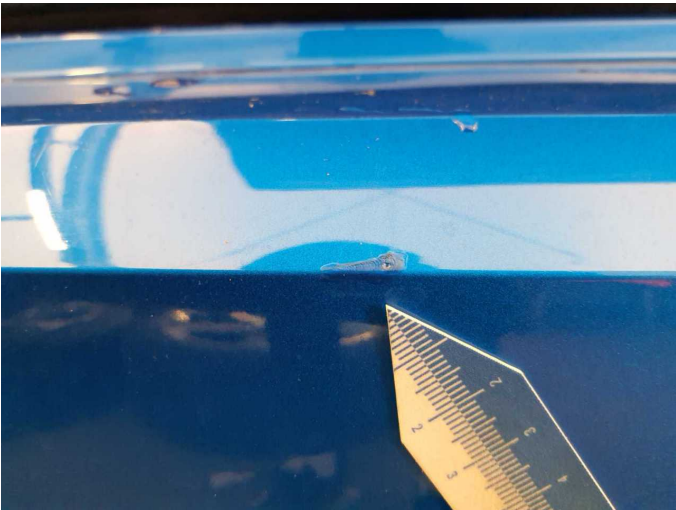
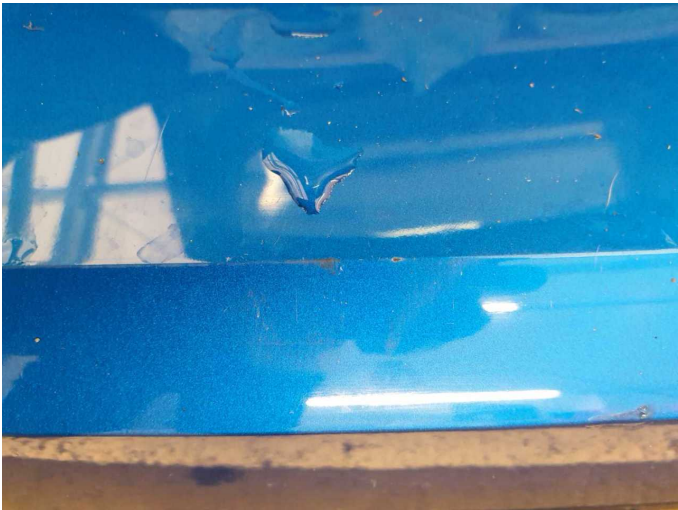
| No. | Component group | Description |
|---|---|---|
| 1 | Rear bumper | Rear bumper - Scratch(es) - Smart repair |

Damage 1: Rear bumper: Rear bumper - Scratch(es) - Smart repair

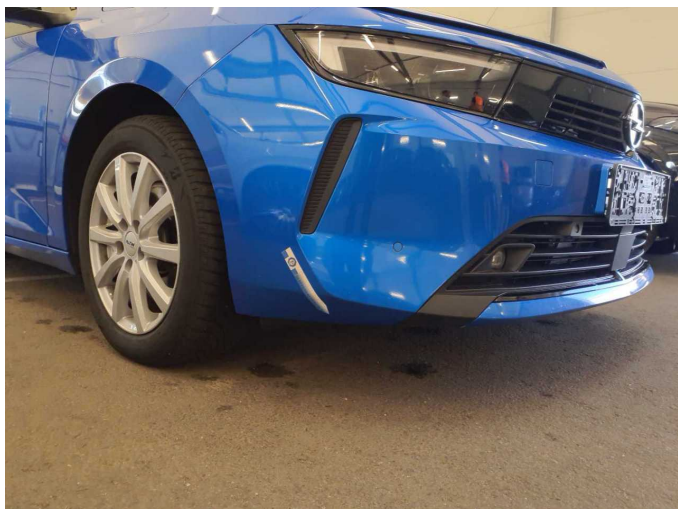
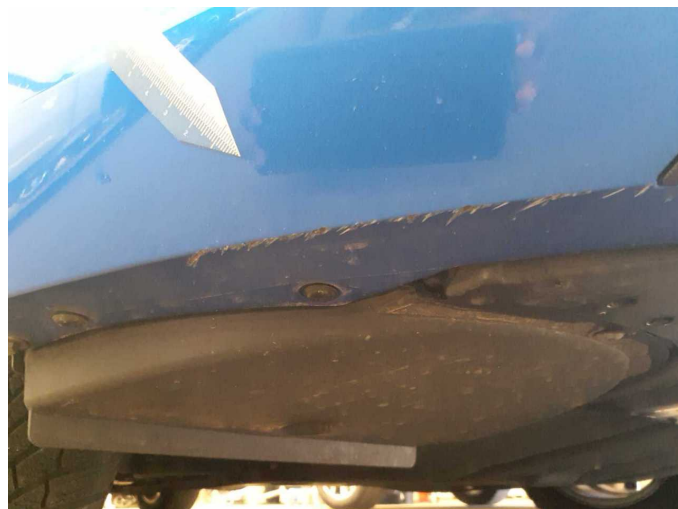
| No. | Component group | Description |
|---|---|---|
| 2 | Front bumper | Front bumper - Scratch(es) - Paint |

**Damage 2:** Front bumper: Front bumper - Scratch(es) - Paint
