Expertise

Protocol number: 46554109  
Order No. / Reference: 26530434  
Inspection date: 14 Jul 2026

Manufacturer: Skoda  
VIN: TMBJJ7NS5N8051359

Model: Kodiaq 2.0 TDI DSG Tour

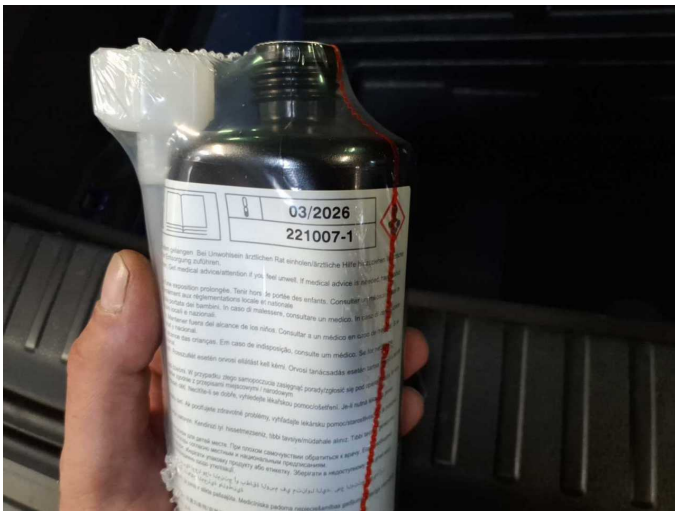
Damage 1: Equipment: Tirefit filler - Expired - Replace

| No. | Component group | Description |
|---|---|---|
| 1 | Equipment | Tirefit filler - Expired - Replace |

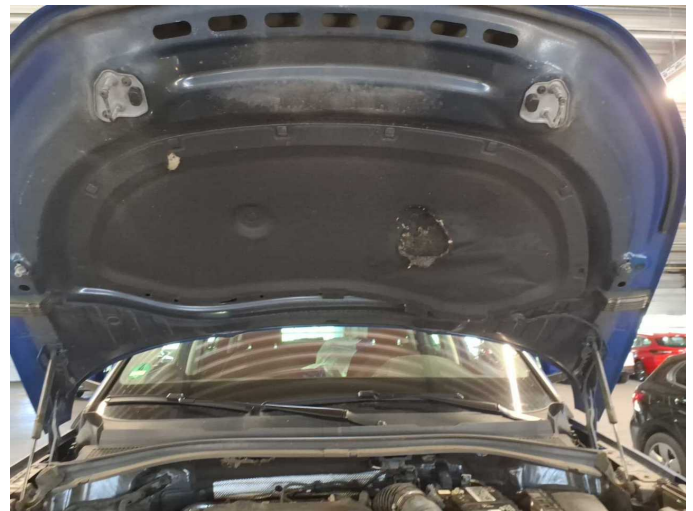
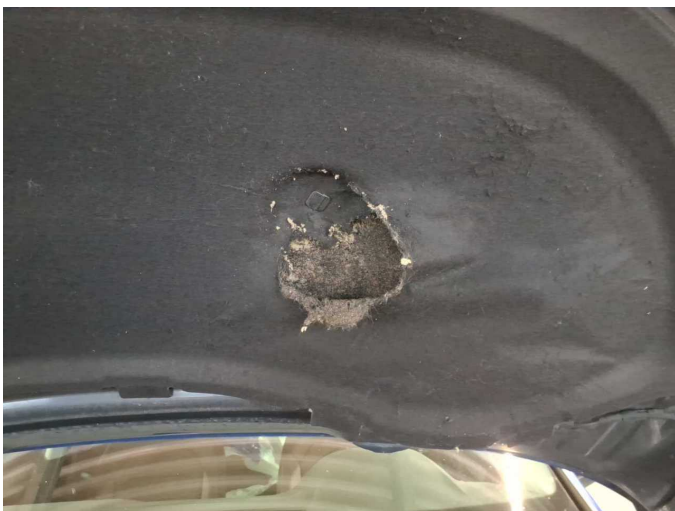
Damage 2: Bonnet: Insulation lining - Damage caused by marten / rodent - Replace

| No. | Component group | Description |
|---|---|---|
| 2 | Bonnet | Insulation lining - Damage caused by marten / rodent - Replace |

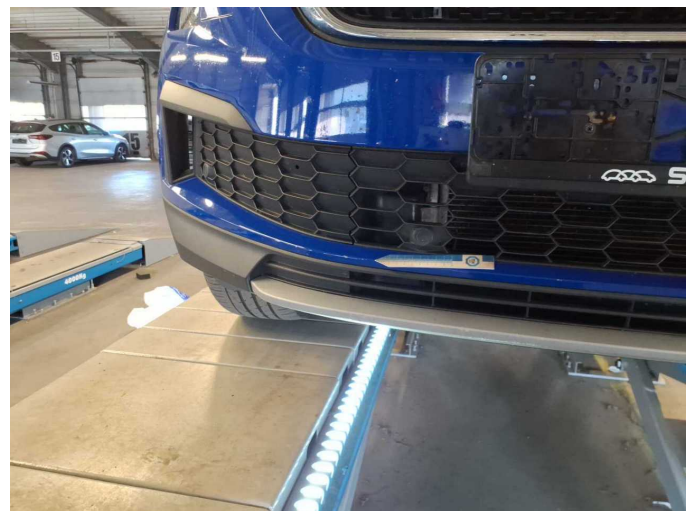
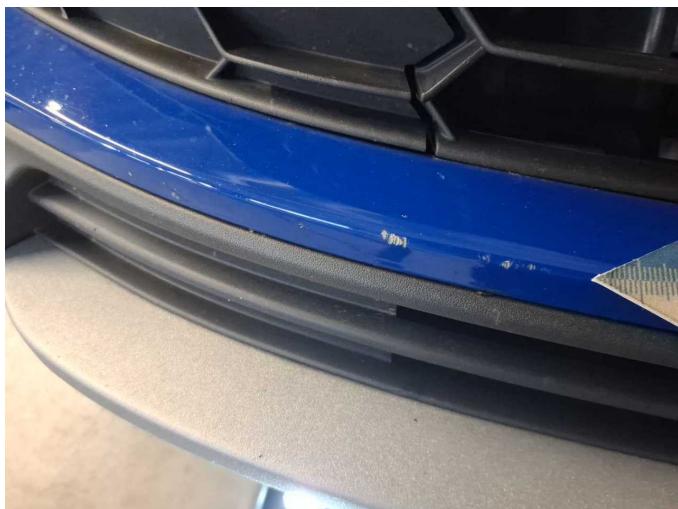
Damage 3: Front bumper: Front bumper - Scratched - Smart repair

**Damage 3:** Front bumper: Front bumper - Scratched - Smart repair

| No. | Component group | Description |
|---|---|---|
| 3 | Front bumper | Front bumper - Scratched - Smart repair |

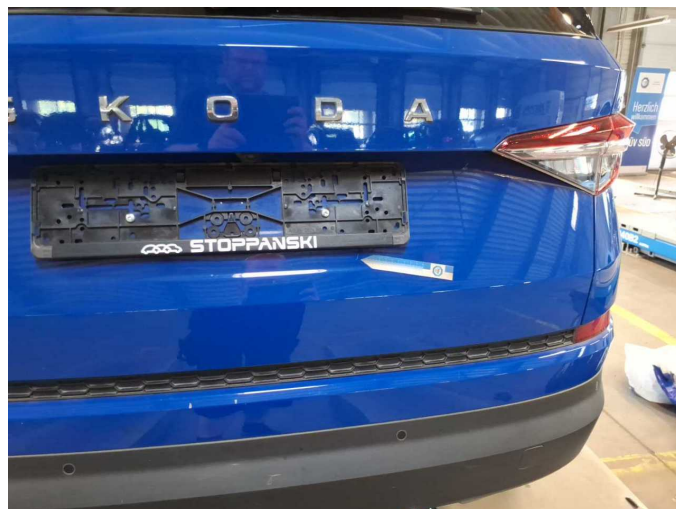
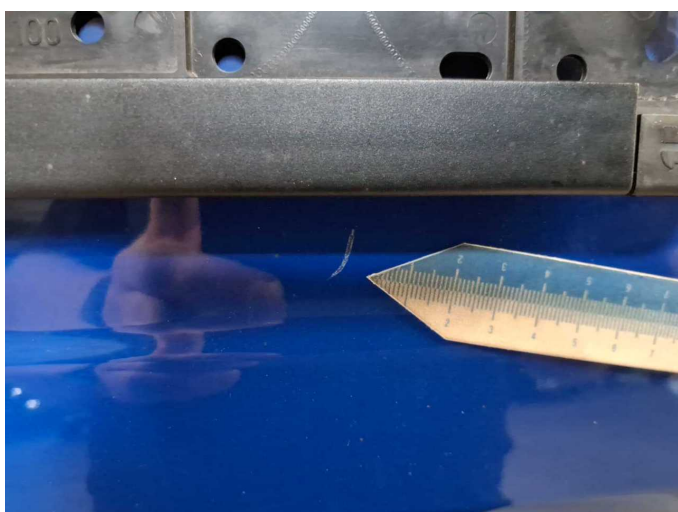
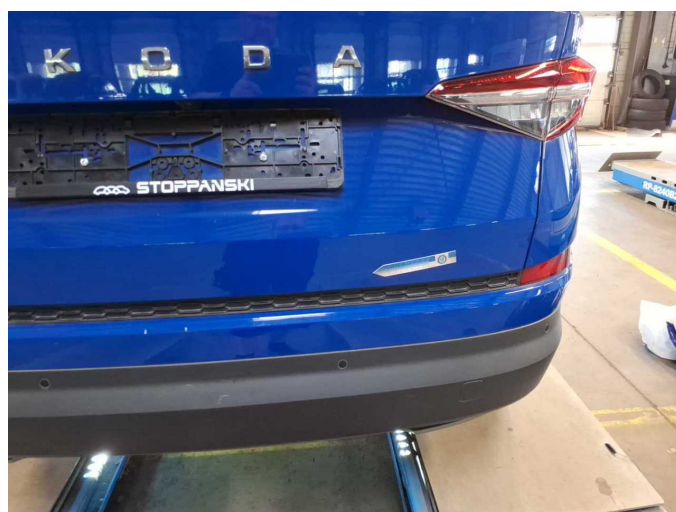
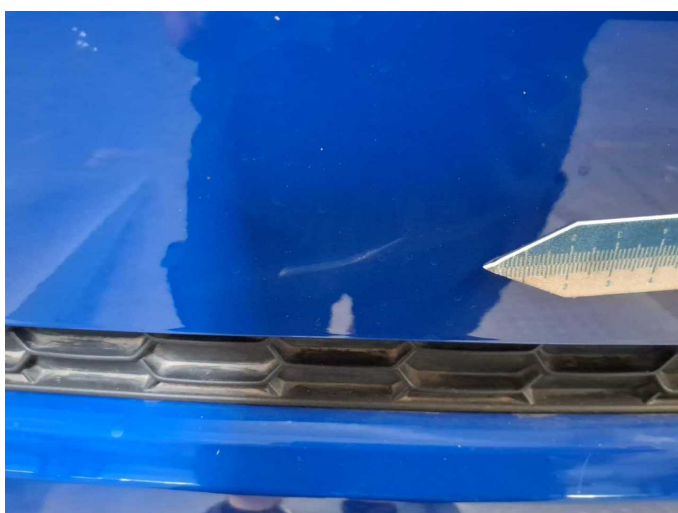
**Damage 4:** Boot lid / rear door: Boot lid - Scratched - Smart repair

| No. | Component group | Description |
|---|---|---|
| 4 | Boot lid / rear door | Boot lid - Scratched - Smart repair |

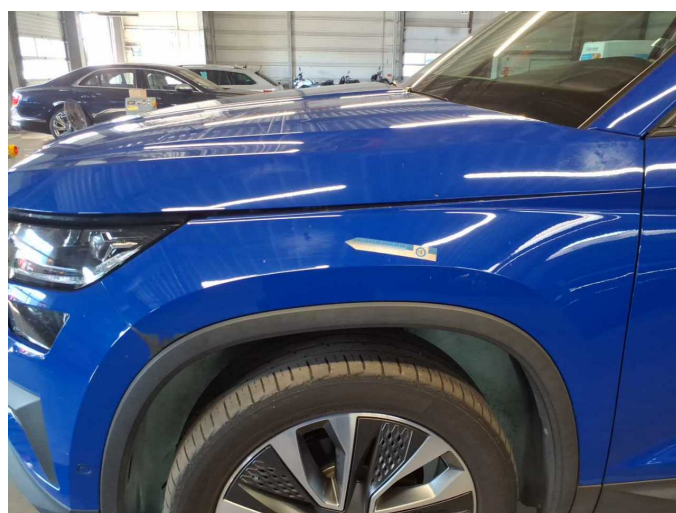
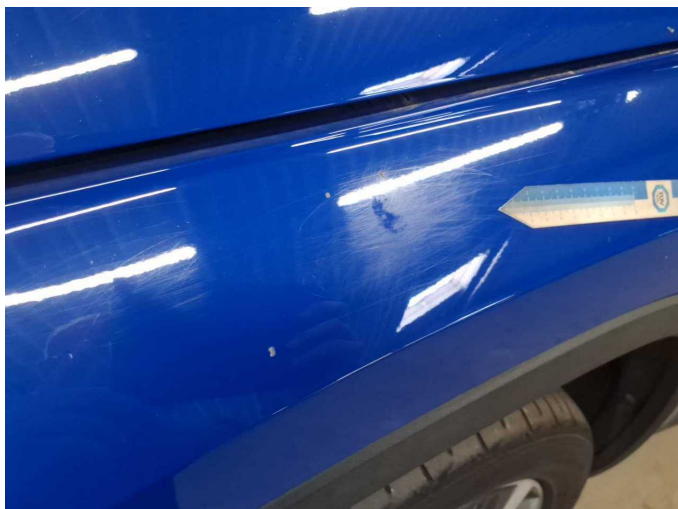
**Damage 5:** Mudguard - left side: Mudguard - left side (schleifen + polieren) - Scratched - Smart repair

| No. | Component group | Description |
|---|---|---|
| 5 | Mudguard - left side | Mudguard - left side (schleifen + polieren) - Scratched - Smart repair |

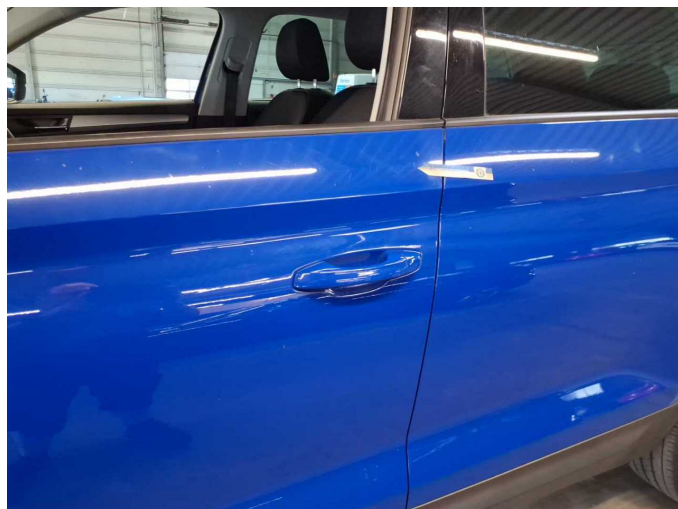
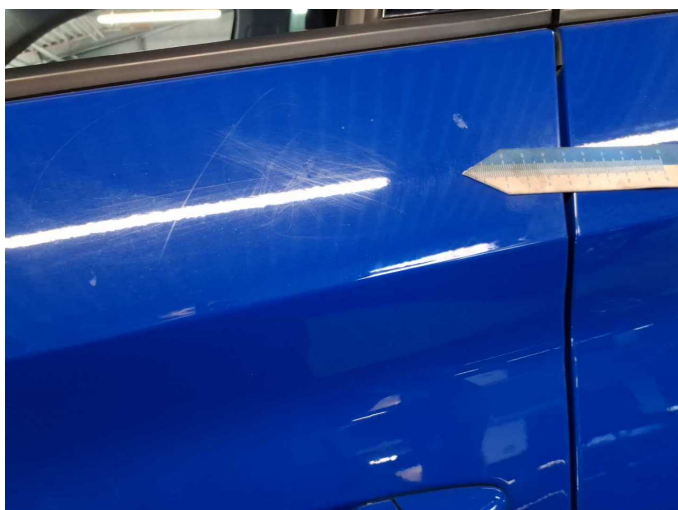
**Damage 6:** Door - front left side: Door (schleifen + polieren) - Scratched - Smart repair

| No. | Component group | Description |
|---|---|---|
| 6 | Door - front left side | Door (schleifen + polieren) - Scratched - Smart repair |

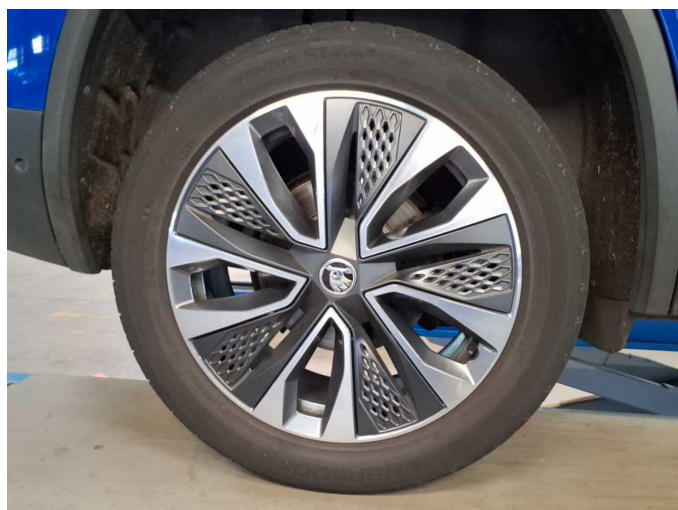
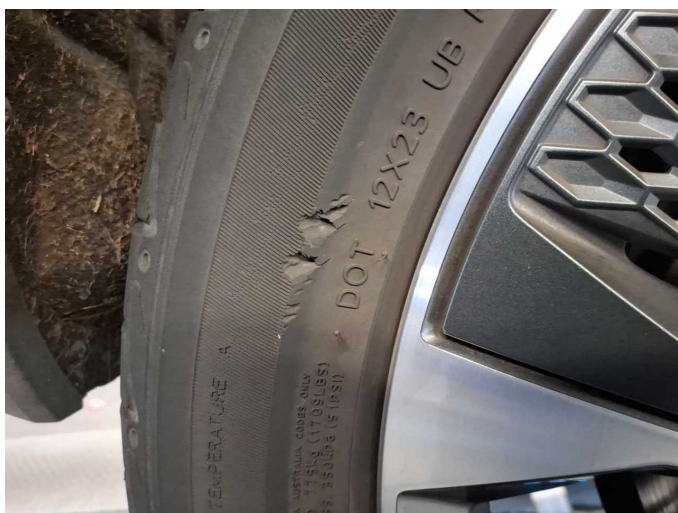
**Damage 7:** Wheel / tyres: Tyre - rear right side - Damaged - Replace

| No. | Component group | Description |
|---|---|---|
| 7 | Wheel / tyres | Tyre - rear right side - Damaged - Replace |

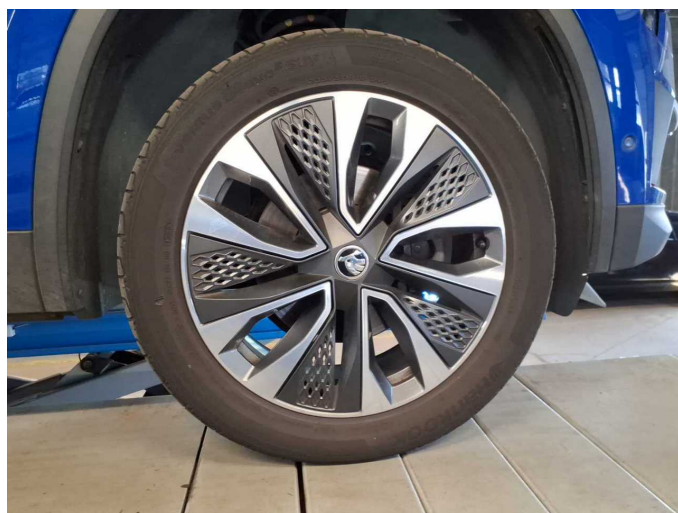
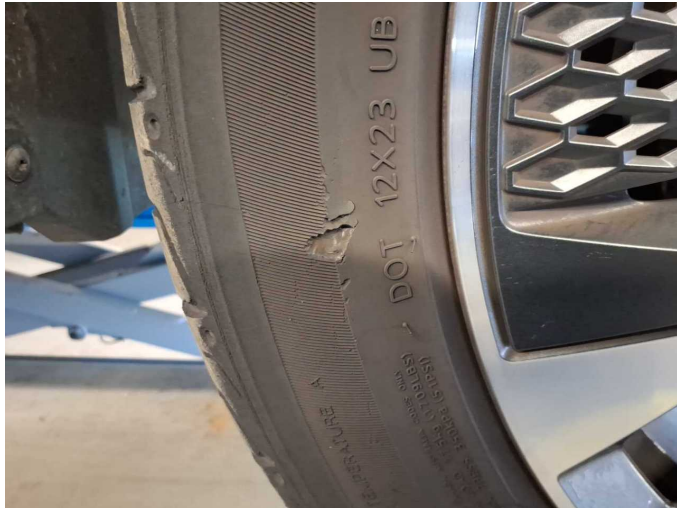
**Damage 8:** Wheel / tyres: Tyre - front right side - Damaged - Replace

| No. | Component group | Description |
|---|---|---|
| 8 | Wheel / tyres | Tyre - front right side - Damaged - Replace |

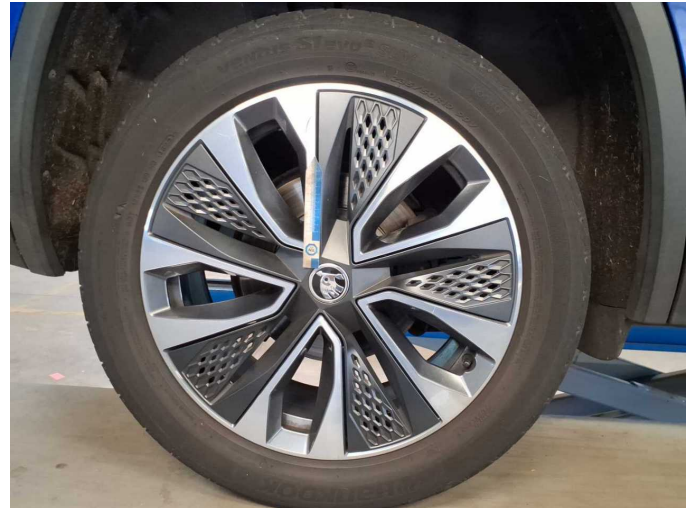
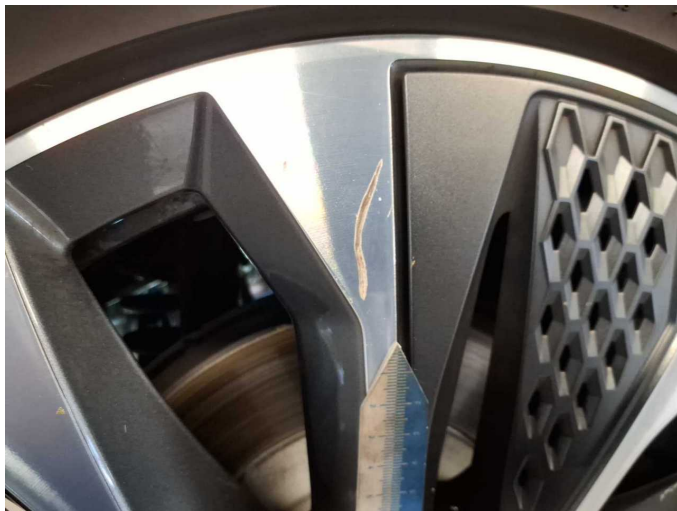
**Damage 9:** Wheel / tyres: Alloy rim - rear right side - Scratched - Loss in value

| No. | Component group | Description |
|---|---|---|
| 9 | Wheel / tyres | Alloy rim - rear right side - Scratched - Loss in value |

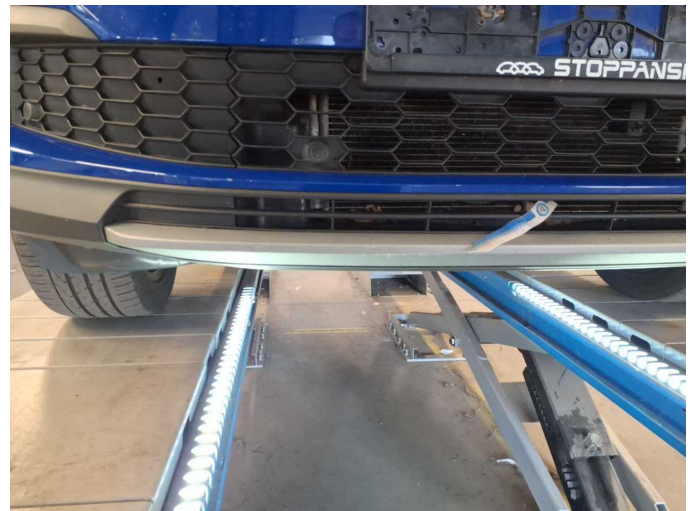
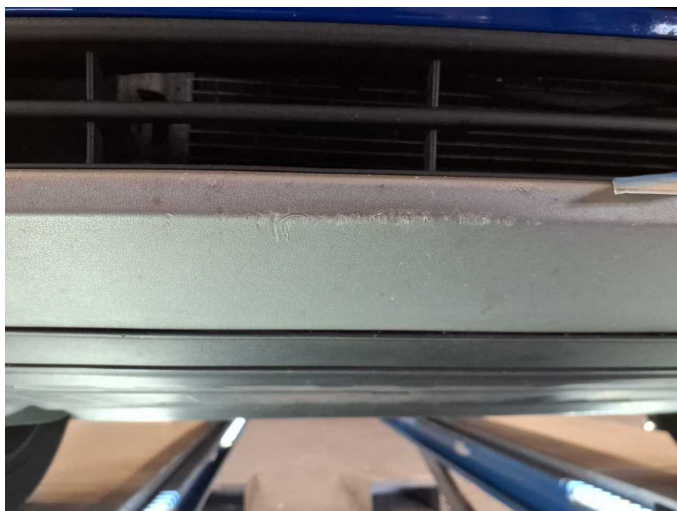
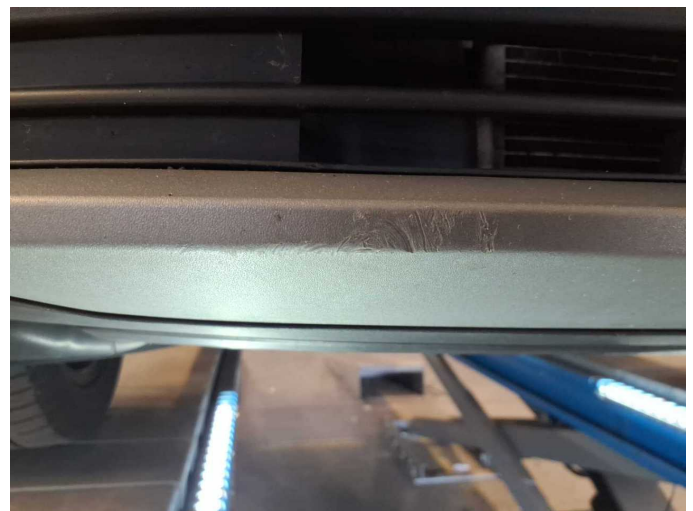
**Damage 10:** Front bumper: Spoiler - Scratched - Replace

| No. | Component group | Description |
|---|---|---|
| 10 | Front bumper | Spoiler - Scratched - Replace |

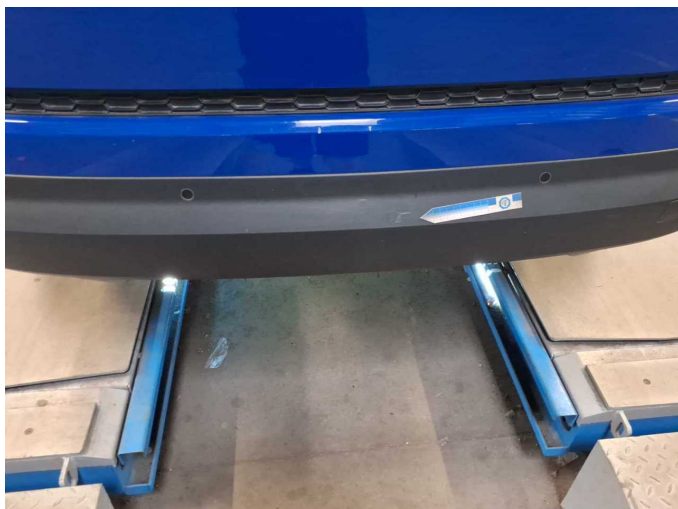
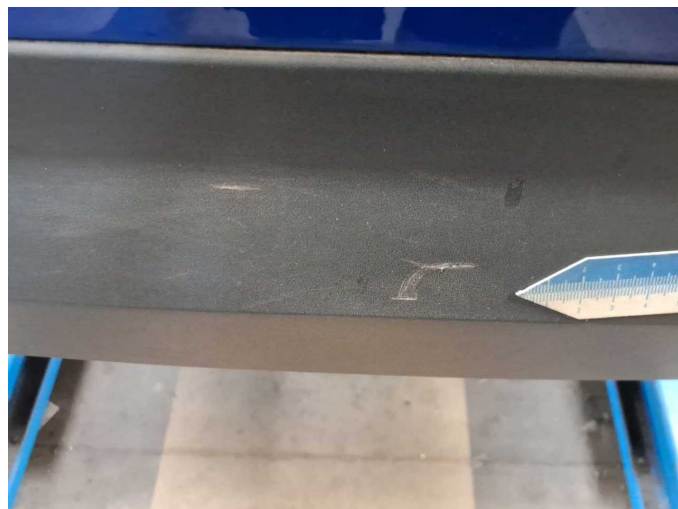
**Damage 11:** Rear bumper: Spoiler - Scratched - Replace

| No. | Component group | Description |
|---|---|---|
| 11 | Rear bumper | Spoiler - Scratched - Replace |

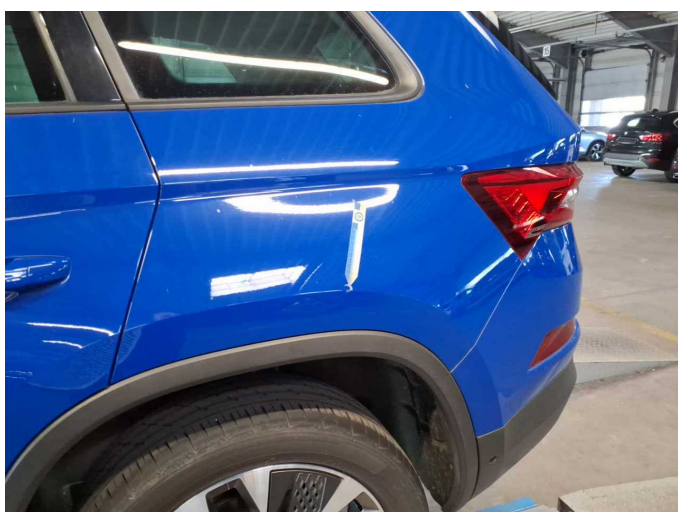
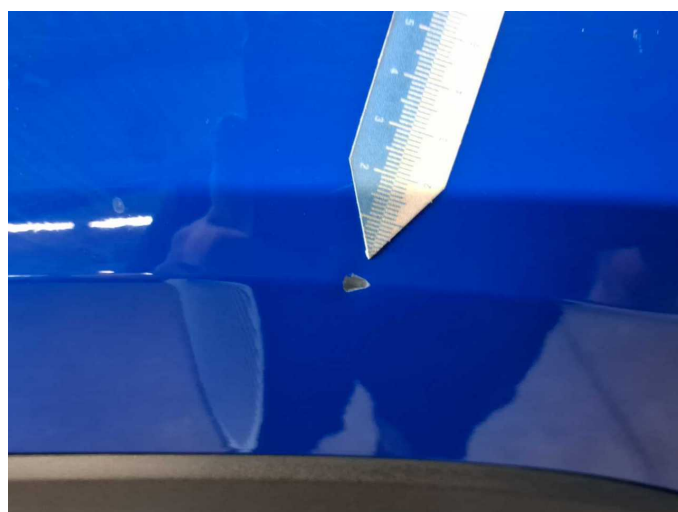
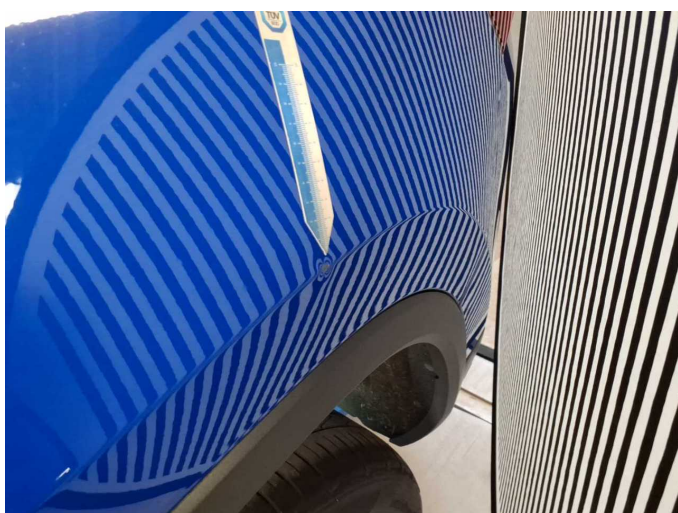
**Damage 12:** Side panel - rear left side: Side panel - Dent / paintcoat damage - Repair and paint

| No. | Component group | Description |
|---|---|---|
| 12 | Side panel - rear left side | Side panel - Dent / paintcoat damage - Repair and paint |

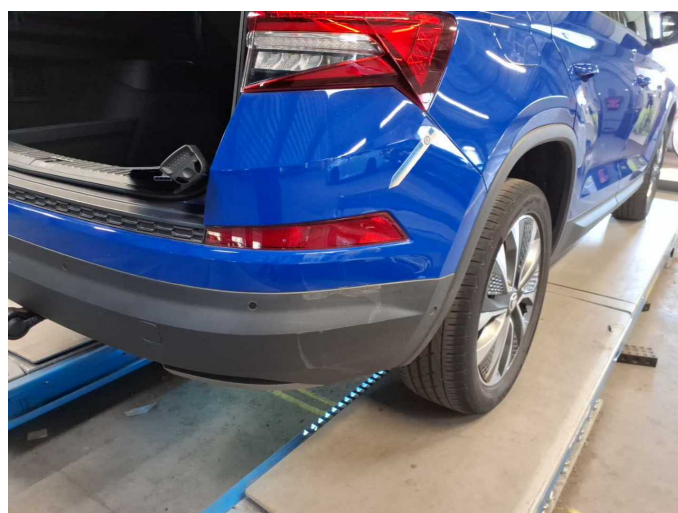
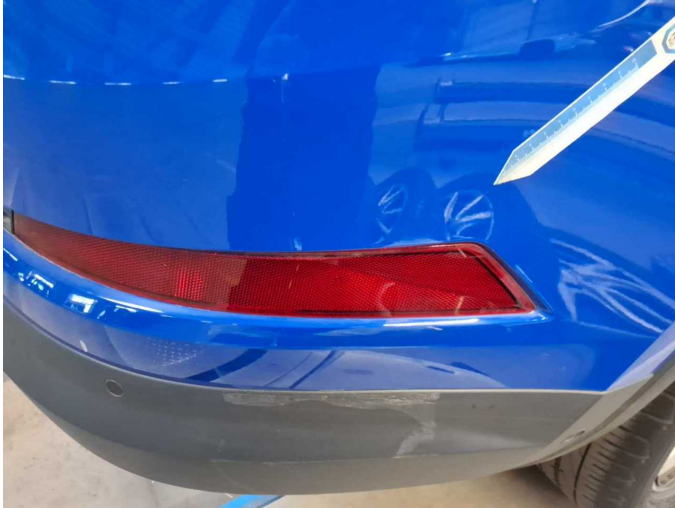
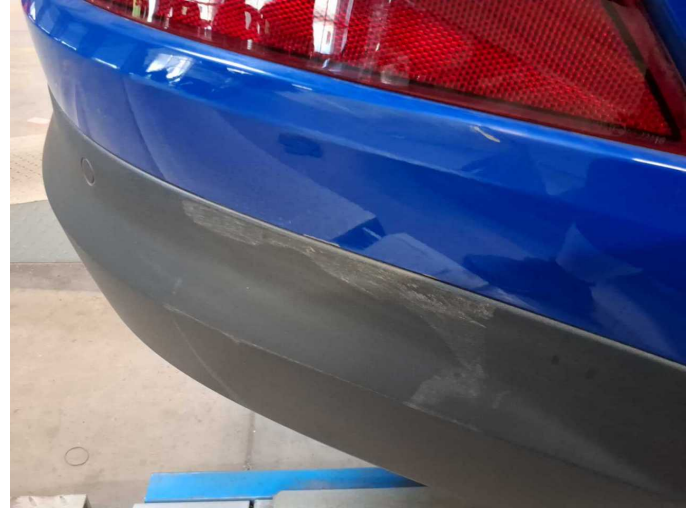
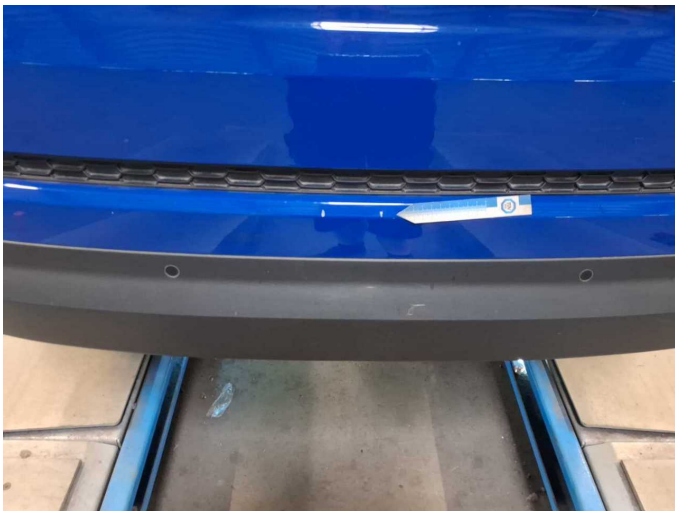
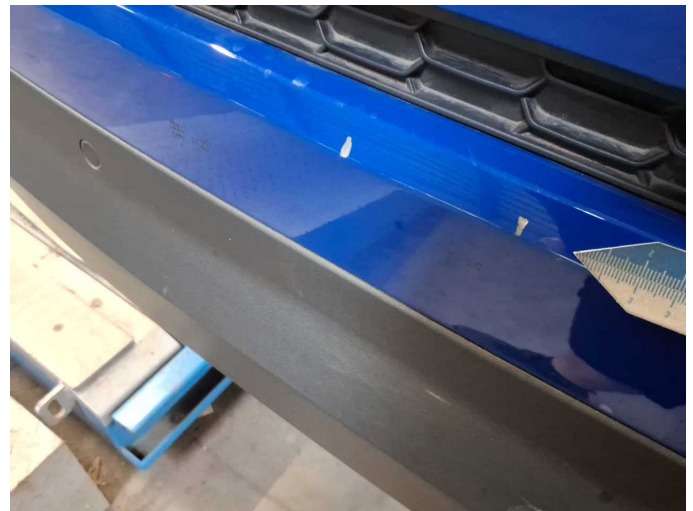
**Damage 13:** Rear bumper: Rear bumper - Scratched - Paint

| No. | Component group | Description |
|---|---|---|
| 13 | Rear bumper | Rear bumper - Scratched - Paint |

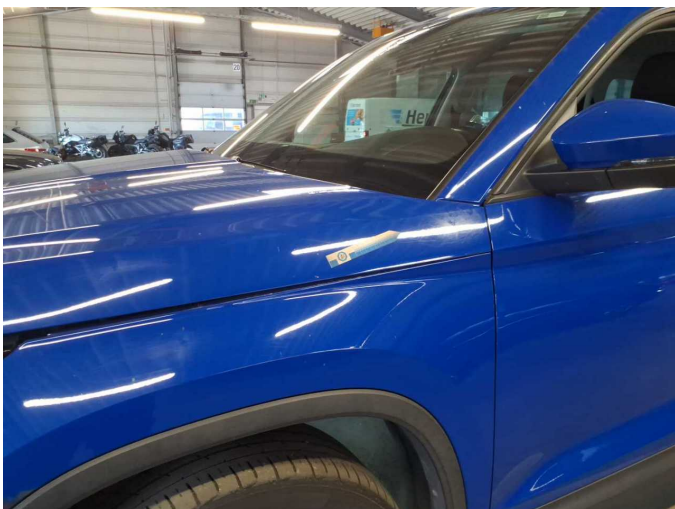
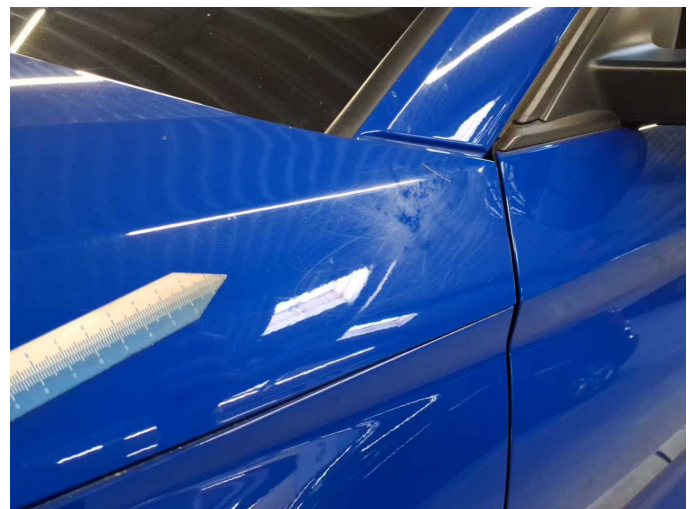
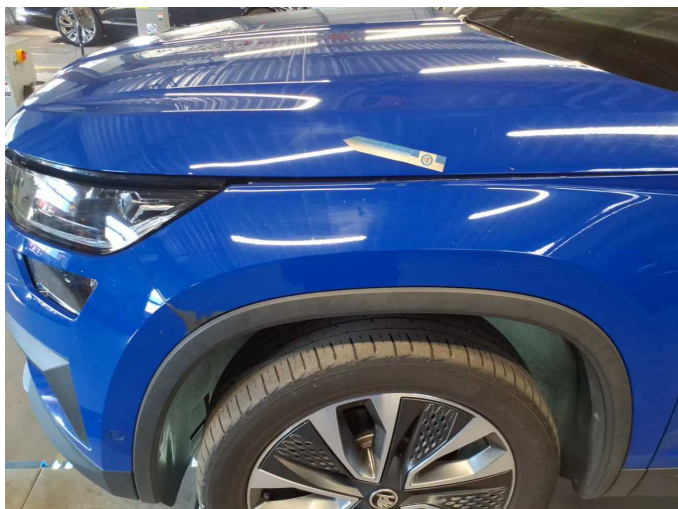
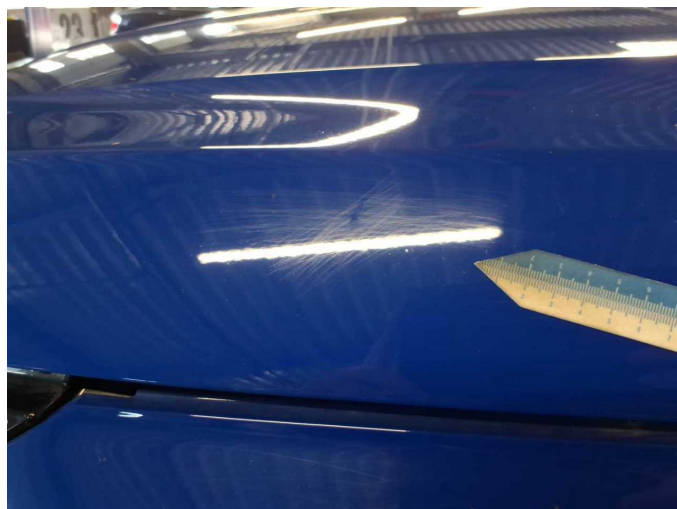
**Damage 14:** Bonnet: Bonnet - Scratched - Paint

| No. | Component group | Description |
|---|---|---|
| 14 | Bonnet | Bonnet - Scratched - Paint |

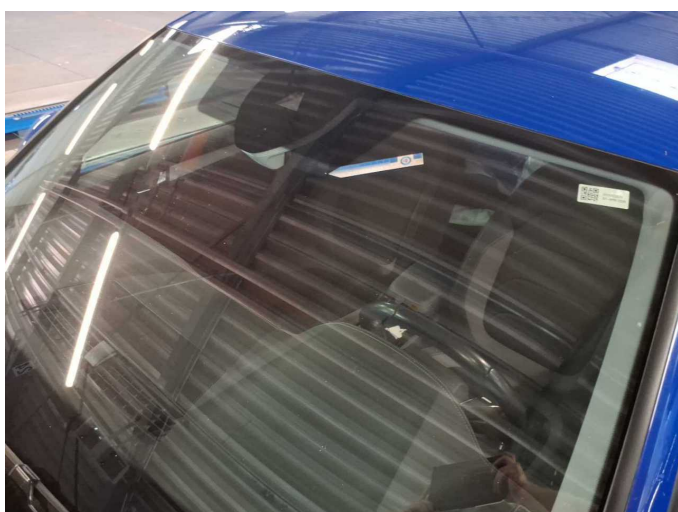
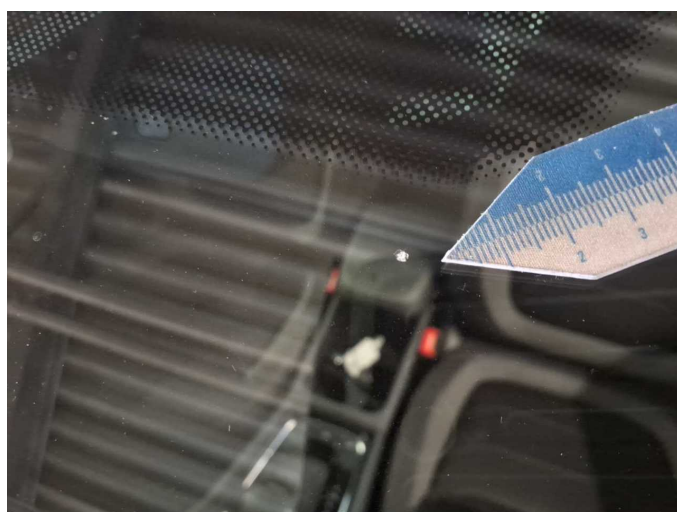
**Damage 15:** Vehicle glazing: Windscreen - Broken / torn - Replace

| No. | Component group | Description |
|---|---|---|
| 15 | Vehicle glazing | Windscreen - Broken / torn - Replace |

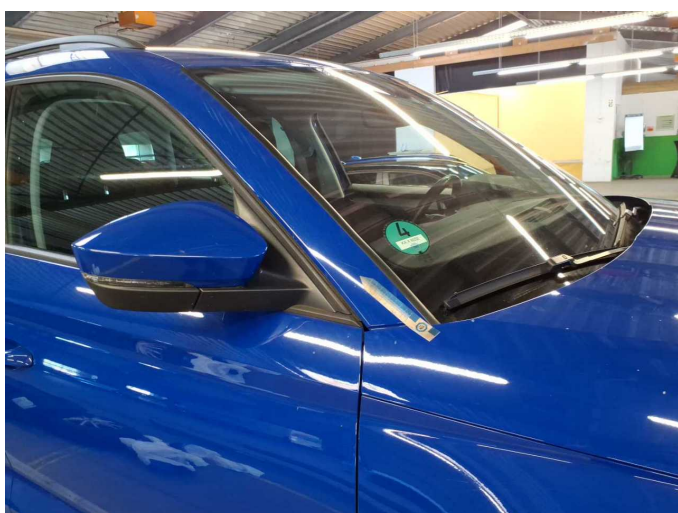
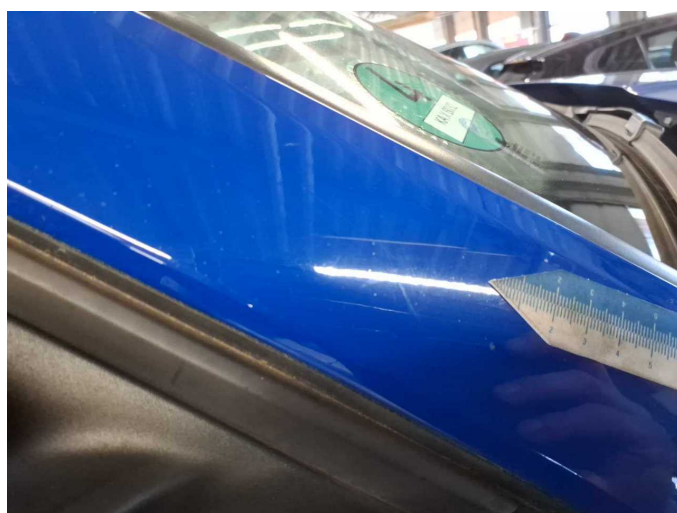
| No. | Component group | Description |
|---|---|---|
| 1 | Body | A-pillar - right side - Scratch(es) - No deduction |

**Wear and tear 1:** Body: A-pillar - right side - Scratch(es) - No deduction

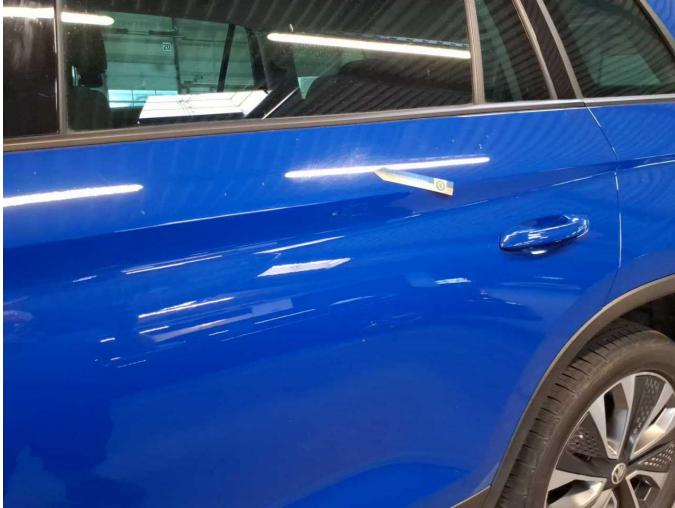
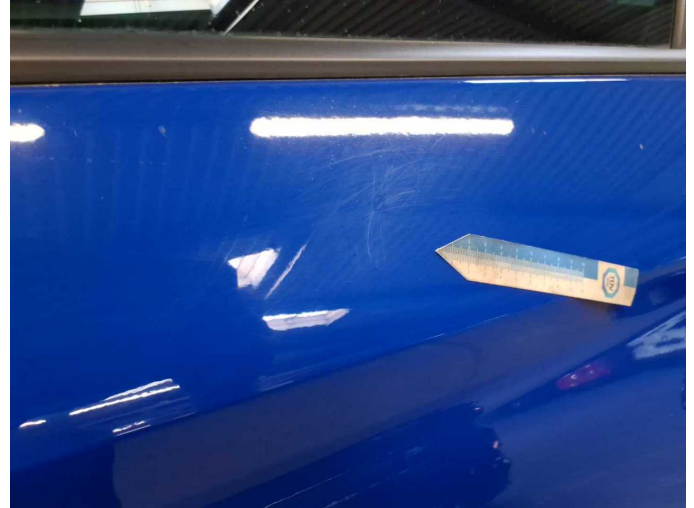
| No. | Component group | Description |
|---|---|---|
| 2 | Door - rear left side | Door - Scratch(es) - No deduction |

**Wear and tear 2:** Door - rear left side: Door - Scratch(es) - No deduction
