Expertise

Protocol number: 46145327  
Order No. / Reference: 26384031  
Inspection date: 24 Jun 2026

Manufacturer: Audi

Model: A4 Avant 35 TDI S tronic

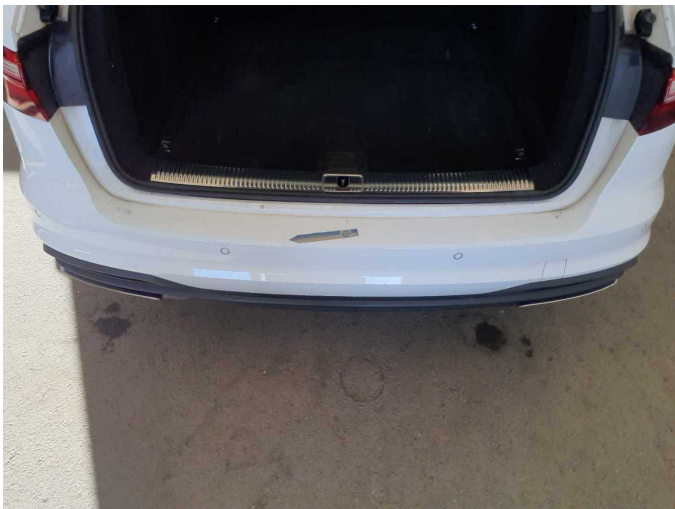
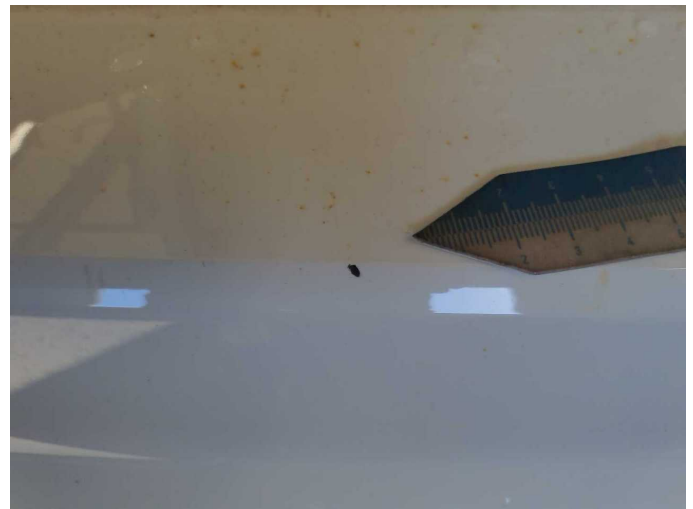
| No. | Component group | Description |
|---|---|---|
| 1 | Rear bumper | Rear bumper - Scratch(es) - Smart repair |

**Damage 1:** Rear bumper: Rear bumper - Scratch(es) - Smart repair

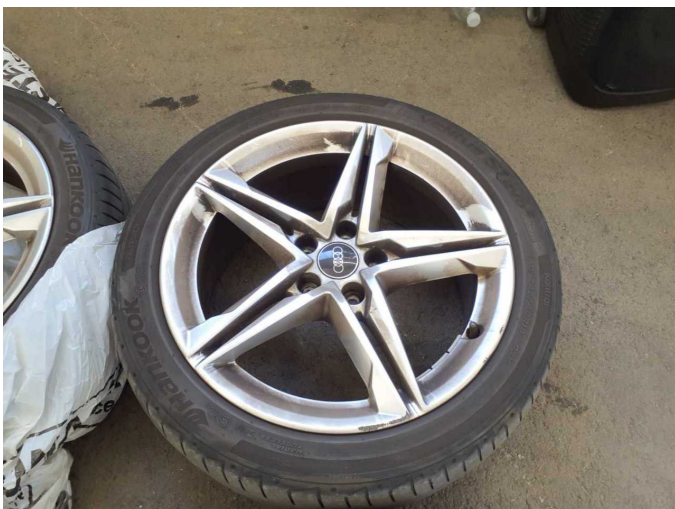
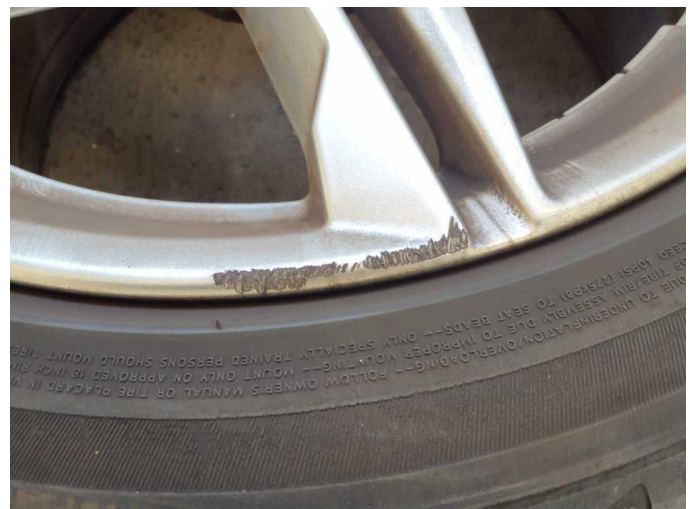
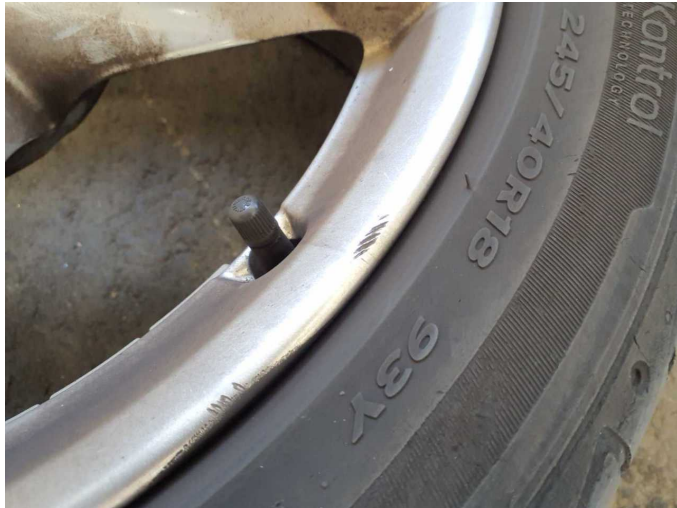
| No. | Component group | Description |
|---|---|---|
| 2 | 2nd wheel set | 1 alloy rim - Scratch(es) - Loss in value |

**Damage 2:** 2nd wheel set: 1 alloy rim - Scratch(es) - Loss in value

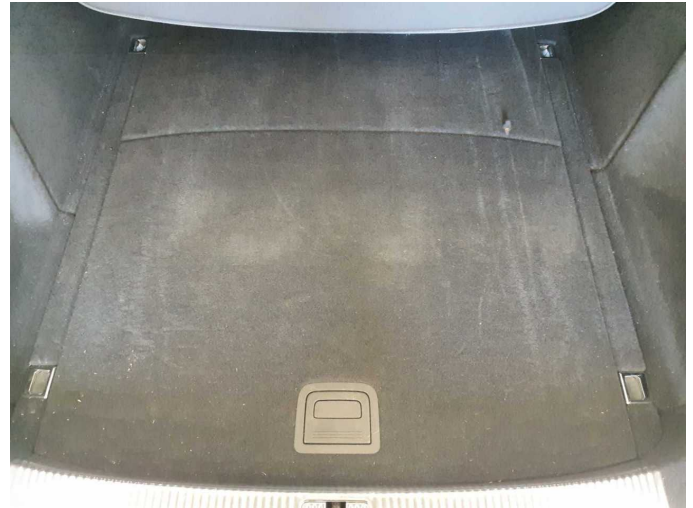
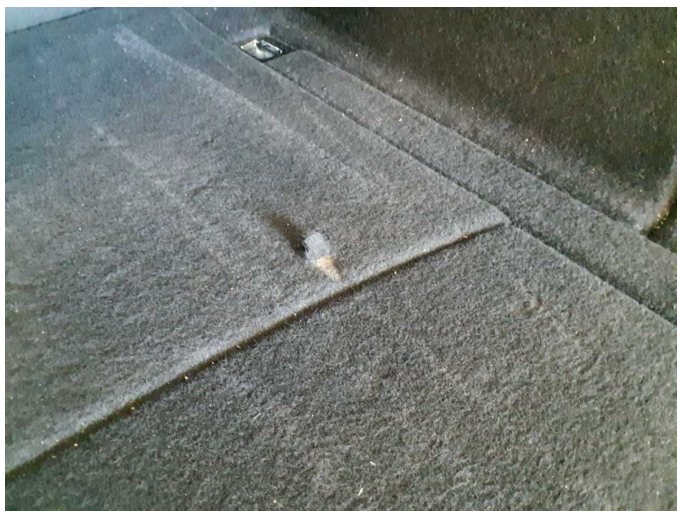
| No. | Component group | Description |
|---|---|---|
| 3 | Interior | Cargo area floor - Broken / torn - Replace |

**Damage 3:** Interior: Cargo area floor - Broken / torn - Replace

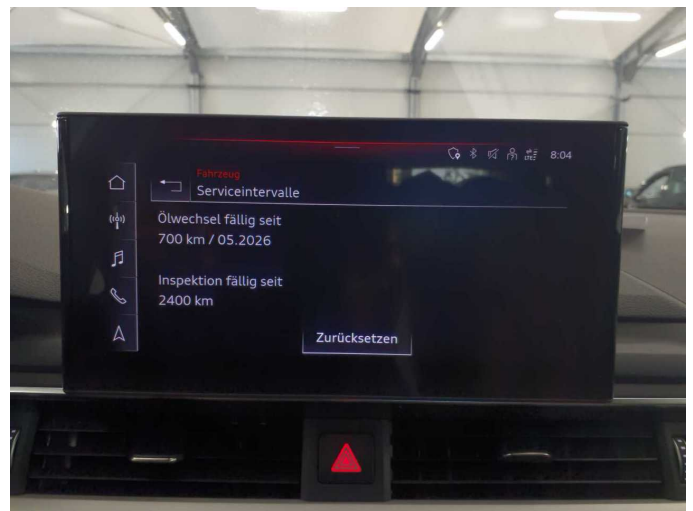
| No. | Component group | Description |
|---|---|---|
| 4 | Misc. | Inspection / maintenance - Due - Replace |

**Damage 4:** Misc.: Inspection / maintenance - Due - Replace

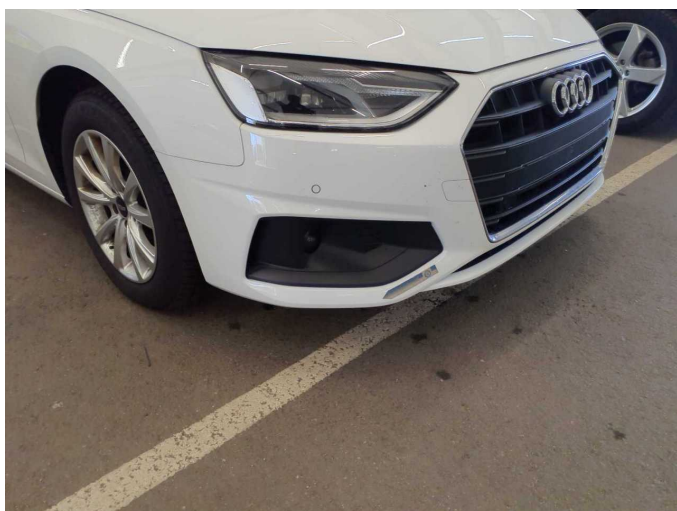
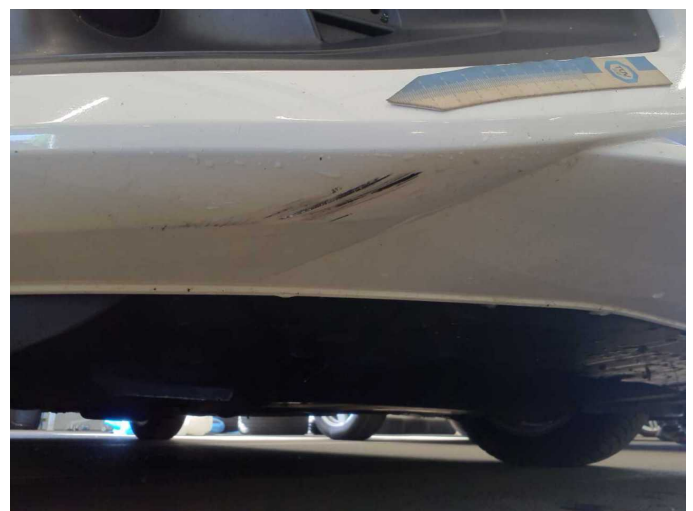
| No. | Component group | Description |
|---|---|---|
| 5 | Front bumper | Front bumper - Scratch(es) - Paint |

**Damage 5:** Front bumper: Front bumper - Scratch(es) - Paint

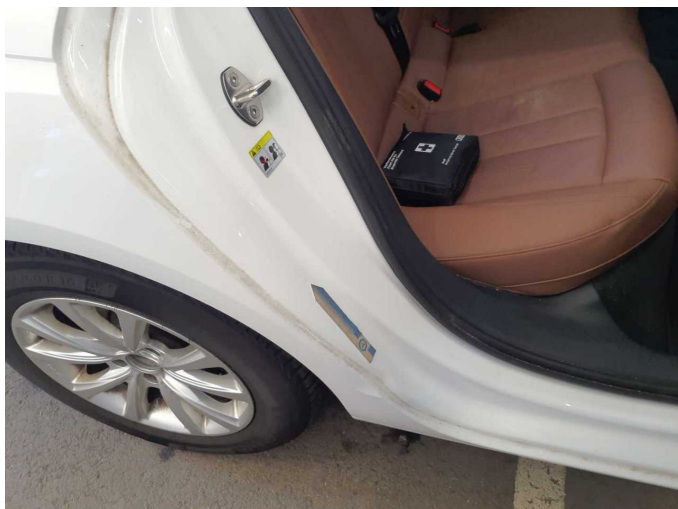
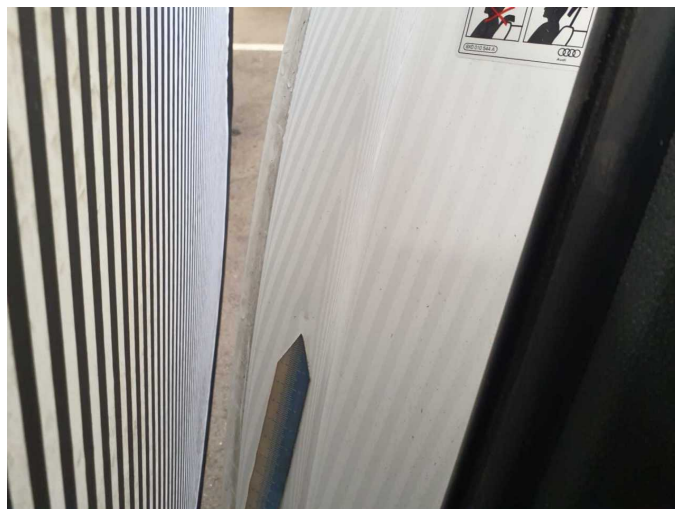
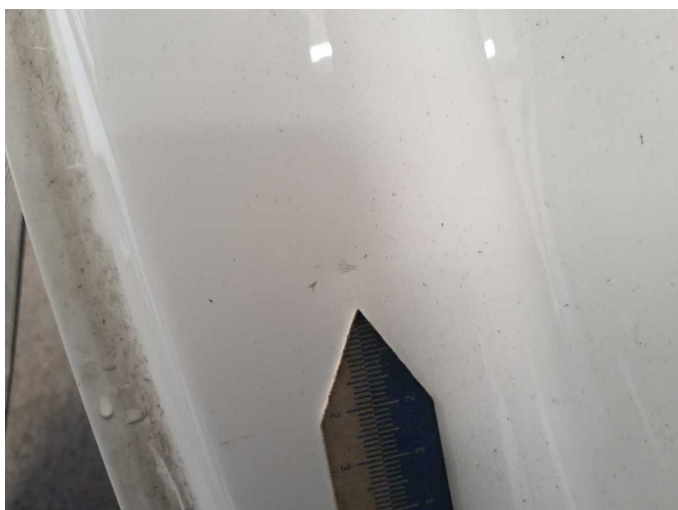
| No. | Component group | Description |
|---|---|---|
| 1 | Sill - right side | Sill - dent(s) - No deduction |

**Wear and tear 1:** Sill - right side: Sill - dent(s) - No deduction
