Expertise

Protocol number: 46055186  
Order No. / Reference: 26501026  
Inspection date: 17 Jun 2026

Manufacturer: Audi  
VIN: WAUZZZF44NA002506

Model: A4 Avant 35 TDI S tronic advanced

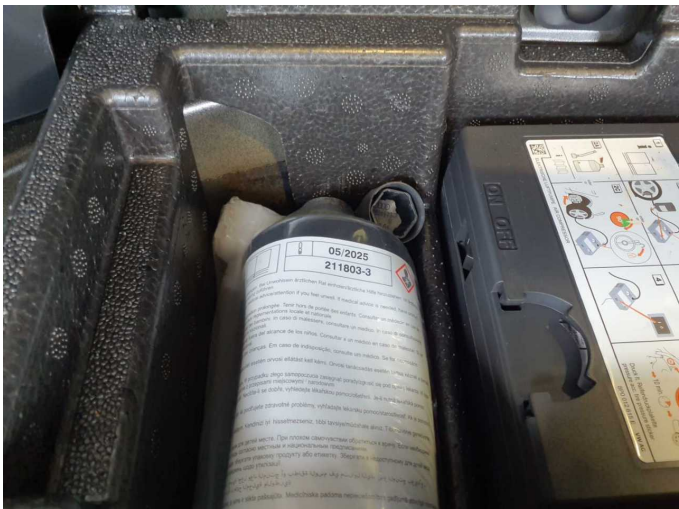
| No. | Component group | Description |
|---|---|---|
| 1 | Equipment | Tirefit filler - Expired - Replace |

Damage 1: Equipment: Tirefit filler - Expired - Replace

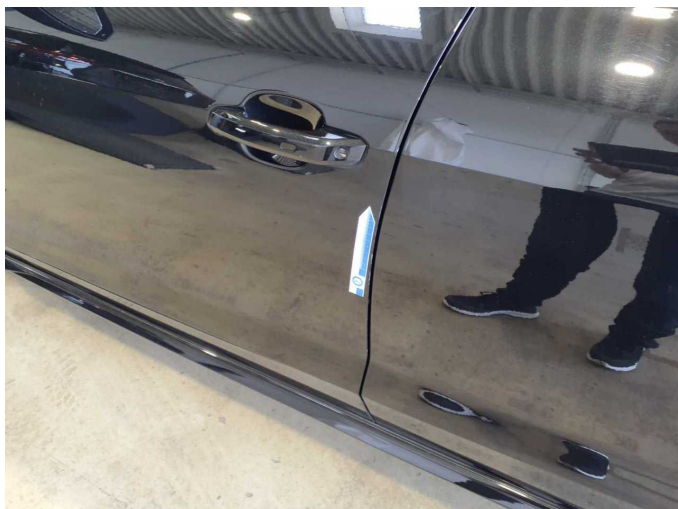
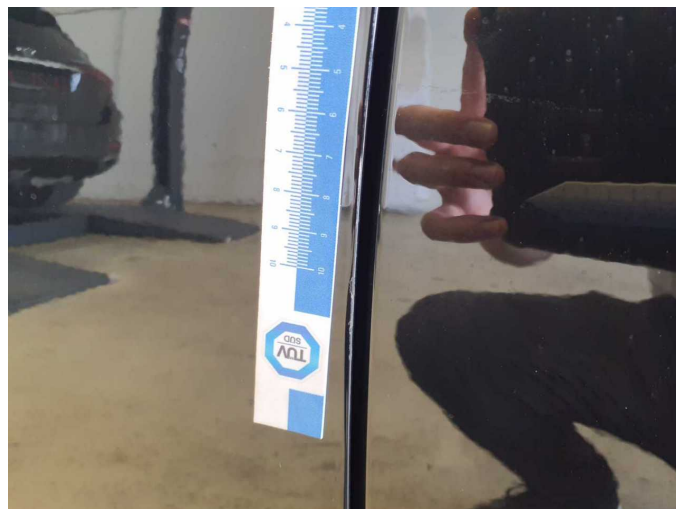
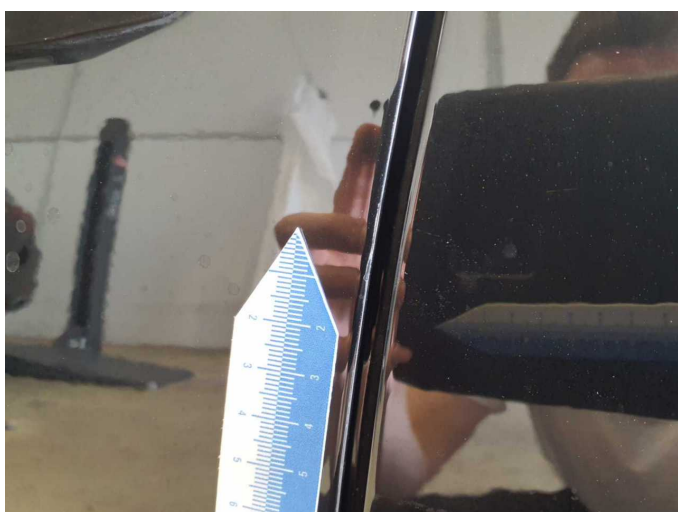
| No. | Component group | Description |
|---|---|---|
| 2 | Door - front left side | Door edge - Scratched - Smart repair |

**Damage 2:** Door - front left side: Door edge - Scratched - Smart repair

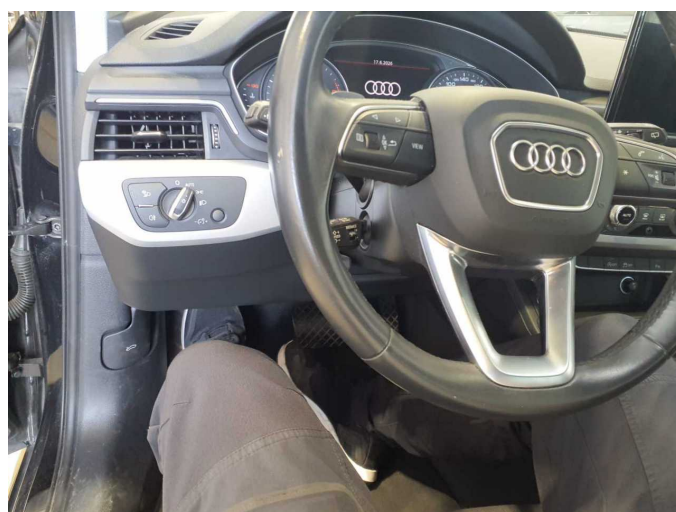
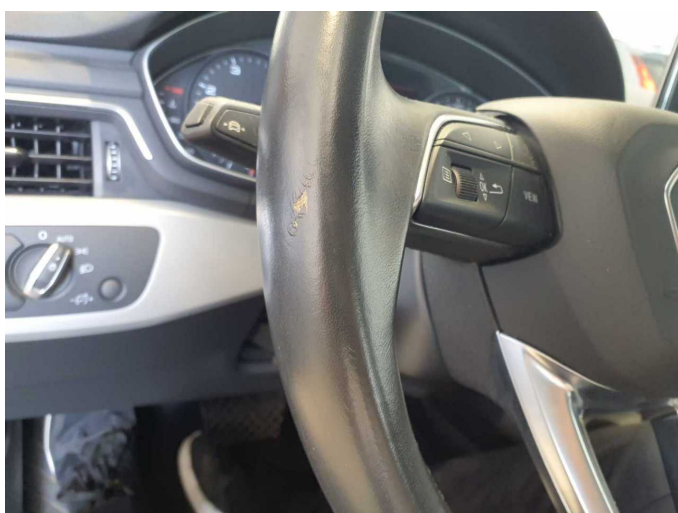
| No. | Component group | Description |
|---|---|---|
| 3 | Steering system | Steering wheel - Scratched - Smart repair |

**Damage 3:** Steering system: Steering wheel - Scratched - Smart repair

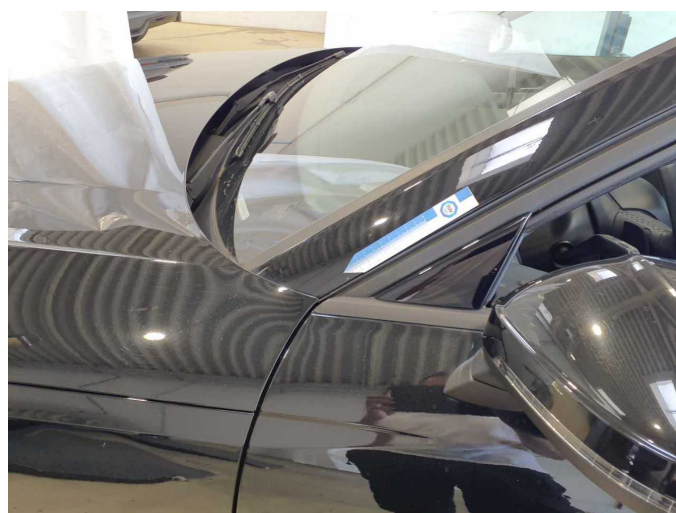
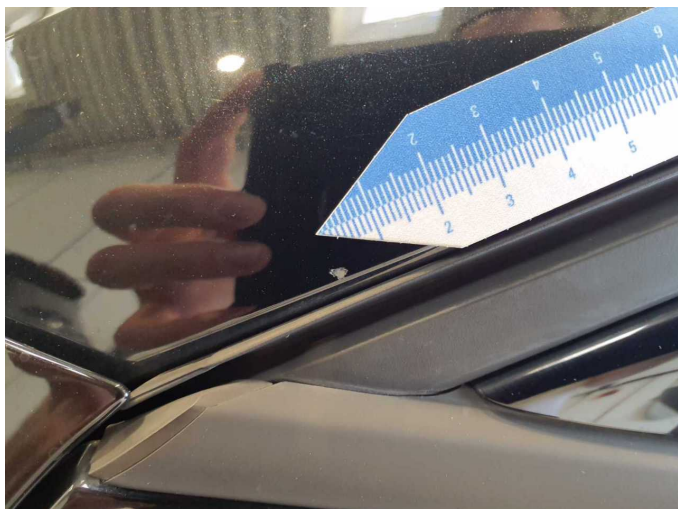
| No. | Component group | Description |
|---|---|---|
| 4 | Body | A-pillar - left side - Stone chips - Smart repair |

**Damage 4:** Body: A-pillar - left side - Stone chips - Smart repair

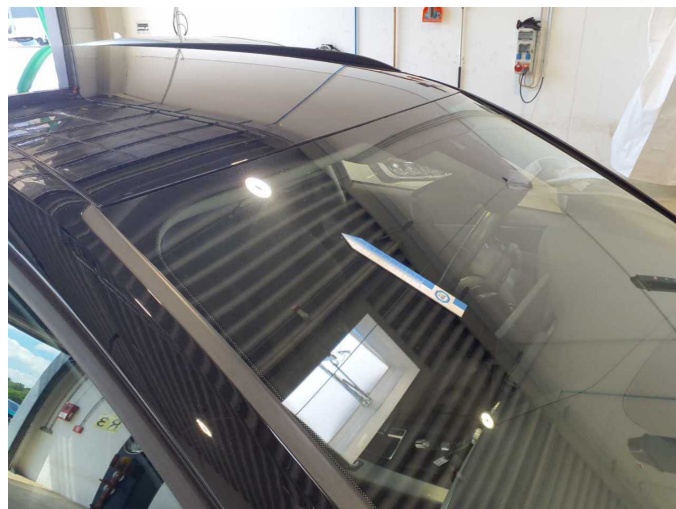
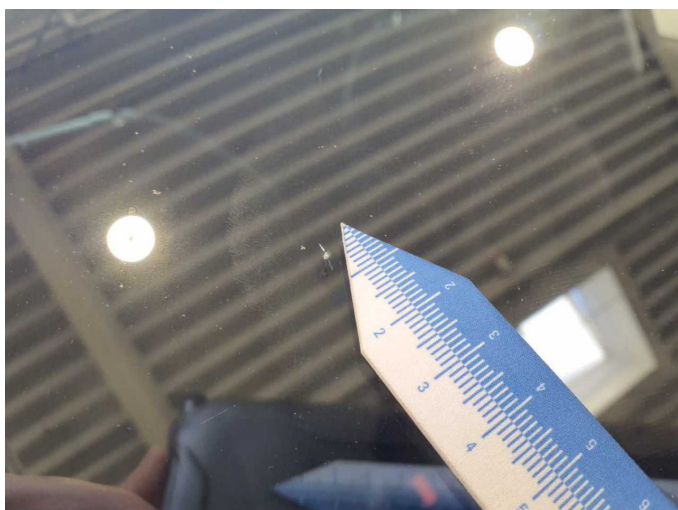
| No. | Component group | Description |
|---|---|---|
| 5 | Vehicle glazing | Windscreen with lane departure assistant - Stone chips - Smart repair |

**Damage 5:** Vehicle glazing: Windscreen with lane departure assistant - Stone chips - Smart repair

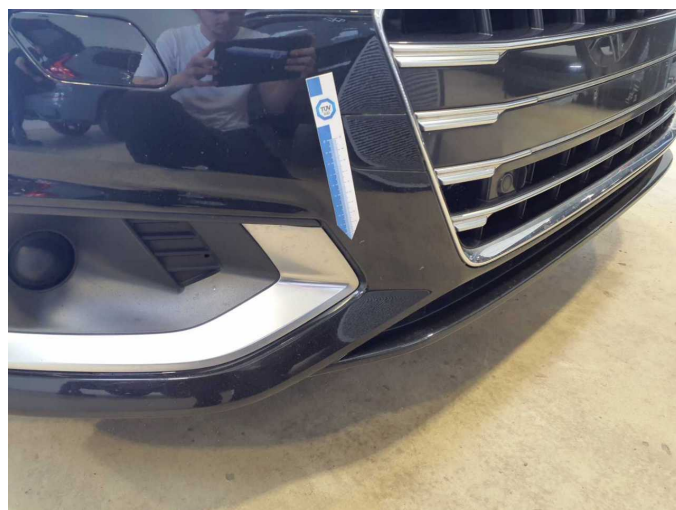
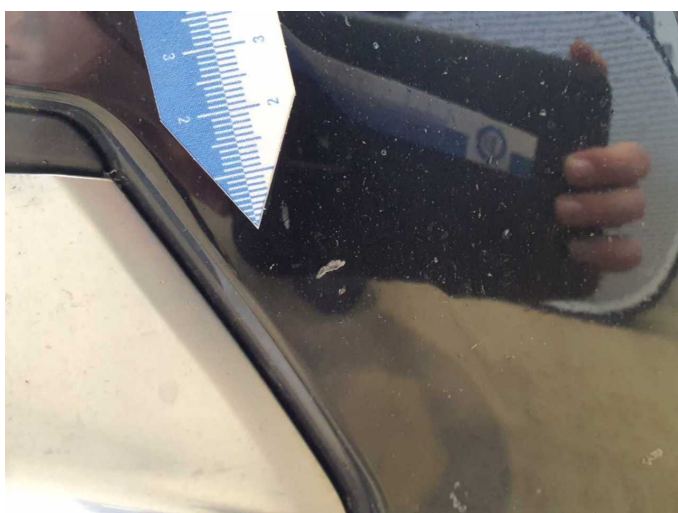
| No. | Component group | Description |
|---|---|---|
| 6 | Front bumper | Front bumper - Scratch(es) - Smart repair |

**Damage 6:** Front bumper: Front bumper - Scratch(es) - Smart repair

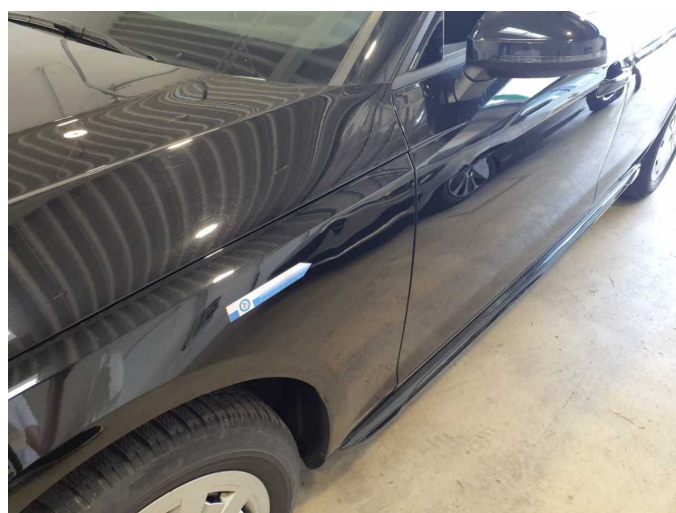
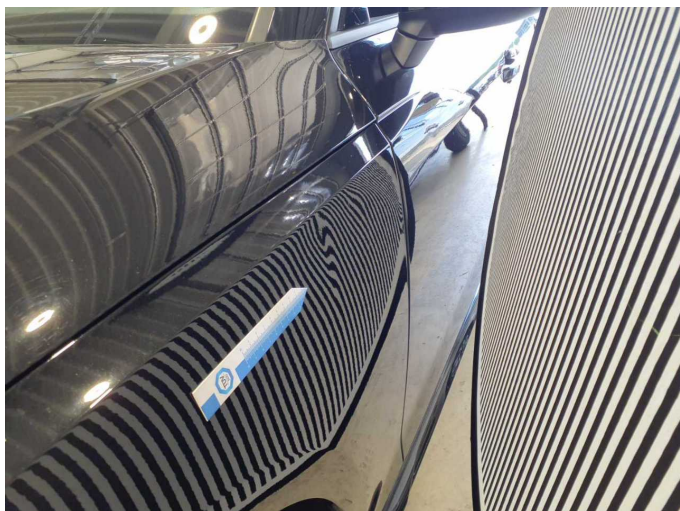
| No. | Component group | Description |
|---|---|---|
| 7 | Mudguard - left side | Mudguard - left side - dent(s) - Repair and paint |

**Damage 7:** Mudguard - left side: Mudguard - left side - dent(s) - Repair and paint

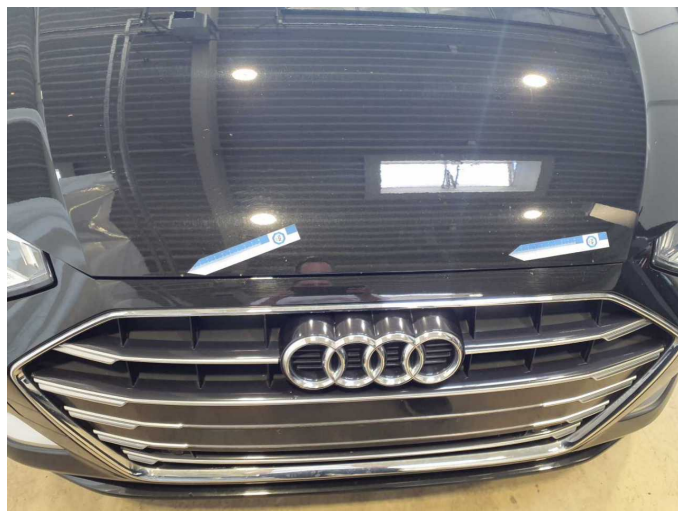
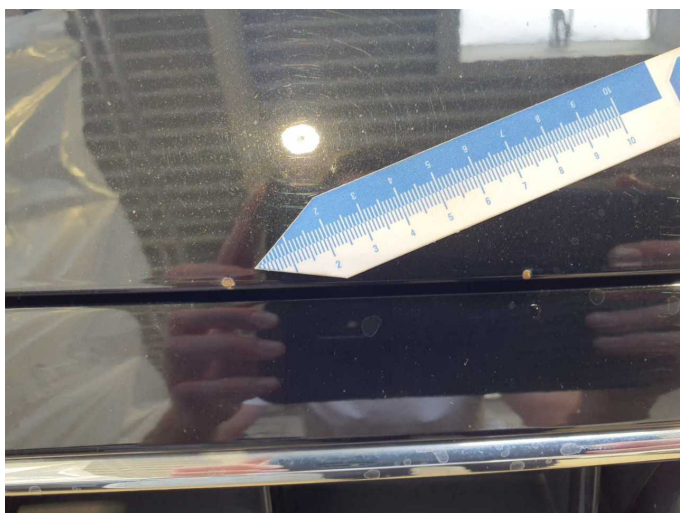
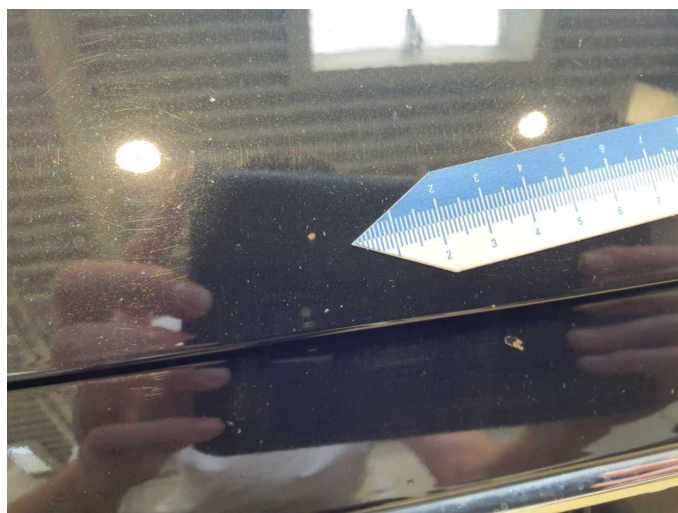
| No. | Component group | Description |
|---|---|---|
| 8 | Bonnet | Bonnet - Corrosion - Repair and paint |

**Damage 8:** Bonnet: Bonnet - Corrosion - Repair and paint

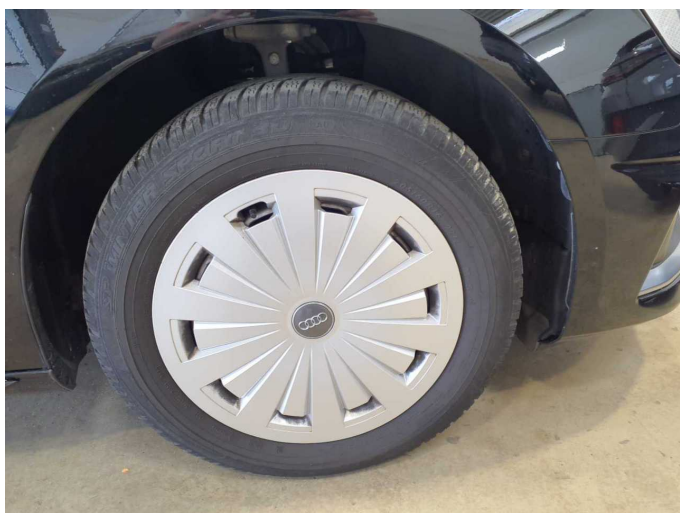
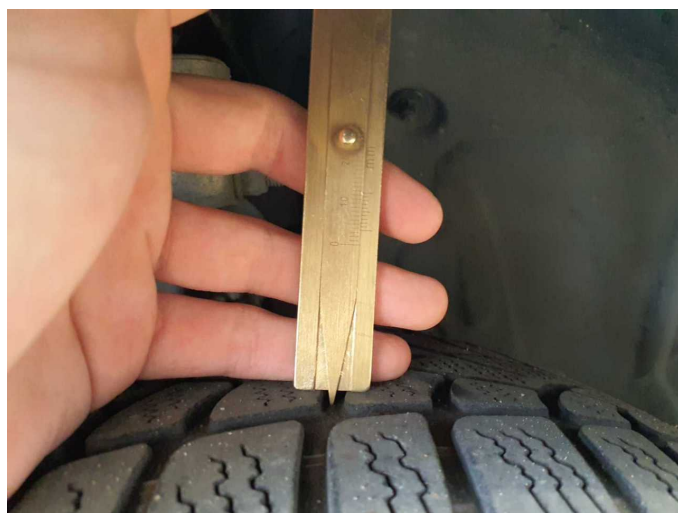
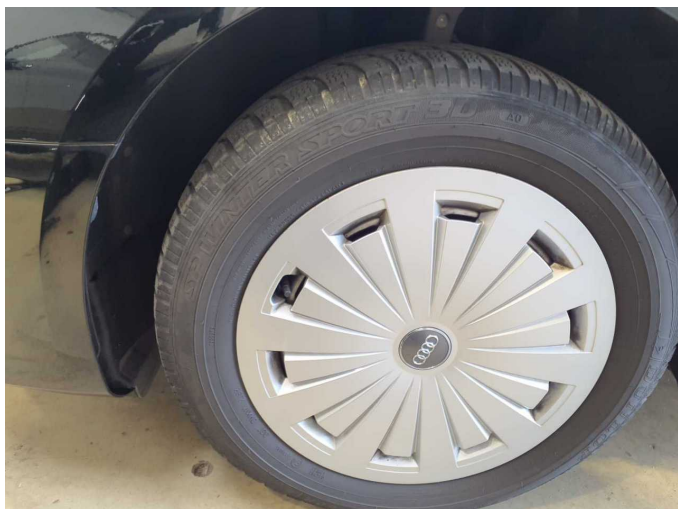
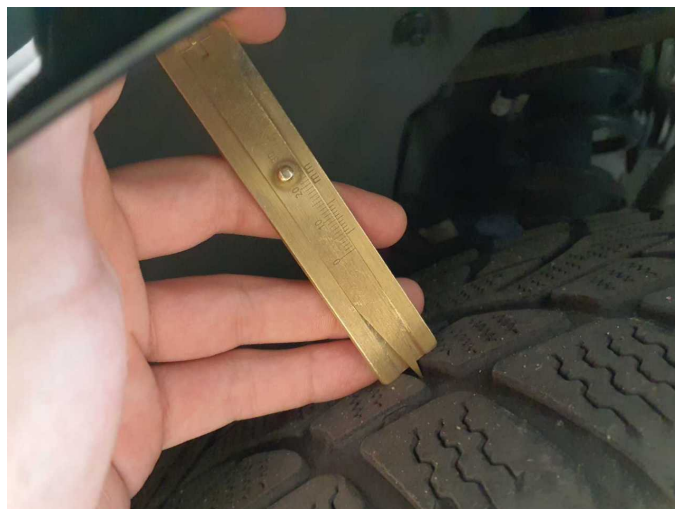
| No. | Component group | Description |
|---|---|---|
| 2 | Wheel / tyres | Tyre - front (Kein Teil der Ausstattung) - Does not meet the leasing specifications - No deduction |

**Wear and tear 2:** Wheel / tyres: Tyre - front (Kein Teil der Ausstattung) - Does not meet the leasing specifications - No deduction

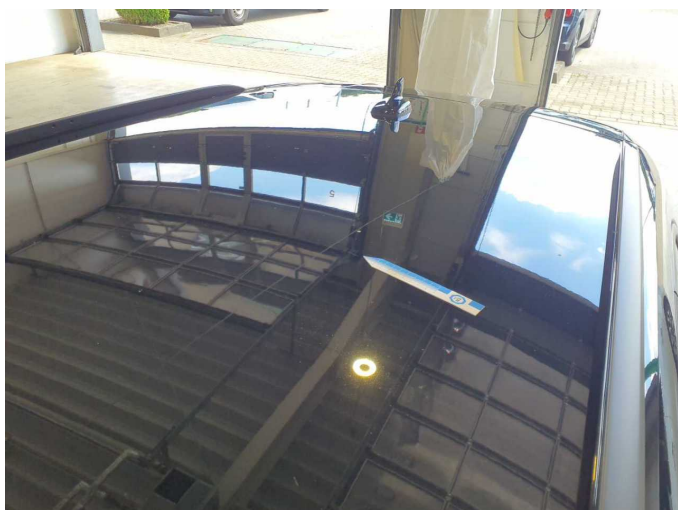
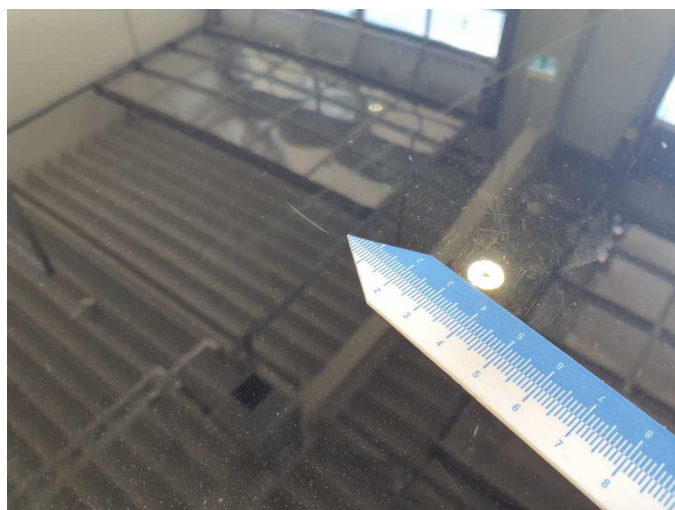
| No. | Component group | Description |
|---|---|---|
| 3 | Roof | Roof (polierbar) - Scratch(es) - No deduction |

**Wear and tear 3:** Roof: Roof (polierbar) - Scratch(es) - No deduction
