Expertise

Protocol number: 46599085  
Order No. / Reference: 26621397  
Inspection date: 17 Jul 2026

| Manufacturer: Ford | Model: Tourneo Lang 230L2 Connect 1.5 EcoBlue Start-Stop Titanium |

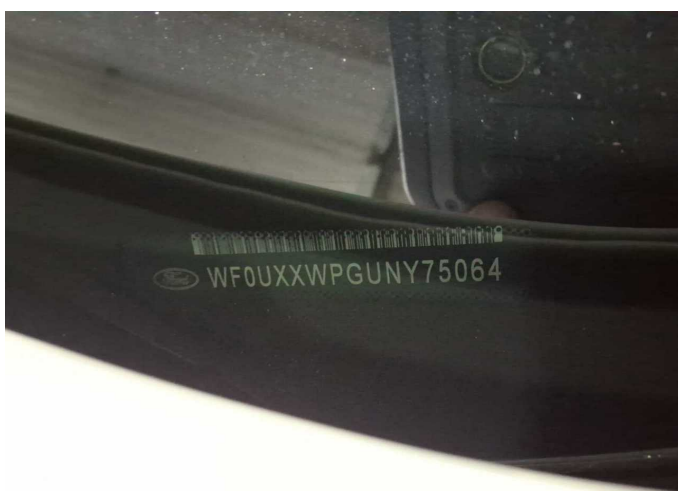
**Figure 11:** VIN

| VIN comparison | The vehicle identification number (VIN) was read from the vehicle and its conformity with the submitted documents was confirmed by the undersigned during the inspection. |

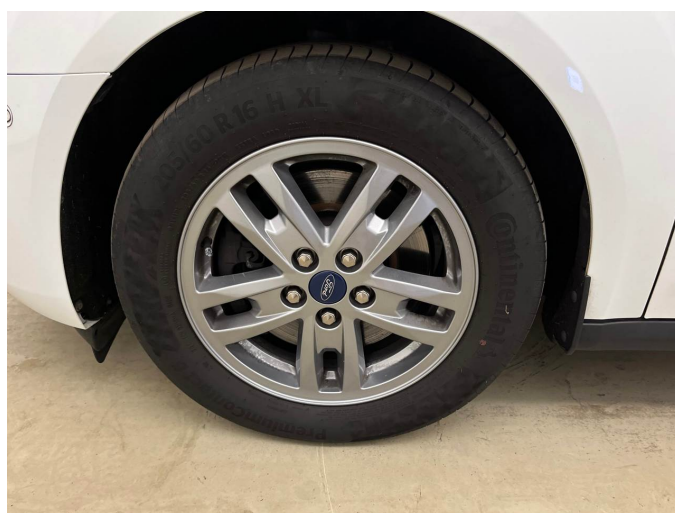
**Figure 12:** Mounted tyres

| Tyres | | | |
|---|---|---|---|
| 1) | 205/60 R16 96H | Summer tyres on Light alloy | 4mm / 4mm |
| 2) | 205/60 R16 96H | Summer tyres on Light alloy | 4mm / 4mm |

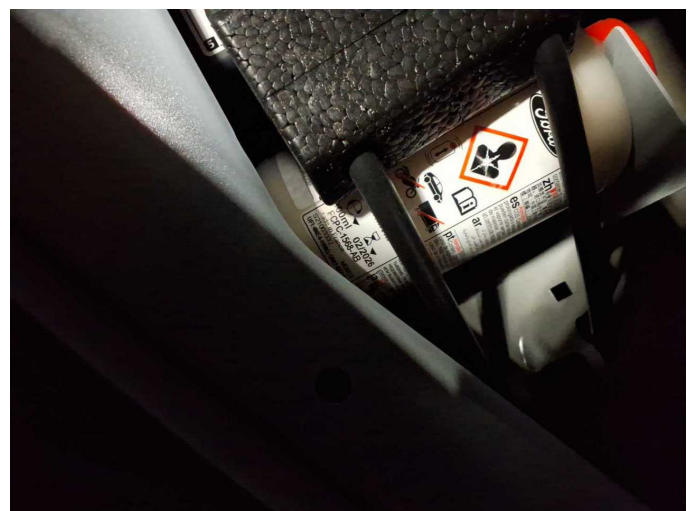
| No. | Component group | Description |
|---|---|---|
| 1 | Equipment | Tirefit filler - Expired - Replace |

Damage 1: Equipment: Tirefit filler - Expired - Replace

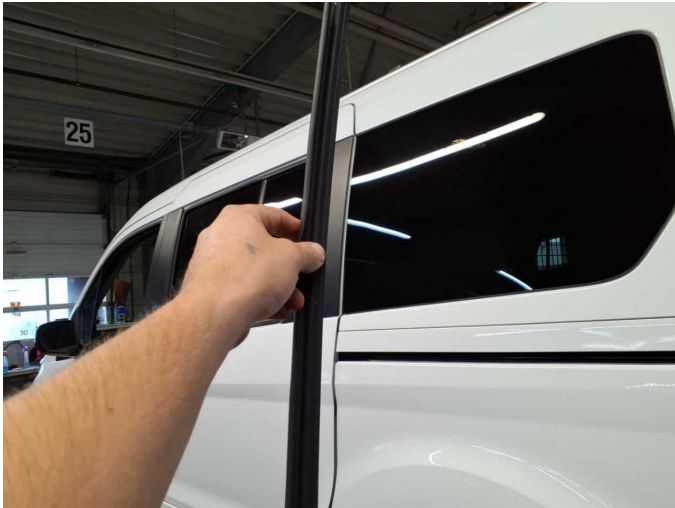
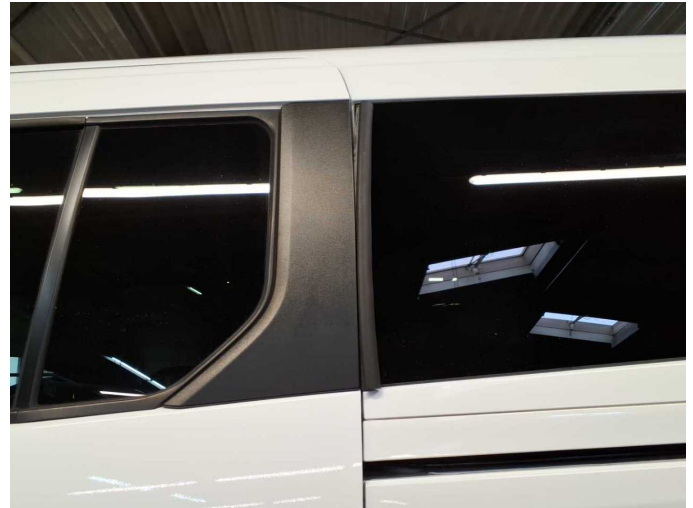
| No. | Component group | Description |
|---|---|---|
| 2 | Sliding door - left side | Sliding door with glass panel (Dichtung ab) - Loose - Replace |

**Damage 2:** Sliding door - left side: Sliding door with glass panel (Dichtung ab) - Loose - Replace

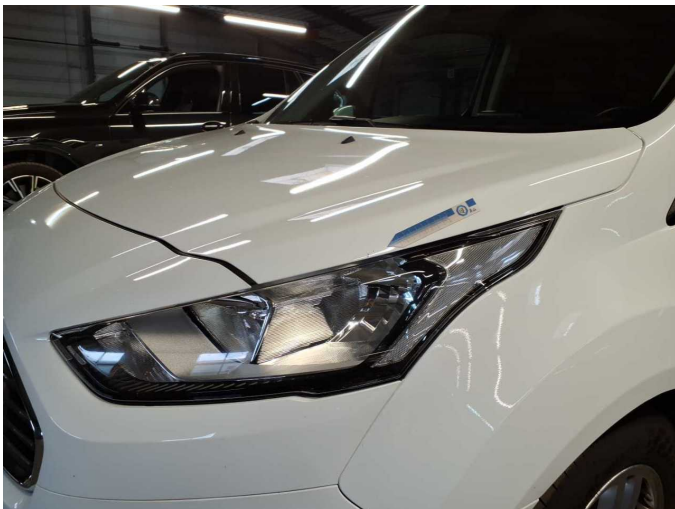
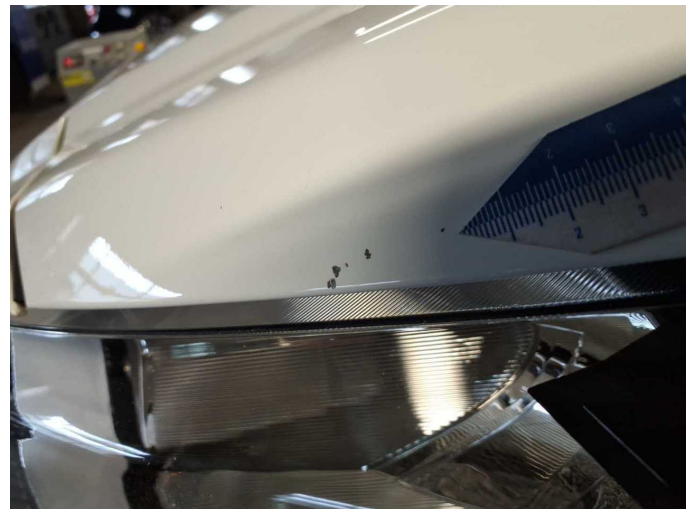
| No. | Component group | Description |
|---|---|---|
| 2 | Bonnet | Bonnet - Stone chips - No deduction |

**Wear and tear 2:** Bonnet: Bonnet - Stone chips - No deduction

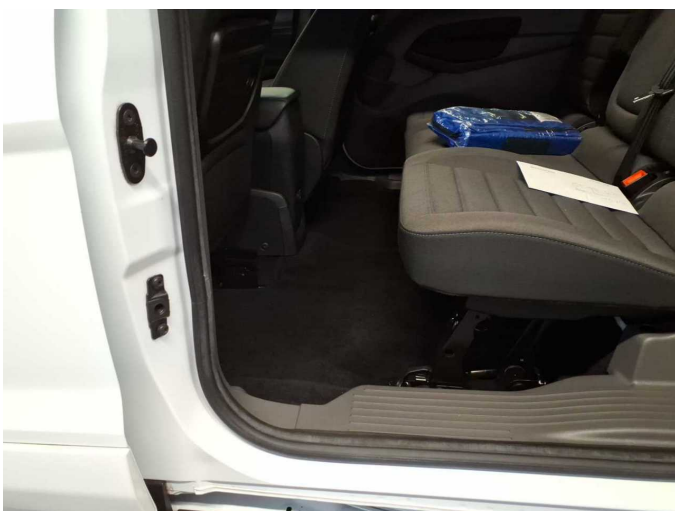
Trim / covers - Floor mats

**Missing part 1:** Trim / covers: Floor mats - Missing - Replace
