Expertise

Protocol number: 46402700  
Order No. / Reference: 26457046  
Inspection date: 8 Jul 2026

Model: C 200 d T 9G-TRONIC Avantgarde

VIN: W1KAH0DB1PF110061

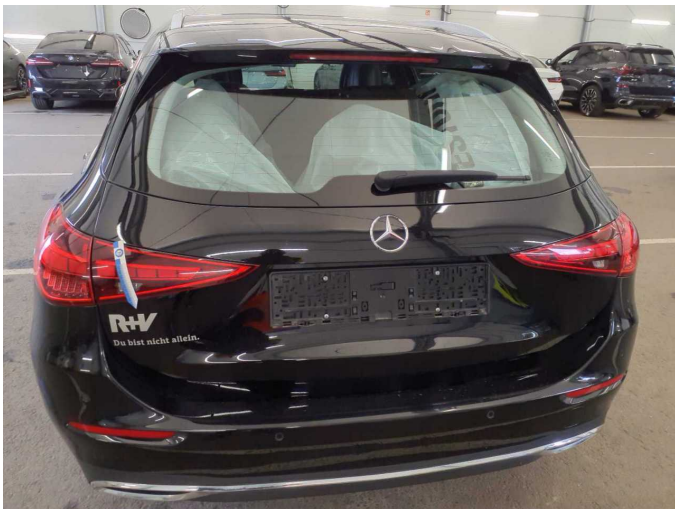
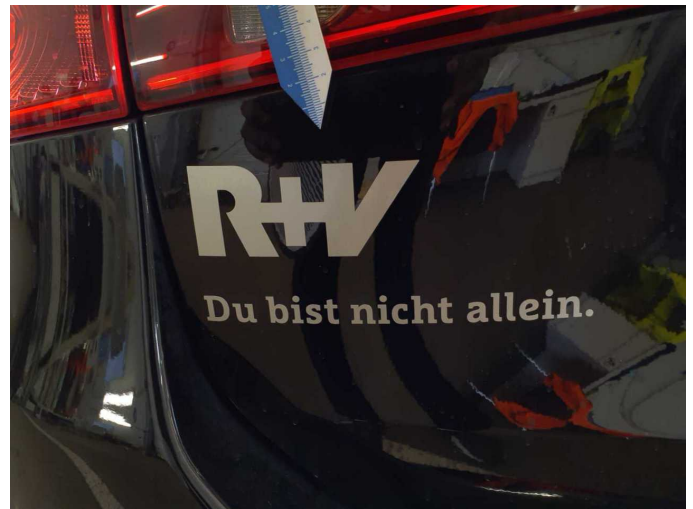
**Damage 1:** Boot lid / rear door: Boot lid - Glued / labelled - De-glue / neutralise

| No. | Component group | Description |
|---|---|---|
| 1 | Boot lid / rear door | Boot lid - Glued / labelled - De-glue / neutralise |

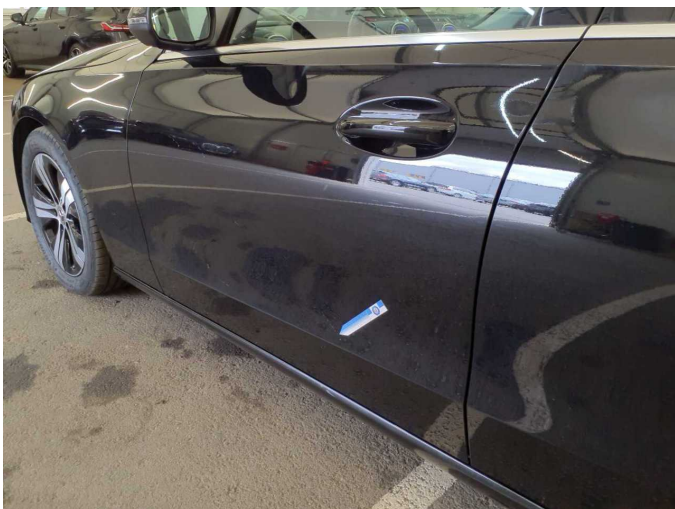
**Damage 2:** Door - front left side: Door - dent(s) - Smart repair

| No. | Component group | Description |
|---|---|---|
| 2 | Door - front left side | Door - dent(s) - Smart repair |

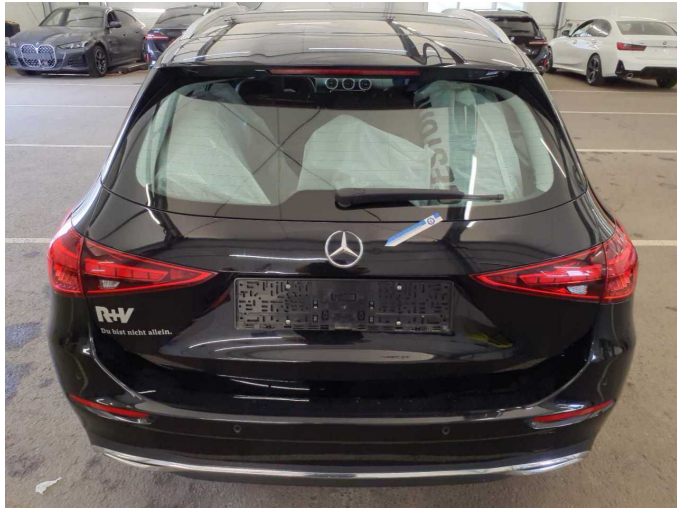
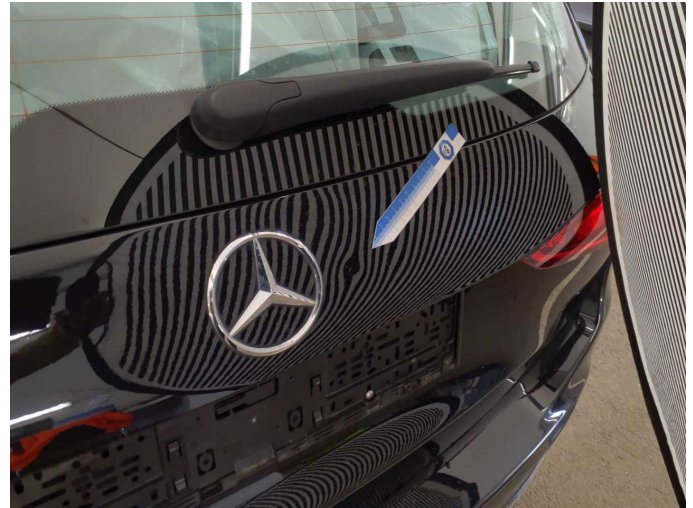
**Damage 3:** Boot lid / rear door: Boot lid - dent(s) - Smart repair

| No. | Component group | Description |
|---|---|---|
| 3 | Boot lid / rear door | Boot lid - dent(s) - Smart repair |

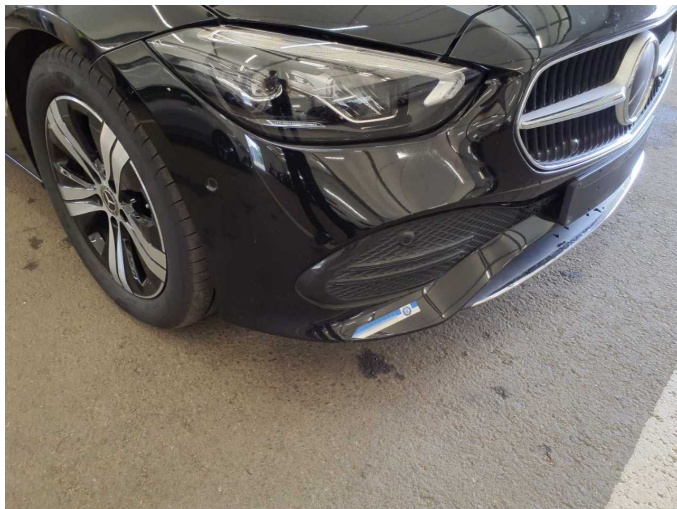
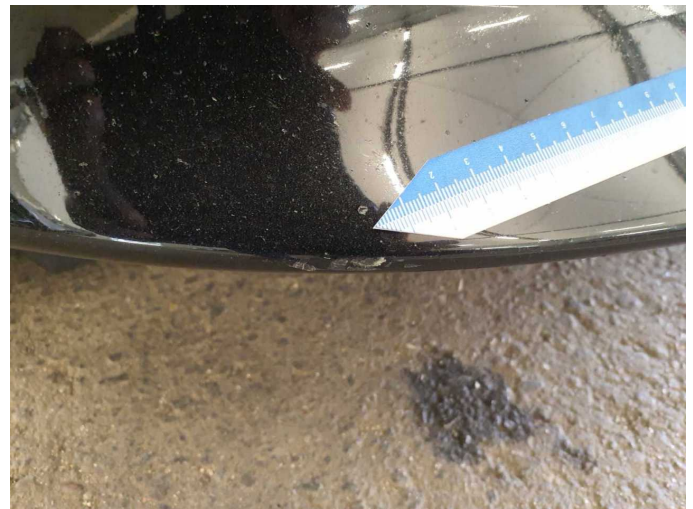
**Damage 4:** Front bumper: Front bumper - Scratch(es) - Smart repair

| No. | Component group | Description |
|---|---|---|
| 4 | Front bumper | Front bumper - Scratch(es) - Smart repair |
