Expertise

Protocol number: 46519150  
Order No. / Reference: 26489891  
Inspection date: 8 Jul 2026

Manufacturer: Mercedes-Benz  
VIN: W1KAF5EBXPR119678

Model: C 300 e 9G-TRONIC Avantgarde

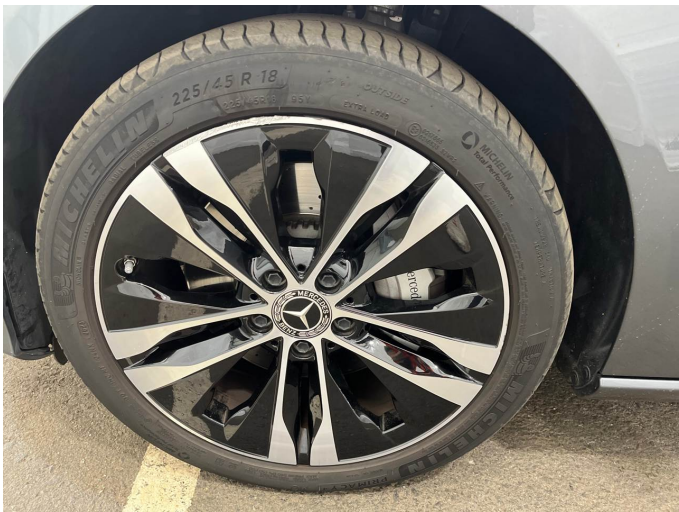
Figure 12: Mounted tyres

| # | Tyre size | Type of tyre | Manufacturer | Tread depth |
|---|---|---|---|---|
| 1) | 225/45 R18 95Y | Summer tyres on Light alloy | Michelin | 5mm / 5mm |
| 2) | 255/40 R18 99Y | Summer tyres on Light alloy | Michelin | 3mm / 3mm |

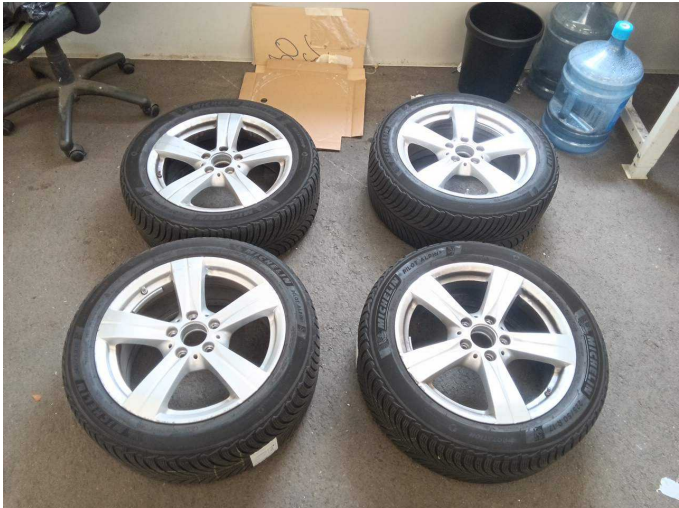
Figure 16: Additional tyres

| # | Tyre size | Type of tyre | Manufacturer | Tread depth |
|---|---|---|---|---|
| 1) | 225/50 R17 98H | Winter tyres on Light alloy | Michelin | 6mm / 6mm |
| 2) | 245/45 R17 99H | Winter tyres on Light alloy | Michelin | 5mm / 5mm |

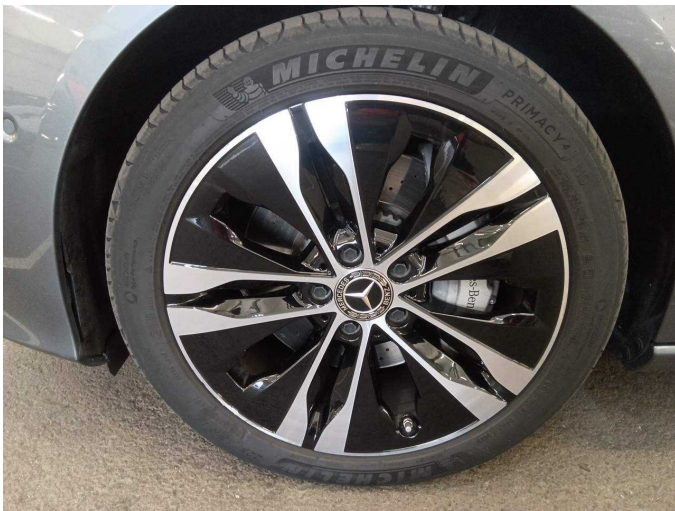
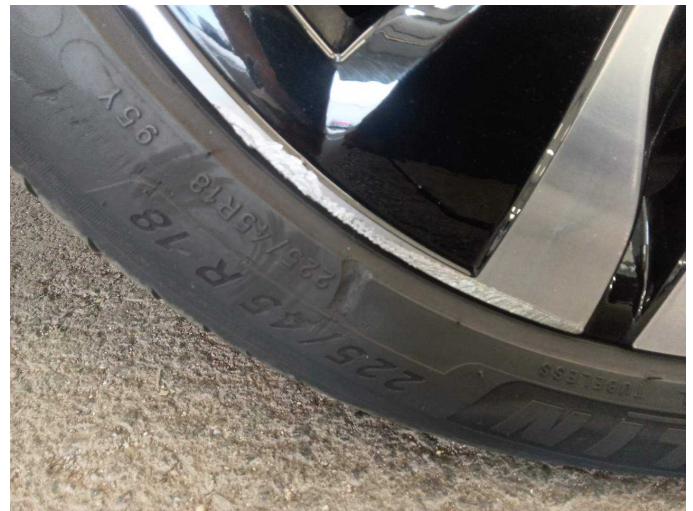
| No. | Component group | Description |
|---|---|---|
| 1 | Wheel / tyres | Tyre - front left side (Flankenbeschädigung) - Damaged - Replace |

**Damage 1:** Wheel / tyres: Tyre - front left side (Flankenbeschädigung) - Damaged - Replace

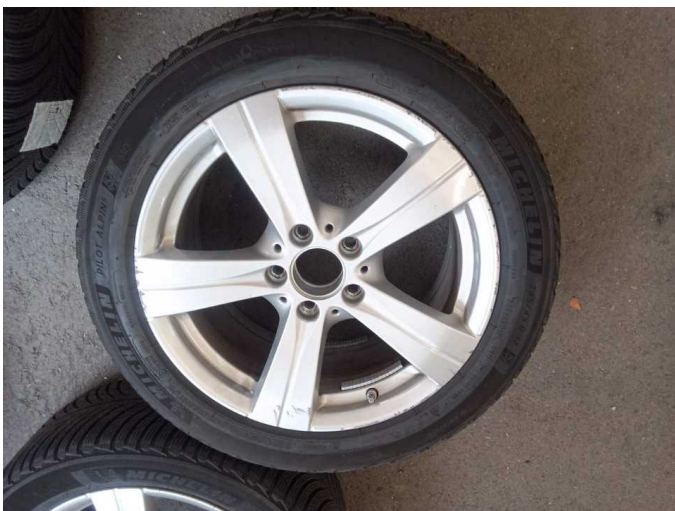
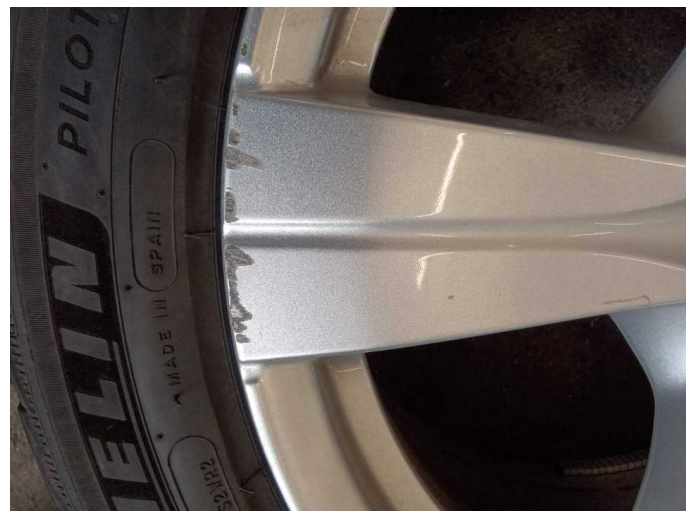
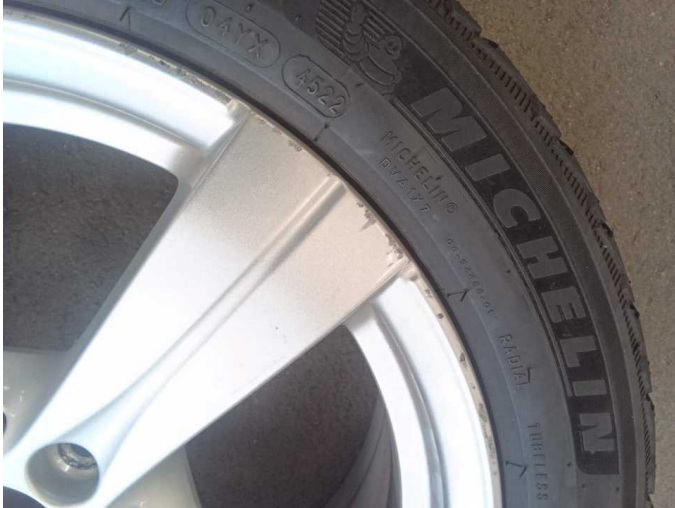
| No. | Component group | Description |
|---|---|---|
| 3 | 2nd wheel set | 1 alloy rim - Scratched - Loss in value |

**Damage 3:** 2nd wheel set: 1 alloy rim - Scratched - Loss in value

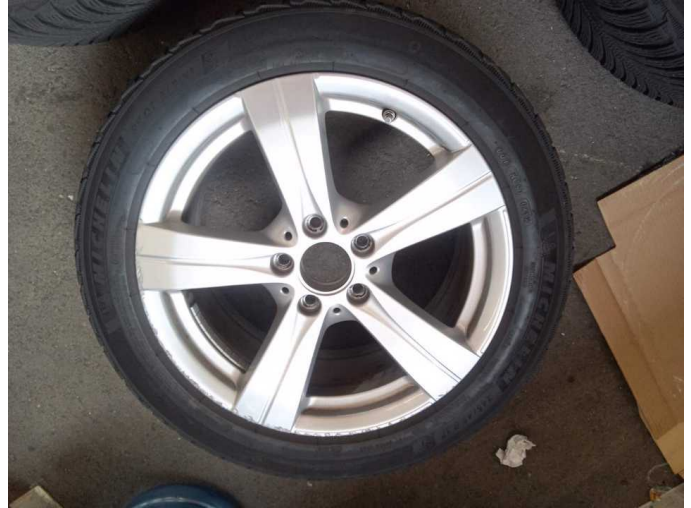
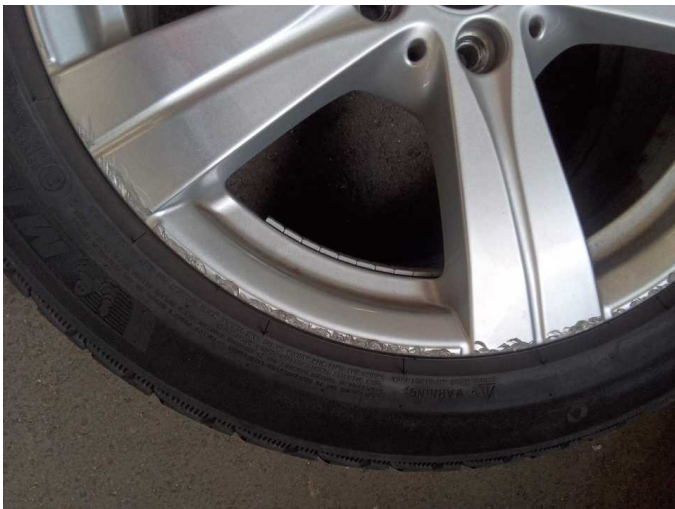
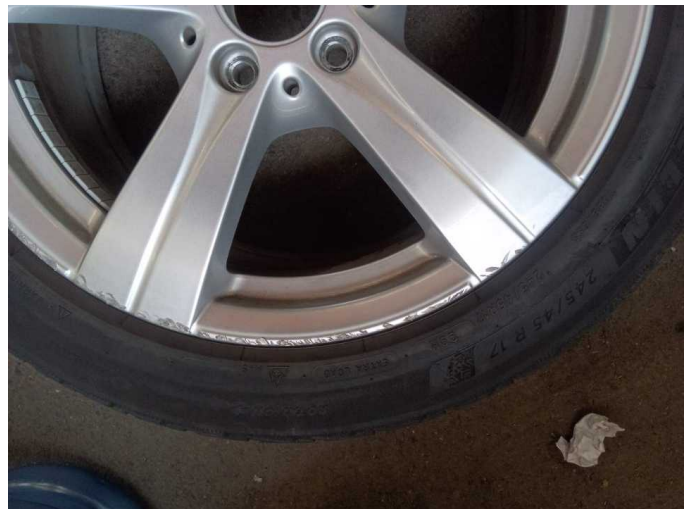
| No. | Component group | Description |
|---|---|---|
| 4 | 2nd wheel set | 1 alloy rim (Mit Materialabtrag) - Scratched - Replace |

**Damage 4:** 2nd wheel set: 1 alloy rim (Mit Materialabtrag) - Scratched - Replace

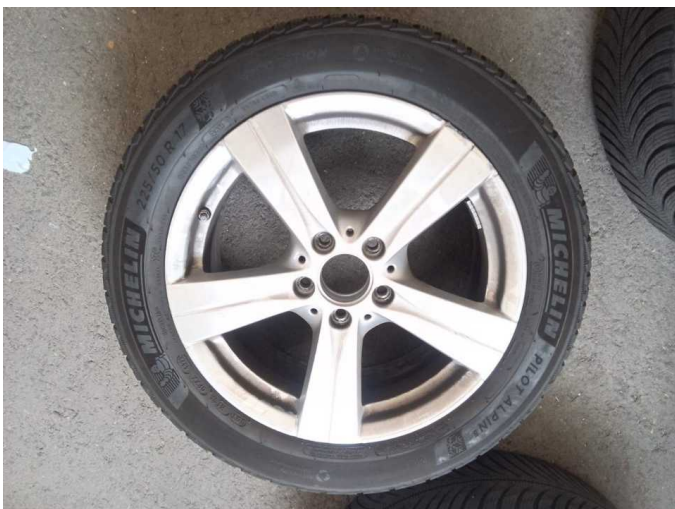
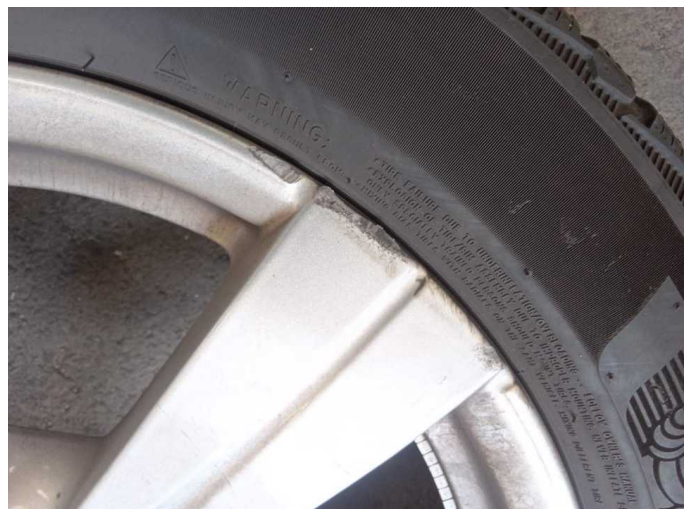
| No. | Component group | Description |
|---|---|---|
| 5 | 2nd wheel set | 1 alloy rim (Mit Materialabtrag) - Scratched - Replace |

**Damage 5:** 2nd wheel set: 1 alloy rim (Mit Materialabtrag) - Scratched - Replace

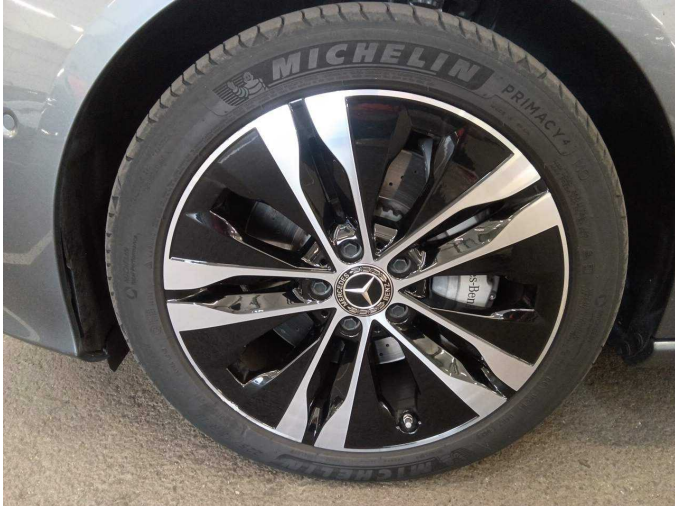
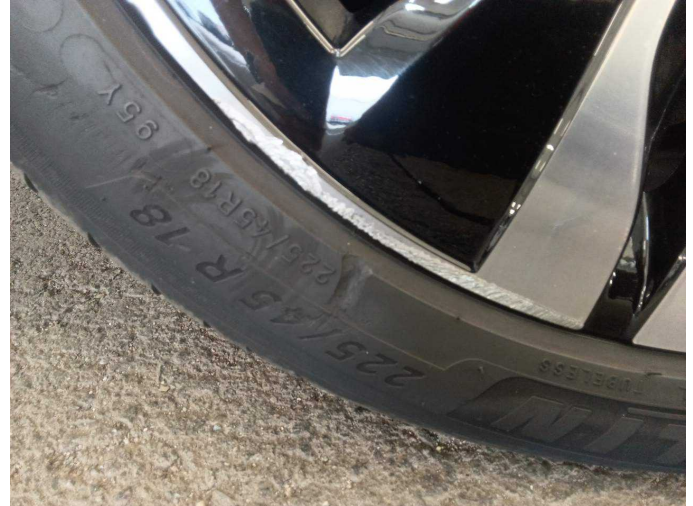
| No. | Component group | Description |
|---|---|---|
| 6 | Wheel / tyres | Alloy rim - front left side (Mit Materialabtrag) - Scratch(es) - Replace |

**Damage 6:** Wheel / tyres: Alloy rim - front left side (Mit Materialabtrag) - Scratch(es) - Replace

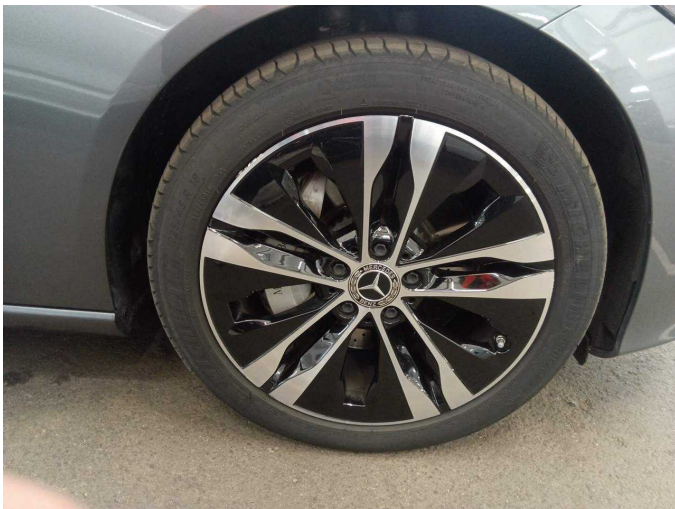
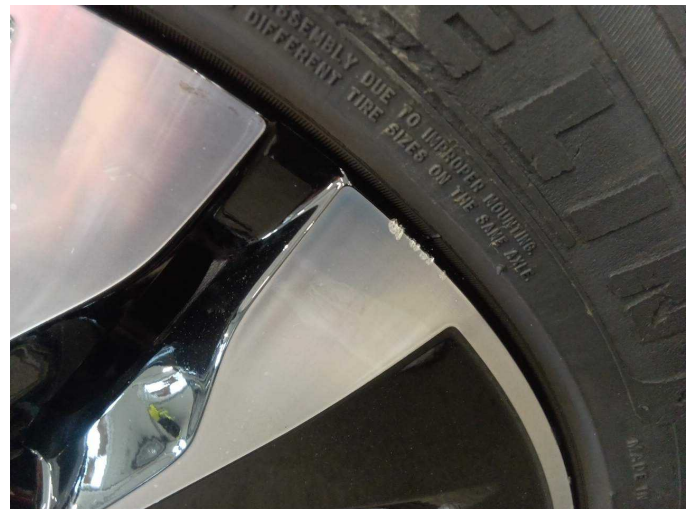
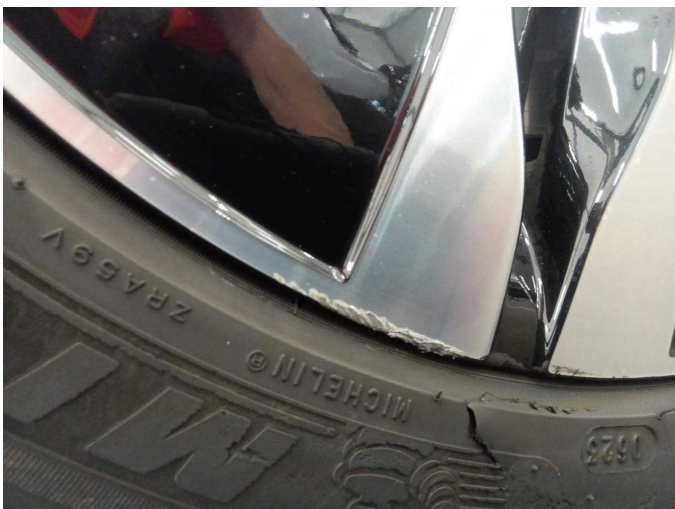
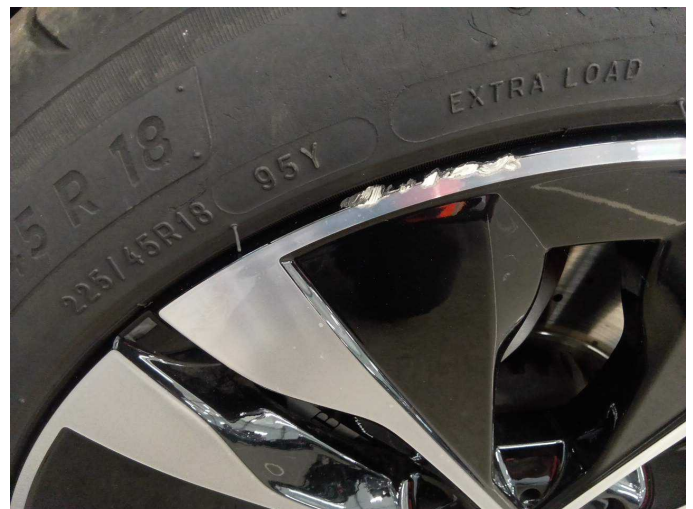
| No. | Component group | Description |
|---|---|---|
| 7 | Wheel / tyres | Alloy rim - front right side (Mit Materialabtrag) - Scratch(es) - Replace |

**Damage 7:** Wheel / tyres: Alloy rim - front right side (Mit Materialabtrag) - Scratch(es) - Replace

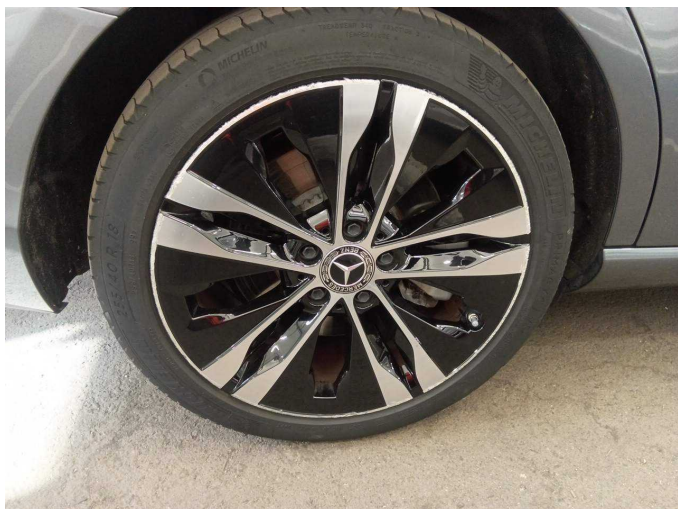
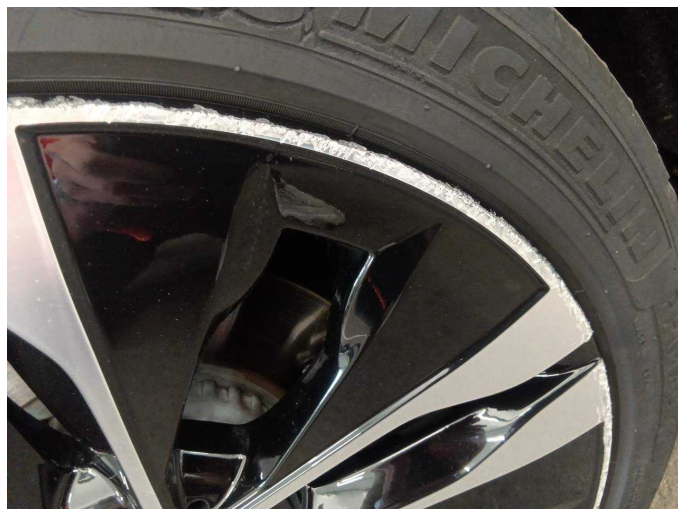
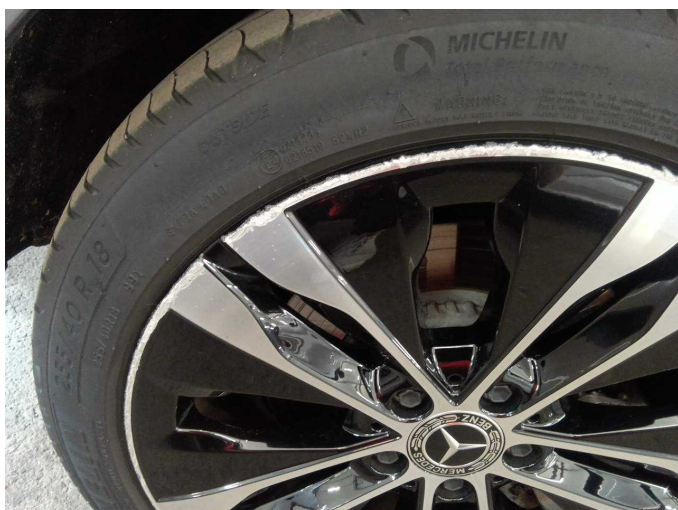
| No. | Component group | Description |
|---|---|---|
| 8 | Wheel / tyres | Alloy rim - rear right side (Großflächig verkratzt) - Scratched - Replace |

**Damage 8:** Wheel / tyres: Alloy rim - rear right side (Großflächig verkratzt) - Scratched - Replace

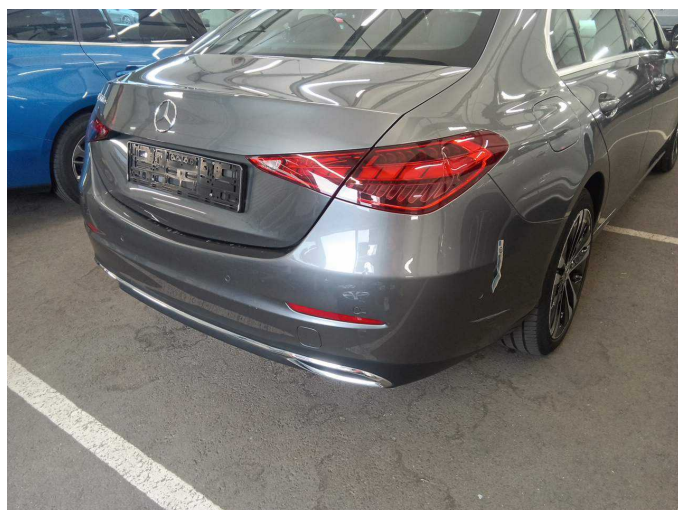
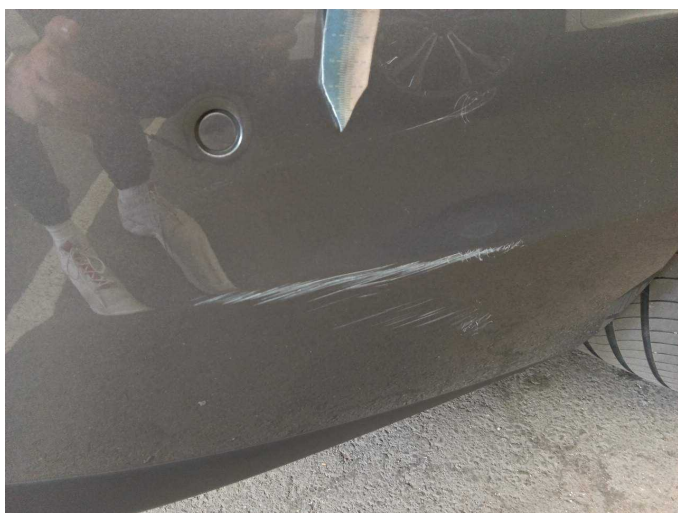
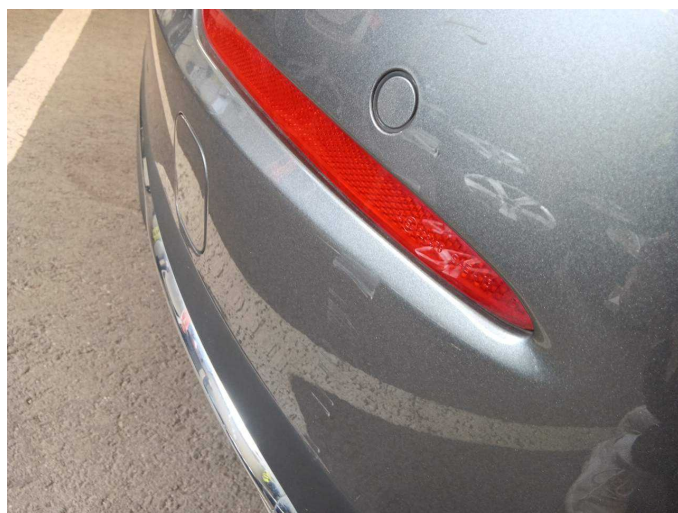
| No. | Component group | Description |
|---|---|---|
| 9 | Rear bumper | Rear bumper - Scratch(es) - Paint |

**Damage 9:** Rear bumper: Rear bumper - Scratch(es) - Paint

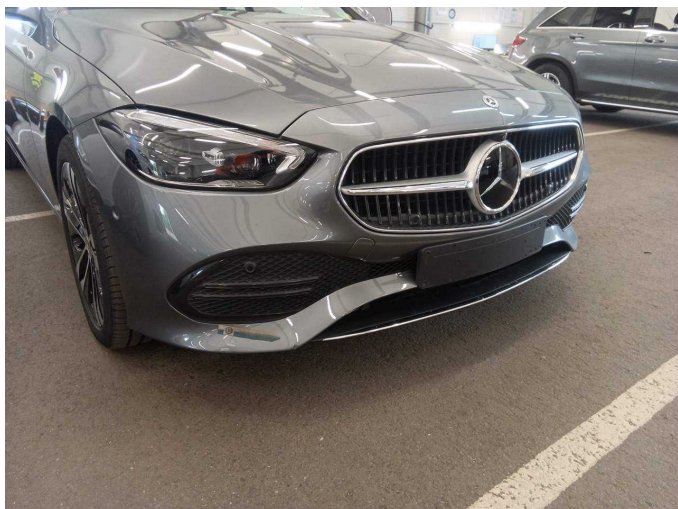
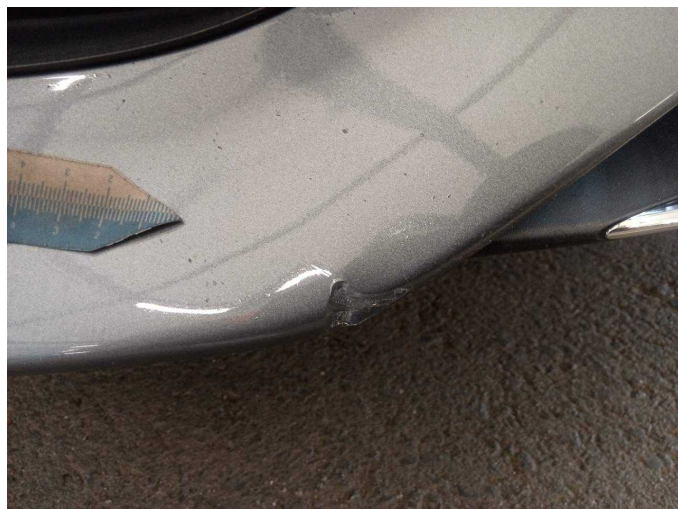
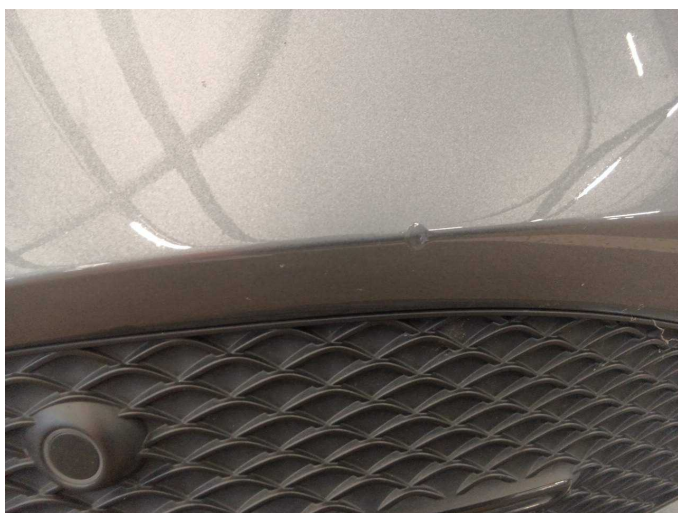
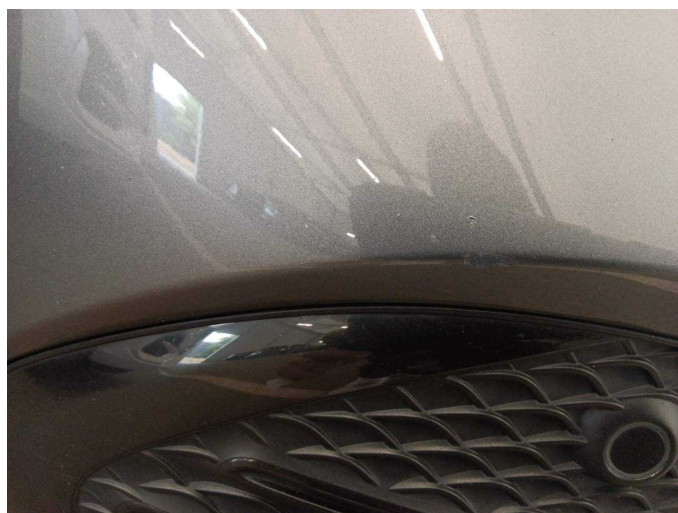
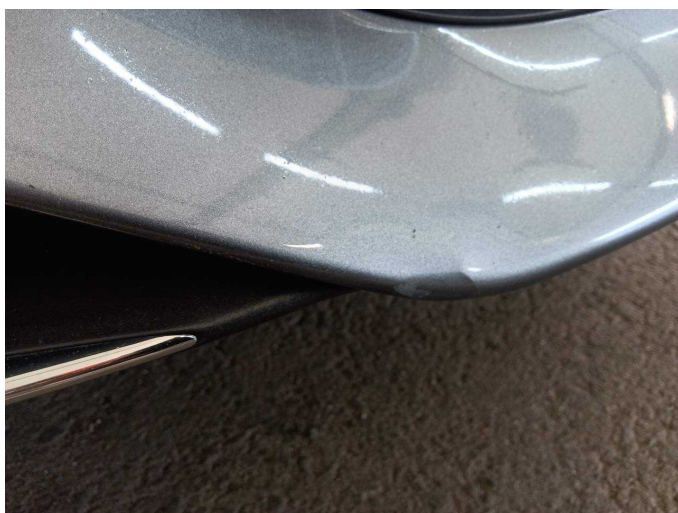
| No. | Component group | Description |
|---|---|---|
| 10 | Front bumper | Front bumper (& Lackschaden) - Deformed - Repair and paint |

**Damage 10:** Front bumper: Front bumper (& Lackschaden) - Deformed - Repair and paint
