Expertise

Protocol number: 46041478  
Order No. / Reference: 26453913-1  
Inspection date: 3 Jun 2026

| Manufacturer: Seat | Model: Alhambra 1.4 TSI S&S DSG OPF Ecomotive XCELLENCE |
| VIN: VSSZZZ7NZMV503617 | |

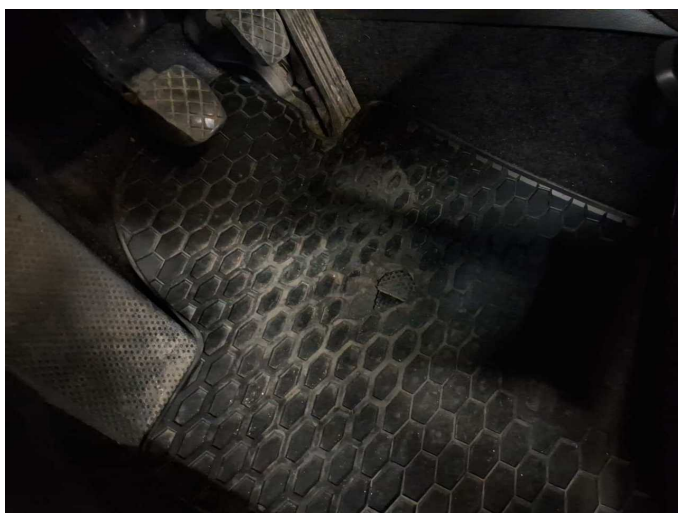
| No. | Component group | Description |
|---|---|---|
| 1 | Trim / covers | Floor mats (VL) - Holes - Replace |

**Damage 1:** Trim / covers: Floor mats (VL) - Holes - Replace

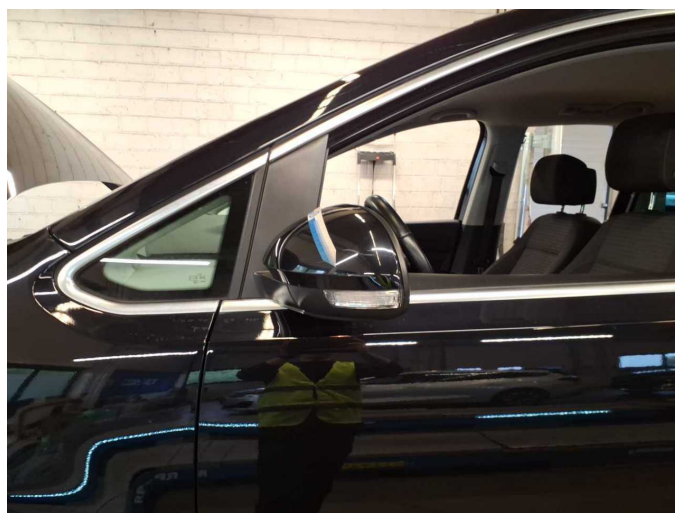
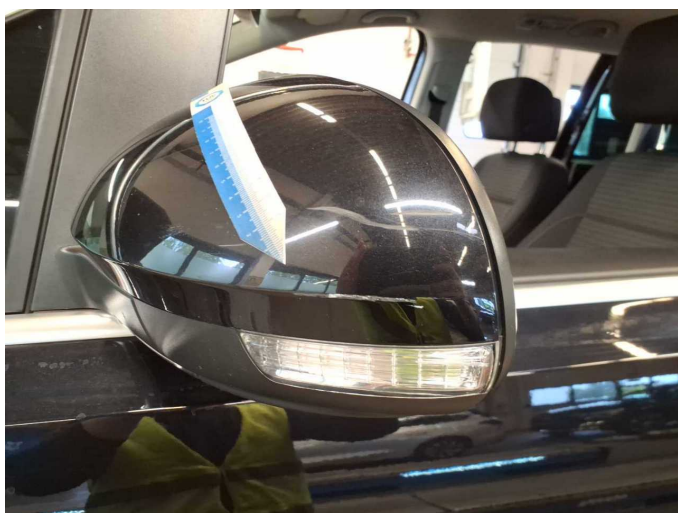
| No. | Component group | Description |
|---|---|---|
| 2 | Wing mirror - left side | Cap - Scratch(es) - Smart repair |

**Damage 2:** Wing mirror - left side: Cap - Scratch(es) - Smart repair

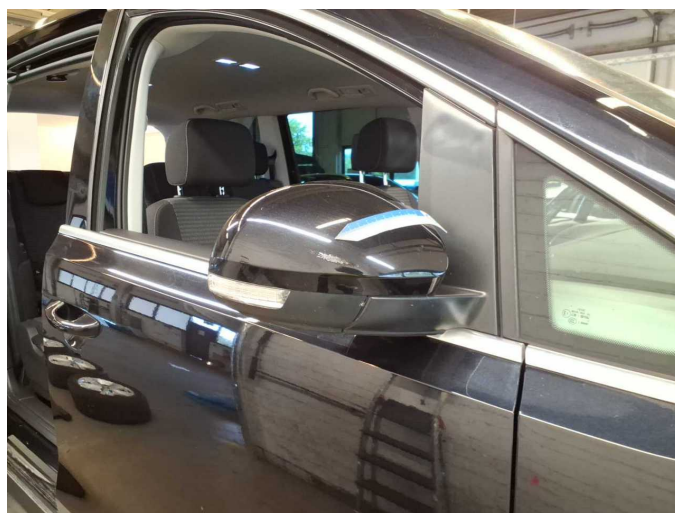
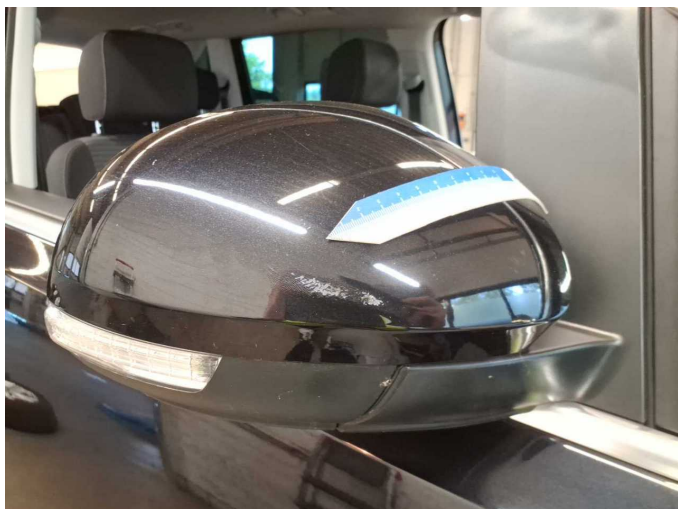
| No. | Component group | Description |
|---|---|---|
| 3 | Wing mirror - right side | Cap - Scratch(es) - Smart repair |

**Damage 3:** Wing mirror - right side: Cap - Scratch(es) - Smart repair

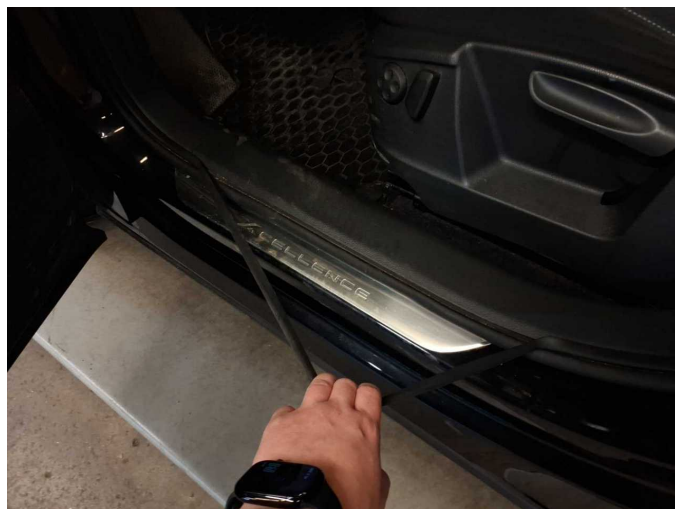
| No. | Component group | Description |
|---|---|---|
| 5 | Door - front left side | Door seal - Broken / torn - Replace |

**Damage 5:** Door - front left side: Door seal - Broken / torn - Replace

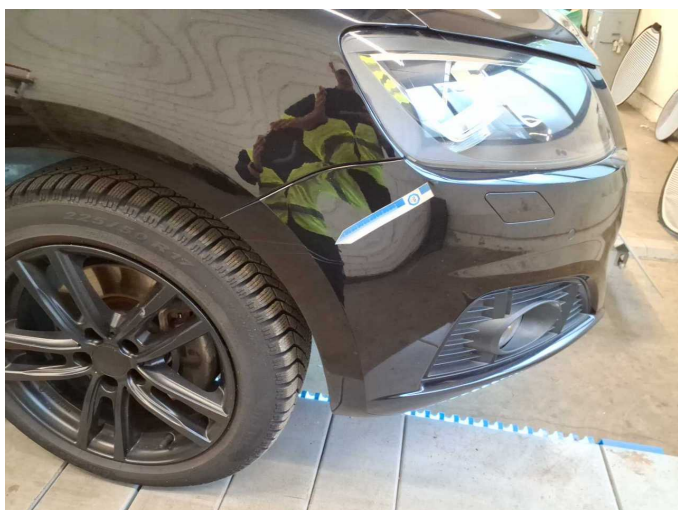
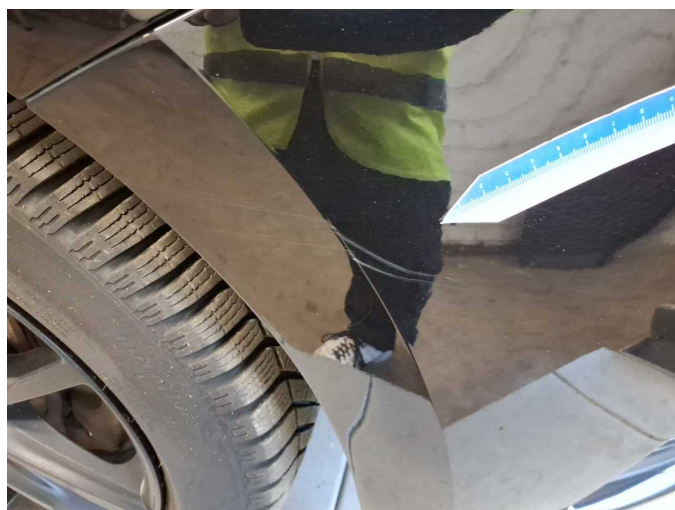
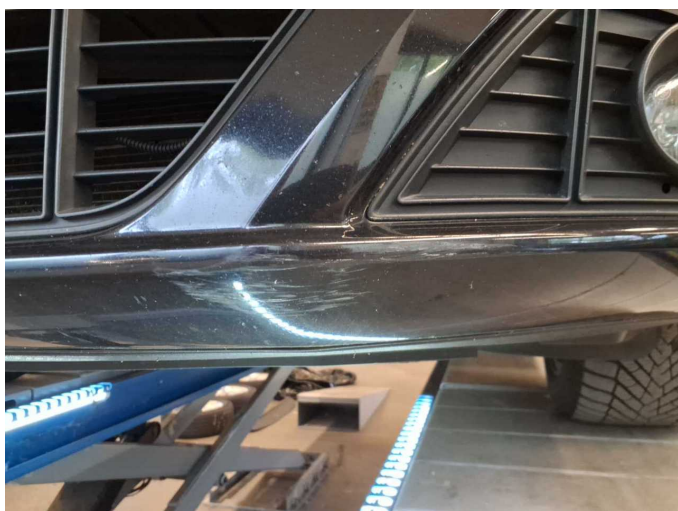
| No. | Component group | Description |
|---|---|---|
| 6 | Front bumper | Front bumper - Scratch(es) - Paint |

**Damage 6:** Front bumper: Front bumper - Scratch(es) - Paint

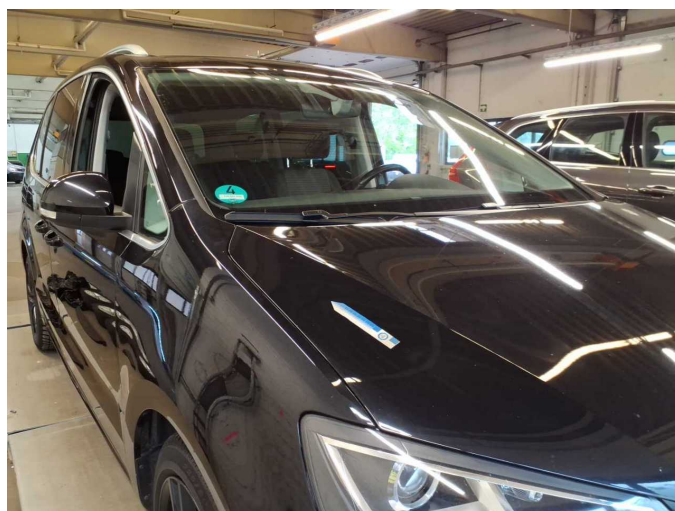
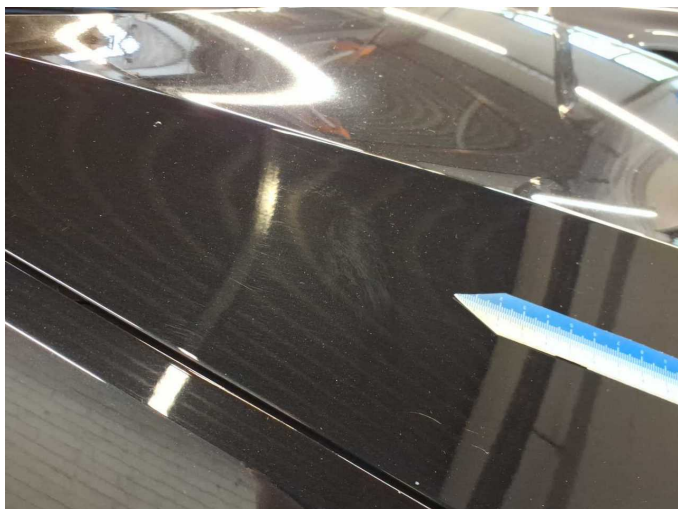
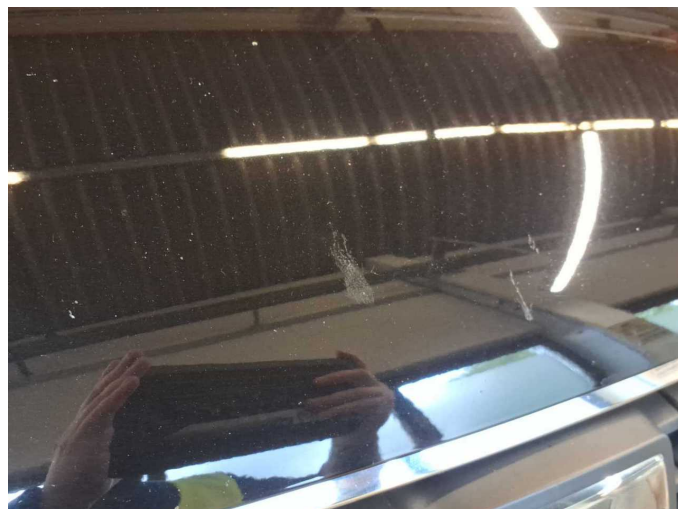
| No. | Component group | Description |
|---|---|---|
| 7 | Bonnet | Bonnet (Vogelkotverätzung) - Paint defect - Paint |

**Damage 7:** Bonnet: Bonnet (Vogelkotverätzung) - Paint defect - Paint

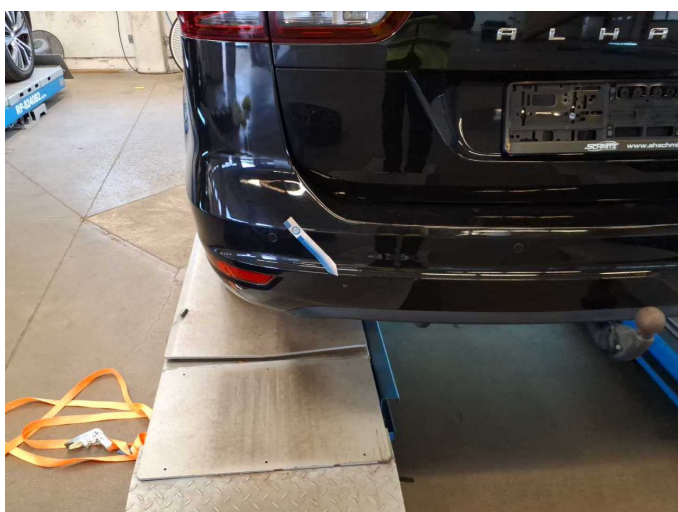
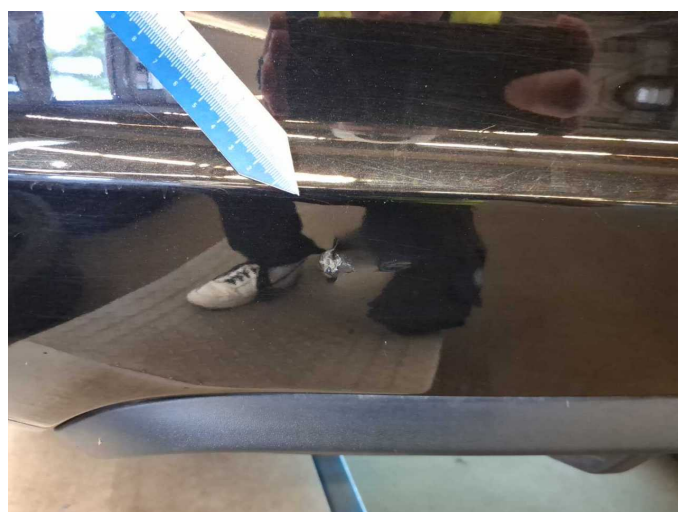
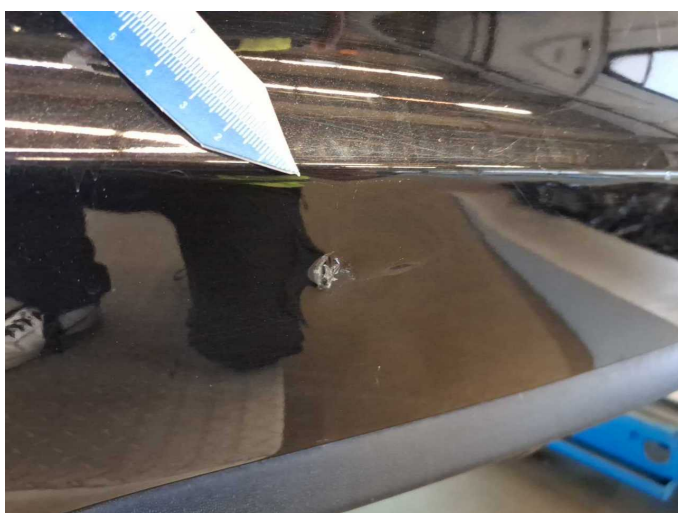
| No. | Component group | Description |
|---|---|---|
| 8 | Rear bumper | Rear bumper - Deformed - Repair and paint |

**Damage 8:** Rear bumper: Rear bumper - Deformed - Repair and paint

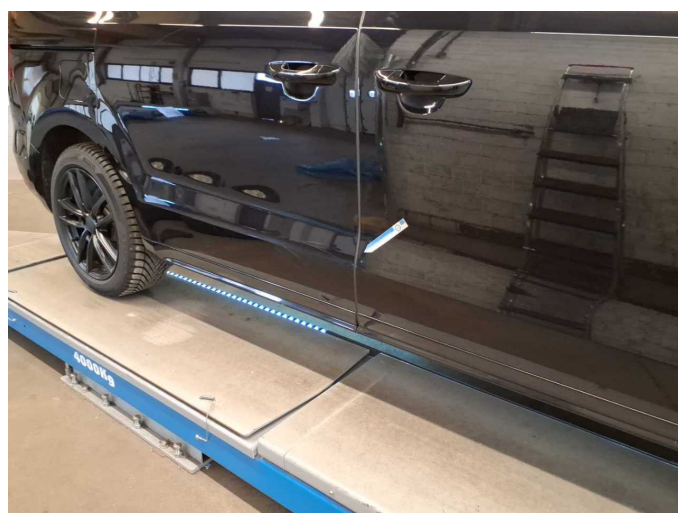
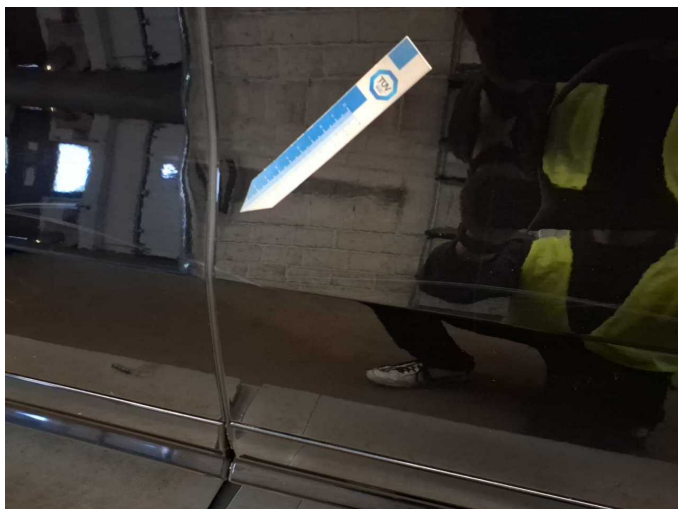
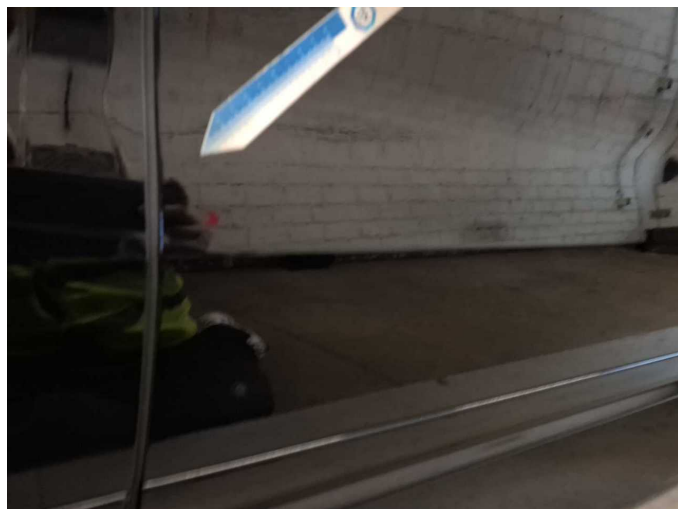
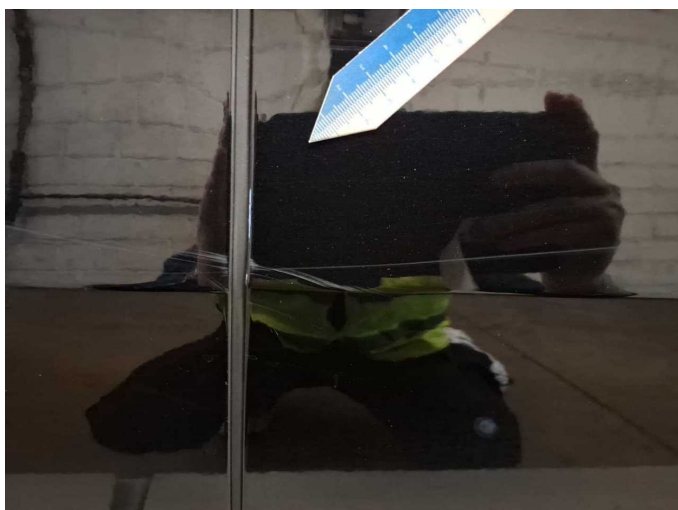
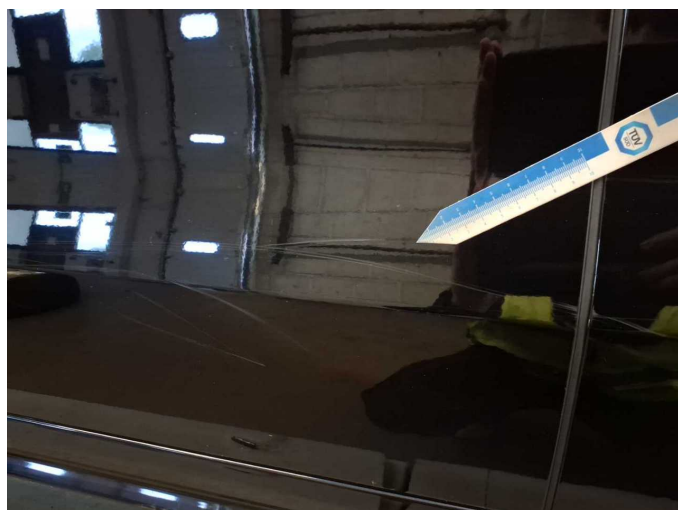
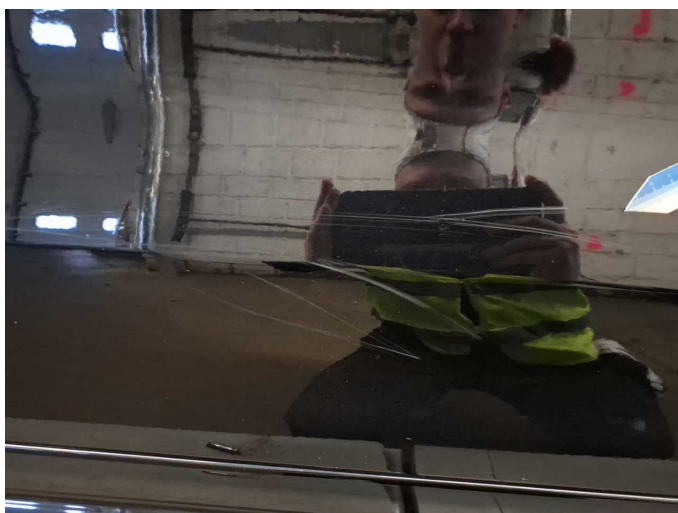
| No. | Accident |
|---|---|
| 1 | Side right |

**Accident 1:** Side right

**Accident 1: Side right**
