# Assessment

- Vehicle Inspection Report -

Number: 10044683  
From: 13.02.2026

**Order number:** 1002318157  
**Order completed:** 13.02.2026 10:21  
**Report number:** 10044683  
**VIN:** WVGZZZ5N5PW408616

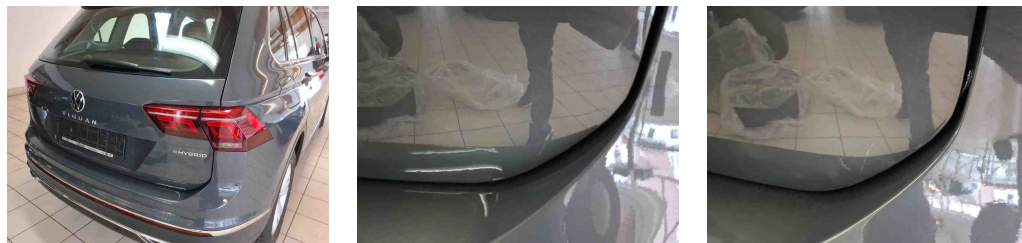
| Nr | Location | Damage type | Repair type |
|---|---|---|---|
| 1 | Tailgate / Boot | Scratch(es) | Paint |

1 - Tailgate / Boot - Scratch(es) - Paint

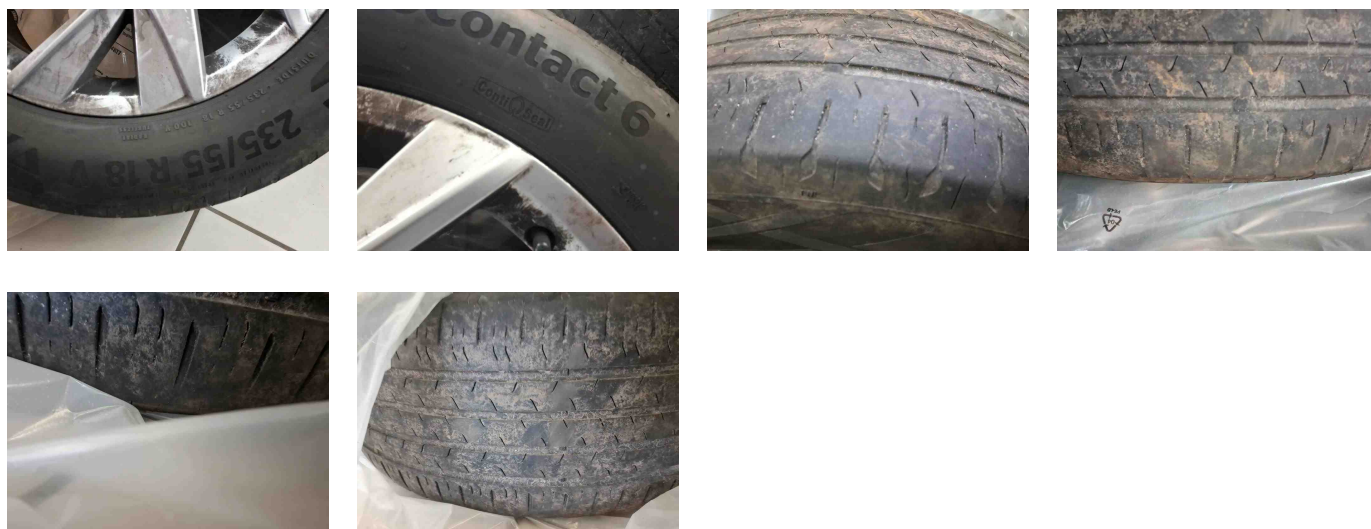
| Make | Location | Position | Type | Rim | Dimensions | Profile depth |
|---|---|---|---|---|---|---|
| Continental | | | Summer | Aluminium | 235/55 R 18 100 W | 2.0 mm |
| Continental | | | Summer | Aluminium | 235/55 R 18 100 W | 3.0 mm |

| Nr | Location | Damage type | Repair type |
|---|---|---|---|
| 2 | Additional tyre(s) | Out of tolerance | Replace |

2 - Additional tyre(s) - Out of tolerance - Replace

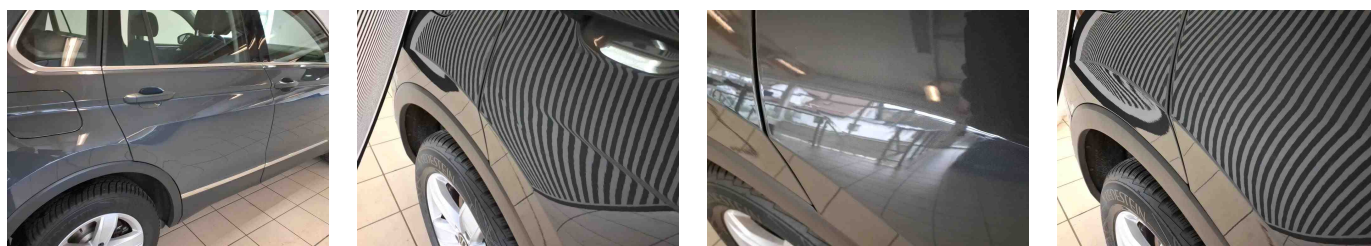
| Nr | Location | Damage type | Repair type |
|---|---|---|---|
| 3 | Door RR | Dent(s) and scratch(es) | Repair and paint (complete) |

3 - Door RR - Dent(s) and scratch(es) - Repair and paint (complete)

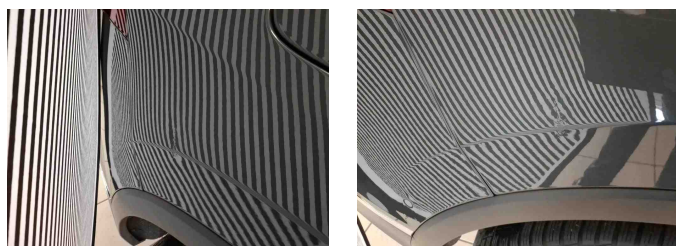
| Nr | Location | Damage type | Repair type |
|---|---|---|---|
| 4 | Side wall RR | Dent(s) and scratch(es) | Repair and paint (complete) |

4 - Side wall RR - Dent(s) and scratch(es) - Repair and paint (complete)

5 - Preparationtime metal painting - Paint preparation - Execute

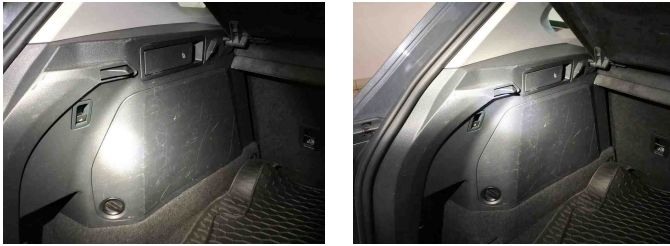
| Nr | Location | Damage type | Repair type |
|---|---|---|---|
| 6 | Internal boot lining L | Scratch(es) | Replace |

6 - Internal boot lining L - Scratch(es) - Replace

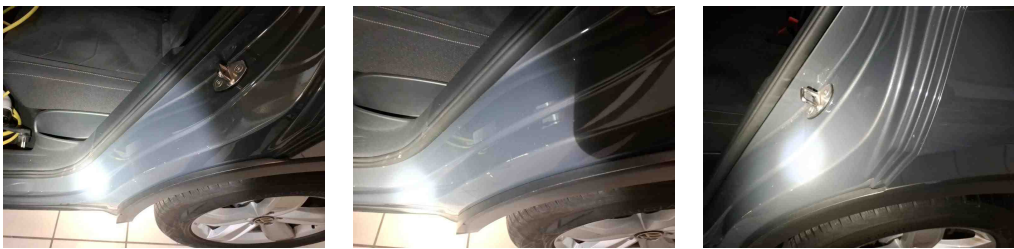
| Nr | Location | Damage type | Repair type |
|---|---|---|---|
| 7 | Inner door sill RL | Scratch(es) | Paint |

7 - Inner door sill RL - Scratch(es) - Paint

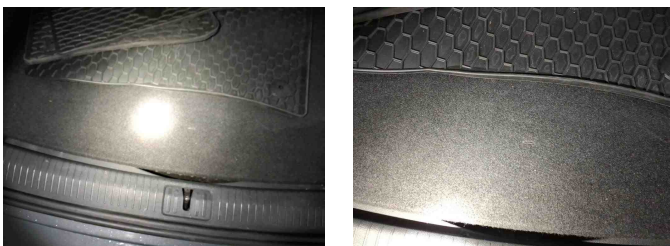
| Nr | Location | Damage type | Repair type |
|---|---|---|---|
| 8 | Boot carpet | Damaged | Replace |

8 - Boot carpet - Damaged - Replace

| Comment | Öse fehlt |

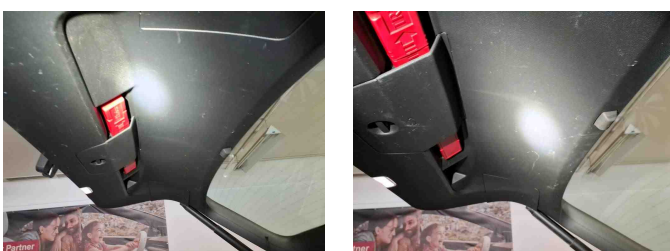
| Nr | Location | Damage type | Repair type |
|---|---|---|---|
| 9 | Boot lid covering R | Scratch(es) | Replace |

9 - Boot lid covering R - Scratch(es) - Replace

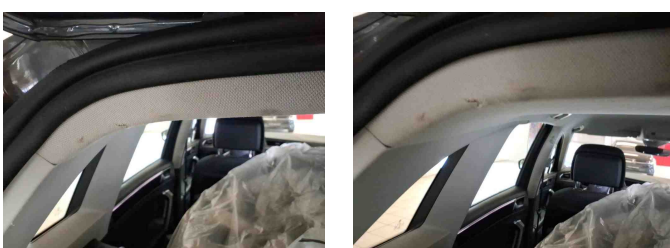
| Nr | Location | Damage type | Repair type |
|---|---|---|---|
| 10 | Roof liner | Scratch(es) | Smart repair |

10 - Roof liner - Scratch(es) - Smart repair
