Expertise

Protocol number: 46548624  
Order No. / Reference: 26604517  
Inspection date: 16 Jul 2026

Manufacturer: Mercedes-Benz

Model: C 200 d T 9G-TRONIC Avantgarde

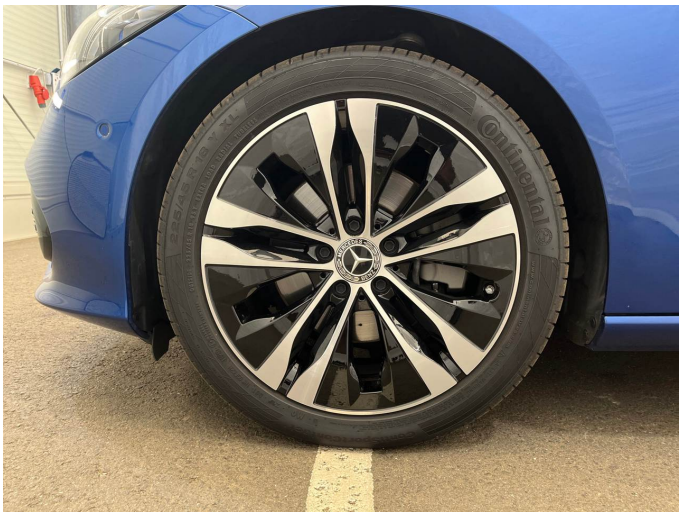
Figure 12: Mounted tyres

| # | Tyre size | Type of tyre | Manufacturer | Tread depth |
|---|---|---|---|---|
| 1) | 225/45 R18 95Y | Summer tyres on Light alloy | Continental | 7mm / 7mm |
| 2) | 245/40 R18 97Y | Summer tyres on Light alloy | Continental | 7mm / 7mm |

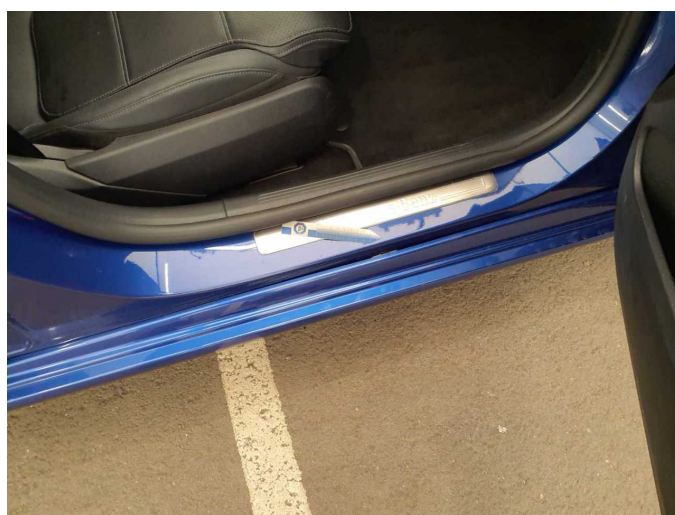
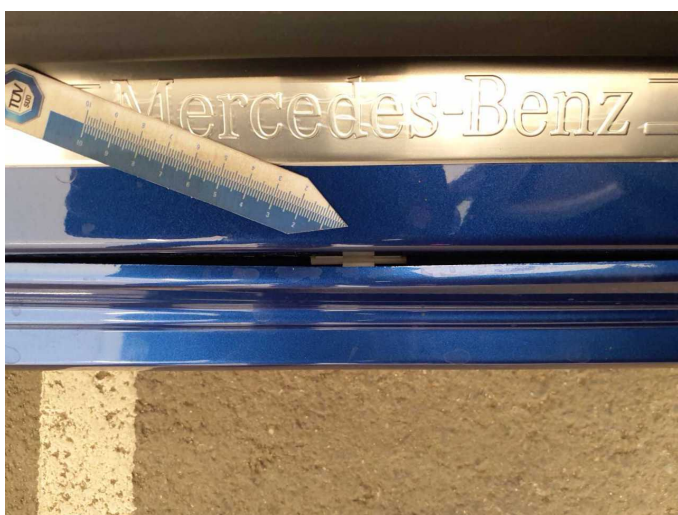
| Value reducing factors | | |
|---|---|---|
| 1 | Sill - right side | Trim - Malposition - Un- / install |

**Damage 1:** Sill - right side: Trim - Malposition - Un- / install

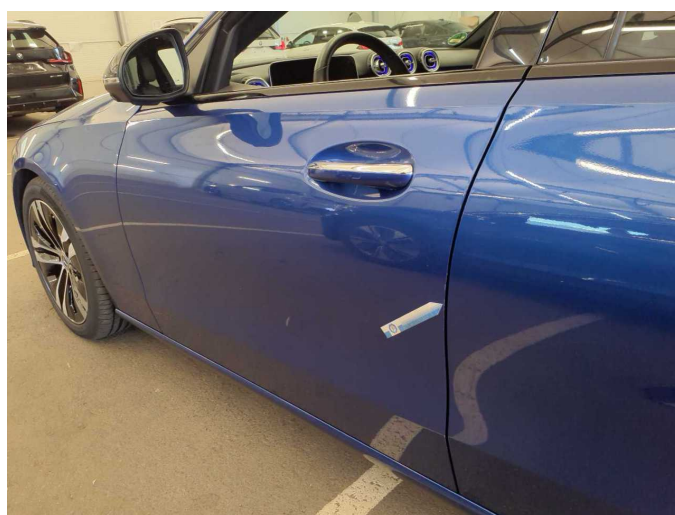
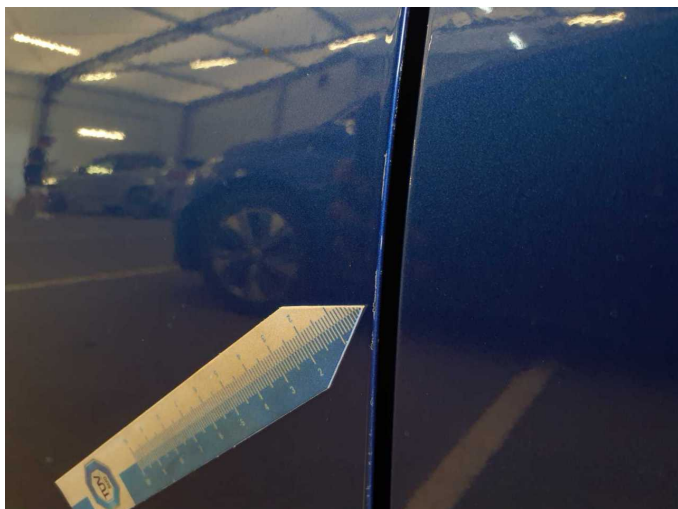
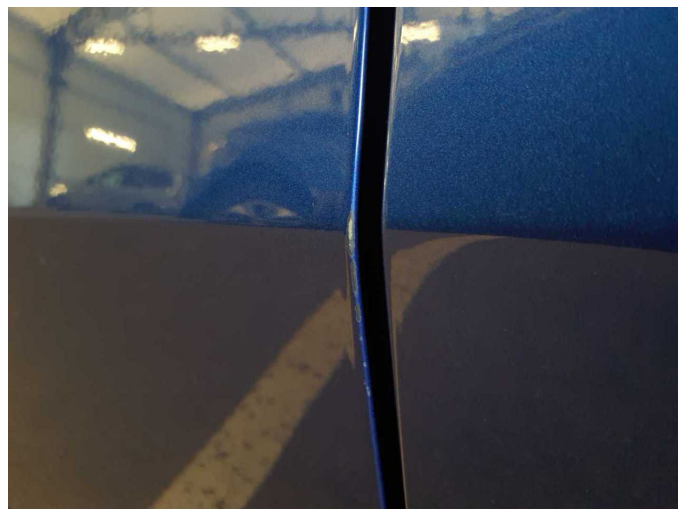
| Value reducing factors | | |
|---|---|---|
| 2 | Door - front left side | Door edge - Scratch(es) - Smart repair |

**Damage 2:** Door - front left side: Door edge - Scratch(es) - Smart repair

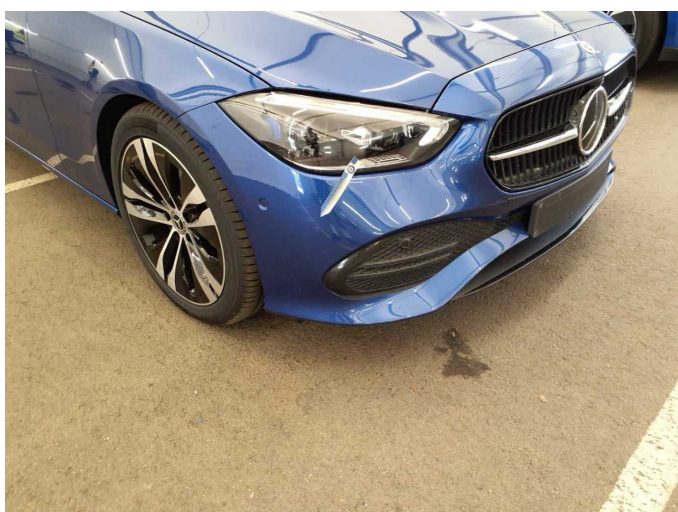
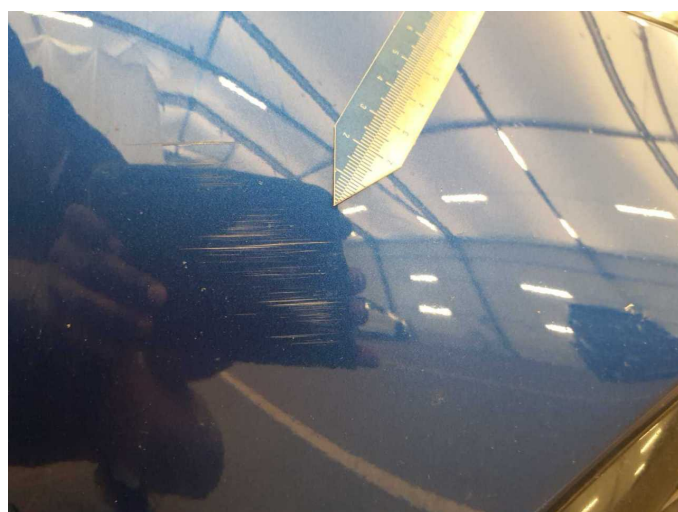
| Value reducing factors | | |
|---|---|---|
| 3 | Front bumper | Front bumper - Scratch(es) - Paint |

**Damage 3:** Front bumper: Front bumper - Scratch(es) - Paint

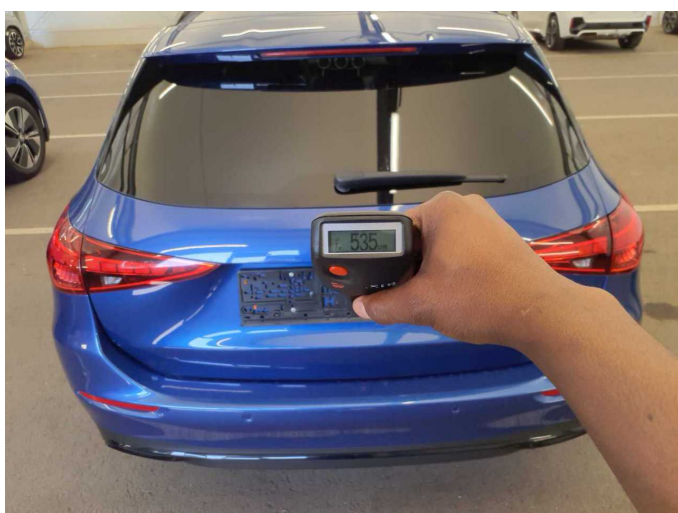
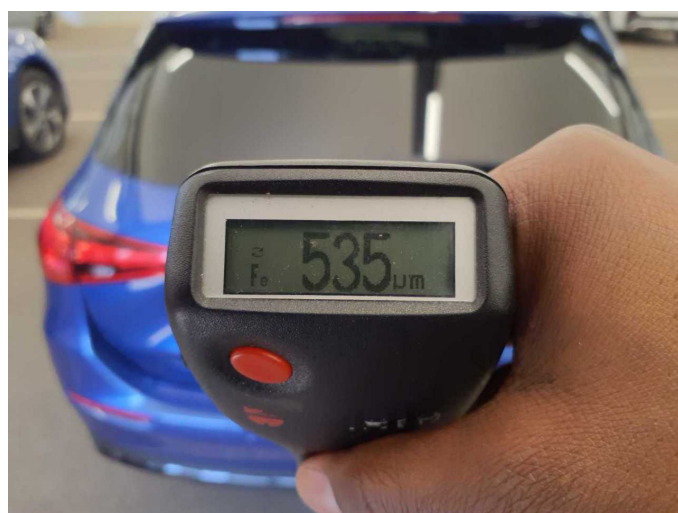
| Repainting | |
|---|---|
| 1 | Boot lid / rear door, Professionally carried out, Invoice of repair done Non-existent |

| Paint coat thickness measurement | | | |
|---|---|---|---|
| Boot lid / rear door | 535 µm | Door - rear right side | 216 µm |

**Repainting 1:** Boot lid / rear door

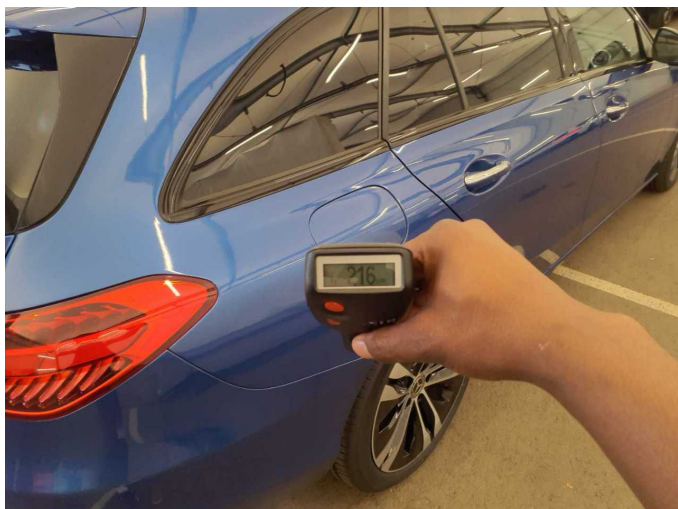
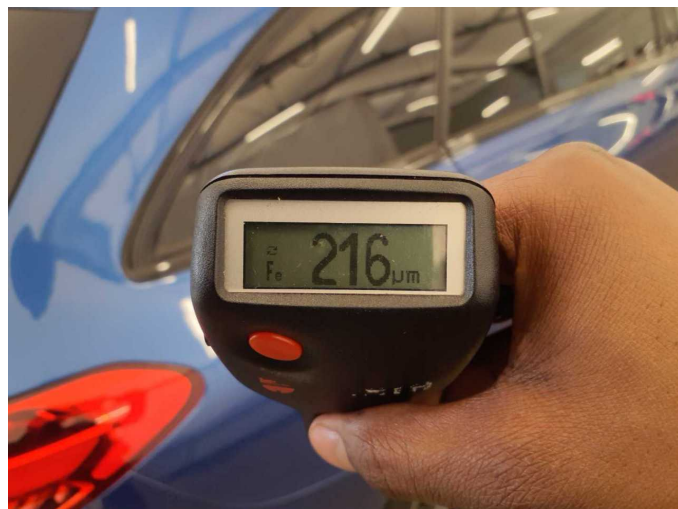
| Repainting | |
|---|---|
| 2 | Side panel - rear right side, Professionally carried out, Invoice of repair done Non-existent |

**Repainting 2:** Side panel - rear right side

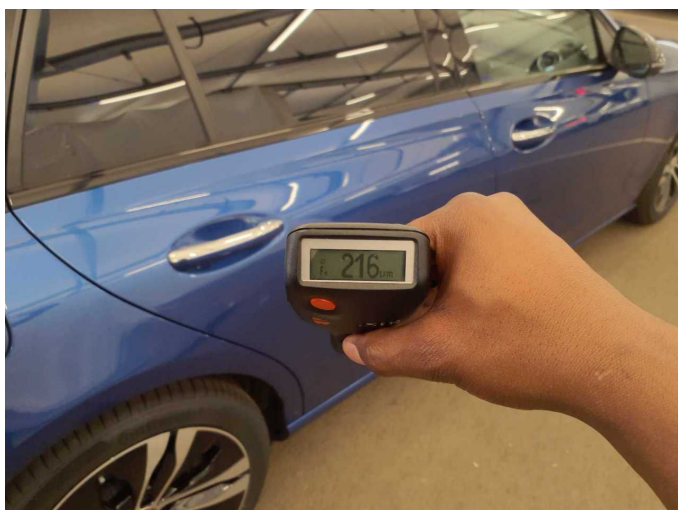
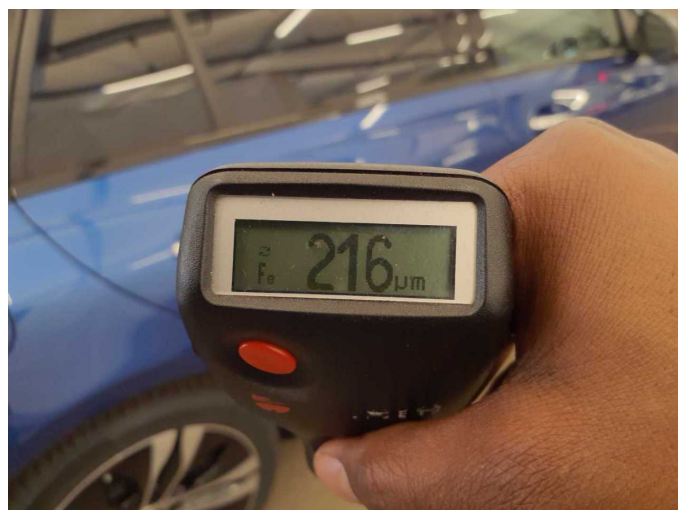
| Repainting | |
|---|---|
| 3 | Door - rear right side, Professionally carried out, Invoice of repair done Non-existent |

**Repainting 3:** Door - rear right side

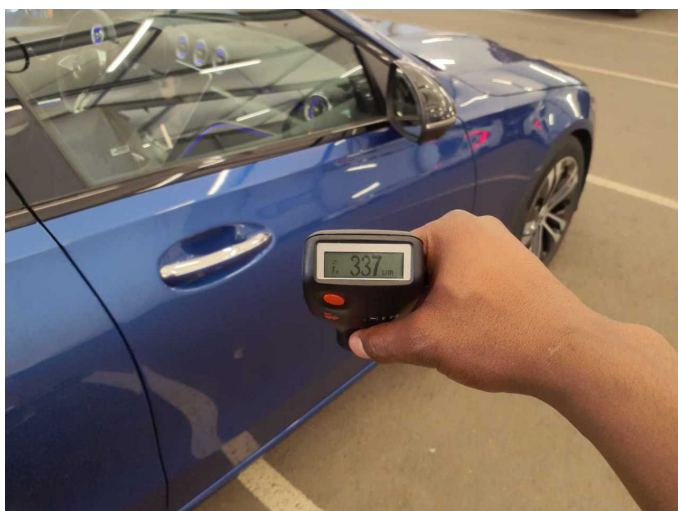
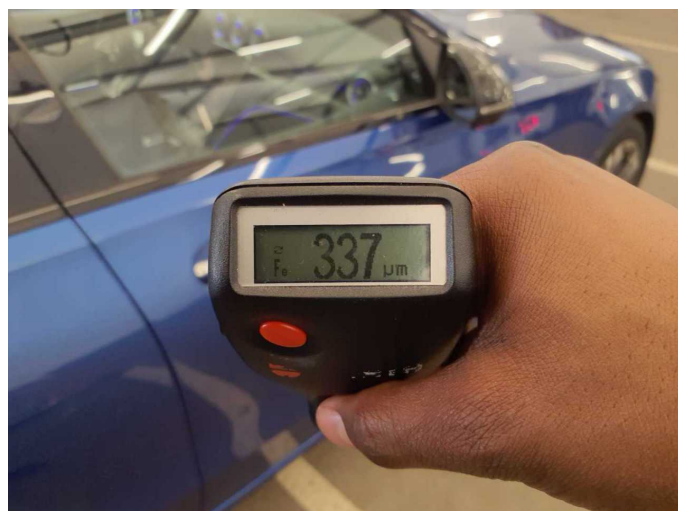
| Repainting | |
|---|---|
| 4 | Door - front right side, Professionally carried out, Invoice of repair done Non-existent |

| Paint coat thickness measurement | | | |
|---|---|---|---|
| Door - front right side | 337 µm | | |

**Repainting 4:** Door - front right side
